**NYC Department of Education**  
**Building Condition Assessment Survey 2023 - 2024**

Architectural Inspection

**K151**

**Asset:** P.S. 151 - BROOKLYN, 763 KNICKERBOCKER AVENUE, New York, 11207

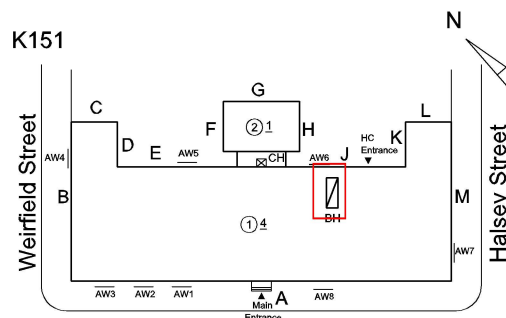
Question	Response
<b>EXTERIOR</b>	
<b>PARAPETS</b>	Inspected
Material Type(s)	Masonry
Replacement Quantity	4,500
Replacement Uom	C.F.
Instance on All Facades	Under Construction
Instance Quantity	4,500
Instance Quantity Uom	C.F.
<b>PLAZA DECK</b>	Does not Exist
<b>ROOF</b>	Inspected
<b>Roofing</b>	Inspected
Replacement Quantity	15,000
Replacement Uom	S.F.
<b>ROOF HATCH/SMOKE HATCH</b>	Does not Exist
<b>LEADERS, GUTTERS, DOWNSPOUTS, SCUPPERS</b>	Inspected
Condition	2 - Between Good and Fair
Deficiency	No deficiencies recorded
<b>ROOF BARRIER/FENCE</b>	Under Construction
<b>ROOF CAGE</b>	Does not Exist
<b>ROOFING</b>	Inspected
Instance on Built-Up: All Roofs	Under Construction
Instance Quantity	15,000
Instance Quantity Uom	S.F.
<b>ROOFING DRAINS</b>	Under Construction
<b>Specialties</b>	Inspected
<b>BULKHEAD/PENTHOUSE</b>	Inspected
Condition	3 - Fair
Deficiency	BULKHEAD/PENTHOUSE CEILING: PLASTER DAMAGED/DETERIORATED
Roof Plan reference

Deficiency Quantity	20
Quantity Uom	S.F.
Potential Action	REPLACE
Urgency of Action	PRIORITY 3
Purpose of Action	LEVEL 2

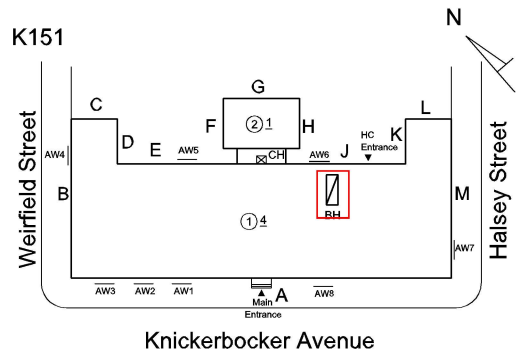
**BULKHEAD/PENTHOUSE WALLS/INTERIOR: PLASTER  
CRACKS/SPALLING**

REPLACE

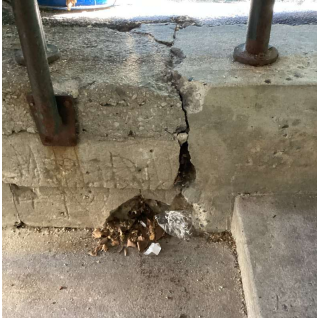
Question	Response
<b>EXTERIOR</b>	
<b>STAIRS/RAMPS: EXTERIOR</b>	
<b>BUILDING CHEEK/FLANK WALLS</b>	
Quantity Uom	S.F.
Potential Action	REPLACE
Urgency of Action	PRIORITY 4
Purpose of Action	LEVEL 2
Deficiency Photo1

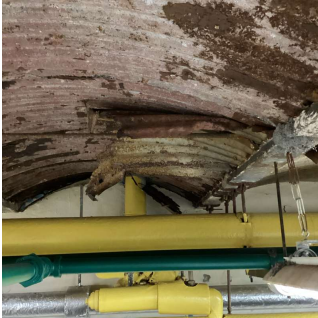
Question	Response
<b>INTERIOR</b>	
<b>STRUCTURAL</b>	
<b>COLUMNS/BEAMS/BEARING WALLS</b>	Inspected
Violations	Sub-basement - sprinkler main No violations recorded.
<b>FLOOR STRUCTURE</b>	Inspected
Condition	4 - Between Fair and Poor
Deficiency	CINDER CONCRETE ARCH: METAL PAN DETERIORATED, SPALLED
Deficiency Location/Instance	Oil Tank Room
Deficiency Quantity	20
Quantity Uom	S.F.
Potential Action	REPAIR
Urgency of Action	PRIORITY 5
Purpose of Action	LEVEL 6
Deficiency Photo1

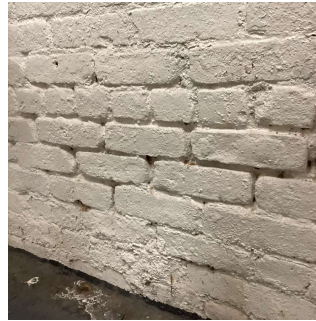
Sub-basement - Gas Meter Room

Violations	Sub-basement - Oil Tank Room No violations recorded.
Deficiency  Deficiency Location/Instance Deficiency Quantity Quantity Uom Potential Action Urgency of Action Purpose of Action	BRICK: DETERIORATED JOINTS  Sub-basement - Oil Tank Room, Gas Meter Room 200 S.F. REPOINT PRIORITY 4 LEVEL 5

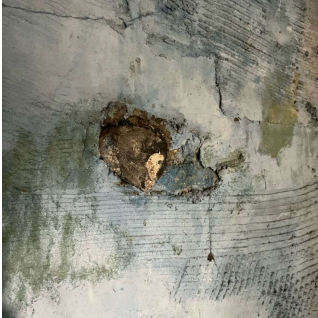
Question	Response
<b>INTERIOR</b>	
<b>STRUCTURAL</b>	
<b>FOUNDATION WALLS</b>	Inspected
Violations	No violations recorded.
<b>ROOF STRUCTURE</b>	Inspected
Condition	2 - Between Good and Fair
Deficiency	No deficiencies recorded
<b>VAULTS-BUNKERS</b>	Inspected
<b>Foundation Walls</b>	Inspected
Condition	3 - Fair
Deficiency	CRACKS, SPALLING
Deficiency Location/Instance	Ash Hoist Vault
Deficiency Quantity	10
Quantity Uom	S.F.
Potential Action	REPAIR
Urgency of Action	PRIORITY 4
Purpose of Action	LEVEL 5
Deficiency Photo1

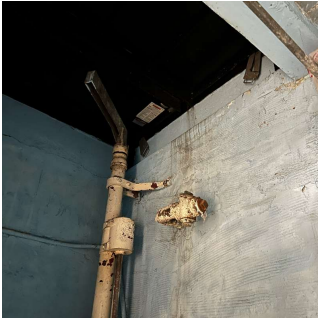
Violations	Ash Hoist Vault No violations recorded.
<b>Slab Structure</b>	Inspected
Condition	2 - Between Good and Fair
Deficiency	No deficiencies recorded
<b>Vault/Ash Hoist Doors and Framing</b>	Inspected
Condition	5 - Poor
Deficiency	WATER INFILTRATION
Deficiency Location/Instance	Ash Hoist Vault
Deficiency Quantity	10
Quantity Uom	S.F.
Potential Action	REPAIR
Urgency of Action	PRIORITY 5
Purpose of Action	LEVEL 2

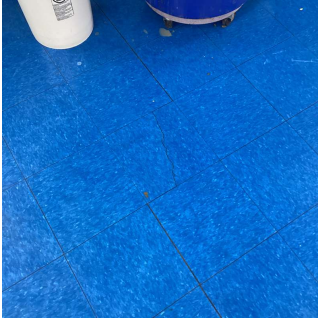
<b>Question</b>	<b>Response</b>
<b>INTERIOR</b>	
<b>CAFETERIA</b>	Inspected
<b>Door(s)</b>	
Violations	No violations recorded.
<b>Fixed Equipment</b>	
Instance on Basement	Does not Exist
<b>Floor Finish</b>	
Instance on Basement	Inspected
Condition	2 - Between Good and Fair
Deficiency	VINYL TILES: DETERIORATED SUBSTRATE
Deficiency Location/Instance	Center
Deficiency Quantity	10
Quantity Uom	S.F.
Potential Action	REPLACE
Urgency of Action	PRIORITY 3
Purpose of Action	LEVEL 2
Deficiency Photo1

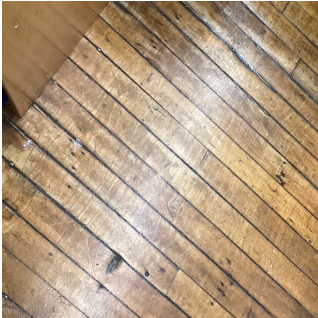
Room B06
Violations	No violations recorded.
<b>Floor Finish</b>	Inspected
Condition	3 - Fair
Deficiency	WOOD: DAMAGED/DETERIORATED
Deficiency Location/Instance	Rooms 201, 202, 301, 302, 303 and others
Deficiency Quantity	200
Quantity Uom	S.F.
Potential Action	REPLACE
Urgency of Action	PRIORITY 3
Purpose of Action	LEVEL 2
Deficiency Photo1

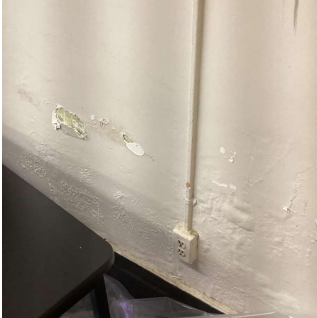
<b>Question</b>	<b>Response</b>
<b>INTERIOR</b>	
<b>CLASSROOMS/CORRIDORS/ADMIN SPACES</b>	
<b>Walls</b>	Inspected
Condition	2 - Between Good and Fair
Deficiency	PLASTER: CRACKS/SPALLING
Deficiency Location/Instance	Staff Lounge, Room 212
Deficiency Quantity	40
Quantity Uom	S.F.
Potential Action	REPLACE
Urgency of Action	PRIORITY 3
Purpose of Action	LEVEL 2
Deficiency Photo1

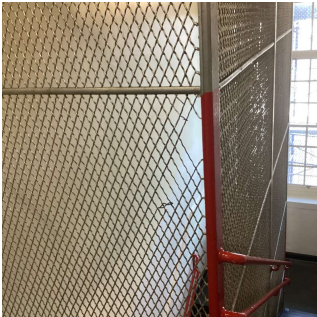
Violations	Staff Lounge No violations recorded.
<b>Specialties</b>	Does not Exist
<b>GYMNASIUM</b>	Does not Exist
<b>INTERIOR DOOR HARDWARE</b>	Inspected
Condition	3 - Fair
Deficiency	No deficiencies recorded
<b>INTERIOR GUARDS</b>	Inspected
Condition	3 - Fair
Deficiency	DETERIORATED/TORN-OUT/MISSING
Deficiency Location/Instance	Stairs D/3, F/Basement
Deficiency Quantity	75
Quantity Uom	S.F.
Potential Action	REPLACE
Urgency of Action	PRIORITY 3
Purpose of Action	LEVEL 2
Deficiency Photo1

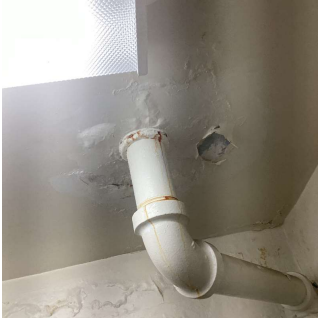
Question	Response
<b>INTERIOR</b>	
<b>KITCHEN</b>	
<b>Ceiling</b>	
Instance on Basement	Inspected
Condition	2 - Between Good and Fair
Deficiency	PLASTER: CRACKS/SPALLING - ACTIVE LEAK
Deficiency Location/Instance	Servery Storage, Servery
Deficiency Quantity	20
Quantity Uom	S.F.
Potential Action	REPLACE
Urgency of Action	PRIORITY 5
Purpose of Action	LEVEL 2
Deficiency Photo1

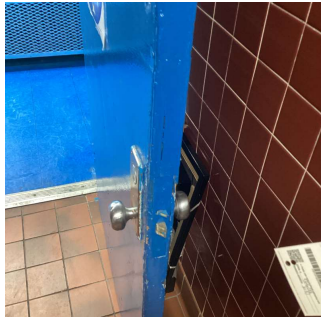
Servery
Violations	No violations recorded.
Deficiency	WOOD: DETERIORATED DOOR
Deficiency Location/Instance	Entrance, Kitchen Staff Locker Room, Storage Room
Deficiency Quantity	3
Quantity Uom	EACH
Potential Action	MAINTENANCE

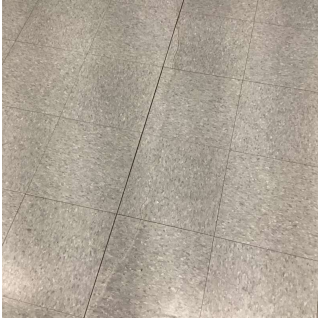
Question	Response
<b>INTERIOR</b>	
<b>MULTI-PURPOSE ROOM</b>	
<b>Floor Finish</b>	
Deficiency Location/Instance	Center, Storage Room
Deficiency Quantity	15
Quantity Uom	S.F.
Potential Action	REPLACE
Urgency of Action	PRIORITY 3
Purpose of Action	LEVEL 2
Deficiency Photo1

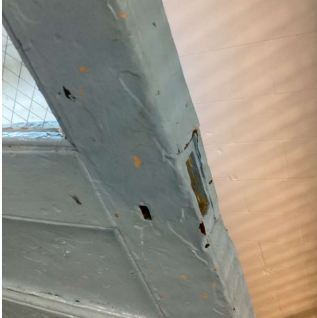
Violations	Perimeter No violations recorded.
<b>Window Curtains/Shades/Blinds</b>	
Instance on 2nd Floor	Inspected
Condition	2 - Between Good and Fair
Deficiency	No deficiencies recorded
Instance on Basement	Does not Exist
<b>SCIENCE DEMO ROOM</b>	Does not Exist
<b>SCIENCE LAB</b>	Does not Exist
<b>SCIENCE PREP ROOM</b>	Does not Exist
<b>SHOWER ROOM</b>	Does not Exist
<b>STAIRS/RAMPS: INTERIOR</b>	
Do Letter Stair Signs Exist?	Inspected Partially
<b>Ceiling</b>	
Condition	Inspected 2 - Between Good and Fair
Deficiency	No deficiencies recorded
<b>Door(s)</b>	
Condition	Inspected 4 - Between Fair and Poor
Deficiency	METAL CLAD WOOD: DETERIORATED DOOR
Deficiency Location/Instance	Stair C/3 (2 Doors) E/Basement
Deficiency Quantity	3
Quantity Uom	EACH
Potential Action	MAINTENANCE
Urgency of Action	PRIORITY 3
Purpose of Action	LEVEL 2

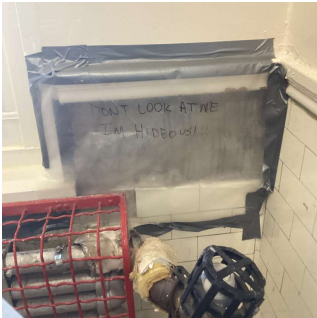
Violations	D/Basement No violations recorded.
<b>Walls</b>	Inspected
Condition	2 - Between Good and Fair
Deficiency	CERAMIC TILE: BROKEN/ MISSING
Deficiency Location/Instance	Stairs BC/2,3, D/Basement, F/Basement , G/3, and others
Deficiency Quantity	70
Quantity Uom	S.F.
Potential Action	REPLACE
Urgency of Action	PRIORITY 3
Purpose of Action	LEVEL 2
Deficiency Photo1

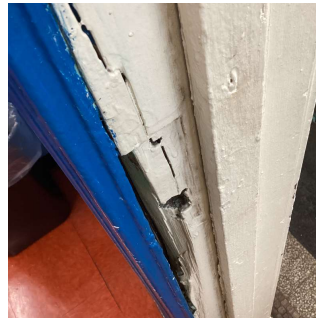
Deficiency	WOOD: DETERIORATED DOOR AND FRAME
Deficiency Location/Instance	3rd Floor Staff
Deficiency Quantity	1
Quantity Uom	EACH
Potential Action	MAINTENANCE
Urgency of Action	PRIORITY 3
Purpose of Action	LEVEL 2
Deficiency Photo1

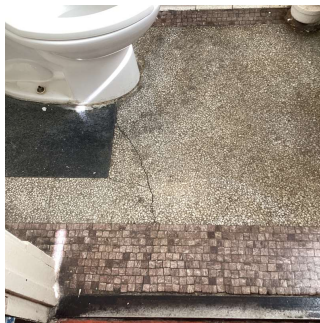
Deficiency	TERRAZZO: CRACKS
Deficiency Location/Instance	3rd Floor, 2nd Floor, 1st Floor
Deficiency Quantity	20
Quantity Uom	S.F.
Potential Action	REPLACE
Urgency of Action	PRIORITY 3
Purpose of Action	LEVEL 2

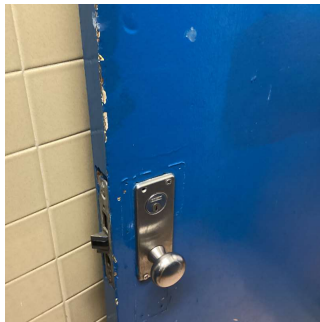
Violations	2nd Floor Boys No violations recorded.
<b>Floor Finish</b>	Inspected
Condition	3 - Fair
Deficiency	CERAMIC TILE: DETERIORATED SUBSTRATE
Deficiency Location/Instance	1st Floor, 2nd Floor
Deficiency Quantity	40
Quantity Uom	S.F.
Potential Action	REPLACE

Violations	3rd Floor Staff No violations recorded.
<b>Stalls</b>	Does not Exist
<b>Walls</b>	Inspected
Condition	2 - Between Good and Fair
Deficiency	No deficiencies recorded
<b>TOILET ROOMS - STUDENTS</b>	
<b>Ceiling</b>	Inspected
Condition	2 - Between Good and Fair
Deficiency	No deficiencies recorded
<b>Door(s)</b>	Inspected
Condition	5 - Poor
Deficiency	WOOD: DETERIORATED DOOR
Deficiency Location/Instance	2nd Floor Boys
Deficiency Quantity	1
Quantity Uom	EACH
Potential Action	MAINTENANCE
Urgency of Action	PRIORITY 3
Purpose of Action	LEVEL 2
Deficiency Photo1

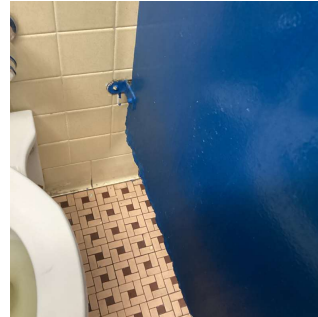
2nd Floor Boys

RUST - MAJOR

REPLACE

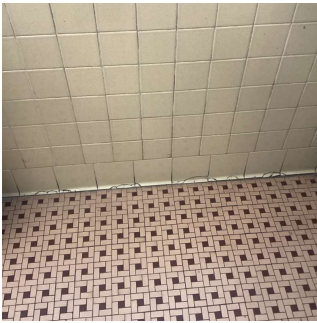
CERAMIC TILE: BROKEN/ MISSING

REPLACE

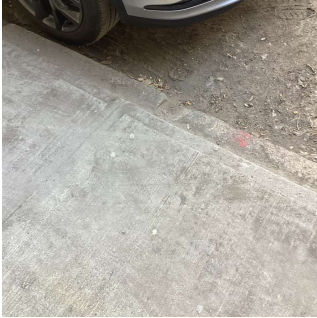
Question	Response
<b>SITE</b>	
<b>PAVING</b>	
<b>DOT Sidewalk</b>	
<b>Concrete</b>	
Condition	4 - Between Fair and Poor
Deficiency	DAMAGED CURBS
Deficiency Location/Instance	Weirfield Street, Knickerbocker Avenue, Hancock Street
Deficiency Quantity	80
Quantity Uom	L.F.
Potential Action	REPLACE
Urgency of Action	PRIORITY 4
Purpose of Action	LEVEL 4
Deficiency Photo1
