NYC Department of Education
Building Condition Assessment Survey 2023 - 2024

Architectural Inspection

Asset: P.S. 154 - BROOKLYN, 1625 11TH AVENUE, New York, 11215

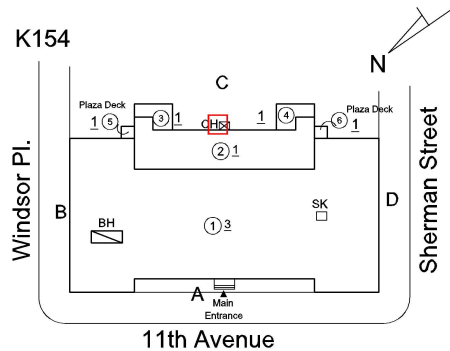
Question	Response
Architectural	
EXTERIOR	Inspected
AREAWAY	Does not Exist
AWNINGS AND CANOPIES	Does not Exist
CHIMNEY	Inspected
Material Type(s)	Masonry
Condition	3 - Fair

Deficiency
 Roof Plan reference
 BRICK: DETERIORATED JOINTS

Deficiency Quantity	20
Quantity Uom	S.F.
Potential Action	REPOINT
Urgency of Action	PRIORITY 4
Purpose of Action	LEVEL 2

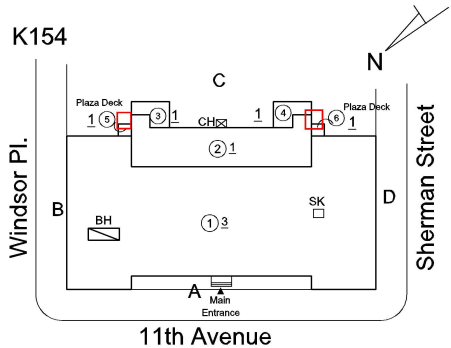
Violations	CH No violations recorded.
COPING	
Condition	Inspected
Deficiency	2 - Between Good and Fair No deficiencies recorded
CORNICE	
Condition	Inspected
Deficiency	2 - Between Good and Fair No deficiencies recorded
DOORS	
DOORS AND FRAMES	
Condition	Inspected
Deficiency	4 - Between Fair and Poor METAL: DETERIORATED DOOR AND FRAME - MAJOR DETERIORATION
Roof Plan reference

Deficiency Quantity	2
Quantity Uom	EACH
Potential Action	REPLACE
Urgency of Action	PRIORITY 4
Purpose of Action	LEVEL 2
Deficiency Photo1

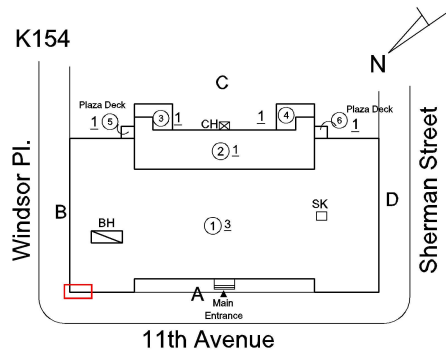
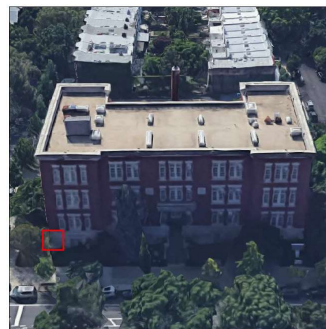
Question	Response
EXTERIOR	
DOORS	
DOOR HARDWARE	Inspected
Condition	3 - Fair
Deficiency	No deficiencies recorded
LINTELS	Inspected
Condition	2 - Between Good and Fair
Deficiency	No deficiencies recorded
TRANSOM/SIDE LIGHT	Does not Exist
EXTERIOR WALLS	Inspected
Material Type(s)	Masonry, Steel
Replacement Quantity	18,000
Replacement Uom	S.F.
Instance on All Facades	Inspected
Instance Condition	3 - Fair
Instance Quantity	18,000
Instance Quantity Uom	S.F.
Deficiency	STONE: CRACKS AT BUILDING CORNERS
Roof Plan reference

35
S.F.
REPLACE
PRIORITY 4
LEVEL 2

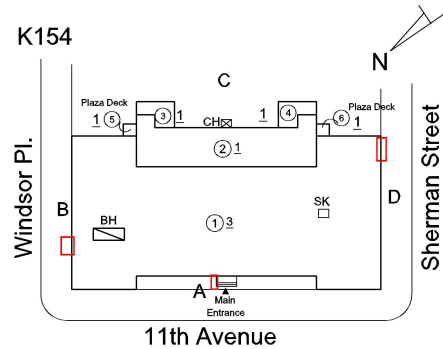
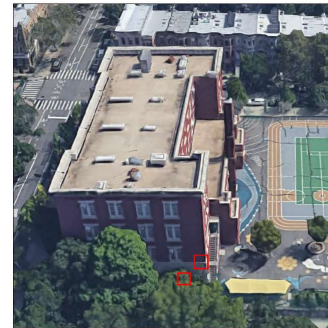
STONE: CHIPPED/SPALLED/BROKEN PIECES - MINOR

REPAIR

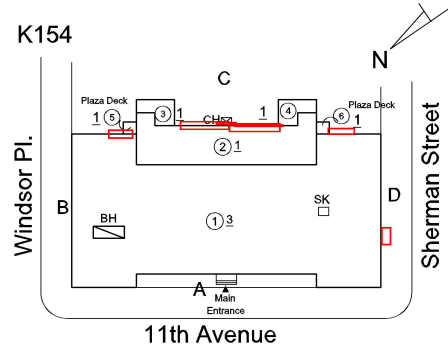
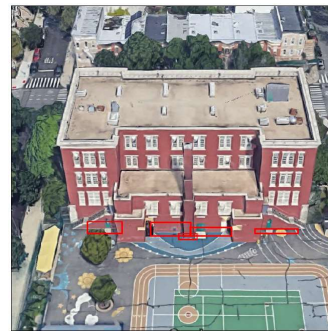
STONE: DETERIORATED JOINTS

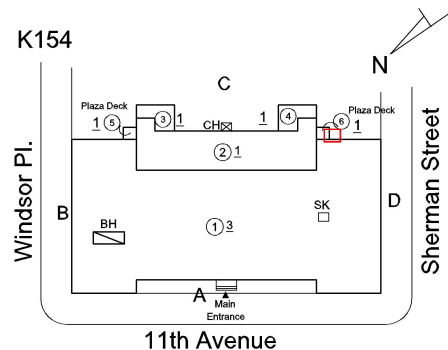
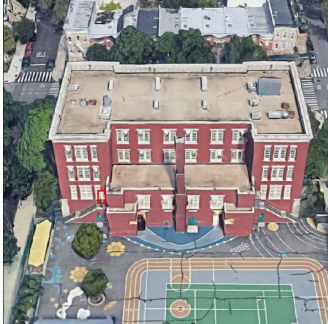
BRICK: DETERIORATED MASONRY SILLS - MINOR

Deficiency Quantity	10
Quantity Uom	L.F.
Potential Action	REPAIR
Urgency of Action	PRIORITY 3
Purpose of Action	LEVEL 2
Deficiency Photo1

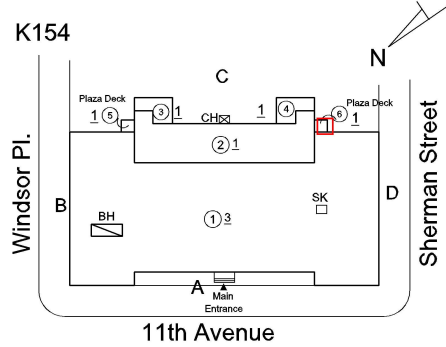
CONCRETE: MAJOR ACTIVE PLAZA DECK LEAKS IN INSTRUCTIONAL SPACE

REPLACE

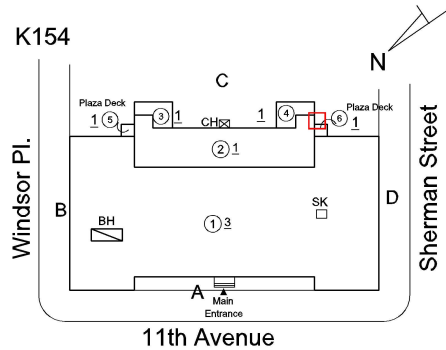
DAMAGED/MISSING

Question	Response
EXTERIOR	
ROOF	
Roofing	
LEADERS, GUTTERS, DOWNSPOUTS, SCUPPERS	
Potential Action	REPLACE
Urgency of Action	PRIORITY 4
Purpose of Action	LEVEL 2
Deficiency Photo1	 
Violations	Facade C No violations recorded.
ROOF BARRIER/FENCE	Inspected
Condition	2 - Between Good and Fair
Deficiency	No deficiencies recorded
ROOF CAGE	Does not Exist
ROOFING	Inspected
Instance on Built-Up: All Roofs	Inspected
Instance Condition	3 - Fair
Instance Photo	 
	Roof 1
Instance Quantity	14,000
Instance Quantity Uom	S.F.
Does the roof have major mechanical equipment sitting on Dunnage Steel less than 18" above the Roofing?	No
Does this roof instance have a Sustainable Roof System?	No
Do solar panels exist on these roofs?	No
Is/Are the roof(s) suitable for Solar Panel installation?	Yes
Installation Year	2015
Source of Installation	Custodial Staff
Deficiency	BUILT-UP: FLASHING: BASE FLASHING DETERIORATED

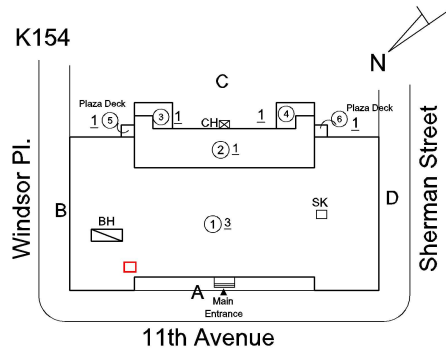
DETERIORATED

1
 EACH
 REPLACE
 PRIORITY 4
 LEVEL 2

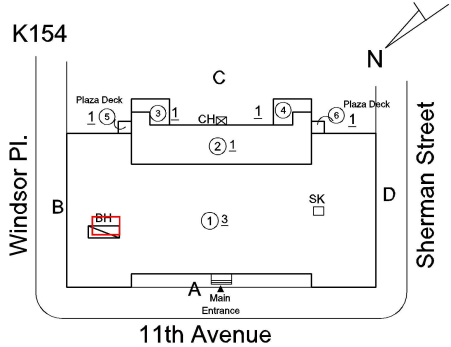
Violations	Roof 1 No violations recorded.
Specialties	Inspected
BULKHEAD/PENTHOUSE	Inspected
Condition	3 - Fair
Deficiency	BULKHEAD/PENTHOUSE WALLS/INTERIOR: PLASTER CRACKS/SPALLING
Roof Plan reference

Deficiency Quantity	15
Quantity Uom	S.F.
Potential Action	REPLACE
Urgency of Action	PRIORITY 3
Purpose of Action	LEVEL 2
Deficiency Photo1

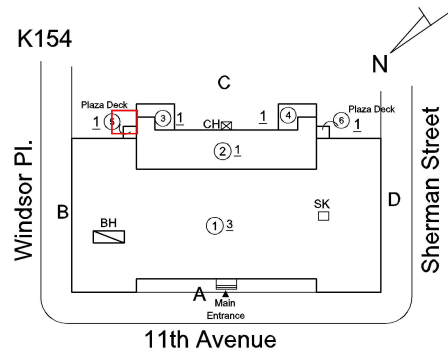
Question	Response
EXTERIOR	
ROOF	
Specialties	
BULKHEAD/PENTHOUSE	
Roof Plan reference	
Deficiency Quantity	25
Quantity Uom	S.F.
Potential Action	REPLACE
Urgency of Action	PRIORITY 4
Purpose of Action	LEVEL 2
Deficiency Photo1	
Violations	BH No violations recorded.
CUPOLA/ SPIRES/ TOWERS	Does not Exist
DORMER	Does not Exist
DUNNAGE STEEL	Does not Exist
SKYLIGHT/ROOF VENT	Inspected
Material Type(s)	Glass
Condition	2 - Between Good and Fair
Deficiency	No deficiencies recorded
ROOF/GRAVITY TANK	Does not Exist
STAIRS/RAMPS: EXTERIOR	Inspected
BUILDING CHEEK/FLANK WALLS	Inspected
Condition	2 - Between Good and Fair
Deficiency	No deficiencies recorded
RAILINGS	Inspected
Condition	2 - Between Good and Fair
Deficiency	No deficiencies recorded
STAIRS/RAMPS	Inspected
Condition	5 - Poor
Deficiency	CONCRETE: CRACKS/SPALLING - MAJOR

30
S.F.
REPLACE
PRIORITY 4
LEVEL 2

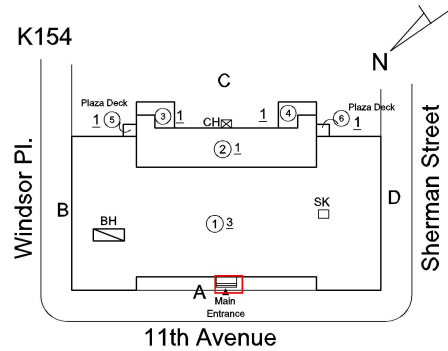
STONE: WATER INFILTRATION IN ELECTRICAL PANEL ROOM BELOW

100
S.F.
INSTALL NEW
PRIORITY 5
LEVEL 6

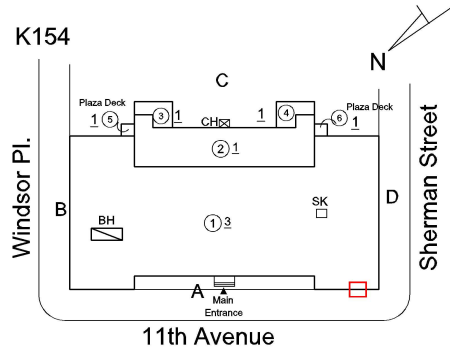
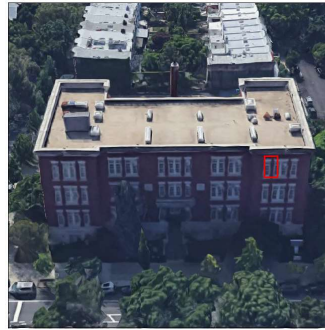
ALUMINUM - DOUBLE HUNG: DETERIORATED

30
S.F.
REPLACE WINDOW
PRIORITY 4
LEVEL 2

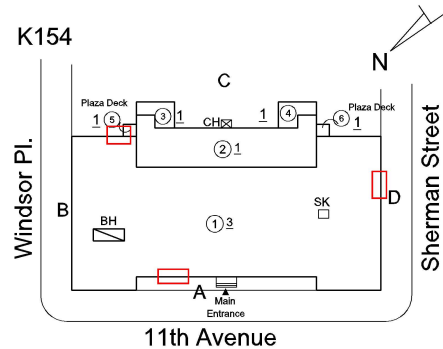
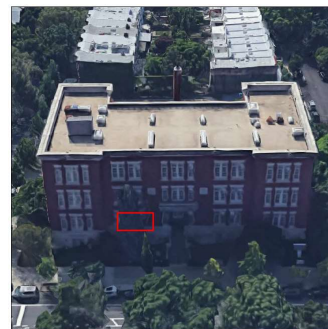
ALUMINUM - DOUBLE HUNG: INOPERABLE BALANCE

Question	Response
EXTERIOR	
WINDOWS	
WINDOWS	
Potential Action	REPLACE BALANCES
Urgency of Action	PRIORITY 3
Purpose of Action	LEVEL 2
Deficiency Photo1

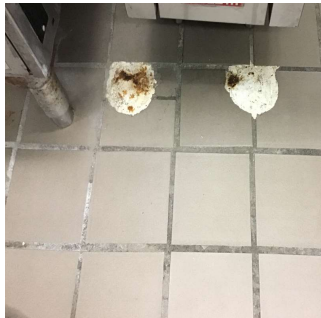
Question	Response
INTERIOR	
KITCHEN	
Ceiling	
Urgency of Action	PRIORITY 3
Purpose of Action	LEVEL 2
Deficiency Photo1	 
Violations	Near sink No violations recorded.
Door(s)	
Instance on Basement	Inspected
Condition	2 - Between Good and Fair
Deficiency	No deficiencies recorded
Floor Finish	
Instance on Basement	Inspected
Condition	2 - Between Good and Fair
Deficiency	QUARRY TILE: BROKEN/MISSING TILES
Deficiency Location/Instance	Near center, sink
Deficiency Quantity	10
Quantity Uom	S.F.
Potential Action	REPLACE
Urgency of Action	PRIORITY 3
Purpose of Action	LEVEL 2
Deficiency Photo1
