NYC Department of Education
Building Condition Assessment Survey 2023 - 2024

Architectural Inspection

Asset: P.S. 155 - BROOKLYN, 1355 HERKIMER STREET, New York, 11233

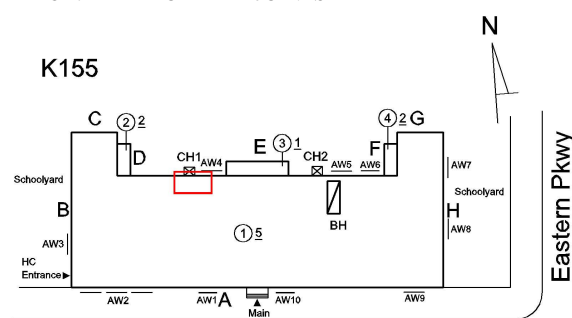
| Question | Response |
|---|--|
| Roof Plan reference | |

| Question | Response |
|---|--|
| Condition | 3 - Fair |
| Deficiency | BRICK: DETERIORATED JOINTS |

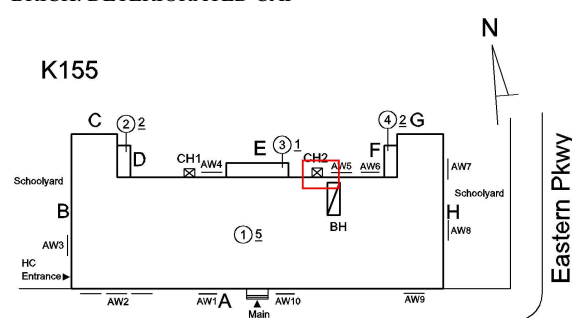
| Question | Response |
|---|--|
| Roof Plan reference | |

| Question | Response |
|---|--|
| BRICK: DETERIORATED CAP | |

| Question | Response |
|---|--|
| Potential Action | REPLACE |

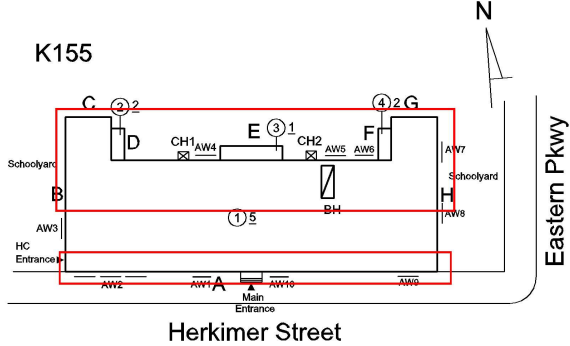
| Question | Response |
|---|--|
| Roof Plan reference | |

| Question | Response |
|---|--|
| Condition | Inspected 3 - Fair |
| Deficiency | CAST STONE: DETERIORATED TRANSVERSE JOINTS |

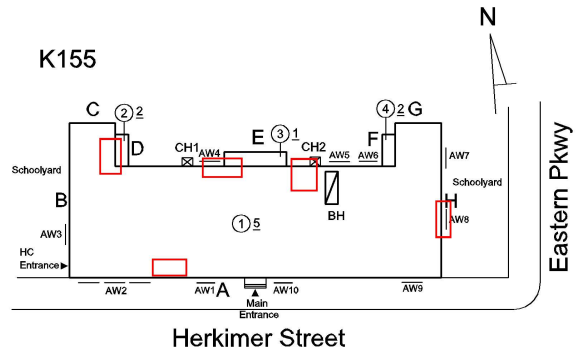
Roof Plan reference

| Question | Response |
|---|--|
| Deficiency | CAST STONE: CRACKED/BROKEN PIECES |

80
 L.F.
 REPLACE-IN-KIND
 PRIORITY 4
 LEVEL 2

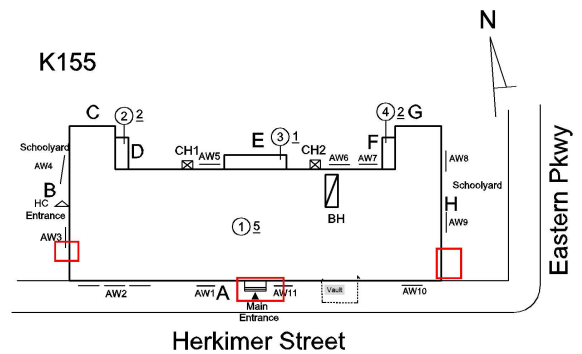
Roof Plan reference

METAL CLAD: DETERIORATED DOOR AND FRAME - MAJOR DETERIORATION

6
 EACH
 REPLACE
 PRIORITY 4
 LEVEL 2

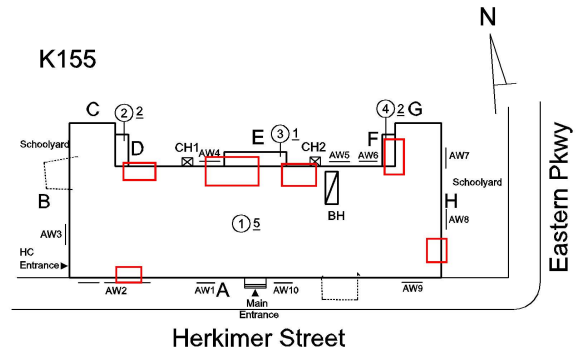
Roof Plan reference

| Question | Response |
|---|--|
| Deficiency | BRICK: MAJOR DETERIORATION/CRACKS |

100
 S.F.
 REMOVE AND REBUILD
 PRIORITY 4
 LEVEL 2

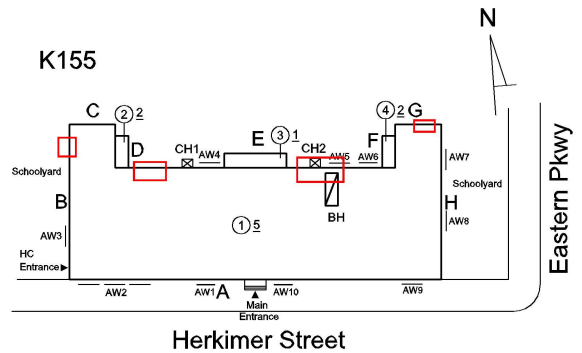
Roof Plan reference

BRICK: MINOR CRACKS, SPALLING

50
 S.F.
 REPAIR
 PRIORITY 3
 LEVEL 2

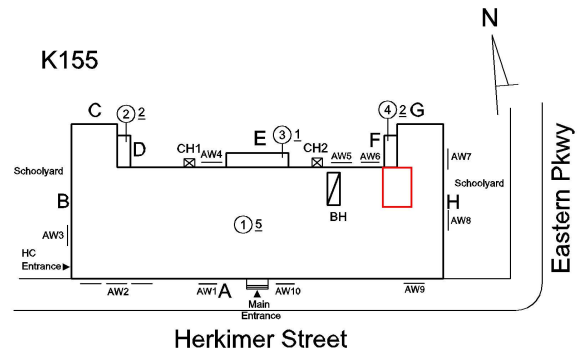
Roof Plan reference

| Condition | 5 - Poor |

| Deficiency | CLOGGED |

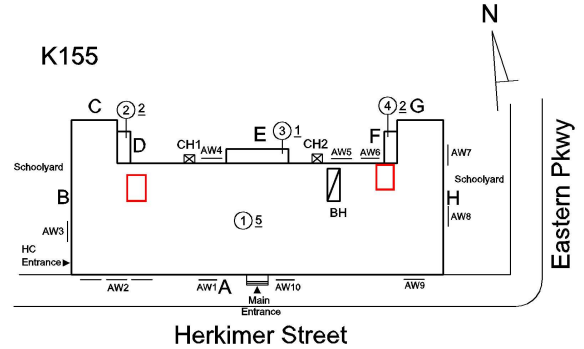
Roof Plan reference

DETERIORATED

REPLACE

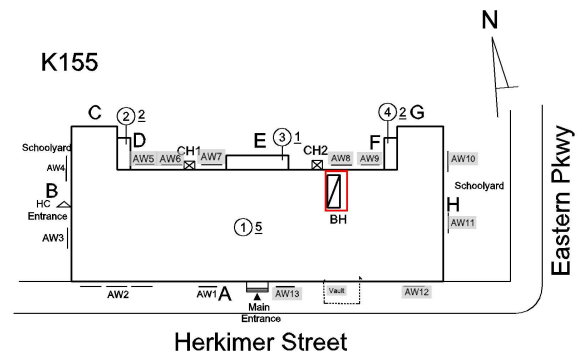
Roof Plan reference

BULKHEAD/PENTHOUSE WALLS/EXTERIOR: DAMAGED METAL SIDING

REPLACE

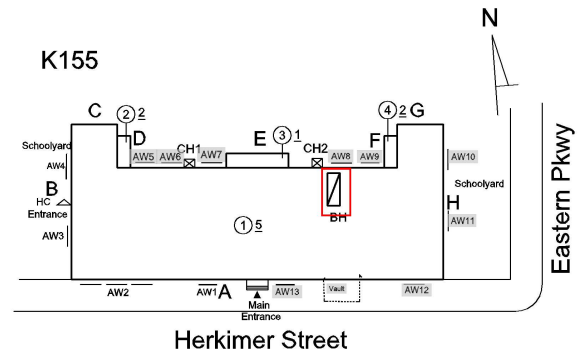
Roof Plan reference

BULKHEAD/PENTHOUSE WALLS/INTERIOR: PLASTER CRACKS/SPALLING

REPLACE

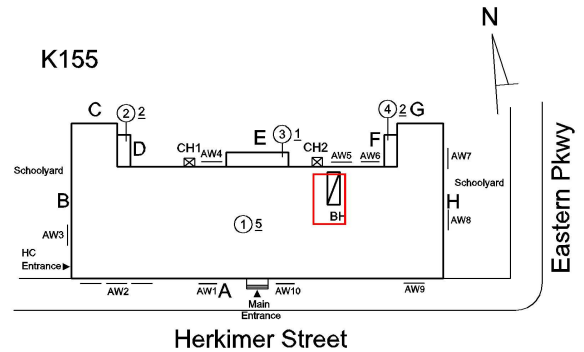
Roof Plan reference

BULKHEAD/PENTHOUSE WINDOWS: DAMAGED, DETERIORATED WINDOWS

30
S.F.
REPLACE
PRIORITY 4
LEVEL 2

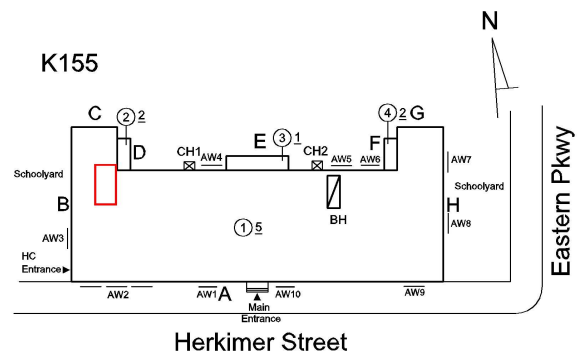
Roof Plan reference

HEIGHT LESS THAN 18"

30
L.F.
REPLACE
PRIORITY 3
LEVEL 2

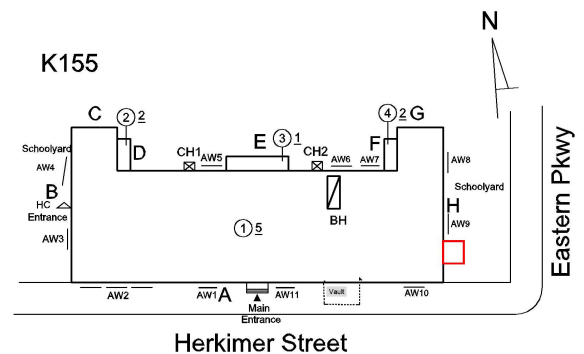
Roof Plan reference

STONE: CRACKS/SPALLING - MINOR

REPAIR

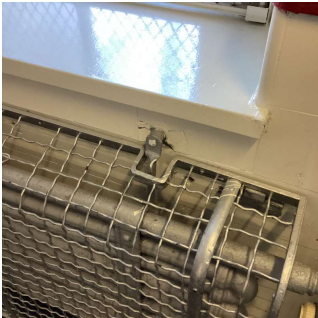
| Question | Response |
|---|--|
| Urgency of Action | PRIORITY 3 |
| Violations | Stair B/2 No violations recorded. |

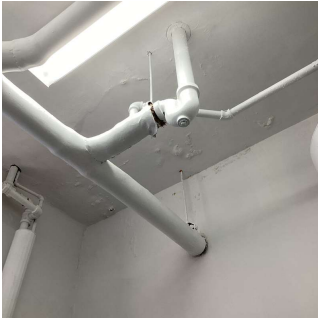
| Question | Response |
|---|--|
| Condition | 2 - Between Good and Fair |
| Deficiency | PLASTER: CRACKS/SPALLING |
| Deficiency Location/Instance | 1st Floor Staff |
| Deficiency Quantity | 10 |

| Question | Response |
|---|--|
| Potential Action | REPLACE |

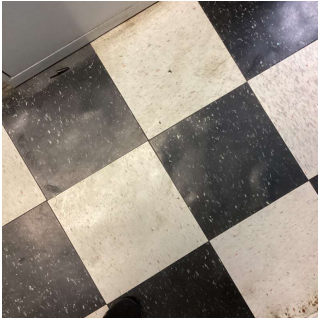
| Question | Response |
|---|--|
| Deficiency | VINYL TILES: DETERIORATED SUBSTRATE |
| Deficiency Location/Instance | Kitchen Staff Toilet |
| Deficiency Quantity | 10 |

| Question | Response |
|---|--|
| Potential Action | REPLACE |

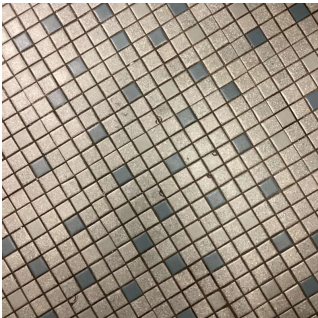
| Question | Response |
|---|--|
| Deficiency | CERAMIC TILE: BROKEN/MISSING TILES |
| Deficiency Location/Instance | Room 402A, Nurse Office |
| Deficiency Quantity | 10 |

| Question | Response |
|---|--|
| Potential Action | REPLACE |

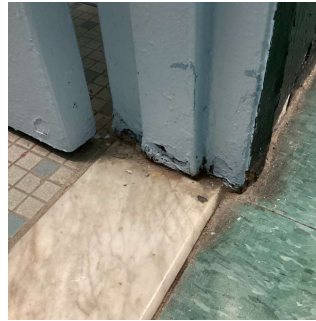
| Question | Response |
|---|--|
| Condition | 3 - Fair |
| Deficiency | METAL: DETERIORATED DOOR AND FRAME |
| Deficiency Location/Instance | Multi-Purpose Room Boys |

Multi-Purpose Room Boys
No violations recorded.

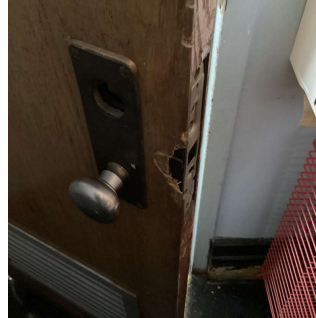
WOOD: DETERIORATED DOOR

In Room 112
No violations recorded.

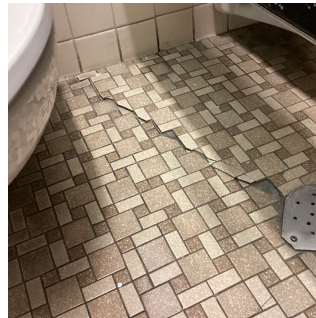
CERAMIC TILE: DETERIORATED SUBSTRATE

| Question | Response |
|---|--|
| Violations | In Room 111 No violations recorded. |

REPLACE

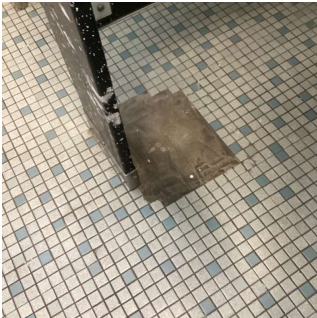
| Question | Response |
|---|--|
| Deficiency | CERAMIC TILE: BROKEN/MISSING TILES |
| Deficiency Location/Instance | Rooms 302, 402B, 414, In Rooms 102, 112, Cafeteria Girls |
| Deficiency Quantity | 120 |

| Question | Response |
|---|--|
| Potential Action | REPLACE |

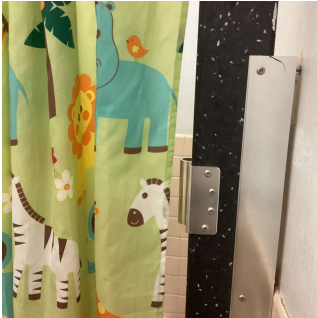
| Question | Response |
|---|--|
| Condition | 2 - Between Good and Fair |
| Deficiency | BROKEN/MISSING |
| Deficiency Location/Instance | In Room 111 |

| Question | Response |
|---|--|
| Potential Action | REPLACE |

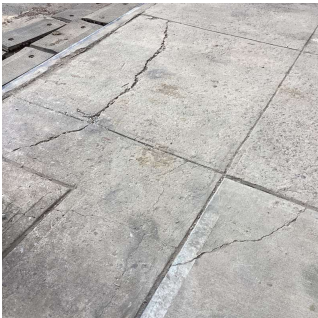
| Question | Response |
|---|--|
| Condition | 4 - Between Fair and Poor |
| Violations | Herkimer Street No violations recorded. |
