NYC Department of Education
Building Condition Assessment Survey 2023 - 2024

Architectural Inspection

Asset: P.S. 160 - BROOKLYN, 5105 FORT HAMILTON PARKWAY, New York, 11219

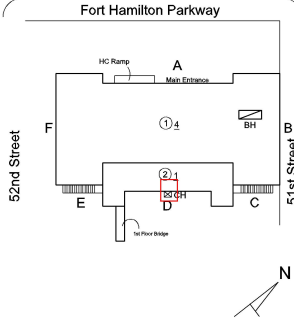
Question	Response
Architectural	
EXTERIOR	Inspected
AREAWAY	Does not Exist
AWNINGS AND CANOPIES	Does not Exist
CHIMNEY	Inspected
Material Type(s)	Masonry
Condition	3 - Fair
Deficiency	BRICK: DETERIORATED JOINTS
Roof Plan reference	K160

Deficiency Quantity	60
Quantity Uom	S.F.
Potential Action	REPOINT
Urgency of Action	PRIORITY 3
Purpose of Action	LEVEL 2

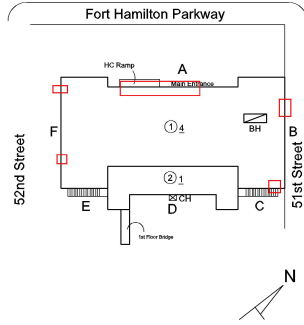
Violations	Roof 1 No violations recorded.
CORNICE	
Condition	Inspected 2 - Between Good and Fair
Deficiency	No deficiencies recorded
DOORS	
Inspected	
DOORS AND FRAMES	
Condition	Inspected 5 - Poor
Deficiency	METAL CLAD: DETERIORATED DOOR AND FRAME - MAJOR DETERIORATION

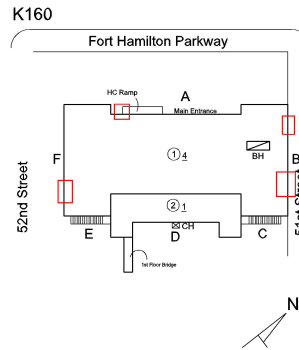
DOORS AND FRAMES

4
EACH
REPLACE
PRIORITY 4
LEVEL 2

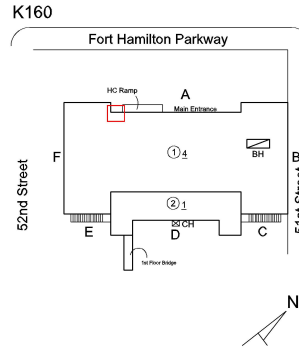
Deficiency METAL: AIR/WATER INFILTRATION, DETERIORATED JOINTS WITH DAMAGED CAULKING

25
L.F.
MAINTENANCE
PRIORITY 3
LEVEL 2

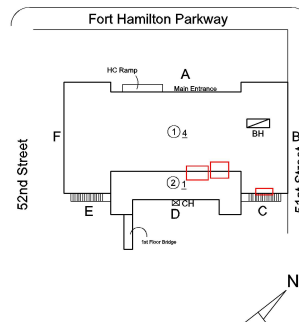
BRICK: WATER INFILTRATION IN INSTRUCTIONAL SPACE

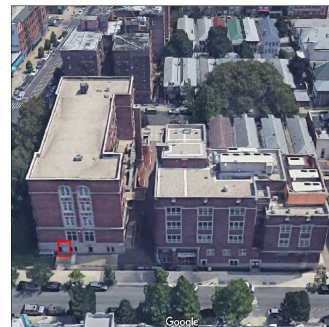
STONE: CHIPPED/SPALLED/BROKEN PIECES - MAJOR

10

REPLACE

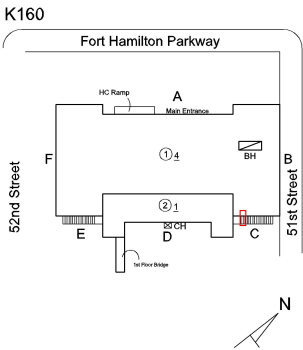
Question	Response
EXTERIOR	
EXTERIOR WALLS	
Urgency of Action	PRIORITY 4
Purpose of Action	LEVEL 2
Deficiency Photo1	 
Violations	Facade F No violations recorded.
EXTERIOR SOFFITS	Inspected
Condition	2 - Between Good and Fair
Deficiency	No deficiencies recorded
LOADING DOCK	Does not Exist
LOUVER	Inspected
Condition	2 - Between Good and Fair
Deficiency	No deficiencies recorded
PARAPETS	Inspected
Material Type(s)	Masonry
Replacement Quantity	3,000
Replacement Uom	C.F.
Instance on All Roofs	Inspected
Instance Condition	2 - Between Good and Fair
Instance Quantity	3,000
Instance Quantity Uom	C.F.
Deficiency	No deficiencies recorded
PLAZA DECK	Does not Exist
ROOF	Inspected
Roofing	Inspected
Replacement Quantity	13,700
Replacement Uom	S.F.
ROOF HATCH/SMOKE HATCH	Does not Exist
LEADERS, GUTTERS, DOWNSPOUTS, SCUPPERS	Inspected
Condition	3 - Fair
Deficiency	DAMAGED/MISSING

Deficiency Quantity	20
Quantity Uom	L.F.
Potential Action	REPLACE
Urgency of Action	PRIORITY 4
Purpose of Action	LEVEL 2
Deficiency Photo1

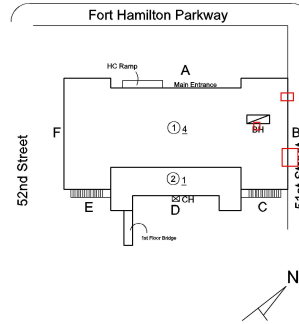
BUILT-UP: FLASHING: DETERIORATED JOINTS
K160

20
L.F.
MAINTENANCE
PRIORITY 3
LEVEL 2

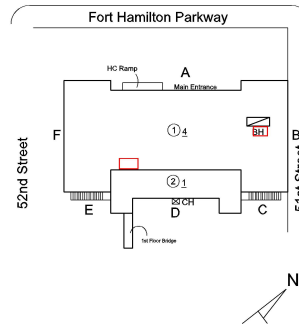
BUILT-UP: ROOFING: LOSS OF GRAVEL
K160

10
S.F.
INSTALL NEW GRAVEL
PRIORITY 3
LEVEL 2

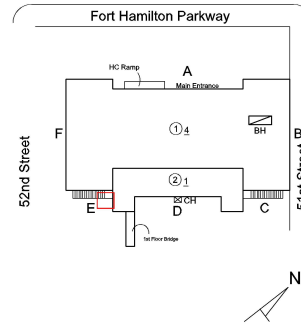
BRICK: DETERIORATED JOINTS

10

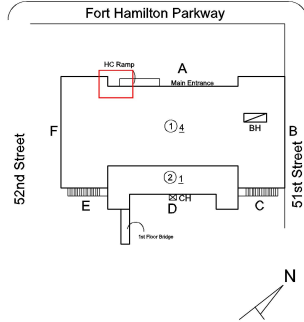
Violations	Facade A No violations recorded.
RAILINGS	
Condition	Inspected 5 - Poor
Deficiency	RUST - MAJOR
Roof Plan reference	K160

Deficiency Quantity	35
Quantity Uom	L.F.
Potential Action	REPLACE
Urgency of Action	PRIORITY 4
Purpose of Action	LEVEL 2
Deficiency Photo1

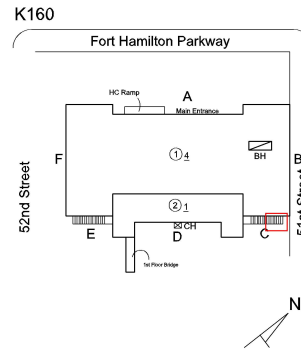
Violations	Facade A No violations recorded.
STAIRS/RAMPS	
Condition	Inspected 4 - Between Fair and Poor
Deficiency	CONCRETE: WORN-OUT TREAD/RISER/NOSING

10
S.F.
REPLACE
PRIORITY 4
LEVEL 2

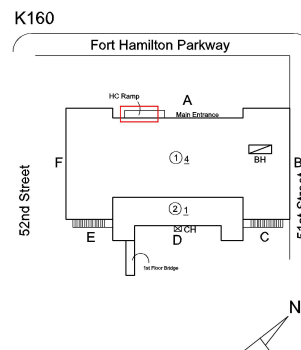
CONCRETE: CRACKS/SPALLING - MAJOR

10
S.F.
REPLACE
PRIORITY 4
LEVEL 2

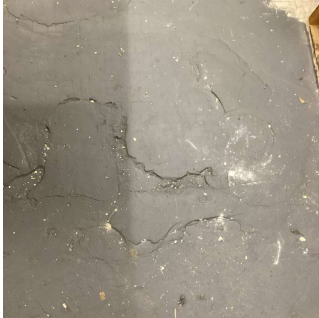
Violations	Basement - Gas Meter Room No violations recorded.
Deficiency	CONCRETE SLAB ON GRADE: THRU CRACKS
Deficiency Location/Instance	Basement - Boiler Room, Room B3
Deficiency Quantity	90
Quantity Uom	S.F.
Potential Action	REPLACE
Urgency of Action	PRIORITY 4
Purpose of Action	LEVEL 5
Deficiency Photo1

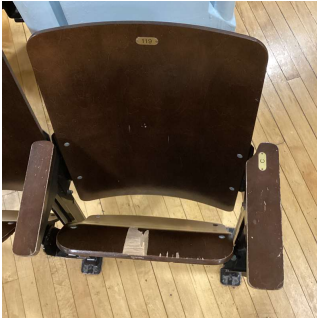
Question	Response
INTERIOR	
AUDITORIUM	
Fixed H/C Lift	
Instance on 1st Floor (509 Seats)	Does not Exist
Fixed Seating	
Instance on 1st Floor (509 Seats)	Inspected
Condition	2 - Between Good and Fair
Deficiency	DAMAGED/BROKEN/INOPERABLE
Deficiency Location/Instance	Seat C/119
Deficiency Quantity	1
Quantity Uom	EACH
Potential Action	REPLACE
Urgency of Action	PRIORITY 3
Purpose of Action	LEVEL 2
Deficiency Photo1

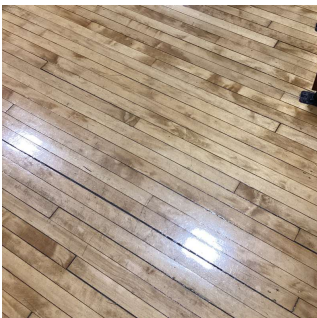
Near Stage
Violations	No violations recorded.
Sliding-folding Partition	
Instance on 1st Floor (509 Seats)	Does not Exist
Stage	
Instance on 1st Floor (509 Seats)	Inspected

Seat C/119
Violations	No violations recorded.
Floor Finish	
Instance on 1st Floor (509 Seats)	Inspected
Condition	2 - Between Good and Fair
Deficiency	WOOD: DAMAGED/DETERIORATED
Deficiency Location/Instance	Near Stage
Deficiency Quantity	10
Quantity Uom	S.F.
Potential Action	REPLACE
Urgency of Action	PRIORITY 3
Purpose of Action	LEVEL 2
Deficiency Photo1

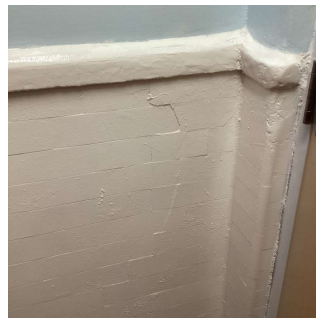
Instance on 1st Floor (509 Seats)	Inspected
Condition	2 - Between Good and Fair
Deficiency	CERAMIC TILE: BROKEN/ MISSING
Deficiency Location/Instance	Exit 6 Vestibule
Deficiency Quantity	10
Quantity Uom	S.F.
Potential Action	REPLACE
Urgency of Action	PRIORITY 3
Purpose of Action	LEVEL 2
Deficiency Photo1

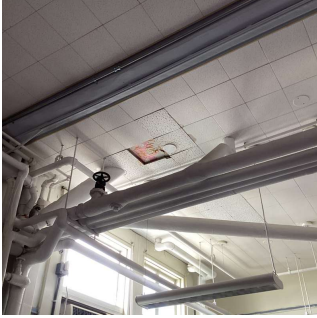
Room 309
Violations	No violations recorded.
Deficiency	PLASTER: CRACKS/SPALLING
Deficiency Location/Instance	Rooms 409, 306, 206
Deficiency Quantity	60
Quantity Uom	S.F.
Potential Action	REPLACE
Urgency of Action	PRIORITY 3
Purpose of Action	LEVEL 2
Deficiency Photo1

Question	Response
INTERIOR	
CAFETERIA	Inspected
Window Curtains/Shades/Blinds	
Instance on Basement	Does not Exist
CLASSROOMS/CORRIDORS/ADMIN SPACES	
Ceiling	Inspected
Condition	2 - Between Good and Fair
Deficiency	ACOUSTIC TILES ON PLASTER: DAMAGED/MISSING
Deficiency Location/Instance	Room 309
Deficiency Quantity	20
Quantity Uom	S.F.
Potential Action	REPLACE
Urgency of Action	PRIORITY 3
Purpose of Action	LEVEL 2
Deficiency Photo1

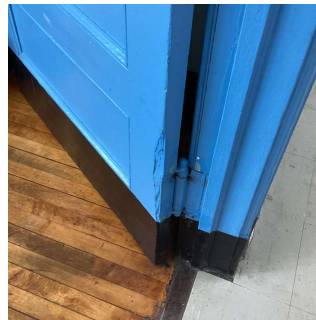
Room 404B

WOOD: DETERIORATED DOOR

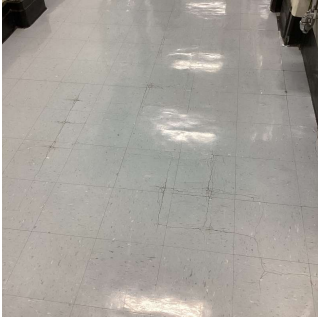
Question	Response
INTERIOR	
CLASSROOMS/CORRIDORS/ADMIN SPACES	
Door(s)	Inspected Room 401
Violations	No violations recorded.
Floor Finish	Inspected
Condition	3 - Fair
Deficiency	VINYL TILES: BROKEN/DETERIORATED/MISSING TILES
Deficiency Location/Instance	Rooms 401, 208, 207, 203, 201and others
Deficiency Quantity	900
Quantity Uom	S.F.
Potential Action	REPLACE
Urgency of Action	PRIORITY 3
Purpose of Action	LEVEL 2
Deficiency Photo1	No photo recorded
Violations	No violations recorded.
Deficiency	VINYL TILES: DETERIORATED SUBSTRATE
Deficiency Location/Instance	Corridor near Rooms 407, 405, 405B, 404A, 309 and others
Deficiency Quantity	1,600
Quantity Uom	S.F.
Potential Action	REPLACE
Urgency of Action	PRIORITY 3
Purpose of Action	LEVEL 2
Deficiency Photo1

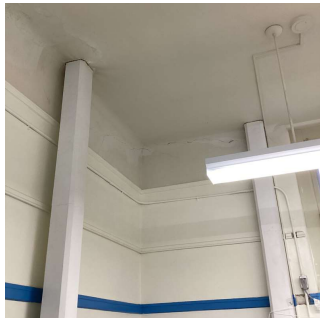
Question	Response
INTERIOR	
CLASSROOMS/CORRIDORS/ADMIN SPACES	
Floor Finish	Inspected
	Room 404B
Violations	No violations recorded.
Walls	Inspected
Condition	2 - Between Good and Fair
Deficiency	PLASTER: CRACKS/SPALLING
Deficiency Location/Instance	Rooms 410, 407, 406, 306, 203 and others
Deficiency Quantity	200
Quantity Uom	S.F.
Potential Action	REPLACE
Urgency of Action	PRIORITY 3
Purpose of Action	LEVEL 2
Deficiency Photo1

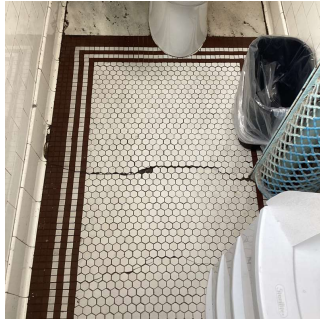
Room 314A
Violations	No violations recorded.
Floor Finish	Inspected
Condition	3 - Fair
Deficiency	CERAMIC TILE: BROKEN/MISSING TILES
Deficiency Location/Instance	Rooms 314A, 214A
Deficiency Quantity	20
Quantity Uom	S.F.
Potential Action	REPLACE
Urgency of Action	PRIORITY 3
Purpose of Action	LEVEL 2
Deficiency Photo1

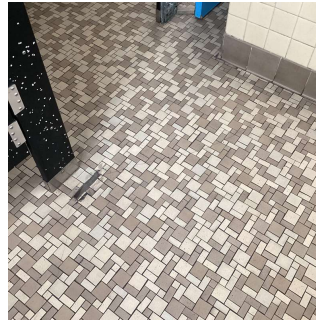
4th Floor - Boys

Floor Finish

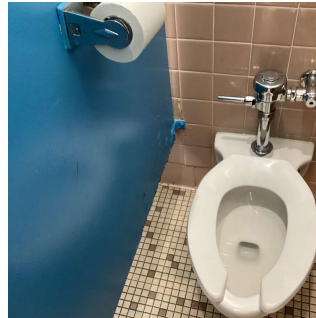
Room 109A

RUST - MAJOR

REPLACE

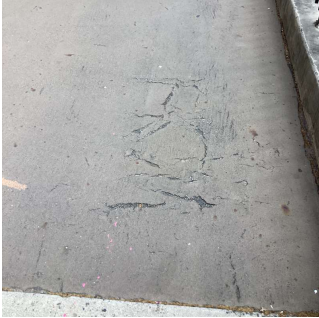
Question	Response
SITE	
PAVING	
Site Sidewalks & Walkways	
Asphalt	Inspected
Condition	2 - Between Good and Fair
Deficiency	CRACKS - MAJOR
Deficiency Location/Instance	Exit 12
Deficiency Quantity	40
Quantity Uom	S.F.
Potential Action	REPLACE
Urgency of Action	PRIORITY 3
Purpose of Action	LEVEL 2
Deficiency Photo1

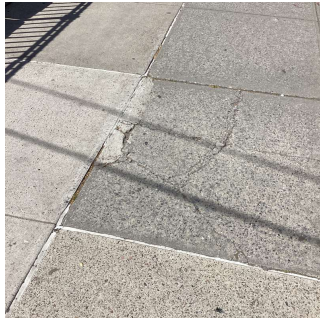
Question	Response
SITE	
PAVING	
DOT Sidewalk	
Concrete	
Deficiency Quantity	70
Quantity Uom	L.F.
Potential Action	REPLACE
Urgency of Action	PRIORITY 3
Purpose of Action	LEVEL 2
Deficiency Photo1	 
	52nd Street
Violations	No violations recorded.
Deficiency	HEAVING
Deficiency Location/Instance	51st Street, Fort Hamilton Parkway
Deficiency Quantity	150
Quantity Uom	S.F.
Potential Action	REPLACE
Urgency of Action	PRIORITY 3
Purpose of Action	LEVEL 2
Deficiency Photo1	 
	51st Street
Violations	No violations recorded.
Deficiency	DAMAGED/DETERIORATED/MISSING SECTIONS
Deficiency Location/Instance	51st Street, 52nd Street, Fort Hamilton Parkway
Deficiency Quantity	1,350
Quantity Uom	S.F.
Potential Action	REPLACE
Urgency of Action	PRIORITY 3
Purpose of Action	LEVEL 2

51st Street
Violations	No violations recorded.
Pavers	Does not Exist
PLAYGROUNDS	Inspected
Instance on 51st Street	Inspected
Benches	
Instance on 51st Street	Does not Exist
Fence	
Instance on 51st Street	Inspected
Condition	2 - Between Good and Fair
Deficiency	No deficiencies recorded
Pavement	
Instance on 51st Street	Does not Exist
Play Equipment	
Instance on 51st Street	Inspected
Condition	2 - Between Good and Fair
Deficiency	No deficiencies recorded
Safety Surfacing	
Instance on 51st Street	Inspected
Condition	2 - Between Good and Fair
Deficiency	No deficiencies recorded
Unpaved Area	
Instance on 51st Street	Does not Exist
PLAYING SURFACE	Does not Exist
RETAINING WALLS	Inspected
Are there any Retaining Walls 6' OR higher facing public street/sidewalk?	No
Condition	2 - Between Good and Fair
Deficiency	CAST IN PLACE CONCRETE: DETERIORATED CONTROL/EXPANSION JOINT
