NYC Department of Education
Building Condition Assessment Survey 2023 - 2024

Architectural Inspection

Asset: P.S. 161 - BROOKLYN, 330 CROWN STREET, New York, 11225

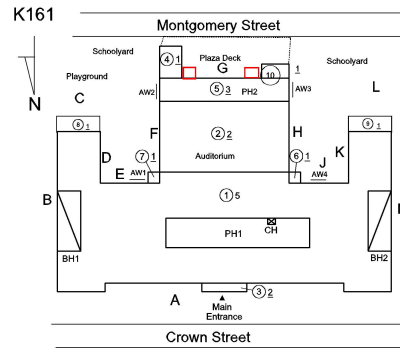
SKYLIGHT/ROOF VENT	Does not Exist
ROOF/GRAVITY TANK	Does not Exist
STAIRS/RAMPS: EXTERIOR	Inspected
BUILDING CHEEK/FLANK WALLS	Inspected
Condition	3 - Fair
Deficiency	CAST IN PLACE CONCRETE: CRACKS/SPALLING - MAJOR

15
S.F.
REPLACE
PRIORITY 4
LEVEL 2

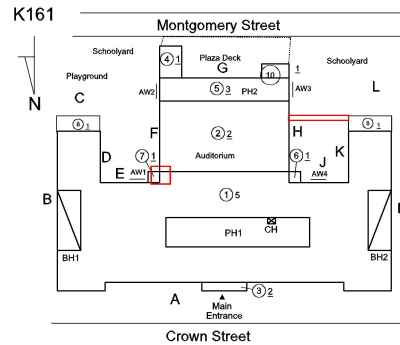
CONCRETE: CRACKS/SPALLING - MAJOR

20
S.F.
REPLACE
PRIORITY 4
LEVEL 2

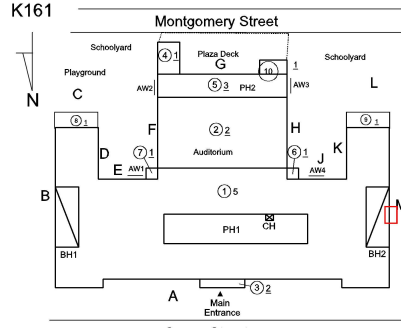
<p align="center">Facade E - Exit 6</p> <p align="center">No violations recorded.</p>
Deficiency Quantity Quantity Uom Potential Action Urgency of Action Purpose of Action Deficiency Photo1	<p>STONE: CRACKS/SPALLING - MINOR</p> <p>K161</p>

<p align="center">10 S.F. REPAIR PRIORITY 3 LEVEL 2</p>
Violations

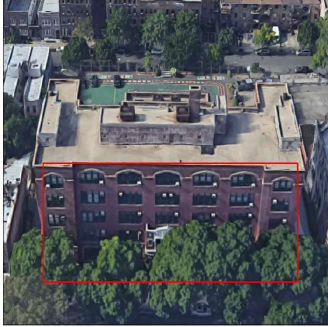
Question	Response
EXTERIOR	
WINDOWS	
WINDOWS	
Instance Quantity	10,000
Instance Quantity Uom	S.F.
Are these windows insulated	Yes
Installation Year	2008
Source of Installation	Custodial Staff
Deficiency	ALUMINUM - DOUBLE HUNG: BROKEN PANE
Roof Plan reference	<p>K161</p>
Elevation	
Deficiency Quantity	30
Quantity Uom	S.F.
Potential Action	MAINTENANCE
Urgency of Action	PRIORITY 3
Purpose of Action	LEVEL 2
Deficiency Photo1	
Violations	No violations recorded.
Deficiency	ALUMINUM - DOUBLE HUNG: INOPERABLE BALANCE

Deficiency Quantity	166
Quantity Uom	EACH
Potential Action	REPLACE BALANCES
Urgency of Action	PRIORITY 3
Purpose of Action	LEVEL 2
Deficiency Photo1

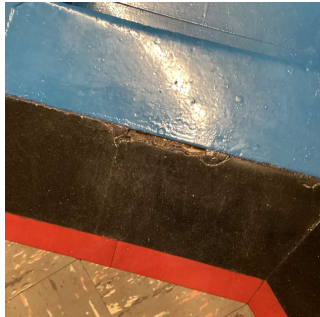
Violations	Left side No violations recorded.
Deficiency	DAMAGED FLOOR
Deficiency Location/Instance	Right side, center, left side
Deficiency Quantity	15
Quantity Uom	S.F.
Potential Action	REPLACE
Urgency of Action	PRIORITY 3
Purpose of Action	LEVEL 2

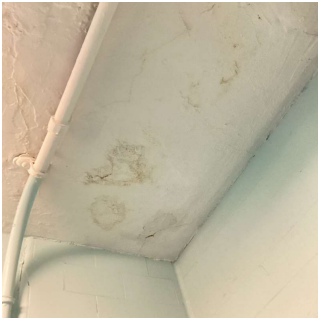
Question	Response
INTERIOR	
CAFETERIA	
Walls	
Violations	Near center No violations recorded.
Window Curtains/Shades/Blinds	
Instance on 1st Floor	Does not Exist
CLASSROOMS/CORRIDORS/ADMIN SPACES	
Ceiling	Inspected
Condition	2 - Between Good and Fair
Deficiency	PLASTER: CRACKS/SPALLING
Deficiency Location/Instance	Exit 6
Deficiency Quantity	10
Quantity Uom	S.F.
Potential Action	REPLACE
Urgency of Action	PRIORITY 3
Purpose of Action	LEVEL 2
Deficiency Photo1

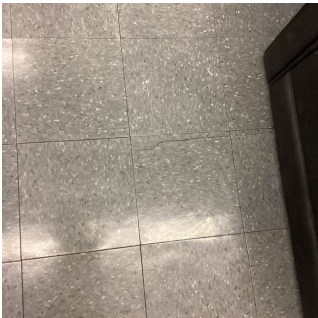
Room 411A

Violations	Exit 6 No violations recorded.
Door(s)	Inspected
Condition	2 - Between Good and Fair
Deficiency	No deficiencies recorded
Floor Finish	Inspected
Condition	2 - Between Good and Fair
Deficiency	VINYL TILES: DETERIORATED SUBSTRATE
Deficiency Location/Instance	Room 411A, 313, 302
Deficiency Quantity	15
Quantity Uom	S.F.
Potential Action	REPLACE
Urgency of Action	PRIORITY 3
Purpose of Action	LEVEL 2
Deficiency Photo1

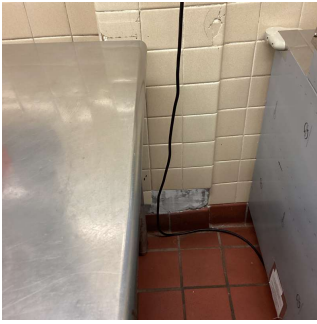
Question	Response
INTERIOR	
KITCHEN	
Floor Finish	
Deficiency Photo1	 
Violations	Kitchen Staff Locker No violations recorded.
Walls	
Instance on 1st Floor	Inspected
Condition	2 - Between Good and Fair
Deficiency	CERAMIC TILE: BROKEN/ MISSING
Deficiency Location/Instance	Near Windows, sink, Entrance
Deficiency Quantity	15
Quantity Uom	S.F.
Potential Action	REPLACE
Urgency of Action	PRIORITY 3
Purpose of Action	LEVEL 2
Deficiency Photo1

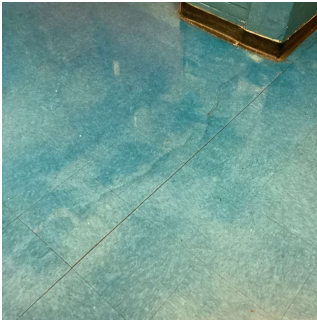
Near Stair FG/1
Violations	No violations recorded.
Instance on 1st Floor - East	Inspected
Condition	2 - Between Good and Fair
Deficiency	VINYL TILES: DETERIORATED SUBSTRATE
Deficiency Location/Instance	Near Exit 7
Deficiency Quantity	10
Quantity Uom	S.F.
Potential Action	REPLACE
Urgency of Action	PRIORITY 3
Purpose of Action	LEVEL 2
Deficiency Photo1

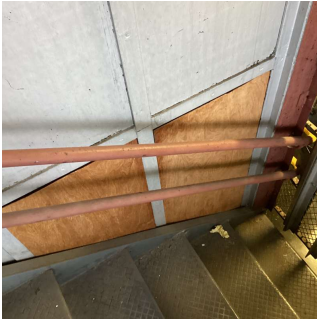
Violations	Stair BC/1 No violations recorded.
Deficiency	GLASS PANEL: DAMAGED/DETERIORATED
Deficiency Location/Instance	Stair BC/Bulkhead, 4, 2, FG/Bulkhead, 5, and others
Deficiency Quantity	60
Quantity Uom	S.F.
Potential Action	REPLACE
Urgency of Action	PRIORITY 3
Purpose of Action	LEVEL 2
Deficiency Photo1

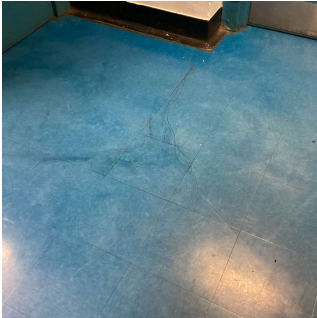
Question	Response
INTERIOR	
STAIRS/RAMPS: INTERIOR	
Stairs and Landings	
Deficiency	VINYL TILES: DETERIORATED SUBSTRATE
Deficiency Location/Instance	Stair D/1, 2, 3, E/5, 3, and others
Deficiency Quantity	70
Quantity Uom	S.F.
Potential Action	REPLACE
Urgency of Action	PRIORITY 3
Purpose of Action	LEVEL 2
Deficiency Photo1

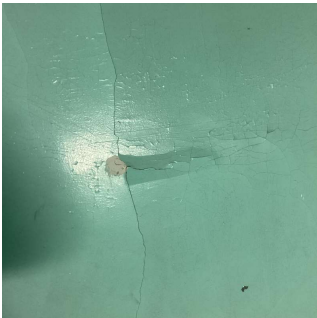
Violations	Stair D/1 No violations recorded.
Walls	Inspected
Condition	2 - Between Good and Fair
Deficiency	PLASTER: CRACKS/SPALLING
Deficiency Location/Instance	Stair H/2, 1
Deficiency Quantity	10
Quantity Uom	S.F.
Potential Action	REPLACE
Urgency of Action	PRIORITY 3
Purpose of Action	LEVEL 2
Deficiency Photo1

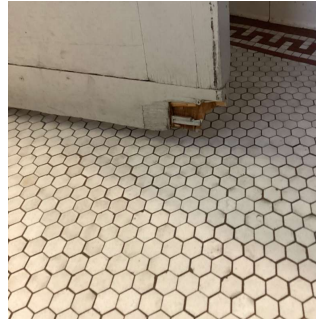
Room 411A
No violations recorded.

Violations	Stair H/2 No violations recorded.
TOILET ROOMS - STAFF	
Inspected	
Ceiling	
Inspected	
Condition	2 - Between Good and Fair
Deficiency	No deficiencies recorded
Door(s)	
Inspected	
Condition	5 - Poor
Deficiency	WOOD: DETERIORATED DOOR
Deficiency Location/Instance	Room 411A, Nurses Office

Quantity Uom	EACH
Potential Action	MAINTENANCE
Urgency of Action	PRIORITY 3
Purpose of Action	LEVEL 2
Deficiency Photo1

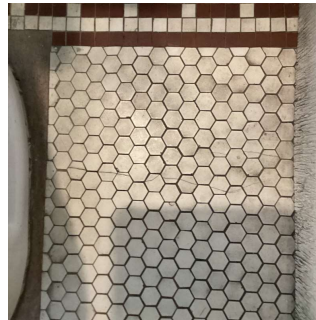
Room 411A
No violations recorded.

Deficiency	CERAMIC TILE: BROKEN/MISSING TILES
Deficiency Location/Instance	Room 411A
Deficiency Quantity	10
Quantity Uom	S.F.
Potential Action	REPLACE
Urgency of Action	PRIORITY 3
Purpose of Action	LEVEL 2
Deficiency Photo1

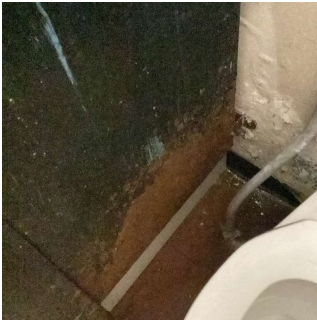
Violations	Kitchen Staff No violations recorded.
Stalls	Inspected
Condition	5 - Poor
Deficiency	RUST - MAJOR
Deficiency Location/Instance	Kitchen staff
Deficiency Quantity	1
Quantity Uom	EACH
Potential Action	REPLACE
Urgency of Action	PRIORITY 3
Purpose of Action	LEVEL 2
Deficiency Photo1

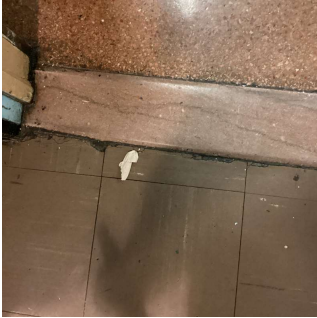
Question	Response
INTERIOR	
TOILET ROOMS - STUDENTS	
Floor Finish	Inspected
Condition	4 - Between Fair and Poor
Deficiency	VINYL TILES: BROKEN/DETERIORATED/MISSING TILES
Deficiency Location/Instance	Room 151
Deficiency Quantity	10
Quantity Uom	S.F.
Potential Action	REPLACE
Urgency of Action	PRIORITY 3
Purpose of Action	LEVEL 2
Deficiency Photo1

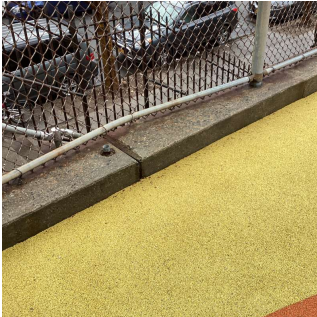
Violations	Schoolyard No violations recorded.
Deficiency	CHAIN LINK: DAMAGED POST/RAIL
Deficiency Location/Instance	Schoolyard
Deficiency Quantity	40
Quantity Uom	L.F.
Potential Action	REPLACE
Urgency of Action	PRIORITY 3
Purpose of Action	LEVEL 2
Deficiency Photo1

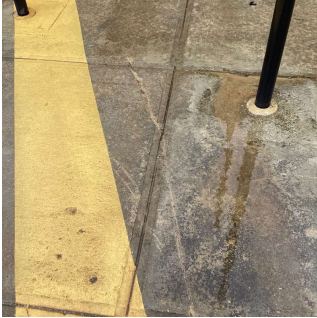
Violations	Schoolyard No violations recorded.
Concrete	Inspected
Condition	3 - Fair
Deficiency	DAMAGED/DETERIORATED/MISSING SECTIONS
Deficiency Location/Instance	Schoolyard
Deficiency Quantity	200
Quantity Uom	S.F.
Potential Action	REPLACE
Urgency of Action	PRIORITY 3
Purpose of Action	LEVEL 2
Deficiency Photo1

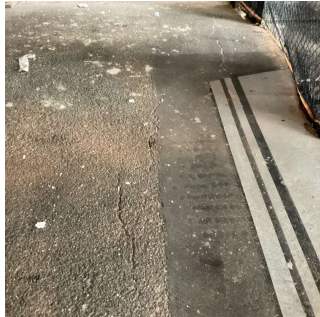
Violations	Schoolyard No violations recorded.
Pavers	Inaccessible
Site Sidewalks & Walkways	Inspected
Asphalt	Inspected
Condition	2 - Between Good and Fair
Deficiency	CRACKS - MAJOR
Deficiency Location/Instance	Near exit 2
Deficiency Quantity	20
Quantity Uom	S.F.
Potential Action	REPLACE
Urgency of Action	PRIORITY 3
Purpose of Action	LEVEL 2

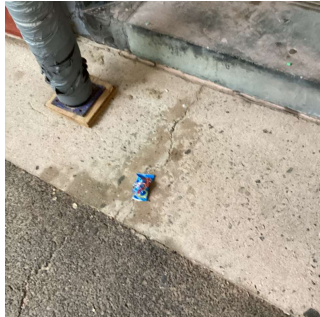
Violations	Near exit 2 No violations recorded.
Concrete	Inspected
Condition	3 - Fair
Deficiency	DAMAGED/DETERIORATED/MISSING SECTIONS
Deficiency Location/Instance	Near exit 2, 3, 4, 7
Deficiency Quantity	100
Quantity Uom	S.F.
Potential Action	REPLACE
Urgency of Action	PRIORITY 3
Purpose of Action	LEVEL 2
Deficiency Photo1

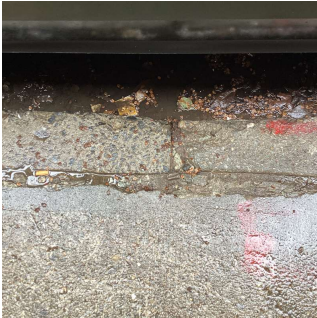
Violations	Along Crown Street No violations recorded.
Deficiency	DAMAGED CURBS
Deficiency Location/Instance	Along Crown Street, Montgomery Street
Deficiency Quantity	175
Quantity Uom	L.F.
Potential Action	REPLACE
Urgency of Action	PRIORITY 3
Purpose of Action	LEVEL 2
Deficiency Photo1

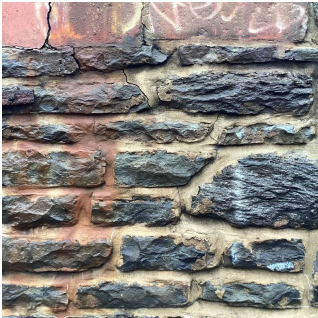
Question	Response
SITE	
PLAYGROUNDS	
Safety Surfacing	
Instance on Schoolyard	Inspected
Condition	1 - Good
Deficiency	No deficiencies recorded
Unpaved Area	
Instance on Schoolyard	Inspected
Condition	2 - Between Good and Fair
Deficiency	No deficiencies recorded
PLAYING SURFACE	Inspected
Playing Field	Inspected
Instance on Schoolyard	Inspected
Instance Condition	1 - Good
Deficiency	No deficiencies recorded
Running Track	Does not Exist
RETAINING WALLS	Inspected
Are there any Retaining Walls 6' OR higher facing public street/sidewalk?	Yes
Condition	3 - Fair
Deficiency	STONE: CRACKS/SPALLING - MAJOR
Deficiency Location/Instance	Along Montgomery Street
Deficiency Quantity	25
Quantity Uom	S.F.
Potential Action	REPLACE
Urgency of Action	PRIORITY 3
Purpose of Action	LEVEL 2
Deficiency Photo1

Violations	Along Montgomery Street No violations recorded.
SEATING	Inspected
Benches	Inspected
Concrete	Does not Exist
Metal/Wood/Plastic	Inspected

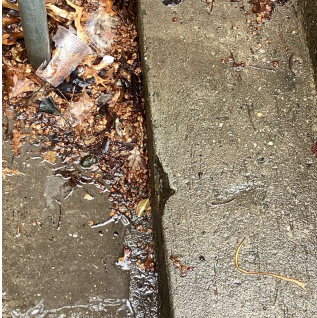
Question	Response
SITE	
STAIRS/RAMPS: EXTERIOR	Inspected
Railings	Inspected
Condition	2 - Between Good and Fair
Deficiency	No deficiencies recorded
Site Cheek/flank Walls	Inspected
Condition	2 - Between Good and Fair
Deficiency	No deficiencies recorded
Stairs/ramps	Inspected
Condition	2 - Between Good and Fair
Deficiency	CAST IN PLACE CONCRETE: CRACKS/SPALLING - MAJOR
Deficiency Location/Instance	Along Montgomery Street
Deficiency Quantity	10
Quantity Uom	S.F.
Potential Action	REPLACE
Urgency of Action	PRIORITY 3
Purpose of Action	LEVEL 2
Deficiency Photo1

Along Montgomery Street
Violations	No violations recorded.
ARTWORK	Does not Exist
