NYC Department of Education
Building Condition Assessment Survey 2023 - 2024

Architectural Inspection

Asset: I.S. 162 - BROOKLYN, 1390 WILLOUGHBY AVENUE, New York, 11237

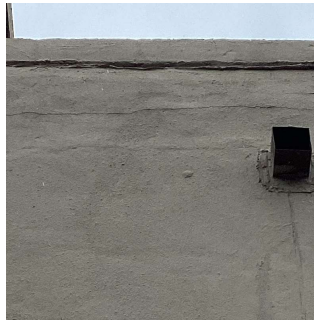
Facade G

| Question | Response |
|---|---|
| Deficiency | STUCCO CEMENT SURFACE: CRACKS, SPALLING |

REPLACE

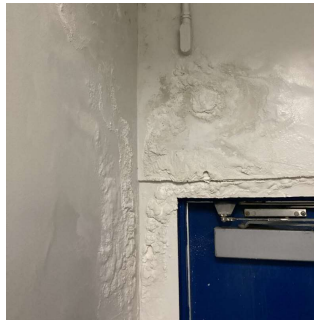
Facade H - Exit 8 Vestibule, Facade F - Exit 9 Vestibule (Shown)

BRICK: WATER INFILTRATION IN INSTRUCTIONAL SPACE

REPAIR

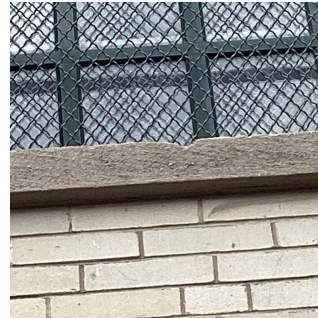
Facade L

BRICK: DETERIORATED MASONRY SILLS - MINOR

REPAIR

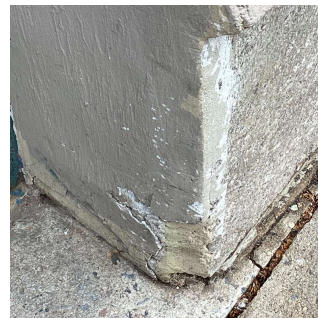
Facade A

STONE: CRACKS AT BUILDING CORNERS

REPLACE

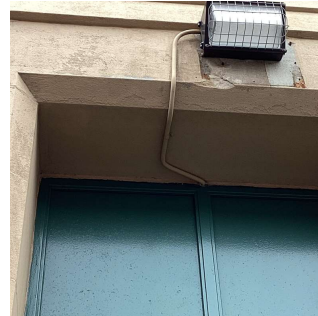
Facade B

STONE: CHIPPED/SPALLED/BROKEN PIECES - MAJOR

REPLACE

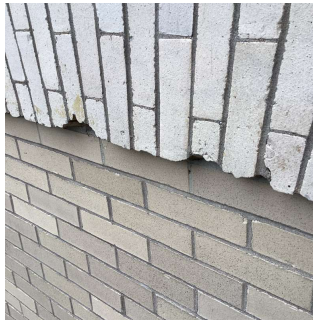
Facade F

BRICK: MAJOR / THRU CRACKS

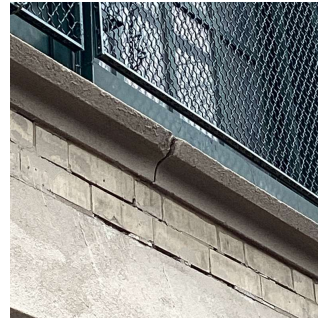
Facade C

BRICK: DETERIORATED MASONRY SILLS - MAJOR

REMOVE AND REPLACE

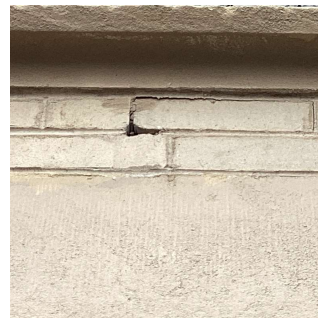
Facade K

BRICK: DETERIORATED JOINTS

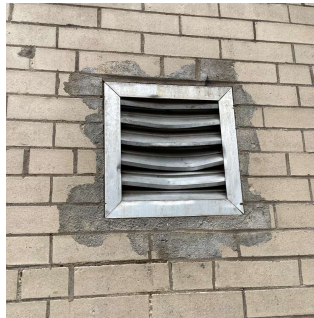
Facade E

| Question | Response |
|---|--|
| Deficiency | BROKEN/ DENTED BLADES |

REPLACE

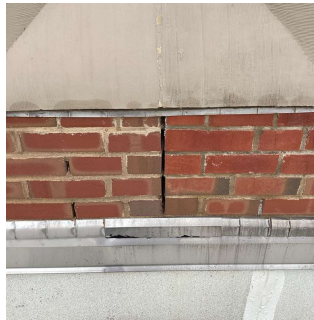
Roof 1
 No violations recorded.

BRICK: DETERIORATED CONTROL/EXPANSION JOINT

10
 L.F.
 MAINTENANCE
 PRIORITY 3
 LEVEL 2

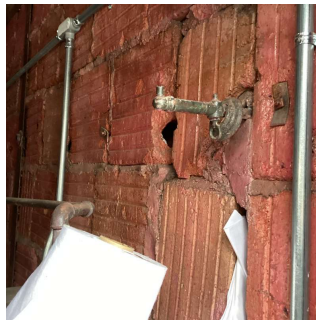
BULKHEAD/PENTHOUSE

90
S.F.
REPLACE
PRIORITY 4
LEVEL 2

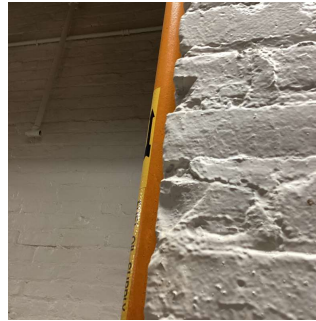
Basement - Boiler Room

| Question | Response |
|---|--|
| Deficiency | STEEL COLUMNS/BEAMS: DETERIORATED MASONRY FIREPROOFING |

| Question | Response |
|---|--|
| Potential Action | REPLACE |

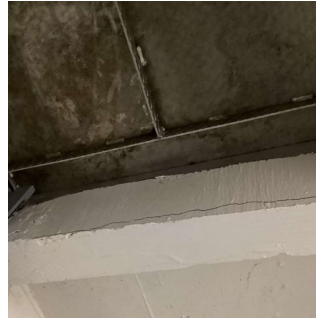
Basement - Vault

STEEL COLUMNS/BEAMS: DETERIORATED CONCRETE FIREPROOFING

REPLACE

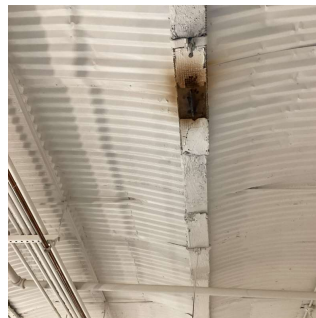
STEEL COLUMNS/BEAMS: DETERIORATED/MISSING PLASTER FIREPROOFING

REPLACE

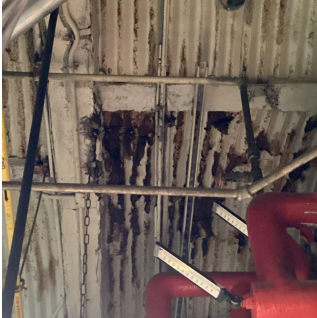
| Question | Response |
|---|--|
| Deficiency | CINDER CONCRETE ARCH: METAL PAN DETERIORATED, SPALLED |
| Deficiency Location/Instance | Basement - Oil Tank Room, Room B32 |
| Deficiency Quantity | 50 |

| Question | Response |
|---|--|
| Potential Action | REPAIR |

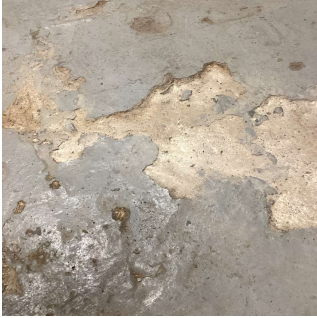
| Question | Response |
|---|--|
| Deficiency | CONCRETE SLAB ON GRADE: THRU CRACKS |
| Deficiency Location/Instance | Basement - Boiler Room, Storage Room |
| Deficiency Quantity | 40 |

| Question | Response |
|---|--|
| Potential Action | REPLACE |

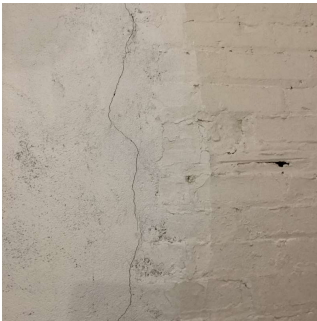
| Question | Response |
|---|--|
| Deficiency | BRICK: CRACKED/SPALLED |
| Deficiency Location/Instance | Basement - Oil Tank Room, Fan Room, Gas Meter Room |

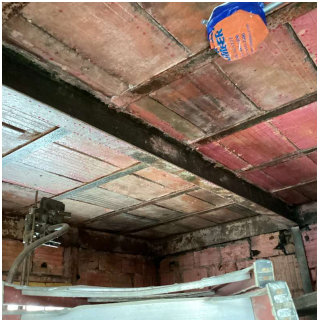
| Question | Response |
|--|--|
| Deficiency | STEEL COLUMNS/BEAMS: MAJOR RUSTING |
| Deficiency Location/Instance | PH |

| Question | Response |
|--|--|
| Potential Action | REPLACE |

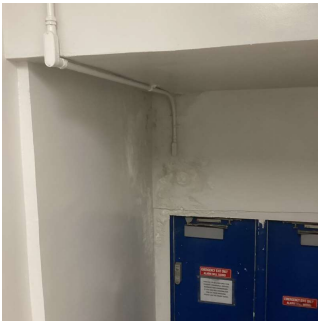
| Question | Response |
|---|--|
| Deficiency | PLASTER: CRACKS/SPALLING - ACTIVE LEAK |
| Deficiency Location/Instance | Exits 8, 9 - Vestibules |

| Question | Response |
|---|--|
| Potential Action | REPLACE |

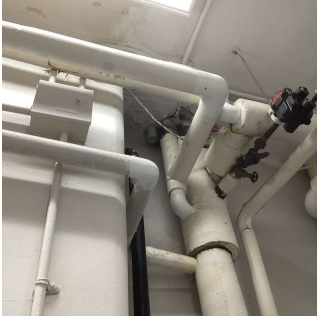
| Question | Response |
|---|--|
| Deficiency | PLASTER: CRACKS/SPALLING |
| Deficiency Location/Instance | Near Exit 1A, Exits 3, 7 - Vestibules, by Elevator Machine Room |

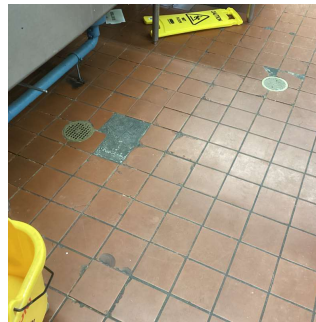
Near Sink

| Condition | 5 - Poor |

| Deficiency | QUARRY TILE: BROKEN/MISSING TILES |
| Deficiency Location/Instance | Near Sink, Servery, Preparation Area, Office Room, by Fridges and others |

| Potential Action | REPLACE |

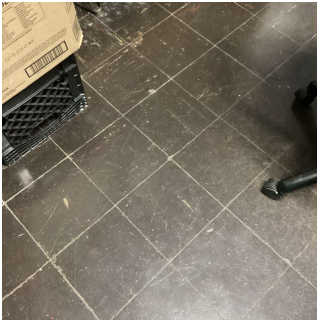
| Deficiency | VINYL TILES: BROKEN/DETERIORATED/MISSING TILES |
| Deficiency Location/Instance | Kitchen Locker Room |

| Potential Action | REPLACE |

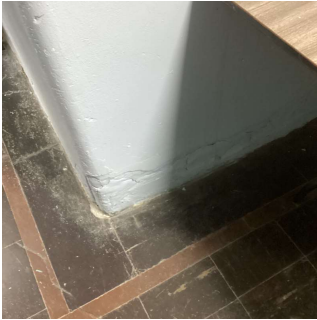
| Question | Response |
|---|--|
| Condition | 2 - Between Good and Fair |
| Deficiency | PLASTER: CRACKS/SPALLING |
| Deficiency Location/Instance | Kitchen Locker Room |

| Question | Response |
|---|--|
| Potential Action | REPLACE |

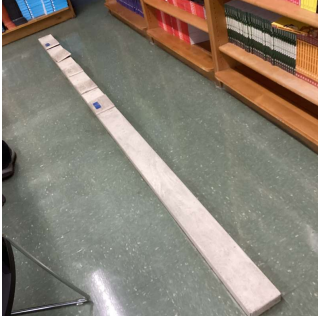
| Question | Response |
|---|--|
| | Left Side |

| Question | Response |
|---|--|
| Condition | 3 - Fair |
| Deficiency | VINYL TILES: TRIPPING HAZARD - ELECTRICAL OUTLET |
| Deficiency Location/Instance | Left Side |

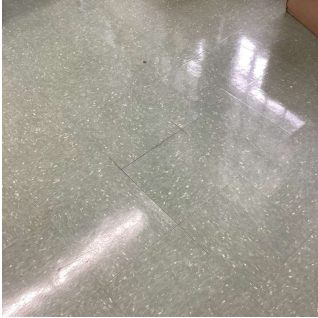
| Question | Response |
|---|--|
| | Near Windows |

| Question | Response |
|---|--|
| Deficiency | VINYL TILES: BROKEN/DETERIORATED/MISSING TILES |
| Deficiency Location/Instance | Near Windows, Center, Right Side |

| Question | Response |
|---|--|
| Potential Action | REPLACE |

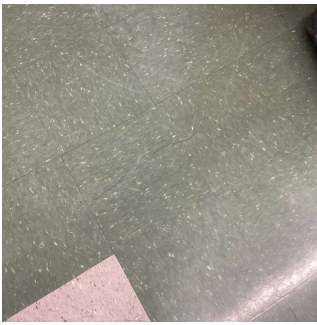
| Question | Response |
|---|--|
| Center | Center |

| Question | Response |
|---|--|
| Deficiency | VINYL TILES: DETERIORATED SUBSTRATE |
| Deficiency Location/Instance | Center |

| Question | Response |
|---|--|
| Potential Action | REPLACE |

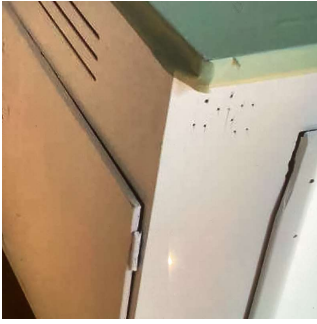
| Question | Response |
|---|--|
| Room 301 | Room 301 |

| Question | Response |
|---|--|
| Condition | 5 - Poor |
| Deficiency | DEMO TABLE: DAMAGED/DETERIORATED |
| Deficiency Location/Instance | Room 301 |

| Question | Response |
|---|--|
| Potential Action | REPLACE |

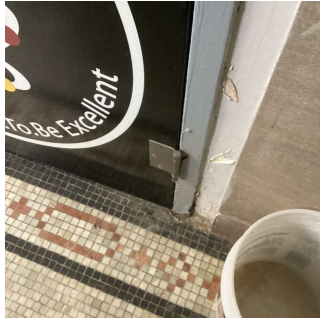
| Question | Response |
|---|--|
| Deficiency | METAL: DETERIORATED DOOR AND FRAME |
| Deficiency Location/Instance | Stair A/Basement |

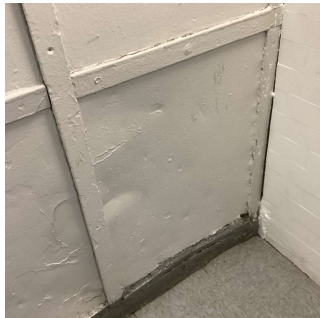
| Question | Response |
|---|--|
| Condition | 2 - Between Good and Fair |
| Deficiency | METAL PANEL: DAMAGED/DETERIORATED |
| Deficiency Location/Instance | Stair F/Basement |

| Question | Response |
|---|--|
| Potential Action | REPLACE |

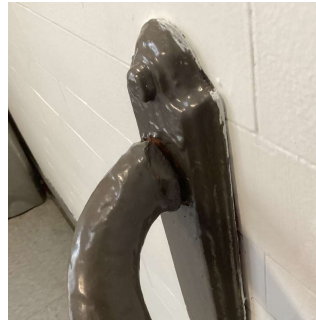
Stair F/3

| Question | Response |
|---|--|
| Condition | 5 - Poor |
| Deficiency | METAL: BROKEN BRACKET |
| Deficiency Location/Instance | Stairs F/3, 4 |

| Question | Response |
|---|--|
| Potential Action | REPLACE |

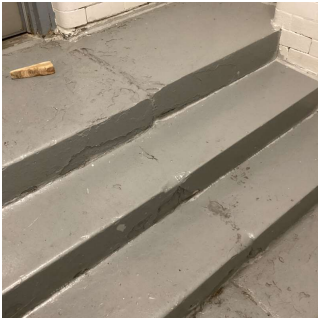
| Question | Response |
|---|--|
| Deficiency | STONE: BROKEN/MISSING |
| Deficiency Location/Instance | Exits 7, 8 - Vestibules |

| Question | Response |
|---|--|
| Potential Action | REPLACE |

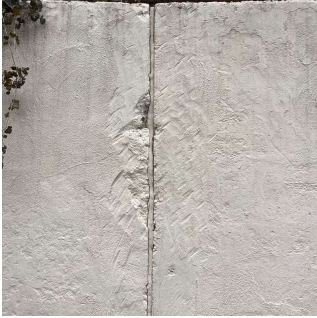
| Question | Response |
|---|--|
| Deficiency | STONE: CRACKS/SPALLING - MAJOR |

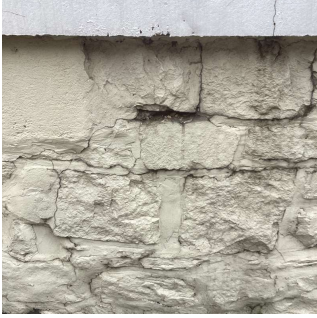
| Question | Response |
|---|--|
| Deficiency | STONE: DETERIORATED COPING STONE |
