NYC Department of Education
Building Condition Assessment Survey 2023 - 2024

Architectural Inspection

Asset: P.S. 164 - BROOKLYN, 4211 14TH AVENUE, New York, 11219

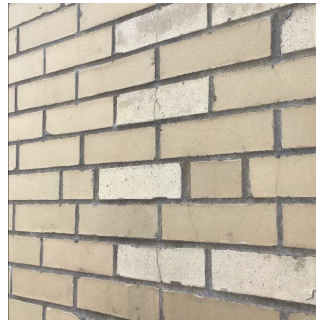
Roof 1 - Chimney 1
No violations recorded.

Question	Response
Architectural	
EXTERIOR	Inspected
AREAWAY	Inspected
Instance on AW1-AW10	Inspected
Instance Condition	2 - Between Good and Fair
Instance Quantity	10
Instance Quantity Uom	EACH
Deficiency	No deficiencies recorded
AWNINGS AND CANOPIES	Does not Exist
CHIMNEY	Inspected
Material Type(s)	Masonry
Condition	3 - Fair
Deficiency	BRICK: MINOR CRACKS AND SPALLING

30
S.F.
RESTITCH
PRIORITY 3
LEVEL 2

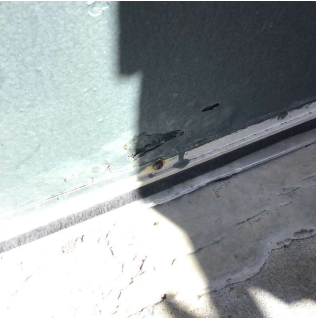
METAL CLAD: DETERIORATED DOOR AND FRAME - MAJOR DETERIORATION

Deficiency Quantity	2
Quantity Uom	EACH
Potential Action	REPLACE
Urgency of Action	PRIORITY 4
Purpose of Action	LEVEL 2
Deficiency Photo1

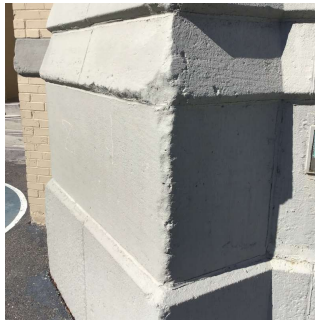
Facade D

STONE: CRACKS AT BUILDING CORNERS

REPLACE

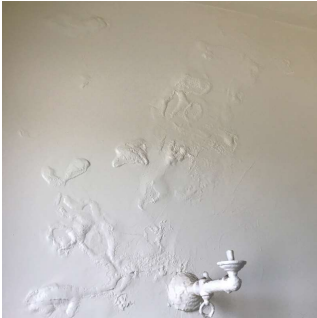
Violations	Roof 1 - Bulkhead No violations recorded.
Deficiency	BULKHEAD/PENTHOUSE WALLS/EXTERIOR: WATER INFILTRATION
Roof Plan reference

BULKHEAD/PENTHOUSE WALLS/INTERIOR: PLASTER CRACKS/SPALLING

Question	Response
EXTERIOR	
ROOF	
Specialties	
BULKHEAD/PENTHOUSE	
Quantity Uom	S.F.
Potential Action	REPLACE
Urgency of Action	PRIORITY 3
Purpose of Action	LEVEL 2
Deficiency Photo1

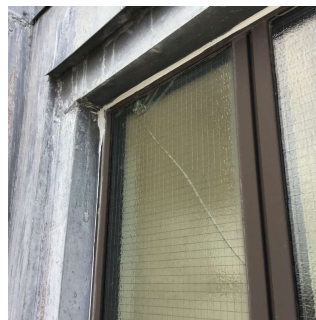
Violations	Roof 1 - Bulkhead No violations recorded.
Deficiency	BULKHEAD/PENTHOUSE WINDOWS: DAMAGED, DETERIORATED WINDOWS

30
 S.F.
 REPLACE
 PRIORITY 4
 LEVEL 2

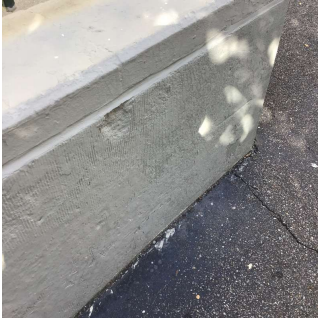
Violations	Facade L No violations recorded.
RAILINGS	Inspected
Condition	2 - Between Good and Fair
Deficiency	No deficiencies recorded
STAIRS/RAMPS	Inspected
Condition	5 - Poor
Deficiency	CONCRETE: CRACKS/SPALLING - MAJOR
Roof Plan reference

MASONRY UNIT: CRACKS/SPALLING - MINOR

Question	Response
EXTERIOR	
STAIRS/RAMPS: EXTERIOR	
BUILDING CHEEK/FLANK WALLS	
Quantity Uom	S.F.
Potential Action	REPAIR
Urgency of Action	PRIORITY 3
Purpose of Action	LEVEL 2
Deficiency Photo1

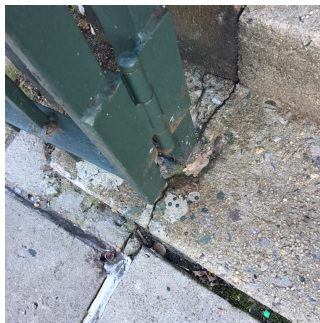
Violations	Facade B No violations recorded.
Deficiency	STONE: WORN-OUT TREAD/RISER/NOSING
Roof Plan reference

CONCRETE: CRACKS/SPALLING - MINOR

REPAIR

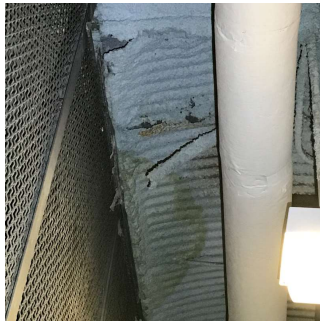
Violations	Sub-Basement - Storage Room No violations recorded.
Deficiency	CINDER CONCRETE ARCH: METAL PAN DETERIORATED, SPALLED
Deficiency Location/Instance	Sub-Basement - North Storage Room
Deficiency Quantity	30
Quantity Uom	S.F.
Potential Action	REPAIR
Urgency of Action	PRIORITY 4
Purpose of Action	LEVEL 5
Deficiency Photo1

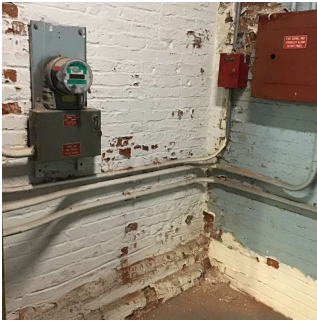
Violations	Sub-Basement - North Storage Room No violations recorded.
FOUNDATION WALLS	Inspected
Material Type(s)	Masonry
Condition	5 - Poor
Deficiency	BRICK: WATER INFILTRATION IN ELECTRICAL PANEL ROOM
Deficiency Location/Instance	Sub-Basement - Electrical Panel Room
Deficiency Quantity	100
Quantity Uom	S.F.
Potential Action	INSTALL WATERPROOFING
Urgency of Action	PRIORITY 5
Purpose of Action	LEVEL 6

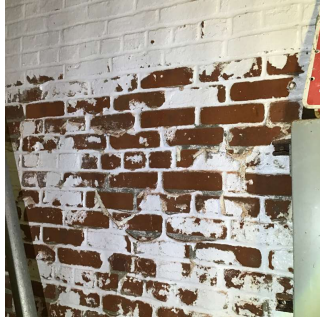
Sub-Basement - Electrical Panel Room
Violations	No violations recorded.
Deficiency	BRICK: WATER INFILTRATION IN NON- INSTRUCTIONAL SPACE
Deficiency Location/Instance	Sub-Basement - Boiler Room, Storage Room, Paint Storage Room, Gas Gas Meter Room, Water Main Service Room, Fan Area
Deficiency Quantity	500
Quantity Uom	S.F.
Potential Action	INSTALL WATERPROOFING
Urgency of Action	PRIORITY 5
Purpose of Action	LEVEL 5
Deficiency Photo1	 
	Sub-Basement - Fan Area
Violations	No violations recorded.
ROOF STRUCTURE	
Condition	Inspected
Deficiency	2 - Between Good and Fair
Deficiency	No deficiencies recorded
VAULTS-BUNKERS	
Condition	Inspected
Foundation Walls	
Condition	4 - Between Fair and Poor
Deficiency	WATER INFILTRATION IN NON- INSTRUCTIONAL SPACE
Deficiency Location/Instance	Sub-Basement - Sidewalk Elevator Motor Room
Deficiency Quantity	100

Quantity Uom	S.F.
Potential Action	INSTALL WATERPROOFING
Urgency of Action	PRIORITY 5
Purpose of Action	LEVEL 5

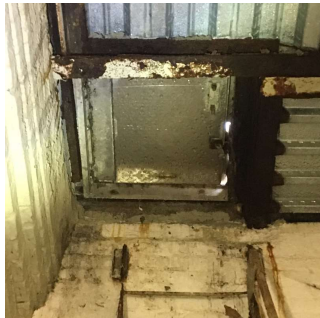
Violations	Sub-Basement - Sidewalk Elevator Motor Room No violations recorded.
Slab Structure	Inspected
Condition	3 - Fair
Deficiency	METAL DECK AND CONCRETE: WATER INFILTRATION IN NON- INSTRUCTIONAL SPACE
Deficiency Location/Instance	Sub-Basement - Escape Door in Elevator Motor Room
Deficiency Quantity	30
Quantity Uom	S.F.
Potential Action	INSTALL WATERPROOFING
Urgency of Action	PRIORITY 5
Purpose of Action	LEVEL 5
Deficiency Photo1

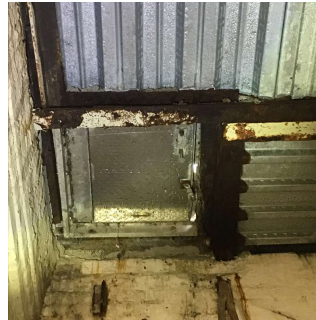
Violations	Sub-Basement - Escape Door in Elevator Motor Room No violations recorded.
Vault/Ash Hoist Doors and Framing	Inspected
Condition	5 - Poor
Deficiency	DETERIORATED/DAMAGED VAULT/ASH HOIST DOORS AND FRAMING
Deficiency Location/Instance	Sub-Basement - Escape Door
Deficiency Quantity	1
Quantity Uom	EACH
Potential Action	REPLACE
Urgency of Action	PRIORITY 4
Purpose of Action	LEVEL 2

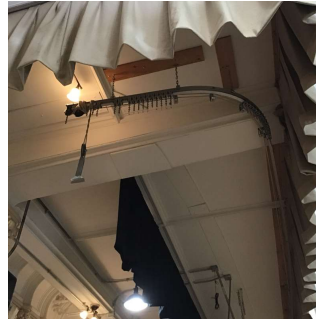
Stage
No violations recorded.

Instance on Basement (660 Seats)	Inspected
Condition	5 - Poor
Deficiency	WORN/DETERIORATED
Deficiency Location/Instance	Stage
Deficiency Quantity	1,100
Quantity Uom	S.F.
Potential Action	REPLACE
Urgency of Action	PRIORITY 3
Purpose of Action	LEVEL 2
Deficiency Photo1

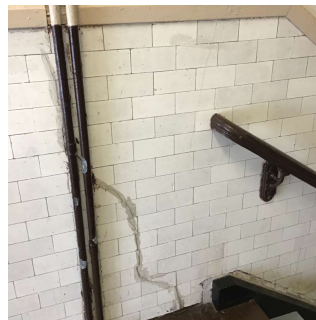
Exit 10/Vestibule

Instance on Basement (660 Seats)	Inspected
Condition	2 - Between Good and Fair
Deficiency	CERAMIC TILE: BROKEN/ MISSING
Deficiency Location/Instance	Exits 11,10/Vestibule
Deficiency Quantity	20
Quantity Uom	S.F.
Potential Action	REPLACE
Urgency of Action	PRIORITY 3
Purpose of Action	LEVEL 2
Deficiency Photo1

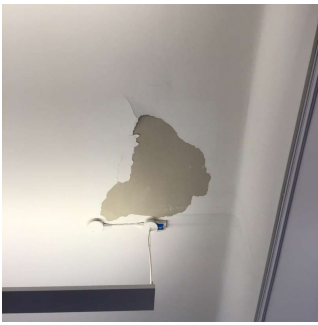
Violations	Exit 2/Vestibule No violations recorded.
Window Curtains/Shades/Blinds	
Instance on Basement	Does not Exist
CLASSROOMS/CORRIDORS/ADMIN SPACES	
Ceiling	Inspected
Condition	2 - Between Good and Fair
Deficiency	ACOUSTIC TILES ON PLASTER: DAMAGED/MISSING
Deficiency Location/Instance	Room 407
Deficiency Quantity	50
Quantity Uom	S.F.
Potential Action	REPLACE
Urgency of Action	PRIORITY 3
Purpose of Action	LEVEL 2
Deficiency Photo1

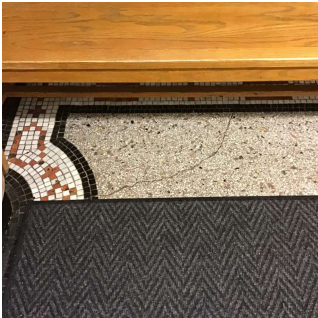
Question	Response
INTERIOR	
CLASSROOMS/CORRIDORS/ADMIN SPACES	
Floor Finish	
Violations	Corridor near Room 404 No violations recorded.
Deficiency	TERRAZZO: CRACKS
Deficiency Location/Instance	Main Entrance Lobby, Corridor near Auditorium
Deficiency Quantity	150
Quantity Uom	S.F.
Potential Action	REPLACE
Urgency of Action	PRIORITY 3
Purpose of Action	LEVEL 2
Deficiency Photo1

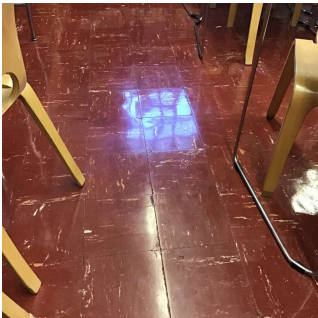
Violations	Main Entrance Lobby No violations recorded.
Deficiency	VINYL TILES: BROKEN/DETERIORATED/MISSING TILES
Deficiency Location/Instance	Corridor near Rooms 413,102A, Rooms 311,302,202 and others
Deficiency Quantity	2,500
Quantity Uom	S.F.
Potential Action	REPLACE
Urgency of Action	PRIORITY 3
Purpose of Action	LEVEL 2
Deficiency Photo1

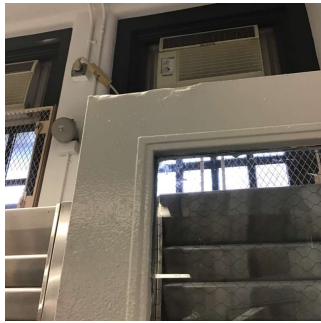
Question	Response
INTERIOR	
KITCHEN	
Ceiling	
Violations	Storage Room No violations recorded.
Door(s)	
Instance on Basement (600 SF)	Inspected
Condition	3 - Fair
Deficiency	METAL: DETERIORATED DOOR
Deficiency Location/Instance	Entrance
Deficiency Quantity	1
Quantity Uom	EACH
Potential Action	MAINTENANCE
Urgency of Action	PRIORITY 3
Purpose of Action	LEVEL 2
Deficiency Photo1

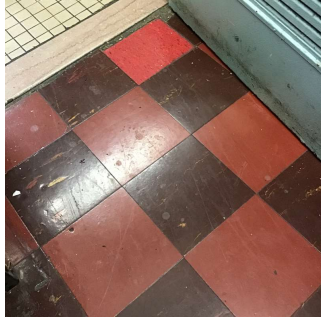
Violations	Entrance No violations recorded.
Floor Finish	
Instance on Basement (600 SF)	Inspected
Condition	5 - Poor
Deficiency	VINYL TILES: BROKEN/DETERIORATED/MISSING TILES
Deficiency Location/Instance	Storage Room
Deficiency Quantity	50
Quantity Uom	S.F.
Potential Action	REPLACE
Urgency of Action	PRIORITY 3
Purpose of Action	LEVEL 2
Deficiency Photo1

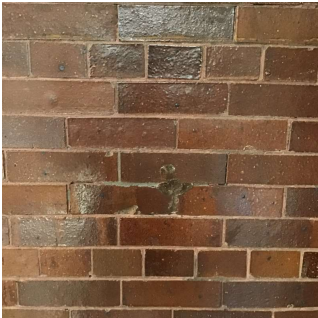
Sliding-folding Partition	
Instance on Basement	Does not Exist
Stage	
Instance on Basement	Does not Exist
Walls	
Instance on Basement	Inspected
Condition	2 - Between Good and Fair
Deficiency	SALT GLAZED BRICK: CRACKS/SPALLING
Deficiency Location/Instance	Near Stair C/Basement, By Exits 3,5

Question	Response
INTERIOR	
MULTI-PURPOSE ROOM	Inspected
Walls	
Deficiency Quantity	30
Quantity Uom	S.F.
Potential Action	REPLACE
Urgency of Action	PRIORITY 3
Purpose of Action	LEVEL 2
Deficiency Photo1

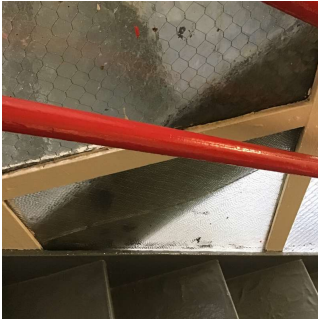
Violations	Stair AB/1 No violations recorded.
Partition	Inspected
Condition	3 - Fair
Deficiency	GLASS PANEL: DAMAGED/DETERIORATED
Deficiency Location/Instance	Stairs AB/1,4, EF/2,4,3
Deficiency Quantity	80
Quantity Uom	S.F.
Potential Action	REPLACE
Urgency of Action	PRIORITY 3
Purpose of Action	LEVEL 2
Deficiency Photo1

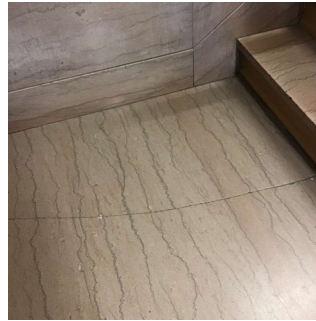
Violations	Stair EF/2 No violations recorded.
Railings	Inspected
Condition	2 - Between Good and Fair
Deficiency	No deficiencies recorded
Stairs and Landings	Inspected
Condition	5 - Poor
Deficiency	STONE: BROKEN/MISSING
Deficiency Location/Instance	Main Entrance Lobby Stair
Deficiency Quantity	50
Quantity Uom	S.F.
Potential Action	REPLACE
Urgency of Action	PRIORITY 3
Purpose of Action	LEVEL 2

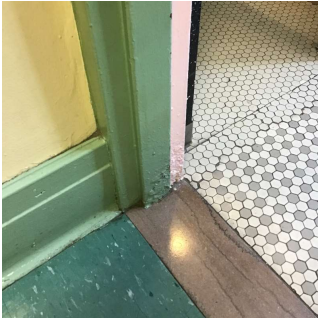
Question	Response
INTERIOR	
TOILET ROOMS - STUDENTS	Inspected
Ceiling	Inspected
Condition	2 - Between Good and Fair
Deficiency	No deficiencies recorded
Door(s)	Inspected
Condition	5 - Poor
Deficiency	WOOD: DETERIORATED DOOR AND FRAME
Deficiency Location/Instance	Room 112A
Deficiency Quantity	1
Quantity Uom	EACH
Potential Action	MAINTENANCE
Urgency of Action	PRIORITY 3
Purpose of Action	LEVEL 2
Deficiency Photo1

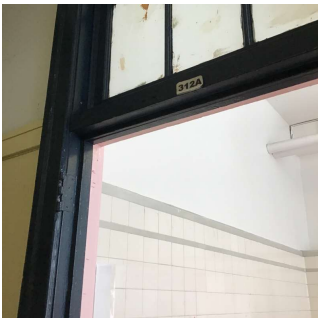
Violations	Room 112A No violations recorded.
Deficiency	WOOD: MISSING DOOR
Deficiency Location/Instance	Room 312A
Deficiency Quantity	1
Quantity Uom	EACH
Potential Action	MAINTENANCE
Urgency of Action	PRIORITY 3
Purpose of Action	LEVEL 2
Deficiency Photo1

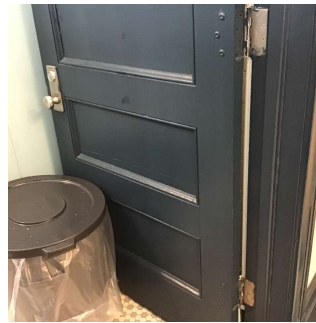
Violations	Room 312A No violations recorded.
Deficiency	WOOD: DETERIORATED DOOR
Deficiency Location/Instance	Room 402A
Deficiency Quantity	1
Quantity Uom	EACH
Potential Action	MAINTENANCE
Urgency of Action	PRIORITY 3
Purpose of Action	LEVEL 2

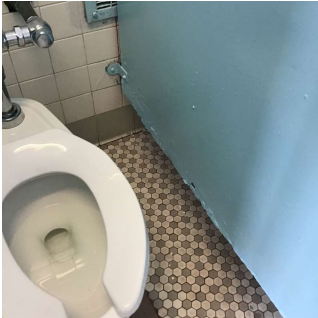
Question	Response
INTERIOR	
TOILET ROOMS - STUDENTS	
Floor Finish	Inspected
	Room 402A
Violations	No violations recorded.
Stalls	Inspected
Condition	5 - Poor
Deficiency	RUST - MAJOR
Deficiency Location/Instance	Rooms 402A,312A
Deficiency Quantity	8
Quantity Uom	EACH
Potential Action	REPLACE
Urgency of Action	PRIORITY 3
Purpose of Action	LEVEL 2
Deficiency Photo1

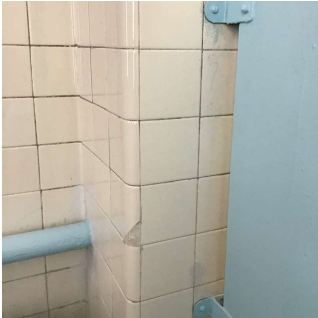
Room 402A
Violations	No violations recorded.
Walls	Inspected
Condition	2 - Between Good and Fair
Deficiency	CERAMIC TILE: BROKEN/ MISSING
Deficiency Location/Instance	Rooms 402A,312A,112A
Deficiency Quantity	30
Quantity Uom	S.F.
Potential Action	REPLACE
Urgency of Action	PRIORITY 3
Purpose of Action	LEVEL 2
Deficiency Photo1

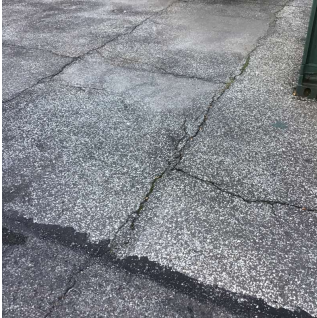
Deficiency	CRACKS - MAJOR
Deficiency Location/Instance	43rd Street

Question	Response
SITE	
PAVING	
Student Non-Use	
Asphalt	
Deficiency Quantity	500
Quantity Uom	S.F.
Potential Action	REPLACE
Urgency of Action	PRIORITY 3
Purpose of Action	LEVEL 2
Deficiency Photo1

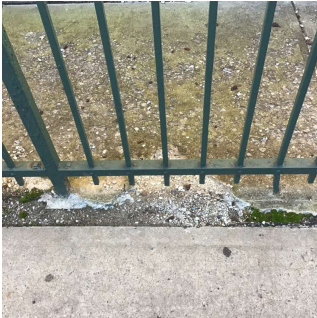
42nd Street
Violations	No violations recorded.
Pavers	
	Does not Exist
Student Use	
Gravel Exists?	No
Asphalt	
Condition	4 - Between Fair and Poor
Deficiency	CRACKS - MAJOR
Deficiency Location/Instance	Schoolyard
Deficiency Quantity	1,000
Quantity Uom	S.F.
Potential Action	REPLACE

43rd Street
Violations	No violations recorded.
Concrete	
	Inspected
Condition	3 - Fair
Deficiency	CRACKS - MAJOR
Deficiency Location/Instance	42nd Street, 43rd Street
Deficiency Quantity	225
Quantity Uom	S.F.
Potential Action	REPLACE
Urgency of Action	PRIORITY 3
Purpose of Action	LEVEL 2
Deficiency Photo1

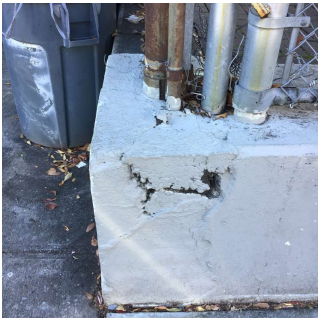
Along 42nd Street
Violations	No violations recorded.
Deficiency	CAST IN PLACE CONCRETE: DETERIORATED CONTROL/EXPANSION JOINT
Deficiency Location/Instance	42nd Street
Deficiency Quantity	10
Quantity Uom	L.F.
Potential Action	REPLACE
Urgency of Action	PRIORITY 3
Purpose of Action	LEVEL 2

Question	Response
SITE	
PLAYGROUNDS	Inspected
Unpaved Area	
Instance on Schoolyard	Does not Exist
PLAYING SURFACE	Inspected
Playing Field	Inspected
Instance on Schoolyard	Inspected
Instance Condition	2 - Between Good and Fair
Deficiency	No deficiencies recorded
Running Track	Does not Exist
RETAINING WALLS	Inspected
Are there any Retaining Walls 6' OR higher facing public street/sidewalk?	Yes
Condition	3 - Fair
Deficiency	CAST IN PLACE CONCRETE: CRACKS/SPALLING - MAJOR
Deficiency Location/Instance	Along 42nd Street
Deficiency Quantity	40
Quantity Uom	S.F.
Potential Action	REPLACE
Urgency of Action	PRIORITY 3
Purpose of Action	LEVEL 2
Deficiency Photo1
