NYC Department of Education
Building Condition Assessment Survey 2023 - 2024

Architectural Inspection

Asset: P.S. 165 - BROOKLYN, 76 LOTT AVENUE, New York, 11212

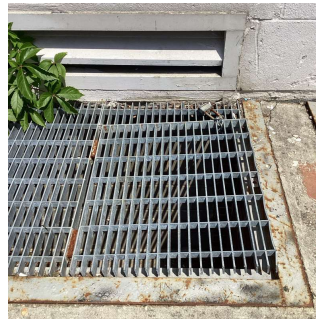
AW11

AREAWAY GRATINGS: MAJOR RUSTING / OR BROKEN

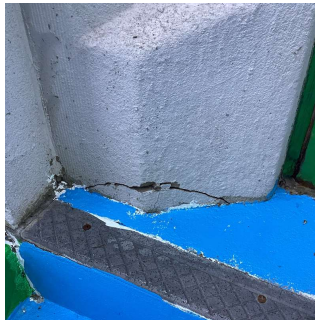
Facade D

CAST IN PLACE / PRE-CAST CONCRETE: MAJOR CRACKS/SPALLING

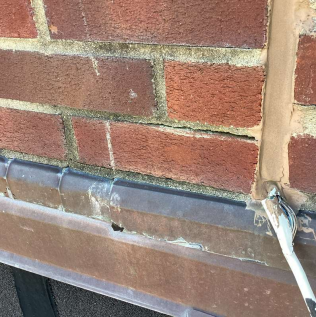
Question	Response
EXTERIOR	
PARAPETS	
Instance on All Facades	Inspected
Instance Condition	3 - Fair
Instance Quantity	9,000
Instance Quantity Uom	C.F.
Deficiency	BRICK: DETERIORATED JOINTS
Roof Plan reference	<p>K165</p>

<p>Thomas S. Boyland Street</p> <p>Amboy Street</p> <p>Lott Avenue</p>
Deficiency Quantity	10
Quantity Uom	S.F.
Potential Action	REPOINT
Urgency of Action	PRIORITY 4
Purpose of Action	LEVEL 2
Deficiency Photo1

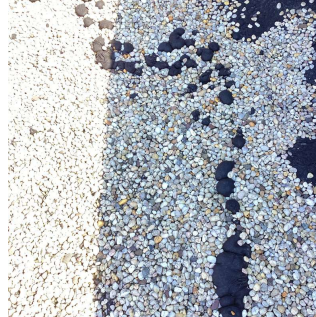
Roof 1
Instance Quantity	15,000
Instance Quantity Uom	S.F.
Does the roof have major mechanical equipment sitting on Dunnage Steel less than 18" above the Roofing?	No
Does this roof instance have a Sustainable Roof System?	No
Do solar panels exist on these roofs?	No
Is/Are the roof(s) suitable for Solar Panel installation?	Yes
Installation Year	2010
Source of Installation	Custodial Staff
Deficiency	BUILT-UP: ROOFING: DELAMINATION

Deficiency Quantity	60
Quantity Uom	S.F.
Potential Action	REPLACE ROOFING WITHOUT MAJOR EQUIPMENT REMOVAL
Urgency of Action	PRIORITY 5
Purpose of Action	LEVEL 4

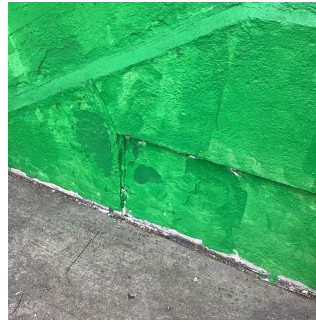
Facade D

STONE: BULGING/DISPLACED

30
 S.F.
 REPLACE
 PRIORITY 4
 LEVEL 2

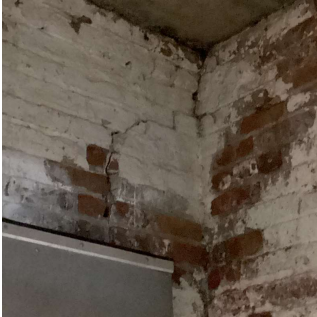
Question	Response
INTERIOR	
STRUCTURAL	
VAULTS-BUNKERS	
Foundation Walls	
Deficiency Photo1

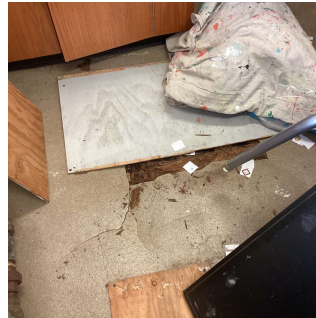
Room 402A

VINYL TILES: BROKEN/DETERIORATED/MISSING TILES

REPLACE

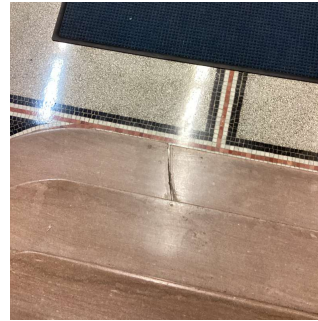
Main Entrance Lobby

Stairs and Landings

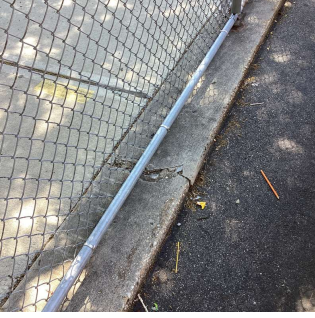
Violations	<p>Thomas S Boyland Street No violations recorded.</p>
Deficiency	CONCRETE CURB: DAMAGED/DETERIORATED
Deficiency Location/Instance	Thomas S Boyland Street, schoolyard, Amboy Street
Deficiency Quantity	180
Quantity Uom	S.F.
Potential Action	REPLACE
Urgency of Action	PRIORITY 3
Purpose of Action	LEVEL 2
Deficiency Photo1

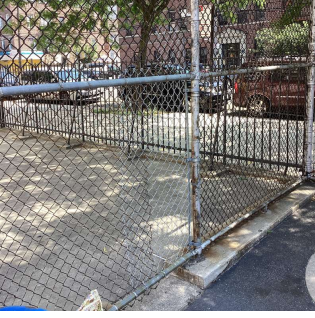
Violations	<p>Thomas S Boyland Street No violations recorded.</p>
Deficiency	CHAIN LINK: DAMAGED/DETERIORATED
Deficiency Location/Instance	Thomas S Boyland Street
Deficiency Quantity	200
Quantity Uom	S.F.
Potential Action	REPLACE
Urgency of Action	PRIORITY 3
Purpose of Action	LEVEL 2
Deficiency Photo1

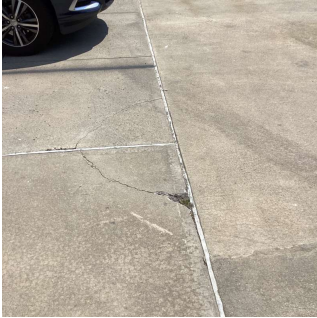
Question	Response
SITE	
IRRIGATION SYSTEM	Does not Exist
PAVING	Inspected
Student Non-Use	Inspected
Gravel Exists?	No
Asphalt	Does not Exist
Concrete	Inspected
Condition	3 - Fair
Deficiency	CRACKS - MAJOR
Deficiency Location/Instance	Parking Lot
Deficiency Quantity	75
Quantity Uom	S.F.
Potential Action	REPLACE
Urgency of Action	PRIORITY 3
Purpose of Action	LEVEL 2
Deficiency Photo1

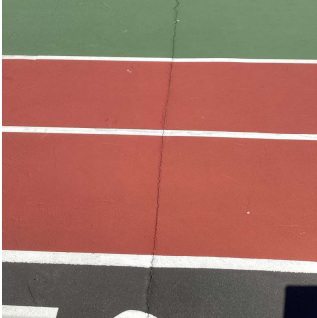
Parking Lot
Violations	No violations recorded.
Pavers	Does not Exist
Student Use	Inspected
Gravel Exists?	No
Asphalt	Inspected
Condition	4 - Between Fair and Poor
Deficiency	CRACKS - MAJOR
Deficiency Location/Instance	Schoolyard
Deficiency Quantity	800
Quantity Uom	S.F.
Potential Action	REPLACE
Urgency of Action	PRIORITY 3
Purpose of Action	LEVEL 2
Deficiency Photo1

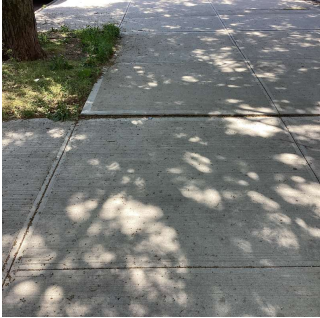
Question	Response
SITE	
PAVING	Inspected
Student Use	Inspected
Concrete	Inspected
Condition	2 - Between Good and Fair
Deficiency	No deficiencies recorded
Pavers	Does not Exist
Site Sidewalks & Walkways	Inspected
Asphalt	Does not Exist
Concrete	Inspected
Condition	2 - Between Good and Fair
Deficiency	No deficiencies recorded
Pavers	Does not Exist
DOT Sidewalk	Inspected
Asphalt	Does not Exist
Concrete	Inspected
Condition	3 - Fair
Deficiency	HEAVING
Deficiency Location/Instance	Thomas S Boyland Street, Amboy Street
Deficiency Quantity	100
Quantity Uom	S.F.
Potential Action	REPLACE
Urgency of Action	PRIORITY 3
Purpose of Action	LEVEL 2
Deficiency Photo1

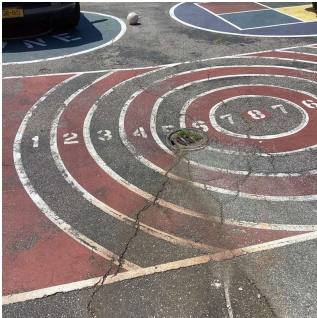
Lott Avenue
Violations	No violations recorded.
Pavers	Does not Exist
PLAYGROUNDS	Inspected
Instance on Amboy Street	Inspected
Benches	
Instance on Amboy Street	Inspected
Condition	2 - Between Good and Fair
Deficiency	No deficiencies recorded
Fence	
Instance on Amboy Street	Inspected
Condition	2 - Between Good and Fair
Deficiency	No deficiencies recorded
Pavement	
Instance on Amboy Street	Inspected
Condition	3 - Fair
Deficiency	ASPHALT: CRACKS - MAJOR
Deficiency Location/Instance	Near Entrance
Deficiency Quantity	200
Quantity Uom	S.F.
Potential Action	REPLACE
Urgency of Action	PRIORITY 3
Purpose of Action	LEVEL 2
Deficiency Photo1

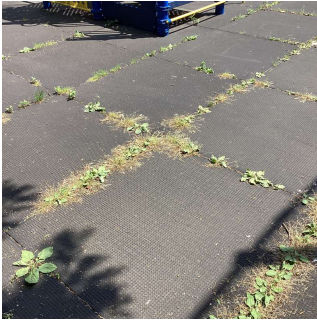
Question	Response
SITE	
PLAYGROUNDS	
Play Equipment	
Deficiency	No deficiencies recorded
Safety Surfacing	
Instance on Amboy Street	Inspected
Condition	3 - Fair
Deficiency	DETERIORATED/MISSING
Deficiency Location/Instance	Rear
Deficiency Quantity	100
Quantity Uom	S.F.
Potential Action	REPLACE
Urgency of Action	PRIORITY 3
Purpose of Action	LEVEL 2
Deficiency Photo1

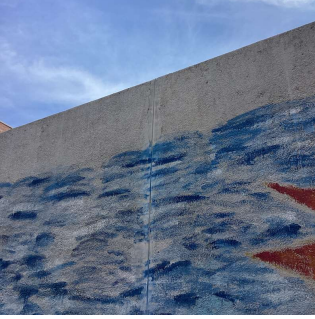
Rear
Violations	No violations recorded.
Unpaved Area	
Instance on Amboy Street	Does not Exist
PLAYING SURFACE	Does not Exist
RETAINING WALLS	Does not Exist
SEATING	Inspected
Benches	Inspected
Concrete	Does not Exist
Metal/Wood/Plastic	Inspected
Condition	2 - Between Good and Fair
Deficiency	No deficiencies recorded
Bleachers	Does not Exist
SITE WALLS (NOT RETAINING WALLS)	Inspected
Condition	3 - Fair
Deficiency	CAST IN PLACE CONCRETE: CRACKS/SPALLING - MAJOR
Deficiency Location/Instance	Playground Area
Deficiency Quantity	40
Quantity Uom	S.F.
Potential Action	REPLACE

Urgency of Action	PRIORITY 3
Purpose of Action	LEVEL 2
