NYC Department of Education
Building Condition Assessment Survey 2023 - 2024

Architectural Inspection

Asset: P.S. 167 - BROOKLYN, 1025 EASTERN PKWY, New York, 11213

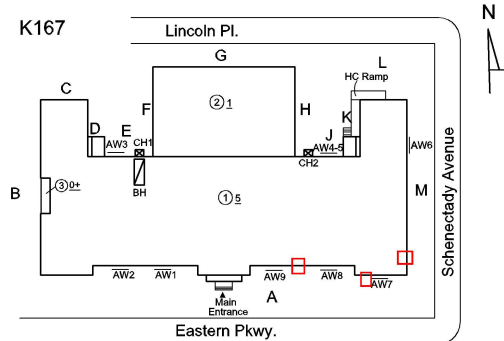
Roof Plan reference

Deficiency

CAST IN PLACE / PRE-CAST CONCRETE: MINOR
CRACKS/SPALLING

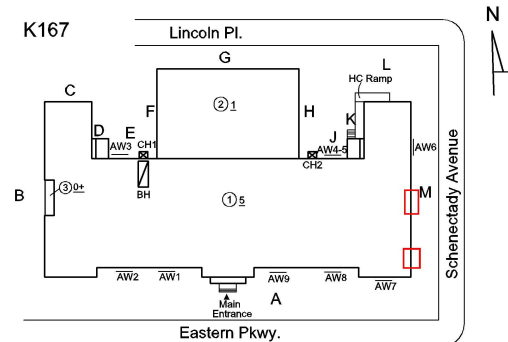
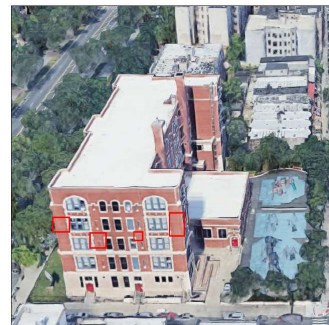
Roof Plan reference

Deficiency

BRICK: EFFLORESCENCE

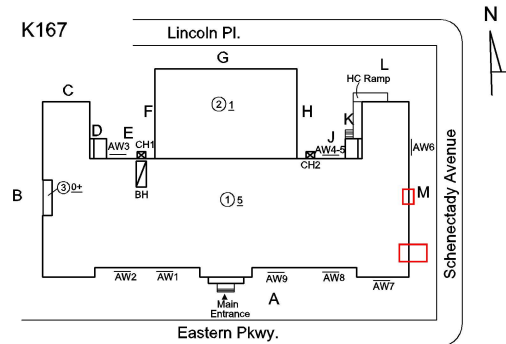
Roof Plan reference

Deficiency

BRICK: DETERIORATED JOINTS

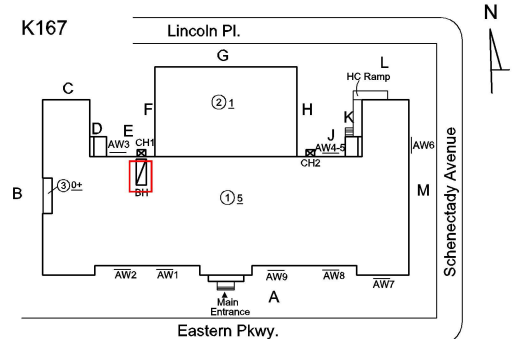
Question	Response
EXTERIOR	
ROOF	
Specialties	Inspected
BULKHEAD/PENTHOUSE	Inspected
Condition	3 - Fair
Deficiency	BULKHEAD/PENTHOUSE CEILING: PLASTER DAMAGED/DETERIORATED
Roof Plan reference

Deficiency Quantity	20
Quantity Uom	S.F.
Potential Action	REPLACE
Urgency of Action	PRIORITY 4
Purpose of Action	LEVEL 2
Deficiency Photo1

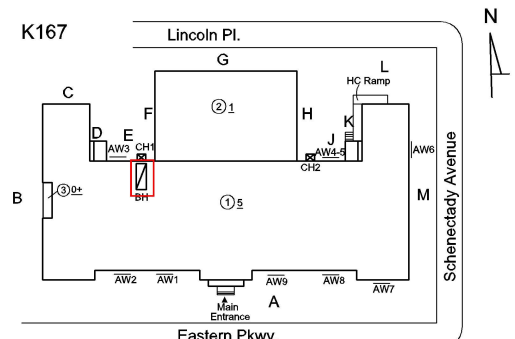
Violations	No violations recorded.
Deficiency	BULKHEAD/PENTHOUSE WALLS/INTERIOR: PLASTER CRACKS/SPALLING
Roof Plan reference

Deficiency Quantity	40
Quantity Uom	S.F.
Potential Action	REPLACE
Urgency of Action	PRIORITY 3
Purpose of Action	LEVEL 2

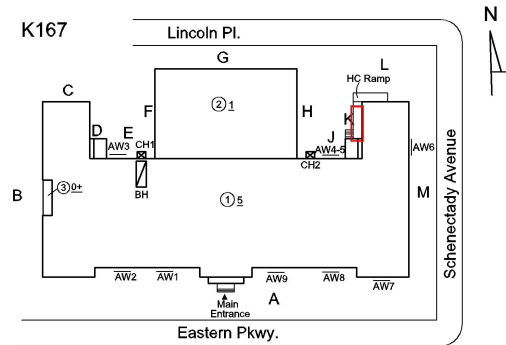
Roof Plan reference

Deficiency

STONE: DETERIORATED COPING STONE

REPLACE

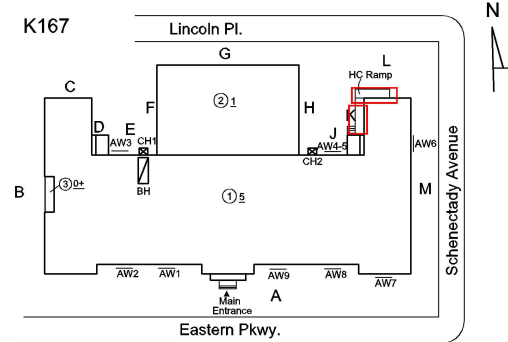
Roof Plan reference

Deficiency

STONE: CRACKS/SPALLING - MAJOR

REPLACE

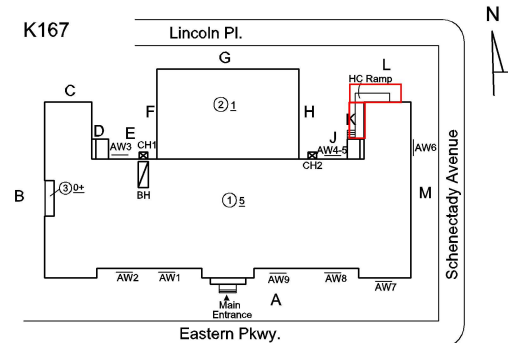
Roof Plan reference

Deficiency

STONE: DETERIORATED JOINTS

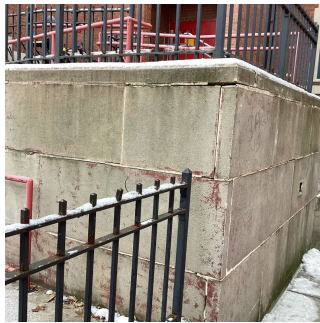
Question	Response
EXTERIOR	
STAIRS/RAMPS: EXTERIOR	
BUILDING CHEEK/FLANK WALLS	
Deficiency Photo1

Violations	Facade L - HC Ramp No violations recorded.
RAILINGS	Inspected
Condition	2 - Between Good and Fair
Deficiency	No deficiencies recorded
STAIRS/RAMPS	Inspected
Condition	5 - Poor
Deficiency	STONE: WORN-OUT TREAD/RISER/NOSING
Roof Plan reference

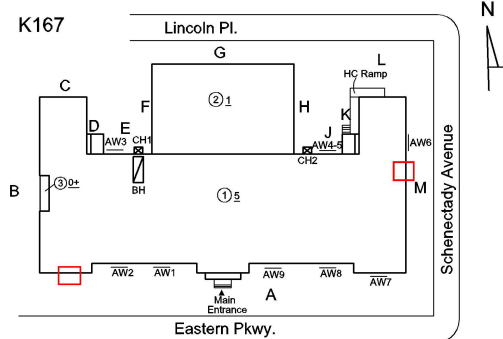
Deficiency Quantity	70
Quantity Uom	S.F.
Potential Action	REPLACE
Urgency of Action	PRIORITY 4
Purpose of Action	LEVEL 2
Deficiency Photo1

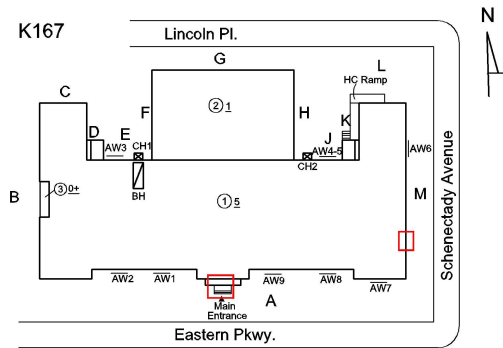
Roof Plan reference

Violations	Facade M - Exit 9 No violations recorded.
Deficiency	CONCRETE: CRACKS/SPALLING - MINOR

50
S.F.
REPAIR
PRIORITY 3
LEVEL 2

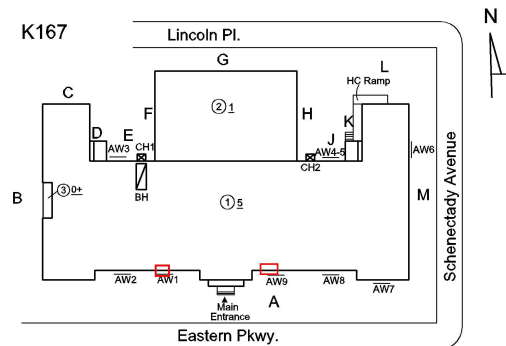
Roof Plan reference

Deficiency

DETERIORATED/TORN-OUT/MISSING

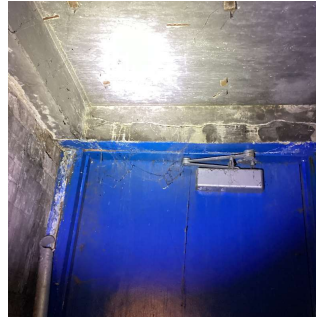
Ash Hoist Vault

Deficiency

CONCRETE: CRACKS/SPALLED/REINFORCEMENT EXPOSED

REPAIR

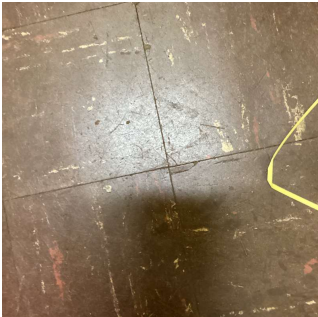
Seat C/1
Violations	No violations recorded.
Floor Finish	
Instance on Ground Floor (500 Seats)	Inspected
Condition	2 - Between Good and Fair
Deficiency	VINYL TILES: BROKEN/DETERIORATED/MISSING TILES
Deficiency Location/Instance	Storage
Deficiency Quantity	10
Quantity Uom	S.F.
Potential Action	REPLACE
Urgency of Action	PRIORITY 3
Purpose of Action	LEVEL 2
Deficiency Photo1

Storage
Violations	No violations recorded.
Deficiency	TERRAZZO: CRACKS
Deficiency Location/Instance	Exit 5, exit 6
Deficiency Quantity	20
Quantity Uom	S.F.
Potential Action	REPLACE
Urgency of Action	PRIORITY 3
Purpose of Action	LEVEL 2

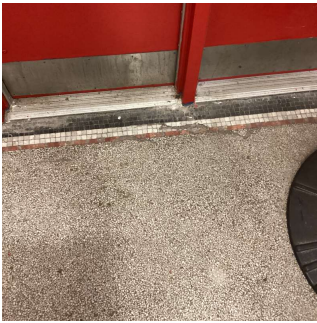
Exit 5
Violations	No violations recorded.
Sliding-folding Partition	
Instance on Ground Floor (500 Seats)	Does not Exist
Stage	
Instance on Ground Floor (500 Seats)	Inspected
Stage	
Instance on Ground Floor (500 Seats)	Inspected
Condition	2 - Between Good and Fair
Deficiency	DAMAGED FLOOR
Deficiency Location/Instance	Left side
Deficiency Quantity	10
Quantity Uom	S.F.
Potential Action	REPLACE
Urgency of Action	PRIORITY 3
Purpose of Action	LEVEL 2
Deficiency Photo1

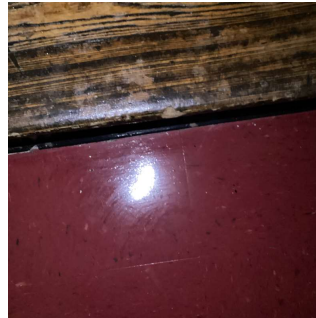
Left side
Violations	No violations recorded.
Deficiency	DAMAGED STEPS
Deficiency Location/Instance	Right side
Deficiency Quantity	10
Quantity Uom	S.F.
Potential Action	REPLACE
Urgency of Action	PRIORITY 3
Purpose of Action	LEVEL 2

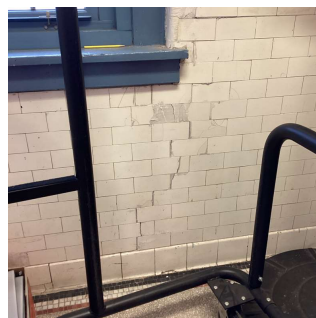
Deficiency

CERAMIC TILE: BROKEN/ MISSING

REPLACE

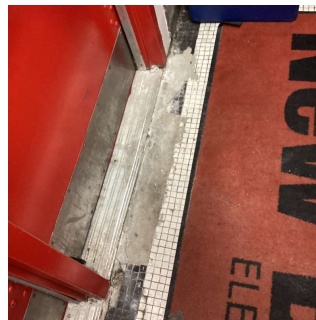
Deficiency

CERAMIC TILE: BROKEN/MISSING TILES

REPLACE

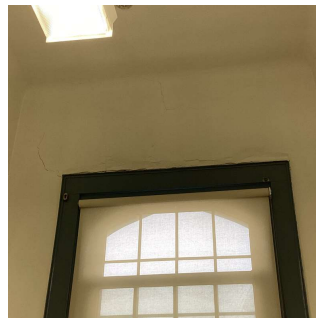
Deficiency

PLASTER: CRACKS/SPALLING

REPLACE

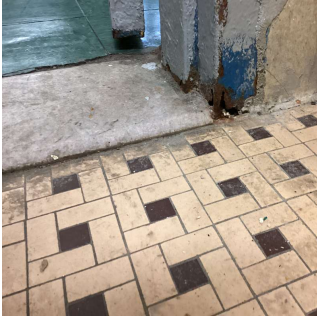
Question	Response
INTERIOR	
CLASSROOMS/CORRIDORS/ADMIN SPACES	Inspected
Walls	Inspected
Violations	Room 414 No violations recorded.
Specialties	Does not Exist
GYMNASIUM	Does not Exist
INTERIOR DOOR HARDWARE	Inspected
Condition	3 - Fair
Deficiency	No deficiencies recorded
INTERIOR GUARDS	Inspected
Condition	2 - Between Good and Fair
Deficiency	No deficiencies recorded
KITCHEN	Inspected
Instance on Ground Floor	Inspected
Ceiling	
Instance on Ground Floor	Inspected
Condition	2 - Between Good and Fair
Deficiency	No deficiencies recorded
Door(s)	
Instance on Ground Floor	Inspected
Condition	4 - Between Fair and Poor
Deficiency	METAL: DETERIORATED DOOR AND FRAME
Deficiency Location/Instance	Slop sink area
Deficiency Quantity	1
Quantity Uom	EACH
Potential Action	MAINTENANCE
Urgency of Action	PRIORITY 3
Purpose of Action	LEVEL 2
Deficiency Photo1

Violations	Slop sink area No violations recorded.
Deficiency	METAL: DETERIORATED DOOR

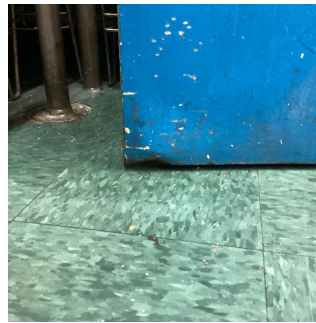
Deficiency Location/Instance	Entrance
Deficiency Quantity	1
Quantity Uom	EACH
Potential Action	MAINTENANCE
Urgency of Action	PRIORITY 3
Purpose of Action	LEVEL 2

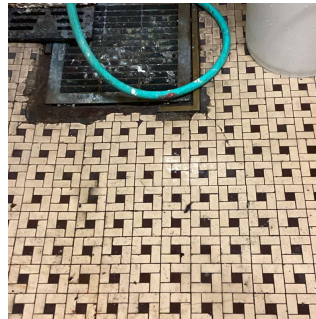
Condition	2 - Between Good and Fair
-----------	---------------------------

Deficiency CERAMIC TILE: BROKEN/MISSING TILES

Deficiency Location/Instance Slop sink area

Deficiency Quantity 10

Potential Action REPLACE

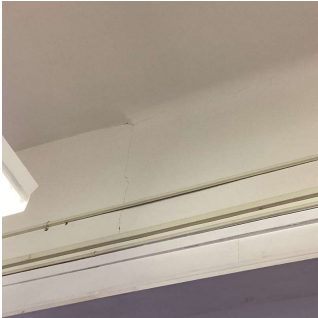
Question	Response
INTERIOR	
LIBRARY	Inspected
Walls	
Deficiency	PLASTER: CRACKS/SPALLING
Deficiency Location/Instance	Near center, windows
Deficiency Quantity	20
Quantity Uom	S.F.
Potential Action	REPLACE
Urgency of Action	PRIORITY 3
Purpose of Action	LEVEL 2
Deficiency Photo1

Violations	Near center No violations recorded.
LOCKER ROOM	Does not Exist
MULTI-PURPOSE ROOM	Inspected
Instance on Ground Floor	Inspected
Ceiling	
Instance on Ground Floor	Inspected
Condition	2 - Between Good and Fair
Deficiency	ACOUSTIC TILES ON PLASTER: DAMAGED/MISSING
Deficiency Location/Instance	Near Entrance, center
Deficiency Quantity	20
Quantity Uom	S.F.
Potential Action	REPLACE
Urgency of Action	PRIORITY 3
Purpose of Action	LEVEL 2
Deficiency Photo1

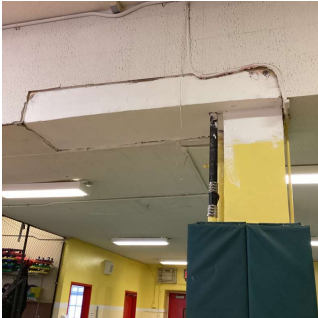
Violations	Near center No violations recorded.
Door(s)	
Instance on Ground Floor	Inspected
Condition	2 - Between Good and Fair
Deficiency	No deficiencies recorded
Fixed Equipment

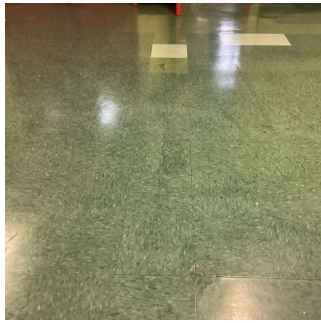
Near stair EF/Ground Floor

Instance on Ground Floor	Inspected
Condition	2 - Between Good and Fair
Deficiency	VINYL TILES: DETERIORATED SUBSTRATE
Deficiency Location/Instance	Near stair EF/Ground Floor, near exit 9, exit 10
Deficiency Quantity	50
Quantity Uom	S.F.
Potential Action	REPLACE
Urgency of Action	PRIORITY 3
Purpose of Action	LEVEL 2
Deficiency Photo1

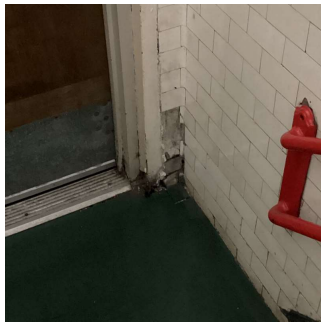
Instance on Ground Floor	Inspected
Condition	3 - Fair
Deficiency	CERAMIC TILE: BROKEN/ MISSING
Deficiency Location/Instance	Exit 10
Deficiency Quantity	10
Quantity Uom	S.F.
Potential Action	REPLACE
Urgency of Action	PRIORITY 3
Purpose of Action	LEVEL 2
Deficiency Photo1

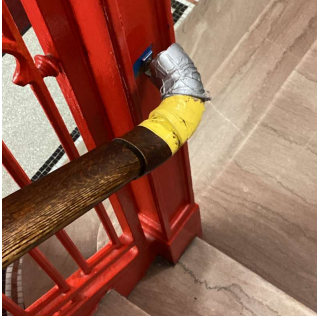
Question	Response
INTERIOR	
STAIRS/RAMPS: INTERIOR	
Ceiling	Inspected
Condition	2 - Between Good and Fair
Deficiency	No deficiencies recorded
Door(s)	Inspected
Condition	2 - Between Good and Fair
Deficiency	No deficiencies recorded
Partition	Does not Exist
Railings	Inspected
Condition	4 - Between Fair and Poor
Deficiency	WOOD: DAMAGED
Deficiency Location/Instance	Main Lobby Stairs
Deficiency Quantity	10
Quantity Uom	L.F.
Potential Action	REPLACE
Urgency of Action	PRIORITY 3
Purpose of Action	LEVEL 2
Deficiency Photo1

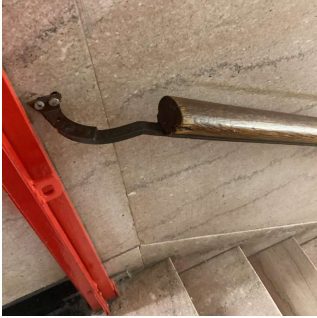
Violations	Main Lobby Stairs No violations recorded.
Deficiency	WOOD: MISSING
Deficiency Location/Instance	Main Lobby Stairs
Deficiency Quantity	10
Quantity Uom	L.F.
Potential Action	REPLACE
Urgency of Action	PRIORITY 5
Purpose of Action	LEVEL 6
Deficiency Photo1

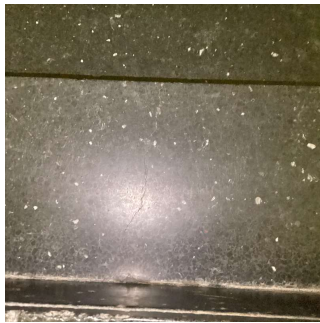
Question	Response
INTERIOR	
STAIRS/RAMPS: INTERIOR	
Stairs and Landings	
Deficiency Location/Instance	Stair EF/1,2,AB/1,2
Deficiency Quantity	20
Quantity Uom	S.F.
Potential Action	REPLACE
Urgency of Action	PRIORITY 3
Purpose of Action	LEVEL 2
Deficiency Photo1	 
Violations	Stair EF/1 No violations recorded.
Deficiency	STONE: BROKEN/MISSING
Deficiency Location/Instance	Exit 10, Main Lobby Stairs
Deficiency Quantity	50
Quantity Uom	S.F.
Potential Action	REPLACE
Urgency of Action	PRIORITY 3
Purpose of Action	LEVEL 2
Deficiency Photo1	 
Violations	Main Lobby Stairs No violations recorded.
Deficiency	TERRAZZO: CRACKS
Deficiency Location/Instance	Exit 6
Deficiency Quantity	10
Quantity Uom	S.F.
Potential Action	REPLACE
Urgency of Action	PRIORITY 3
Purpose of Action	LEVEL 2

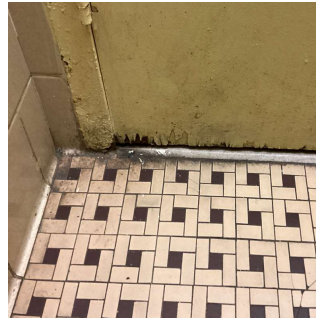
Kitchen Staff

WOOD: DETERIORATED DOOR

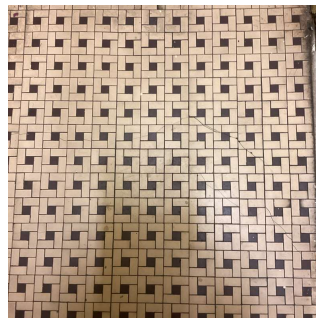
CERAMIC TILE: BROKEN/MISSING TILES

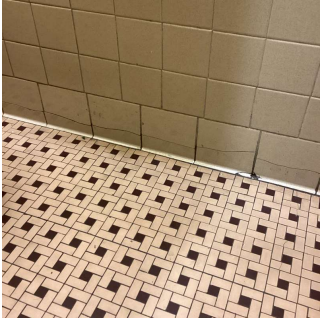
Question	Response
INTERIOR	
TOILET ROOMS - STAFF	
Floor Finish	Inspected
	Kitchen Staff
Violations	No violations recorded.
Stalls	Does not Exist
Walls	Inspected
Condition	2 - Between Good and Fair
Deficiency	CERAMIC TILE: BROKEN/ MISSING
Deficiency Location/Instance	Kitchen Staff,107,152,252
Deficiency Quantity	25
Quantity Uom	S.F.
Potential Action	REPLACE
Urgency of Action	PRIORITY 3
Purpose of Action	LEVEL 2
Deficiency Photo1

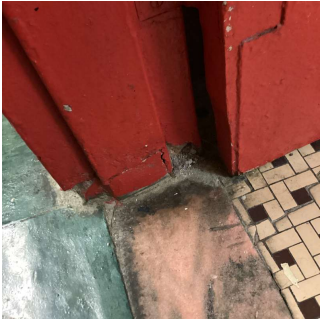
Ground Floor - Boys

Violations	Kitchen Staff No violations recorded.
TOILET ROOMS - STUDENTS	
	Inspected
Ceiling	Inspected
Condition	2 - Between Good and Fair
Deficiency	No deficiencies recorded
Door(s)	Inspected
Condition	5 - Poor
Deficiency	WOOD: DETERIORATED DOOR AND FRAME
Deficiency Location/Instance	Ground Floor - Boys,Girls
Deficiency Quantity	2
Quantity Uom	EACH
Potential Action	MAINTENANCE
Urgency of Action	PRIORITY 3
Purpose of Action	LEVEL 2
Deficiency Photo1

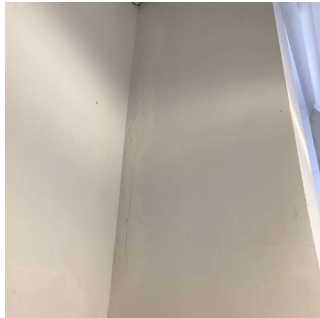
Room 250
Violations	No violations recorded.
Deficiency	PLASTER: CRACKS/SPALLING
Deficiency Location/Instance	Room 450,250, Ground Floor - Boys,Girls
Deficiency Quantity	30
Quantity Uom	S.F.
Potential Action	REPLACE
Urgency of Action	PRIORITY 3
Purpose of Action	LEVEL 2
Deficiency Photo1

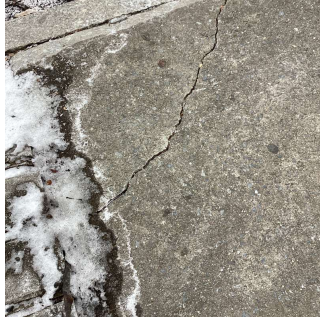
Question	Response
SITE	
PAVING	
Site Sidewalks & Walkways	
Concrete	
Deficiency Photo1	 
	Main Entrance
Violations	No violations recorded.
Pavers	Does not Exist
DOT Sidewalk	Inspected
Asphalt	Does not Exist
Concrete	Inspected
Condition	4 - Between Fair and Poor
Deficiency	DAMAGED CURBS
Deficiency Location/Instance	Along Eastern Parkway, Schenectady Avenue
Deficiency Quantity	60
Quantity Uom	L.F.
Potential Action	REPLACE
Urgency of Action	PRIORITY 3
Purpose of Action	LEVEL 2
Deficiency Photo1	 
	Along Eastern Parkway
Violations	No violations recorded.
Deficiency	DAMAGED/DETERIORATED/MISSING SECTIONS
Deficiency Location/Instance	Along Eastern Parkway, Schenectady Avenue
Deficiency Quantity	450
Quantity Uom	S.F.
Potential Action	REPLACE
Urgency of Action	PRIORITY 3
Purpose of Action	LEVEL 2

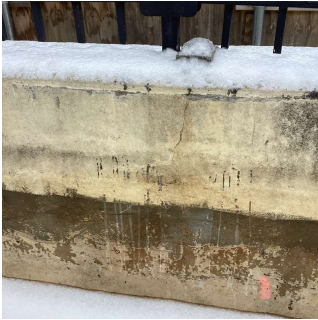
Violations	Along Eastern Parkway No violations recorded.
Pavers	Does not Exist
PLAYGROUNDS	Inspected
Instance on Schoolyard	Inspected
Benches	
Instance on Schoolyard	Does not Exist
Fence	
Instance on Schoolyard	Does not Exist
Pavement	
Instance on Schoolyard	Does not Exist
Play Equipment	
Instance on Schoolyard	Under Construction
Safety Surfacing	
Instance on Schoolyard	Under Construction
Unpaved Area	
Instance on Schoolyard	Does not Exist
PLAYING SURFACE	Does not Exist
RETAINING WALLS	Inspected
Are there any Retaining Walls 6' OR higher facing public street/sidewalk?	No
Condition	2 - Between Good and Fair
Deficiency	CAST IN PLACE CONCRETE: CRACKS/SPALLING - MAJOR
Deficiency Location/Instance	Schoolyard
Deficiency Quantity	10
Quantity Uom	S.F.
Potential Action	REPLACE
Urgency of Action	PRIORITY 3
Purpose of Action	LEVEL 2

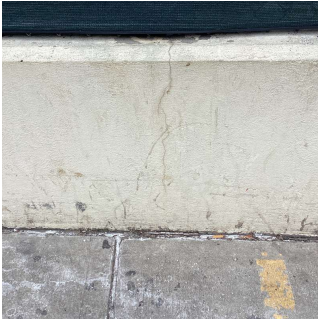
Violations	Schoolyard No violations recorded.
SEATING	Inspected
Benches	Inspected
Concrete	Does not Exist
Metal/Wood/Plastic	Inspected
Condition	2 - Between Good and Fair
Deficiency	No deficiencies recorded
Bleachers	Does not Exist
SITE WALLS (NOT RETAINING WALLS)	Inspected
Condition	3 - Fair
Deficiency	CAST IN PLACE CONCRETE: CRACKS/SPALLING - MAJOR
Deficiency Location/Instance	Along Schenectady Avenue, Schoolyard
Deficiency Quantity	25
Quantity Uom	S.F.
Potential Action	REPLACE
Urgency of Action	PRIORITY 3
Purpose of Action	LEVEL 2
Deficiency Photo1
