NYC Department of Education
Building Condition Assessment Survey 2023 - 2024

Architectural Inspection

Asset: P.S. 169 - BROOKLYN, 4305 7TH AVENUE, New York, 11232

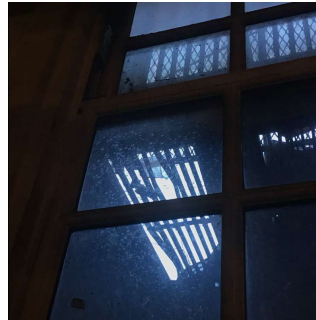
AW1
No violations recorded.

Instance on AW1	Inspected
Instance Condition	3 - Fair
Instance Quantity	1
Instance Quantity Uom	EACH
Deficiency	AREAWAY GRATINGS: MAJOR RUSTING / OR BROKEN
Roof Plan reference

30
S.F.
REPLACE
PRIORITY 4
LEVEL 2

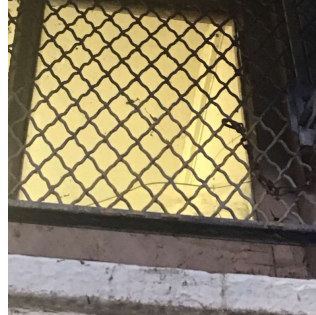
Facade B

WOOD: BROKEN GLASS

40
S.F.
MAINTENANCE

PRIORITY 3
LEVEL 2

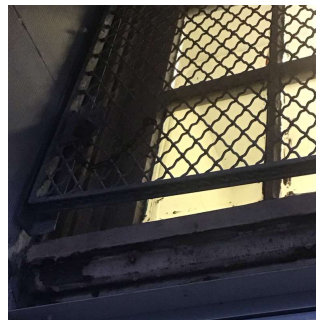
Facade B

WOOD: EXCESSIVELY WEATHERED

80
S.F.
REPAIR
PRIORITY 3
LEVEL 2

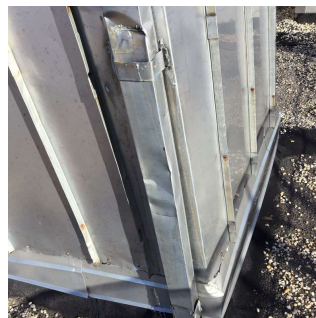
SK

Question	Response
EXTERIOR	
EXTERIOR SOFFITS	Does not Exist
LOADING DOCK	Does not Exist
LOUVER	Inspected
Condition	2 - Between Good and Fair
Deficiency	No deficiencies recorded
PARAPETS	Inspected
Material Type(s)	Masonry
Replacement Quantity	7,000
Replacement Uom	C.F.
Instance on All Roofs	Under Construction
Instance Quantity	7,000
Instance Quantity Uom	C.F.
PLAZA DECK	Inspected
Instance on Concrete: Roof 5	Under Construction
Instance Quantity	4,000
Instance Quantity Uom	S.F.
ROOF	Inspected
Roofing	Inspected
Replacement Quantity	27,200
Replacement Uom	S.F.
ROOF HATCH/SMOKE HATCH	Inaccessible
LEADERS, GUTTERS, DOWNSPOUTS, SCUPPERS	Inspected
Condition	3 - Fair
Deficiency	DAMAGED/MISSING
Roof Plan reference

10
L.F.
REPLACE
PRIORITY 4
LEVEL 2

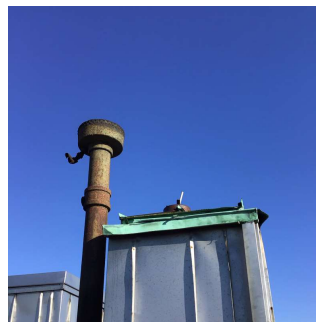
Violations	SK No violations recorded.
Deficiency	BROKEN FRAMING

SKYLIGHT/ROOF VENT

10
 L.F.
 MAINTENANCE
 PRIORITY 3
 LEVEL 2

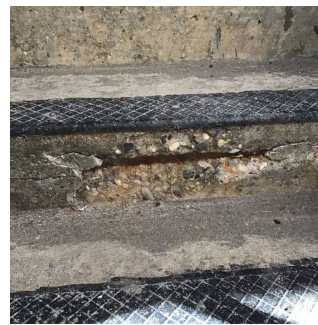
Question	Response
EXTERIOR	
STAIRS/RAMPS: EXTERIOR	
BUILDING CHEEK/FLANK WALLS	
Deficiency Photo1	 
Violations	Facade B No violations recorded.
RAILINGS	
Condition	Inspected 2 - Between Good and Fair
Deficiency	No deficiencies recorded
STAIRS/RAMPS	
Condition	Inspected 5 - Poor
Deficiency	CONCRETE: CRACKS/SPALLING - MINOR
Roof Plan reference	 
Deficiency Quantity	30
Quantity Uom	S.F.
Potential Action	REPAIR
Urgency of Action	PRIORITY 3
Purpose of Action	LEVEL 2
Deficiency Photo1	 
Violations	Facade B No violations recorded.
Deficiency	CONCRETE: CRACKS/SPALLING - MAJOR

STAIRS/RAMPS

30
S.F.
REPLACE
PRIORITY 4
LEVEL 2

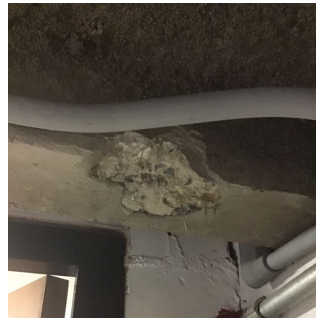
Basement (1937 Addition) - Room 123A

STEEL COLUMNS/BEAMS: DETERIORATED CONCRETE FIREPROOFING

REPLACE

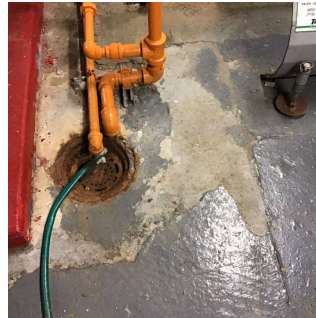
Basement (Original Building) - Fan Room, Gas Meter Room

CONCRETE SLAB ON GRADE: THRU CRACKS

REPLACE

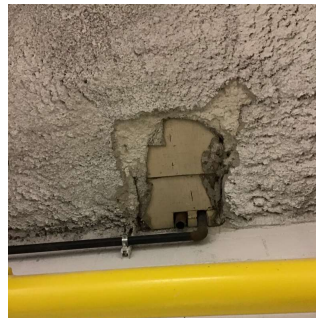
Basement (Original Building) - Gas Meter Room

CONCRETE: CRACKS/SPALLED/REINFORCEMENT EXPOSED

REPAIR

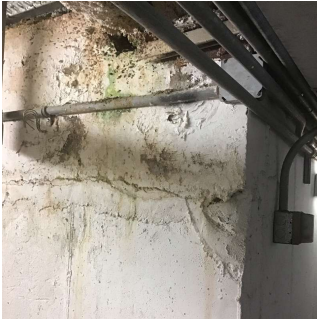
Question	Response
INTERIOR	
STRUCTURAL	
FOUNDATION WALLS	Inspected
Material Type(s)	Concrete
Condition	4 - Between Fair and Poor
Deficiency	CONCRETE: CRACKED/SPALLED/REINFORCEMENT EXPOSED
Deficiency Location/Instance	Basement (1937 Addition) - Room 123A, Basement (1937 Addition) - Mechanical Room
Deficiency Quantity	50
Quantity Uom	S.F.
Potential Action	REPAIR
Urgency of Action	PRIORITY 4
Purpose of Action	LEVEL 5
Deficiency Photo1

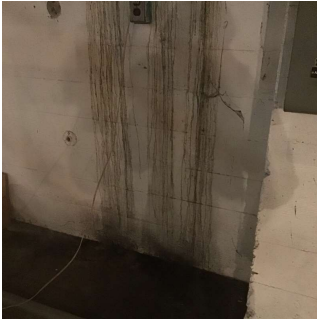
Violations	Basement (1937 Addition) - Room 123A No violations recorded.
Deficiency	CONCRETE: WATER INFILTRATION IN NON- INSTRUCTIONAL SPACE
Deficiency Location/Instance	Basement (1937 Addition) - Mechanical Room
Deficiency Quantity	100
Quantity Uom	S.F.
Potential Action	INSTALL WATERPROOFING
Urgency of Action	PRIORITY 5
Purpose of Action	LEVEL 5
Deficiency Photo1

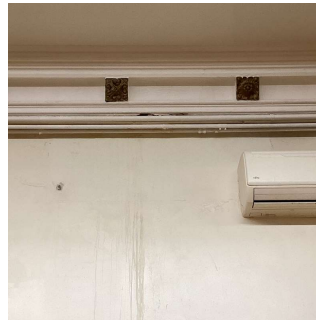
Instance on 2nd Floor (600 Seats)	Inspected
Condition	2 - Between Good and Fair
Deficiency	PLASTER: CRACKS/SPALLING
Deficiency Location/Instance	Right Side
Deficiency Quantity	20
Quantity Uom	S.F.
Potential Action	REPLACE
Urgency of Action	PRIORITY 3
Purpose of Action	LEVEL 2
Deficiency Photo1

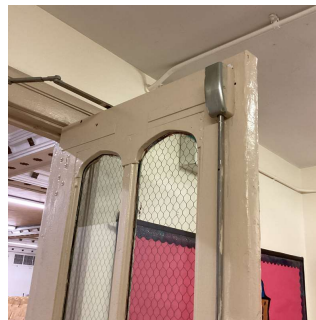
Right Side Exit

Instance on 2nd Floor (600 Seats)	Inspected
Condition	5 - Poor
Deficiency	METAL CLAD WOOD: DETERIORATED DOOR
Deficiency Location/Instance	Right Side Exit, Right and Center Main Entrance
Deficiency Quantity	4
Quantity Uom	EACH
Potential Action	MAINTENANCE
Urgency of Action	PRIORITY 3
Purpose of Action	LEVEL 2
Deficiency Photo1

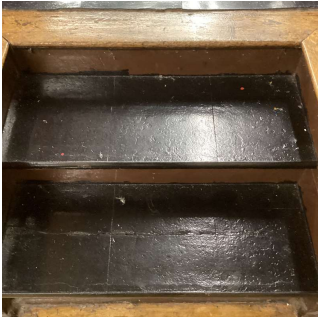
Question	Response
INTERIOR	
AUDITORIUM	
Stage	
Stage	
Deficiency Photo1	 
Violations	Right Side No violations recorded.
Deficiency	DAMAGED STEPS
Deficiency Location/Instance	Right and Left Side
Deficiency Quantity	20
Quantity Uom	S.F.
Potential Action	REPLACE
Urgency of Action	PRIORITY 3
Purpose of Action	LEVEL 2
Deficiency Photo1

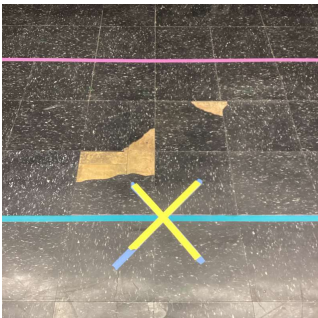
Violations	Center

Violations	Left Side No violations recorded.
Deficiency	DAMAGED FLOOR
Deficiency Location/Instance	Right, Center and Left Side
Deficiency Quantity	30
Quantity Uom	S.F.
Potential Action	REPLACE
Urgency of Action	PRIORITY 3
Purpose of Action	LEVEL 2
Deficiency Photo1

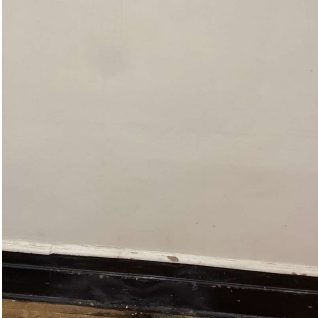
Question	Response
INTERIOR	
AUDITORIUM	
Stage	
Stage	Inspected
Violations	No violations recorded.
Stage Curtain Rigging	
Stage Curtain Rigging	Inspected
Instance on 2nd Floor (600 Seats)	Inspected
Condition	1 - Good
Deficiency	No deficiencies recorded
Stage Curtains	
Stage Curtains	Inspected
Instance on 2nd Floor (600 Seats)	Inspected
Condition	1 - Good
Deficiency	No deficiencies recorded
Walls	
Instance on 2nd Floor (600 Seats)	Inspected
Condition	2 - Between Good and Fair
Deficiency	PLASTER: CRACKS/SPALLING
Deficiency Location/Instance	Right Side
Deficiency Quantity	10
Quantity Uom	S.F.
Potential Action	REPLACE
Urgency of Action	PRIORITY 3
Purpose of Action	LEVEL 2
Deficiency Photo1

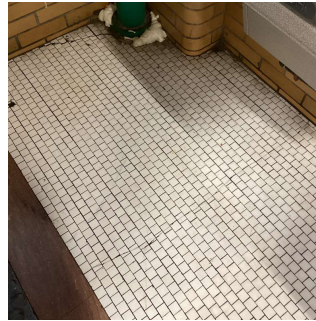
Question	Response
INTERIOR	
CAFETERIA	
Ceiling	
Deficiency Photo1	 
Violations	Near Main Entrance No violations recorded.
Door(s)	
Instance on 1st Floor	Inspected
Condition	4 - Between Fair and Poor
Deficiency	WOOD: DETERIORATED DOOR
Deficiency Location/Instance	Main Entrance
Deficiency Quantity	2
Quantity Uom	EACH
Potential Action	MAINTENANCE
Urgency of Action	PRIORITY 3
Purpose of Action	LEVEL 2
Deficiency Photo1	 
Violations	Main Entrance No violations recorded.
Fixed Equipment	
Instance on 1st Floor	Does not Exist
Floor Finish	
Instance on 1st Floor	Inspected
Condition	3 - Fair
Deficiency	CERAMIC TILE: DETERIORATED SUBSTRATE
Deficiency Location/Instance	Right Side near Windows
Deficiency Quantity	10
Quantity Uom	S.F.
Potential Action	REPLACE
Urgency of Action	PRIORITY 3
Purpose of Action	LEVEL 2

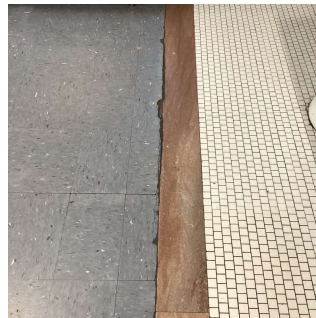
Right Side near Windows

VINYL TILES: BROKEN/DETERIORATED/MISSING TILES

REPLACE

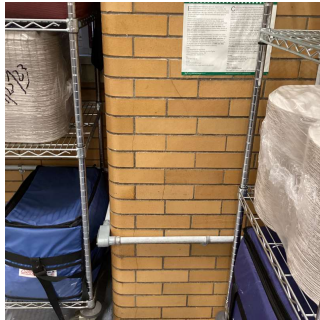
Question	Response
INTERIOR	
CAFETERIA	
Sliding-folding Partition	
Instance on 1st Floor	Does not Exist
Stage	
Instance on 1st Floor	Does not Exist
Walls	
Instance on 1st Floor	Inspected
Condition	2 - Between Good and Fair
Deficiency	SALT GLAZED BRICK: CRACKS/SPALLING
Deficiency Location/Instance	Left Side near Windows, Right Side, near Stair D/1, by Main Entrance
Deficiency Quantity	70
Quantity Uom	S.F.
Potential Action	REPLACE
Urgency of Action	PRIORITY 3
Purpose of Action	LEVEL 2
Deficiency Photo1

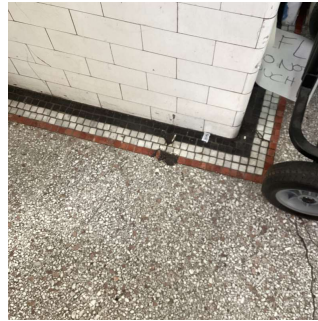
Near Exit 10

Violations	Room 241B No violations recorded.
Deficiency	CERAMIC TILE: BROKEN/MISSING TILES
Deficiency Location/Instance	Near Exit 10, Main Entrance - Vestibule
Deficiency Quantity	20
Quantity Uom	S.F.
Potential Action	REPLACE
Urgency of Action	PRIORITY 3
Purpose of Action	LEVEL 2

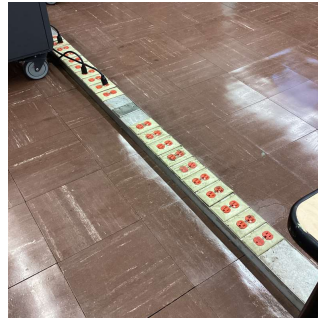
Room 343

VINYL TILES: TRIPPING HAZARD - ELECTRICAL OUTLET

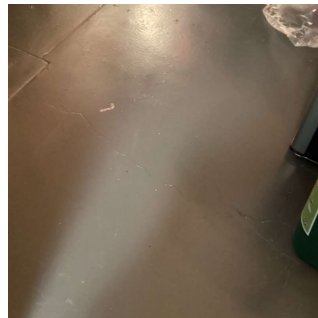
Room 531

CONCRETE: CRACKS

REPLACE

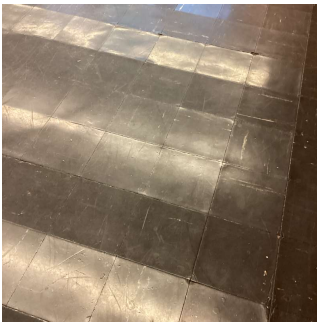
Question	Response
INTERIOR	
CLASSROOMS/CORRIDORS/ADMIN SPACES	
Floor Finish	
Deficiency Deficiency Location/Instance Deficiency Quantity Quantity Uom Potential Action Urgency of Action Purpose of Action Deficiency Photo1	TERRAZZO: CRACKS Near Exit 10, Main Entrance 80 S.F. REPLACE PRIORITY 3 LEVEL 2  
Violations	Near Exit 10 No violations recorded.
Deficiency Deficiency Location/Instance Deficiency Quantity Quantity Uom Potential Action Urgency of Action Purpose of Action Deficiency Photo1	VINYL TILES: DETERIORATED SUBSTRATE Corridor near Rooms 529, 142, 139, By Cafeteria, next to Girls Toilet Room - 4th Floor and others 600 S.F. REPLACE PRIORITY 3 LEVEL 2  
Violations	Corridor near Room 139 No violations recorded.
Deficiency Deficiency Location/Instance Deficiency Quantity Quantity Uom Potential Action Urgency of Action Purpose of Action	VINYL TILES: BROKEN/DETERIORATED/MISSING TILES Rooms 541, 520, 421, 144, 142 and others 2,000 S.F. REPLACE PRIORITY 3 LEVEL 2

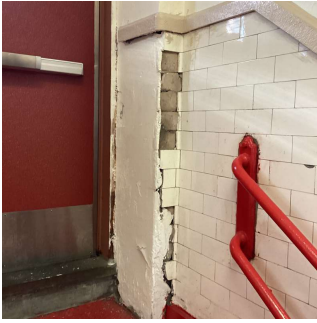
Violations	Room 421 No violations recorded.
Walls	
Condition	Inspected 2 - Between Good and Fair
Deficiency	CERAMIC TILE: BROKEN/ MISSING
Deficiency Location/Instance	Corridor near Plaza Deck - 3rd Floor, by Exit 10
Deficiency Quantity	60
Quantity Uom	S.F.
Potential Action	REPLACE
Urgency of Action	PRIORITY 3
Purpose of Action	LEVEL 2
Deficiency Photo1

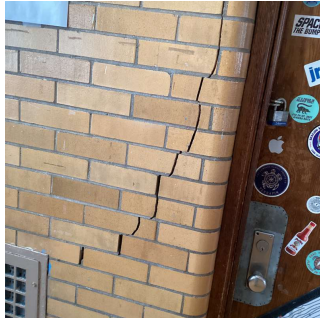
Question	Response
INTERIOR	
GYMNASIUM	
Stage	
Instance on 5th Floor	Does not Exist
Walls	
Instance on 5th Floor	Inspected
Condition	2 - Between Good and Fair
Deficiency	SALT GLAZED BRICK: CRACKS/SPALLING
Deficiency Location/Instance	Right and Left Side, Rear Wall, near Office Room
Deficiency Quantity	80
Quantity Uom	S.F.
Potential Action	REPLACE
Urgency of Action	PRIORITY 3
Purpose of Action	LEVEL 2
Deficiency Photo1

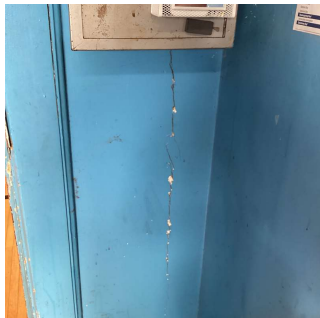
Violations	Near Office No violations recorded.
Deficiency	PLASTER: CRACKS/SPALLING
Deficiency Location/Instance	Office Room
Deficiency Quantity	30
Quantity Uom	S.F.
Potential Action	REPLACE
Urgency of Action	PRIORITY 3
Purpose of Action	LEVEL 2
Deficiency Photo1

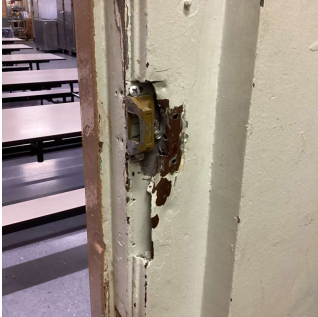
Stair A/3
Violations	No violations recorded.
KITCHEN	
	Inspected
Instance on 1st Floor	Inspected
Ceiling	
Instance on 1st Floor	Inspected
Condition	2 - Between Good and Fair
Deficiency	No deficiencies recorded
Door(s)	
Instance on 1st Floor	Inspected
Condition	4 - Between Fair and Poor
Deficiency	METAL: DETERIORATED DOOR AND FRAME
Deficiency Location/Instance	Storage Room
Deficiency Quantity	1
Quantity Uom	EACH
Potential Action	MAINTENANCE
Urgency of Action	PRIORITY 3
Purpose of Action	LEVEL 2
Deficiency Photo1

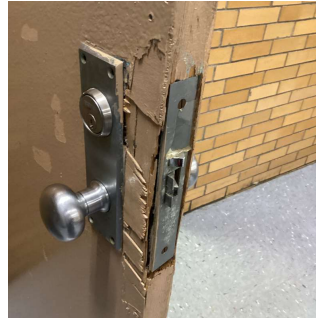
Storage Room
Violations	No violations recorded.
Deficiency	WOOD: DETERIORATED DOOR
Deficiency Location/Instance	Locker Room

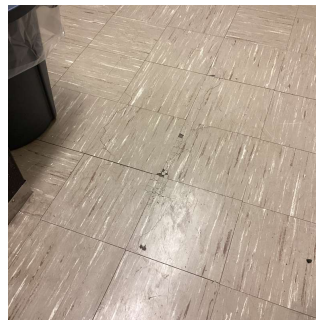
Lockers Room

Instance on 1st Floor	Inspected
Condition	3 - Fair
Deficiency	VINYL TILES: BROKEN/DETERIORATED/MISSING TILES
Deficiency Location/Instance	Lockers Room, Storage Room
Deficiency Quantity	30
Quantity Uom	S.F.
Potential Action	REPLACE
Urgency of Action	PRIORITY 3
Purpose of Action	LEVEL 2
Deficiency Photo1

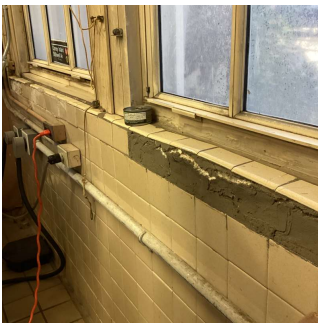
Question	Response
INTERIOR	
KITCHEN	
Floor Finish	
Deficiency Photo1	 
Violations	Preparation Area No violations recorded.
Walls	
Instance on 1st Floor	Inspected
Condition	3 - Fair
Deficiency	PLASTER: CRACKS/SPALLING
Deficiency Location/Instance	Storage Room
Deficiency Quantity	20
Quantity Uom	S.F.
Potential Action	REPLACE
Urgency of Action	PRIORITY 3
Purpose of Action	LEVEL 2
Deficiency Photo1	 
Violations	Storage Room No violations recorded.
Deficiency	CERAMIC TILE: BROKEN/ MISSING
Deficiency Location/Instance	By Servery, near Windows
Deficiency Quantity	30
Quantity Uom	S.F.
Potential Action	REPLACE
Urgency of Action	PRIORITY 3
Purpose of Action	LEVEL 2

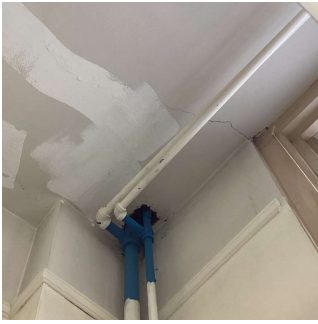
Violations	Near Windows No violations recorded.
LIBRARY	Inspected
Instance on Room 341	Inspected
Built-in Furnishing	
Instance on Room 341	Inspected
Condition	2 - Between Good and Fair
Deficiency	No deficiencies recorded
Ceiling	
Instance on Room 341	Inspected
Condition	2 - Between Good and Fair
Deficiency	PLASTER: CRACKS/SPALLING
Deficiency Location/Instance	Near Windows
Deficiency Quantity	10
Quantity Uom	S.F.
Potential Action	REPLACE
Urgency of Action	PRIORITY 3
Purpose of Action	LEVEL 2
Deficiency Photo1

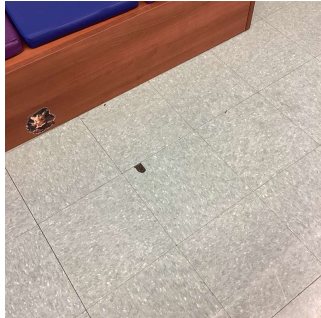
Instance on Room 341	Inspected
Condition	2 - Between Good and Fair
Deficiency	VINYL TILES: BROKEN/DETERIORATED/MISSING TILES
Deficiency Location/Instance	Center, near sink
Deficiency Quantity	20
Quantity Uom	S.F.
Potential Action	REPLACE
Urgency of Action	PRIORITY 3
Purpose of Action	LEVEL 2
Deficiency Photo1

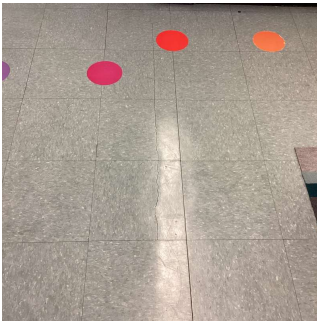
Deficiency	VINYL TILES: DETERIORATED SUBSTRATE
Deficiency Location/Instance	Center
Deficiency Quantity	10
Quantity Uom	S.F.
Potential Action	REPLACE
Urgency of Action	PRIORITY 3
Purpose of Action	LEVEL 2

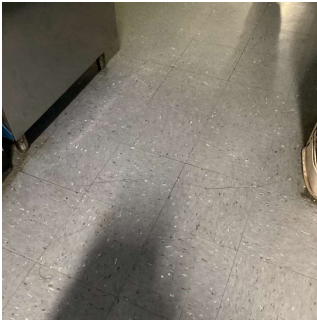
Question	Response
INTERIOR	
MULTI-PURPOSE ROOM	
Floor Finish	
Deficiency	VINYL TILES: DETERIORATED SUBSTRATE
Deficiency Location/Instance	Near Exit 6 - Vestibule, By Stair A/1, Right and Center Side, next to Main Entrance and others
Deficiency Quantity	80
Quantity Uom	S.F.
Potential Action	REPLACE
Urgency of Action	PRIORITY 3
Purpose of Action	LEVEL 2
Deficiency Photo1

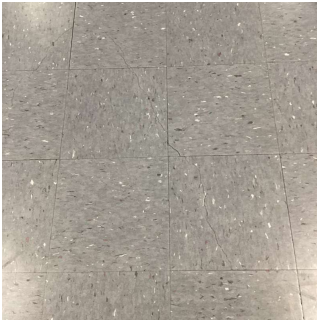
By Stair A/1
Violations	No violations recorded.
Instance on 1st Floor - South	Inspected
Condition	2 - Between Good and Fair
Deficiency	VINYL TILES: DETERIORATED SUBSTRATE
Deficiency Location/Instance	Center, near Stair B/1
Deficiency Quantity	40
Quantity Uom	S.F.
Potential Action	REPLACE
Urgency of Action	PRIORITY 3
Purpose of Action	LEVEL 2
Deficiency Photo1

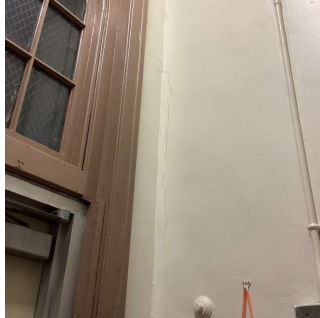
Question	Response
INTERIOR	
MULTI-PURPOSE ROOM	
Floor Finish	
Purpose of Action	LEVEL 2
Deficiency Photo1	 
	Near Windows
Violations	No violations recorded.
Sliding-folding Partition	
Instance on 1st Floor - North	Does not Exist
Instance on 1st Floor - South	Does not Exist
Stage	
Instance on 1st Floor - North	Does not Exist
Instance on 1st Floor - South	Does not Exist
Walls	
Instance on 1st Floor - South	Inspected
Condition	2 - Between Good and Fair
Deficiency	BRICK: CRACKS/SPALLING
Deficiency Location/Instance	Near Windows
Deficiency Quantity	10
Quantity Uom	S.F.
Potential Action	REPLACE
Urgency of Action	PRIORITY 3
Purpose of Action	LEVEL 2
Deficiency Photo1	 
	Near Windows
Violations	No violations recorded.
Instance on 1st Floor - North	Inspected
Condition	2 - Between Good and Fair
Deficiency	PLASTER: CRACKS/SPALLING
Deficiency Location/Instance	Exit - Vestibule
Deficiency Quantity	10
Quantity Uom	S.F.
Potential Action	REPLACE

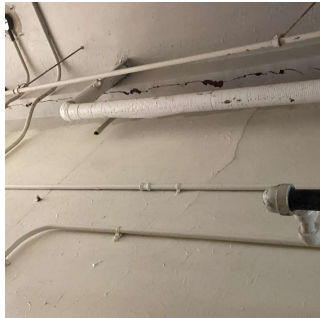
Violations	Exit - Vestibule No violations recorded.
Instance on 1st Floor - South	Inspected
Condition	2 - Between Good and Fair
Deficiency	PLASTER: CRACKS/SPALLING
Deficiency Location/Instance	Near Exit - Vestibule
Deficiency Quantity	10
Quantity Uom	S.F.
Potential Action	REPLACE
Urgency of Action	PRIORITY 3
Purpose of Action	LEVEL 2
Deficiency Photo1

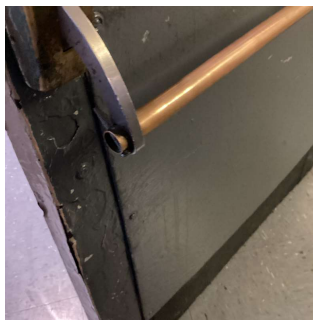
Stair A/1

Exit 15 - Vestibule
Violations	No violations recorded.
Deficiency	PLASTER: CRACKS/SPALLING
Deficiency Location/Instance	Stairs A/3, D/5, C/5
Deficiency Quantity	50
Quantity Uom	S.F.
Potential Action	REPLACE
Urgency of Action	PRIORITY 3
Purpose of Action	LEVEL 2
Deficiency Photo1	 
	Stair D/5
Violations	No violations recorded.
Door(s)	Inspected
Condition	5 - Poor
Deficiency	METAL CLAD WOOD: DETERIORATED DOOR
Deficiency Location/Instance	Stairs A/1, 5, B/1, 3
Deficiency Quantity	8
Quantity Uom	EACH
Potential Action	MAINTENANCE
Urgency of Action	PRIORITY 3
Purpose of Action	LEVEL 2

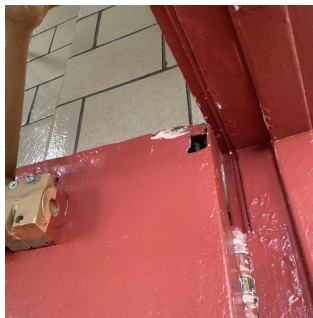
Stair D/4

METAL: DETERIORATED DOOR

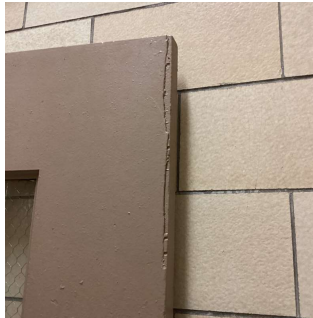
Stair C Exit - Vestibule

WOOD: DETERIORATED DOOR

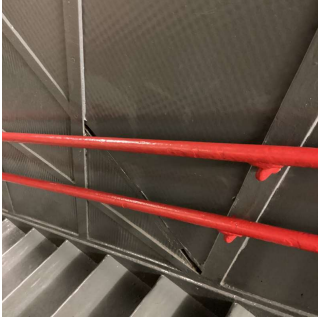
Question	Response
INTERIOR	
STAIRS/RAMPS: INTERIOR	
Partition	Inspected
Condition	2 - Between Good and Fair
Deficiency	METAL FRAME: DAMAGED/DETERIORATED
Deficiency Location/Instance	Stair A/1
Deficiency Quantity	10
Quantity Uom	L.F.
Potential Action	REPLACE
Urgency of Action	PRIORITY 3
Purpose of Action	LEVEL 2
Deficiency Photo1

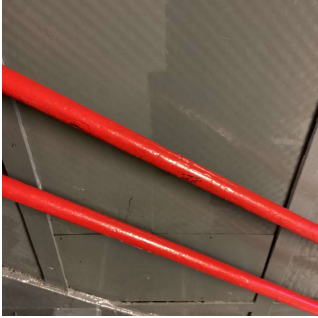
Violations	Stair A/1 No violations recorded.
Deficiency	GLASS PANEL: DAMAGED/DETERIORATED
Deficiency Location/Instance	Stair A/1
Deficiency Quantity	10
Quantity Uom	S.F.
Potential Action	REPLACE
Urgency of Action	PRIORITY 3
Purpose of Action	LEVEL 2
Deficiency Photo1

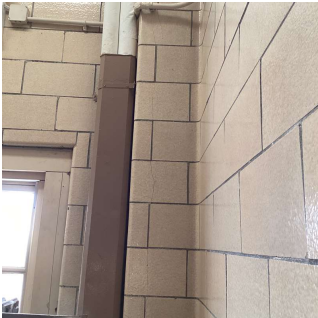
Question	Response
INTERIOR	
STAIRS/RAMPS: INTERIOR	
Walls	
Violations	Stair A/5 No violations recorded.
Deficiency	GLAZED BLOCK: CRACKS/SPALLING
Deficiency Location/Instance	Stairs C/1, 2, 3, 4, 5 and others
Deficiency Quantity	120
Quantity Uom	S.F.
Potential Action	REPLACE
Urgency of Action	PRIORITY 3
Purpose of Action	LEVEL 2
Deficiency Photo1

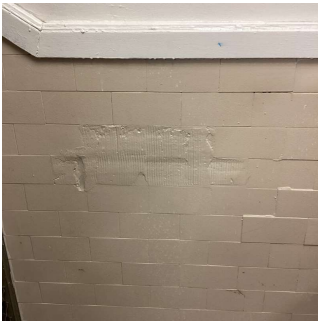
Violations	Stair C/3 No violations recorded.
Deficiency	CERAMIC TILE: BROKEN/ MISSING
Deficiency Location/Instance	Stairs A/5, B/1, 2, 3
Deficiency Quantity	50
Quantity Uom	S.F.
Potential Action	REPLACE
Urgency of Action	PRIORITY 3
Purpose of Action	LEVEL 2
Deficiency Photo1

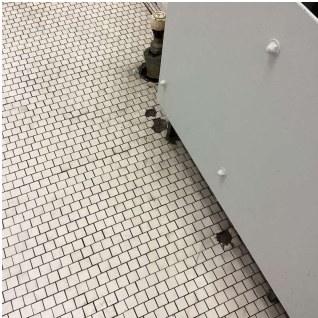
Question	Response
INTERIOR	
TOILET ROOMS - STAFF	
Floor Finish	
Violations	In Kitchen Locker Room No violations recorded.
Deficiency	CERAMIC TILE: BROKEN/MISSING TILES
Deficiency Location/Instance	Rooms 507, 533, Staff Toilet Room - 5th Floor
Deficiency Quantity	30
Quantity Uom	S.F.
Potential Action	REPLACE
Urgency of Action	PRIORITY 3
Purpose of Action	LEVEL 2
Deficiency Photo1

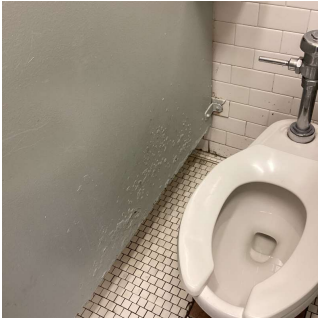
Violations	Room 533 No violations recorded.
Stalls	Inspected
Condition	5 - Poor
Deficiency	RUST - MAJOR
Deficiency Location/Instance	Room 533
Deficiency Quantity	1
Quantity Uom	EACH
Potential Action	REPLACE
Urgency of Action	PRIORITY 3
Purpose of Action	LEVEL 2
Deficiency Photo1

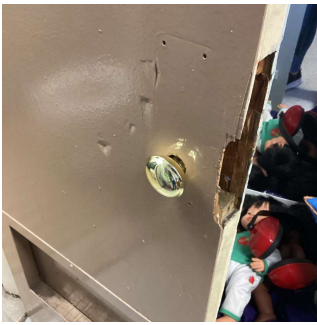
Question	Response
INTERIOR	
TOILET ROOMS - STUDENTS	
Door(s)	
Deficiency Photo1

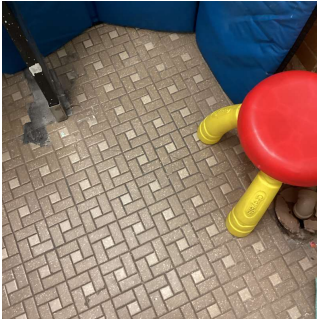
Violations	In Room 243A No violations recorded.
Floor Finish	Inspected
Condition	2 - Between Good and Fair
Deficiency	CERAMIC TILE: BROKEN/MISSING TILES
Deficiency Location/Instance	In Rooms 243A, 243B, Room 110
Deficiency Quantity	30
Quantity Uom	S.F.
Potential Action	REPLACE
Urgency of Action	PRIORITY 3
Purpose of Action	LEVEL 2
Deficiency Photo1

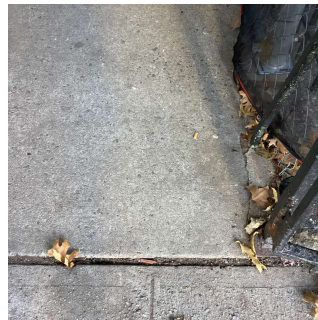
43rd Street

Question	Response
SITE	
Drainage System for Concrete	
Catch Basins/Manhole - Surrounded by concrete	
Potential Action	MAINTENANCE
Urgency of Action	PRIORITY 3
Purpose of Action	LEVEL 2
Deficiency Photo1	No photo recorded
Violations	No violations recorded.
Culverts - Concrete Covering	
	Does not Exist
Drainage System for Soil	
	Inspected
Catch Basins/Manhole - Surrounded by Soil	
	Inspected
Condition	2 - Between Good and Fair
Deficiency	No deficiencies recorded
Culverts - Soil Covering	
	Does not Exist
DRINKING FOUNTAINS	
	Inaccessible
FENCES	
	Inaccessible
IRRIGATION SYSTEM	
	Does not Exist
PAVING	
	Inspected
Student Non-Use	
Gravel Exists?	No
Asphalt	
	Does not Exist
Concrete	
	Inaccessible
Pavers	
	Does not Exist
Student Use	
Gravel Exists?	No
Asphalt	
	Inaccessible
Concrete	
	Inaccessible
Pavers	
	Does not Exist
Site Sidewalks & Walkways	
	Inspected
Asphalt	
	Does not Exist
Concrete	
Condition	3 - Fair
Deficiency	DAMAGED/DETERIORATED/MISSING SECTIONS

Deficiency Location/Instance	43rd Street, near Exit 13
Deficiency Quantity	75
Quantity Uom	S.F.
Potential Action	REPLACE
Urgency of Action	PRIORITY 3
Purpose of Action	LEVEL 2
Deficiency Photo1

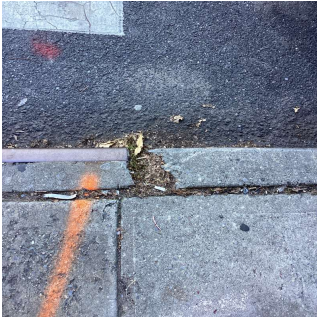
Question	Response
SITE	
PAVING	
Site Sidewalks & Walkways	Inspected
Concrete	Inspected
Violations	No violations recorded.
Pavers	Does not Exist
DOT Sidewalk	Inspected
Asphalt	Does not Exist
Concrete	Inspected
Condition	4 - Between Fair and Poor
Deficiency	HEAVING
Deficiency Location/Instance	44th Street, 43rd Street
Deficiency Quantity	150
Quantity Uom	S.F.
Potential Action	REPLACE
Urgency of Action	PRIORITY 3
Purpose of Action	LEVEL 2
Deficiency Photo1	 
	44th Street
Violations	No violations recorded.
Deficiency	DAMAGED/DETERIORATED/MISSING SECTIONS
Deficiency Location/Instance	7th Avenue, 43rd Street, 44th Street
Deficiency Quantity	500
Quantity Uom	S.F.
Potential Action	REPLACE
Urgency of Action	PRIORITY 3
Purpose of Action	LEVEL 2
Deficiency Photo1	 
	7th Avenue
Violations	No violations recorded.
Deficiency	DAMAGED CURBS
Deficiency Location/Instance	43rd Street, 7th Avenue, 44th Street
Deficiency Quantity	160

Question	Response
SITE	
PAVING	
DOT Sidewalk	Inspected
Concrete	
Quantity Uom	L.F.
Potential Action	REPLACE
Urgency of Action	PRIORITY 3
Purpose of Action	LEVEL 2
Deficiency Photo1
