NYC Department of Education
Building Condition Assessment Survey 2023 - 2024

Architectural Inspection

Asset: P.S. 170 - BROOKLYN, 7109 6TH AVENUE, New York, 11209

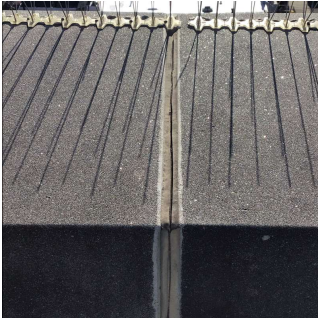
CAST STONE: DETERIORATED TRANSVERSE JOINTS

Violations	Roof 4 No violations recorded.
CORNICE	Inspected
Condition	2 - Between Good and Fair
Deficiency	No deficiencies recorded
DOORS	Inspected
DOORS AND FRAMES	Inspected
Condition	4 - Between Fair and Poor
Deficiency	METAL CLAD: DETERIORATED DOOR AND FRAME - MAJOR DETERIORATION
Roof Plan reference

25
L.F.
MAINTENANCE
PRIORITY 3
LEVEL 2

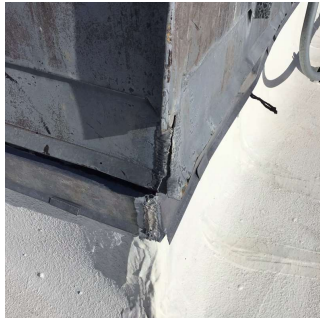
Roof 5
Instance Quantity	7,500
Instance Quantity Uom	S.F.
Does the roof have major mechanical equipment sitting on Dunnage Steel less than 18" above the Roofing?	No
Does this roof instance have a Sustainable Roof System?	No
Do solar panels exist on these roofs?	No
Is/Are the roof(s) suitable for Solar Panel installation?	No
Installation Year	2015
Source of Installation	Custodial Staff
Deficiency	No deficiencies recorded
ROOFING DRAINS	Inspected
Condition	2 - Between Good and Fair
Deficiency	No deficiencies recorded
Specialties	Inspected
BULKHEAD/PENTHOUSE	Inspected
Condition	3 - Fair
Deficiency	BULKHEAD/PENTHOUSE WALLS/EXTERIOR: DAMAGED METAL SIDING
Roof Plan reference

Deficiency Quantity	10
Quantity Uom	S.F.
Potential Action	REPLACE
Urgency of Action	PRIORITY 4
Purpose of Action	LEVEL 2

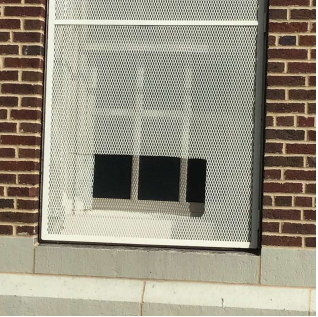
BH1
Violations	No violations recorded.
CUPOLA/ SPIRES/ TOWERS	Does not Exist
DORMER	Does not Exist
DUNNAGE STEEL	Inspected
Condition	2 - Between Good and Fair
Deficiency	No deficiencies recorded
SKYLIGHT/ROOF VENT	Does not Exist
ROOF/GRAVITY TANK	Does not Exist
STAIRS/RAMPS: EXTERIOR	Inspected
BUILDING CHEEK/FLANK WALLS	Inspected
Condition	2 - Between Good and Fair
Deficiency	No deficiencies recorded
RAILINGS	Inspected
Condition	2 - Between Good and Fair
Deficiency	No deficiencies recorded
STAIRS/RAMPS	Inspected
Condition	2 - Between Good and Fair
Deficiency	No deficiencies recorded
WINDOWS	Inspected
Replacement Quantity	13,000
Replacement Uom	S.F.
EXTERIOR GUARDS	Inspected
Condition	3 - Fair
Deficiency	DETERIORATED/TORN-OUT/MISSING
Roof Plan reference

Violations	Facade A No violations recorded.
LINTELS	Inspected
Condition	2 - Between Good and Fair
Deficiency	No deficiencies recorded
WINDOWS	Inspected
Material Type(s)	Aluminum
Instance on Aluminum - Other: 2015 Addition Facades	Inspected
Instance Condition	2 - Between Good and Fair
Instance Quantity	3,000
Instance Quantity Uom	S.F.
Are these windows insulated	Yes
Installation Year	2015
Source of Installation	Custodial Staff
Deficiency	No deficiencies recorded
Instance on Aluminum - Double Hung: Original Building Facades	Inspected
Instance Condition	3 - Fair
Instance Quantity	10,000
Instance Quantity Uom	S.F.
Are these windows insulated	No
Installation Year	2003
Source of Installation	Custodial Staff
Deficiency	No deficiencies recorded

Deficiency Quantity	60
Quantity Uom	S.F.
Potential Action	REPLACE
Urgency of Action	PRIORITY 4
Purpose of Action	LEVEL 2
Deficiency Photo1

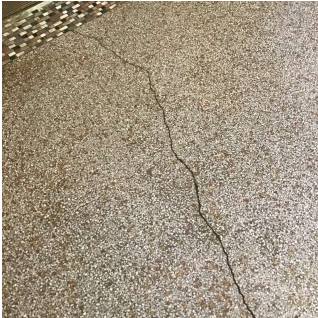
Question	Response
INTERIOR	
AUDITORIUM	
Door(s)	
Condition	2 - Between Good and Fair
Deficiency	No deficiencies recorded
Fixed H/C Lift	
Instance on 2nd Floor (601 Seats)	Inspected
Condition	2 - Between Good and Fair
Deficiency	No deficiencies recorded
Fixed Seating	
Instance on 2nd Floor (601 Seats)	Inspected
Condition	2 - Between Good and Fair
Deficiency	No deficiencies recorded
Floor Finish	
Instance on 2nd Floor (601 Seats)	Inspected
Condition	2 - Between Good and Fair
Deficiency	TERRAZZO: CRACKS
Deficiency Location/Instance	Exit H - Vestibule
Deficiency Quantity	30
Quantity Uom	S.F.
Potential Action	REPLACE
Urgency of Action	PRIORITY 3
Purpose of Action	LEVEL 2
Deficiency Photo1

Violations	No violations recorded.
Sliding-folding Partition	
Instance on 2nd Floor (601 Seats)	Does not Exist
Stage	
Instance on 2nd Floor (601 Seats)	Inspected
Stage	
Instance on 2nd Floor (601 Seats)	Inspected
Condition	2 - Between Good and Fair

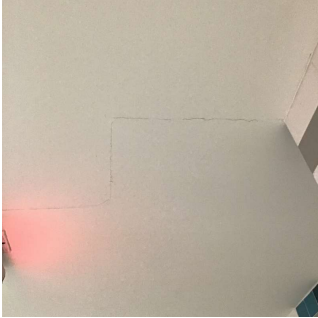
Violations	Near Stair B/1 No violations recorded.

Violations	Exit H - Vestibule No violations recorded.
Window Curtains/Shades/Blinds	
Instance on 2nd Floor (601 Seats)	Does not Exist
CAFETERIA	
Instance on 1st Floor	Inspected
Ceiling	
Instance on 1st Floor	Inspected
Condition	3 - Fair
Deficiency	GYPSUM BOARD: DAMAGED/DETERIORATED
Deficiency Location/Instance	Near Stair B/1, By Servery, Close Rooms 173B,173A, near Windows and others
Deficiency Quantity	150
Quantity Uom	S.F.
Potential Action	REPLACE
Urgency of Action	PRIORITY 3
Purpose of Action	LEVEL 2
Deficiency Photo1

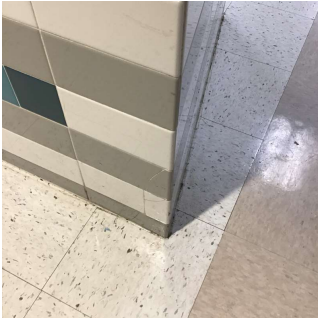
Near Stair B/1
Violations	No violations recorded.
Window Curtains/Shades/Blinds	
Instance on 1st Floor	Does not Exist
CLASSROOMS/CORRIDORS/ADMIN SPACES	
	Inspected
Ceiling	
	Inspected
Condition	2 - Between Good and Fair

Question	Response
INTERIOR	
CAFETERIA	
Door(s)	
Instance on 1st Floor	Inspected
Condition	2 - Between Good and Fair
Deficiency	No deficiencies recorded
Fixed Equipment	
Instance on 1st Floor	Does not Exist
Floor Finish	
Instance on 1st Floor	Inspected
Condition	2 - Between Good and Fair
Deficiency	No deficiencies recorded
Sliding-folding Partition	
Instance on 1st Floor	Does not Exist
Stage	
Instance on 1st Floor	Does not Exist
Walls	
Instance on 1st Floor	Inspected
Condition	2 - Between Good and Fair
Deficiency	CERAMIC TILE: BROKEN/ MISSING
Deficiency Location/Instance	Near Stair B/1, By Servery
Deficiency Quantity	20
Quantity Uom	S.F.
Potential Action	REPLACE
Urgency of Action	PRIORITY 3
Purpose of Action	LEVEL 2
Deficiency Photo1

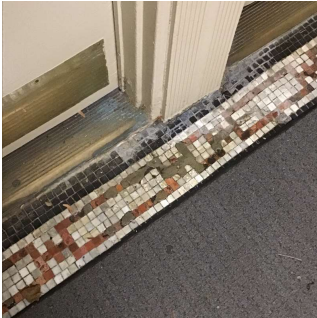
Question	Response
INTERIOR	
CLASSROOMS/CORRIDORS/ADMIN SPACES	
Door(s)	Inspected
	Exit G -4B Vestibule
Violations	No violations recorded.
Floor Finish	Inspected
Condition	2 - Between Good and Fair
Deficiency	CERAMIC TILE: BROKEN/MISSING TILES
Deficiency Location/Instance	Old Main Entrance Vestibule
Deficiency Quantity	10
Quantity Uom	S.F.
Potential Action	REPLACE
Urgency of Action	PRIORITY 3
Purpose of Action	LEVEL 2
Deficiency Photo1

Violations	Old Main Entrance Vestibule No violations recorded.
Deficiency	WOOD: DAMAGED/DETERIORATED
Deficiency Location/Instance	Rooms 503,501
Deficiency Quantity	20
Quantity Uom	S.F.
Potential Action	REPLACE
Urgency of Action	PRIORITY 3
Purpose of Action	LEVEL 2
Deficiency Photo1

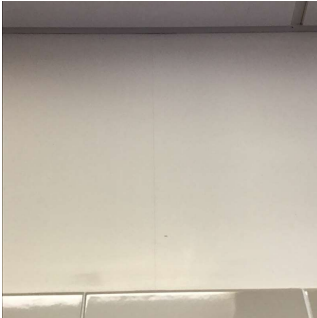
Question	Response
INTERIOR	
CLASSROOMS/CORRIDORS/ADMIN SPACES	
Walls	
Violations	Corridor near Room 204 No violations recorded.
Deficiency	CERAMIC TILE: BROKEN/ MISSING
Deficiency Location/Instance	Corridor near Rooms 471,C083
Deficiency Quantity	20
Quantity Uom	S.F.
Potential Action	REPLACE
Urgency of Action	PRIORITY 3
Purpose of Action	LEVEL 2
Deficiency Photo1	 
Violations	Corridor near Room C083 No violations recorded.
Deficiency	GYPSUM BOARD: DETERIORATED
Deficiency Location/Instance	Main Entrance Vestibule , Main Entrance Lobby, Rooms 559,101, Corridor near Plaza Deck and others
Deficiency Quantity	150
Quantity Uom	S.F.
Potential Action	REPLACE
Urgency of Action	PRIORITY 3
Purpose of Action	LEVEL 2
Deficiency Photo1

Violations	Main Entrance Lobby No violations recorded.
Specialties	Inspected
Classroom Locker(s)	Inspected
Condition	2 - Between Good and Fair
Deficiency	No deficiencies recorded
Fixed Seating	Does not Exist

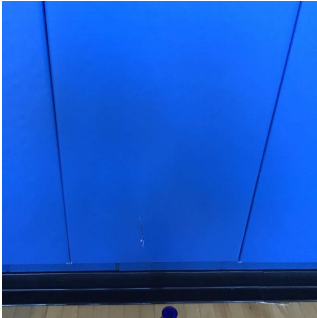
Question	Response
INTERIOR	
GYMNASIUM	
Floor Finish	
Violations	Near Drinking Fountain No violations recorded.
Seating	
Instance on 5th Floor	Does not Exist
Sliding-folding Partition	
Instance on 5th Floor	Does not Exist
Stage	
Instance on 5th Floor	Does not Exist
Walls	
Instance on 5th Floor	Inspected
Condition	2 - Between Good and Fair
Deficiency	WALL PADDING: DETERIORATED
Deficiency Location/Instance	Right and Left Side
Deficiency Quantity	40
Quantity Uom	S.F.
Potential Action	REPLACE
Urgency of Action	PRIORITY 3
Purpose of Action	LEVEL 2
Deficiency Photo1

Violations	Right Side No violations recorded.
Window Curtains/Shades/Blinds	
Instance on 5th Floor	Does not Exist
INTERIOR DOOR HARDWARE	
Condition	Inspected
Deficiency	3 - Fair No deficiencies recorded
INTERIOR GUARDS	
Condition	Inspected
Deficiency	2 - Between Good and Fair No deficiencies recorded
KITCHEN	
Instance on 1st Floor	Inspected
Ceiling	
Instance on 1st Floor	Inspected

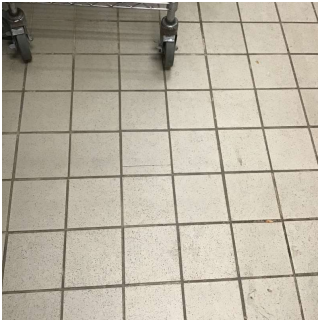
Question	Response
INTERIOR	
KITCHEN	
Floor Finish	
Instance on 1st Floor	Inspected
Condition	2 - Between Good and Fair
Deficiency	QUARRY TILE: BROKEN/MISSING TILES
Deficiency Location/Instance	Room 180C
Deficiency Quantity	10
Quantity Uom	S.F.
Potential Action	REPLACE
Urgency of Action	PRIORITY 3
Purpose of Action	LEVEL 2
Deficiency Photo1

Violations	Room 180C No violations recorded.
Walls	
Instance on 1st Floor	Inspected
Condition	2 - Between Good and Fair
Deficiency	GYPSUM BOARD: DETERIORATED
Deficiency Location/Instance	Office Room
Deficiency Quantity	10
Quantity Uom	S.F.
Potential Action	REPLACE
Urgency of Action	PRIORITY 3
Purpose of Action	LEVEL 2
Deficiency Photo1

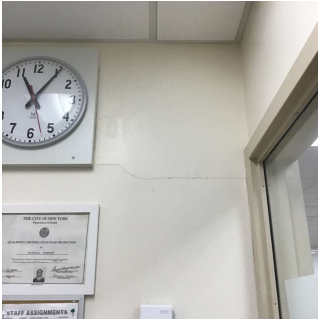
Violations	Office Room No violations recorded.
LIBRARY	
Instance on Room 471	Inspected
Built-in Furnishing	
Instance on Room 471	Does not Exist
Ceiling	
Instance on Room 471	Inspected

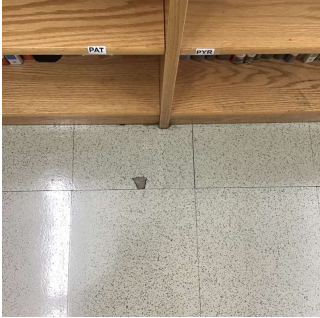
Question	Response
INTERIOR	
LIBRARY	
Ceiling	
Condition	2 - Between Good and Fair
Deficiency	No deficiencies recorded
Door(s)	
Instance on Room 471	Inspected
Condition	2 - Between Good and Fair
Deficiency	No deficiencies recorded
Floor Finish	
Instance on Room 471	Inspected
Condition	2 - Between Good and Fair
Deficiency	VINYL TILES: BROKEN/DETERIORATED/MISSING TILES
Deficiency Location/Instance	Near Entrance
Deficiency Quantity	10
Quantity Uom	S.F.
Potential Action	REPLACE
Urgency of Action	PRIORITY 3
Purpose of Action	LEVEL 2
Deficiency Photo1

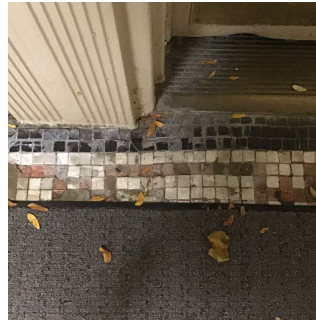
Stair FG/1
Violations	No violations recorded.
Railings	Inspected
Condition	2 - Between Good and Fair
Deficiency	No deficiencies recorded
Stairs and Landings	Inspected
Condition	5 - Poor
Deficiency	CONCRETE: CRACKS/SPALLING - MAJOR
Deficiency Location/Instance	Stair A/Basement
Deficiency Quantity	10
Quantity Uom	S.F.
Potential Action	REPLACE
Urgency of Action	PRIORITY 3
Purpose of Action	LEVEL 2
Deficiency Photo1	 
	Stair A/Basement
Violations	No violations recorded.
Deficiency	CERAMIC TILE: BROKEN/MISSING
Deficiency Location/Instance	Exit E - Vestibule
Deficiency Quantity	10
Quantity Uom	S.F.
Potential Action	REPLACE
Urgency of Action	PRIORITY 3
Purpose of Action	LEVEL 2

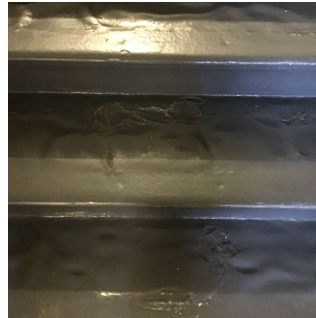
Stair FG/1

ROLLED ASPHALT: DETERIORATED SUBSTRATE

REPLACE

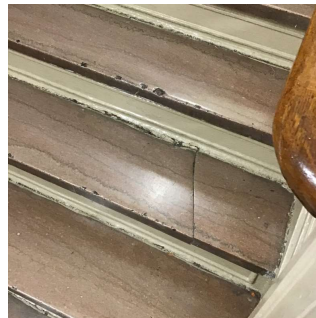
Stair E/1

STONE: BROKEN/MISSING

REPLACE

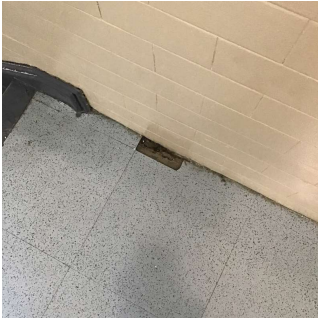
Question	Response
INTERIOR	
STAIRS/RAMPS: INTERIOR	
Stairs and Landings	
Deficiency	VINYL TILES: BROKEN/DETERIORATED/MISSING TILES
Deficiency Location/Instance	Stair CD/5
Deficiency Quantity	10
Quantity Uom	S.F.
Potential Action	REPLACE
Urgency of Action	PRIORITY 3
Purpose of Action	LEVEL 2
Deficiency Photo1

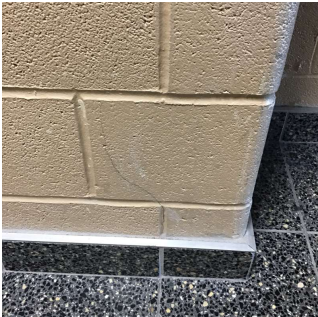
Stair CD/5
Violations	No violations recorded.
Walls	Inspected
Condition	2 - Between Good and Fair
Deficiency	MASONRY: CRACKS/SPALLING
Deficiency Location/Instance	Stair A/5
Deficiency Quantity	10
Quantity Uom	S.F.
Potential Action	REPLACE
Urgency of Action	PRIORITY 3
Purpose of Action	LEVEL 2
Deficiency Photo1

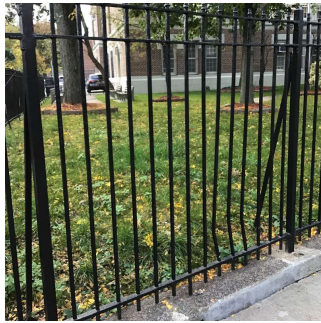
Deficiency	No deficiencies recorded
Culverts - Soil Covering	Does not Exist
DRINKING FOUNTAINS	Does not Exist
FENCES	Inspected
Condition	4 - Between Fair and Poor
Deficiency	WROUGHT IRON: DAMAGED/DETERIORATED
Deficiency Location/Instance	6th Avenue, 72nd Street, 71st Street
Deficiency Quantity	360
Quantity Uom	S.F.
Potential Action	REPLACE
Urgency of Action	PRIORITY 3

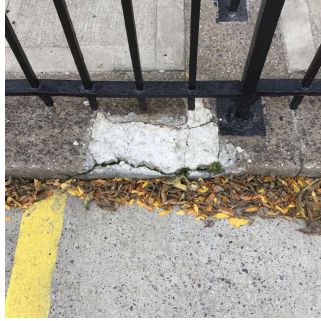
6th Avenue
Violations	No violations recorded.
Deficiency	CONCRETE CURB: DAMAGED/DETERIORATED
Deficiency Location/Instance	6th Avenue, 72nd Street, 71st Street
Deficiency Quantity	360
Quantity Uom	S.F.
Potential Action	REPLACE
Urgency of Action	PRIORITY 3
Purpose of Action	LEVEL 2
Deficiency Photo1

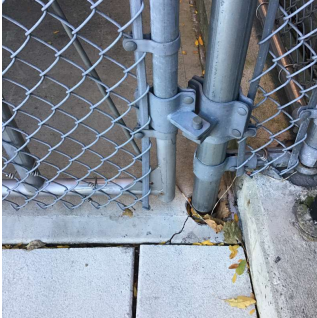
71st Street
Violations	No violations recorded.
IRRIGATION SYSTEM	Does not Exist
PAVING	Inspected
Student Non-Use	Inspected
Gravel Exists?	No
Asphalt	Inspected
Condition	2 - Between Good and Fair
Deficiency	No deficiencies recorded
Concrete	Inspected
Condition	2 - Between Good and Fair
Deficiency	DAMAGED/DETERIORATED/MISSING SECTIONS
Deficiency Location/Instance	72nd Street
Deficiency Quantity	25
Quantity Uom	S.F.
Potential Action	REPLACE
Urgency of Action	PRIORITY 3
Purpose of Action	LEVEL 2

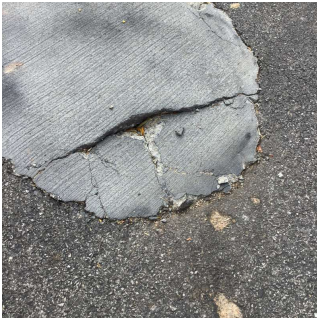
72nd Street
Violations	No violations recorded.
Pavers	Does not Exist
Student Use	Inspected
Gravel Exists?	No
Asphalt	Inspected
Condition	3 - Fair
Deficiency	POTHOLES
Deficiency Location/Instance	Schoolyard
Deficiency Quantity	10
Quantity Uom	S.F.
Potential Action	REPAIR
Urgency of Action	PRIORITY 3
Purpose of Action	LEVEL 2
Deficiency Photo1

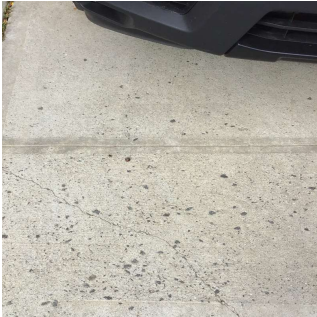
Question	Response
SITE	
PAVING	
Student Use	
Asphalt	
Deficiency Photo1	 
Violations	Schoolyard No violations recorded.
Concrete	Inspected
Condition	3 - Fair
Deficiency	CRACKS - MAJOR
Deficiency Location/Instance	Schoolyard
Deficiency Quantity	50
Quantity Uom	S.F.
Potential Action	REPLACE
Urgency of Action	PRIORITY 3
Purpose of Action	LEVEL 2
Deficiency Photo1

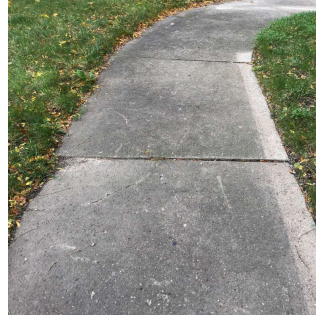
72nd Street

Violations	Schoolyard No violations recorded.
Pavers	Does not Exist
Site Sidewalks & Walkways	Inspected
Asphalt	Does not Exist
Concrete	Inspected
Condition	3 - Fair
Deficiency	HEAVING
Deficiency Location/Instance	72nd Street, 6th Avenue, 71st Street
Deficiency Quantity	100
Quantity Uom	S.F.
Potential Action	REPLACE
Urgency of Action	PRIORITY 3
Purpose of Action	LEVEL 2

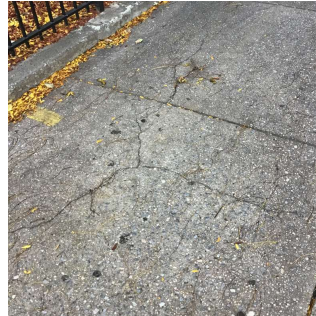
6th Avenue

DAMAGED/DETERIORATED/MISSING SECTIONS

REPLACE

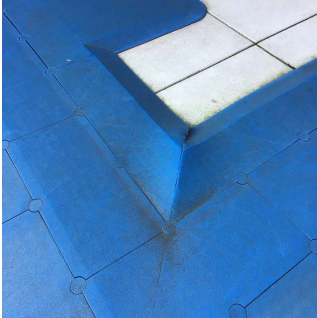
Question	Response
SITE	
PAVING	Inspected
DOT Sidewalk	
Pavers	
Deficiency Photo1	 
	71st Street
Violations	No violations recorded.
PLAYGROUNDS	Inspected
Instance on 2nd Floor - Plaza Deck	Inspected
Benches	
Instance on 2nd Floor - Plaza Deck	Inspected
Condition	3 - Fair
Deficiency	DAMAGED/DETERIORATED
Deficiency Location/Instance	Left Side
Deficiency Quantity	1
Quantity Uom	EACH
Potential Action	REPLACE
Urgency of Action	PRIORITY 3
Purpose of Action	LEVEL 2
Deficiency Photo1	 
	Left Side
Violations	No violations recorded.
Fence	
Instance on 2nd Floor - Plaza Deck	Does not Exist
Pavement	
Instance on 2nd Floor - Plaza Deck	Does not Exist
Play Equipment	
Instance on 2nd Floor - Plaza Deck	Does not Exist
Safety Surfacing	
Instance on 2nd Floor - Plaza Deck	Inspected
Condition	2 - Between Good and Fair
Deficiency	DETERIORATED/MISSING
Deficiency Location/Instance	Plaza Deck - near West Corner
Deficiency Quantity	20

Plaza Deck - near West Corner
Violations	No violations recorded.
Deficiency	DETERIORATED/MISSING
Deficiency Location/Instance	Plaza Deck - near South Corner
Deficiency Quantity	10
Quantity Uom	S.F.
Potential Action	REPLACE
Urgency of Action	PRIORITY 5
Purpose of Action	LEVEL 6
Deficiency Photo1

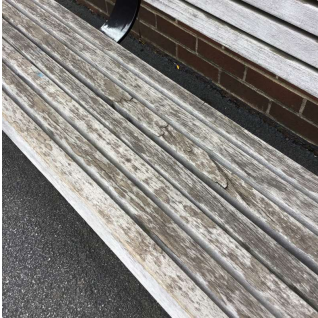
Plaza Deck - near South Corner
Violations	No violations recorded.
Unpaved Area	
Instance on 2nd Floor - Plaza Deck	Does not Exist
PLAYING SURFACE	Does not Exist
RETAINING WALLS	Does not Exist
SEATING	Inspected
Benches	Inspected
Concrete	Does not Exist
Metal/Wood/Plastic	Inspected
Condition	3 - Fair
Deficiency	DAMAGED/DETERIORATED
Deficiency Location/Instance	Center
Deficiency Quantity	1
Quantity Uom	EACH

Question	Response
SITE	
SEATING	
Benches	
Metal/Wood/Plastic	
Potential Action	REPLACE
Urgency of Action	PRIORITY 3
Purpose of Action	LEVEL 2
Deficiency Photo1
