**NYC Department of Education**  
**Building Condition Assessment Survey 2023 - 2024**

Architectural Inspection

**Asset:**        **I.S. 171 - BROOKLYN, 528 RIDGEWOOD AVENUE, New York, 11208**

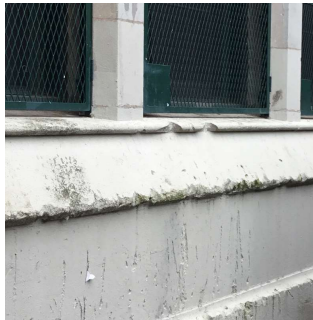
Facade A

**STONE: DETERIORATED MASONRY SILLS - MAJOR**

REMOVE AND REPLACE

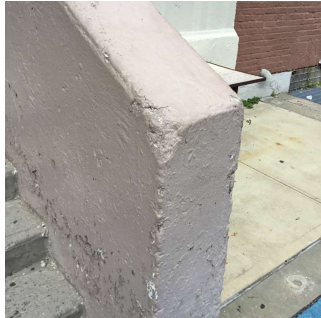
Question	Response
<b>EXTERIOR</b>	
<b>ROOF</b>	
<b>Specialties</b>	
<b>BULKHEAD/PENTHOUSE</b>	Inspected
Condition	2 - Between Good and Fair
Deficiency	No deficiencies recorded
<b>CUPOLA/ SPIRES/ TOWERS</b>	Does not Exist
<b>DORMER</b>	Does not Exist
<b>DUNNAGE STEEL</b>	Inspected
Condition	2 - Between Good and Fair
Deficiency	No deficiencies recorded
<b>SKYLIGHT/ROOF VENT</b>	Inspected
Material Type(s)	Glass
Condition	2 - Between Good and Fair
Deficiency	No deficiencies recorded
<b>ROOF/GRAVITY TANK</b>	Does not Exist
<b>STAIRS/RAMPS: EXTERIOR</b>	Inspected
<b>BUILDING CHEEK/FLANK WALLS</b>	Inspected
Condition	5 - Poor
Deficiency	CAST IN PLACE CONCRETE: CRACKS/SPALLING - MINOR
Roof Plan reference	K171
Deficiency Quantity	10
Quantity Uom	S.F.
Potential Action	REPAIR
Urgency of Action	PRIORITY 3
Purpose of Action	LEVEL 2
Deficiency Photo1

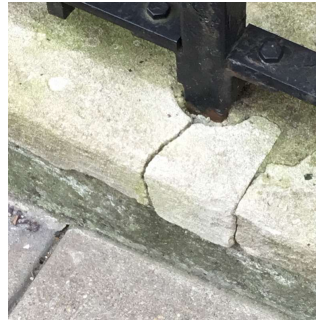
Facade A

**STONE: DETERIORATED COPING STONE**

15  
S.F.  
REPLACE  
PRIORITY 4  
LEVEL 2

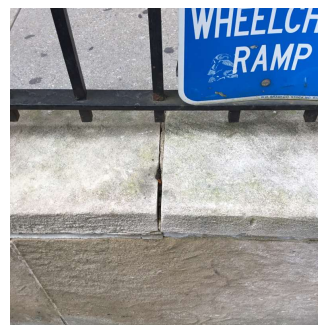
Facade A

**STONE: DETERIORATED JOINTS AT COPING STONES**

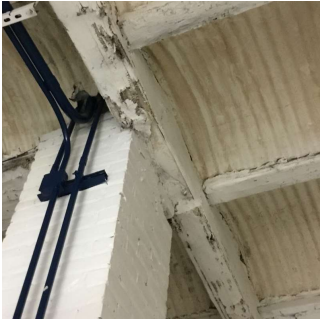
<b>Question</b>	<b>Response</b>
<b>INTERIOR</b>	Inspected
<b>POOLS</b>	Does not Exist
<b>STRUCTURAL</b>	Inspected
<b>COLUMNS/BEAMS/BEARING WALLS</b>	Inspected
Condition	4 - Between Fair and Poor
Deficiency	STEEL COLUMNS/BEAMS: DETERIORATED/MISSING PLASTER FIREPROOFING
Deficiency Location/Instance	Basement
Deficiency Quantity	40
Quantity Uom	S.F.
Potential Action	REPLACE
Urgency of Action	PRIORITY 4
Purpose of Action	LEVEL 5
Deficiency Photo1

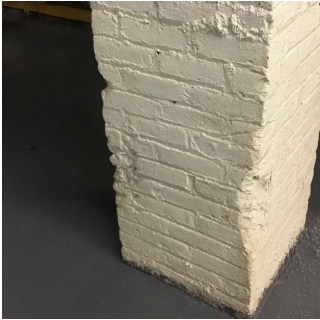
Basement Storage Area
Violations	No violations recorded.
Deficiency	STEEL COLUMNS/BEAMS: DETERIORATED MASONRY FIREPROOFING
Deficiency Location/Instance	Basement
Deficiency Quantity	35
Quantity Uom	S.F.
Potential Action	REPLACE
Urgency of Action	PRIORITY 3
Purpose of Action	LEVEL 5
Deficiency Photo1

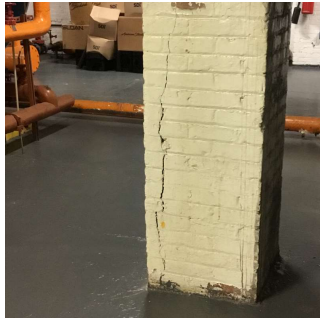
Boiler Room
Violations	No violations recorded.
Deficiency	STEEL COLUMNS/BEAMS: DETERIORATED MASONRY FIREPROOFING
Deficiency Location/Instance	Basement
Deficiency Quantity	90

Quantity Uom	S.F.
Potential Action	REPLACE
Urgency of Action	PRIORITY 4

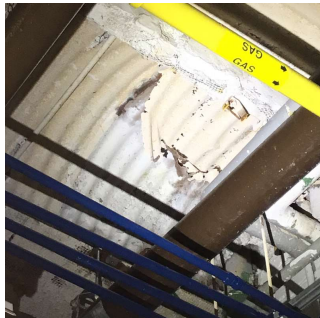
Violations	Boiler Room No violations recorded.
<b>FLOOR STRUCTURE</b>	
Condition	Inspected
Deficiency	4 - Between Fair and Poor
Deficiency Location/Instance	CINDER CONCRETE ARCH: METAL PAN DETERIORATED, SPALLED
Deficiency Quantity	Basement
Quantity Uom	70
Potential Action	S.F.
Urgency of Action	REPAIR
Purpose of Action	PRIORITY 4
Deficiency Photo1	LEVEL 5

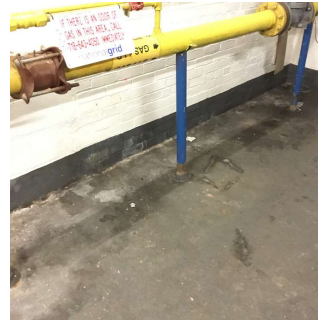
Violations	Basement Corridor (Boiler Room, Basement Storage Area, Gas Meter Room similar) No violations recorded.
Deficiency	CONCRETE SLAB ON GRADE: WATER INFILTRATION IN NON-INSTRUCTIONAL SPACE
Deficiency Location/Instance	Basement
Deficiency Quantity	100
Quantity Uom	S.F.
Potential Action	INSTALL WATERPROOFING
Urgency of Action	PRIORITY 5
Purpose of Action	LEVEL 5

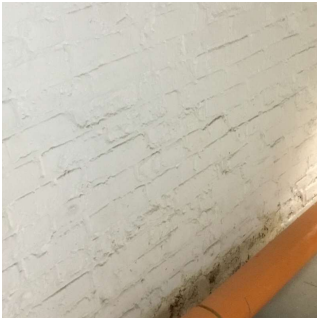
Violations	Basement Storage Area No violations recorded.
Deficiency	BRICK: CRACKED/SPALLED
Deficiency Location/Instance	Basement
Deficiency Quantity	25
Quantity Uom	S.F.
Potential Action	RESTITCH
Urgency of Action	PRIORITY 4
Purpose of Action	LEVEL 5
Deficiency Photo1

Question	Response
<b>INTERIOR</b>	
<b>STRUCTURAL</b>	
<b>FOUNDATION WALLS</b>	Inspected
Material Type(s)	Masonry
Condition	4 - Between Fair and Poor
Deficiency	BRICK: CRACKED/SPALLED
Deficiency Location/Instance	Basement
Deficiency Quantity	70
Quantity Uom	S.F.
Potential Action	RESTITCH
Urgency of Action	PRIORITY 3
Purpose of Action	LEVEL 5
Deficiency Photo1

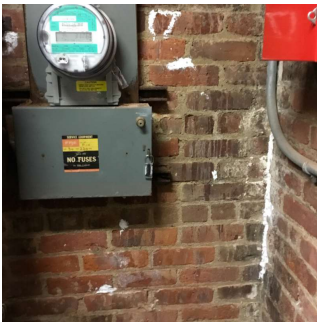
Violations	Electrical Panel Room No violations recorded.
Deficiency	BRICK: WATER INFILTRATION IN ELECTRICAL PANEL ROOM
Deficiency Location/Instance	Basement
Deficiency Quantity	100
Quantity Uom	S.F.
Potential Action	INSTALL WATERPROOFING
Urgency of Action	PRIORITY 5
Purpose of Action	LEVEL 6

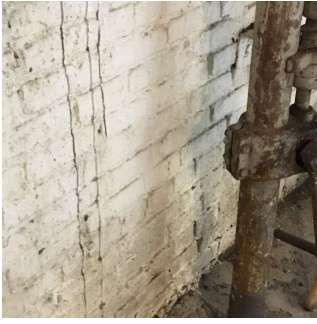
Violations	Electrical Panel Room No violations recorded.
<b>ROOF STRUCTURE</b>	
Condition	Inspected
Deficiency	2 - Between Good and Fair
Deficiency	No deficiencies recorded
<b>VAULTS-BUNKERS</b>	
Condition	Inspected
Condition	Inspected
Deficiency	3 - Fair
Deficiency	DETERIORATED JOINTS
Deficiency Location/Instance	Vault
Deficiency Quantity	60
Quantity Uom	S.F.
Potential Action	REPOINT
Urgency of Action	PRIORITY 3
Purpose of Action	LEVEL 5
Deficiency Photo1

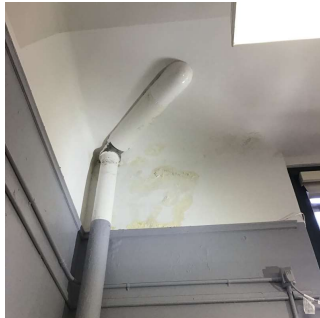
Room 113
Violations	No violations recorded.
Deficiency	PLASTER: CRACKS/SPALLING
Deficiency Location/Instance	Rooms 406, 408, 303, 214, 104, and others
Deficiency Quantity	260
Quantity Uom	S.F.
Potential Action	REPLACE
Urgency of Action	PRIORITY 3
Purpose of Action	LEVEL 2
Deficiency Photo1

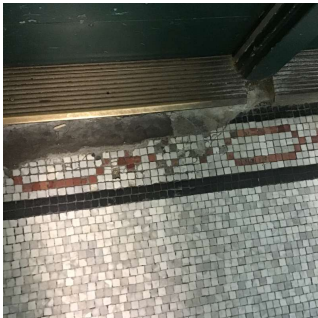
Main Entrance No violations recorded.
Deficiency Deficiency Location/Instance Deficiency Quantity Quantity Uom Potential Action Urgency of Action Purpose of Action Deficiency Photo1           Violations	TERRAZZO: CRACKS Main Entrance 50 S.F. REPLACE PRIORITY 3 LEVEL 2

Rooms 413 No violations recorded.
Deficiency Deficiency Location/Instance Deficiency Quantity Quantity Uom Potential Action Urgency of Action Purpose of Action Deficiency Photo1           Violations	CERAMIC TILE: BROKEN/MISSING TILES Main Entrance 20 S.F. REPLACE PRIORITY 3 LEVEL 2

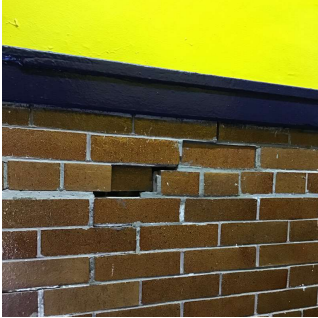
Question	Response
<b>INTERIOR</b>	
<b>CLASSROOMS/CORRIDORS/ADMIN SPACES</b>	
<b>Walls</b>	Inspected
Condition	2 - Between Good and Fair
Deficiency	SALT GLAZED BRICK: CRACKS/SPALLING
Deficiency Location/Instance	Corridor near Exit 6, Exit 5, East Kitchen, West Kitchen
Deficiency Quantity	60
Quantity Uom	S.F.
Potential Action	REPLACE
Urgency of Action	PRIORITY 3
Purpose of Action	LEVEL 2
Deficiency Photo1

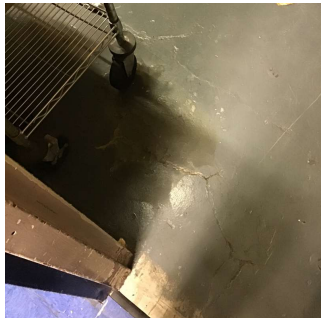
Storage Room near Cafeteria Entrance
Violations	No violations recorded.

<b>Floor Finish</b>	
Instance on Ground Floor - West	Inspected
Condition	3 - Fair
Deficiency	CONCRETE: CRACKS
Deficiency Location/Instance	Storage Room near Cafeteria Entrance
Deficiency Quantity	20
Quantity Uom	S.F.
Potential Action	REPLACE
Urgency of Action	PRIORITY 3
Purpose of Action	LEVEL 2
Deficiency Photo1

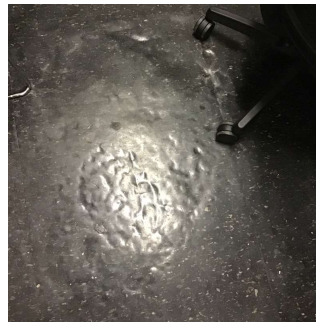
Deficiency	VINYL TILES: DETERIORATED SUBSTRATE
Deficiency Location/Instance	Storage/Office
Deficiency Quantity	10
Quantity Uom	S.F.
Potential Action	REPLACE
Urgency of Action	PRIORITY 3
Purpose of Action	LEVEL 2

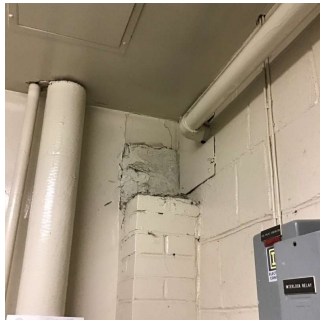
Violations	Storage/Office No violations recorded.
Deficiency	CERAMIC TILE: BROKEN/ MISSING
Deficiency Location/Instance	Near Servery
Deficiency Quantity	20

Violations	Near the Windows No violations recorded.
Instance on Ground Floor - West	Inspected
Condition	2 - Between Good and Fair
Deficiency	PLASTER: CRACKS/SPALLING
Deficiency Location/Instance	Storage/Office
Deficiency Quantity	10
Quantity Uom	S.F.
Potential Action	REPLACE
Urgency of Action	PRIORITY 3
Purpose of Action	LEVEL 2
Deficiency Photo1

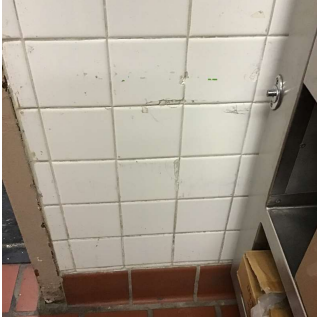
Quantity Uom	S.F.

Question	Response
<b>INTERIOR</b>	
<b>KITCHEN</b>	
<b>Walls</b>	
Potential Action	REPLACE
Urgency of Action	PRIORITY 3
Purpose of Action	LEVEL 2
Deficiency Photo1

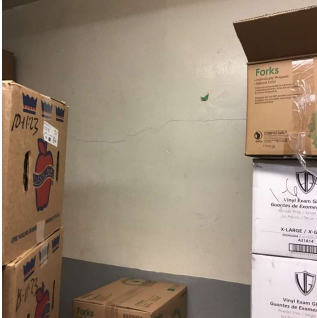
Near Servery
Violations	No violations recorded.
Instance on Ground Floor - East	Inspected
Condition	2 - Between Good and Fair
Deficiency	PLASTER: CRACKS/SPALLING
Deficiency Location/Instance	Storage
Deficiency Quantity	10
Quantity Uom	S.F.
Potential Action	REPLACE
Urgency of Action	PRIORITY 3
Purpose of Action	LEVEL 2
Deficiency Photo1

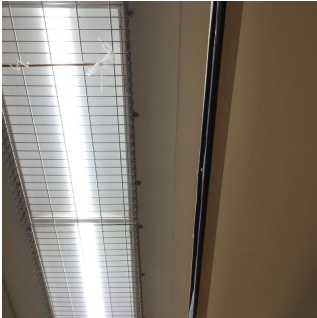
Question	Response
<b>INTERIOR</b>	
<b>MULTI-PURPOSE ROOM</b>	
<b>Ceiling</b>	
Deficiency	PLASTER: CRACKS/SPALLING
Deficiency Location/Instance	Stage, near window
Deficiency Quantity	10
Quantity Uom	S.F.
Potential Action	REPLACE
Urgency of Action	PRIORITY 3
Purpose of Action	LEVEL 2
Deficiency Photo1

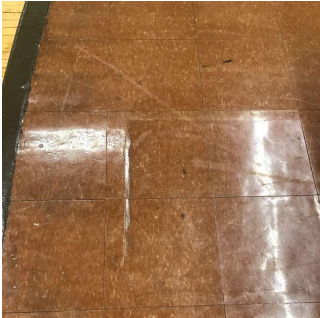
Question	Response
<b>INTERIOR</b>	
<b>MULTI-PURPOSE ROOM</b>	
<b>Stage</b>	
Instance on Ground Floor	Inspected
<b>Stage</b>	Inspected
Instance on Ground Floor	Inspected
Condition	2 - Between Good and Fair
Deficiency	DAMAGED FLOOR
Deficiency Location/Instance	Near center, left, and right
Deficiency Quantity	20
Quantity Uom	S.F.
Potential Action	REPLACE
Urgency of Action	PRIORITY 3
Purpose of Action	LEVEL 2
Deficiency Photo1

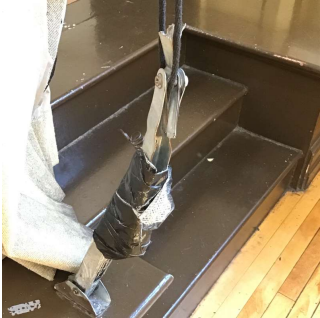
Left Side
Violations	No violations recorded.
<b>Stage Curtains</b>	Inspected
Instance on Ground Floor	Inspected
Condition	5 - Poor
Deficiency	WORN/DETERIORATED

Near center
Violations	No violations recorded.
<b>Stage Curtain Rigging</b>	Inspected
Instance on Ground Floor	Inspected
Condition	5 - Poor
Deficiency	INOPERABLE
Deficiency Location/Instance	Left Side
Deficiency Quantity	1
Quantity Uom	EACH
Potential Action	MAINTENANCE
Urgency of Action	PRIORITY 3
Purpose of Action	LEVEL 2
Deficiency Photo1

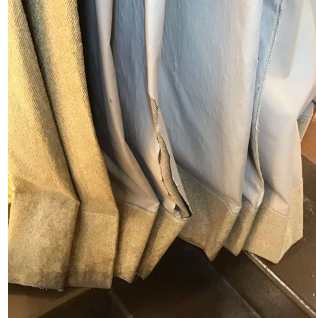
Left side

Deficiency Location/Instance	Left and right sides
Deficiency Quantity	1,000
Quantity Uom	S.F.
Potential Action	REPLACE
Urgency of Action	PRIORITY 3
Purpose of Action	LEVEL 2
Deficiency Photo1

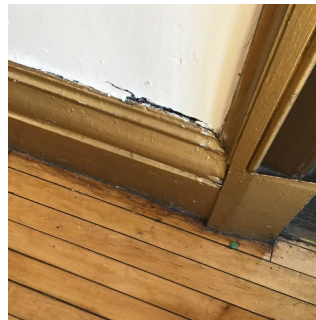
Near Entrance

Instance on Ground Floor	Inspected
Condition	2 - Between Good and Fair
Deficiency	PLASTER: CRACKS/SPALLING
Deficiency Location/Instance	Near Entrance, near stage, near window
Deficiency Quantity	20
Quantity Uom	S.F.
Potential Action	REPLACE
Urgency of Action	PRIORITY 3
Purpose of Action	LEVEL 2
Deficiency Photo1

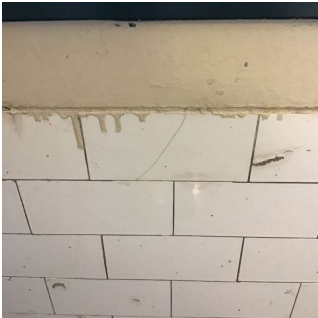
Question	Response
<b>INTERIOR</b>	
<b>STAIRS/RAMPS: INTERIOR</b>	
<b>Walls</b>	
Violations	Stair G/3 No violations recorded.
Deficiency	CERAMIC TILE: BROKEN/ MISSING
Deficiency Location/Instance	Stair BC/1, G/1,2,3,4, and others
Deficiency Quantity	60
Quantity Uom	S.F.
Potential Action	REPLACE
Urgency of Action	PRIORITY 3
Purpose of Action	LEVEL 2
Deficiency Photo1

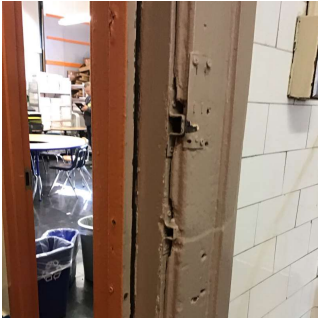
Violations	Stair BC/1 No violations recorded.
<b>TOILET ROOMS - STAFF</b>	
<b>Ceiling</b>	Inspected
Condition	Inspected
Deficiency	2 - Between Good and Fair
Deficiency	No deficiencies recorded
<b>Door(s)</b>	Inspected
Condition	5 - Poor
Deficiency	WOOD: DETERIORATED DOOR AND FRAME
Deficiency Location/Instance	4th Floor - Womens
Deficiency Quantity	1
Quantity Uom	EACH
Potential Action	MAINTENANCE
Urgency of Action	PRIORITY 3
Purpose of Action	LEVEL 2
Deficiency Photo1

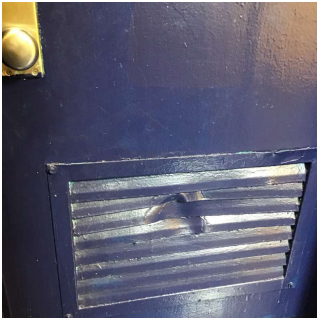
Violations	4th Floor - Womens No violations recorded.
Deficiency	WOOD: DAMAGED LOUVER

Deficiency Location/Instance	Ground Floor - Men's

Question	Response
<b>INTERIOR</b>	
<b>TOILET ROOMS - STAFF</b>	
<b>Door(s)</b>	
Deficiency Quantity	1
Quantity Uom	EACH
Potential Action	MAINTENANCE
Urgency of Action	PRIORITY 3
Purpose of Action	LEVEL 2
Deficiency Photo1

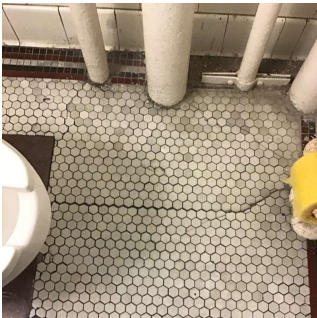
Ground Floor - Mens
Violations	No violations recorded.
<b>Floor Finish</b>	Inspected
Condition	3 - Fair
Deficiency	CERAMIC TILE: BROKEN/MISSING TILES
Deficiency Location/Instance	Room 360, 251
Deficiency Quantity	20
Quantity Uom	S.F.
Potential Action	REPLACE
Urgency of Action	PRIORITY 3
Purpose of Action	LEVEL 2
Deficiency Photo1

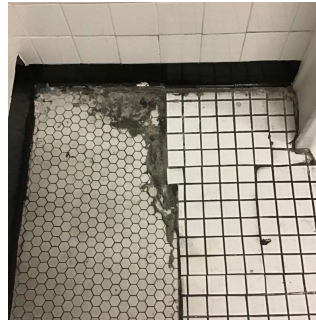
Ground Floor Boy

BROKEN/MISSING

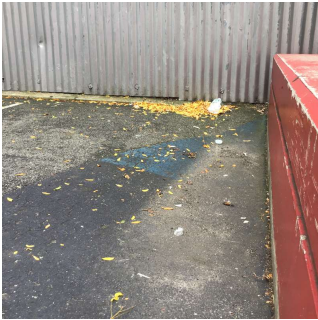
Question	Response
<b>SITE</b>	
<b>FENCES</b>	
Deficiency Photo1	 
Violations	Near Playground No violations recorded.
<b>IRRIGATION SYSTEM</b>	Does not Exist
<b>PAVING</b>	Inspected
<b>Student Non-Use</b>	Inspected
Gravel Exists?	No
<b>Asphalt</b>	Does not Exist
<b>Concrete</b>	Inspected
Condition	2 - Between Good and Fair
Deficiency	No deficiencies recorded
<b>Pavers</b>	Does not Exist
<b>Student Use</b>	Inspected
Gravel Exists?	No
<b>Asphalt</b>	Inspected
Condition	3 - Fair
Deficiency	LOCALIZED SINK AREA
Deficiency Location/Instance	Near Playground
Deficiency Quantity	10
Quantity Uom	S.F.
Potential Action	REPAIR
Urgency of Action	PRIORITY 3
Purpose of Action	LEVEL 2
Deficiency Photo1

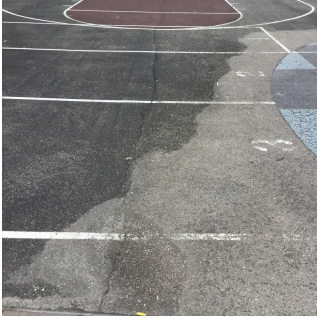
Violations	Near Playground No violations recorded.
Deficiency	CRACKS - MAJOR
Deficiency Location/Instance	Near center, left and right side
Deficiency Quantity	50
Quantity Uom	S.F.
Potential Action	REPLACE

Question	Response
<b>SITE</b>	
<b>PAVING</b>	
<b>Student Use</b>	
<b>Asphalt</b>	
Urgency of Action	PRIORITY 3
Purpose of Action	LEVEL 2
Deficiency Photo1

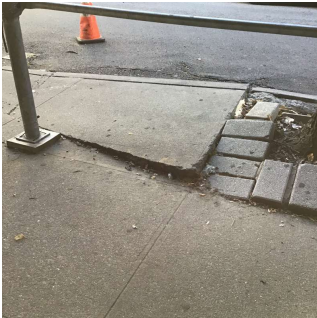
Violations	Along Lincoln Avenue

Violations	Near Right side No violations recorded.
<b>Concrete</b>	Inspected
Condition	2 - Between Good and Fair
Deficiency	No deficiencies recorded
<b>Pavers</b>	Does not Exist
<b>Site Sidewalks &amp; Walkways</b>	Inspected
<b>Asphalt</b>	Does not Exist
<b>Concrete</b>	Inspected
Condition	2 - Between Good and Fair
Deficiency	No deficiencies recorded
<b>Pavers</b>	Does not Exist
<b>DOT Sidewalk</b>	Inspected
<b>Asphalt</b>	Does not Exist
<b>Concrete</b>	Inspected
Condition	4 - Between Fair and Poor
Deficiency	HEAVING
Deficiency Location/Instance	Along Lincoln Avenue, Ridgewood Avenue, Nichols Avenue
Deficiency Quantity	175
Quantity Uom	S.F.
Potential Action	REPLACE
Urgency of Action	PRIORITY 4
Purpose of Action	LEVEL 4
Deficiency Photo1

Deficiency	76114 DAMAGED/DETERIORATED/MISSING SECTIONS
