NYC Department of Education
Building Condition Assessment Survey 2023 - 2024

Architectural Inspection

K172

Asset: P.S. 172 - BROOKLYN, 825 4TH AVENUE, New York, 11232

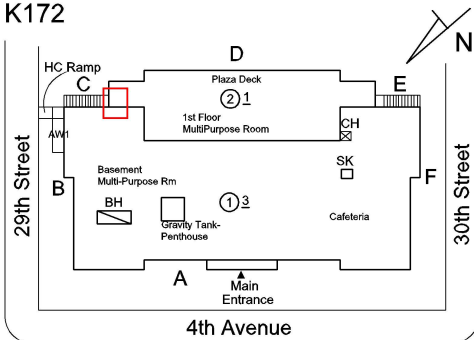
Question	Response
EXTERIOR	
COPING	
CORNICE	Under Construction
DOORS	Inspected
DOORS AND FRAMES	Inspected
Condition	3 - Fair
Deficiency	METAL: DETERIORATED DOOR AND FRAME - MAJOR DETERIORATION
Roof Plan reference	K172

Deficiency Quantity	2
Quantity Uom	EACH
Potential Action	REPLACE
Urgency of Action	PRIORITY 4
Purpose of Action	LEVEL 2
Deficiency Photo1

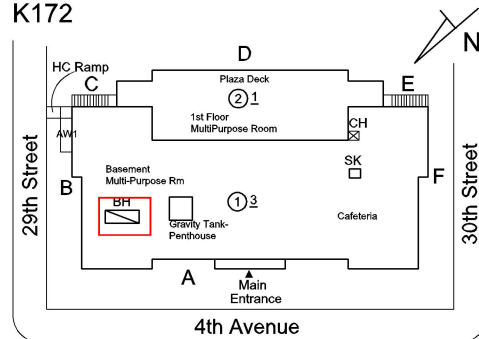
Deficiency	BULKHEAD/PENTHOUSE WALLS/INTERIOR: PLASTER CRACKS/SPALLING
Roof Plan reference	K172
Deficiency Quantity	20
Quantity Uom	S.F.
Potential Action	REPLACE
Urgency of Action	PRIORITY 3

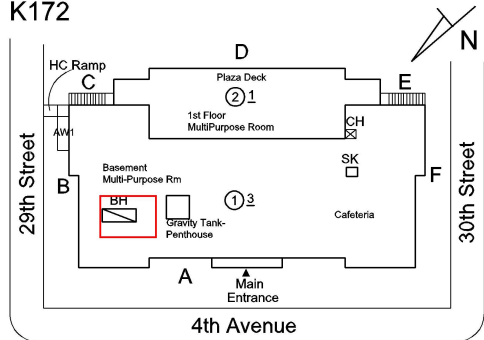
Violations	BH No violations recorded.
Deficiency	BULKHEAD/PENTHOUSE ROOF: DETERIORATED
Roof Plan reference	K172

Deficiency Quantity	60
Quantity Uom	S.F.
Potential Action	REPLACE
Urgency of Action	PRIORITY 4
Purpose of Action	LEVEL 2
Deficiency Photo1

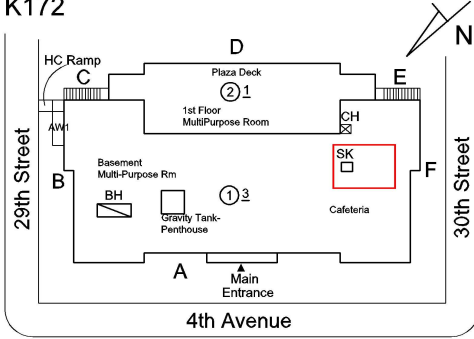
Question	Response
EXTERIOR	
ROOF	
Specialties	
SKYLIGHT/ROOF VENT	
Condition	2 - Between Good and Fair
Deficiency	BROKEN FRAMING
Roof Plan reference	K172

Deficiency Quantity	10
Quantity Uom	L.F.
Potential Action	MAINTENANCE
Urgency of Action	PRIORITY 3
Purpose of Action	LEVEL 2
Deficiency Photo1

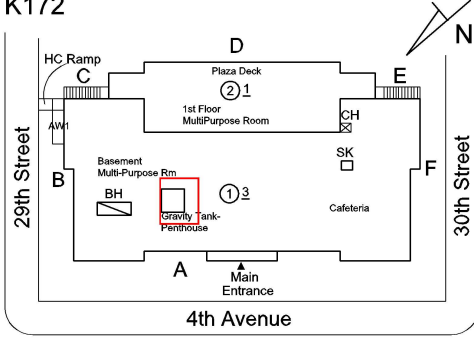
Violations	Roof 1 No violations recorded.
ROOF/GRAVITY TANK	
Condition	Inspected
Deficiency	3 - Fair
Roof Plan reference	TANK: NOT IN USE - MINOR DETERIORATION
	K172

Deficiency Quantity	1
Quantity Uom	EACH
Potential Action	NO ACTION
Urgency of Action	PRIORITY 1
Purpose of Action	LEVEL 1

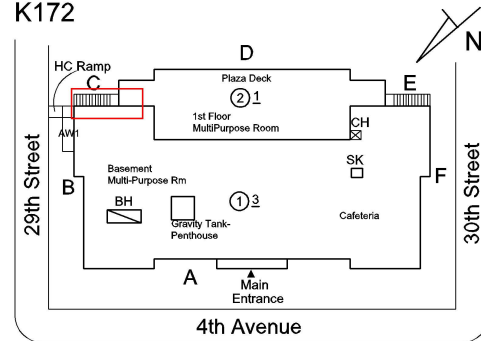
MISSING RAILING

REPLACE

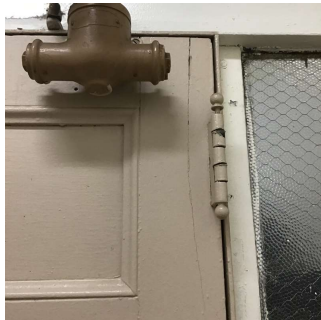
Question	Response
INTERIOR	
STRUCTURAL	
FOUNDATION WALLS	Inspected
Violations	No violations recorded.
ROOF STRUCTURE	Inspected
Condition	2 - Between Good and Fair
Deficiency	No deficiencies recorded
VAULTS-BUNKERS	Does not Exist
AUDITORIUM	Does not Exist
CAFETERIA	Inspected
Instance on Basement	Inspected
Ceiling	
Instance on Basement	Inspected
Condition	2 - Between Good and Fair
Deficiency	No deficiencies recorded
Door(s)	
Instance on Basement	Inspected
Condition	4 - Between Fair and Poor
Deficiency	WOOD: DETERIORATED DOOR
Deficiency Location/Instance	Exit 3 Vestibule, Exit 5 Vestibule
Deficiency Quantity	2
Quantity Uom	EACH
Potential Action	MAINTENANCE
Urgency of Action	PRIORITY 3
Purpose of Action	LEVEL 2
Deficiency Photo1

Violations	Exit 3 Vestibule No violations recorded.
Fixed Equipment	
Instance on Basement	Inspected
Condition	2 - Between Good and Fair
Deficiency	No deficiencies recorded
Floor Finish	
Instance on Basement	Inspected

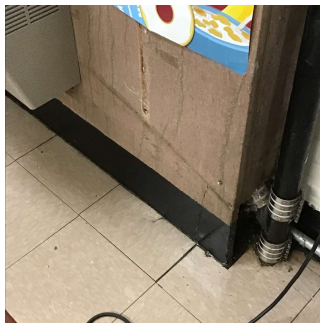
Question	Response
INTERIOR	
CAFETERIA	
Walls	
Deficiency Photo1

Near Drinking Fountain
Violations	No violations recorded.
Deficiency	BRICK: CRACKS/SPALLING - ACTIVE LEAK
Deficiency Location/Instance	Near Windows
Deficiency Quantity	30
Quantity Uom	S.F.
Potential Action	REPLACE
Urgency of Action	PRIORITY 5
Purpose of Action	LEVEL 2
Deficiency Photo1

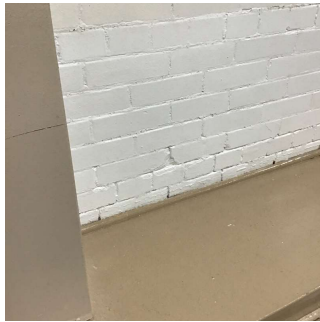
Near Windows
Violations	No violations recorded.
Window Curtains/Shades/Blinds	
Instance on Basement	Does not Exist
CLASSROOMS/CORRIDORS/ADMIN SPACES	
Ceiling	
Condition	Inspected
Condition	2 - Between Good and Fair
Deficiency	PLASTER: CRACKS/SPALLING
Deficiency Location/Instance	Rooms 202, 204, Corridor near Rooms 103, 106, 309, and others
Deficiency Quantity	250
Quantity Uom	S.F.
Potential Action	REPLACE
Urgency of Action	PRIORITY 3
Purpose of Action	LEVEL 2

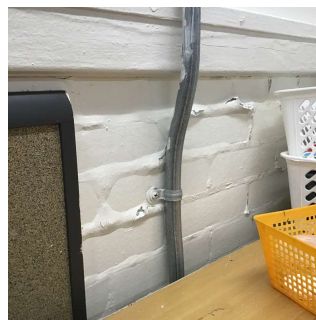
Question	Response
INTERIOR	
CLASSROOMS/CORRIDORS/ADMIN SPACES	
Walls	
Violations	Basement Art Room No violations recorded.
Deficiency	PLASTER: CRACKS/SPALLING
Deficiency Location/Instance	Rooms 102, 201, 202, 302, 304, and others
Deficiency Quantity	1,900
Quantity Uom	S.F.
Potential Action	REPLACE
Urgency of Action	PRIORITY 3
Purpose of Action	LEVEL 2
Deficiency Photo1

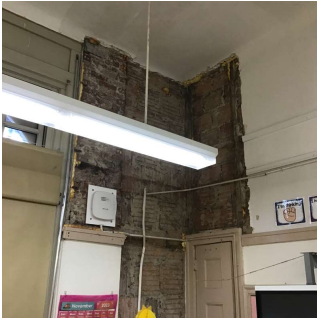
Violations	Room 304 No violations recorded.
Specialties	Does not Exist
GYMNASIUM	Does not Exist
INTERIOR DOOR HARDWARE	Inspected
Condition	3 - Fair
Deficiency	No deficiencies recorded
INTERIOR GUARDS	Inspected
Condition	2 - Between Good and Fair
Deficiency	No deficiencies recorded
KITCHEN	Inspected
Instance on Basement	Inspected
Ceiling	
Instance on Basement	Inspected
Condition	2 - Between Good and Fair
Deficiency	PLASTER: CRACKS/SPALLING
Deficiency Location/Instance	Center, Store Room
Deficiency Quantity	25
Quantity Uom	S.F.
Potential Action	REPLACE

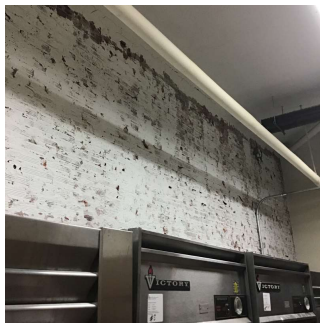
Question	Response
INTERIOR	
KITCHEN	Inspected
Walls	
Deficiency Photo1

Store Room
Violations	No violations recorded.
LIBRARY	Does not Exist
LOCKER ROOM	Does not Exist
MULTI-PURPOSE ROOM	Inspected
Instance on Basement	Inspected
Instance on 1st Floor	Inspected
Ceiling	
Instance on 1st Floor	Inspected
Condition	2 - Between Good and Fair
Deficiency	PLASTER: CRACKS/SPALLING
Deficiency Location/Instance	Rear Left Side
Deficiency Quantity	15
Quantity Uom	S.F.
Potential Action	REPLACE
Urgency of Action	PRIORITY 3
Purpose of Action	LEVEL 2
Deficiency Photo1

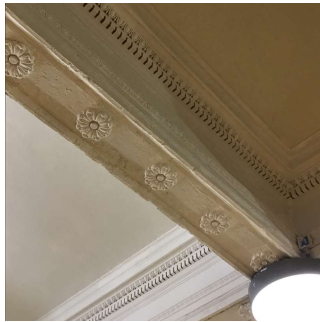
Rear Left Side
Violations	No violations recorded.
Instance on Basement	Inspected
Condition	2 - Between Good and Fair
Deficiency	PLASTER: CRACKS/SPALLING
Deficiency Location/Instance	Exit 4 Vestibule, Center
Deficiency Quantity	20
Quantity Uom	S.F.
Potential Action	REPLACE
Urgency of Action	PRIORITY 3
Purpose of Action	LEVEL 2

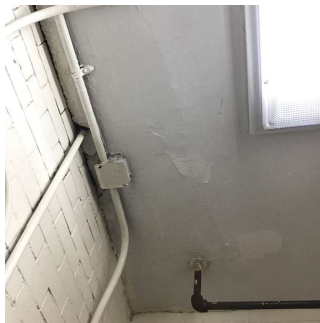
Violations	Exit 4 Vestibule No violations recorded.
Door(s)	
Instance on Basement	Inspected
Condition	5 - Poor
Deficiency	WOOD: DETERIORATED DOOR
Deficiency Location/Instance	Exit 2 Vestibule, Exit 4 Vestibule
Deficiency Quantity	3
Quantity Uom	EACH
Potential Action	MAINTENANCE
Urgency of Action	PRIORITY 3
Purpose of Action	LEVEL 2
Deficiency Photo1	 
Violations	Exit 2 Vestibule No violations recorded.
Fixed Equipment	
Instance on Basement	Does not Exist
Instance on 1st Floor	Does not Exist
Floor Finish	
Instance on 1st Floor	Inspected
Condition	2 - Between Good and Fair
Deficiency	WOOD: DAMAGED/DETERIORATED
Deficiency Location/Instance	Left Side, Center, Right Side, Rear, Near Stage Right
Deficiency Quantity	60
Quantity Uom	S.F.
Potential Action	REPLACE
Urgency of Action	PRIORITY 3
Purpose of Action	LEVEL 2

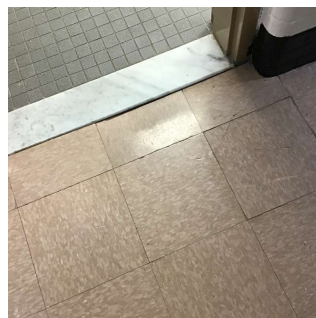
VINYL TILES: BROKEN/DETERIORATED/MISSING TILES

Question	Response
INTERIOR	
MULTI-PURPOSE ROOM	
Floor Finish	
Violations	Near Girls Toilet Room No violations recorded.
Sliding-folding Partition	
Instance on 1st Floor	Does not Exist
Instance on Basement	Does not Exist
Stage	
Instance on 1st Floor	Inspected
Instance on Basement	Does not Exist
Stage	
Instance on 1st Floor	Inspected
Condition	3 - Fair
Deficiency	DAMAGED FLOOR
Deficiency Location/Instance	Center
Deficiency Quantity	40
Quantity Uom	S.F.
Potential Action	REPLACE
Urgency of Action	PRIORITY 3
Purpose of Action	LEVEL 2
Deficiency Photo1

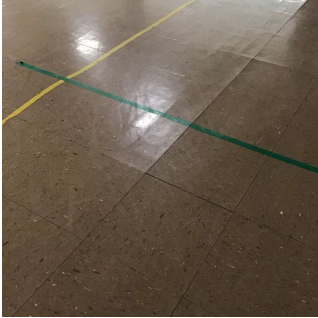
Violations	Center No violations recorded.
Stage Curtain Rigging	
Instance on 1st Floor	Inspected
Condition	2 - Between Good and Fair
Deficiency	No deficiencies recorded
Stage Curtains	
Instance on 1st Floor	Inspected
Condition	3 - Fair
Deficiency	WORN/DETERIORATED
Deficiency Location/Instance	Right Side
Deficiency Quantity	100
Quantity Uom	S.F.
Potential Action	REPLACE
Urgency of Action	PRIORITY 3

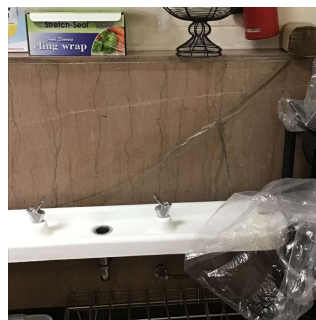
STONE: CRACKS/SPALLING

Question	Response
INTERIOR	
MULTI-PURPOSE ROOM	
Walls	
Violations	Near Drinking Fountain No violations recorded.
Window Curtains/Shades/Blinds	
Instance on 1st Floor	Inspected
Condition	3 - Fair
Deficiency	DAMAGED SHADES
Deficiency Location/Instance	Rear
Deficiency Quantity	30
Quantity Uom	S.F.
Potential Action	MAINTENANCE
Urgency of Action	PRIORITY 3
Purpose of Action	LEVEL 2
Deficiency Photo1	 
Violations	Rear No violations recorded.
SCIENCE DEMO ROOM	Does not Exist
SCIENCE LAB	Does not Exist
SCIENCE PREP ROOM	Does not Exist
SHOWER ROOM	Does not Exist
STAIRS/RAMPS: INTERIOR	Inspected
Do Letter Stair Signs Exist?	Yes
Ceiling	Inspected
Condition	2 - Between Good and Fair
Deficiency	No deficiencies recorded
Door(s)	Inspected
Condition	2 - Between Good and Fair
Deficiency	No deficiencies recorded
Partition	Inspected
Condition	2 - Between Good and Fair
Deficiency	GLASS PANEL: DAMAGED/DETERIORATED
Deficiency Location/Instance	Stairs BC/1, DE/1,2

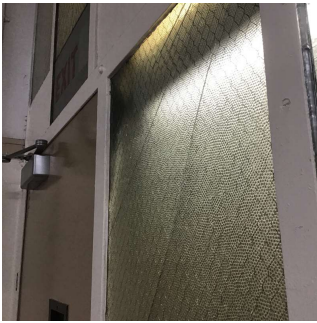
Violations	Stair BC/1 No violations recorded.
Deficiency	METAL PANEL: DAMAGED/DETERIORATED
Deficiency Location/Instance	Stair BC/Basement
Deficiency Quantity	10
Quantity Uom	S.F.
Potential Action	REPLACE
Urgency of Action	PRIORITY 3
Purpose of Action	LEVEL 2
Deficiency Photo1

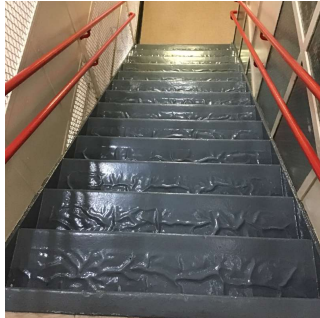
Question	Response
INTERIOR	
STAIRS/RAMPS: INTERIOR	
Stairs and Landings	
Deficiency	ROLLED ASPHALT: CRACKS
Deficiency Location/Instance	Stairs BC/Basement, 1-3, DE/Basement, 1-3
Deficiency Quantity	1,040
Quantity Uom	S.F.
Potential Action	REPLACE
Urgency of Action	PRIORITY 3
Purpose of Action	LEVEL 2
Deficiency Photo1

Violations	Stair BC/3 No violations recorded.
Walls	Inspected
Condition	2 - Between Good and Fair
Deficiency	PLASTER: CRACKS/SPALLING
Deficiency Location/Instance	Stair CD/3
Deficiency Quantity	30
Quantity Uom	S.F.
Potential Action	REPLACE
Urgency of Action	PRIORITY 3
Purpose of Action	LEVEL 2
Deficiency Photo1

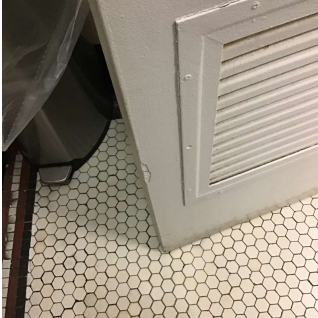
Violations	Stair CD/3 No violations recorded.
TOILET ROOMS - STAFF	
Inspected	
Ceiling	
Inspected	
Condition	2 - Between Good and Fair
Deficiency	No deficiencies recorded
Door(s)	
Inspected	
Condition	5 - Poor
Deficiency	WOOD: DETERIORATED DOOR
Deficiency Location/Instance	In Room 254, Kitchen Staff

Question	Response
INTERIOR	
TOILET ROOMS - STAFF	
Door(s)	
Quantity Uom	EACH
Potential Action	MAINTENANCE
Urgency of Action	PRIORITY 3
Purpose of Action	LEVEL 2
Deficiency Photo1

Violations	In Room 254 No violations recorded.
Floor Finish	Inspected
Condition	2 - Between Good and Fair
Deficiency	No deficiencies recorded
Stalls	Inspected
Condition	2 - Between Good and Fair
Deficiency	No deficiencies recorded
Walls	Inspected
Condition	2 - Between Good and Fair
Deficiency	PLASTER: CRACKS/SPALLING
Deficiency Location/Instance	In Room 254, Kitchen Staff
Deficiency Quantity	20
Quantity Uom	S.F.
Potential Action	REPLACE
Urgency of Action	PRIORITY 3
Purpose of Action	LEVEL 2
Deficiency Photo1

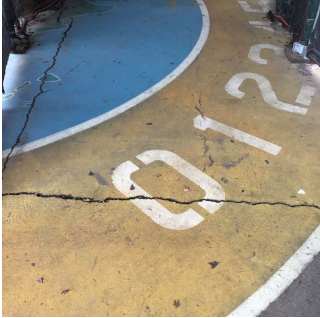
Question	Response
SITE	
IRRIGATION SYSTEM	Does not Exist
PAVING	Inspected
Student Non-Use	Inspected
Gravel Exists?	No
Asphalt	Inaccessible
Concrete	Inspected
Condition	1 - Good
Deficiency	No deficiencies recorded
Pavers	Inaccessible
Student Use	Inspected
Gravel Exists?	No
Asphalt	Inspected
Condition	3 - Fair
Deficiency	CRACKS - MAJOR
Deficiency Location/Instance	Schoolyard
Deficiency Quantity	150
Quantity Uom	S.F.
Potential Action	REPLACE
Urgency of Action	PRIORITY 3
Purpose of Action	LEVEL 2
Deficiency Photo1

Schoolyard
Violations	No violations recorded.
Concrete	Inspected
Condition	1 - Good
Deficiency	No deficiencies recorded
Pavers	Does not Exist
Site Sidewalks & Walkways	Inspected
Asphalt	Does not Exist
Concrete	Inspected
Condition	3 - Fair
Deficiency	DAMAGED/DETERIORATED/MISSING SECTIONS
Deficiency Location/Instance	30th Street, 29th Street
Deficiency Quantity	225
Quantity Uom	S.F.
Potential Action	REPLACE
Urgency of Action	PRIORITY 3

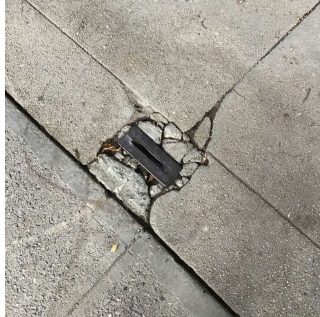
Question	Response
SITE	
PAVING	
Site Sidewalks & Walkways	
Concrete	
Deficiency Photo1

Violations	30th Street No violations recorded.
Pavers	Does not Exist
DOT Sidewalk	Inspected
Asphalt	Does not Exist
Concrete	Inspected
Condition	4 - Between Fair and Poor
Deficiency	DAMAGED CURBS
Deficiency Location/Instance	30th Street, 4th Avenue, 29th Street
Deficiency Quantity	110
Quantity Uom	L.F.
Potential Action	REPLACE
Urgency of Action	PRIORITY 3
Purpose of Action	LEVEL 2
Deficiency Photo1	 
Violations	30th Street No violations recorded.
Deficiency	DAMAGED/DETERIORATED/MISSING SECTIONS
Deficiency Location/Instance	30th Street, 4th Avenue, 29th Street
Deficiency Quantity	1,525
Quantity Uom	S.F.
Potential Action	REPLACE
Urgency of Action	PRIORITY 3
Purpose of Action	LEVEL 2

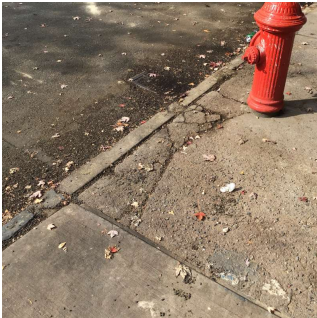
Question	Response
SITE	
PAVING	
DOT Sidewalk	
Concrete	
Deficiency Photo1

Violations	30th Street No violations recorded.
Pavers	Does not Exist
PLAYGROUNDS	Inspected
Instance on Plaza Deck	Inspected
Instance on Schoolyard	Inspected
Benches	
Instance on Plaza Deck	Does not Exist
Instance on Schoolyard	Does not Exist
Fence	
Instance on Schoolyard	Inspected
Condition	3 - Fair
Deficiency	CHAIN LINK: DAMAGED/DETERIORATED
Deficiency Location/Instance	Right Side
Deficiency Quantity	150
Quantity Uom	S.F.
Potential Action	REPLACE
Urgency of Action	PRIORITY 3
Purpose of Action	LEVEL 2
Deficiency Photo1

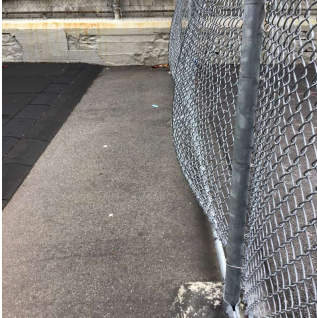
Violations	Right Side No violations recorded.
Pavement	
Instance on Schoolyard	Inspected
Condition	3 - Fair
Deficiency	ASPHALT: CRACKS - MAJOR
Deficiency Location/Instance	Near Entrance Gate, Right Side
Deficiency Quantity	80

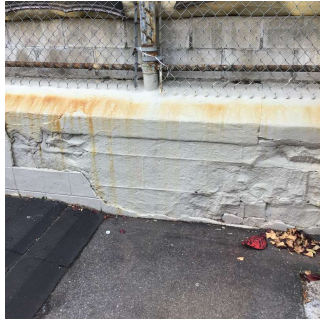
Question	Response
SITE	
RETAINING WALLS	
street/sidewalk?	
Condition	4 - Between Fair and Poor
Deficiency	CAST IN PLACE CONCRETE: CRACKS/SPALLING - MAJOR
Deficiency Location/Instance	Playground
Deficiency Quantity	15
Quantity Uom	S.F.
Potential Action	REPLACE
Urgency of Action	PRIORITY 3
Purpose of Action	LEVEL 2
Deficiency Photo1	 
	Playground
Violations	No violations recorded.
Deficiency	STONE: DETERIORATED COPING STONE
Deficiency Location/Instance	Playground, Schoolyard
Deficiency Quantity	130
Quantity Uom	S.F.
Potential Action	REPLACE
Urgency of Action	PRIORITY 3
Purpose of Action	LEVEL 2
Deficiency Photo1	 
	Playground
Violations	No violations recorded.
Deficiency	STONE: CRACKS/SPALLING - MAJOR
Deficiency Location/Instance	Playground, Schoolyard
Deficiency Quantity	200
Quantity Uom	S.F.
Potential Action	REPLACE
Urgency of Action	PRIORITY 3
Purpose of Action	LEVEL 2

Question	Response
SITE	
RETAINING WALLS	
Deficiency Photo1

Violations	Playground No violations recorded.
SEATING	Inspected
Benches	Inspected
Concrete	Does not Exist
Metal/Wood/Plastic	Inspected
Condition	2 - Between Good and Fair
Deficiency	No deficiencies recorded
Bleachers	Does not Exist
SITE WALLS (NOT RETAINING WALLS)	Does not Exist
STAIRS/RAMPS: EXTERIOR	Inspected
Railings	Does not Exist
Site Cheek/flank Walls	Does not Exist
Stairs/ramps	Inspected
Condition	2 - Between Good and Fair
Deficiency	STONE: CRACKS/SPALLING
Deficiency Location/Instance	30th Street
Deficiency Quantity	10
Quantity Uom	S.F.
Potential Action	REPLACE
Urgency of Action	PRIORITY 3
Purpose of Action	LEVEL 2
Deficiency Photo1
