**NYC Department of Education**  
**Building Condition Assessment Survey 2023 - 2024**

Architectural Inspection

**Asset:** P.S. 174 - BROOKLYN, 574 DUMONT AVENUE, New York, 11207

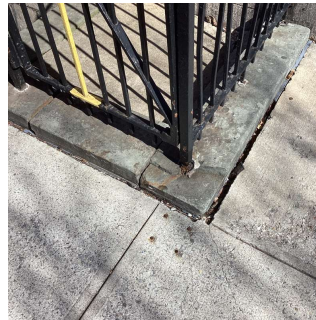
AW8  
 No violations recorded.

| Question | Response |
|---|--|
| Deficiency | AREAWAY WALLS: DETERIORATED COPING STONE |

30  
 S.F.  
 REPLACE  
 PRIORITY 4  
 LEVEL 2

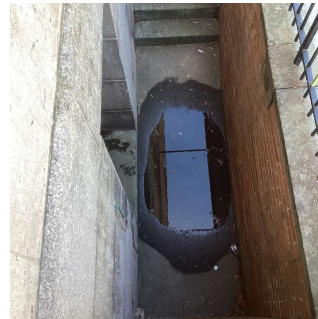
AW4

AREAWAY DRAINS: CLOGGED

4

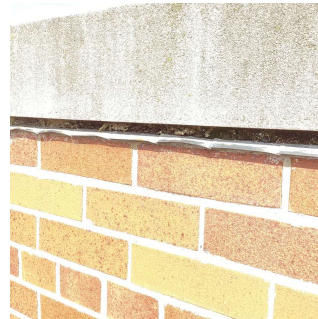
Roof 1

**CAST STONE: DETERIORATED BED JOINT**

300

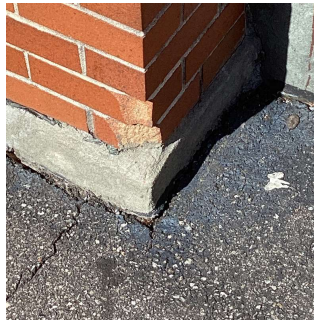
Facade G

| Question | Response |
|---|---|
| Deficiency | BRICK: CRACKS/DISPLACED/SPALLED BRICK AT BUILDING CORNERS |

10

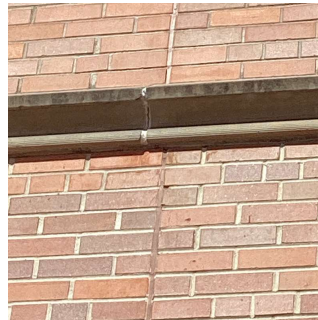
Facade G

STONE: DETERIORATED JOINTS

25

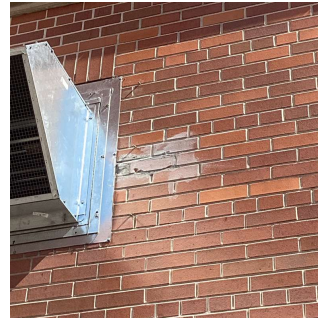
Facade H

BRICK: MINOR CRACKS AND SPALLING

10

PRIORITY 3  
LEVEL 2

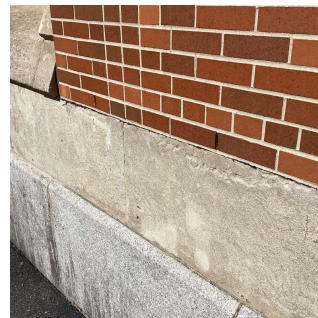
Facade K

STONE: CHIPPED/SPALLED/BROKEN PIECES - MAJOR

30

REPLACE

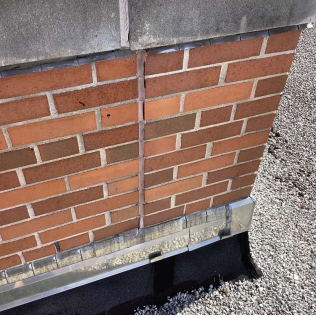
| Question | Response |
|---|--|
| Deficiency | BRICK: OUT OF PLUMB |
| Deficiency Quantity | 15 |
| Urgency of Action | PRIORITY 4 |

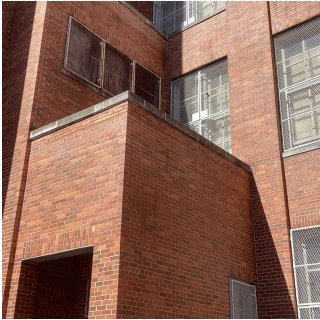
**BRICK: DETERIORATED JOINTS**

200

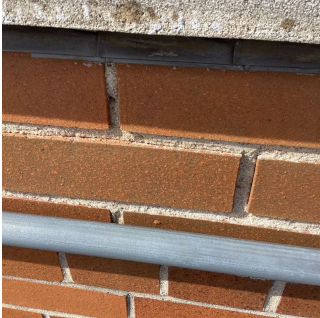
| Question | Response |
|---|--|
| Deficiency | <b>BRICK: DETERIORATED JOINTS</b> |
| Deficiency Quantity | 150 |
| Urgency of Action | PRIORITY 3 |

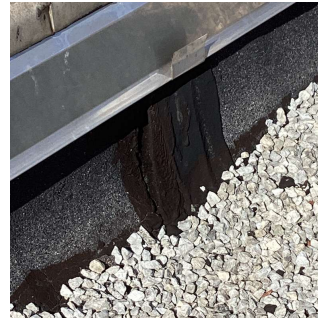
Roof 1

**BUILT-UP: FLASHING: DETERIORATED JOINTS**

20

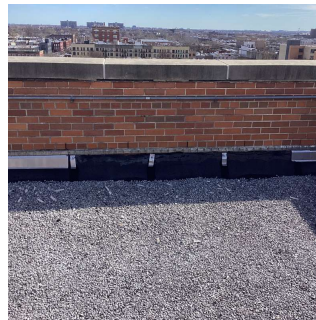
Roof 1

15  
 L.F.  
 INSTALL NEW  
 PRIORITY 4  
 LEVEL 2

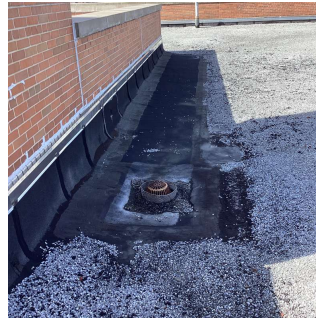
Roof 1

**BUILT-UP: ROOFING: LOSS OF GRAVEL**

200  
 S.F.  
 INSTALL NEW GRAVEL  
 PRIORITY 3  
 LEVEL 2

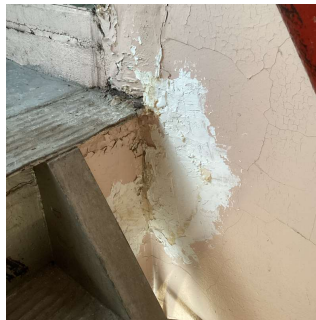
Roof 1  
No violations recorded.

10  
L.F.  
MAINTENANCE  
PRIORITY 3  
LEVEL 2

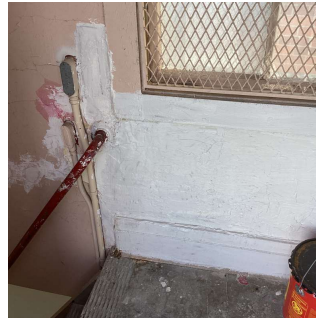
Roof 1

Deficiency **BULKHEAD/PENTHOUSE WALLS/INTERIOR: PLASTER CRACKS/SPALLING**

25  
S.F.  
REPLACE  
PRIORITY 3  
LEVEL 2

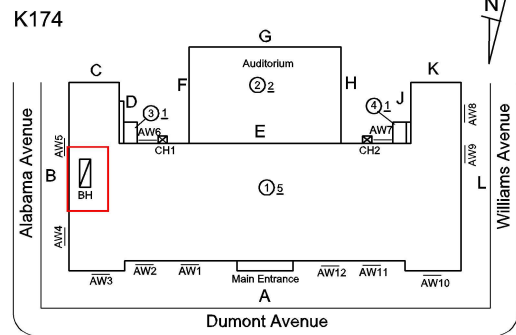
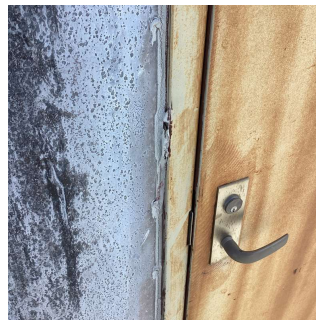
Roof 1

**BULKHEAD/PENTHOUSE WALLS/EXTERIOR: DAMAGED METAL SIDING**

REPLACE

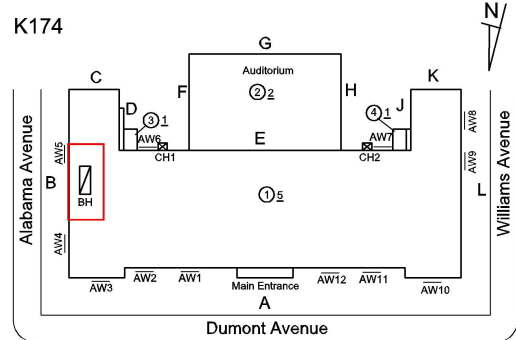
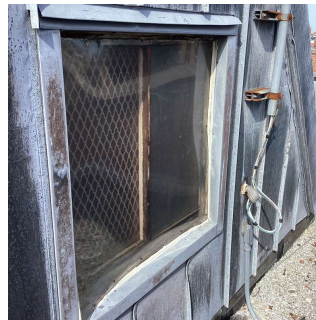
Roof 1

**BULKHEAD/PENTHOUSE WINDOWS: DAMAGED, DETERIORATED WINDOWS**

30  
 S.F.  
 REPLACE  
 PRIORITY 4  
 LEVEL 2

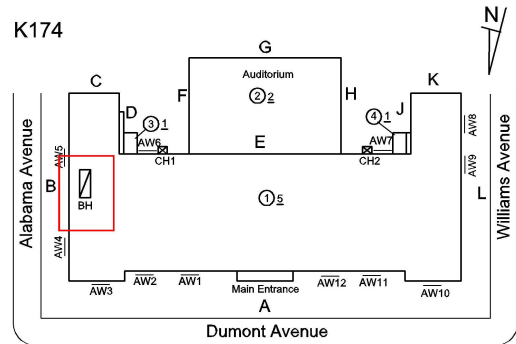
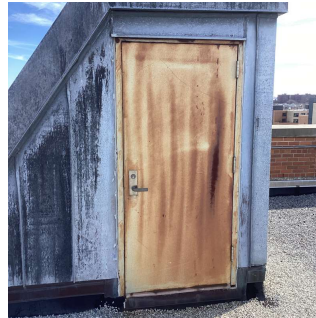
Roof 1

**BULKHEAD/PENTHOUSE DOORS: DETERIORATED DOOR AND FRAME**

1  
 EACH  
 REPLACE DOOR AND FRAME  
 PRIORITY 4  
 LEVEL 2

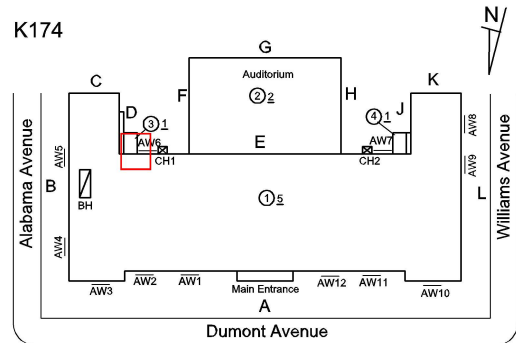
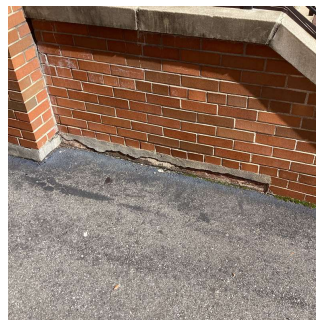
Exit 6

BRICK: CRACKS/SPALLING - MAJOR

REPLACE

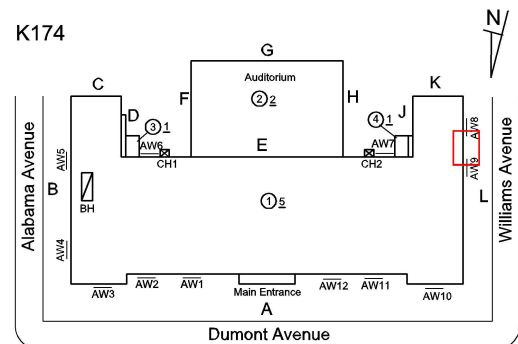
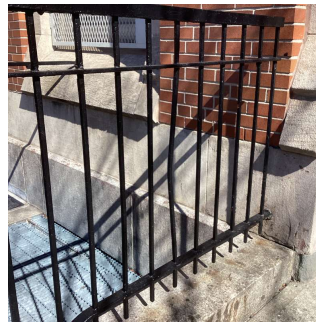
Exit 4

DAMAGED

REPLACE

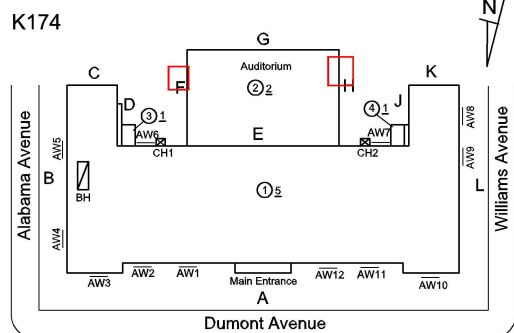
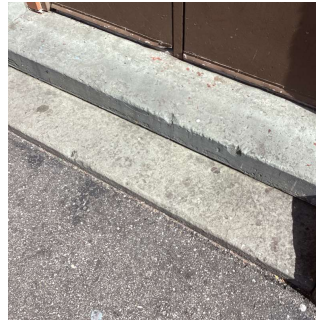
Facade H

**STONE: CRACKS/SPALLING - MAJOR**

20  
S.F.  
REPLACE  
PRIORITY 4  
LEVEL 2

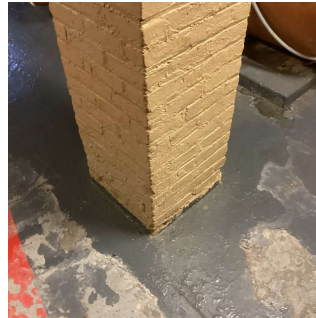
Boiler Room

| Question | Response |
|---|--|
| Deficiency | STEEL COLUMNS/BEAMS: DETERIORATED MASONRY FIREPROOFING |

| Question | Response |
|---|--|
| Potential Action | REPLACE |

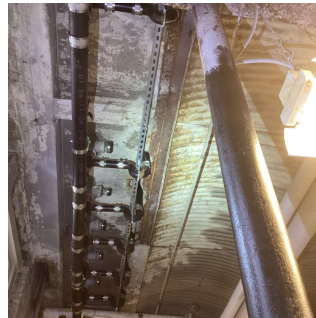
Fan Area

STEEL COLUMNS/BEAMS: MAJOR RUSTING

REPLACE

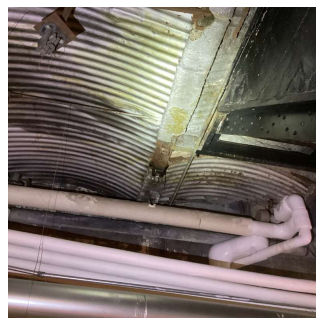
STEEL COLUMNS/BEAMS: DETERIORATED/MISSING PLASTER FIREPROOFING

REPLACE

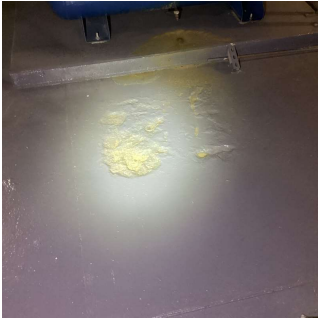
| Question | Response |
|---|--|
| Deficiency | CONCRETE SLAB ON GRADE: THRU CRACKS |
| Deficiency Location/Instance | Boiler Room |

| Question | Response |
|---|--|
| Potential Action | REPLACE |

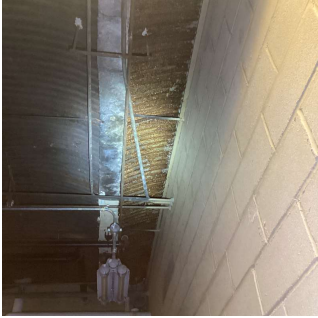
| Question | Response |
|---|--|
| Deficiency | CINDER CONCRETE ARCH: METAL PAN DETERIORATED, SPALLED |
| Deficiency Location/Instance | Fan Area, Oil Tank Room |

| Question | Response |
|---|--|
| Potential Action | REPAIR |

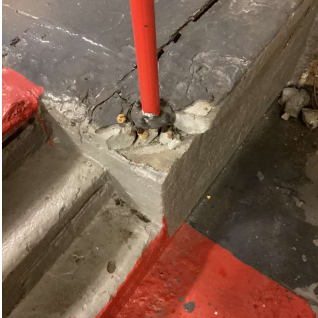
| Question | Response |
|---|--|
| Deficiency | BRICK: BULGING/DISPLACED |
| Deficiency Location/Instance | Boiler Room |

| Question | Response |
|---|--|
| Potential Action | REPLACE |

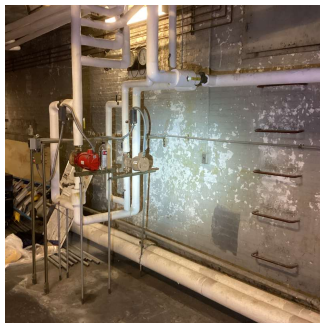
| Question | Response |
|--|--|
| | Boiler Room |

| Question | Response |
|---|--|
| Deficiency | BRICK: WATER INFILTRATION IN NON- INSTRUCTIONAL SPACE |
| Deficiency Location/Instance | Boiler Room |

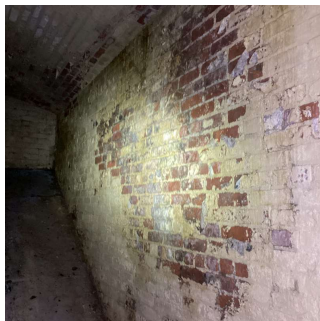
| Question | Response |
|--|--|
| | Oil Tank Room |

| Question | Response |
|--|--|
| Deficiency | DETERIORATED JOINTS |
| Deficiency Location/Instance | Oil Tank Room |

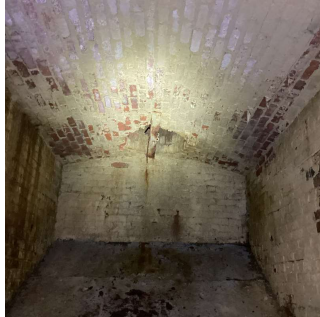
| Question | Response |
|--|--|
| | Oil Tank Room |

| Question | Response |
|--|--|
| Deficiency | WATER INFILTRATION |
| Deficiency Location/Instance | Oil Tank Room, Boiler Room |

| Question | Response |
|--|--|
| Potential Action | REPAIR |

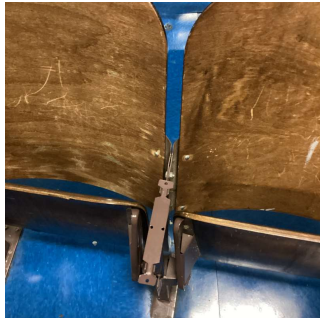
| Question | Response |
|--|--|
| | Seat K/5 |

| Question | Response |
|--|--|
| Deficiency | DAMAGED/BROKEN/INOPERABLE |
| Deficiency Location/Instance | Seats K/5, 9, L/1, N/107, P/109,Q/1 |

| Question | Response |
|--|--|
| Potential Action | REPLACE |

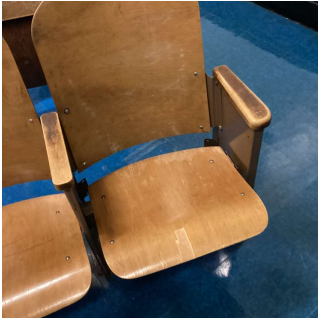
| Question | Response |
|---|--|
| | Seat A/17 |

| Question | Response |
|--|--|
| Deficiency | DAMAGED/BROKEN/INOPERABLE |
| Deficiency Location/Instance | Seats A/7,17, B/9, C/1, D/3,11 and others |

| Question | Response |
|---|--|
| Potential Action | REPLACE |

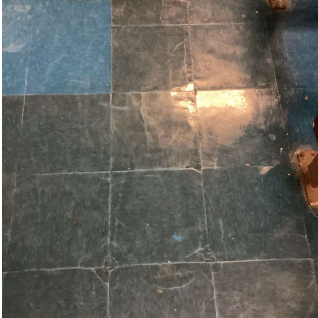
| Question | Response |
|---|--|
| | Near Seat B/101 |

| Question | Response |
|---|--|
| Deficiency | VINYL TILES: DETERIORATED SUBSTRATE |
| Deficiency Location/Instance | Near Seat B/101, E101, F101, G101, H101 and others |

| Question | Response |
|---|--|
| Potential Action | REPLACE |

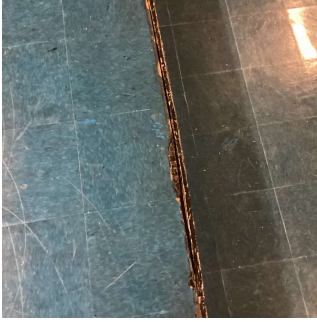
| Question | Response |
|---|--|
| Deficiency | DAMAGED FLOOR |
| Deficiency Location/Instance | Center, Left, Right |

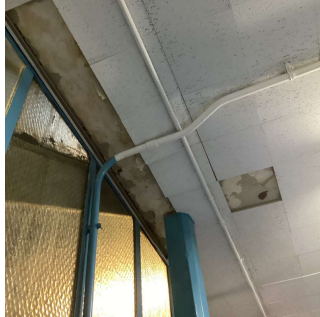
| Question | Response |
|--|--|
| | Stair AB/1 |

| Question | Response |
|--|--|
| Deficiency | ACOUSTIC TILES ON PLASTER: DAMAGED/MISSING |

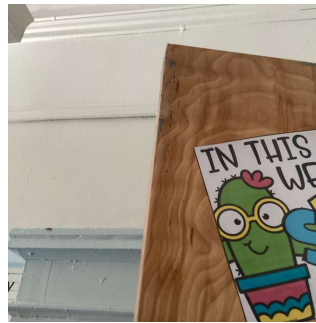
Room 310

| Question | Response |
|--|--|
| Deficiency | WOOD: DETERIORATED DOOR |

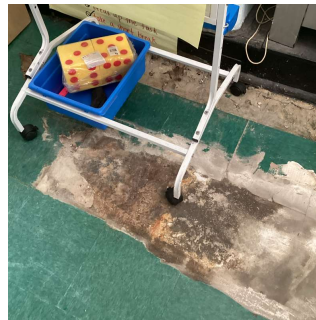
Room 106

VINYL TILES: BROKEN/DETERIORATED/MISSING TILES  
Rooms 403, 402, 401, 210, 106 and others  
350  
S.F.  
REPLACE  
PRIORITY 3  
LEVEL 2

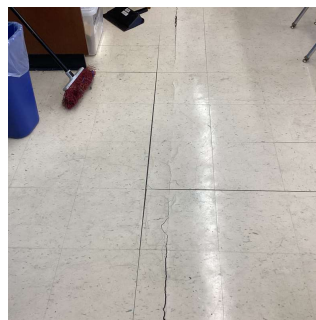
VINYL TILES: DETERIORATED SUBSTRATE  
Main Office, Corridor near room 106, 107, 108, Room 407  
1,000  
S.F.  
REPLACE  
PRIORITY 3  
LEVEL 2

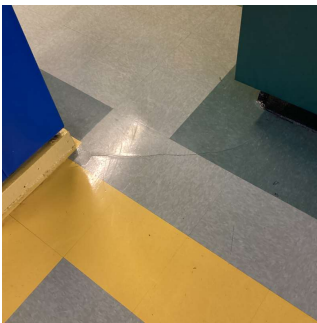
| Question | Response |
|---|--|
| Violations | Near Entrance<br>No violations recorded. |

| Question | Response |
|---|--|
| Deficiency | VINYL TILES: DETERIORATED SUBSTRATE |
| Deficiency Location/Instance | Near Entrance, Near Stair C |

| Question | Response |
|---|--|
| Potential Action | REPLACE |

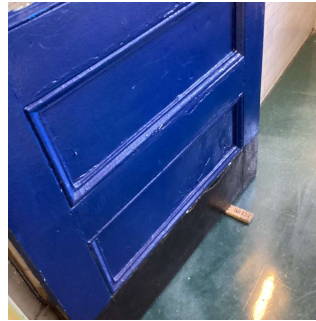
Stair EF/4

| Question | Response |
|---|--|
| Deficiency | METAL CLAD WOOD: DETERIORATED DOOR |
| Deficiency Location/Instance | Stairs EF/4 (2 Doors), D/2 (2 Doors), D/4 |

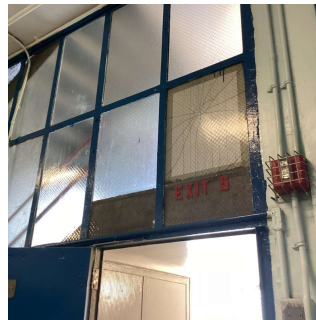
Stair AB/1

GLASS PANEL: DAMAGED/DETERIORATED

REPLACE

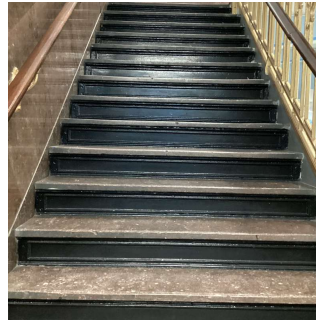
Lobby Grand Stairs

STONE: WORN-OUT TREAD/NOSINGS

REPLACE

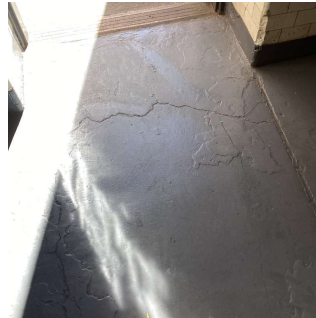
Stair D/1

ROLLED ASPHALT: CRACKS

REPLACE

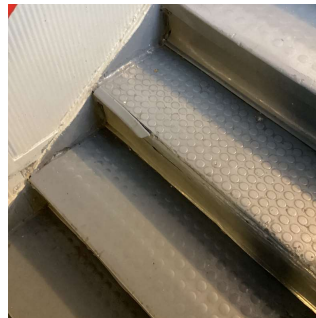
Stair EF/1

SHEET VINYL: WORN-OUT TREAD/NOSINGS

REPLACE

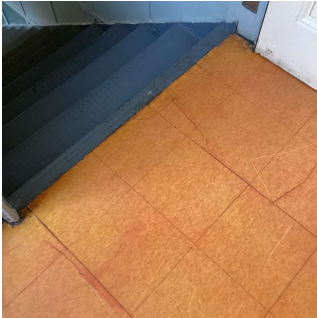
| Question | Response |
|---|--|
| Violations | Stair EF/2<br>No violations recorded. |

| Question | Response |
|---|--|
| Deficiency | VINYL TILES: DETERIORATED SUBSTRATE |
| Deficiency Location/Instance | Stairs EF/2, D/1,2, B/2 and others |

| Question | Response |
|---|--|
| Potential Action | REPLACE |

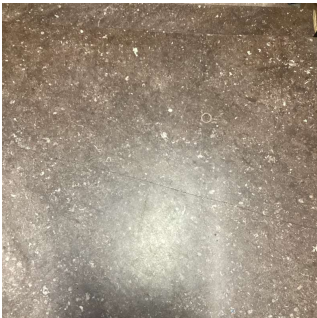
| Question | Response |
|---|--|
| Violations | Lobby Grand Stair<br>No violations recorded. |

| Question | Response |
|---|--|
| Deficiency | STONE: BROKEN/MISSING |
| Deficiency Location/Instance | Lobby Grand Stair |

| Question | Response |
|---|--|
| Potential Action | REPLACE |

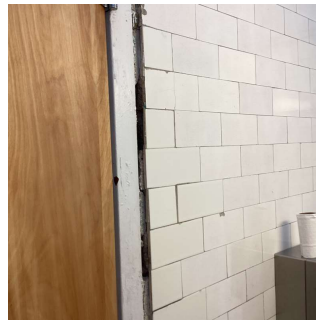
| Question | Response |
|---|--|
| Deficiency | WOOD: DAMAGED LOUVER |
| Deficiency Location/Instance | Room 251 |

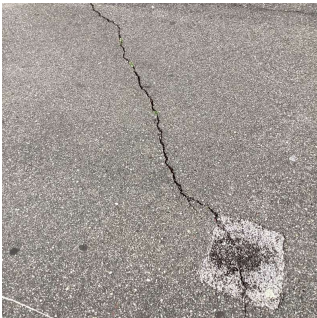
| Question | Response |
|---|--|
| Violations | Schoolyard<br>No violations recorded. |

| Question | Response |
|---|--|
| <b>Deficiency</b> | <b>CRACKS - MAJOR</b> |
