NYC Department of Education
Building Condition Assessment Survey 2023 - 2024

Architectural Inspection

Asset: P.S. 176 - BROOKLYN, 1225 69 STREET, New York, 11219

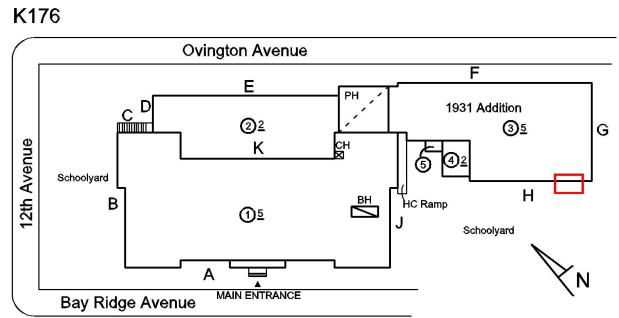
Roof Plan reference

Question	Response
Architectural	
EXTERIOR	Inspected
AREAWAY	Does not Exist
AWNINGS AND CANOPIES	Does not Exist
CHIMNEY	Under Construction
COPING	Under Construction
CORNICE	Does not Exist
DOORS	Inspected
DOORS AND FRAMES	Inspected
Condition	5 - Poor

Deficiency METAL CLAD: DETERIORATED DOOR AND FRAME - MAJOR DETERIORATION

REPLACE

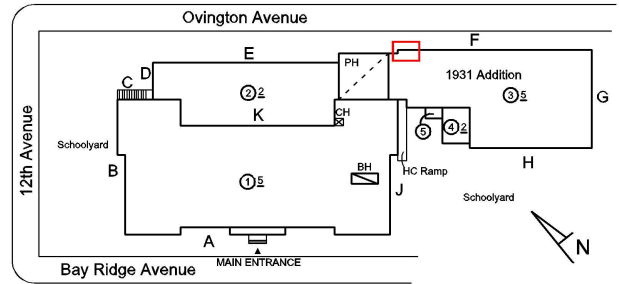
Roof Plan reference

METAL CLAD: DETERIORATED DOOR AND FRAME - MINOR DETERIORATION

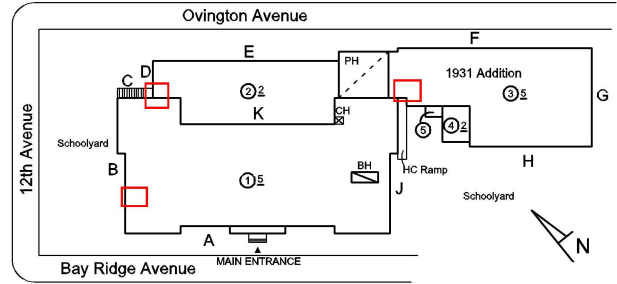
Roof Plan reference

METAL: DETERIORATED DOOR AND FRAME - MAJOR DETERIORATION

5
EACH
REPLACE
PRIORITY 4
LEVEL 4

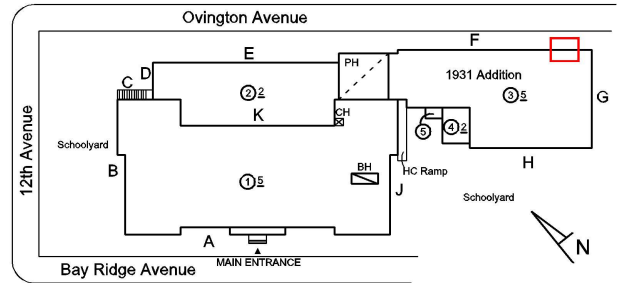
Roof Plan reference

METAL: DENTED, MAJOR RUSTING

10
S.F.
REPLACE
PRIORITY 4
LEVEL 2

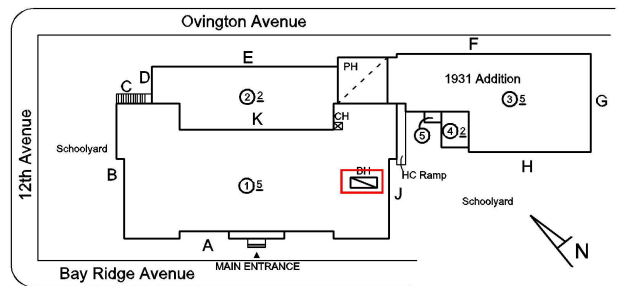
Condition	3 - Fair
Deficiency	BULKHEAD/PENTHOUSE CEILING: PLASTER DAMAGED/DETERIORATED
Roof Plan reference	K176

Deficiency Quantity	10
Quantity Uom	S.F.
Potential Action	REPLACE
Urgency of Action	PRIORITY 3
Purpose of Action	LEVEL 2

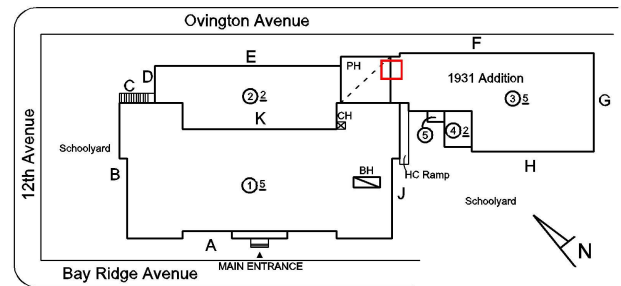
Roof Plan reference

BULKHEAD/PENTHOUSE WALLS/EXTERIOR: WATER INFILTRATION

REPAIR

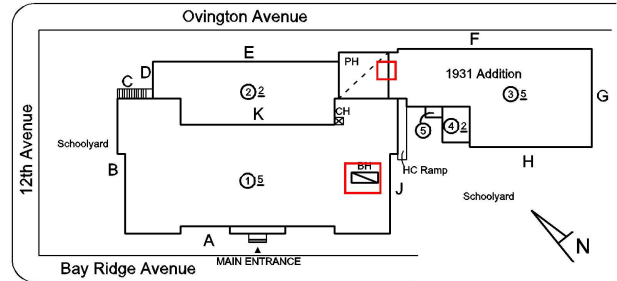
Roof Plan reference

BULKHEAD/PENTHOUSE WALLS/INTERIOR: PLASTER CRACKS/SPALLING

20
S.F.
REPLACE
PRIORITY 3
LEVEL 2

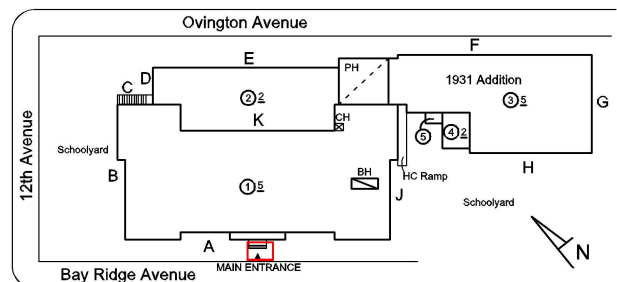
Roof Plan reference

CAST IN PLACE CONCRETE: CRACKS/SPALLING - MAJOR
K176

10
S.F.
REPLACE

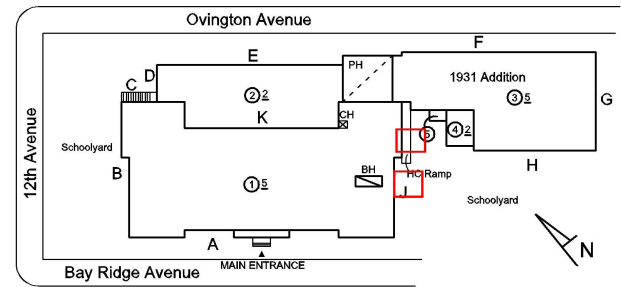
Roof Plan reference

CAST IN PLACE CONCRETE: CRACKS/SPALLING - MINOR

REPAIR

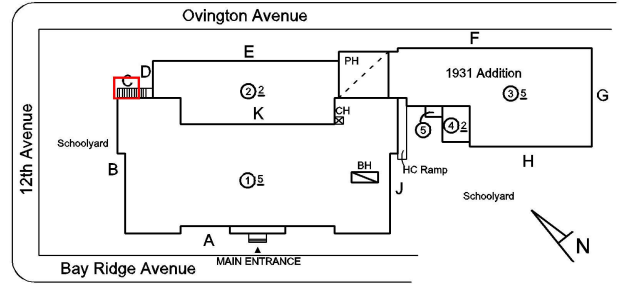
Roof Plan reference

BRICK: CRACKS/SPALLING - MAJOR

REPLACE

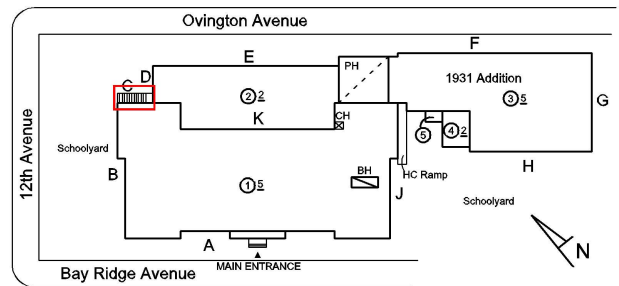
Roof Plan reference

BRICK: DETERIORATED JOINTS

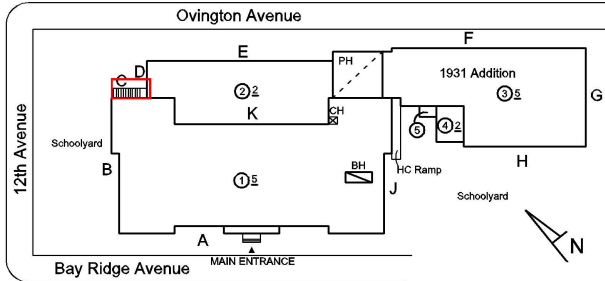
Facade C
Violations	No violations recorded.
RAILINGS	
Condition	Inspected
	5 - Poor
Deficiency	DAMAGED
Roof Plan reference	K176

Deficiency Quantity	30
Quantity Uom	L.F.
Potential Action	REPLACE
Urgency of Action	PRIORITY 4
Purpose of Action	LEVEL 2
Deficiency Photo1

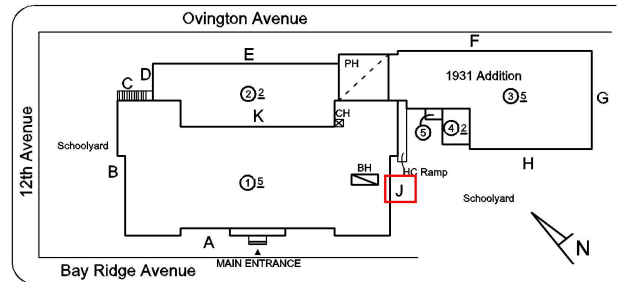
STONE: CRACKS/SPALLING - MINOR
 K176

10
 S.F.
 REPAIR
 PRIORITY 3
 LEVEL 2

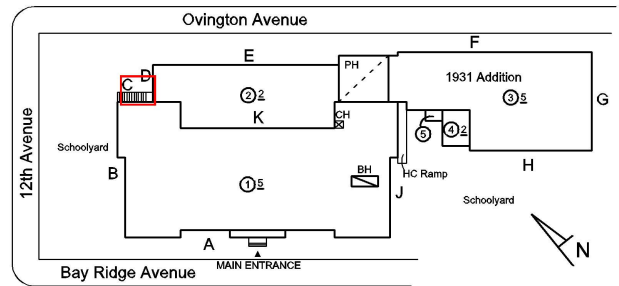
Roof Plan reference

STONE: CRACKS/SPALLING - MAJOR

REPLACE

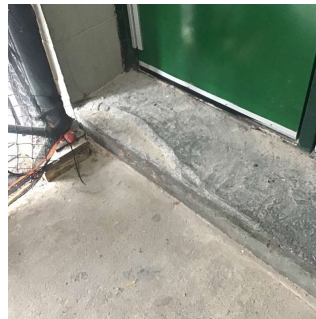
Facade C - Exit 10 Stairs on North corner of the building

Priority Condition Exist Last Year?	Priority Category	Condition Description	Component Affected	Location Description	Person(s) Notified	Person(s) Title	PhotoImage
No	Tripping Hazard	Deteriorated stone tread is a potential tripping hazard.	EXTERIOR STAIRS/RAMP S: EXTERIOR STAIRS/RAMP S	Exit 10 exterior stairs on North corner of the building	Julius Serrano	Custodian

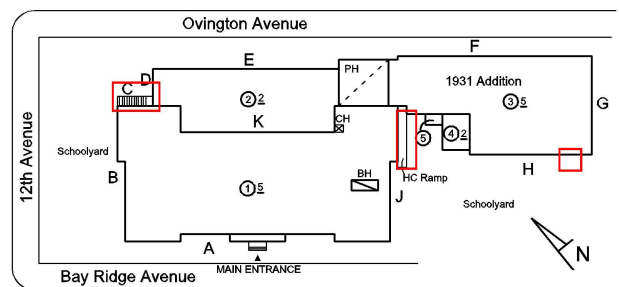
Roof Plan reference

CONCRETE: CRACKS/SPALLING - MINOR

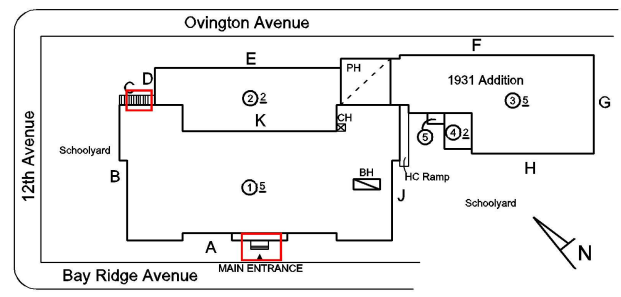
**CONCRETE: CRACKS/SPALLING - MAJOR
K176**

100

REPLACE

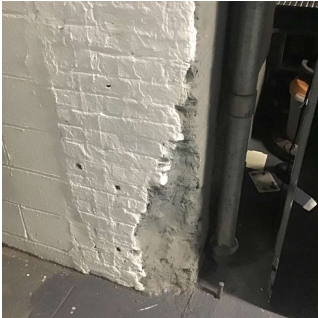
Question	Response
EXTERIOR	
WINDOWS	
WINDOWS	Inspected
Material Type(s)	Aluminum
Instance on Aluminum - Double Hung: All Facades	Under Construction
Instance Quantity	10,000
Instance Quantity Uom	S.F.
INTERIOR	Inspected
POOLS	Does not Exist
STRUCTURAL	Inspected
COLUMNS/BEAMS/BEARING WALLS	Inspected
Condition	3 - Fair
Deficiency	STEEL COLUMNS/BEAMS: DETERIORATED MASONRY FIREPROOFING
Deficiency Location/Instance	Basement - Boiler Room
Deficiency Quantity	30
Quantity Uom	S.F.
Potential Action	REPLACE
Urgency of Action	PRIORITY 4
Purpose of Action	LEVEL 5
Deficiency Photo1

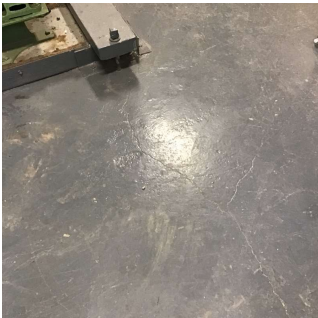
PH - Fan Room

Boiler Room
Violations	No violations recorded.
FLOOR STRUCTURE	Inspected
Condition	4 - Between Fair and Poor
Deficiency	CONCRETE: CRACKS/SPALLED/REINFORCEMENT EXPOSED
Deficiency Location/Instance	PH - Fan Room, 2nd Floor - Room 264
Deficiency Quantity	50
Quantity Uom	S.F.
Potential Action	REPAIR
Urgency of Action	PRIORITY 3
Purpose of Action	LEVEL 5

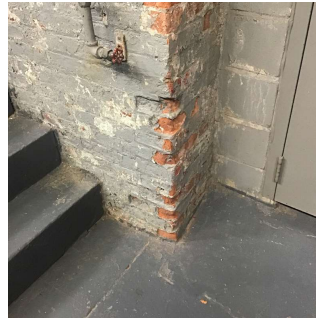
Boiler Room

BRICK: CRACKED/SPALLED

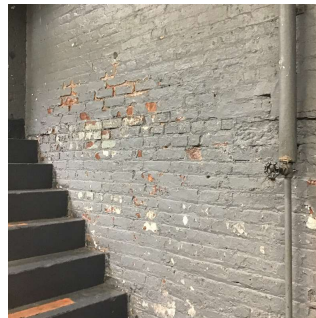
Boiler Room

BRICK: WATER INFILTRATION IN NON- INSTRUCTIONAL SPACE

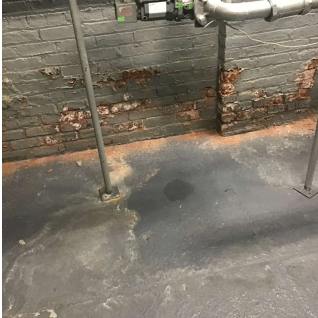
Question	Response
INTERIOR	
STRUCTURAL	
FOUNDATION WALLS	
Violations	35665151L
Deficiency	BRICK: WATER INFILTRATION IN NON- INSTRUCTIONAL SPACE
Deficiency Location/Instance	Basement - Gas Meter Room, Mechanical Equipment Room
Deficiency Quantity	200
Quantity Uom	S.F.
Potential Action	INSTALL WATERPROOFING
Urgency of Action	PRIORITY 5
Purpose of Action	LEVEL 5
Deficiency Photo1

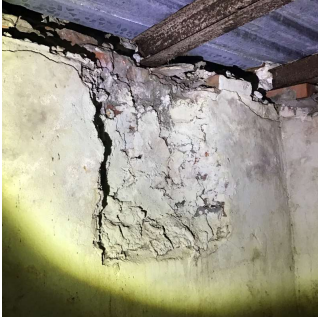
Violations	Gas Meter Room No violations recorded.
ROOF STRUCTURE	
Condition	Inspected
Deficiency	2 - Between Good and Fair
Deficiency	No deficiencies recorded
VAULTS-BUNKERS	
Foundation Walls	
Condition	Inspected
Condition	3 - Fair
Deficiency	CRACKS, SPALLING
Deficiency Location/Instance	Basement - Boiler Room Storage Vault
Deficiency Quantity	10
Quantity Uom	S.F.
Potential Action	REPAIR
Urgency of Action	PRIORITY 4
Purpose of Action	LEVEL 5
Deficiency Photo1

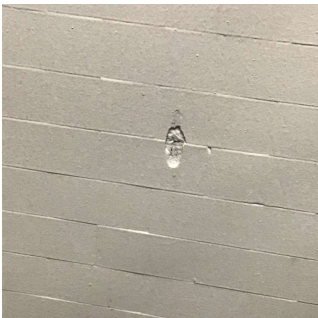
Question	Response
INTERIOR	
MULTI-PURPOSE ROOM	
Floor Finish	
Instance on 1st Floor - East	Inspected
Condition	2 - Between Good and Fair
Deficiency	No deficiencies recorded
Instance on 1st Floor - West	Inspected
Condition	2 - Between Good and Fair
Deficiency	No deficiencies recorded
Sliding-folding Partition	
Instance on 1st Floor - East	Does not Exist
Instance on 1st Floor - West	Does not Exist
Stage	
Instance on 1st Floor - East	Does not Exist
Instance on 1st Floor - West	Does not Exist
Walls	
Instance on 1st Floor - East	Inspected
Condition	2 - Between Good and Fair
Deficiency	CERAMIC TILE: BROKEN/ MISSING
Deficiency Location/Instance	In Exit 3,4
Deficiency Quantity	10
Quantity Uom	S.F.
Potential Action	REPLACE
Urgency of Action	PRIORITY 3
Purpose of Action	LEVEL 2
Deficiency Photo1

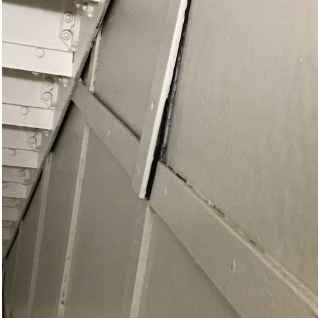
Question	Response
INTERIOR	
STAIRS/RAMPS: INTERIOR	
Partition	
Deficiency Location/Instance	Stair AB/2
Deficiency Quantity	10
Quantity Uom	L.F.
Potential Action	REPLACE
Urgency of Action	PRIORITY 3
Purpose of Action	LEVEL 2
Deficiency Photo1

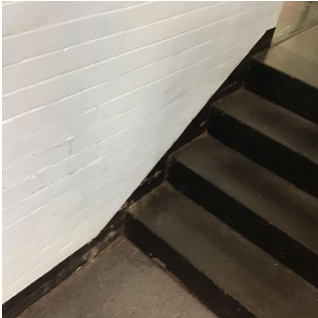
Violations	Stair AB/2 No violations recorded.
Railings	
Condition	Inspected 3 - Fair
Deficiency	WOOD: MISSING
Deficiency Location/Instance	Inside the East, West Multi-Purpose Room
Deficiency Quantity	10
Quantity Uom	L.F.
Potential Action	REPLACE
Urgency of Action	PRIORITY 5
Purpose of Action	LEVEL 6
Deficiency Photo1

Violations	Inside the West Multi-Purpose Room No violations recorded.
Stairs and Landings	
Condition	Inspected 5 - Poor
Deficiency	CONCRETE: CRACKS/SPALLING - MAJOR
Deficiency Location/Instance	In Exit 6
Deficiency Quantity	10
Quantity Uom	S.F.
Potential Action	REPLACE
Urgency of Action	PRIORITY 3
Purpose of Action	LEVEL 2

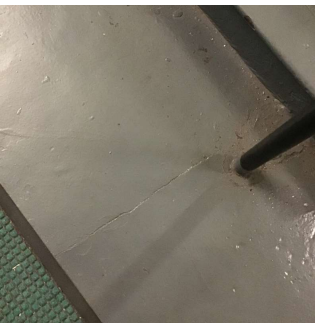
In Exit 6 No violations recorded.
Deficiency Deficiency Location/Instance Deficiency Quantity Quantity Uom Potential Action Urgency of Action Purpose of Action Deficiency Photo1 Violations	STONE: BROKEN/MISSING Stair E/1 Vestibule, Lobby Stair 60 S.F. REPLACE PRIORITY 3 LEVEL 2

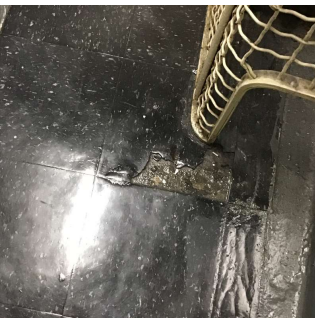
Stair E/1 Vestibule No violations recorded.
Deficiency Deficiency Location/Instance Deficiency Quantity Quantity Uom Potential Action Urgency of Action Purpose of Action Deficiency Photo1 Violations	VINYL TILES: BROKEN/DETERIORATED/MISSING TILES Stairs CD/3, E/3 20 S.F. REPLACE PRIORITY 3 LEVEL 2

Stair E/3 No violations recorded.

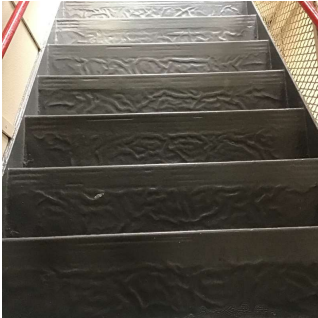
Question	Response
INTERIOR	
STAIRS/RAMPS: INTERIOR	
Stairs and Landings	
Deficiency	ROLLED ASPHALT: CRACKS
Deficiency Location/Instance	Stairs AB/1,2, CD/1,2,5, and others
Deficiency Quantity	1,500
Quantity Uom	S.F.
Potential Action	REPLACE
Urgency of Action	PRIORITY 3
Purpose of Action	LEVEL 2
Deficiency Photo1

Violations	Stair CD/5 No violations recorded.
Walls	Inspected
Condition	2 - Between Good and Fair
Deficiency	PLASTER: CRACKS/SPALLING
Deficiency Location/Instance	Stairs E/1,3, F/2,4
Deficiency Quantity	60
Quantity Uom	S.F.
Potential Action	REPLACE
Urgency of Action	PRIORITY 3
Purpose of Action	LEVEL 2
Deficiency Photo1

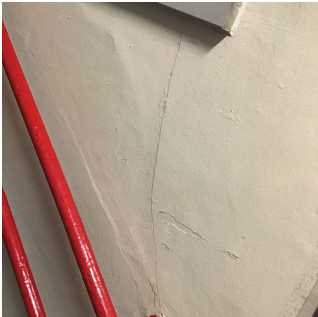
Violations	Stair E/3 No violations recorded.
Deficiency	CERAMIC TILE: BROKEN/ MISSING
Deficiency Location/Instance	Stairs AB/1,2, CD/3,4,5, and others
Deficiency Quantity	100
Quantity Uom	S.F.
Potential Action	REPLACE
Urgency of Action	PRIORITY 3
Purpose of Action	LEVEL 2

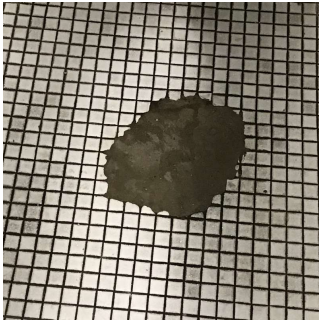
Question	Response
INTERIOR	
TOILET ROOMS - STAFF	
Floor Finish	
Deficiency Photo1

Room 557
Violations	No violations recorded.
Stalls	Inspected
Condition	2 - Between Good and Fair
Deficiency	No deficiencies recorded
Walls	Inspected
Condition	2 - Between Good and Fair
Deficiency	CERAMIC TILE: BROKEN/ MISSING
Deficiency Location/Instance	Rooms 357, 557
Deficiency Quantity	20
Quantity Uom	S.F.
Potential Action	REPLACE
Urgency of Action	PRIORITY 3
Purpose of Action	LEVEL 2
Deficiency Photo1

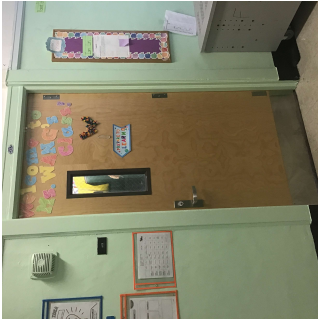
Room 512 shown
Violations	No violations recorded.
STEEL STAIRS	Does not Exist
SITE	Inspected
CONTAINERIZATION	Does not Exist
Drainage System for Asphalt	Inspected
Catch Basins/Manhole - Surrounded by asphalt	Inspected
Condition	2 - Between Good and Fair
Deficiency	No deficiencies recorded
Culverts - Asphalt Covering	Does not Exist
Drainage System for Concrete	Inspected
Catch Basins/Manhole - Surrounded by concrete	Inspected
Condition	2 - Between Good and Fair
Deficiency	No deficiencies recorded
Culverts - Concrete Covering	Does not Exist
Drainage System for Soil	Inspected
Catch Basins/Manhole - Surrounded by Soil	Inspected
Condition	2 - Between Good and Fair
Deficiency	No deficiencies recorded
Culverts - Soil Covering	Does not Exist
DRINKING FOUNTAINS	Inspected
Condition	2 - Between Good and Fair
Deficiency	No deficiencies recorded
FENCES	Inspected

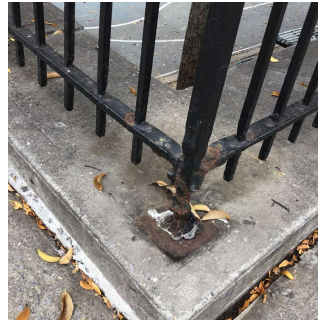
Ovington Avenue

WROUGHT IRON: DAMAGED/DETERIORATED

REPLACE

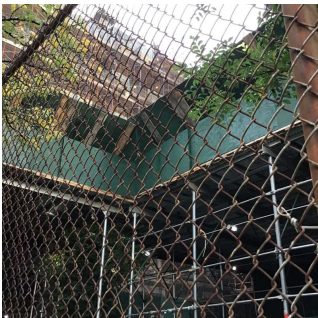
Question	Response
SITE	
FENCES	
Deficiency Location/Instance	Bay Ridge Avenue
Deficiency Quantity	10
Quantity Uom	L.F.
Potential Action	REPLACE
Urgency of Action	PRIORITY 3
Purpose of Action	LEVEL 2
Deficiency Photo1	 
Violations	Bay Ridge Avenue No violations recorded.
Deficiency	CHAIN LINK: RUST - MAJOR
Deficiency Location/Instance	Bay Ridge Avenue
Deficiency Quantity	1,000
Quantity Uom	S.F.
Potential Action	REPLACE
Urgency of Action	PRIORITY 3
Purpose of Action	LEVEL 2
Deficiency Photo1

Violations	Bay Ridge Avenue No violations recorded.
IRRIGATION SYSTEM	Does not Exist
PAVING	Inspected
Student Non-Use	Inspected
Gravel Exists?	No
Asphalt	Does not Exist
Concrete	Inaccessible
Pavers	Does not Exist
Student Use	Inspected
Gravel Exists?	No
Asphalt	Inspected
Condition	3 - Fair
Deficiency	CRACKS - MAJOR

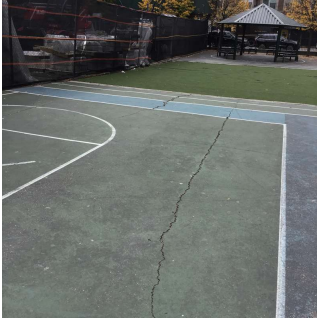
Question	Response
SITE	
PAVING	
Student Use	
Asphalt	
Deficiency Location/Instance	East Schoolyard, West Schoolyard
Deficiency Quantity	500
Quantity Uom	S.F.
Potential Action	REPLACE
Urgency of Action	PRIORITY 3
Purpose of Action	LEVEL 2
Deficiency Photo1

Violations	West Schoolyard No violations recorded.
Concrete	Does not Exist
Pavers	Inspected
Condition	3 - Fair
Deficiency	HEAVING
Deficiency Location/Instance	East Schoolyard, West Schoolyard
Deficiency Quantity	300
Quantity Uom	S.F.
Potential Action	REPLACE
Urgency of Action	PRIORITY 5
Purpose of Action	LEVEL 6
Deficiency Photo1	 
Violations	West Schoolyard No violations recorded.
Site Sidewalks & Walkways	Inspected
Asphalt	Does not Exist
Concrete	Inspected
Condition	2 - Between Good and Fair
Deficiency	No deficiencies recorded
Pavers	Does not Exist
DOT Sidewalk	Inspected
Asphalt	Does not Exist

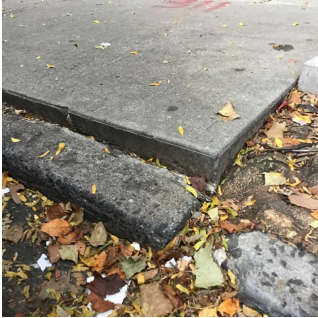
Question	Response
SITE	
PAVING	
DOT Sidewalk	
Asphalt	Does not Exist
Concrete	Inspected
Condition	4 - Between Fair and Poor
Deficiency	HEAVING
Deficiency Location/Instance	Ovington Avenue, Bay Ridge Avenue
Deficiency Quantity	100
Quantity Uom	S.F.
Potential Action	REPLACE
Urgency of Action	PRIORITY 3
Purpose of Action	LEVEL 2
Deficiency Photo1

Violations	Ovington Avenue No violations recorded.
Deficiency	DAMAGED CURBS
Deficiency Location/Instance	Ovington Avenue, Bay Ridge Avenue, 12th Avenue
Deficiency Quantity	265
Quantity Uom	L.F.
Potential Action	REPLACE
Urgency of Action	PRIORITY 3
Purpose of Action	LEVEL 2
Deficiency Photo1

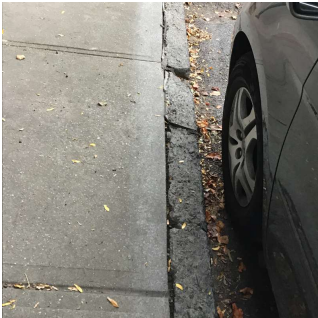
Violations	Ovington Avenue No violations recorded.
Deficiency	DAMAGED/DETERIORATED/MISSING SECTIONS
Deficiency Location/Instance	Ovington Avenue, Bay Ridge Avenue
Deficiency Quantity	275
Quantity Uom	S.F.
Potential Action	REPLACE
Urgency of Action	PRIORITY 3
Purpose of Action	LEVEL 2

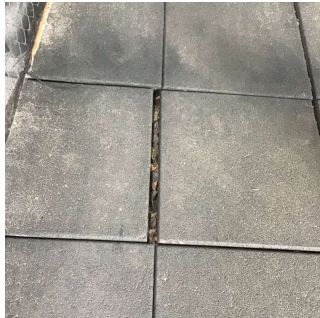
Condition	2 - Between Good and Fair
Deficiency	No deficiencies recorded
Instance on West Schoolyard - West Playground	Inspected
Condition	2 - Between Good and Fair
Deficiency	No deficiencies recorded
Safety Surfacing	
Instance on East Schoolyard	Inspected
Condition	3 - Fair
Deficiency	DETERIORATED/MISSING
Deficiency Location/Instance	East Schoolyard
Deficiency Quantity	100
Quantity Uom	S.F.
Potential Action	MAINTENANCE
Urgency of Action	PRIORITY 3

East Schoolyard
Violations	No violations recorded.
Unpaved Area	
Instance on East Schoolyard	Does not Exist
Instance on West Schoolyard - East Playground	Does not Exist
Instance on West Schoolyard - West Playground	Does not Exist
PLAYING SURFACE	
Playing Field	Inspected
Instance on West Schoolyard	Inspected
Instance Condition	5 - Poor
Deficiency	ARTIFICIAL TURF: MISSING AREAS
Deficiency Location/Instance	West Schoolyard
Deficiency Quantity	10
Quantity Uom	S.F.
Potential Action	REPLACE
Urgency of Action	PRIORITY 5
Purpose of Action	LEVEL 6
Deficiency Photo1

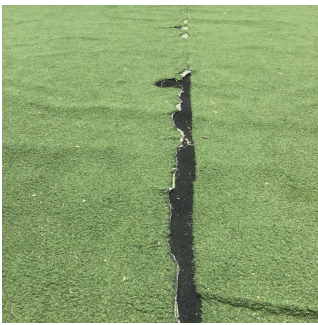
West Schoolyard
Violations	No violations recorded.
Deficiency	ARTIFICIAL TURF: DAMAGED/WORN OUT
Deficiency Location/Instance	West Schoolyard
Deficiency Quantity	2,000
Quantity Uom	S.F.
Potential Action	REPLACE
Urgency of Action	PRIORITY 3
Purpose of Action	LEVEL 2

Violations	Schoolyard No violations recorded.
Running Track	Does not Exist
RETAINING WALLS	
Are there any Retaining Walls 6' OR higher facing public street/sidewalk?	Inspected No
Condition	3 - Fair
Deficiency	CAST IN PLACE CONCRETE: DETERIORATED CONTROL/EXPANSION JOINT
Deficiency Location/Instance	West Schoolyard
Deficiency Quantity	30
Quantity Uom	L.F.
Potential Action	REPLACE
Urgency of Action	PRIORITY 3
Purpose of Action	LEVEL 2
Deficiency Photo1

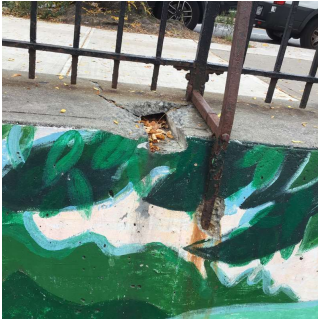
Violations	West Schoolyard No violations recorded.
Deficiency	CAST IN PLACE CONCRETE: CRACKS/SPALLING - MAJOR
Deficiency Location/Instance	West Schoolyard
Deficiency Quantity	150
Quantity Uom	S.F.
Potential Action	REPLACE
Urgency of Action	PRIORITY 3
Purpose of Action	LEVEL 2

Violations	West Schoolyard No violations recorded.
SEATING	Inspected
Benches	Inspected
Concrete	Does not Exist
Metal/Wood/Plastic	Inspected
Condition	4 - Between Fair and Poor
Deficiency	DAMAGED/DETERIORATED
Deficiency Location/Instance	West Schoolyard
Deficiency Quantity	2
Quantity Uom	EACH
Potential Action	REPLACE
Urgency of Action	PRIORITY 3
Purpose of Action	LEVEL 2
Deficiency Photo1

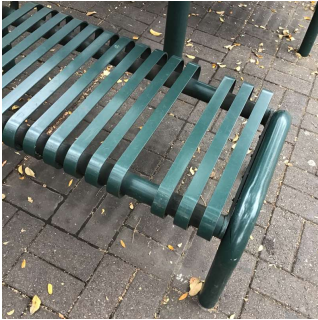
Violations	West Schoolyard No violations recorded.
Bleachers	Does not Exist
SITE WALLS (NOT RETAINING WALLS)	Does not Exist
STAIRS/RAMPS: EXTERIOR	Inspected
Railings	Inspected
Condition	3 - Fair
Deficiency	MISSING
Deficiency Location/Instance	West Schoolyard
Deficiency Quantity	10
Quantity Uom	L.F.
Potential Action	REPLACE
Urgency of Action	PRIORITY 5
Purpose of Action	LEVEL 6

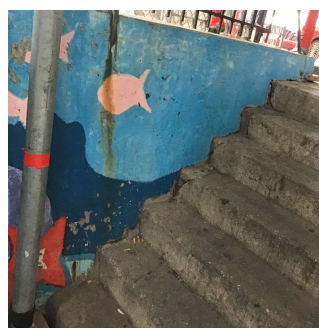
Violations	West Schoolyard No violations recorded.
Site Cheek/flank Walls	
Condition	Inspected
Deficiency	2 - Between Good and Fair
Deficiency	No deficiencies recorded
Stairs/ramps	
Condition	Inspected
Deficiency	3 - Fair
Deficiency Location/Instance	CAST IN PLACE CONCRETE: CRACKS/SPALLING - MAJOR
Deficiency Quantity	West Schoolyard
Quantity Uom	60
Potential Action	S.F.
Urgency of Action	REPLACE
Purpose of Action	PRIORITY 5
Deficiency Photo1	LEVEL 6

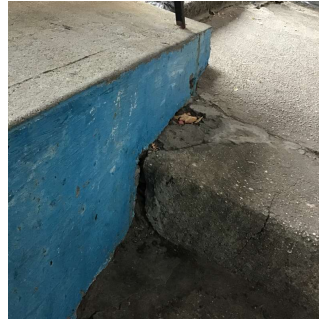
Violations	West Schoolyard No violations recorded.
ARTWORK	
	Does not Exist
