NYC Department of Education
Building Condition Assessment Survey 2023 - 2024

Architectural Inspection

Asset: P.S. 177 - BROOKLYN, 346 AVENUE P, New York, 11204

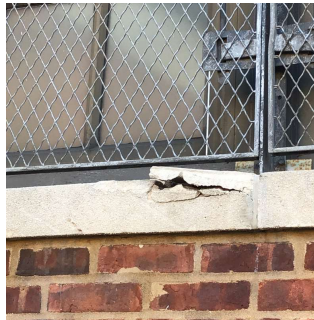
Facade K

BRICK: DETERIORATED MASONRY SILLS - MAJOR

REMOVE AND REPLACE

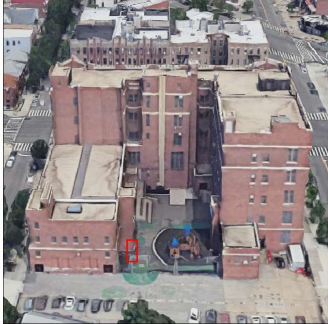
BRICK: DETERIORATED MASONRY SILLS - MINOR

Deficiency Quantity	10
Quantity Uom	L.F.
Potential Action	REPAIR
Urgency of Action	PRIORITY 3
Purpose of Action	LEVEL 2
Deficiency Photo1	 
Violations	Facade H No violations recorded.
EXTERIOR SOFFITS	Does not Exist
LOADING DOCK	Does not Exist
LOUVER	Inspected
Condition	2 - Between Good and Fair
Deficiency	No deficiencies recorded
PARAPETS	Inspected
Material Type(s)	Masonry
Replacement Quantity	7,500
Replacement Uom	C.F.
Instance on All Facades	Inspected
Instance Condition	4 - Between Fair and Poor
Instance Quantity	7,500
Instance Quantity Uom	C.F.
Deficiency	BRICK: DETERIORATED JOINTS

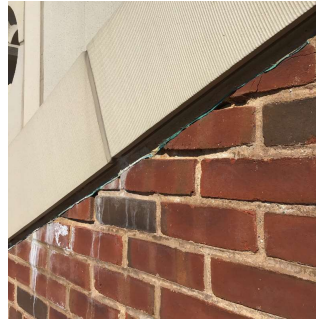
Roof 1
No violations recorded.

PARAPETS

100
S.F.
REPOINT
PRIORITY 4
LEVEL 2

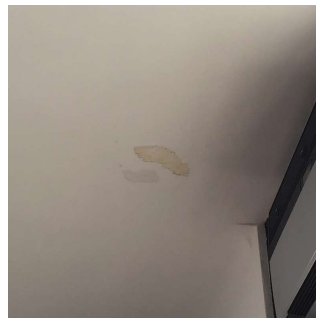
BUILT-UP: ROOFING: MAJOR ACTIVE ROOF LEAKS IN INSTRUCTIONAL SPACE

Question	Response
EXTERIOR	
ROOF	
Roofing	
ROOFING	Inspected
Violations	Roof 1 - Room 507, also Corridor near Room 505, Rooms 512, 513, Roof 2 - Room 502, No violations recorded.
ROOFING DRAINS	Inspected
Condition	2 - Between Good and Fair
Deficiency	No deficiencies recorded
Specialties	Inspected
BULKHEAD/PENTHOUSE	Inspected
Condition	3 - Fair
Deficiency	BULKHEAD/PENTHOUSE WALLS/EXTERIOR: WATER INFILTRATION
Roof Plan reference

REPLACE ROOFING WITHOUT MAJOR EQUIPMENT REMOVAL

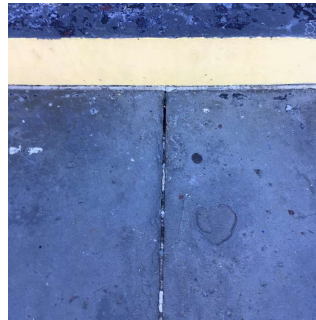
Facade K

STONE: DETERIORATED JOINTS

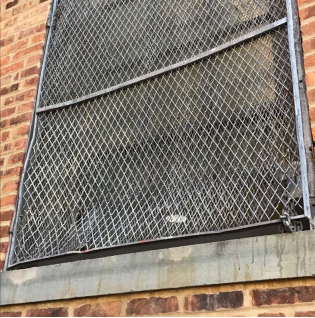
DETERIORATED/TORN-OUT/MISSING

Violations	Facade F No violations recorded.
LINTELS	Inspected
Condition	2 - Between Good and Fair
Deficiency	No deficiencies recorded
WINDOWS	Inspected
Material Type(s)	Aluminum
Instance on Aluminum - Double Hung: All Facades	Inspected
Instance Condition	3 - Fair
Instance Quantity	17,000
Instance Quantity Uom	S.F.
Are these windows insulated	No
Installation Year	1994
Source of Installation	Custodial Staff
Deficiency	ALUMINUM - DOUBLE HUNG: AIR/WATER INFILTRATION

Deficiency Quantity	40
Quantity Uom	S.F.
Potential Action	REPLACE
Urgency of Action	PRIORITY 4
Purpose of Action	LEVEL 2
Deficiency Photo1

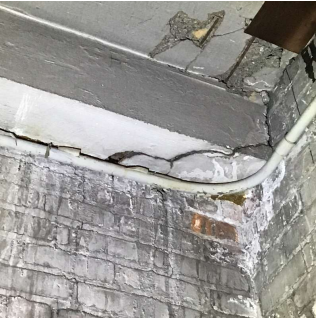
Deficiency Quantity	300
Quantity Uom	EACH
Potential Action	REPLACE BALANCES
Urgency of Action	PRIORITY 3
Purpose of Action	LEVEL 2
Deficiency Photo1	No photo recorded
Violations	No violations recorded.
INTERIOR	Inspected
POOLS	Does not Exist
STRUCTURAL	Inspected
COLUMNS/BEAMS/BEARING WALLS	Inspected
Condition	3 - Fair
Deficiency	STEEL COLUMNS/BEAMS: DETERIORATED CONCRETE FIREPROOFING
Deficiency Location/Instance	Roof 1 - Penthouse, Basement Fan Area
Deficiency Quantity	30
Quantity Uom	S.F.
Potential Action	REPLACE
Urgency of Action	PRIORITY 4
Purpose of Action	LEVEL 5
Deficiency Photo1

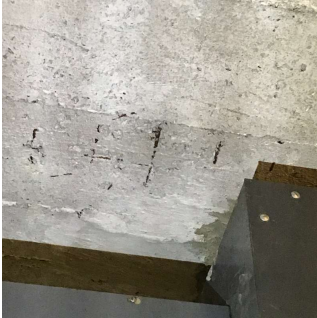
Violations	Roof 1 - Penthouse No violations recorded.
FLOOR STRUCTURE	Inspected
Condition	4 - Between Fair and Poor
Deficiency	CONCRETE: CRACKS/SPALLED/REINFORCEMENT EXPOSED
Deficiency Location/Instance	Basement - Electrical Panel Room
Deficiency Quantity	30
Quantity Uom	S.F.

Question	Response
INTERIOR	
STRUCTURAL	
FLOOR STRUCTURE	
Urgency of Action	PRIORITY 3
Purpose of Action	LEVEL 5
Deficiency Photo1

Potential Action	REPAIR

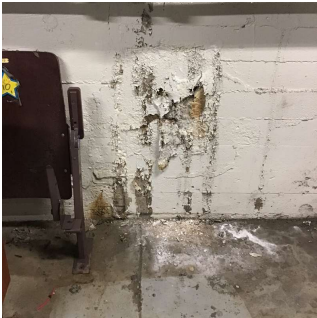
Basement - Electrical Panel Room
Violations	No violations recorded.
Deficiency	CONCRETE SLAB ON GRADE: WATER INFILTRATION IN NON-INSTRUCTIONAL SPACE
Deficiency Location/Instance	Basement - Gas Meter Room, Basement - Lower Level - Fan Area
Deficiency Quantity	200
Quantity Uom	S.F.
Potential Action	INSTALL WATERPROOFING
Urgency of Action	PRIORITY 5
Purpose of Action	LEVEL 5
Deficiency Photo1

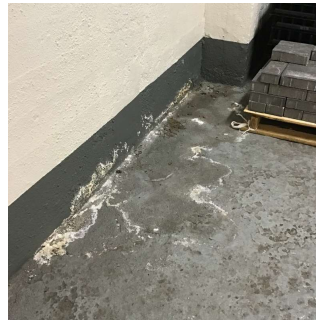
Basement - Old Coal Chute Area

CONCRETE: WATER INFILTRATION IN NON- INSTRUCTIONAL SPACE

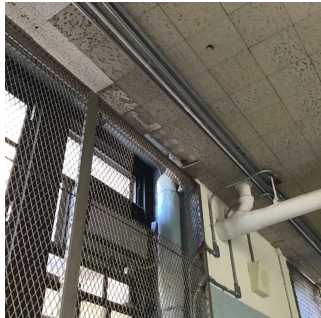
Right Side Windows	
Violations	No violations recorded.
Door(s)	
Instance on 1st Floor	Inspected
Condition	2 - Between Good and Fair
Deficiency	No deficiencies recorded
Fixed Equipment	
Instance on 1st Floor	Does not Exist
Floor Finish	
Instance on 1st Floor	Inspected
Condition	1 - Good

Question	Response
INTERIOR	
AUDITORIUM	
Walls	
Condition	2 - Between Good and Fair
Deficiency	No deficiencies recorded
Window Curtains/Shades/Blinds	
Instance on 2nd Floor (680 Seats)	Inspected
Condition	2 - Between Good and Fair
Deficiency	No deficiencies recorded
CAFETERIA	
Instance on 1st Floor	Inspected
Ceiling	
Instance on 1st Floor	Inspected
Condition	2 - Between Good and Fair
Deficiency	ACOUSTIC TILES ON PLASTER: DAMAGED/MISSING
Deficiency Location/Instance	Center, Right and Left Side Windows, By Servery
Deficiency Quantity	100
Quantity Uom	S.F.
Potential Action	REPLACE
Urgency of Action	PRIORITY 3
Purpose of Action	LEVEL 2
Deficiency Photo1

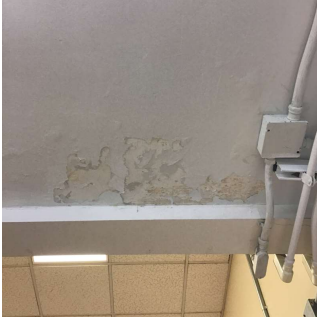
Corridor near Room 505
Violations	No violations recorded.
Door(s)	Inspected
Condition	5 - Poor
Deficiency	WOOD: DETERIORATED DOOR AND FRAME
Deficiency Location/Instance	Rooms 402,405,409,509,513

Question	Response
INTERIOR	
CAFETERIA	Inspected
Window Curtains/Shades/Blinds	
Instance on 1st Floor	Does not Exist
CLASSROOMS/CORRIDORS/ADMIN SPACES	Inspected
Ceiling	Inspected
Condition	2 - Between Good and Fair
Deficiency	PLASTER: CRACKS/SPALLING
Deficiency Location/Instance	Rooms 507,506
Deficiency Quantity	30
Quantity Uom	S.F.
Potential Action	REPLACE
Urgency of Action	PRIORITY 3
Purpose of Action	LEVEL 2
Deficiency Photo1	 
	Room 507
Violations	No violations recorded.
Deficiency	PLASTER: CRACKS/SPALLING - ACTIVE LEAK
Deficiency Location/Instance	Rooms 309,502,507,512,513, Corridor near Room 505
Deficiency Quantity	60
Quantity Uom	S.F.
Potential Action	REPLACE
Urgency of Action	PRIORITY 5
Purpose of Action	LEVEL 2
Deficiency Photo1

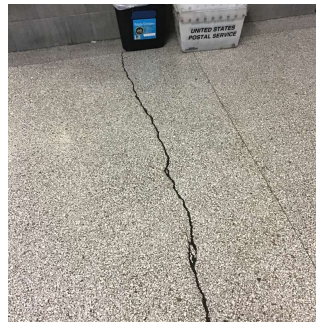
Corridor near Room 211

VINYL TILES: DETERIORATED SUBSTRATE

REPLACE

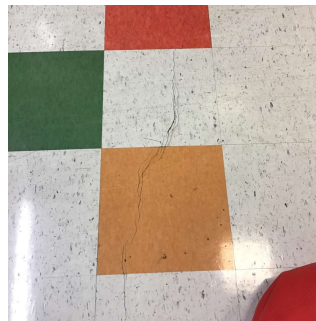
Corridor near Room 505

VINYL TILES: BROKEN/DETERIORATED/MISSING TILES

REPLACE

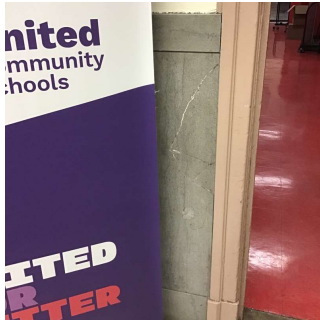
Question	Response
INTERIOR	
CLASSROOMS/CORRIDORS/ADMIN SPACES	
Walls	Inspected
Condition	2 - Between Good and Fair
Deficiency	STONE: CRACKS/SPALLING
Deficiency Location/Instance	Corridor near Auditorium, Main Entrance Lobby and Vestibule
Deficiency Quantity	30
Quantity Uom	S.F.
Potential Action	REPLACE
Urgency of Action	PRIORITY 3
Purpose of Action	LEVEL 2
Deficiency Photo1

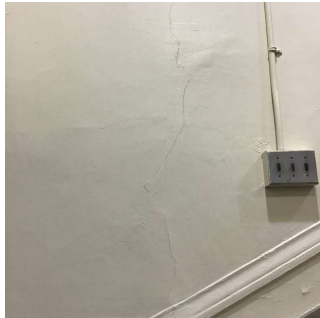
Violations	Main Entrance Lobby No violations recorded.
Deficiency	PLASTER: CRACKS/SPALLING
Deficiency Location/Instance	Main Entrance Vestibule and Lobby, Room 506, Corridor near Rooms 504,503 and others
Deficiency Quantity	220
Quantity Uom	S.F.
Potential Action	REPLACE
Urgency of Action	PRIORITY 3
Purpose of Action	LEVEL 2
Deficiency Photo1

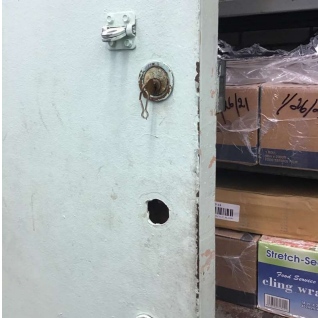
Question	Response
INTERIOR	
KITCHEN	Inspected
Door(s)	
Deficiency Location/Instance	Storage Room
Deficiency Quantity	1
Quantity Uom	EACH
Potential Action	MAINTENANCE
Urgency of Action	PRIORITY 3
Purpose of Action	LEVEL 2
Deficiency Photo1

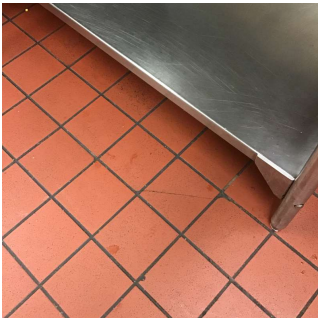
Violations	Storage Room No violations recorded.
Floor Finish	
Instance on 1st Floor	Inspected
Condition	2 - Between Good and Fair
Deficiency	QUARRY TILE: BROKEN/MISSING TILES
Deficiency Location/Instance	Preparing Area, near Entrance
Deficiency Quantity	20
Quantity Uom	S.F.
Potential Action	REPLACE
Urgency of Action	PRIORITY 3
Purpose of Action	LEVEL 2
Deficiency Photo1

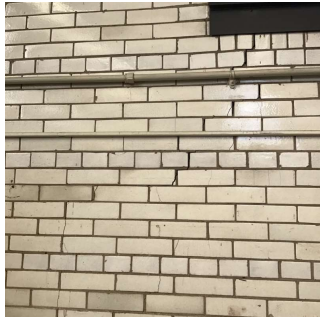
Violations	Preparing Area No violations recorded.
Walls	
Instance on 1st Floor	Inspected
Condition	3 - Fair
Deficiency	BRICK: CRACKS/SPALLING
Deficiency Location/Instance	Storage Room
Deficiency Quantity	30
Quantity Uom	S.F.
Potential Action	REPLACE
Urgency of Action	PRIORITY 3

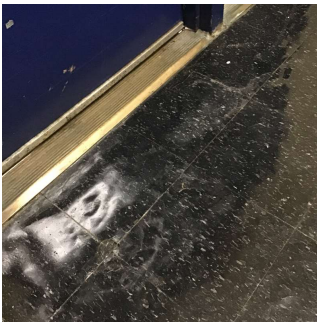
Question	Response
INTERIOR	
MULTI-PURPOSE ROOM	
Door(s)	
Deficiency Photo1	 
Violations	Entrance No violations recorded.
Fixed Equipment	
Instance on 1st Floor - West	Does not Exist
Instance on 1st Floor - East	Does not Exist
Floor Finish	
Instance on 1st Floor - West	Inspected
Condition	2 - Between Good and Fair
Deficiency	VINYL TILES: DETERIORATED SUBSTRATE
Deficiency Location/Instance	Exit 8/Vestibule, near Entrance
Deficiency Quantity	20
Quantity Uom	S.F.
Potential Action	REPLACE
Urgency of Action	PRIORITY 3
Purpose of Action	LEVEL 2
Deficiency Photo1

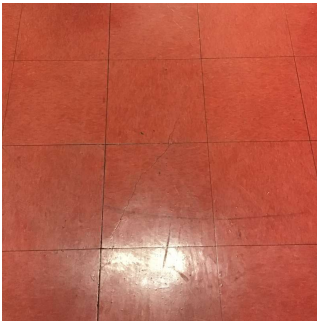
Violations	Exit 8/Vestibule No violations recorded.
Instance on 1st Floor - East	Inspected
Condition	2 - Between Good and Fair
Deficiency	VINYL TILES: DETERIORATED SUBSTRATE
Deficiency Location/Instance	Near Entrance
Deficiency Quantity	10
Quantity Uom	S.F.
Potential Action	REPLACE
Urgency of Action	PRIORITY 3
Purpose of Action	LEVEL 2

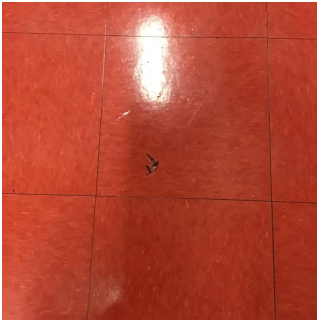
Near Entrance
Violations	No violations recorded.
Instance on 1st Floor - West	Inspected
Condition	2 - Between Good and Fair
Deficiency	VINYL TILES: BROKEN/DETERIORATED/MISSING TILES
Deficiency Location/Instance	Center
Deficiency Quantity	10
Quantity Uom	S.F.
Potential Action	REPLACE
Urgency of Action	PRIORITY 3
Purpose of Action	LEVEL 2
Deficiency Photo1

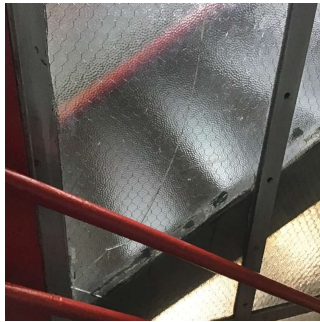
Violations	Stair EF/1 No violations recorded.
Deficiency	GLASS PANEL: DAMAGED/DETERIORATED
Deficiency Location/Instance	Stairs EF/Bulkhead,4,3
Deficiency Quantity	40
Quantity Uom	S.F.
Potential Action	REPLACE
Urgency of Action	PRIORITY 3
Purpose of Action	LEVEL 2
Deficiency Photo1

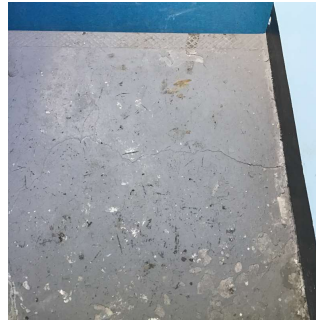
Violations	Stair EF/3 No violations recorded.
Railings	Inspected
Condition	2 - Between Good and Fair
Deficiency	No deficiencies recorded
Stairs and Landings	Inspected
Condition	2 - Between Good and Fair
Deficiency	CONCRETE: CRACKS/SPALLING - MAJOR
Deficiency Location/Instance	Stairs CD/Bulkhead
Deficiency Quantity	10
Quantity Uom	S.F.
Potential Action	REPLACE
Urgency of Action	PRIORITY 3
Purpose of Action	LEVEL 2

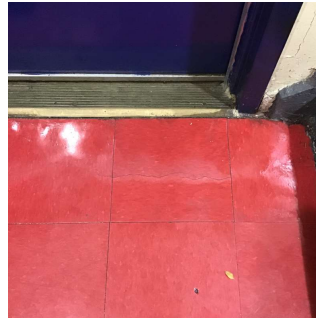
Exit 6 -7/Vestibule

VINYL TILES: DETERIORATED SUBSTRATE

REPLACE

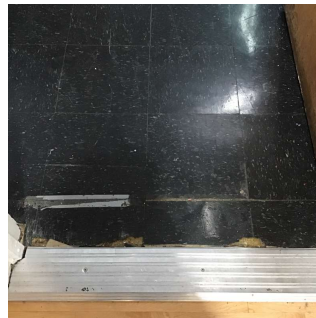
Stair H/1 - Lower Level

VINYL TILES: BROKEN/DETERIORATED/MISSING TILES

REPLACE

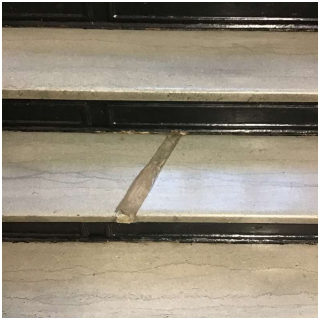
Question	Response
INTERIOR	
STAIRS/RAMPS: INTERIOR	
Stairs and Landings	
Violations	No violations recorded.
Deficiency	STONE: BROKEN/MISSING
Deficiency Location/Instance	Main Entrance Lobby
Deficiency Quantity	30
Quantity Uom	S.F.
Potential Action	REPLACE
Urgency of Action	PRIORITY 3
Purpose of Action	LEVEL 2
Deficiency Photo1

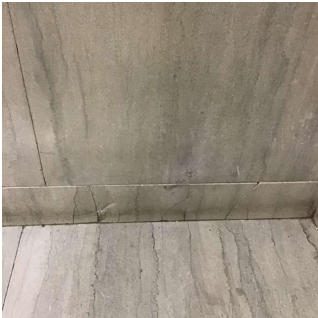
Violations	Main Entrance Lobby No violations recorded.
Walls	Inspected
Condition	2 - Between Good and Fair
Deficiency	STONE MOLDINGS: CRACKS/SPALLING
Deficiency Location/Instance	Main Entrance Lobby
Deficiency Quantity	10
Quantity Uom	L.F.
Potential Action	REPLACE
Urgency of Action	PRIORITY 3
Purpose of Action	LEVEL 2
Deficiency Photo1

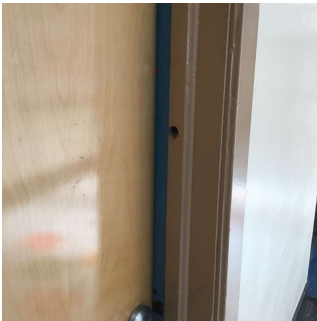
Question	Response
INTERIOR	
TOILET ROOMS - STAFF	
Door(s)	
Deficiency Photo1

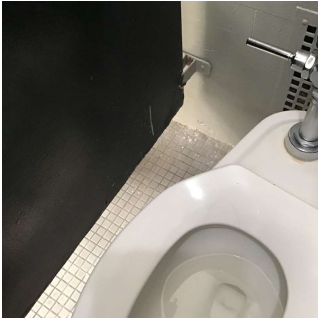
Question	Response
INTERIOR	
TOILET ROOMS - STUDENTS	
Floor Finish	Inspected
	Room 555
Violations	No violations recorded.
Stalls	Inspected
Condition	4 - Between Fair and Poor
Deficiency	RUST - MAJOR
Deficiency Location/Instance	Room 557
Deficiency Quantity	4
Quantity Uom	EACH
Potential Action	REPLACE
Urgency of Action	PRIORITY 3
Purpose of Action	LEVEL 2
Deficiency Photo1

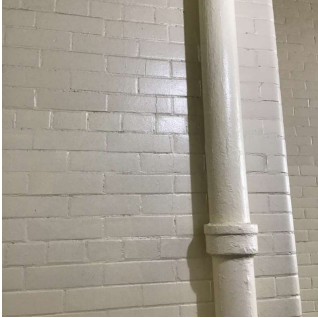
Room 557
Violations	No violations recorded.
Walls	Inspected
Condition	2 - Between Good and Fair
Deficiency	SALT GLAZED BRICK: CRACKS/SPALLING
Deficiency Location/Instance	Room 100B
Deficiency Quantity	20
Quantity Uom	S.F.
Potential Action	REPLACE
Urgency of Action	PRIORITY 3
Purpose of Action	LEVEL 2
Deficiency Photo1

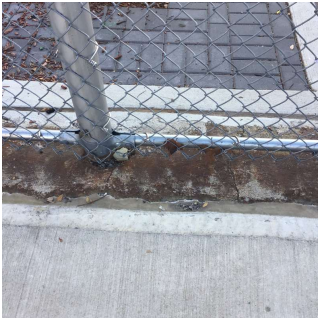
Question	Response
SITE	
Drainage System for Soil	Does not Exist
DRINKING FOUNTAINS	Does not Exist
FENCES	Inspected
Condition	4 - Between Fair and Poor
Deficiency	CONCRETE CURB: DAMAGED/DETERIORATED
Deficiency Location/Instance	West 1st Street, Avenue P
Deficiency Quantity	70
Quantity Uom	S.F.
Potential Action	REPLACE
Urgency of Action	PRIORITY 3
Purpose of Action	LEVEL 2
Deficiency Photo1

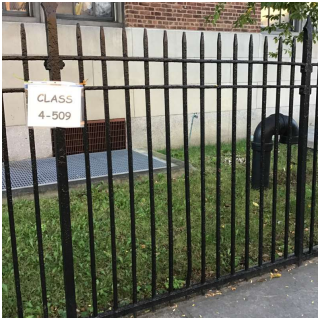
Violations	Avenue P No violations recorded.
IRRIGATION SYSTEM	Does not Exist
PAVING	Inspected
Student Non-Use	Inspected
Gravel Exists?	No
Asphalt	Does not Exist
Concrete	Inspected
Condition	3 - Fair
Deficiency	CRACKS - MAJOR

Violations	West 1st Street No violations recorded.
Deficiency	WROUGHT IRON: DAMAGED/DETERIORATED
Deficiency Location/Instance	Avenue P, West 1st Street, Dahill Road
Deficiency Quantity	440
Quantity Uom	S.F.
Potential Action	REPLACE
Urgency of Action	PRIORITY 3
Purpose of Action	LEVEL 2
Deficiency Photo1

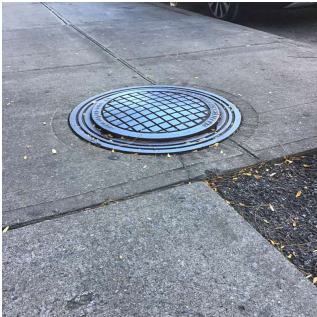
Violations	Avenue P No violations recorded.
Deficiency	HEAVING
Deficiency Location/Instance	Dahill Road, Avenue P
Deficiency Quantity	225
Quantity Uom	S.F.
Potential Action	REPLACE
Urgency of Action	PRIORITY 3
Purpose of Action	LEVEL 2
Deficiency Photo1

Question	Response
SITE	
PAVING	
Site Sidewalks & Walkways	
Concrete	Inspected
Condition	2 - Between Good and Fair
Deficiency	No deficiencies recorded
Pavers	Does not Exist
DOT Sidewalk	Inspected
Asphalt	Does not Exist
Concrete	Inspected
Condition	4 - Between Fair and Poor
Deficiency	HEAVING
Deficiency Location/Instance	Avenue P
Deficiency Quantity	25
Quantity Uom	S.F.
Potential Action	REPLACE
Urgency of Action	PRIORITY 5
Purpose of Action	LEVEL 6
Deficiency Photo1
