NYC Department of Education
Building Condition Assessment Survey 2023 - 2024

Architectural Inspection

Asset: P.S. 183 - BROOKLYN, 76 RIVERDALE AVENUE, New York, 11212

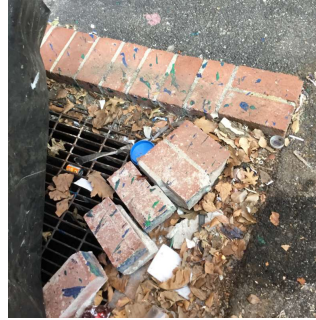
AW1

Question	Response
Architectural	
EXTERIOR	Inspected
AREAWAY	Inspected
Instance on AW1-AW4	Inspected
Instance Condition	3 - Fair
Instance Quantity	4
Instance Quantity Uom	EACH
Deficiency	AREAWAY WALLS: CRACKS AND SPALLING
Roof Plan reference

Deficiency Quantity	25
Quantity Uom	S.F.
Potential Action	REPLACE
Urgency of Action	PRIORITY 4
Purpose of Action	LEVEL 2

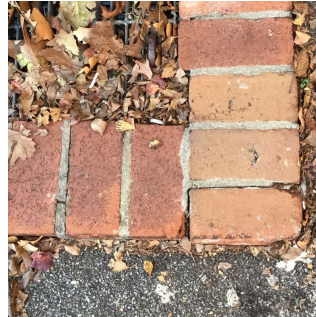
AW2

AREAWAY WALLS: DETERIORATED JOINTS

10

REPAIR

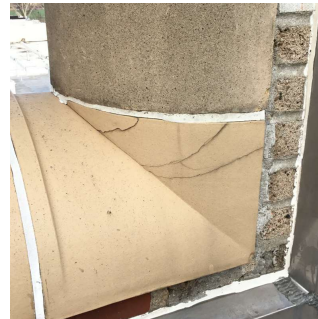
Roof 1

TERRA COTTA: CRACKED/BROKEN PIECES

100

L.F.

REPLACE-IN-KIND

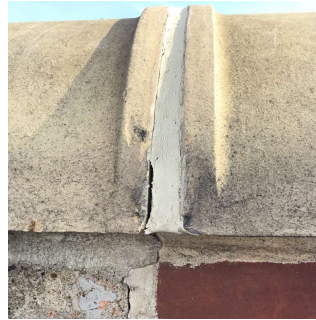
Roof 1
 No violations recorded.

TERRA COTTA: DETERIORATED TRANSVERSE JOINTS

170
 L.F.
 MAINTENANCE
 PRIORITY 3
 LEVEL 2

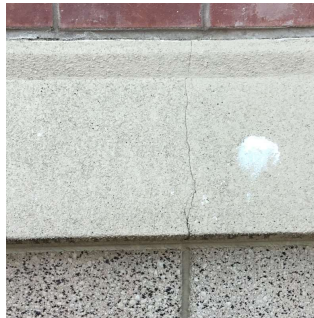
Facade B

STONE: CHIPPED/SPALLED/BROKEN PIECES - MINOR

25

REPAIR

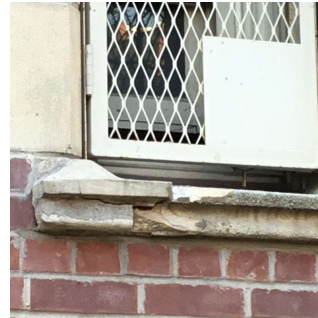
Facade A

BRICK: DETERIORATED MASONRY SILLS - MAJOR

70

REMOVE AND REPLACE

PRIORITY 4
LEVEL 2

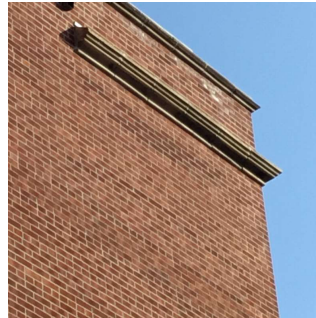
Auditorium PH

**BULKHEAD/PENTHOUSE WALLS/EXTERIOR:
EFFLORESCENCE**

25
S.F.
MAINTENANCE
PRIORITY 1
LEVEL 1

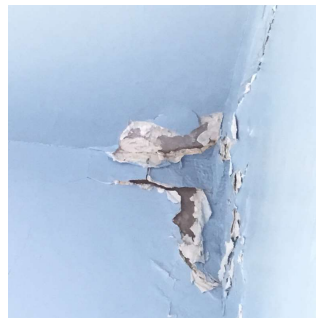
Auditorium PH

BULKHEAD/PENTHOUSE ROOF: MAJOR LEAKAGE

50

REPLACE

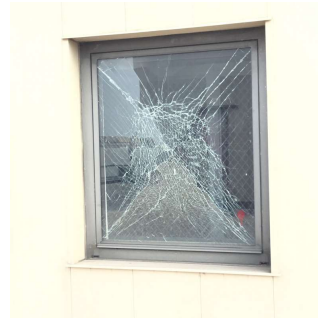
BH1

Deficiency **BULKHEAD/PENTHOUSE WINDOWS: DAMAGED, DETERIORATED WINDOWS**

30
 S.F.
 REPLACE
 PRIORITY 4
 LEVEL 2

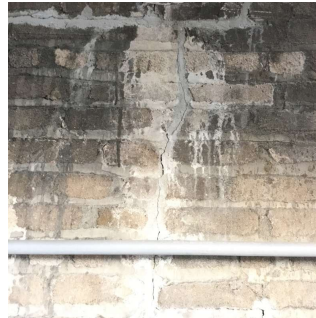
BH3 (PH, Auditorium PH similar)

Deficiency **BULKHEAD/PENTHOUSE WALLS/INTERIOR: BRICK CRACKS/SPALLING**

160
S.F.
REPLACE
PRIORITY 3
LEVEL 2

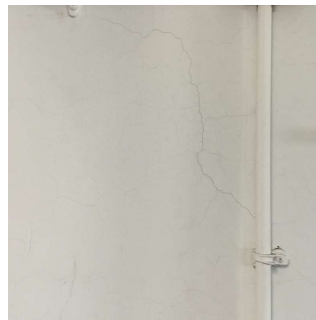
BH3 (Auditorium PH similar)

**BULKHEAD/PENTHOUSE WALLS/INTERIOR: PLASTER
CRACKS/SPALLING**

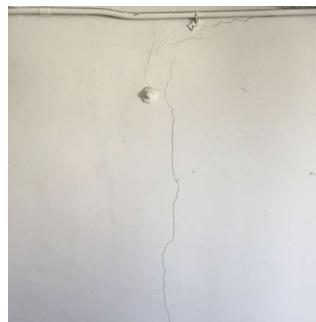
BH3
No violations recorded.

**BULKHEAD/PENTHOUSE WALLS/INTERIOR: PLASTER
CRACKS/SPALLING**

240
S.F.
REPLACE
PRIORITY 4
LEVEL 2

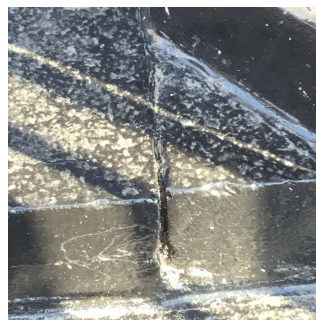
Facade M

STONE: DETERIORATED JOINTS

10
L.F.
REPOINT
PRIORITY 4
LEVEL 2

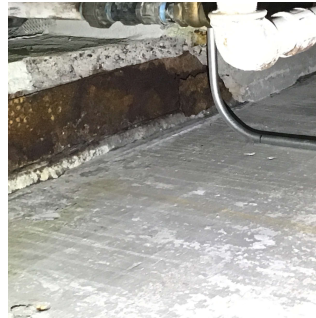
Fan Room East

STEEL COLUMNS/BEAMS: MAJOR RUSTING

REPLACE

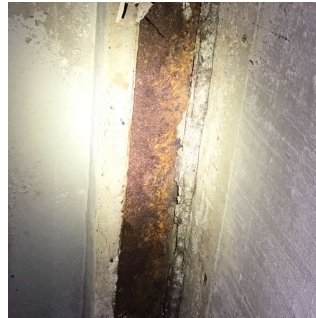
Basement Fan Room West

STEEL COLUMNS/BEAMS: DETERIORATED CONCRETE FIREPROOFING

REPLACE

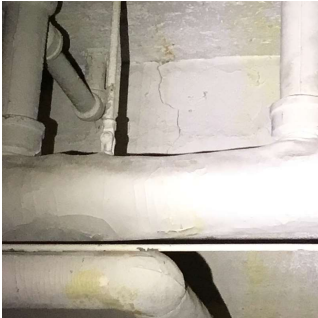
Question	Response
INTERIOR	
STRUCTURAL	
COLUMNS/BEAMS/BEARING WALLS	
Violations	No violations recorded.
Deficiency	STEEL COLUMNS/BEAMS: DETERIORATED CONCRETE FIREPROOFING
Deficiency Location/Instance	Basement
Deficiency Quantity	60
Quantity Uom	S.F.
Potential Action	REPLACE
Urgency of Action	PRIORITY 3
Purpose of Action	LEVEL 5
Deficiency Photo1

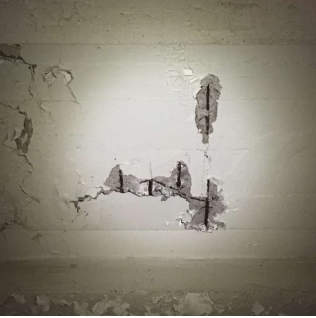
Question	Response
INTERIOR	
STRUCTURAL	
FLOOR STRUCTURE	
Purpose of Action	LEVEL 6
Deficiency Photo1

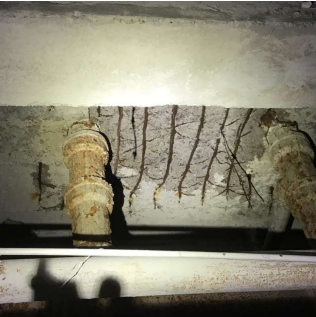
<p data-bbox="917 672 1230 735">Boiler Room access stair at Exit 6 No violations recorded.</p>
Violations	No violations recorded.
Deficiency	CONCRETE: CRACKS/SPALLED/REINFORCEMENT EXPOSED
Deficiency Location/Instance	Basement, PH
Deficiency Quantity	80
Quantity Uom	S.F.
Potential Action	REPAIR
Urgency of Action	PRIORITY 4
Purpose of Action	LEVEL 5
Deficiency Photo1

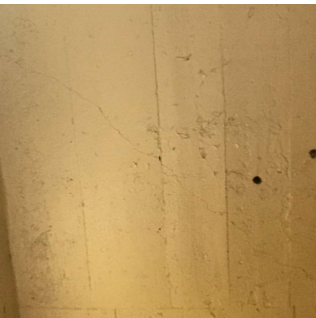
<p data-bbox="917 1323 1230 1386">Basement Fan Room West (PH similar) No violations recorded.</p>
Violations	No violations recorded.
Deficiency	CONCRETE: CRACKS/SPALLED/REINFORCEMENT EXPOSED
Deficiency Location/Instance	Basement, PH
Deficiency Quantity	85
Quantity Uom	S.F.
Potential Action	REPAIR
Urgency of Action	PRIORITY 3
Purpose of Action	LEVEL 5
Deficiency Photo1

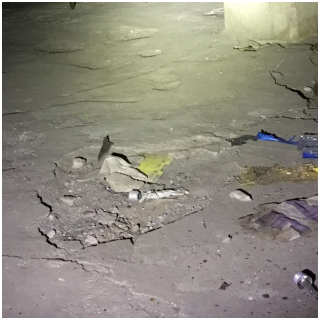
Question	Response
INTERIOR	
STRUCTURAL	
FLOOR STRUCTURE	
Violations	No violations recorded.
Deficiency	CONCRETE SLAB ON GRADE: THRU CRACKS
Deficiency Location/Instance	Basement
Deficiency Quantity	90
Quantity Uom	S.F.
Potential Action	REPLACE
Urgency of Action	PRIORITY 4
Purpose of Action	LEVEL 5
Deficiency Photo1

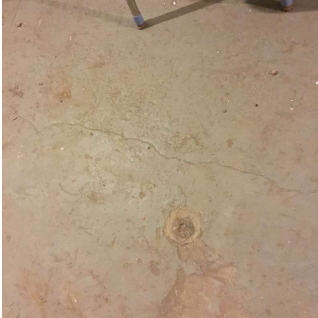
Violations	Crawl Space (Boiler Room similar) No violations recorded.
Deficiency	CONCRETE SLAB ON GRADE: THRU CRACKS
Deficiency Location/Instance	Basement
Deficiency Quantity	160
Quantity Uom	S.F.
Potential Action	REPAIR
Urgency of Action	PRIORITY 3
Purpose of Action	LEVEL 5
Deficiency Photo1

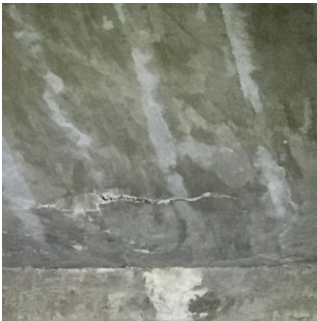
PH (BH1, Auditorium PH similar)
Violations	No violations recorded.
Deficiency	CONCRETE: CRACKED/SPALLED/REINFORCEMENT EXPOSED
Deficiency Location/Instance	PH
Deficiency Quantity	70
Quantity Uom	S.F.
Potential Action	REPAIR
Urgency of Action	PRIORITY 4
Purpose of Action	LEVEL 5

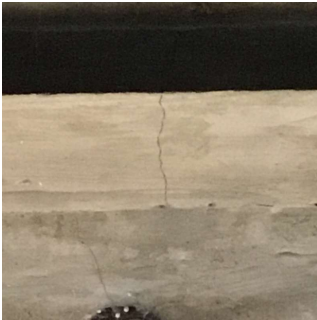
Violations	PH (Auditorium PH similar) No violations recorded.
Deficiency	STEEL COLUMNS/BEAMS: DETERIORATED CONCRETE FIREPROOFING
Deficiency Location/Instance	PH, BH
Deficiency Quantity	40
Quantity Uom	S.F.
Potential Action	REPLACE
Urgency of Action	PRIORITY 3
Purpose of Action	LEVEL 5
Deficiency Photo1

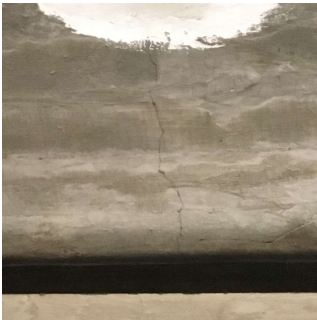
Violations	PH (BH1, Auditorium PH similar) No violations recorded.
Deficiency	CONCRETE: CRACKED/SPALLED/REINFORCEMENT EXPOSED
Deficiency Location/Instance	PH, BH
Deficiency Quantity	50
Quantity Uom	S.F.
Potential Action	REPAIR
Urgency of Action	PRIORITY 3
Purpose of Action	LEVEL 5
Deficiency Photo1

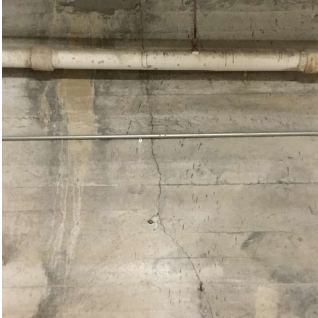
Question	Response
INTERIOR	
STRUCTURAL	
ROOF STRUCTURE	Inspected
Violations	No violations recorded.
VAULTS-BUNKERS	Inspected
Foundation Walls	Inspected
Condition	4 - Between Fair and Poor
Deficiency	CRACKS, SPALLING
Deficiency Location/Instance	Basement - Vault
Deficiency Quantity	35
Quantity Uom	S.F.
Potential Action	REPAIR
Urgency of Action	PRIORITY 4
Purpose of Action	LEVEL 5
Deficiency Photo1

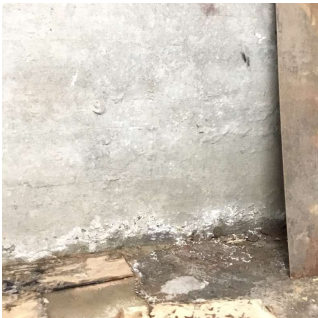
Violations	Basement Storage Room at Gas Meter Room No violations recorded.
Deficiency	WATER INFILTRATION IN NON- INSTRUCTIONAL SPACE
Deficiency Location/Instance	Basement
Deficiency Quantity	200
Quantity Uom	S.F.
Potential Action	INSTALL WATERPROOFING
Urgency of Action	PRIORITY 5
Purpose of Action	LEVEL 5
Deficiency Photo1

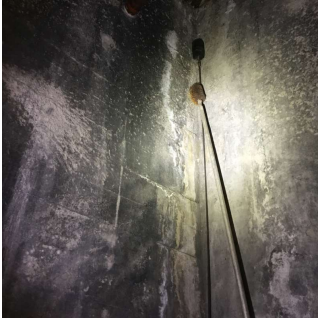
Violations	Basement Storage at Oil Tank Room No violations recorded.
Slab Structure	Inspected
Condition	3 - Fair
Deficiency	CONCRETE: WATER INFILTRATION IN NON- INSTRUCTIONAL SPACE
Deficiency Location/Instance	Vault

Question	Response
INTERIOR	
STRUCTURAL	
VAULTS-BUNKERS	Inspected
Slab Structure	
Potential Action	INSTALL WATERPROOFING
Urgency of Action	PRIORITY 5
Purpose of Action	LEVEL 5
Deficiency Photo1

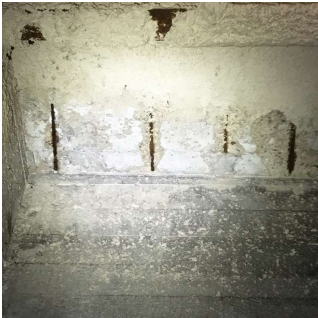
Violations	Vault No violations recorded.
Deficiency	CONCRETE: CRACKS/SPALLED/REINFORCEMENT EXPOSED
Deficiency Location/Instance	Vault
Deficiency Quantity	20
Quantity Uom	S.F.
Potential Action	REPAIR
Urgency of Action	PRIORITY 4
Purpose of Action	LEVEL 5
Deficiency Photo1

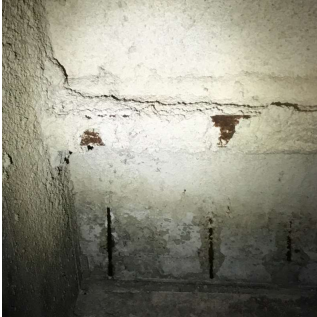
Violations	Vault No violations recorded.
Deficiency	STEEL COLUMNS/BEAMS: DETERIORATED/MISSING SPRAY-ON FIREPROOFING
Deficiency Location/Instance	Vault
Deficiency Quantity	10
Quantity Uom	S.F.
Potential Action	REPLACE
Urgency of Action	PRIORITY 3
Purpose of Action	LEVEL 5

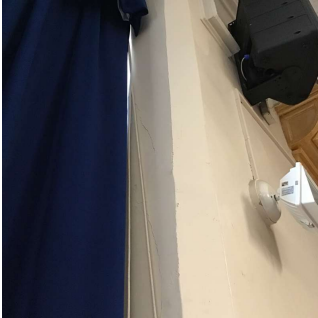
Question	Response
INTERIOR	
AUDITORIUM	
Walls	
Condition	2 - Between Good and Fair
Deficiency	PLASTER: CRACKS/SPALLING
Deficiency Location/Instance	Near Windows, storage
Deficiency Quantity	20
Quantity Uom	S.F.
Potential Action	REPLACE
Urgency of Action	PRIORITY 3
Purpose of Action	LEVEL 2
Deficiency Photo1

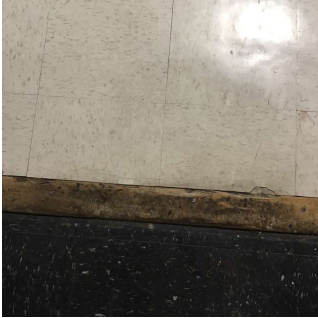
Question	Response
INTERIOR	
CAFETERIA	
Door(s)	
Instance on 1st Floor	Inspected
Condition	2 - Between Good and Fair
Deficiency	No deficiencies recorded
Fixed Equipment	
Instance on 1st Floor	Does not Exist
Floor Finish	
Instance on 1st Floor	Inspected
Condition	2 - Between Good and Fair
Deficiency	VINYL TILES: DETERIORATED SUBSTRATE
Deficiency Location/Instance	Near exit 4
Deficiency Quantity	10
Quantity Uom	S.F.
Potential Action	REPLACE
Urgency of Action	PRIORITY 3
Purpose of Action	LEVEL 2
Deficiency Photo1

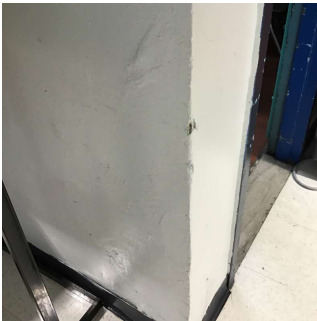
Near exit 4
Violations	No violations recorded.
Sliding-folding Partition	
Instance on 1st Floor	Does not Exist
Stage	
Instance on 1st Floor	Does not Exist
Walls	
Instance on 1st Floor	Inspected
Condition	2 - Between Good and Fair
Deficiency	PLASTER: CRACKS/SPALLING
Deficiency Location/Instance	Near kitchen, Room 128
Deficiency Quantity	20
Quantity Uom	S.F.
Potential Action	REPLACE
Urgency of Action	PRIORITY 3
Purpose of Action	LEVEL 2

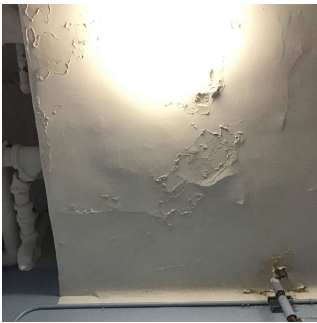
Violations	Near kitchen No violations recorded.
Window Curtains/Shades/Blinds	
Instance on 1st Floor	Does not Exist
CLASSROOMS/CORRIDORS/ADMIN SPACES	
Ceiling	
Condition	2 - Between Good and Fair
Deficiency	PLASTER: CRACKS/SPALLING
Deficiency Location/Instance	Exit 2,3,4,6, exit near cafeteria, and others
Deficiency Quantity	80
Quantity Uom	S.F.
Potential Action	REPLACE
Urgency of Action	PRIORITY 3
Purpose of Action	LEVEL 2
Deficiency Photo1

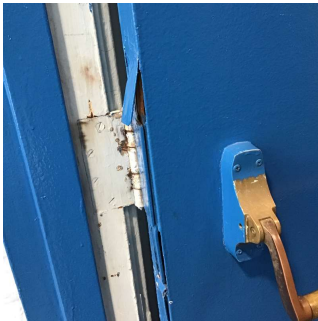
Violations	Exit 3 No violations recorded.
Door(s)	
Condition	5 - Poor
Deficiency	METAL: DETERIORATED DOOR
Deficiency Location/Instance	Exit 2
Deficiency Quantity	1
Quantity Uom	EACH
Potential Action	MAINTENANCE
Urgency of Action	PRIORITY 5
Purpose of Action	LEVEL 6

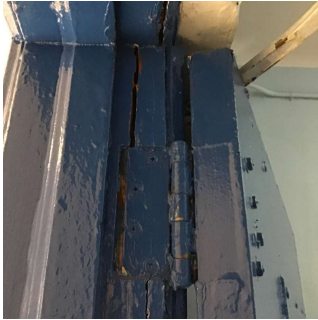
Exit 2 No violations recorded.
Deficiency Deficiency Location/Instance Deficiency Quantity Quantity Uom Potential Action Urgency of Action Purpose of Action Deficiency Photo1 Violations	WOOD: DETERIORATED DOOR AND FRAME Exit near cafeteria, Room 506,502,412,408,402, and others 8 EACH MAINTENANCE PRIORITY 3 LEVEL 2

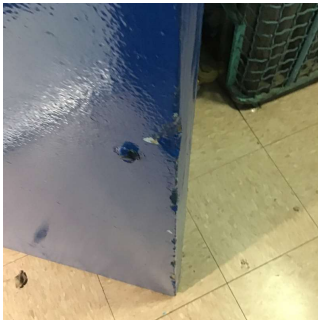
Exit 6 No violations recorded.

Exit near cafeteria No violations recorded.
Deficiency Deficiency Location/Instance Deficiency Quantity Quantity Uom Potential Action Urgency of Action Purpose of Action Deficiency Photo1 Violations	WOOD: DETERIORATED DOOR Exit 6, Corridor near Cafeteria, Room 201 5 EACH MAINTENANCE PRIORITY 3 LEVEL 2

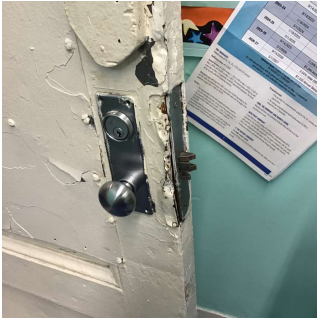
Question	Response
INTERIOR	
CLASSROOMS/CORRIDORS/ADMIN SPACES	
Door(s)	
Deficiency	METAL: DETERIORATED DOOR
Deficiency Location/Instance	Exit 3, Room 254,213,212,205
Deficiency Quantity	6
Quantity Uom	EACH
Potential Action	MAINTENANCE
Urgency of Action	PRIORITY 3
Purpose of Action	LEVEL 2
Deficiency Photo1

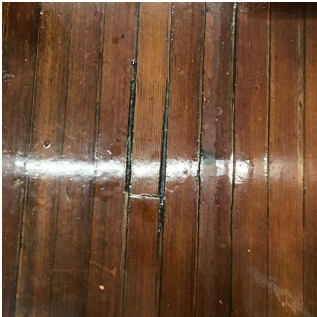
Room 210
Violations	No violations recorded.
Deficiency	VINYL TILES: TRIPPING HAZARD - ELECTRICAL OUTLET
Deficiency Location/Instance	Room 506
Deficiency Quantity	10
Quantity Uom	S.F.
Potential Action	REMOVE
Urgency of Action	PRIORITY 5
Purpose of Action	LEVEL 6

Room 254
Violations	No violations recorded.
Floor Finish	Inspected
Condition	2 - Between Good and Fair
Deficiency	WOOD: DAMAGED/DETERIORATED
Deficiency Location/Instance	Room 210
Deficiency Quantity	20
Quantity Uom	S.F.
Potential Action	REPLACE
Urgency of Action	PRIORITY 3
Purpose of Action	LEVEL 2
Deficiency Photo1

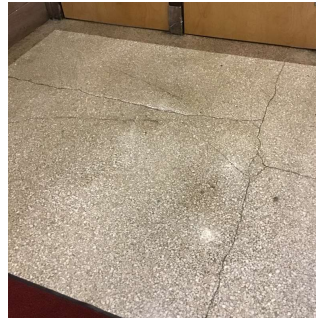
Main Entrance Vestibule

TERRAZZO: CRACKS

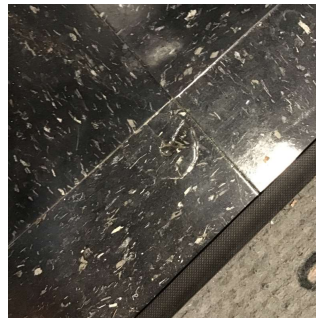
Exit 3

VINYL TILES: BROKEN/DETERIORATED/MISSING TILES

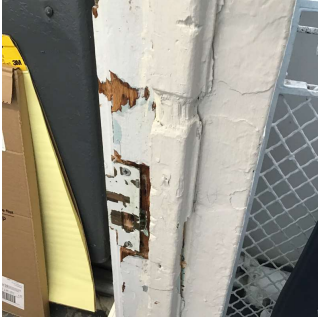
Deficiency	WOOD: DETERIORATED DOOR AND FRAME
Deficiency Location/Instance	Office
Deficiency Quantity	1
Quantity Uom	EACH
Potential Action	MAINTENANCE
Urgency of Action	PRIORITY 3
Purpose of Action	LEVEL 2
Deficiency Photo1

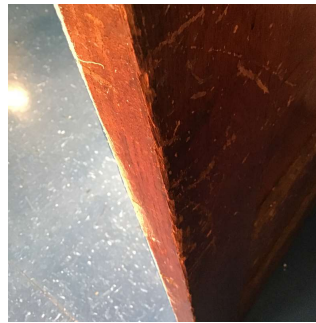
Deficiency	WOOD: DETERIORATED DOOR
Deficiency Location/Instance	Storage
Deficiency Quantity	1
Quantity Uom	EACH
Potential Action	MAINTENANCE
Urgency of Action	PRIORITY 3
Purpose of Action	LEVEL 2

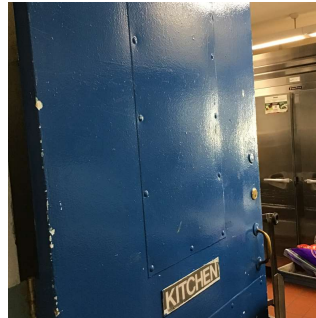
Entrance

METAL: DETERIORATED DOOR

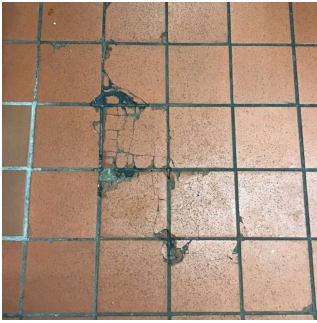
QUARRY TILE: BROKEN/MISSING TILES

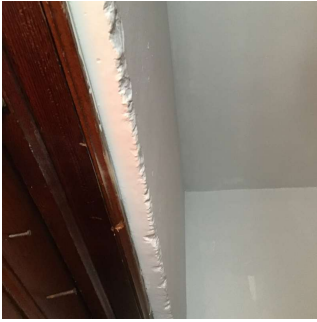
Storage
Violations	No violations recorded.
Deficiency	CERAMIC TILE: BROKEN/ MISSING
Deficiency Location/Instance	Near center, sink, stoves
Deficiency Quantity	30
Quantity Uom	S.F.
Potential Action	REPLACE
Urgency of Action	PRIORITY 3
Purpose of Action	LEVEL 2

Near center
Violations	No violations recorded.
Walls	
Instance on 1st Floor	Inspected
Condition	2 - Between Good and Fair
Deficiency	PLASTER: CRACKS/SPALLING
Deficiency Location/Instance	Storage
Deficiency Quantity	10
Quantity Uom	S.F.
Potential Action	REPLACE
Urgency of Action	PRIORITY 3
Purpose of Action	LEVEL 2
Deficiency Photo1

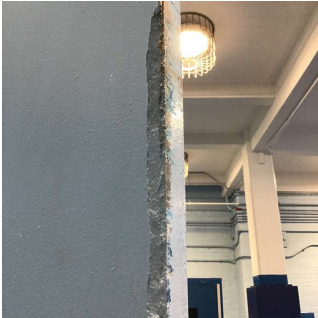
Violations	Stair C/1 No violations recorded.
Deficiency	METAL: DETERIORATED DOOR
Deficiency Location/Instance	Stair AB/1,2,4,C/2,4, and others
Deficiency Quantity	17
Quantity Uom	EACH
Potential Action	MAINTENANCE
Urgency of Action	PRIORITY 3
Purpose of Action	LEVEL 2
Deficiency Photo1

Question	Response
INTERIOR	
STAIRS/RAMPS: INTERIOR	
Ceiling	Inspected
Condition	2 - Between Good and Fair
Deficiency	No deficiencies recorded
Door(s)	Inspected
Condition	5 - Poor
Deficiency	WOOD: DETERIORATED DOOR
Deficiency Location/Instance	Stair C/1
Deficiency Quantity	1
Quantity Uom	EACH
Potential Action	MAINTENANCE
Urgency of Action	PRIORITY 3
Purpose of Action	LEVEL 2
Deficiency Photo1

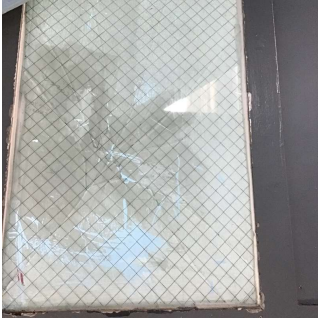
Violations	Stair EF/3 No violations recorded.
Railings	
Condition	Inspected 3 - Fair
Deficiency	METAL: DAMAGED
Deficiency Location/Instance	Stair EF/Bulkhead
Deficiency Quantity	15
Quantity Uom	L.F.
Potential Action	REPLACE
Urgency of Action	PRIORITY 3
Purpose of Action	LEVEL 2
Deficiency Photo1

Violations	Stair AB/1 No violations recorded.
Partition	Inspected
Condition	2 - Between Good and Fair
Deficiency	GLASS PANEL: DAMAGED/DETERIORATED
Deficiency Location/Instance	Stair EF/3,4
Deficiency Quantity	10
Quantity Uom	S.F.
Potential Action	REPLACE

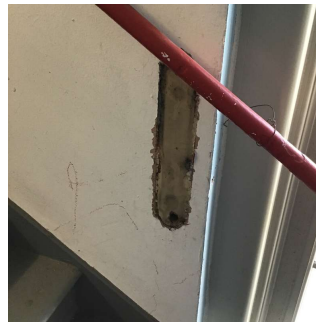
Violations	Stair EF/Bulkhead No violations recorded.
Deficiency	METAL: BROKEN BRACKET
Deficiency Location/Instance	Stair AB/Bulkhead, EF/Bulkhead
Deficiency Quantity	3
Quantity Uom	EACH
Potential Action	REPLACE
Urgency of Action	PRIORITY 3
Purpose of Action	LEVEL 2

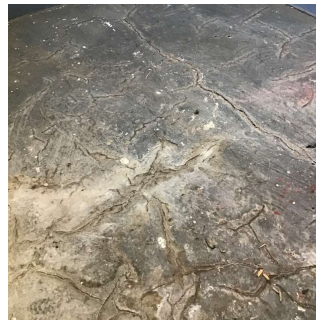
Stair AB/Bulkhead

ROLLED ASPHALT: CRACKS

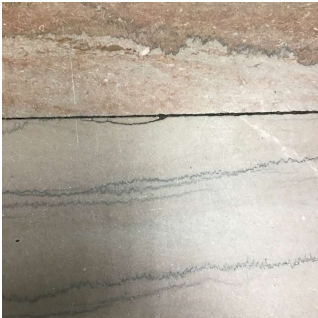
Question	Response
INTERIOR	
STAIRS/RAMPS: INTERIOR	
Stairs and Landings	
Violations	Stair D/5 No violations recorded.
Deficiency	STONE: BROKEN/MISSING
Deficiency Location/Instance	Main Entrance Stairs
Deficiency Quantity	40
Quantity Uom	S.F.
Potential Action	REPLACE
Urgency of Action	PRIORITY 3
Purpose of Action	LEVEL 2
Deficiency Photo1

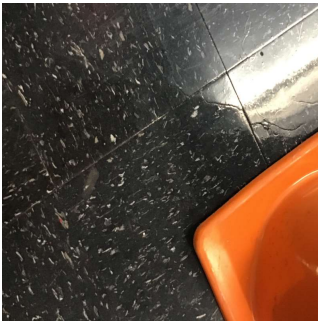
Violations	Stair AB/1 No violations recorded.
Walls	Inspected
Condition	2 - Between Good and Fair
Deficiency	PLASTER: CRACKS/SPALLING
Deficiency Location/Instance	Stair C/1, I/1,2,J/1,2, and others
Deficiency Quantity	100
Quantity Uom	S.F.
Potential Action	REPLACE

Violations	Main Entrance Stairs No violations recorded.
Deficiency	VINYL TILES: BROKEN/DETERIORATED/MISSING TILES
Deficiency Location/Instance	Stair AB/1, D/1,2,3,4, and others
Deficiency Quantity	200
Quantity Uom	S.F.
Potential Action	REPLACE
Urgency of Action	PRIORITY 3
Purpose of Action	LEVEL 2
Deficiency Photo1

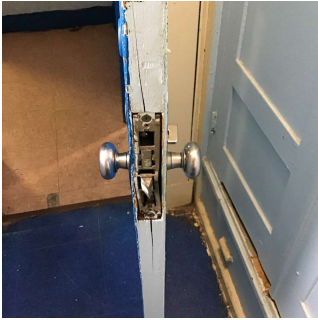
Violations	Kitchen staff No violations recorded.
Floor Finish	Inspected
Condition	4 - Between Fair and Poor
Deficiency	CONCRETE: CRACKS
Deficiency Location/Instance	Room 351, 254
Deficiency Quantity	20
Quantity Uom	S.F.
Potential Action	REPLACE
Urgency of Action	PRIORITY 3
Purpose of Action	LEVEL 2

Violations	Stair J/2 No violations recorded.
TOILET ROOMS - STAFF	Inspected
Ceiling	Inspected
Condition	2 - Between Good and Fair
Deficiency	No deficiencies recorded
Door(s)	Inspected
Condition	5 - Poor
Deficiency	WOOD: DETERIORATED DOOR
Deficiency Location/Instance	Kitchen staff, 254
Deficiency Quantity	2
Quantity Uom	EACH
Potential Action	MAINTENANCE
Urgency of Action	PRIORITY 3
Purpose of Action	LEVEL 2
Deficiency Photo1

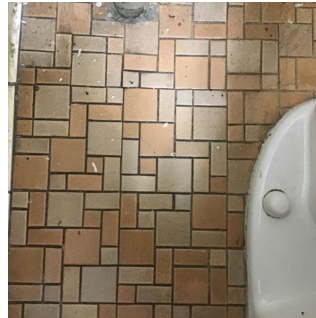
Room 451

CERAMIC TILE: BROKEN/MISSING TILES

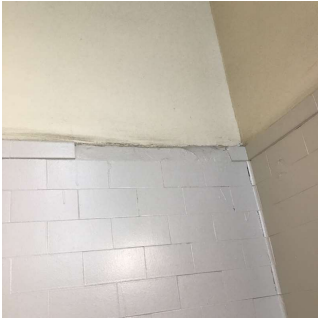
Room 254
Violations	No violations recorded.
Deficiency	PLASTER: CRACKS/SPALLING
Deficiency Location/Instance	Kitchen staff, Room 451
Deficiency Quantity	10
Quantity Uom	S.F.
Potential Action	REPLACE
Urgency of Action	PRIORITY 3
Purpose of Action	LEVEL 2
Deficiency Photo1

Question	Response
INTERIOR	
TOILET ROOMS - STAFF	
Stalls	Inspected
	Kitchen staff
Violations	No violations recorded.
Walls	Inspected
Condition	2 - Between Good and Fair
Deficiency	CERAMIC TILE: BROKEN/ MISSING
Deficiency Location/Instance	Room 254
Deficiency Quantity	10
Quantity Uom	S.F.
Potential Action	REPLACE
Urgency of Action	PRIORITY 3
Purpose of Action	LEVEL 2
Deficiency Photo1

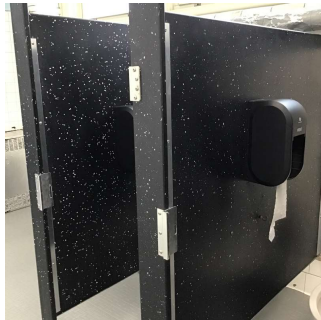
Room 122
Violations	No violations recorded.
Walls	Inspected
Condition	3 - Fair
Deficiency	PLASTER: CRACKS/SPALLING
Deficiency Location/Instance	Room 358,251,124
Deficiency Quantity	30
Quantity Uom	S.F.
Potential Action	REPLACE
Urgency of Action	PRIORITY 3
Purpose of Action	LEVEL 2
Deficiency Photo1

Question	Response
INTERIOR	
TOILET ROOMS - STUDENTS	
Floor Finish	Inspected
	Room 122
Violations	No violations recorded.
Stalls	Inspected
Condition	5 - Poor
Deficiency	BROKEN/MISSING
Deficiency Location/Instance	Room 122, 124
Deficiency Quantity	4
Quantity Uom	EACH
Potential Action	REPLACE
Urgency of Action	PRIORITY 3
Purpose of Action	LEVEL 2
Deficiency Photo1

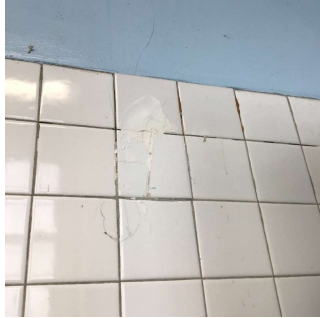
Room 124
Violations	No violations recorded.
Deficiency	CERAMIC TILE: BROKEN/ MISSING
Deficiency Location/Instance	Room 358,251,201/203,124,122
Deficiency Quantity	100
Quantity Uom	S.F.
Potential Action	REPLACE

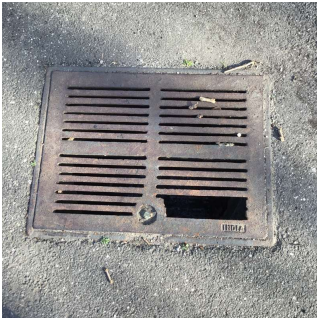
Question	Response
SITE	
CONTAINERIZATION	
Deficiency Photo1	 
Violations	Near exit 7 No violations recorded.
Drainage System for Asphalt	Inspected
Catch Basins/Manhole - Surrounded by asphalt	Inspected
Condition	3 - Fair
Deficiency	DAMAGED COVER
Deficiency Location/Instance	Schoolyard
Deficiency Quantity	1
Quantity Uom	EACH
Potential Action	REPLACE
Urgency of Action	PRIORITY 3
Purpose of Action	LEVEL 2
Deficiency Photo1

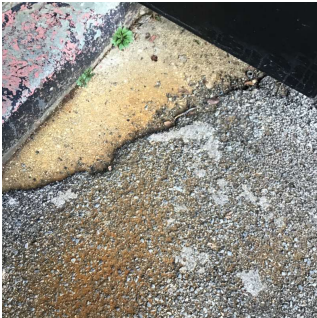
Along Strauss Street
Violations	No violations recorded.
Pavers	Does not Exist
Student Use	Inspected
Gravel Exists?	No
Asphalt	Inspected
Condition	4 - Between Fair and Poor
Deficiency	CRACKS - MAJOR
Deficiency Location/Instance	Near Exit 4
Deficiency Quantity	10

Question	Response
SITE	
PAVING	
Student Use	
Asphalt	
Quantity Uom	S.F.
Potential Action	REPLACE
Urgency of Action	PRIORITY 5
Purpose of Action	LEVEL 6
Deficiency Photo1

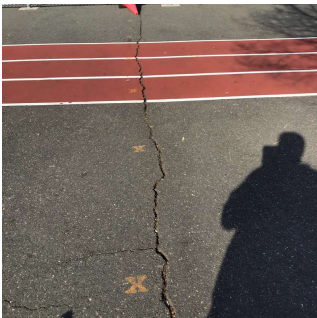
Near Exit 4
Violations	No violations recorded.
Cracks	
Deficiency	CRACKS - MAJOR
Deficiency Location/Instance	Schoolyard
Deficiency Quantity	2,500
Quantity Uom	S.F.
Potential Action	REPLACE
Urgency of Action	PRIORITY 3
Purpose of Action	LEVEL 2
Deficiency Photo1

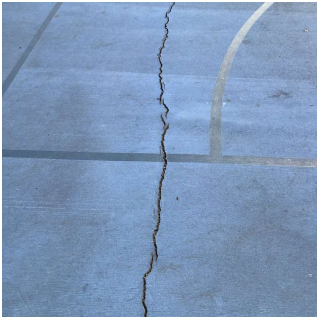
Schoolyard
Violations	No violations recorded.
Concrete	
Condition	Inspected
	4 - Between Fair and Poor
Deficiency	DAMAGED/DETERIORATED/MISSING SECTIONS
Deficiency Location/Instance	Schoolyard
Deficiency Quantity	500
Quantity Uom	S.F.
Potential Action	REPLACE
Urgency of Action	PRIORITY 3
Purpose of Action	LEVEL 2

Question	Response
SITE	
PAVING	
Student Use	
Concrete	
Deficiency Photo1

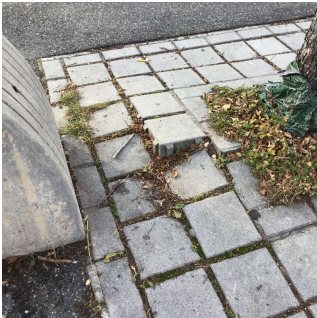
Violations	Schoolyard No violations recorded.
Pavers	Inspected
Condition	2 - Between Good and Fair
Deficiency	HEAVING
Deficiency Location/Instance	Near fountain
Deficiency Quantity	10
Quantity Uom	S.F.
Potential Action	REPLACE
Urgency of Action	PRIORITY 5
Purpose of Action	LEVEL 6
Deficiency Photo1

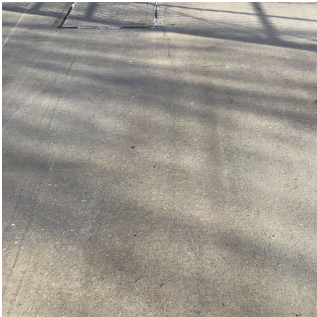
Violations	Near fountain No violations recorded.
Site Sidewalks & Walkways	Inspected
Asphalt	Does not Exist
Concrete	Inspected
Condition	3 - Fair
Deficiency	DAMAGED/DETERIORATED/MISSING SECTIONS
Deficiency Location/Instance	Near Schoolyard
Deficiency Quantity	75
Quantity Uom	S.F.
Potential Action	REPLACE
Urgency of Action	PRIORITY 3
Purpose of Action	LEVEL 2

Question	Response
SITE	
PAVING	
Site Sidewalks & Walkways	
Concrete	
Deficiency Photo1

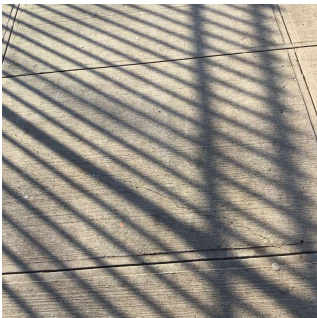
Violations	Near Schoolyard No violations recorded.
Pavers	Does not Exist
DOT Sidewalk	Inspected
Asphalt	Does not Exist
Concrete	Inspected
Condition	4 - Between Fair and Poor
Deficiency	DAMAGED/DETERIORATED/MISSING SECTIONS
Deficiency Location/Instance	Along Strauss Street, Riverdale Avenue, Herzl Street
Deficiency Quantity	475
Quantity Uom	S.F.
Potential Action	REPLACE
Urgency of Action	PRIORITY 3
Purpose of Action	LEVEL 2
Deficiency Photo1

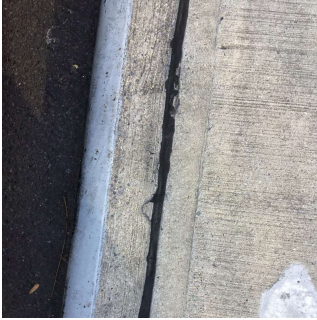
Violations	Along Riverdale Avenue No violations recorded.
Deficiency	DAMAGED CURBS
Deficiency Location/Instance	Along Strauss Street, Riverdale Avenue, Herzl Street
Deficiency Quantity	40
Quantity Uom	L.F.
Potential Action	REPLACE
Urgency of Action	PRIORITY 3
Purpose of Action	LEVEL 2

Question	Response
SITE	
PAVING	
DOT Sidewalk	
Concrete	
Deficiency Photo1

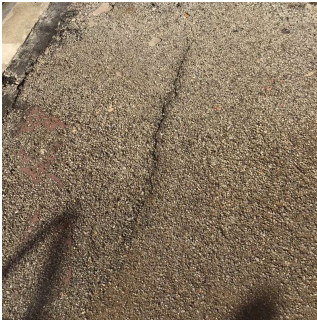
Violations	Along Strauss Street No violations recorded.
Pavers	Does not Exist
PLAYGROUNDS	Inspected
Instance on Schoolyard	Inspected
Instance on West side adjacent to building	Inspected
Benches	
Instance on West side adjacent to building	Inspected
Condition	2 - Between Good and Fair
Deficiency	No deficiencies recorded
Instance on Schoolyard	Does not Exist
Fence	
Instance on Schoolyard	Does not Exist
Instance on West side adjacent to building	Inspected
Condition	2 - Between Good and Fair
Deficiency	No deficiencies recorded
Pavement	
Instance on West side adjacent to building	Inspected
Condition	3 - Fair
Deficiency	ASPHALT: CRACKS - MAJOR
Deficiency Location/Instance	Schoolyard
Deficiency Quantity	100
Quantity Uom	S.F.
Potential Action	REPLACE
Urgency of Action	PRIORITY 3
Purpose of Action	LEVEL 2
Deficiency Photo1

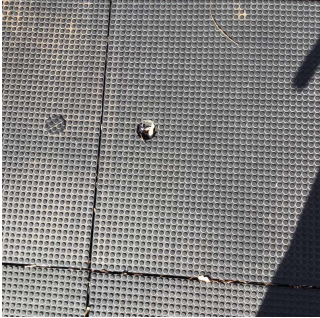
Question	Response
SITE	
PLAYGROUNDS	
Play Equipment	
Instance on Schoolyard	Inspected
Condition	2 - Between Good and Fair
Deficiency	No deficiencies recorded
Instance on West side adjacent to building	Inspected
Condition	2 - Between Good and Fair
Deficiency	No deficiencies recorded
Safety Surfacing	
Instance on West side adjacent to building	Inspected
Condition	2 - Between Good and Fair
Deficiency	DETERIORATED/MISSING
Deficiency Location/Instance	Schoolyard
Deficiency Quantity	10
Quantity Uom	S.F.
Potential Action	MAINTENANCE
Urgency of Action	PRIORITY 3
Purpose of Action	LEVEL 2
Deficiency Photo1

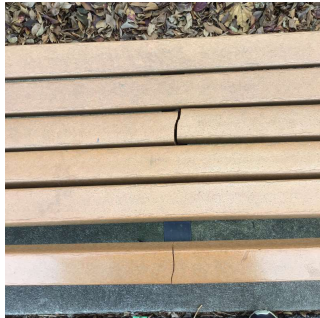
Concrete	
	Does not Exist
Metal/Wood/Plastic	
	Inspected
Condition	4 - Between Fair and Poor
Deficiency	DAMAGED/DETERIORATED
Deficiency Location/Instance	Schoolyard
Deficiency Quantity	2
Quantity Uom	EACH
Potential Action	REPLACE
Urgency of Action	PRIORITY 3
Purpose of Action	LEVEL 2

Question	Response
SITE	
SEATING	
Benches	
Metal/Wood/Plastic	
Deficiency Photo1
