**NYC Department of Education**  
**Building Condition Assessment Survey 2023 - 2024**

Architectural Inspection

**Asset:** P.S. 184 - BROOKLYN, 273 NEWPORT STREET, New York, 11212

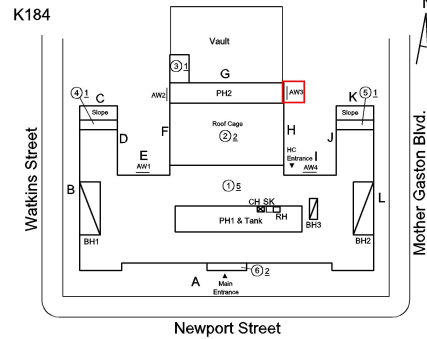
**AREAWAY SLAB: CRACKS AND SPALLING**

REPLACE

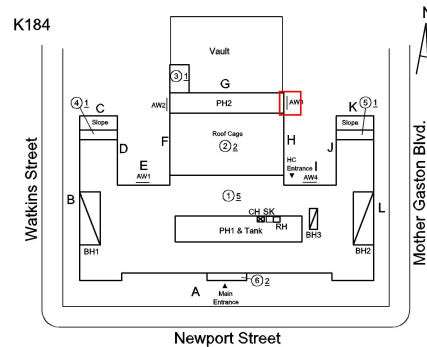
**AREAWAY DRAINS: DETERIORATED**

REPLACE

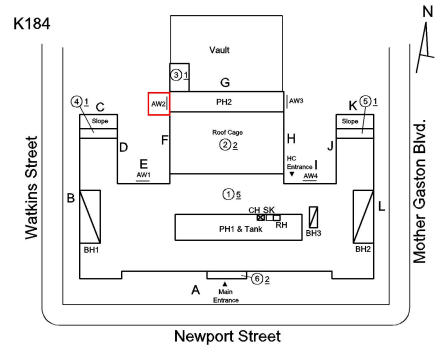
**AREAWAY WALLS: CRACKS AND SPALLING**

REPAIR

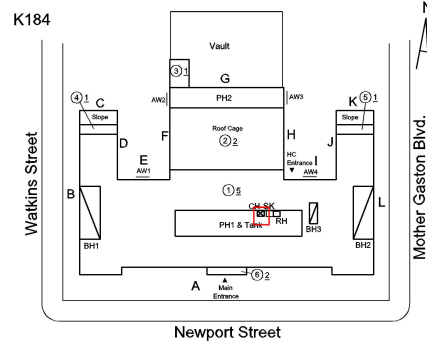
STONE/TERRA COTTA BAND: MINOR DETERIORATION

REPAIR

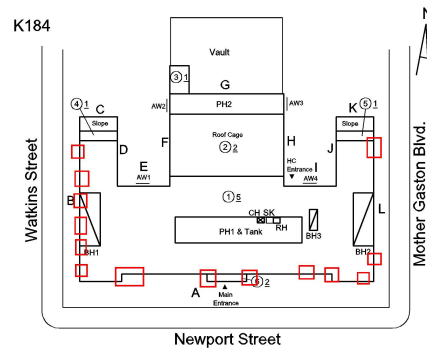
TERRA COTTA: MINOR CRACKS, SPALLING

REPAIR

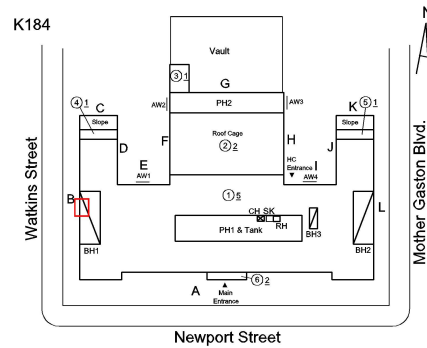
METAL: DETERIORATED DOOR AND FRAME - MAJOR DETERIORATION

REPLACE

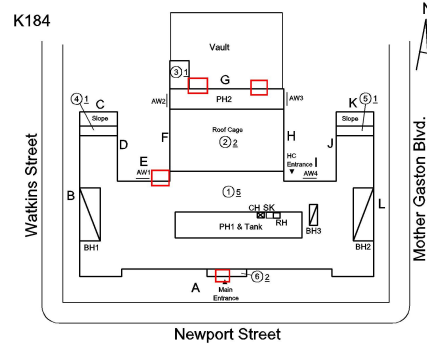
METAL: DETERIORATED DOOR AND FRAME - MINOR DETERIORATION

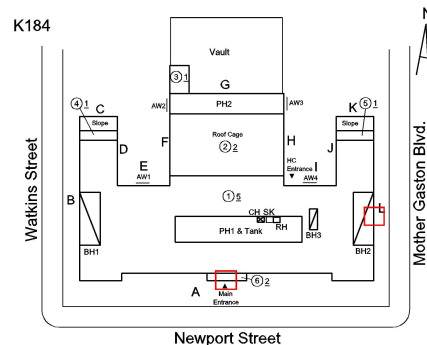
WOOD: EXCESSIVELY WEATHERED

60  
S.F.  
REPLACE

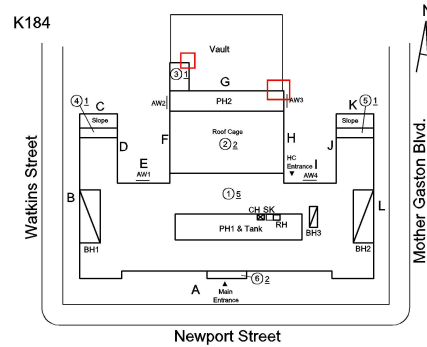
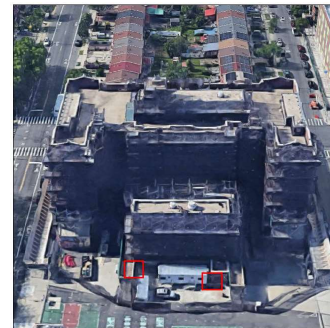
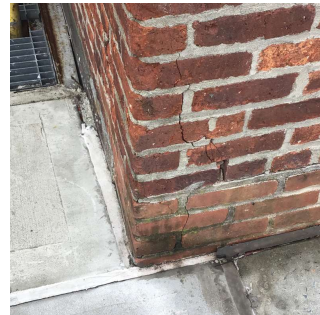
Corner of Facades G and H

**BRICK: CRACKS/DISPLACED/SPALLED BRICK AT BUILDING CORNERS**

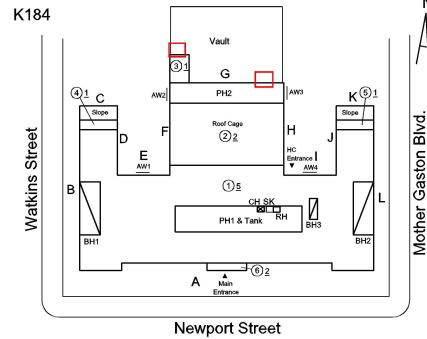
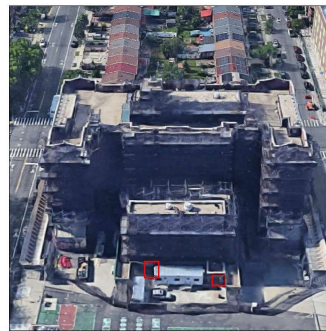
**BRICK: MINOR CRACKS AND SPALLING**

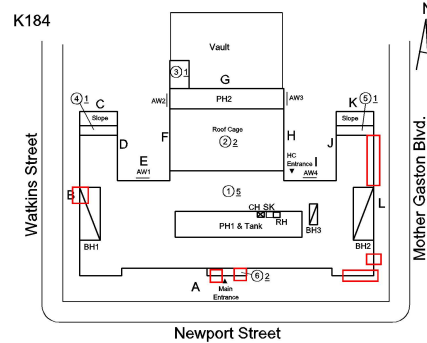
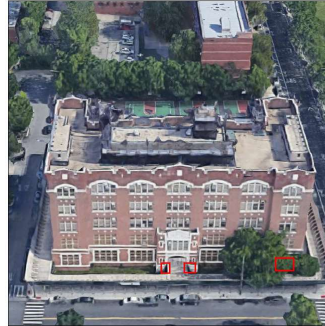
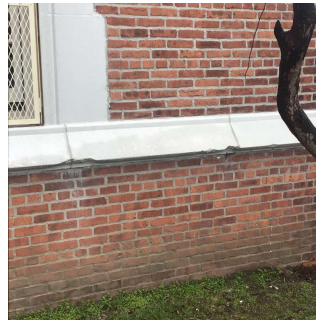
Facade A

**STONE: CHIPPED/SPALLED/BROKEN PIECES - MINOR**

REPAIR

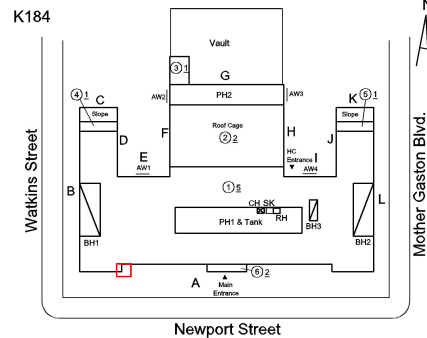
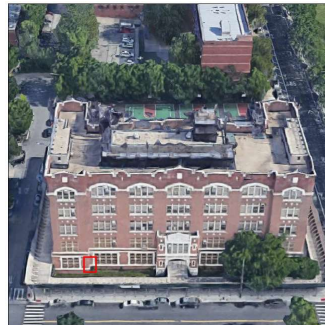
BRICK: DETERIORATED JOINTS

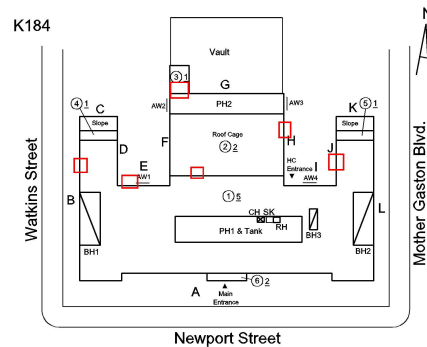
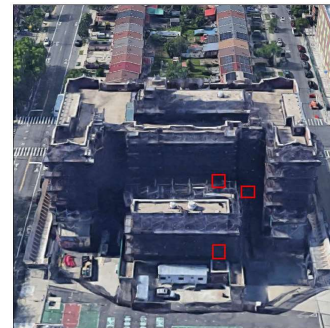
**BRICK: DETERIORATED MASONRY SILLS - MINOR**

REPAIR

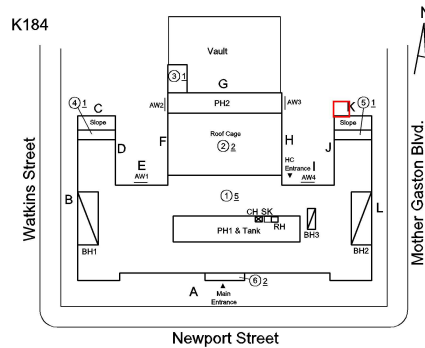
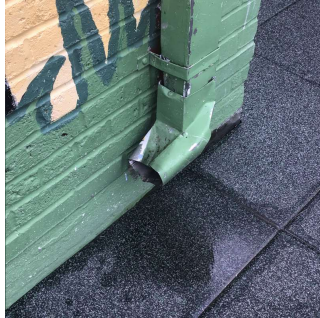
Question	Response
<b>EXTERIOR</b>	
<b>EXTERIOR WALLS</b>	Inspected
Violations	No violations recorded.
<b>EXTERIOR SOFFITS</b>	Does not Exist
<b>LOADING DOCK</b>	Does not Exist
<b>LOUVER</b>	Inspected
Condition	2 - Between Good and Fair
Deficiency	No deficiencies recorded
<b>PARAPETS</b>	Inspected
Material Type(s)	Masonry
Replacement Quantity	6,500
Replacement Uom	C.F.
Instance on All Facades	Inspected
Instance Condition	2 - Between Good and Fair
Instance Quantity	6,500
Instance Quantity Uom	C.F.
Deficiency	No deficiencies recorded
<b>PLAZA DECK</b>	Does not Exist
<b>ROOF</b>	Inspected
<b>Roofing</b>	Inspected
Replacement Quantity	17,000
Replacement Uom	S.F.
<b>ROOF HATCH/SMOKE HATCH</b>	Inspected
Condition	1 - Good
Deficiency	No deficiencies recorded
<b>LEADERS, GUTTERS, DOWNSPOUTS, SCUPPERS</b>	Inspected
Condition	3 - Fair
Deficiency	DAMAGED/MISSING
Roof Plan reference	
Deficiency Quantity	10
Quantity Uom	L.F.
Potential Action	REPLACE

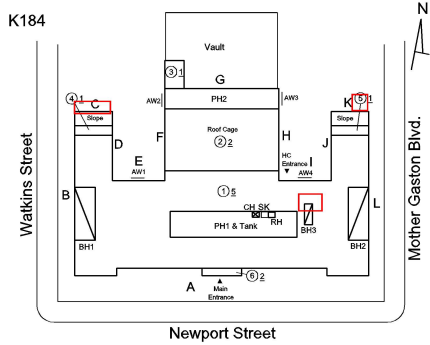
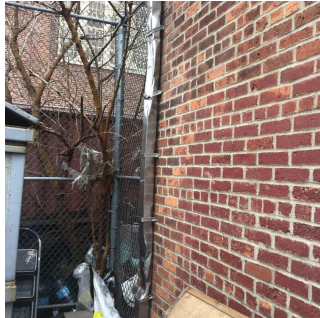
Violations	Facade K No violations recorded.
Deficiency	<b>DAMAGED/MISSING</b>
Roof Plan reference

Deficiency Quantity	50
Quantity Uom	L.F.
Potential Action	REPLACE
Urgency of Action	PRIORITY 4
Purpose of Action	LEVEL 2
Deficiency Photo1

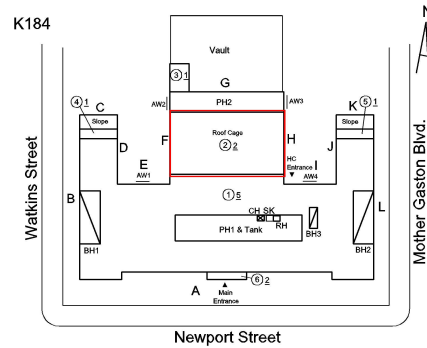
Violations	Facade C No violations recorded.
<b>ROOF BARRIER/FENCE</b>	Inspected
Condition	2 - Between Good and Fair
Deficiency	No deficiencies recorded
<b>ROOF CAGE</b>	Inspected
Condition	4 - Between Fair and Poor
Deficiency	STEEL FRAME: MAJOR RUSTING

200  
 S.F.  
 REPAIR  
 PRIORITY 4  
 LEVEL 2

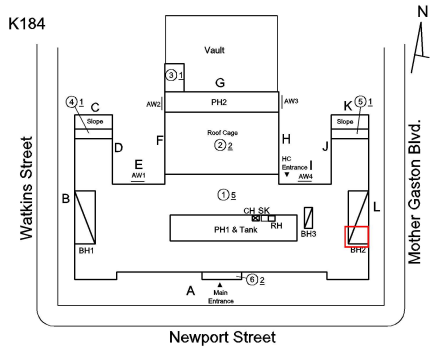
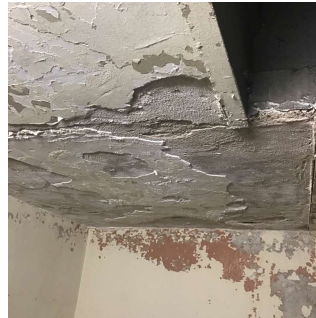
BH2 (Stair 6 and 7)

Roof 4
Instance Quantity	1,000
Instance Quantity Uom	S.F.
Does the roof have major mechanical equipment sitting on Dunnage Steel less than 18" above the Roofing?	No
Does this roof instance have a Sustainable Roof System?	No
Do solar panels exist on these roofs?	No
Is/Are the roof(s) suitable for Solar Panel installation?	No
Installation Year	2023
Source of Installation	Custodial Staff
Deficiency	No deficiencies recorded
<b>ROOFING DRAINS</b>	
	Inspected
Condition	1 - Good
Deficiency	No deficiencies recorded
<b>Specialties</b>	
	Inspected
<b>BULKHEAD/PENTHOUSE</b>	
	Inspected
Condition	4 - Between Fair and Poor
Deficiency	BULKHEAD/PENTHOUSE CEILING: PLASTER DAMAGED/DETERIORATED
Roof Plan reference

Quantity Uom	S.F.
Potential Action	REPLACE
Urgency of Action	PRIORITY 4
Purpose of Action	LEVEL 4

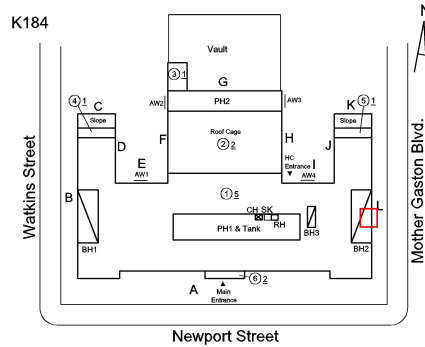
**BULKHEAD/PENTHOUSE WALLS/INTERIOR: PLASTER  
CRACKS/SPALLING**

REPLACE

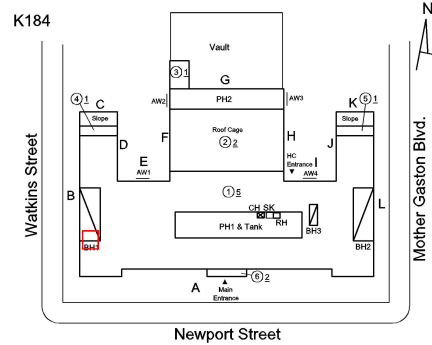
BH1  
No violations recorded.

**BULKHEAD/PENTHOUSE WALLS/EXTERIOR: WATER  
INFILTRATION**

100  
S.F.  
REPAIR  
PRIORITY 5  
LEVEL 2

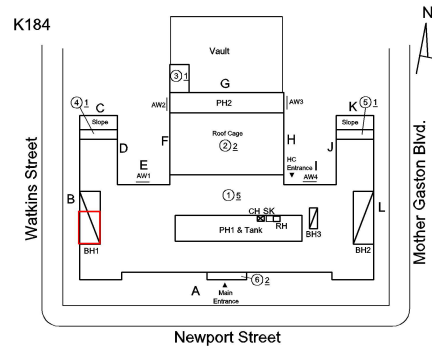
**BULKHEAD/PENTHOUSE WALLS/INTERIOR: PLASTER  
CRACKS/SPALLING**

50  
S.F.  
REPLACE  
PRIORITY 3  
LEVEL 2

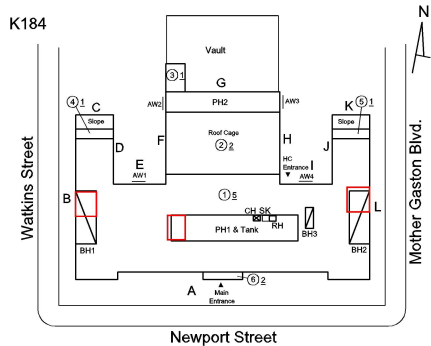
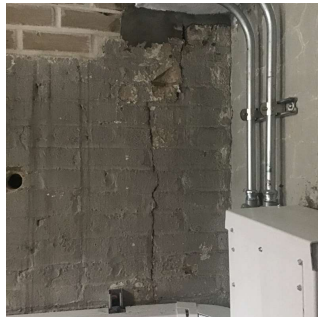
BH1	
Violations	No violations recorded.
Deficiency	<b>BULKHEAD/PENTHOUSE WALLS/INTERIOR: BRICK CRACKS/SPALLING</b>
Roof Plan reference

Deficiency Quantity	150
Quantity Uom	S.F.
Potential Action	REPLACE
Urgency of Action	PRIORITY 3
Purpose of Action	LEVEL 2
Deficiency Photo1

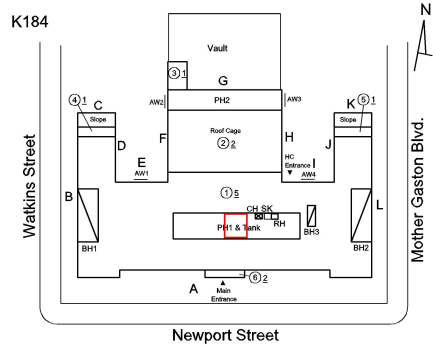
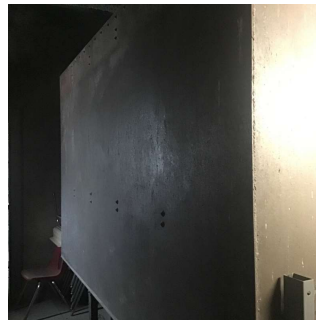
Penthouse Gravity Roof Tank Room

TANK: NOT IN USE - MINOR DETERIORATION

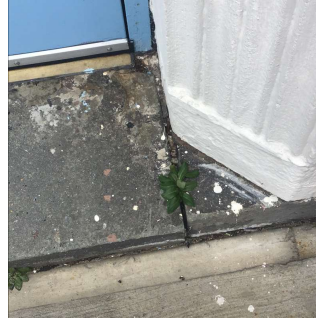
Facade B

STONE: DETERIORATED JOINTS

REPOINT  
 PRIORITY 3  
 LEVEL 2

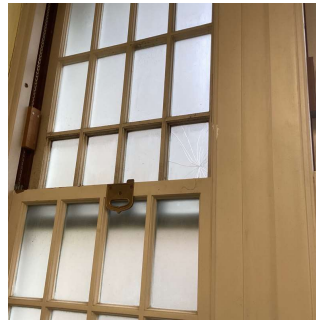
Facade F - Kitchen Locker Room  
No violations recorded.

WOOD: BROKEN PANE

30  
S.F.  
MAINTENANCE  
PRIORITY 3  
LEVEL 2

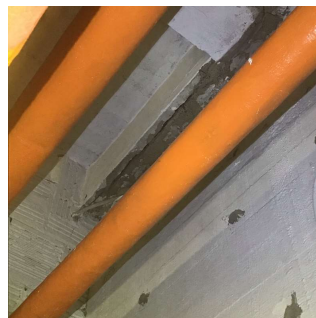
STEEL COLUMNS/BEAMS: DETERIORATED CONCRETE  
FIREPROOFING

REPLACE

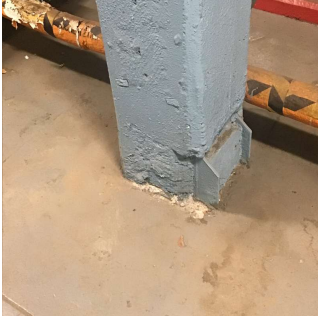
Question	Response
<b>INTERIOR</b>	
<b>STRUCTURAL</b>	
<b>COLUMNS/BEAMS/BEARING WALLS</b>	
Violations	Stair D/Basement No violations recorded.
Deficiency	STEEL COLUMNS/BEAMS: DETERIORATED CONCRETE FIREPROOFING
Deficiency Location/Instance	Basement - Boiler Room
Deficiency Quantity	10
Quantity Uom	S.F.
Potential Action	REPLACE
Urgency of Action	PRIORITY 3
Purpose of Action	LEVEL 5
Deficiency Photo1

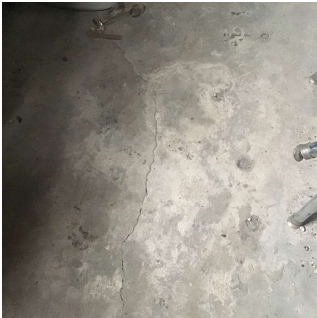
Violations	Boiler Room No violations recorded.
Deficiency	CONCRETE: CRACKS/SPALLED/REINFORCEMENT EXPOSED
Deficiency Location/Instance	PH1
Deficiency Quantity	50
Quantity Uom	S.F.
Potential Action	REPAIR

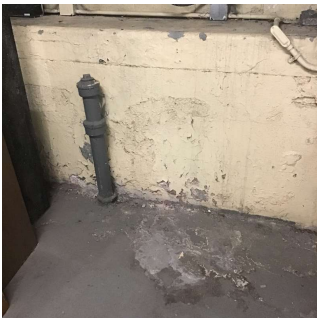
Violations	PH1 No violations recorded.
<b>FOUNDATION WALLS</b>	
Material Type(s)	Inspected Concrete
Condition	4 - Between Fair and Poor
Deficiency	CONCRETE: WATER INFILTRATION IN NON- INSTRUCTIONAL SPACE
Deficiency Location/Instance	Basement - Boiler Room
Deficiency Quantity	100
Quantity Uom	S.F.
Potential Action	INSTALL WATERPROOFING
Urgency of Action	PRIORITY 5
Purpose of Action	LEVEL 5
Deficiency Photo1

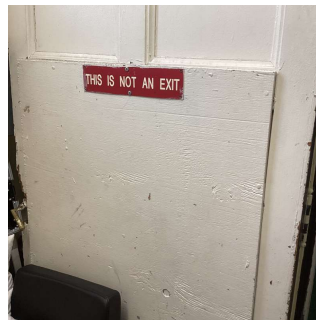
Right Side Backstage  
No violations recorded.

Instance on 2nd Floor (538 Seats)	Inspected
Condition	4 - Between Fair and Poor
Deficiency	WOOD: DETERIORATED DOOR
Deficiency Location/Instance	Right Side Backstage
Deficiency Quantity	1
Quantity Uom	EACH
Potential Action	MAINTENANCE
Urgency of Action	PRIORITY 3
Purpose of Action	LEVEL 2
Deficiency Photo1

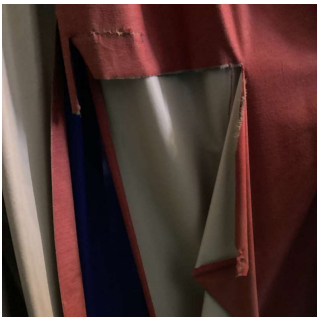
Question	Response
<b>INTERIOR</b>	
<b>AUDITORIUM</b>	
<b>Stage</b>	
<b>Stage Curtains</b>	
Instance on 2nd Floor (538 Seats)	Inspected
Condition	4 - Between Fair and Poor
Deficiency	WORN/DETERIORATED
Deficiency Location/Instance	Left Side
Deficiency Quantity	300
Quantity Uom	S.F.
Potential Action	REPLACE
Urgency of Action	PRIORITY 3
Purpose of Action	LEVEL 2
Deficiency Photo1

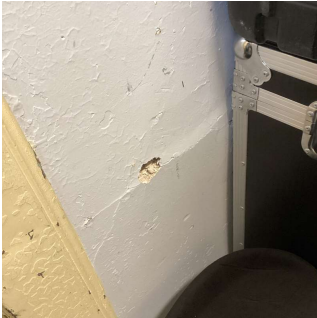
Left Side
Violations	No violations recorded.
<b>Walls</b>	
Instance on 2nd Floor (538 Seats)	Inspected
Condition	2 - Between Good and Fair
Deficiency	PLASTER: CRACKS/SPALLING
Deficiency Location/Instance	Right and Left Side
Deficiency Quantity	30
Quantity Uom	S.F.
Potential Action	REPLACE
Urgency of Action	PRIORITY 3
Purpose of Action	LEVEL 2
Deficiency Photo1

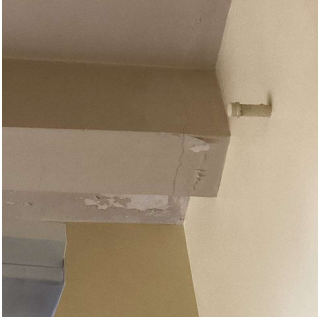
Condition	2 - Between Good and Fair
Deficiency	No deficiencies recorded
<b>Window Curtains/Shades/Blinds</b>	
Instance on 1st Floor	Does not Exist
<b>CLASSROOMS/CORRIDORS/ADMIN SPACES</b>	
	Inspected
<b>Ceiling</b>	
	Inspected
Condition	2 - Between Good and Fair
Deficiency	PLASTER: CRACKS/SPALLING
Deficiency Location/Instance	Room 361
Deficiency Quantity	10

Question	Response
<b>INTERIOR</b>	
<b>CLASSROOMS/CORRIDORS/ADMIN SPACES</b>	
<b>Ceiling</b>	
Quantity Uom	S.F.
Potential Action	REPLACE
Urgency of Action	PRIORITY 3
Purpose of Action	LEVEL 2
Deficiency Photo1

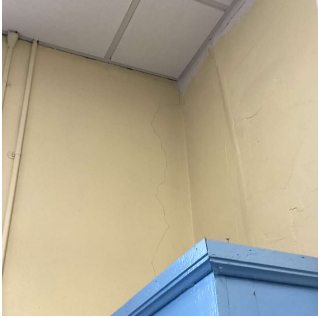
<b>Question</b>	<b>Response</b>
<b>INTERIOR</b>	
<b>CLASSROOMS/CORRIDORS/ADMIN SPACES</b>	
<b>Floor Finish</b>	Inspected
Violations	No violations recorded.
<b>Walls</b>	Inspected
Condition	2 - Between Good and Fair
Deficiency	PLASTER: CRACKS/SPALLING
Deficiency Location/Instance	Room 512, 511, Corridor near Rooms 405, 402, by Stair D/2 and others
Deficiency Quantity	70
Quantity Uom	S.F.
Potential Action	REPLACE
Urgency of Action	PRIORITY 3
Purpose of Action	LEVEL 2
Deficiency Photo1

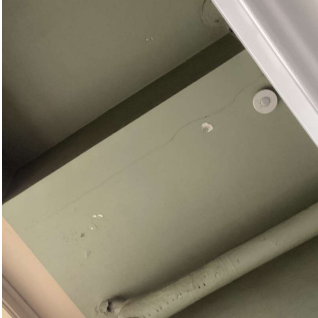
Violations	Room 511 No violations recorded.
<b>Specialties</b>	Does not Exist
<b>GYMNASIUM</b>	
Instance on 3rd Floor (1300 SF)	Inspected
<b>Ceiling</b>	Inspected
Instance on 3rd Floor (1300 SF)	Inspected
Condition	2 - Between Good and Fair
Deficiency	PLASTER: CRACKS/SPALLING
Deficiency Location/Instance	Office Room
Deficiency Quantity	10
Quantity Uom	S.F.
Potential Action	REPLACE
Urgency of Action	PRIORITY 3
Purpose of Action	LEVEL 2

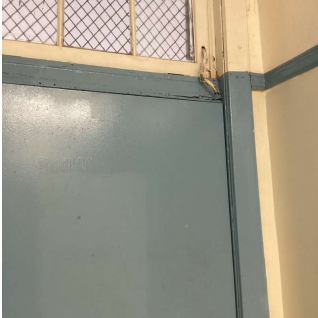
Question	Response
<b>INTERIOR</b>	
<b>GYMNASIUM</b>	
<b>Door(s)</b>	
Instance on 3rd Floor (1300 SF)	Inspected
Condition	5 - Poor
Deficiency	METAL: DETERIORATED DOOR AND FRAME
Deficiency Location/Instance	Main Entrance
Deficiency Quantity	2
Quantity Uom	EACH
Potential Action	MAINTENANCE
Urgency of Action	PRIORITY 3
Purpose of Action	LEVEL 2
Deficiency Photo1

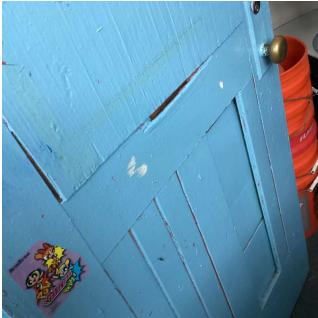
Violations	Main Entrance No violations recorded.
Deficiency	WOOD: DETERIORATED DOOR
Deficiency Location/Instance	Office Room, Storage Room
Deficiency Quantity	2
Quantity Uom	EACH
Potential Action	MAINTENANCE
Urgency of Action	PRIORITY 3
Purpose of Action	LEVEL 2
Deficiency Photo1

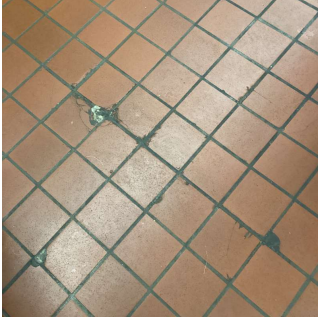
Question	Response
<b>INTERIOR</b>	
<b>KITCHEN</b>	
<b>Door(s)</b>	
Condition	2 - Between Good and Fair
Deficiency	No deficiencies recorded
<b>Floor Finish</b>	
Instance on 1st Floor	Inspected
Condition	2 - Between Good and Fair
Deficiency	QUARRY TILE: BROKEN/MISSING TILES
Deficiency Location/Instance	Servery, Near Sink
Deficiency Quantity	20
Quantity Uom	S.F.
Potential Action	REPLACE
Urgency of Action	PRIORITY 3
Purpose of Action	LEVEL 2
Deficiency Photo1

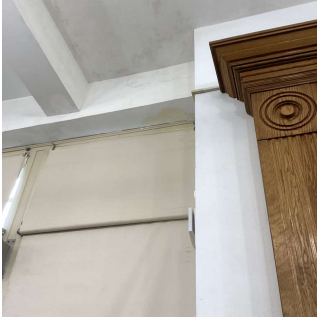
Question	Response
<b>INTERIOR</b>	
<b>LIBRARY</b>	
<b>Floor Finish</b>	
Violations	No violations recorded.
<b>Walls</b>	
Instance on Room 411	Inspected
Condition	2 - Between Good and Fair
Deficiency	PLASTER: CRACKS/SPALLING
Deficiency Location/Instance	Near Windows
Deficiency Quantity	10
Quantity Uom	S.F.
Potential Action	REPLACE
Urgency of Action	PRIORITY 3
Purpose of Action	LEVEL 2
Deficiency Photo1

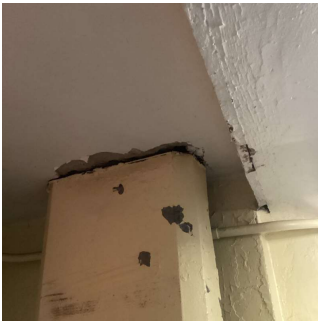
Question	Response
<b>INTERIOR</b>	
<b>SCIENCE PREP ROOM</b>	Inspected
<b>Fixed Equipment</b>	
Condition	2 - Between Good and Fair
Deficiency	No deficiencies recorded
<b>SHOWER ROOM</b>	Does not Exist
<b>STAIRS/RAMPS: INTERIOR</b>	Inspected
Do Letter Stair Signs Exist?	Partially
<b>Ceiling</b>	
Condition	2 - Between Good and Fair
Deficiency	PLASTER: CRACKS/SPALLING
Deficiency Location/Instance	Exit 2 - Vestibule
Deficiency Quantity	10
Quantity Uom	S.F.
Potential Action	REPLACE
Urgency of Action	PRIORITY 3
Purpose of Action	LEVEL 2
Deficiency Photo1

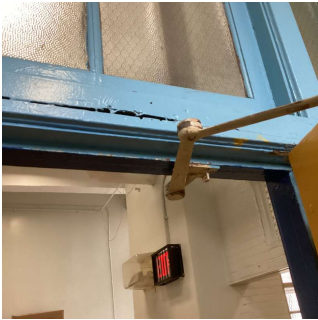
Violations	Exit 2 - Vestibule No violations recorded.
<b>Door(s)</b>	
Condition	2 - Between Good and Fair
Deficiency	WOOD: DETERIORATED DOOR
Deficiency Location/Instance	Exit 7 - Vestibule
Deficiency Quantity	1
Quantity Uom	EACH
Potential Action	MAINTENANCE
Urgency of Action	PRIORITY 3
Purpose of Action	LEVEL 2
Deficiency Photo1

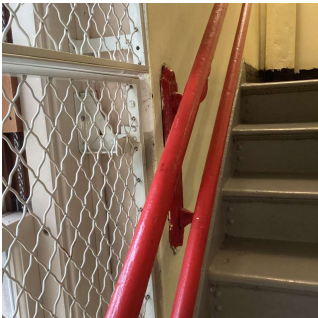
<b>Question</b>	<b>Response</b>
<b>INTERIOR</b>	
<b>STAIRS/RAMPS: INTERIOR</b>	Inspected
<b>Partition</b>	
Deficiency	GLASS PANEL: DAMAGED/DETERIORATED
Deficiency Location/Instance	Stairs BC/1, 2, 3, 4, FG/4 and others
Deficiency Quantity	70
Quantity Uom	S.F.
Potential Action	REPLACE
Urgency of Action	PRIORITY 3
Purpose of Action	LEVEL 2
Deficiency Photo1	 
Violations	Stair B/1 No violations recorded.
<b>Railings</b>	
Condition	Inspected
Deficiency	3 - Fair
Deficiency	METAL: BROKEN BRACKET
Deficiency Location/Instance	Stairs B/1, 3, 4
Deficiency Quantity	3
Quantity Uom	EACH
Potential Action	REPLACE
Urgency of Action	PRIORITY 3
Purpose of Action	LEVEL 2
Deficiency Photo1

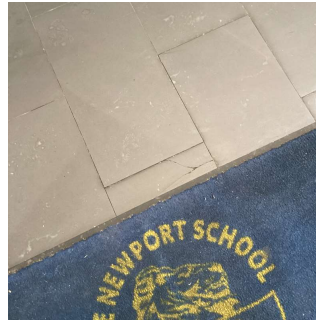
Violations	Stair B/1 No violations recorded.
<b>Stairs and Landings</b>	
Condition	Inspected
Deficiency	4 - Between Fair and Poor
Deficiency	CERAMIC TILE: BROKEN/MISSING
Deficiency Location/Instance	Exit 7 - Vestibule
Deficiency Quantity	10
Quantity Uom	S.F.

Potential Action	REPLACE
Urgency of Action	PRIORITY 3
Purpose of Action	LEVEL 2

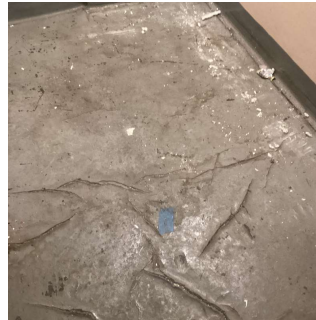
Stair B/5

ROLLED ASPHALT: CRACKS

REPLACE

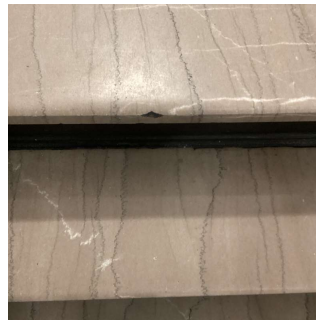
Main Entrance Lobby Stair

STONE: BROKEN/MISSING

REPLACE

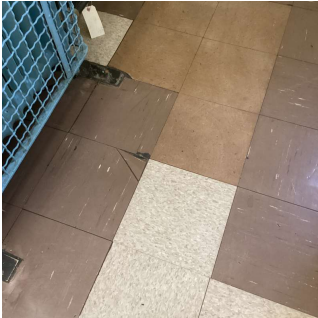
Question	Response
<b>INTERIOR</b>	
<b>STAIRS/RAMPS: INTERIOR</b>	
<b>Stairs and Landings</b>	
Deficiency	VINYL TILES: BROKEN/DETERIORATED/MISSING TILES
Deficiency Location/Instance	Stairs D/2, 3, 5, E/3, FG/5 and others
Deficiency Quantity	70
Quantity Uom	S.F.
Potential Action	REPLACE
Urgency of Action	PRIORITY 3
Purpose of Action	LEVEL 2
Deficiency Photo1

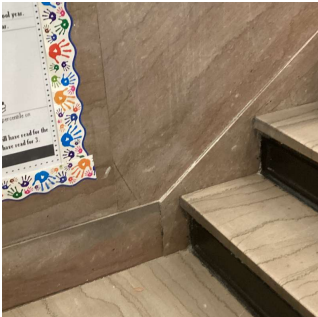
Violations	Stair FG/5 No violations recorded.
<b>Walls</b>	Inspected
Condition	2 - Between Good and Fair
Deficiency	STONE: CRACKS/SPALLING
Deficiency Location/Instance	Main Entrance Lobby Stair
Deficiency Quantity	10
Quantity Uom	S.F.
Potential Action	REPLACE
Urgency of Action	PRIORITY 3
Purpose of Action	LEVEL 2
Deficiency Photo1

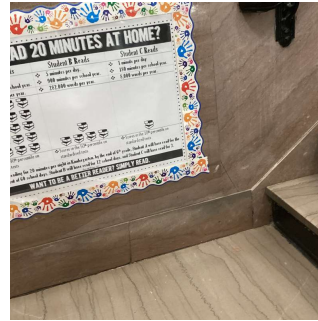
Violations	Main Entrance Lobby Stair No violations recorded.
Deficiency	STONE MOLDINGS: CRACKS/SPALLING
Deficiency Location/Instance	Main Entrance Lobby Stair
Deficiency Quantity	10
Quantity Uom	L.F.
Potential Action	REPLACE
Urgency of Action	PRIORITY 3

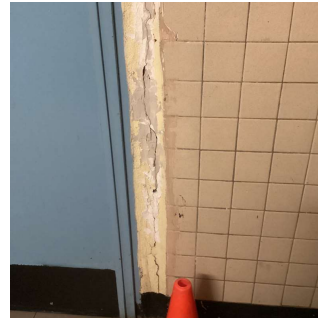
Exit 2 - Vestibule

**PLASTER: CRACKS/SPALLING**

REPLACE

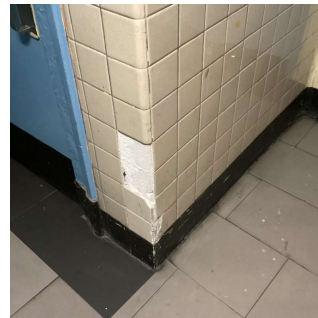
Exit 2 - Vestibule

**CERAMIC TILE: BROKEN/ MISSING**

REPLACE

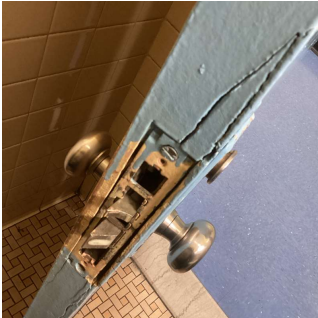
Question	Response
<b>INTERIOR</b>	
<b>TOILET ROOMS - STAFF</b>	Inspected
<b>Ceiling</b>	Inspected
Condition	2 - Between Good and Fair
Deficiency	No deficiencies recorded
<b>Door(s)</b>	Inspected
Condition	5 - Poor
Deficiency	WOOD: DETERIORATED DOOR
Deficiency Location/Instance	Women Toilet Room - 4th, 3rd Floor
Deficiency Quantity	2
Quantity Uom	EACH
Potential Action	MAINTENANCE
Urgency of Action	PRIORITY 3
Purpose of Action	LEVEL 2
Deficiency Photo1

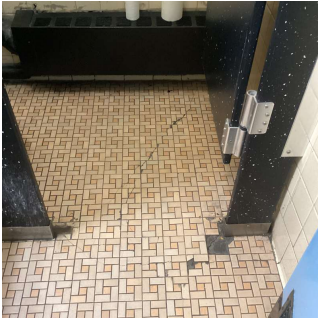
Violations	Women Toilet Room - 4th Floor No violations recorded.
<b>Floor Finish</b>	Inspected
Condition	4 - Between Fair and Poor
Deficiency	CERAMIC TILE: DETERIORATED SUBSTRATE
Deficiency Location/Instance	Women Toilet Room - 5th, 4th, 3rd Floor
Deficiency Quantity	30
Quantity Uom	S.F.
Potential Action	REPLACE
Urgency of Action	PRIORITY 3
Purpose of Action	LEVEL 2
Deficiency Photo1

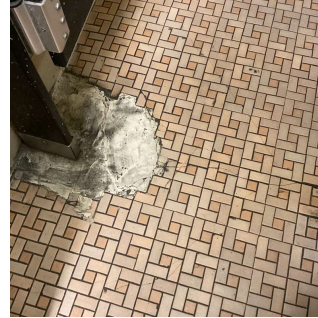
Women Toilet Room - 5th Floor

Violations	Women Toilet Room - 4th Floor No violations recorded.
Deficiency	CERAMIC TILE: BROKEN/MISSING TILES

Deficiency Location/Instance	Women Toilet Room - 5th Floor, In Room 108
Deficiency Quantity	10
Quantity Uom	S.F.
Potential Action	REPLACE

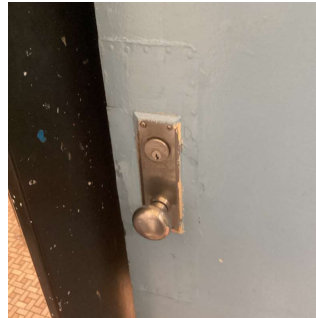
Room 412C

WOOD: DETERIORATED DOOR

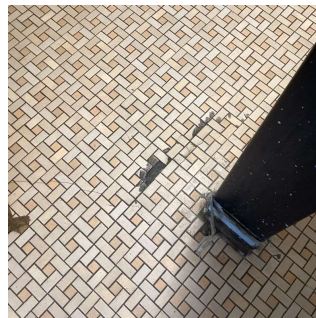
CERAMIC TILE: BROKEN/MISSING TILES

REPLACE

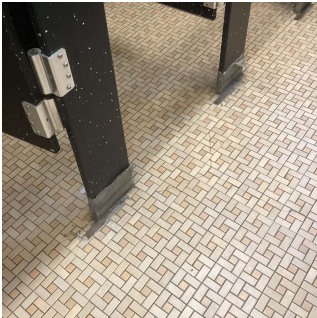
Question	Response
<b>INTERIOR</b>	
<b>TOILET ROOMS - STUDENTS</b>	
<b>Floor Finish</b>	
Violations	Boys Toilet Room - 4th Floor No violations recorded.
Deficiency	CERAMIC TILE: DETERIORATED SUBSTRATE
Deficiency Location/Instance	Rooms 512B, 412C, In Rooms 211, 213
Deficiency Quantity	40
Quantity Uom	S.F.
Potential Action	REPLACE
Urgency of Action	PRIORITY 3
Purpose of Action	LEVEL 2
Deficiency Photo1

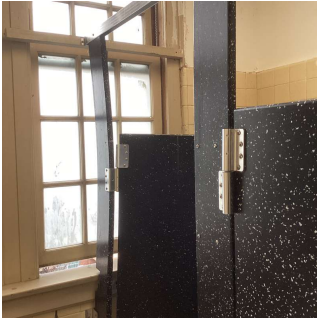
Violations	Room 512B No violations recorded.
<b>Stalls</b>	Inspected
Condition	3 - Fair
Deficiency	BROKEN/MISSING
Deficiency Location/Instance	Boys Toilet - 3rd Floor, Room 312C
Deficiency Quantity	2
Quantity Uom	EACH
Potential Action	REPLACE
Urgency of Action	PRIORITY 3
Purpose of Action	LEVEL 2
Deficiency Photo1

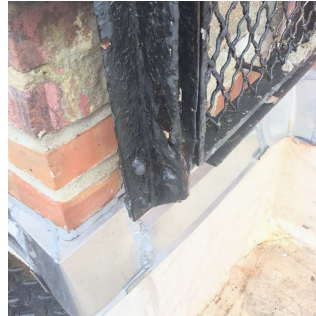
Facade I - East Exit

MAJOR RUSTING

REPLACE

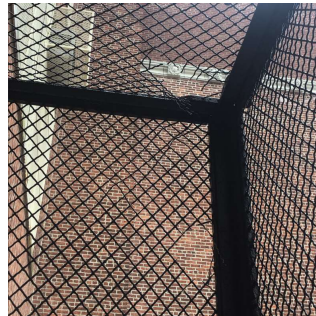
Facade E - West Exit

DAMAGED

REPLACE

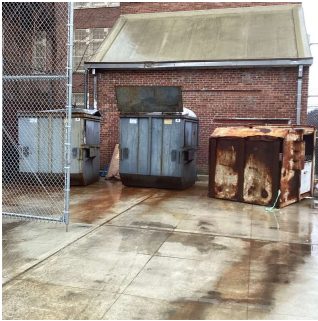
<b>Question</b>	<b>Response</b>
<b>LIFE SAFETY</b>	Inspected
<b>STEEL STAIRS</b>	Inspected
Violations	No violations recorded.
<b>SITE</b>	Inspected
<b>CONTAINERIZATION</b>	Inspected
Condition	5 - Poor
Deficiency	CONTAINER DAMAGED
Deficiency Location/Instance	Watkins Street
Deficiency Quantity	2
Quantity Uom	EACH
Potential Action	REPLACE
Urgency of Action	PRIORITY 3
Purpose of Action	LEVEL 2
Deficiency Photo1

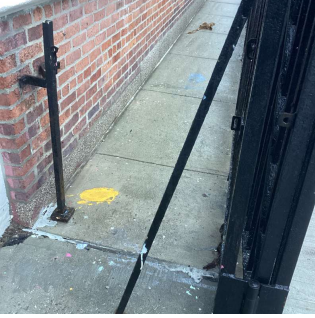
<b>DRINKING FOUNTAINS</b>	Does not Exist
<b>FENCES</b>	Inspected
Condition	4 - Between Fair and Poor
Deficiency	WROUGHT IRON: MISSING SECTIONS
Deficiency Location/Instance	Mother Gaston Boulevard
Deficiency Quantity	40
Quantity Uom	S.F.
Potential Action	REPLACE
Urgency of Action	PRIORITY 3
Purpose of Action	LEVEL 2

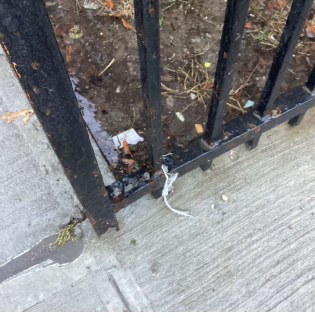
Violations	Mother Gaston Boulevard No violations recorded.
Deficiency	<b>WROUGHT IRON: RUST - MAJOR</b>
Deficiency Location/Instance	Watkins Street, Mother Gaston Boulevard, Newport Street
Deficiency Quantity	160
Quantity Uom	S.F.
Potential Action	REPLACE
Urgency of Action	PRIORITY 3
Purpose of Action	LEVEL 2
Deficiency Photo1

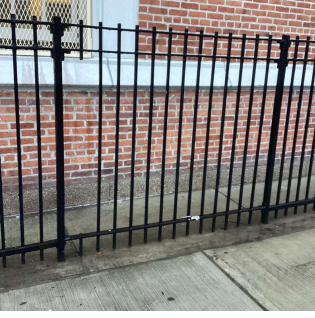
Violations	Mother Gaston Boulevard No violations recorded.
Deficiency	<b>WROUGHT IRON: DAMAGED/DETERIORATED</b>
Deficiency Location/Instance	Watkins Street, Mother Gaston Boulevard, Newport Street
Deficiency Quantity	480
Quantity Uom	S.F.
Potential Action	REPLACE
Urgency of Action	PRIORITY 3
Purpose of Action	LEVEL 2
Deficiency Photo1

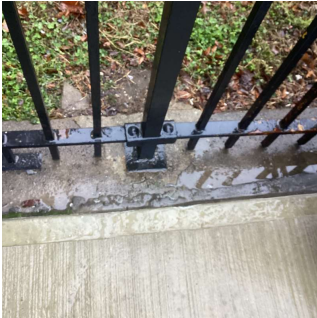
Violations	Mother Gaston Boulevard No violations recorded.
Deficiency	<b>CONCRETE CURB: DAMAGED/DETERIORATED</b>

Question	Response
<b>SITE</b>	
<b>FENCES</b>	
Deficiency Location/Instance	Newport Street
Deficiency Quantity	10
Quantity Uom	S.F.
Potential Action	REPLACE
Urgency of Action	PRIORITY 3
Purpose of Action	LEVEL 2
Deficiency Photo1

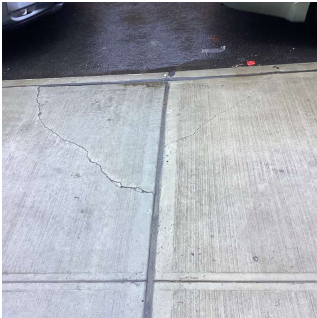
Question	Response
<b>SITE</b>	
<b>PAVING</b>	
<b>Student Use</b>	
<b>Asphalt</b>	Inspected
Condition	1 - Good
Deficiency	No deficiencies recorded
<b>Concrete</b>	Inspected
Condition	1 - Good
Deficiency	No deficiencies recorded
<b>Pavers</b>	Does not Exist
<b>Site Sidewalks &amp; Walkways</b>	Inspected
<b>Asphalt</b>	Does not Exist
<b>Concrete</b>	Inspected
Condition	1 - Good
Deficiency	No deficiencies recorded
<b>Pavers</b>	Does not Exist
<b>DOT Sidewalk</b>	Inspected
<b>Asphalt</b>	Does not Exist
<b>Concrete</b>	Inspected
Condition	3 - Fair
Deficiency	DAMAGED CURBS
Deficiency Location/Instance	Mother Gaston Boulevard, Watkins Street
Deficiency Quantity	20
Quantity Uom	L.F.
Potential Action	REPLACE
Urgency of Action	PRIORITY 3
Purpose of Action	LEVEL 2
Deficiency Photo1	 
Mother Gaston Boulevard	
Violations	No violations recorded.
Deficiency	DAMAGED/DETERIORATED/MISSING SECTIONS
Deficiency Location/Instance	Mother Gaston Boulevard, Watkins Street

Deficiency Quantity	75
Quantity Uom	S.F.
Potential Action	REPLACE
Urgency of Action	PRIORITY 3
Purpose of Action	LEVEL 2
