NYC Department of Education
Building Condition Assessment Survey 2023 - 2024

Architectural Inspection

Asset: P.S. 189 - BROOKLYN, 1100 EAST NEW YORK AVE, New York, 11212

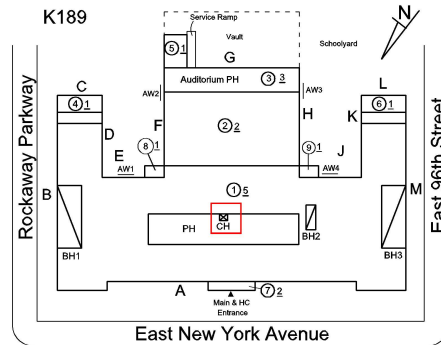
STONE/TERRA COTTA BAND: MINOR DETERIORATION

REPAIR

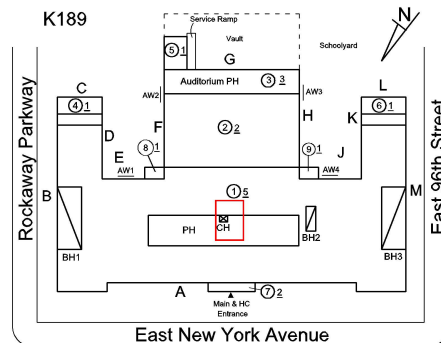
BRICK: DETERIORATED JOINTS

Question	Response
EXTERIOR	
CHIMNEY	
Quantity Uom	S.F.
Potential Action	REPOINT
Urgency of Action	PRIORITY 3
Purpose of Action	LEVEL 2
Deficiency Photo1

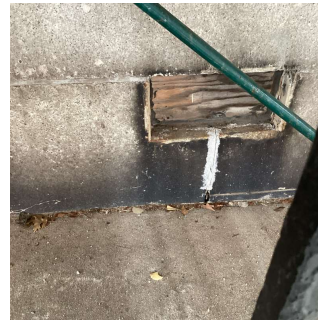
Facade B

Violations	CH No violations recorded.
COPING	Under Construction
CORNICE	Inaccessible
DOORS	Inspected
DOORS AND FRAMES	Inspected
Condition	2 - Between Good and Fair
Deficiency	No deficiencies recorded
DOOR HARDWARE	Inspected
Condition	3 - Fair
Deficiency	No deficiencies recorded
LINTELS	Inspected
Condition	2 - Between Good and Fair
Deficiency	No deficiencies recorded
TRANSOM/SIDE LIGHT	Does not Exist
EXTERIOR WALLS	Inspected
Material Type(s)	Masonry
Replacement Quantity	35,000
Replacement Uom	S.F.
Instance on All Facades	Under Construction
Instance Quantity	35,000
Instance Quantity Uom	S.F.
EXTERIOR SOFFITS	Does not Exist
LOADING DOCK	Does not Exist
LOUVER	Inspected
Condition	3 - Fair
Deficiency	BROKEN/ DENTED BLADES

REPLACE

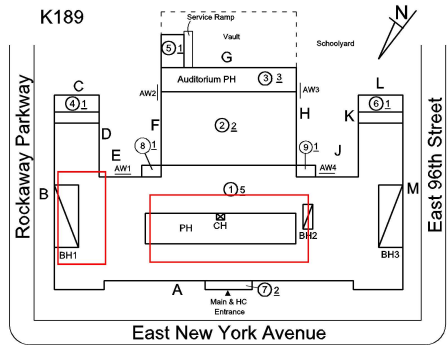
ROOFING DRAINS	Under Construction
Specialties	Inspected
BULKHEAD/PENTHOUSE	Inspected
Condition	3 - Fair
Deficiency	BULKHEAD/PENTHOUSE WALLS/INTERIOR: BRICK CRACKS/SPALLING
Roof Plan reference

Deficiency Quantity	80
Quantity Uom	S.F.
Potential Action	REPLACE

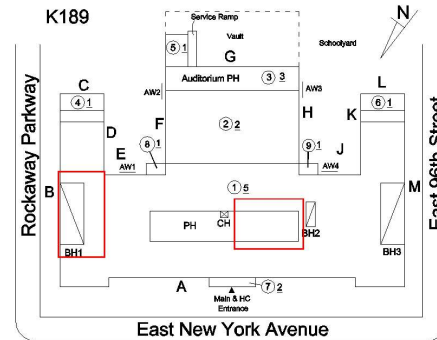
BULKHEAD/PENTHOUSE WALLS/INTERIOR: PLASTER
CRACKS/SPALLING

60
S.F.
REPLACE
PRIORITY 4
LEVEL 2

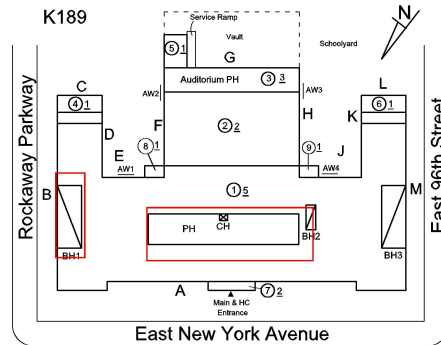
BULKHEAD/PENTHOUSE WALLS/INTERIOR: BRICK
CRACKS/SPALLING

60
S.F.
REPLACE
PRIORITY 3
LEVEL 2

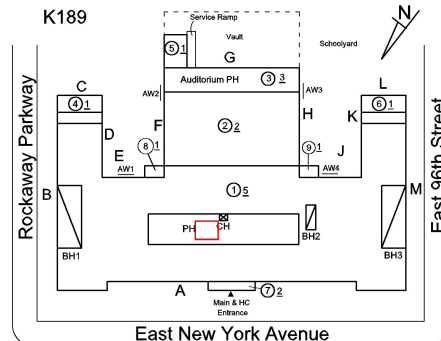
TANK: NOT IN USE - MINOR DETERIORATION

1
EACH
NO ACTION

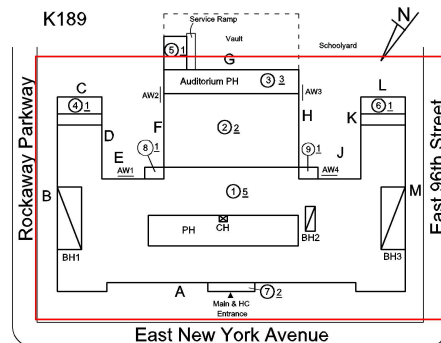
Deficiency	ALUMINUM - DOUBLE HUNG: INOPERABLE BALANCE
------------	--

Question	Response
EXTERIOR	
WINDOWS	
WINDOWS	
Elevation	 
Deficiency Quantity	50
Quantity Uom	EACH
Potential Action	REPLACE BALANCES
Urgency of Action	PRIORITY 3
Purpose of Action	LEVEL 2
Deficiency Photo1	No photo recorded
Violations	No violations recorded.
INTERIOR	
	Inspected
POOLS	
	Does not Exist
STRUCTURAL	
	Inspected
COLUMNS/BEAMS/BEARING WALLS	
Condition	4 - Between Fair and Poor
Deficiency	STEEL COLUMNS/BEAMS: DETERIORATED CONCRETE FIREPROOFING
Deficiency Location/Instance	Basement - Boiler Room, Blower Room
Deficiency Quantity	70
Quantity Uom	S.F.
Potential Action	REPLACE
Urgency of Action	PRIORITY 5
Purpose of Action	LEVEL 6
Deficiency Photo1	 
	Basement - Boiler Room
Violations	No violations recorded.
Deficiency	STEEL COLUMNS/BEAMS: DETERIORATED CONCRETE FIREPROOFING
Deficiency Location/Instance	Basement - Room 012, Boiler Room, Blower Room
Deficiency Quantity	70
Quantity Uom	S.F.
Potential Action	REPLACE
Urgency of Action	PRIORITY 4

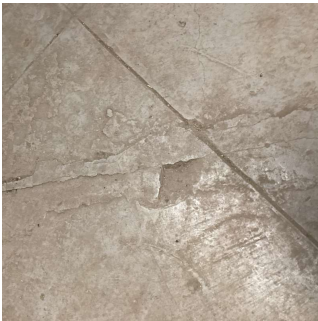
Violations	Basement - Blower Room
	No violations recorded.
Deficiency	CONCRETE SLAB ON GRADE: THRU CRACKS
Deficiency Location/Instance	Basement - Boiler Room, Blower Room
Deficiency Quantity	100
Quantity Uom	S.F.
Potential Action	REPLACE
Urgency of Action	PRIORITY 4
Purpose of Action	LEVEL 5

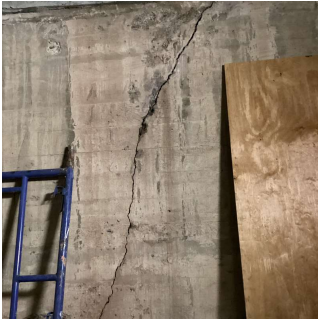
<p>Basement - Boiler Room</p> <p>No violations recorded.</p>
Violations	
FOUNDATION WALLS	
Material Type(s)	Inspected Concrete
Condition	4 - Between Fair and Poor
Deficiency	CONCRETE: CRACKED/SPALLED/REINFORCEMENT EXPOSED
Deficiency Location/Instance	Basement - Blower Room
Deficiency Quantity	20
Quantity Uom	S.F.
Potential Action	REPAIR
Urgency of Action	PRIORITY 4
Purpose of Action	LEVEL 5
Deficiency Photo1

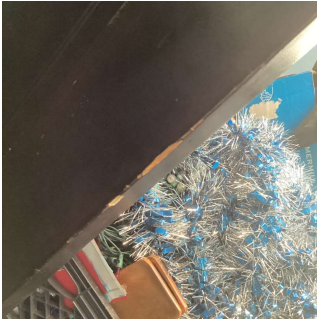
Question	Response
INTERIOR	
AUDITORIUM	
Ceiling	
Deficiency Photo1	 
Violations	Right Side Room near Stage No violations recorded.
Door(s)	
Instance on 2nd Floor (540 Seats)	Inspected
Condition	4 - Between Fair and Poor
Deficiency	WOOD: DETERIORATED DOOR
Deficiency Location/Instance	Left Side Room near Stage
Deficiency Quantity	1
Quantity Uom	EACH
Potential Action	MAINTENANCE
Urgency of Action	PRIORITY 3
Purpose of Action	LEVEL 2
Deficiency Photo1

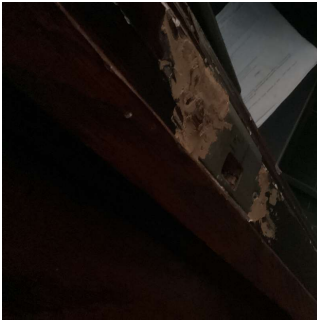
Violations	Left Side Room near Stage No violations recorded.
Deficiency	WOOD: DETERIORATED DOOR AND FRAME
Deficiency Location/Instance	Right Side Room near Stage
Deficiency Quantity	1
Quantity Uom	EACH
Potential Action	MAINTENANCE
Urgency of Action	PRIORITY 3
Purpose of Action	LEVEL 2

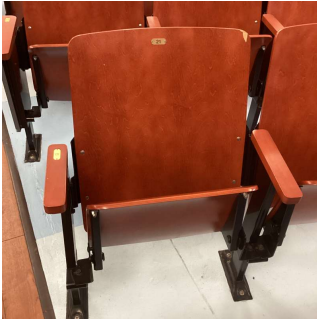
Violations	Right Side Room near Stage No violations recorded.
Fixed H/C Lift	
Instance on 2nd Floor (540 Seats)	Does not Exist
Fixed Seating	
Instance on 2nd Floor (540 Seats)	Inspected
Condition	2 - Between Good and Fair
Deficiency	DAMAGED/BROKEN/INOPERABLE
Deficiency Location/Instance	Seats B/21, G/28, H/7, J/29, L14
Deficiency Quantity	5
Quantity Uom	EACH
Potential Action	REPLACE
Urgency of Action	PRIORITY 3
Purpose of Action	LEVEL 2
Deficiency Photo1

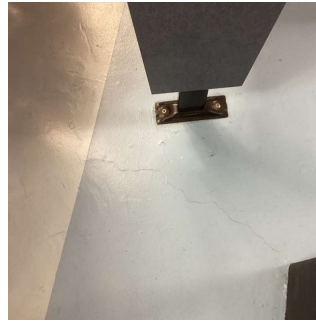
Violations	Seat B/21 No violations recorded.
Floor Finish	
Instance on 2nd Floor (540 Seats)	Inspected
Condition	2 - Between Good and Fair
Deficiency	CONCRETE: CRACKS
Deficiency Location/Instance	By Row F, Near Seat L/8
Deficiency Quantity	20
Quantity Uom	S.F.
Potential Action	REPLACE
Urgency of Action	PRIORITY 3
Purpose of Action	LEVEL 2

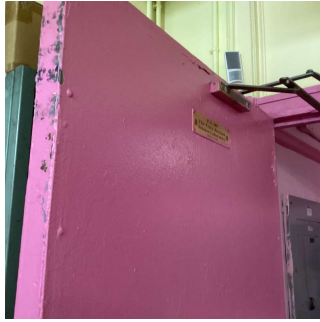
Question	Response
INTERIOR	
CLASSROOMS/CORRIDORS/ADMIN SPACES	
Ceiling	
Purpose of Action	LEVEL 2
Deficiency Photo1	 
	Room 402
Violations	No violations recorded.
Door(s)	
Condition	Inspected
Deficiency	5 - Poor
Deficiency Location/Instance	METAL: DETERIORATED DOOR
Deficiency Quantity	Room 508
Quantity Uom	1
Potential Action	EACH
Urgency of Action	MAINTENANCE
Purpose of Action	PRIORITY 3
Deficiency Photo1	LEVEL 2

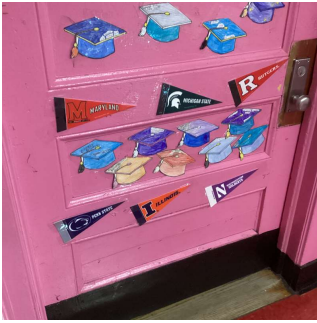
Room 508
Violations	No violations recorded.
Deficiency	WOOD: DETERIORATED DOOR
Deficiency Location/Instance	Rooms 507, 505, 502, 501, Main Entrance - Vestibule and others
Deficiency Quantity	21
Quantity Uom	EACH
Potential Action	MAINTENANCE
Urgency of Action	PRIORITY 3
Purpose of Action	LEVEL 2

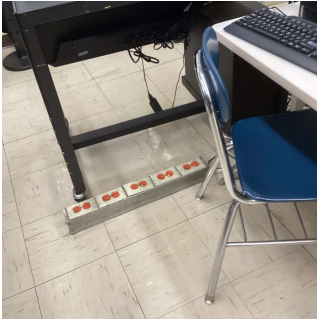
Room 502
Violations	No violations recorded.
Floor Finish	Inspected
Condition	4 - Between Fair and Poor
Deficiency	VINYL TILES: TRIPPING HAZARD - ELECTRICAL OUTLET
Deficiency Location/Instance	Room 211
Deficiency Quantity	10
Quantity Uom	S.F.
Potential Action	REMOVE
Urgency of Action	PRIORITY 5
Purpose of Action	LEVEL 6
Deficiency Photo1

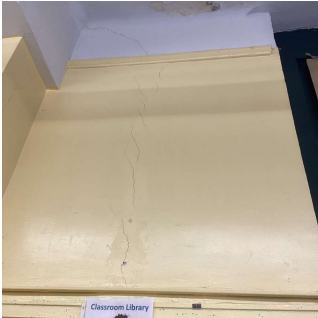
Question	Response
INTERIOR	
CLASSROOMS/CORRIDORS/ADMIN SPACES	
Floor Finish	Inspected
Violations	No violations recorded.
Walls	Inspected
Condition	2 - Between Good and Fair
Deficiency	PLASTER: CRACKS/SPALLING
Deficiency Location/Instance	Rooms 211, 402, 502, Corridor near Room 105
Deficiency Quantity	40
Quantity Uom	S.F.
Potential Action	REPLACE
Urgency of Action	PRIORITY 3
Purpose of Action	LEVEL 2
Deficiency Photo1

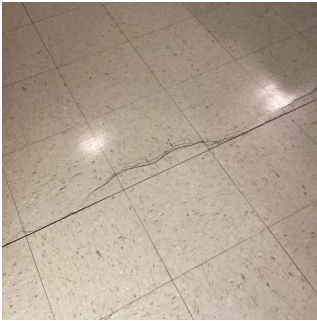
Floor Finish	
Instance on 1st Floor - East (1400 SF)	Inspected
Condition	5 - Poor
Deficiency	VINYL TILES: DETERIORATED SUBSTRATE
Deficiency Location/Instance	Near Rooms 100, 101, by Stair AB/1, Next to Windows
Deficiency Quantity	200
Quantity Uom	S.F.
Potential Action	REPLACE
Urgency of Action	PRIORITY 3
Purpose of Action	LEVEL 2

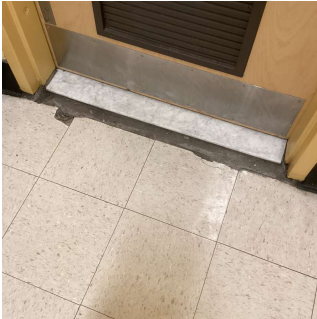
Near Room 101
Violations	No violations recorded.
Instance on 1st Floor - West (1300 SF)	Inspected
Condition	5 - Poor
Deficiency	VINYL TILES: BROKEN/DETERIORATED/MISSING TILES
Deficiency Location/Instance	Near Room 105
Deficiency Quantity	10
Quantity Uom	S.F.
Potential Action	REPLACE
Urgency of Action	PRIORITY 3
Purpose of Action	LEVEL 2
Deficiency Photo1

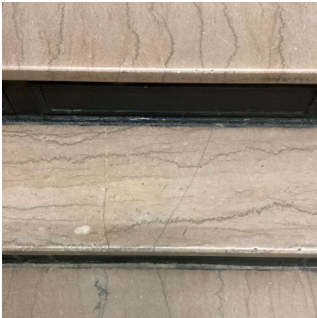
Question	Response
INTERIOR	
STAIRS/RAMPS: INTERIOR	
Railings	Inspected
Violations	Stair Right Side Auditorium/2 No violations recorded.
Stairs and Landings	Inspected
Condition	5 - Poor
Deficiency	STONE: BROKEN/MISSING
Deficiency Location/Instance	Main Entrance Lobby Stair
Deficiency Quantity	30
Quantity Uom	S.F.
Potential Action	REPLACE
Urgency of Action	PRIORITY 3
Purpose of Action	LEVEL 2
Deficiency Photo1

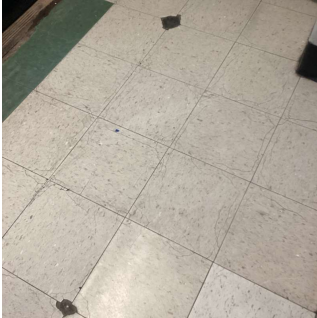
Violations	Main Entrance Lobby Stair No violations recorded.
Deficiency	VINYL TILES: DETERIORATED SUBSTRATE
Deficiency Location/Instance	Exit 6 - Vestibule
Deficiency Quantity	50
Quantity Uom	S.F.
Potential Action	REPLACE
Urgency of Action	PRIORITY 3
Purpose of Action	LEVEL 2
Deficiency Photo1

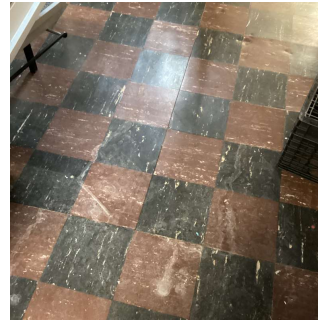
Stair H/2

Violations	Exit 6 - Vestibule No violations recorded.
Deficiency	VINYL TILES: BROKEN/DETERIORATED/MISSING TILES
Deficiency Location/Instance	Exits 2, 3 - Vestibules, Stairs EF/1, G/2, H/2 and others
Deficiency Quantity	630

Quantity Uom	S.F.
Potential Action	REPLACE
Urgency of Action	PRIORITY 3
Purpose of Action	LEVEL 2

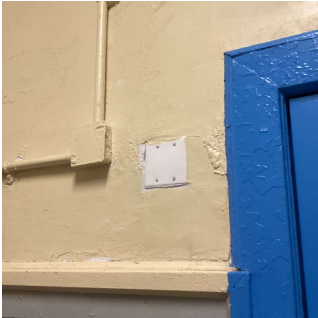
Question	Response
INTERIOR	
STAIRS/RAMPS: INTERIOR	
Walls	Inspected
Condition	2 - Between Good and Fair
Deficiency	CERAMIC TILE: BROKEN/ MISSING
Deficiency Location/Instance	Exits 2, 3, 6, 7 - Vestibules
Deficiency Quantity	70
Quantity Uom	S.F.
Potential Action	REPLACE
Urgency of Action	PRIORITY 3
Purpose of Action	LEVEL 2
Deficiency Photo1	 
Violations	Exit 7 - Vestibule No violations recorded.
Deficiency	PLASTER: CRACKS/SPALLING
Deficiency Location/Instance	Exits 2, 3, 6, 7 - Vestibules, Stair EF/1 and others
Deficiency Quantity	100
Quantity Uom	S.F.
Potential Action	REPLACE
Urgency of Action	PRIORITY 3
Purpose of Action	LEVEL 2
Deficiency Photo1

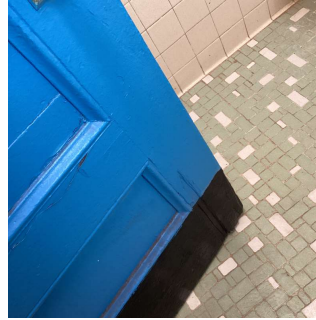
In Kitchen Toilet Room
No violations recorded.

Violations	Exit 7 - Vestibule No violations recorded.
TOILET ROOMS - STAFF	
Ceiling	Inspected
Condition	2 - Between Good and Fair
Deficiency	No deficiencies recorded
Door(s)	Inspected
Condition	5 - Poor
Deficiency	WOOD: DETERIORATED DOOR
Deficiency Location/Instance	In Kitchen Toilet Room, Rooms 258, 461A

Deficiency Quantity	3
Quantity Uom	EACH

Potential Action
Urgency of Action
Purpose of Action
Deficiency Photo1

MAINTENANCE
PRIORITY 3
LEVEL 2

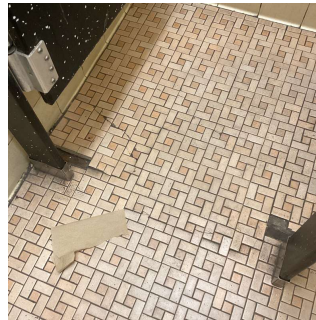
Room 258
No violations recorded.

CERAMIC TILE: DETERIORATED SUBSTRATE
Rooms 361, 258
20
S.F.
REPLACE
PRIORITY 3
LEVEL 2

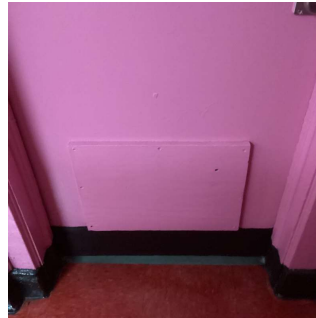
Room 558

WOOD: DAMAGED LOUVER

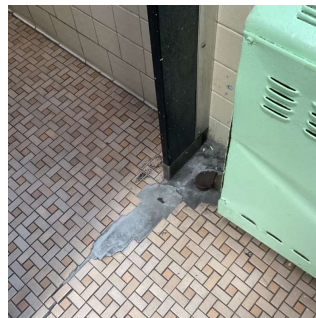
VINYL TILES: BROKEN/DETERIORATED/MISSING TILES

REPLACE

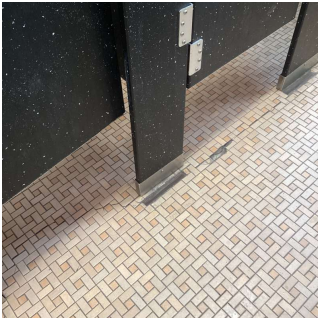
Question	Response
INTERIOR	
TOILET ROOMS - STUDENTS	
Floor Finish	
Violations	Room 471 No violations recorded.
Deficiency	CERAMIC TILE: DETERIORATED SUBSTRATE
Deficiency Location/Instance	Rooms 471, 362, 313, 254, Boys Toilet Room - 4th Floor and others
Deficiency Quantity	60
Quantity Uom	S.F.
Potential Action	REPLACE
Urgency of Action	PRIORITY 3
Purpose of Action	LEVEL 2
Deficiency Photo1

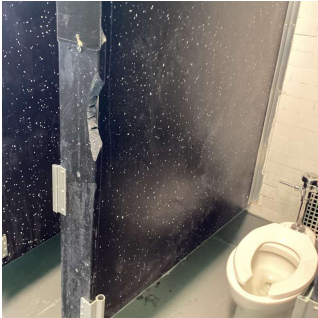
Violations	Room 471 No violations recorded.
Stalls	Inspected
Condition	3 - Fair
Deficiency	BROKEN/MISSING
Deficiency Location/Instance	Room 558
Deficiency Quantity	1
Quantity Uom	EACH
Potential Action	REPLACE
Urgency of Action	PRIORITY 3
Purpose of Action	LEVEL 2
Deficiency Photo1

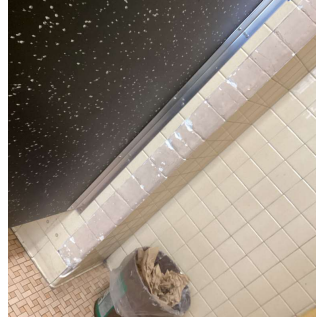
Room 202

Violations	Room 558 No violations recorded.
Walls	Inspected
Condition	2 - Between Good and Fair
Deficiency	CERAMIC TILE: BROKEN/ MISSING
Deficiency Location/Instance	Rooms 471, 362, 254, 202
Deficiency Quantity	50
Quantity Uom	S.F.
Potential Action	REPLACE

Urgency of Action
Purpose of Action
Deficiency Photo1

PRIORITY 3
LEVEL 2

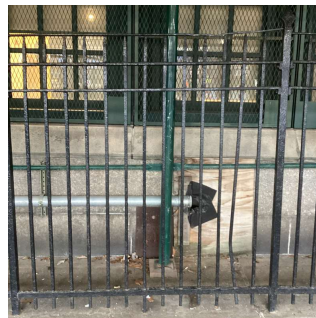
WROUGHT IRON: DAMAGED/DETERIORATED

REPLACE

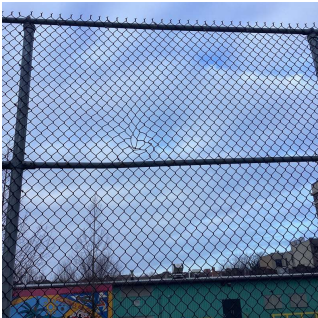
Question	Response
SITE	
FENCES	
Violations	Rockaway Parkway No violations recorded.
Deficiency	CHAIN LINK: DAMAGED/DETERIORATED
Deficiency Location/Instance	Rockaway Parkway
Deficiency Quantity	50
Quantity Uom	S.F.
Potential Action	REPLACE
Urgency of Action	PRIORITY 3
Purpose of Action	LEVEL 2
Deficiency Photo1

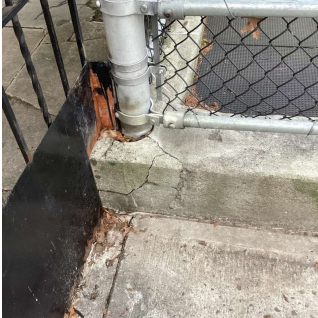
Violations	Rockaway Parkway No violations recorded.
Deficiency	CONCRETE CURB: DAMAGED/DETERIORATED
Deficiency Location/Instance	Rockaway Parkway, East 96th Street
Deficiency Quantity	230
Quantity Uom	S.F.
Potential Action	REPLACE
Urgency of Action	PRIORITY 3
Purpose of Action	LEVEL 2
Deficiency Photo1

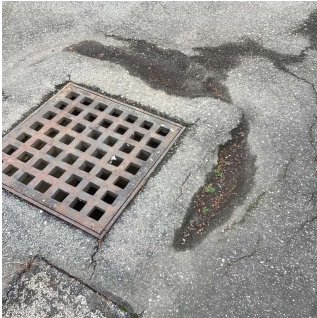
Question	Response
SITE	
PAVING	
Student Use	Inspected
Asphalt	Inaccessible
Concrete	Inaccessible
Pavers	Does not Exist
Site Sidewalks & Walkways	Inspected
Asphalt	Inspected
Condition	4 - Between Fair and Poor
Deficiency	HEAVING
Deficiency Location/Instance	Near Mini Building
Deficiency Quantity	300
Quantity Uom	S.F.
Potential Action	REPLACE
Urgency of Action	PRIORITY 3
Purpose of Action	LEVEL 2
Deficiency Photo1	 
	Near Mini Building
Violations	No violations recorded.
Deficiency	POTHOLES
Deficiency Location/Instance	Near Back Handball Wall
Deficiency Quantity	20
Quantity Uom	S.F.
Potential Action	REPAIR
Urgency of Action	PRIORITY 3
Purpose of Action	LEVEL 2
Deficiency Photo1

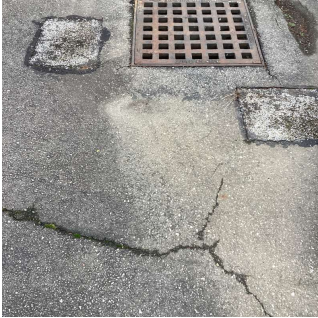
Near Back Handball Wall
Violations	No violations recorded.
Deficiency	CRACKS - MAJOR
Deficiency Location/Instance	Near Mini Building, by Exit 3
Deficiency Quantity	200
Quantity Uom	S.F.
Potential Action	REPLACE

Question	Response
SITE	
PAVING	
Site Sidewalks & Walkways	Inspected
Asphalt	
Urgency of Action	PRIORITY 3
Purpose of Action	LEVEL 2
Deficiency Photo1

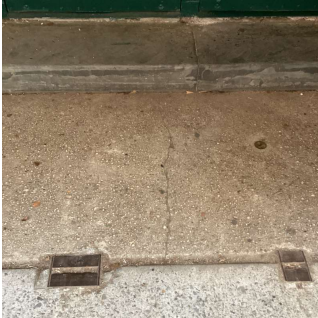
Near Mini Building
Violations	No violations recorded.
Concrete	Inspected
Condition	3 - Fair
Deficiency	DAMAGED/DETERIORATED/MISSING SECTIONS
Deficiency Location/Instance	East New York Avenue, E 96th Street
Deficiency Quantity	50
Quantity Uom	S.F.
Potential Action	REPLACE
Urgency of Action	PRIORITY 3
Purpose of Action	LEVEL 2
Deficiency Photo1

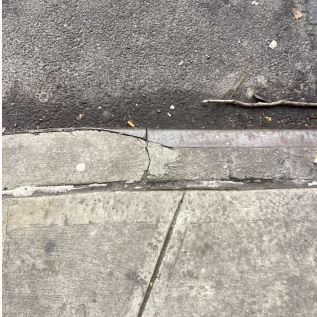
E 96th Street
Violations	No violations recorded.
Pavers	Does not Exist
DOT Sidewalk	Inspected
Asphalt	Does not Exist
Concrete	Inspected
Condition	4 - Between Fair and Poor
Deficiency	DAMAGED CURBS
Deficiency Location/Instance	Rockaway Parkway, East New York Avenue, E 96th Street
Deficiency Quantity	160
Quantity Uom	L.F.
Potential Action	REPLACE
Urgency of Action	PRIORITY 3
Purpose of Action	LEVEL 2

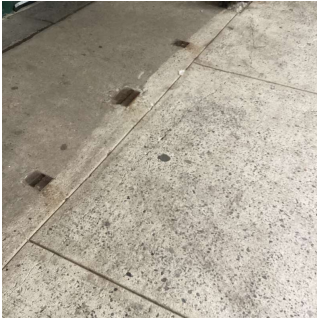
Violations	Rockaway Parkway No violations recorded.
Deficiency	DAMAGED/DETERIORATED/MISSING SECTIONS
Deficiency Location/Instance	Rockaway Parkway, East New York Avenue, E 96th Street
Deficiency Quantity	450
Quantity Uom	S.F.
Potential Action	REPLACE
Urgency of Action	PRIORITY 3
Purpose of Action	LEVEL 2
Deficiency Photo1

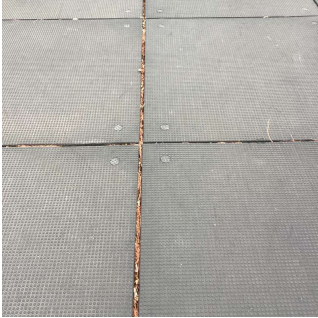
Question	Response
SITE	
PLAYGROUNDS	
Safety Surfacing	
Condition	3 - Fair
Deficiency	DETERIORATED/MISSING
Deficiency Location/Instance	Near Schoolyard
Deficiency Quantity	200
Quantity Uom	S.F.
Potential Action	MAINTENANCE
Urgency of Action	PRIORITY 3
Purpose of Action	LEVEL 2
Deficiency Photo1

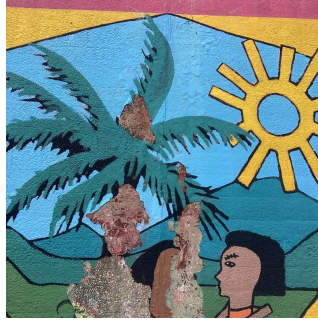
Violations	Near Schoolyard No violations recorded.
Unpaved Area	
Instance on Schoolyard - East	Does not Exist
Instance on Schoolyard - West	Does not Exist
PLAYING SURFACE	Does not Exist
RETAINING WALLS	Inaccessible
SEATING	Inspected
Benches	Inspected
Concrete	Inaccessible
Metal/Wood/Plastic	Inaccessible
Bleachers	Does not Exist
SITE WALLS (NOT RETAINING WALLS)	Inspected
Condition	3 - Fair
Deficiency	CAST IN PLACE CONCRETE: CRACKS/SPALLING - MAJOR
Deficiency Location/Instance	Handball Wall
Deficiency Quantity	30
Quantity Uom	S.F.
Potential Action	REPLACE
Urgency of Action	PRIORITY 3
Purpose of Action	LEVEL 2
