**NYC Department of Education
Building Condition Assessment Survey 2023 - 2024**

Architectural Inspection

Asset: P.S. 192 - BROOKLYN, 4715 18 AVENUE, New York, 11204

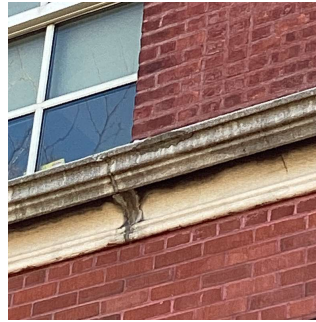
Facade A

STONE: MAJOR CRACKS, SPALLING

10
S.F.
REPLACE
PRIORITY 4
LEVEL 2

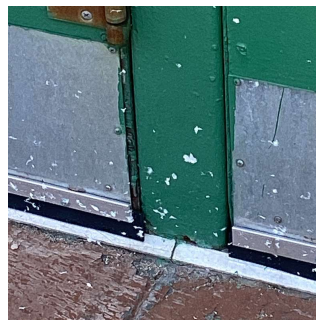
Facade L

METAL CLAD: DETERIORATED DOOR AND FRAME - MINOR DETERIORATION

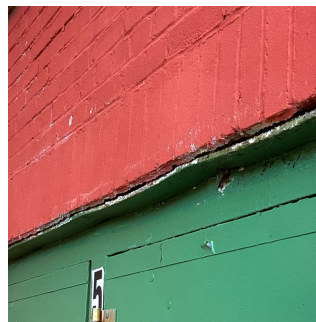
Facade E

STEEL: MAJOR RUSTING

REPLACE

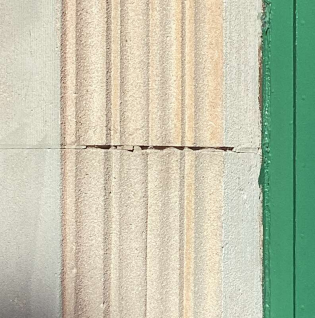
Violations	Facade L No violations recorded.
Deficiency	BRICK: MINOR CRACKS AND SPALLING

Deficiency Quantity	10
Quantity Uom	L.F.
Potential Action	REPOINT
Urgency of Action	PRIORITY 4
Purpose of Action	LEVEL 2
Deficiency Photo1

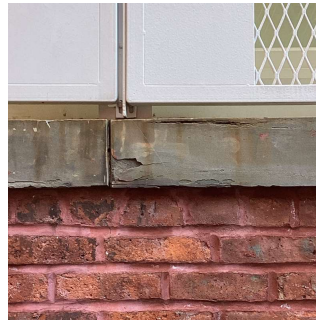
Facade D

BRICK: DETERIORATED MASONRY SILLS - MAJOR

REMOVE AND REPLACE

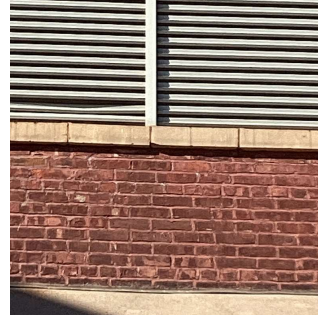
Facade C

BRICK: DETERIORATED MASONRY SILLS - MINOR

REPAIR

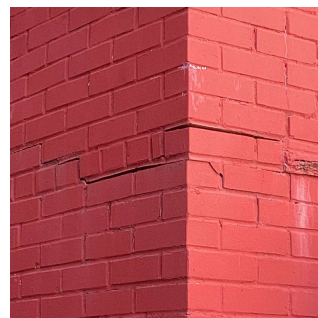
BRICK: CRACKS/DISPLACED/SPALLED BRICK AT BUILDING CORNERS

50
S.F.
REMOVE AND REBUILD
PRIORITY 4
LEVEL 2

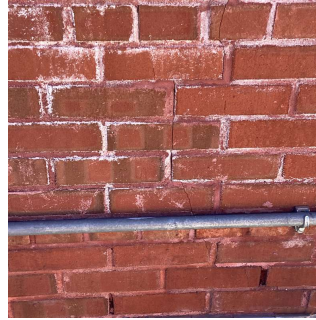
Roof 1

Violations	Facade C No violations recorded.
EXTERIOR SOFFITS	Does not Exist
LOADING DOCK	Does not Exist
LOUVER	Inspected
Condition	2 - Between Good and Fair
Deficiency	No deficiencies recorded
PARAPETS	Inspected
Material Type(s)	Masonry
Replacement Quantity	4,500
Replacement Uom	C.F.
Instance on All Roofs	Inspected
Instance Condition	3 - Fair
Instance Quantity	4,500
Instance Quantity Uom	C.F.
Deficiency	BRICK: MINOR CRACKS, SPALLING
Roof Plan reference	K192
Deficiency Quantity	35
Quantity Uom	S.F.
Potential Action	REPAIR
Urgency of Action	PRIORITY 3
Purpose of Action	LEVEL 2

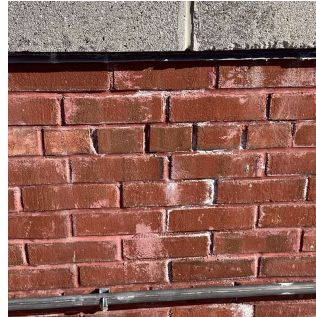
Roof 1

BRICK: DETERIORATED JOINTS

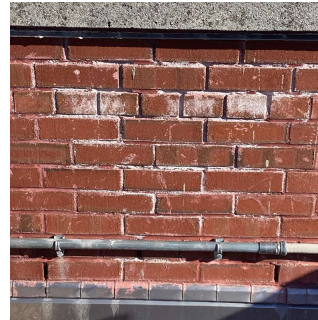
Roof 1

BRICK: EFFLORESCENCE

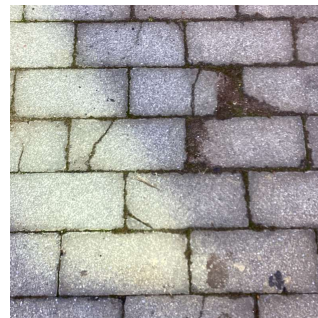
Roof 4

PAVERS: PAVERS IN POOR CONDITION

REPLACE

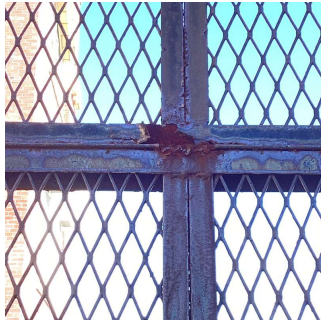
Question	Response
EXTERIOR	
ROOF	
Roofing	
ROOF CAGE	Inspected
Deficiency Photo1

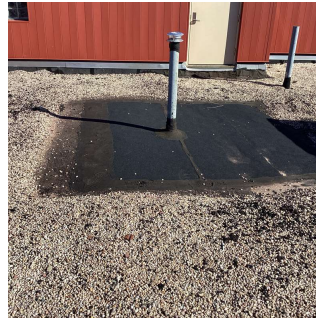
Violations	Plaza Deck No violations recorded.
ROOFING	
Instance on Built-Up: All Roofs	Inspected
Instance Condition	3 - Fair
Instance Photo	
Instance Quantity	Roof 1 12,800
Instance Quantity Uom	S.F.
Does the roof have major mechanical equipment sitting on Dunnage Steel less than 18" above the Roofing?	No
Does this roof instance have a Sustainable Roof System?	No
Do solar panels exist on these roofs?	No
Is/Are the roof(s) suitable for Solar Panel installation?	Yes
Installation Year	2008
Source of Installation	Custodial Staff
Deficiency	BUILT-UP: ROOFING: LOSS OF GRAVEL
Roof Plan reference	K192

Deficiency Quantity	130
Quantity Uom	S.F.
Potential Action	INSTALL NEW GRAVEL
Urgency of Action	PRIORITY 3
Purpose of Action	LEVEL 2

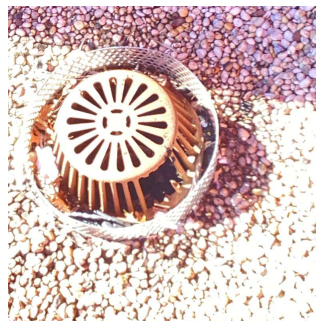
Roof 1

DETERIORATED

REPLACE

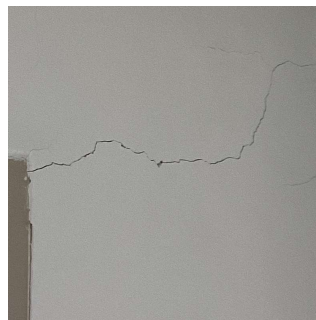
Auditorium PH

BULKHEAD/PENTHOUSE WALLS/INTERIOR: PLASTER
CRACKS/SPALLING

50
 S.F.
 REPLACE
 PRIORITY 3
 LEVEL 2

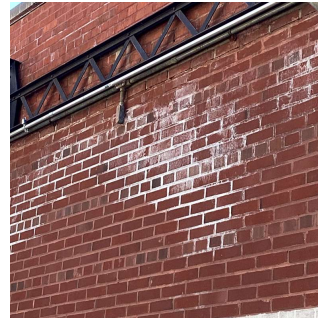
Auditorium PH

**BULKHEAD/PENTHOUSE WALLS/EXTERIOR:
 EFFLORESCENCE**

50
 S.F.
 MAINTENANCE
 PRIORITY 1
 LEVEL 1

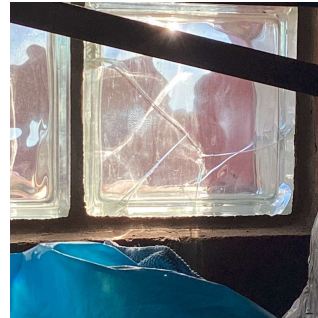
PH

Deficiency **BULKHEAD/PENTHOUSE WINDOWS: DAMAGED, DETERIORATED WINDOWS**

40
S.F.
REPLACE
PRIORITY 4
LEVEL 2

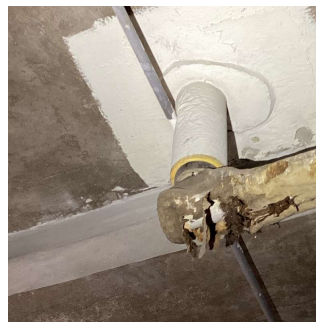
PH
No violations recorded.

BULKHEAD/PENTHOUSE ROOF: MAJOR LEAKAGE

100
S.F.
REPLACE
PRIORITY 5
LEVEL 2

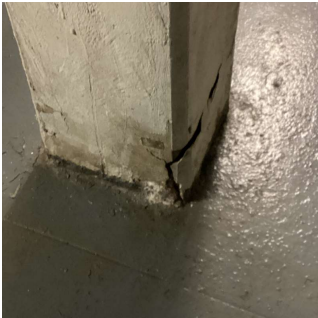
Question	Response
INTERIOR	
STRUCTURAL	Inspected
COLUMNS/BEAMS/BEARING WALLS	Inspected
Condition	4 - Between Fair and Poor
Deficiency	STEEL COLUMNS/BEAMS: DETERIORATED CONCRETE FIREPROOFING
Deficiency Location/Instance	Basement
Deficiency Quantity	30
Quantity Uom	S.F.
Potential Action	REPLACE
Urgency of Action	PRIORITY 4
Purpose of Action	LEVEL 5
Deficiency Photo1

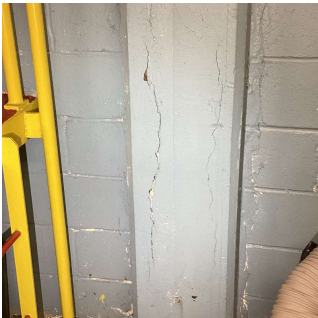
Violations	Basement Fan Area No violations recorded.
Deficiency	STEEL COLUMNS/BEAMS: DETERIORATED CONCRETE FIREPROOFING
Deficiency Location/Instance	Basement
Deficiency Quantity	85
Quantity Uom	S.F.
Potential Action	REPLACE
Urgency of Action	PRIORITY 3
Purpose of Action	LEVEL 5
Deficiency Photo1

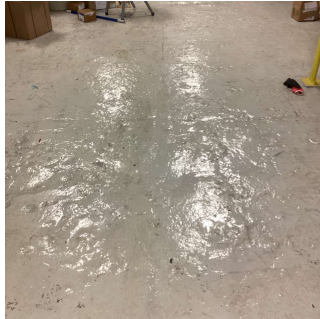
Violations	No violations recorded.
FLOOR STRUCTURE	
Condition	Inspected
Deficiency	4 - Between Fair and Poor
Deficiency Location/Instance	CONCRETE SLAB ON GRADE: THRU CRACKS
Deficiency Quantity	Basement
Quantity Uom	100
Potential Action	S.F.
Urgency of Action	REPAIR
Purpose of Action	PRIORITY 3
Deficiency Photo1	LEVEL 5

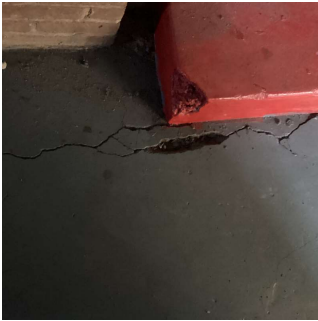
Violations	No violations recorded.
Deficiency	CONCRETE: CRACKS/SPALLED/REINFORCEMENT EXPOSED
Deficiency Location/Instance	PH
Deficiency Quantity	110
Quantity Uom	S.F.
Potential Action	REPAIR
Urgency of Action	PRIORITY 4
Purpose of Action	LEVEL 5

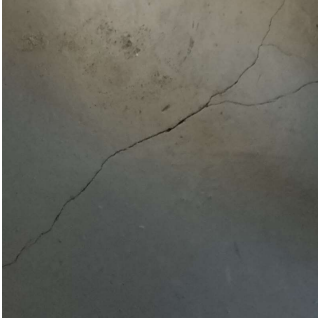
Violations	PH (Auditorium PH similar) No violations recorded.
Deficiency	CONCRETE: CRACKS/SPALLED/REINFORCEMENT EXPOSED
Deficiency Location/Instance	PH
Deficiency Quantity	170
Quantity Uom	S.F.
Potential Action	REPAIR
Urgency of Action	PRIORITY 3
Purpose of Action	LEVEL 5
Deficiency Photo1

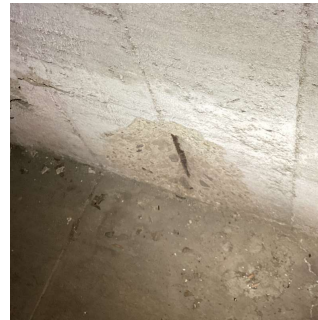
Vent Shaft Corridor

CONCRETE: CRACKED/SPALLED/REINFORCEMENT EXPOSED

REPAIR

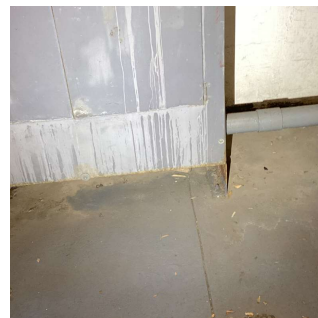
Electrical Panel Room

CONCRETE: WATER INFILTRATION IN ELECTRICAL PANEL ROOM

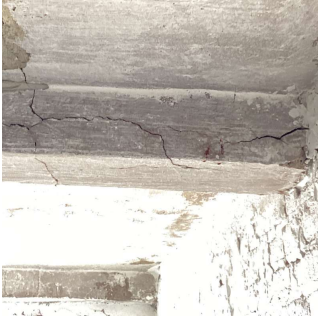
Question	Response
INTERIOR	
STRUCTURAL	
FOUNDATION WALLS	Inspected
Violations	No violations recorded.
ROOF STRUCTURE	Inspected
Condition	3 - Fair
Deficiency	STEEL COLUMNS/BEAMS: DETERIORATED CONCRETE FIREPROOFING
Deficiency Location/Instance	BH, PH
Deficiency Quantity	60
Quantity Uom	S.F.
Potential Action	REPLACE
Urgency of Action	PRIORITY 3
Purpose of Action	LEVEL 5
Deficiency Photo1

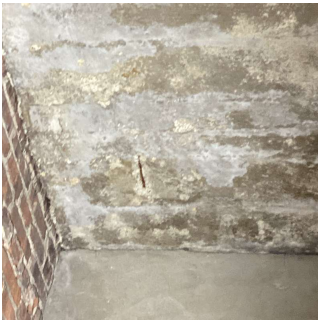
Violations	BH1 (Auditorium PH similar) No violations recorded.
Deficiency	CONCRETE: CRACKED/SPALLED/REINFORCEMENT EXPOSED
Deficiency Location/Instance	PH
Deficiency Quantity	70
Quantity Uom	S.F.
Potential Action	REPAIR
Urgency of Action	PRIORITY 3
Purpose of Action	LEVEL 5
Deficiency Photo1

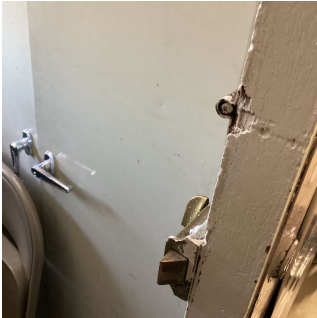
Question	Response
INTERIOR	
AUDITORIUM	
Ceiling	
Deficiency	No deficiencies recorded
Door(s)	
Instance on 2nd Floor (540 Seats)	Inspected
Condition	3 - Fair
Deficiency	WOOD: DETERIORATED DOOR
Deficiency Location/Instance	Storage Room
Deficiency Quantity	1
Quantity Uom	EACH
Potential Action	MAINTENANCE
Urgency of Action	PRIORITY 3
Purpose of Action	LEVEL 2
Deficiency Photo1

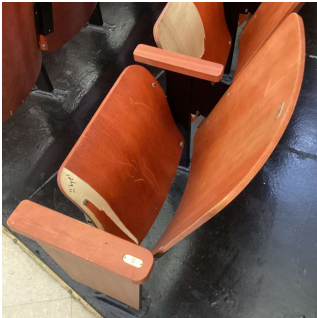
Storage Room
Violations	No violations recorded.
Fixed H/C Lift	
Instance on 2nd Floor (540 Seats)	Does not Exist
Fixed Seating	
Instance on 2nd Floor (540 Seats)	Inspected
Condition	3 - Fair
Deficiency	DAMAGED/BROKEN/INOPERABLE
Deficiency Location/Instance	Seats S/2,4, B/101, 102, 103 and others
Deficiency Quantity	20
Quantity Uom	EACH
Potential Action	REPLACE
Urgency of Action	PRIORITY 3
Purpose of Action	LEVEL 2
Deficiency Photo1

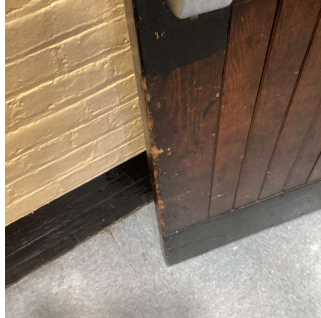
Question	Response
INTERIOR	
AUDITORIUM	Inspected
Window Curtains/Shades/Blinds	
Condition	2 - Between Good and Fair
Deficiency	No deficiencies recorded
CAFETERIA	Inspected
Instance on 1st Floor	Inspected
Ceiling	
Instance on 1st Floor	Does not Exist
Door(s)	
Instance on 1st Floor	Inspected
Condition	5 - Poor
Deficiency	WOOD: DETERIORATED DOOR
Deficiency Location/Instance	Entrance to Multi-Purpose Rooms East and West
Deficiency Quantity	4
Quantity Uom	EACH
Potential Action	MAINTENANCE
Urgency of Action	PRIORITY 3
Purpose of Action	LEVEL 2
Deficiency Photo1

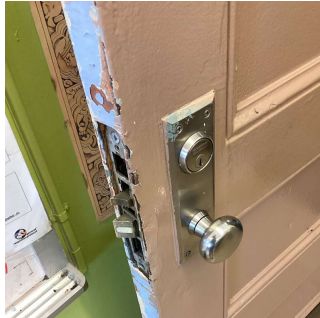
Violations	Room 512 No violations recorded.
Door(s)	
Condition	Inspected 5 - Poor
Deficiency	METAL CLAD WOOD: DETERIORATED DOOR
Deficiency Location/Instance	Rooms 511,509, 507, 505, 503 and others
Deficiency Quantity	7
Quantity Uom	EACH
Potential Action	MAINTENANCE
Urgency of Action	PRIORITY 3
Purpose of Action	LEVEL 2
Deficiency Photo1

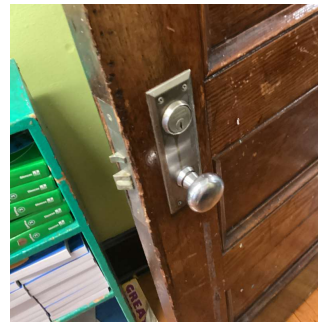
Room 512

Violations	Room 511 No violations recorded.
Deficiency	WOOD: DETERIORATED DOOR
Deficiency Location/Instance	Rooms 551,512,413 410B,305 and others
Deficiency Quantity	16
Quantity Uom	EACH
Potential Action	MAINTENANCE
Urgency of Action	PRIORITY 3
Purpose of Action	LEVEL 2

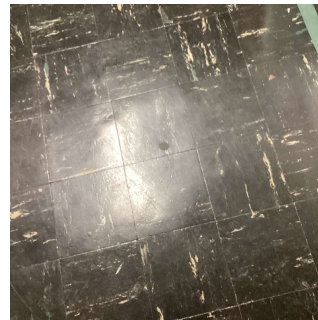
Corridor near room 502

VINYL TILES: BROKEN/DETERIORATED/MISSING TILES
Corridor near room 502, 506,509, 513, 551 Room 551
4,000
S.F.
REPLACE
PRIORITY 3
LEVEL 2

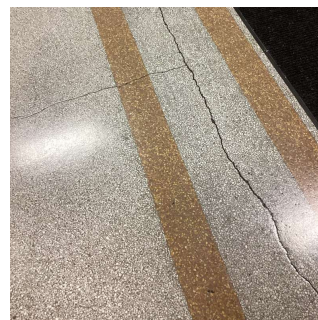
TERRAZZO: CRACKS
Main Entrance Vestibule, Lobby, Corridor near Auditorium,
150
S.F.
REPLACE
PRIORITY 3
LEVEL 2

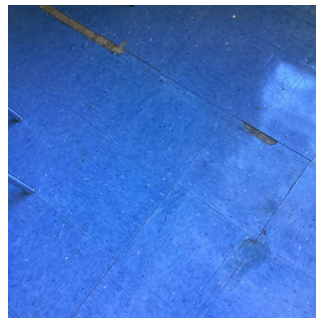
Along Windows

VINYL TILES: DETERIORATED SUBSTRATE

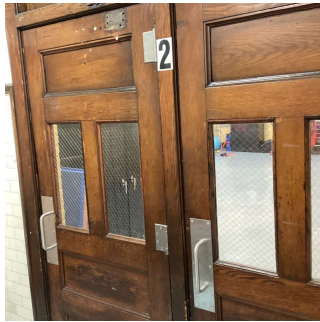
Violations	Exit 2 Vestibule No violations recorded.
Instance on 1st Floor - East	Inspected
Condition	4 - Between Fair and Poor
Deficiency	WOOD: DETERIORATED DOOR
Deficiency Location/Instance	Entrance (2 Doors)

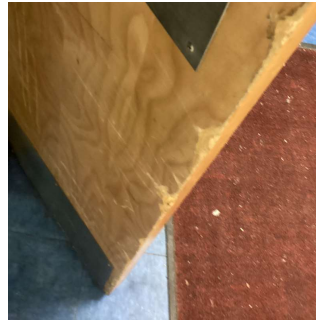
Violations	Stair E/1 Vestibule No violations recorded.
Door(s)	Inspected
Condition	5 - Poor
Deficiency	WOOD: DETERIORATED DOOR

Deficiency Location/Instance	Stair H/1 Vestibule (2 Doors)
Deficiency Quantity	2
Quantity Uom	EACH
Potential Action	MAINTENANCE
Urgency of Action	PRIORITY 3
Purpose of Action	LEVEL 2

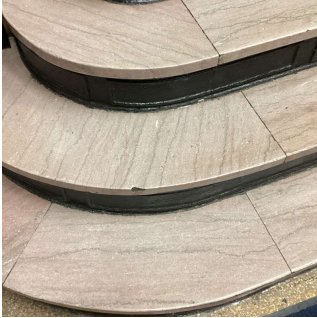
Question	Response
INTERIOR	
STAIRS/RAMPS: INTERIOR	
Partition	Inspected
	Stair G/4
Violations	No violations recorded.
Railings	Inspected
Condition	2 - Between Good and Fair
Deficiency	No deficiencies recorded
Stairs and Landings	Inspected
Condition	5 - Poor
Deficiency	STONE: BROKEN/MISSING
Deficiency Location/Instance	Lobby
Deficiency Quantity	20
Quantity Uom	S.F.
Potential Action	REPLACE
Urgency of Action	PRIORITY 3
Purpose of Action	LEVEL 2
Deficiency Photo1

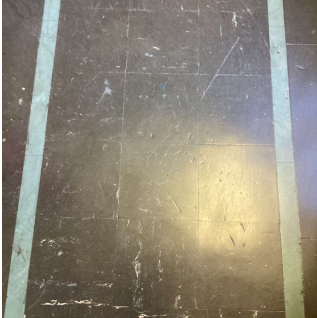
Violations	Lobby No violations recorded.
Deficiency	VINYL TILES: BROKEN/DETERIORATED/MISSING TILES
Deficiency Location/Instance	Stair D/5,4,3,2, E/2 and others
Deficiency Quantity	800
Quantity Uom	S.F.
Potential Action	REPLACE
Urgency of Action	PRIORITY 3
Purpose of Action	LEVEL 2
Deficiency Photo1

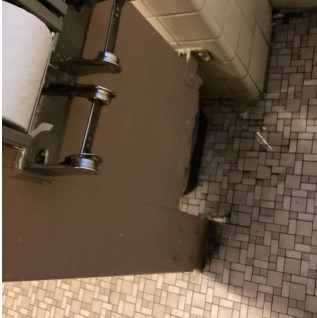
1st Floor Staff
Violations	No violations recorded.
Stalls	Inspected
Condition	5 - Poor
Deficiency	RUST - MAJOR
Deficiency Location/Instance	1st Floor Staff (Both Rooms),Kitchen Staff
Deficiency Quantity	3
Quantity Uom	EACH
Potential Action	REPLACE
Urgency of Action	PRIORITY 3
Purpose of Action	LEVEL 2
Deficiency Photo1

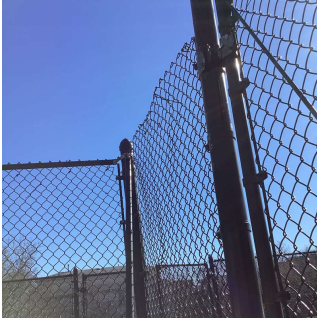
Violations	Schoolyard No violations recorded.
Deficiency	CHAIN LINK: DAMAGED POST/RAIL
Deficiency Location/Instance	47th Street

Question	Response
SITE	
FENCES	
Deficiency Quantity	10
Quantity Uom	L.F.
Potential Action	REPLACE
Urgency of Action	PRIORITY 3
Purpose of Action	LEVEL 2
Deficiency Photo1

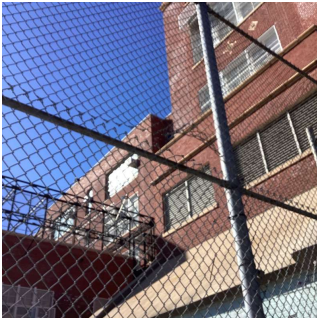
Violations	47th Street No violations recorded.
Deficiency	CHAIN LINK: DAMAGED/DETERIORATED
Deficiency Location/Instance	47th Street
Deficiency Quantity	100
Quantity Uom	S.F.
Potential Action	REPLACE
Urgency of Action	PRIORITY 3
Purpose of Action	LEVEL 2
Deficiency Photo1

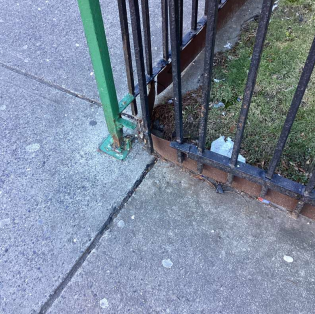
Violations	47th Street No violations recorded.
Deficiency	WROUGHT IRON: RUST - MAJOR
Deficiency Location/Instance	18th Street, 47th Street
Deficiency Quantity	80
Quantity Uom	S.F.
Potential Action	REPLACE
Urgency of Action	PRIORITY 3
Purpose of Action	LEVEL 2

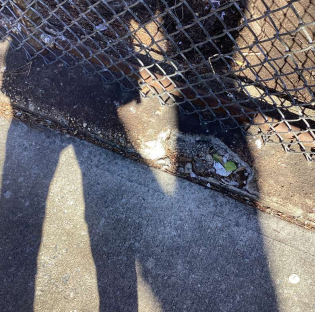
Violations	18th Street No violations recorded.
Deficiency	CONCRETE CURB: DAMAGED/DETERIORATED
Deficiency Location/Instance	48th Street, 47th Street
Deficiency Quantity	80
Quantity Uom	S.F.
Potential Action	REPLACE
Urgency of Action	PRIORITY 3
Purpose of Action	LEVEL 2
Deficiency Photo1

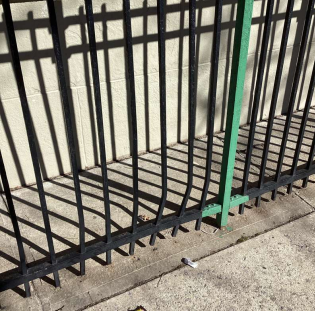
Violations	48th Street No violations recorded.
Deficiency	WROUGHT IRON: DAMAGED/DETERIORATED
Deficiency Location/Instance	48th Street, 47th Street, 18th Avenue
Deficiency Quantity	280
Quantity Uom	S.F.
Potential Action	REPLACE
Urgency of Action	PRIORITY 3
Purpose of Action	LEVEL 2
Deficiency Photo1

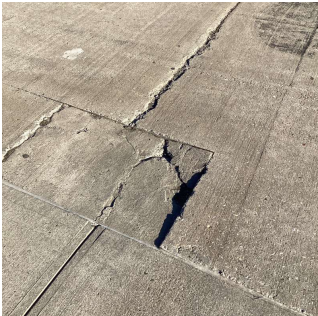
Schoolyard
Violations	No violations recorded.
Concrete	Inspected
Condition	3 - Fair
Deficiency	CRACKS - MAJOR
Deficiency Location/Instance	Near Exit 6
Deficiency Quantity	150
Quantity Uom	S.F.
Potential Action	REPLACE
Urgency of Action	PRIORITY 3
Purpose of Action	LEVEL 2
Deficiency Photo1

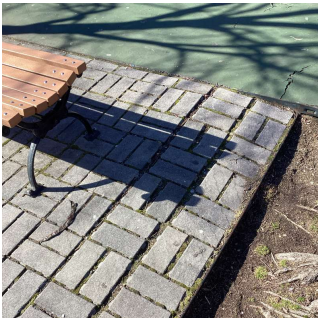
Question	Response
SITE	
PAVING	Inspected
Student Use	
Concrete	Inspected
	Near Exit 6
Violations	No violations recorded.
Pavers	
Condition	3 - Fair
Deficiency	DAMAGED/MISSING
Deficiency Location/Instance	Schoolyard
Deficiency Quantity	50
Quantity Uom	S.F.
Potential Action	REPLACE
Urgency of Action	PRIORITY 3
Purpose of Action	LEVEL 2
Deficiency Photo1

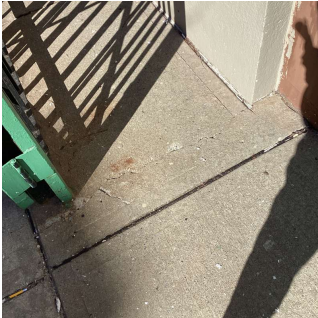
Violations	Schoolyard No violations recorded.
Site Sidewalks & Walkways	
	Inspected
Asphalt	
	Does not Exist
Concrete	
Condition	3 - Fair
Deficiency	CRACKS - MAJOR
Deficiency Location/Instance	Exit on 48th Street
Deficiency Quantity	50
Quantity Uom	S.F.
Potential Action	REPLACE
Urgency of Action	PRIORITY 3
Purpose of Action	LEVEL 2
Deficiency Photo1
