**NYC Department of Education**  
**Building Condition Assessment Survey 2023 - 2024**

Architectural Inspection

**K193**

**Asset: P.S. 193 - BROOKLYN, 2515 AVENUE L, New York, 11210**

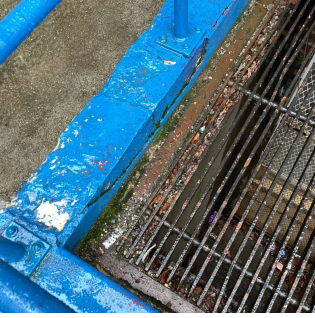
Question	Response
<b>Architectural</b>	
<b>EXTERIOR</b>	Inspected
<b>AREAWAY</b>	Inspected
Instance on AW1 - AW4	Inspected
Instance Condition	3 - Fair
Instance Quantity	4
Instance Quantity Uom	EACH
Deficiency	AREAWAY WALLS: CRACKS AND SPALLING
Roof Plan reference

Deficiency Quantity	20
Quantity Uom	S.F.
Potential Action	REPLACE
Urgency of Action	PRIORITY 4
Purpose of Action	LEVEL 2
Deficiency Photo1

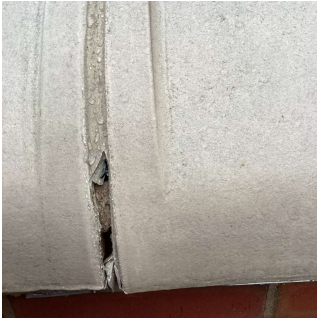
TERRA COTTA: DETERIORATED TRANSVERSE JOINTS

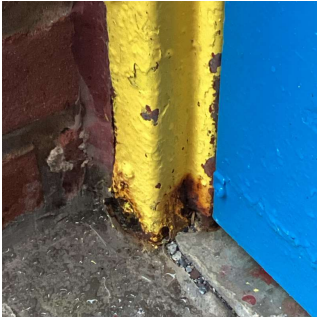
Violations	Facade J No violations recorded.
<b>DOOR HARDWARE</b>	
Condition	Inspected
Deficiency	3 - Fair No deficiencies recorded

Violations	Roof 2 No violations recorded.
<b>CORNICE</b>	
Condition	Inspected
Deficiency	2 - Between Good and Fair No deficiencies recorded
<b>DOORS</b>	
<b>DOORS AND FRAMES</b>	
Condition	Inspected
Deficiency	4 - Between Fair and Poor METAL: DETERIORATED DOOR AND FRAME - MAJOR DETERIORATION
Roof Plan reference

Deficiency Quantity	2
Quantity Uom	EACH
Potential Action	REPLACE
Urgency of Action	PRIORITY 4
Purpose of Action	LEVEL 2
Deficiency Photo1

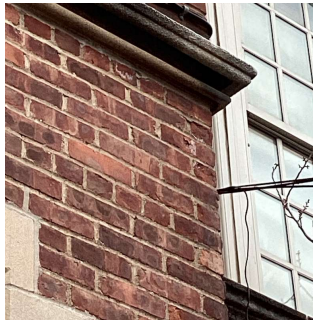
Facade A

**BRICK: CRACKS/DISPLACED/SPALLED BRICK AT BUILDING CORNERS**

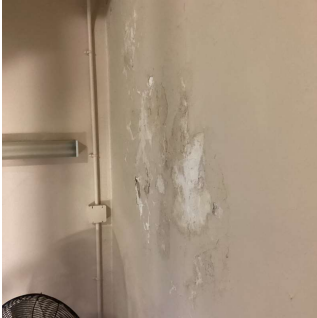
**BRICK: WATER INFILTRATION IN INSTRUCTIONAL SPACE**

Question	Response
<b>EXTERIOR</b>	
<b>EXTERIOR WALLS</b>	
Urgency of Action	PRIORITY 5
Purpose of Action	LEVEL 2
Deficiency Photo1

Facade H - Stair I/2 (shown), Facade A - Room 503, Facade D - Room 502, Facade G - Room 506
Violations	No violations recorded.
Deficiency	<b>BRICK: EFFLORESCENCE</b>
Roof Plan reference	<p>K193</p>

REPAIR

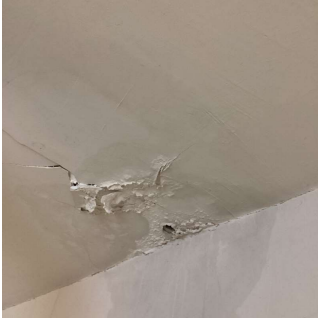
BH2
Violations	No violations recorded.
Deficiency	<b>BULKHEAD/PENTHOUSE WALLS/INTERIOR: PLASTER CRACKS/SPALLING</b>

PH1
Violations	No violations recorded.
Deficiency	<b>BULKHEAD/PENTHOUSE CEILING: PLASTER DAMAGED/DETERIORATED</b>
Roof Plan reference

Deficiency Quantity	20
Quantity Uom	S.F.
Potential Action	REPLACE
Urgency of Action	PRIORITY 4
Purpose of Action	LEVEL 2
Deficiency Photo1

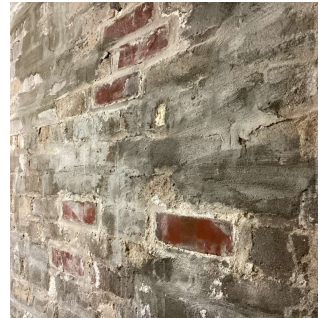
BH2

Deficiency **BULKHEAD/PENTHOUSE WALLS/INTERIOR: BRICK CRACKS/SPALLING**

60  
S.F.  
REPLACE  
PRIORITY 3  
LEVEL 2

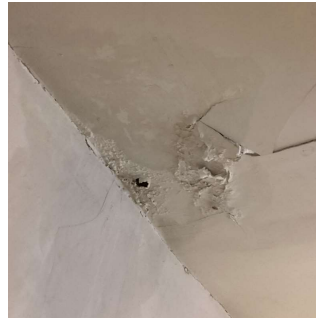
BH2

**BULKHEAD/PENTHOUSE WALLS/EXTERIOR: WATER INFILTRATION**

100  
 S.F.  
 REPAIR  
 PRIORITY 5  
 LEVEL 2

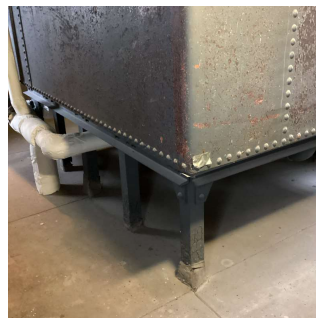
PH1

TANK: NOT IN USE - MINOR DETERIORATION

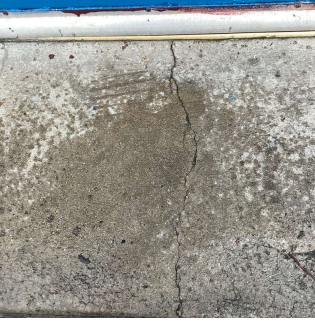
<p>Facade A</p>
Deficiency Quantity	
Quantity Uom	
Potential Action	
Urgency of Action	
Purpose of Action	
Deficiency Photo1	
Violations	No violations recorded.

Question	Response
<b>EXTERIOR</b>	
<b>ROOF</b>	Inspected
<b>Specialties</b>	Inspected
<b>ROOF/GRAVITY TANK</b>	
Violations	No violations recorded.
<b>STAIRS/RAMPS: EXTERIOR</b>	Inspected
<b>BUILDING CHEEK/FLANK WALLS</b>	Does not Exist
<b>RAILINGS</b>	Does not Exist
<b>STAIRS/RAMPS</b>	Inspected
Condition	4 - Between Fair and Poor
Deficiency	<b>CONCRETE: CRACKS/SPALLING - MINOR</b>
Roof Plan reference

<p>K193</p> <p>10 S.F. REPAIR PRIORITY 3 LEVEL 2</p>

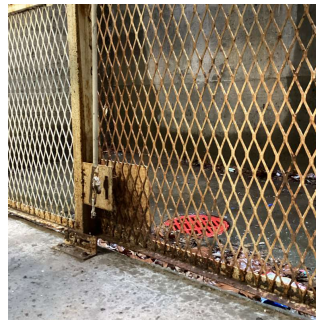
Facade E  
No violations recorded.

Facade M
Violations	No violations recorded.
<b>WINDOWS</b>	Inspected
Replacement Quantity	15,000
Replacement Uom	S.F.
<b>EXTERIOR GUARDS</b>	Inspected
Condition	3 - Fair
Deficiency	RUST - MAJOR

30  
S.F.  
REPLACE  
PRIORITY 4  
LEVEL 2

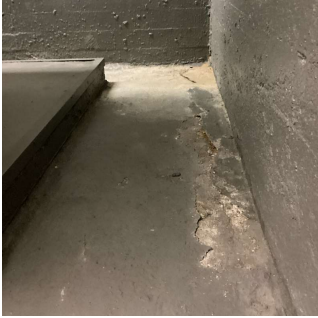
Condition	4 - Between Fair and Poor
Deficiency	CONCRETE SLAB ON GRADE: WATER INFILTRATION IN NON-INSTRUCTIONAL SPACE
Deficiency Location/Instance	Basement - Oil Tank Room
Deficiency Quantity	100
Quantity Uom	S.F.

Basement - Oil Tank Room
Violations	No violations recorded.
Deficiency	CONCRETE SLAB ON GRADE: THRU CRACKS
Deficiency Location/Instance	Basement - Boiler Room
Deficiency Quantity	30
Quantity Uom	S.F.
Potential Action	REPLACE
Urgency of Action	PRIORITY 4
Purpose of Action	LEVEL 5
Deficiency Photo1

Question	Response
<b>INTERIOR</b>	
<b>STRUCTURAL</b>	
<b>FLOOR STRUCTURE</b>	
Potential Action	INSTALL WATERPROOFING
Urgency of Action	PRIORITY 5
Purpose of Action	LEVEL 5
Deficiency Photo1

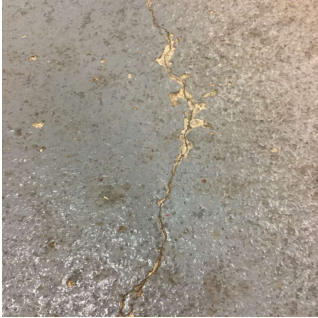
Basement - Boiler Room
Violations	No violations recorded.
Deficiency	CONCRETE: CRACKS/SPALLED/REINFORCEMENT EXPOSED
Deficiency Location/Instance	Basement - Oil Tank Room, Boiler Room
Deficiency Quantity	30
Quantity Uom	S.F.
Potential Action	REPAIR
Urgency of Action	PRIORITY 4
Purpose of Action	LEVEL 5

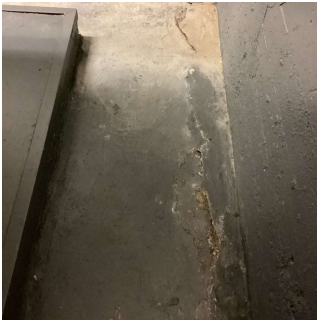
<p>Basement - Oil Tank Room</p> <p>No violations recorded.</p>
Violations	
<b>FOUNDATION WALLS</b>	
Material Type(s)	Inspected Concrete, Masonry
Condition	5 - Poor
Deficiency	BRICK: CRACKED/SPALLED
Deficiency Location/Instance	Basement - Fan Room West
Deficiency Quantity	30
Quantity Uom	S.F.
Potential Action	RESTITCH
Urgency of Action	PRIORITY 4
Purpose of Action	LEVEL 5
Deficiency Photo1

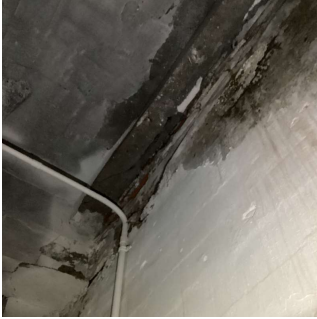
<p>Basement - Fan Room West</p> <p>No violations recorded.</p>
Violations	
Deficiency	CONCRETE: WATER INFILTRATION IN ELECTRICAL PANEL ROOM
Deficiency Location/Instance	Basement - Electrical Room
Deficiency Quantity	100
Quantity Uom	S.F.
Potential Action	INSTALL WATERPROOFING
Urgency of Action	PRIORITY 5
Purpose of Action	LEVEL 6

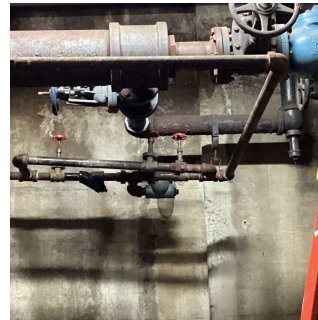
Basement - Blower Room

**CONCRETE: CRACKED/SPALLED/REINFORCEMENT EXPOSED**

REPAIR

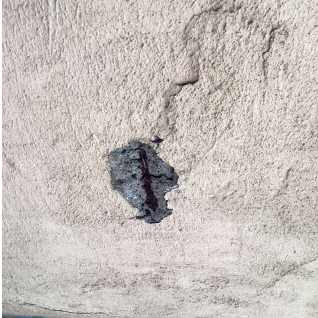
Question	Response
<b>INTERIOR</b>	
<b>STRUCTURAL</b>	
<b>FOUNDATION WALLS</b>	Inspected
	Basement - Gas Meter Room
Violations	No violations recorded.
<b>ROOF STRUCTURE</b>	Inspected
Condition	3 - Fair
Deficiency	CONCRETE: CRACKED/SPALLED/REINFORCEMENT EXPOSED
Deficiency Location/Instance	BH2
Deficiency Quantity	10
Quantity Uom	S.F.
Potential Action	REPAIR
Urgency of Action	PRIORITY 4
Purpose of Action	LEVEL 5
Deficiency Photo1

Violations	BH2 No violations recorded.
<b>VAULTS-BUNKERS</b>	Inspected
<b>Foundation Walls</b>	Inspected
Condition	4 - Between Fair and Poor
Deficiency	CRACKS, SPALLING
Deficiency Location/Instance	Basement - Vault
Deficiency Quantity	20
Quantity Uom	S.F.
Potential Action	REPAIR
Urgency of Action	PRIORITY 4
Purpose of Action	LEVEL 5
Deficiency Photo1

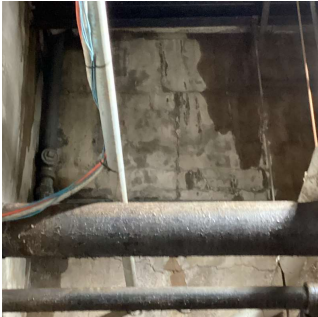
Violations	Basement - Vault No violations recorded.
Deficiency	WATER INFILTRATION IN NON- INSTRUCTIONAL SPACE
Deficiency Location/Instance	Basement - Vault

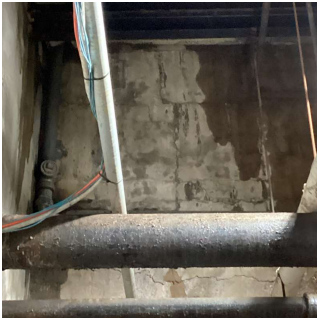
Violations	Basement - Vault No violations recorded.
<b>Slab Structure</b>	Inspected
Condition	4 - Between Fair and Poor
Deficiency	CONCRETE: WATER INFILTRATION IN NON- INSTRUCTIONAL SPACE
Deficiency Location/Instance	Basement - Vault
Deficiency Quantity	100
Quantity Uom	S.F.
Potential Action	INSTALL WATERPROOFING
Urgency of Action	PRIORITY 5
Purpose of Action	LEVEL 5
Deficiency Photo1

Question	Response
<b>INTERIOR</b>	
<b>STRUCTURAL</b>	
<b>VAULTS-BUNKERS</b>	
<b>Foundation Walls</b>	
Quantity Uom	S.F.
Potential Action	INSTALL WATERPROOFING
Urgency of Action	PRIORITY 5
Purpose of Action	LEVEL 5
Deficiency Photo1

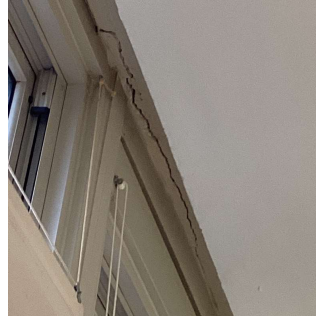
Room 513

PLASTER: CRACKS/SPALLING

REPLACE

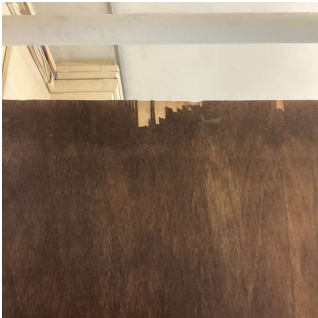
Question	Response
<b>INTERIOR</b>	
<b>CLASSROOMS/CORRIDORS/ADMIN SPACES</b>	
<b>Door(s)</b>	
Violations	Room 511 No violations recorded.
Deficiency	WOOD: DETERIORATED DOOR
Deficiency Location/Instance	Rooms 302, 413, 506, 510, Corridor near Room 205 and others
Deficiency Quantity	20
Quantity Uom	EACH
Potential Action	MAINTENANCE
Urgency of Action	PRIORITY 3
Purpose of Action	LEVEL 2
Deficiency Photo1

Violations	Rom 413 No violations recorded.
<b>Floor Finish</b>	Inspected
Condition	2 - Between Good and Fair
Deficiency	TERRAZZO: CRACKS
Deficiency Location/Instance	Main Entrance Lobby, Main Entrance Vestibule, Corridor near Rooms 205, 209, near Auditorium
Deficiency Quantity	300
Quantity Uom	S.F.
Potential Action	REPLACE
Urgency of Action	PRIORITY 3
Purpose of Action	LEVEL 2
Deficiency Photo1

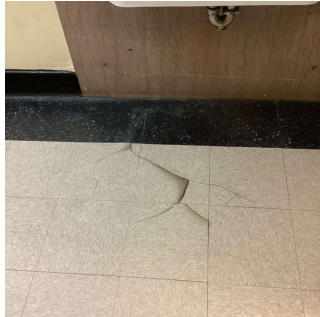
Violations	Main Entrance Lobby, Main Entrance Vestibule No violations recorded.
Deficiency	VINYL TILES: DETERIORATED SUBSTRATE

Deficiency Location/Instance	Rooms 205, 413, Corridor near Rooms 303, 412, 553 and others
Deficiency Quantity	400
Quantity Uom	S.F.
Potential Action	REPLACE
Urgency of Action	PRIORITY 3

Violations	Corridor near Room 412 No violations recorded.
Deficiency	VINYL TILES: BROKEN/DETERIORATED/MISSING TILES
Deficiency Location/Instance	Room 351
Deficiency Quantity	200
Quantity Uom	S.F.
Potential Action	REPLACE
Urgency of Action	PRIORITY 3
Purpose of Action	LEVEL 2
Deficiency Photo1	 
Violations	Room 351 No violations recorded.
<b>Walls</b>	Inspected
Condition	2 - Between Good and Fair
Deficiency	PLASTER: CRACKS/SPALLING
Deficiency Location/Instance	Rooms 402, 506, 513
Deficiency Quantity	30
Quantity Uom	S.F.
Potential Action	REPLACE
Urgency of Action	PRIORITY 3
Purpose of Action	LEVEL 2

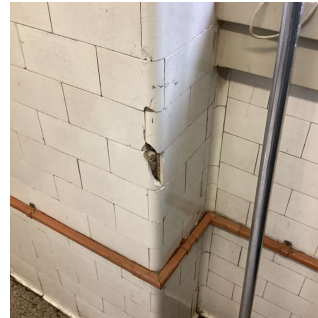
Room 413

CERAMIC TILE: BROKEN/ MISSING

REPLACE

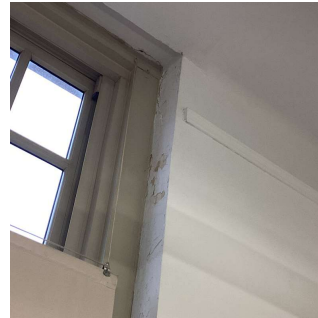
Room 504

PLASTER: CRACKS/SPALLING - ACTIVE LEAK

REPLACE

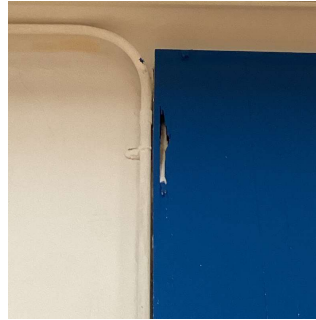
Condition	5 - Poor
Deficiency	DAMAGED/MISSING
Deficiency Location/Instance	Near office
Deficiency Quantity	1
Quantity Uom	EACH
Potential Action	REPLACE
Urgency of Action	PRIORITY 3
Purpose of Action	LEVEL 2
Deficiency Photo1

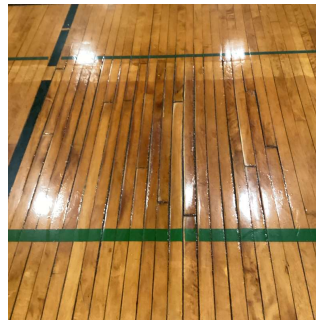
East Side

Condition	3 - Fair
Deficiency	WOOD: DAMAGED/DETERIORATED
Deficiency Location/Instance	East Side, Near windows
Deficiency Quantity	50
Quantity Uom	S.F.
Potential Action	REPLACE
Urgency of Action	PRIORITY 3
Purpose of Action	LEVEL 2
Deficiency Photo1

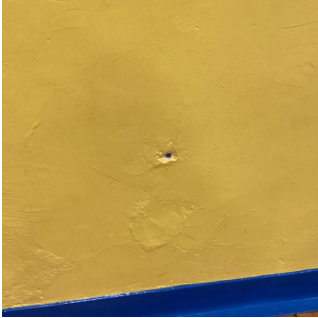
Question	Response
<b>INTERIOR</b>	
<b>GYMNASIUM</b>	
<b>Walls</b>	
Instance on 3rd Floor (1,200 S.F.)	Inspected
Condition	2 - Between Good and Fair
Deficiency	PLASTER: CRACKS/SPALLING
Deficiency Location/Instance	Near entrance
Deficiency Quantity	10
Quantity Uom	S.F.
Potential Action	REPLACE
Urgency of Action	PRIORITY 3
Purpose of Action	LEVEL 2
Deficiency Photo1

Violations	Near entrance No violations recorded.
<b>Window Curtains/Shades/Blinds</b>	
Instance on 3rd Floor (1,200 S.F.)	Does not Exist
<b>INTERIOR DOOR HARDWARE</b>	
Condition	Inspected 3 - Fair
Deficiency	No deficiencies recorded
<b>INTERIOR GUARDS</b>	
Condition	Inspected 2 - Between Good and Fair
Deficiency	No deficiencies recorded
<b>KITCHEN</b>	
Instance on 1st Floor	Inspected
<b>Ceiling</b>	
Instance on 1st Floor	Inspected
Condition	2 - Between Good and Fair
Deficiency	No deficiencies recorded
<b>Door(s)</b>	
Instance on 1st Floor	Inspected
Condition	3 - Fair

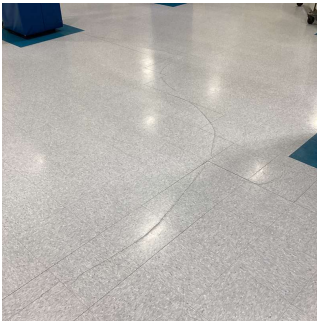
Near Room 173
Violations	No violations recorded.
<b>Floor Finish</b>	
Instance on 1st Floor - West	Inspected
Condition	3 - Fair
Deficiency	VINYL TILES: DETERIORATED SUBSTRATE
Deficiency Location/Instance	Center, near Entrance, near Room 172, near Stair BC, near windows
Deficiency Quantity	200
Quantity Uom	S.F.
Potential Action	REPLACE
Urgency of Action	PRIORITY 3
Purpose of Action	LEVEL 2

Center
Violations	No violations recorded.
Instance on 1st Floor - East	Inspected
Condition	4 - Between Fair and Poor
Deficiency	VINYL TILES: DETERIORATED SUBSTRATE
Deficiency Location/Instance	Center, near Entrance, near drinking fountain, near Room 188
Deficiency Quantity	300
Quantity Uom	S.F.
Potential Action	REPLACE
Urgency of Action	PRIORITY 3
Purpose of Action	LEVEL 2
Deficiency Photo1

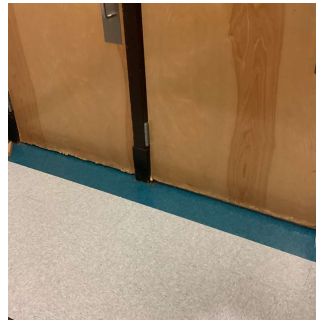
Stair BC/Vestibule

WOOD: DETERIORATED DOOR  
 Stair BC/Vestibule, D/Vestibule, FG/Vestibule, H/1, I/1  
 10  
 EACH  
 MAINTENANCE  
 PRIORITY 3  
 LEVEL 2

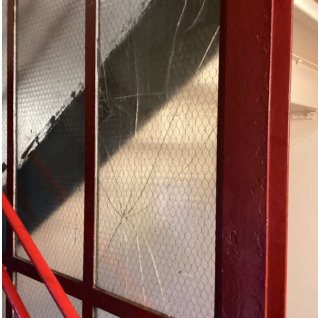
GLASS PANEL: DAMAGED/DETERIORATED

<b>Question</b>	<b>Response</b>
<b>INTERIOR</b>	
<b>STAIRS/RAMPS: INTERIOR</b>	
<b>Partition</b>	
Deficiency Location/Instance	Stairs BC/2, 3, FG/2, 4
Deficiency Quantity	25
Quantity Uom	S.F.
Potential Action	REPLACE
Urgency of Action	PRIORITY 3
Purpose of Action	LEVEL 2
Deficiency Photo1

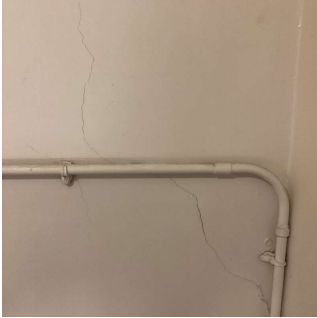
Question	Response
<b>INTERIOR</b>	
<b>STAIRS/RAMPS: INTERIOR</b>	
<b>Walls</b>	Inspected
Condition	2 - Between Good and Fair
Deficiency	PLASTER: CRACKS/SPALLING
Deficiency Location/Instance	Stair E/Vestibule, FG/4, H/3, I/3
Deficiency Quantity	30
Quantity Uom	S.F.
Potential Action	REPLACE
Urgency of Action	PRIORITY 3
Purpose of Action	LEVEL 2
Deficiency Photo1

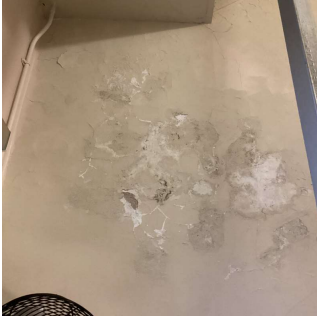
Stair I/3
Violations	No violations recorded.
Deficiency	PLASTER: CRACKS/SPALLING - ACTIVE LEAK
Deficiency Location/Instance	Stair I/2
Deficiency Quantity	50
Quantity Uom	S.F.
Potential Action	REPLACE
Urgency of Action	PRIORITY 5
Purpose of Action	LEVEL 2
Deficiency Photo1

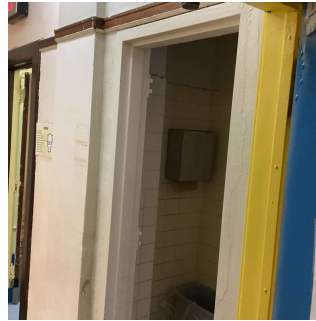
Violations	Room 251 No violations recorded.
<b>TOILET ROOMS - STUDENTS</b>	
<b>Ceiling</b>	Inspected
Condition	2 - Between Good and Fair
Deficiency	No deficiencies recorded
<b>Door(s)</b>	Inspected
Condition	5 - Poor
Deficiency	WOOD: MISSING DOOR
Deficiency Location/Instance	3rd Floor Boys
Deficiency Quantity	1
Quantity Uom	EACH
Potential Action	MAINTENANCE

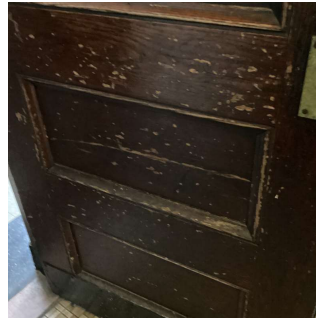
5th Floor Boys

WOOD: DETERIORATED DOOR

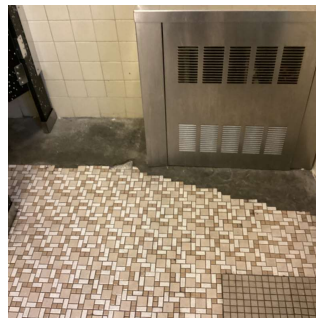
CERAMIC TILE: BROKEN/MISSING TILES

REPLACE

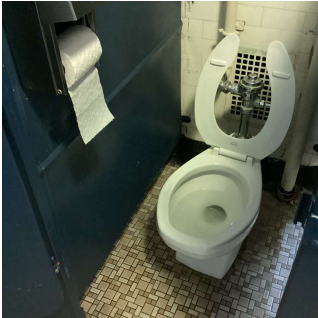
<b>Question</b>	<b>Response</b>
<b>INTERIOR</b>	
<b>TOILET ROOMS - STUDENTS</b>	
<b>Floor Finish</b>	Inspected
	3rd Floor Boys
Violations	No violations recorded.
<b>Stalls</b>	Inspected
Condition	5 - Poor
Deficiency	RUST - MAJOR
Deficiency Location/Instance	5th Floor Boys
Deficiency Quantity	3
Quantity Uom	EACH
Potential Action	REPLACE
Urgency of Action	PRIORITY 3
Purpose of Action	LEVEL 2
Deficiency Photo1

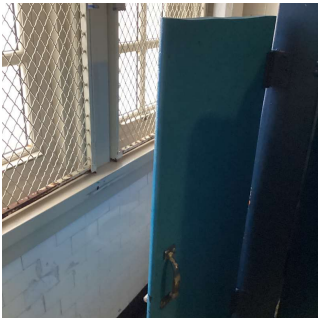
5th Floor Boys
Violations	No violations recorded.
Deficiency	BROKEN/MISSING
Deficiency Location/Instance	5th Floor Boys
Deficiency Quantity	1
Quantity Uom	EACH
Potential Action	REPLACE
Urgency of Action	PRIORITY 3
Purpose of Action	LEVEL 2
Deficiency Photo1

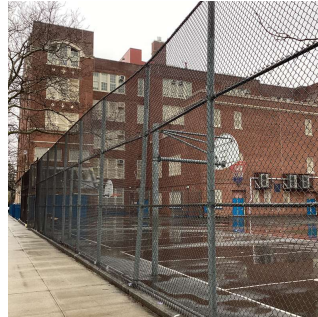
Deficiency Photo1	 
Violations	East 26th Street No violations recorded.
Deficiency	CHAIN LINK: DAMAGED POST/RAIL
Deficiency Location/Instance	East 26th Street2
Deficiency Quantity	20
Quantity Uom	L.F.

REPLACE  
PRIORITY 3  
LEVEL 2

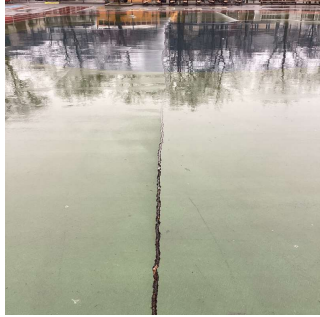
<b>Question</b>	<b>Response</b>
<b>SITE</b>	
<b>PAVING</b>	Inspected
<b>Student Use</b>	
Gravel Exists?	No
<b>Asphalt</b>	Inspected
Condition	4 - Between Fair and Poor
Deficiency	CRACKS - MAJOR
Deficiency Location/Instance	Schoolyard
Deficiency Quantity	2,000
Quantity Uom	S.F.
Potential Action	REPLACE
Urgency of Action	PRIORITY 3
Purpose of Action	LEVEL 2
Deficiency Photo1

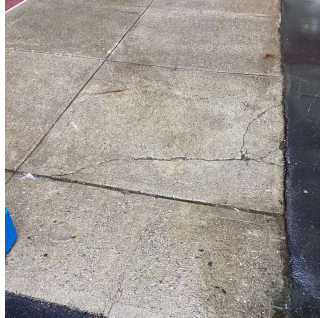
Center of schoolyard
Violations	No violations recorded.
<b>Concrete</b>	Inspected
Condition	2 - Between Good and Fair
Deficiency	DAMAGED/DETERIORATED/MISSING SECTIONS
Deficiency Location/Instance	West Courtyard
Deficiency Quantity	25
Quantity Uom	S.F.
Potential Action	REPLACE
Urgency of Action	PRIORITY 3
Purpose of Action	LEVEL 2
Deficiency Photo1

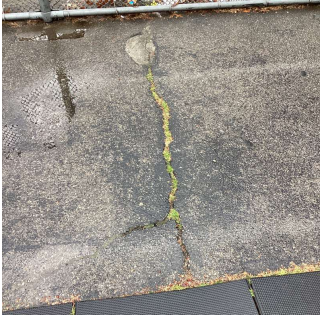
<b>Question</b>	<b>Response</b>
<b>SITE</b>	
<b>PLAYGROUNDS</b>	
<b>Pavement</b>	
Violations	East side of playground No violations recorded.
Instance on Playground West	Inspected
Condition	3 - Fair
Deficiency	ASPHALT: CRACKS - MAJOR
Deficiency Location/Instance	East, North and South side of playground
Deficiency Quantity	50
Quantity Uom	S.F.
Potential Action	REPLACE
Urgency of Action	PRIORITY 3
Purpose of Action	LEVEL 2
Deficiency Photo1
