NYC Department of Education
Building Condition Assessment Survey 2023 - 2024

Architectural Inspection

Asset: P.S. 195 - BROOKLYN, 131 IRWIN STREET, New York, 11235

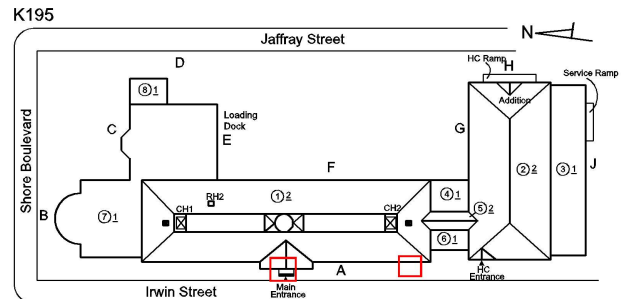
Roof Plan reference

Question	Response
Architectural	
EXTERIOR	Inspected
AREAWAY	Does not Exist
AWNINGS AND CANOPIES	Does not Exist
CHIMNEY	Under Construction
COPING	Under Construction
CORNICE	Under Construction
DOORS	Inspected
DOORS AND FRAMES	Inspected
Condition	5 - Poor

METAL CLAD: DETERIORATED DOOR AND FRAME - MAJOR DETERIORATION

Deficiency Quantity	4
Quantity Uom	EACH
Potential Action	REPLACE
Urgency of Action	PRIORITY 4
Purpose of Action	LEVEL 2
Deficiency Photo1

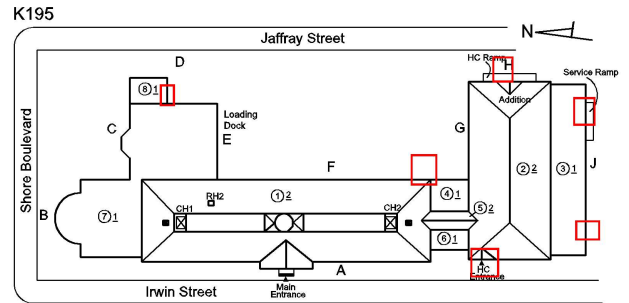
Roof Plan reference

Deficiency METAL: DETERIORATED DOOR AND FRAME - MAJOR DETERIORATION

Deficiency Quantity	10
Quantity Uom	EACH
Potential Action	REPLACE
Urgency of Action	PRIORITY 4
Purpose of Action	LEVEL 2
Deficiency Photo1

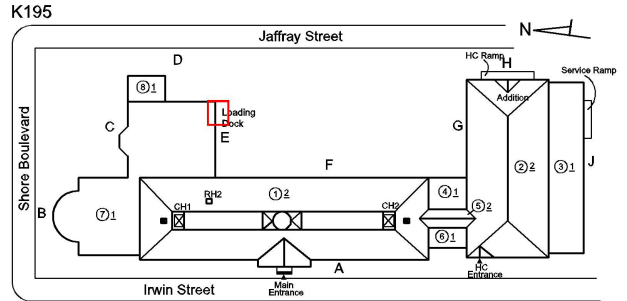
Roof Plan reference

Violations	Loading Dock No violations recorded.
Deficiency	CHEEK WALL/CRACKS, SPALLING - MAJOR

LOADING DOCK

40
S.F.
REPLACE
PRIORITY 4
LEVEL 2

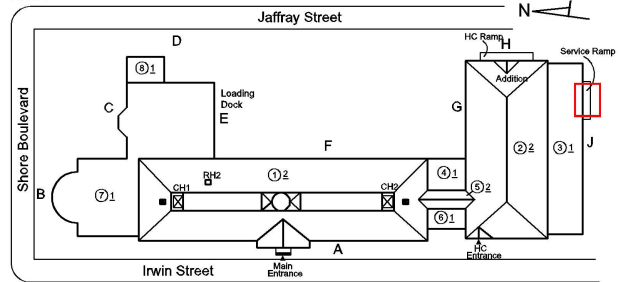
ROOF/GRAVITY TANK	Does not Exist
STAIRS/RAMPS: EXTERIOR	Inspected
BUILDING CHEEK/FLANK WALLS	Inspected
Condition	3 - Fair
Deficiency	CAST IN PLACE CONCRETE: CRACKS/SPALLING - MINOR
Roof Plan reference	K195

Deficiency Quantity	60
Quantity Uom	S.F.

Question	Response
EXTERIOR	
STAIRS/RAMPS: EXTERIOR	
BUILDING CHEEK/FLANK WALLS	
Potential Action	REPAIR
Urgency of Action	PRIORITY 3
Purpose of Action	LEVEL 2
Deficiency Photo1

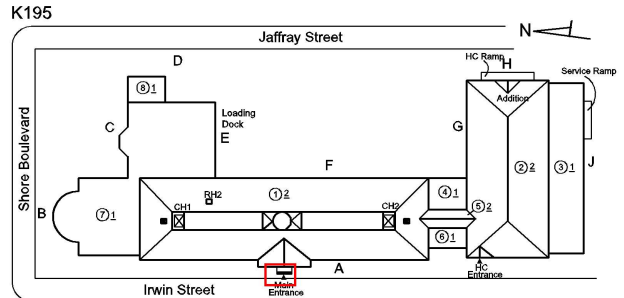
Roof Plan reference

STONE: CRACKS/SPALLING - MAJOR

20
 S.F.
 REPLACE
 PRIORITY 4
 LEVEL 2

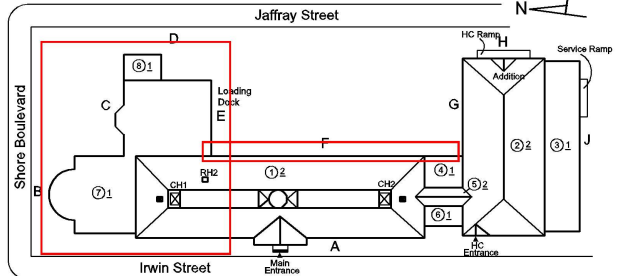
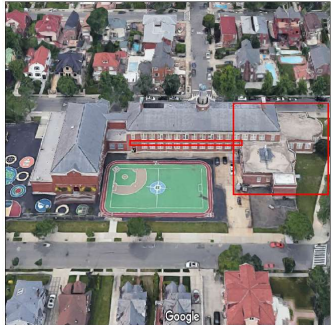
Violations	Facade A - Main Entrance No violations recorded.
WINDOWS	Inspected
Replacement Quantity	6,900
Replacement Uom	S.F.
EXTERIOR GUARDS	Inspected
Condition	5 - Poor
Deficiency	RUST - MAJOR
Roof Plan reference	K195
Elevation

Deficiency Quantity	800
Quantity Uom	S.F.
Potential Action	REPLACE
Urgency of Action	PRIORITY 4
Purpose of Action	LEVEL 2

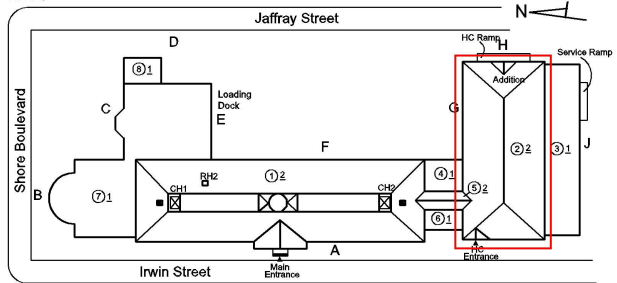
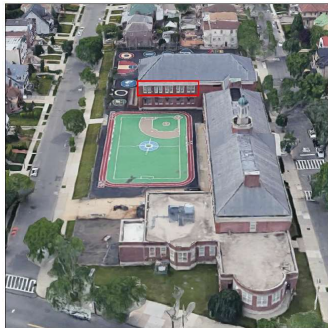
Violations	Facade D No violations recorded.
LINTELS	Inaccessible
WINDOWS	Inspected
Material Type(s)	Solid Wood, Steel
Instance on Wood: 1992 Addition	Inspected
Instance Condition	5 - Poor
Instance Quantity	2,500
Instance Quantity Uom	S.F.
Are these windows insulated	No
Installation Year	1992
Source of Installation	Custodial Staff
Deficiency	WOOD: DETERIORATED
Roof Plan reference	K195
Elevation

Deficiency Quantity	2,500
Quantity Uom	S.F.
Potential Action	REPLACE WINDOW
Urgency of Action	PRIORITY 4
Purpose of Action	LEVEL 2

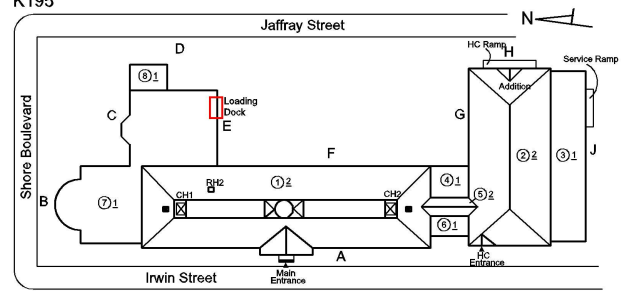
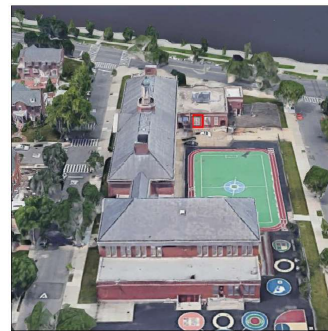
STEEL: DETERIORATED

REPLACE WINDOW

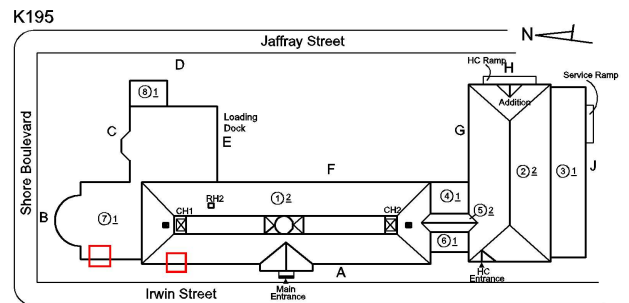
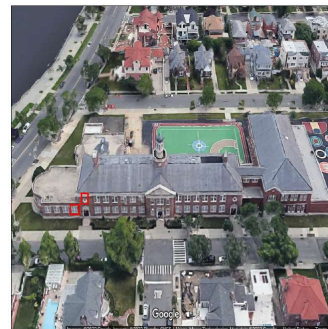
Instance on Wood: Original Building	Inspected
Instance Condition	3 - Fair
Instance Quantity	4,300
Instance Quantity Uom	S.F.
Are these windows insulated	No
Installation Year	2004
Source of Installation	Custodial Staff

Deficiency	WOOD: BROKEN PANE
------------	-------------------

Deficiency Quantity	60
Quantity Uom	S.F.
Potential Action	MAINTENANCE
Urgency of Action	PRIORITY 3
Purpose of Action	LEVEL 2

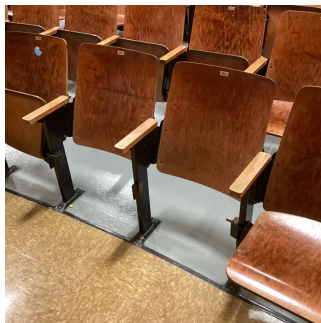
Question	Response
INTERIOR	
STRUCTURAL	
FLOOR STRUCTURE	Inspected
	Room 128
Violations	No violations recorded.
FOUNDATION WALLS	Inspected
Material Type(s)	Concrete
Condition	2 - Between Good and Fair
Deficiency	No deficiencies recorded
ROOF STRUCTURE	Inspected
Condition	2 - Between Good and Fair
Deficiency	No deficiencies recorded
VAULTS-BUNKERS	Does not Exist
AUDITORIUM	Inspected
Instance on 1st Floor	Inspected
Ceiling	
Instance on 1st Floor	Inspected
Condition	2 - Between Good and Fair
Deficiency	No deficiencies recorded
Door(s)	
Instance on 1st Floor	Inspected
Condition	2 - Between Good and Fair
Deficiency	No deficiencies recorded
Fixed H/C Lift	
Instance on 1st Floor	Does not Exist
Fixed Seating	
Instance on 1st Floor	Inspected
Condition	2 - Between Good and Fair
Deficiency	DAMAGED/BROKEN/INOPERABLE
Deficiency Location/Instance	Seats A/111, 112
Deficiency Quantity	2
Quantity Uom	EACH
Potential Action	REPLACE
Urgency of Action	PRIORITY 5

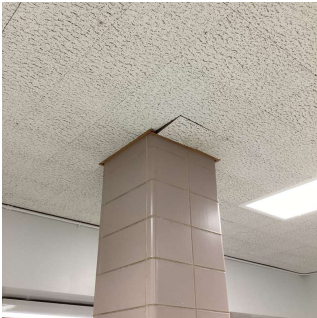
Center
Violations	No violations recorded.
Door(s)	
Instance on 1st Floor	Inspected
Condition	2 - Between Good and Fair
Deficiency	No deficiencies recorded

Question	Response
INTERIOR	
AUDITORIUM	
Stage	
Stage Curtains	
Deficiency Photo1	 
	Left Side
Violations	No violations recorded.
Walls	
Instance on 1st Floor	Inspected
Condition	2 - Between Good and Fair
Deficiency	No deficiencies recorded
Window Curtains/Shades/Blinds	
Instance on 1st Floor	Inspected
Condition	2 - Between Good and Fair
Deficiency	No deficiencies recorded
CAFETERIA	
Instance on 1st Floor	Inspected
Ceiling	
Instance on 1st Floor	Inspected
Condition	2 - Between Good and Fair
Deficiency	ACOUSTIC TILES ON PLASTER: DAMAGED/MISSING
Deficiency Location/Instance	Center
Deficiency Quantity	10
Quantity Uom	S.F.
Potential Action	REPLACE
Urgency of Action	PRIORITY 3
Purpose of Action	LEVEL 2
Deficiency Photo1

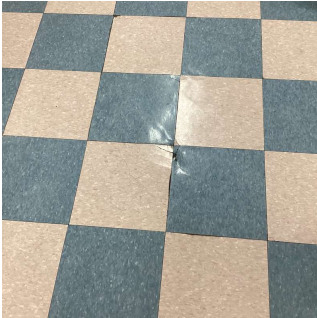
Question	Response
INTERIOR	
CAFETERIA	
Fixed Equipment	
Instance on 1st Floor	Does not Exist
Floor Finish	
Instance on 1st Floor	Inspected
Condition	2 - Between Good and Fair
Deficiency	VINYL TILES: DETERIORATED SUBSTRATE
Deficiency Location/Instance	Right Side
Deficiency Quantity	10
Quantity Uom	S.F.
Potential Action	REPLACE
Urgency of Action	PRIORITY 3
Purpose of Action	LEVEL 2
Deficiency Photo1

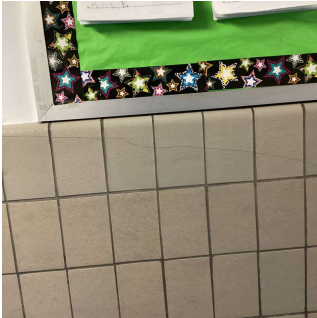
Question	Response
INTERIOR	
CLASSROOMS/CORRIDORS/ADMIN SPACES	
Walls	
Violations	Corridor near Stair B/2 (Addition Side) No violations recorded.
Deficiency	GLAZED BLOCK: CRACKS/SPALLING
Deficiency Location/Instance	Corridor near rooms 222, 2nd Elevator
Deficiency Quantity	15
Quantity Uom	S.F.
Potential Action	REPLACE
Urgency of Action	PRIORITY 3
Purpose of Action	LEVEL 2
Deficiency Photo1

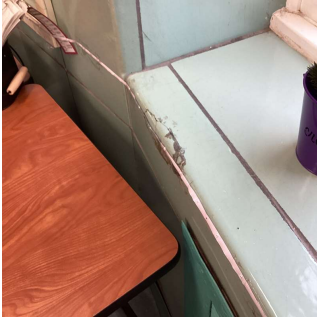
Question	Response
INTERIOR	
LIBRARY	
Built-in Furnishing	
Instance on Room 116	Does not Exist
Ceiling	
Instance on Room 116	Inspected
Condition	2 - Between Good and Fair
Deficiency	No deficiencies recorded
Door(s)	
Instance on Room 116	Inspected
Condition	2 - Between Good and Fair
Deficiency	No deficiencies recorded
Floor Finish	
Instance on Room 116	Inspected
Condition	2 - Between Good and Fair
Deficiency	No deficiencies recorded
Walls	
Instance on Room 116	Inspected
Condition	2 - Between Good and Fair
Deficiency	GLAZED BLOCK: CRACKS/SPALLING
Deficiency Location/Instance	Along Windows
Deficiency Quantity	10
Quantity Uom	S.F.
Potential Action	REPLACE
Urgency of Action	PRIORITY 3
Purpose of Action	LEVEL 2
Deficiency Photo1

Violations	Along Windows No violations recorded.
LOCKER ROOM	Does not Exist
MULTI-PURPOSE ROOM	Does not Exist
SCIENCE DEMO ROOM	Does not Exist
SCIENCE LAB	Does not Exist
SCIENCE PREP ROOM	Does not Exist

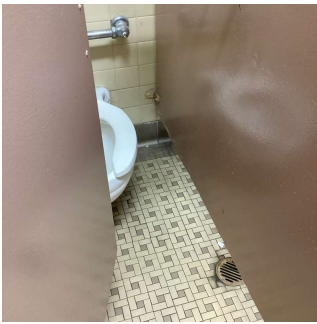
Question	Response
INTERIOR	
TOILET ROOMS - STAFF	
Door(s)	
Deficiency Photo1	 
	Room 120
Violations	No violations recorded.
Floor Finish	Inspected
Condition	2 - Between Good and Fair
Deficiency	No deficiencies recorded
Stalls	Inspected
Condition	5 - Poor
Deficiency	RUST - MAJOR
Deficiency Location/Instance	Room 130
Deficiency Quantity	1
Quantity Uom	EACH
Potential Action	REPLACE
Urgency of Action	PRIORITY 3
Purpose of Action	LEVEL 2
Deficiency Photo1

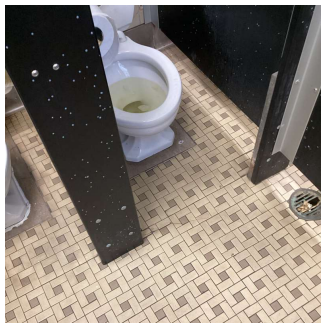
Question	Response
INTERIOR	
TOILET ROOMS - STUDENTS	
Floor Finish	
Deficiency Photo1

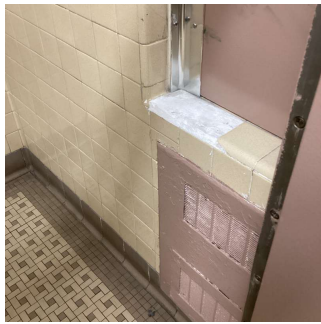
Classroom 135A
Violations	No violations recorded.
Stalls	Inspected
Condition	2 - Between Good and Fair
Deficiency	No deficiencies recorded
Walls	Inspected
Condition	2 - Between Good and Fair
Deficiency	CERAMIC TILE: BROKEN/ MISSING
Deficiency Location/Instance	Room 241
Deficiency Quantity	10
Quantity Uom	S.F.
Potential Action	REPLACE
Urgency of Action	PRIORITY 3
Purpose of Action	LEVEL 2
Deficiency Photo1

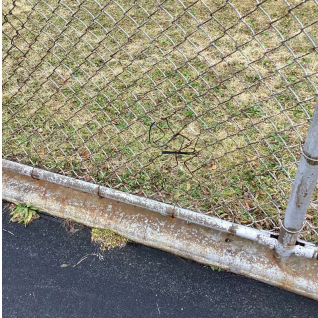
Schoolyard
Violations	No violations recorded.
Deficiency	CHAIN LINK: RUST - MAJOR
Deficiency Location/Instance	Schoolyard
Deficiency Quantity	1,500
Quantity Uom	S.F.
Potential Action	REPLACE
Urgency of Action	PRIORITY 3
Purpose of Action	LEVEL 2
Deficiency Photo1

Question	Response
SITE	
FENCES	
Deficiency	CHAIN LINK: DAMAGED/DETERIORATED
Deficiency Location/Instance	Schoolyard
Deficiency Quantity	50
Quantity Uom	S.F.
Potential Action	REPLACE
Urgency of Action	PRIORITY 3
Purpose of Action	LEVEL 2
Deficiency Photo1

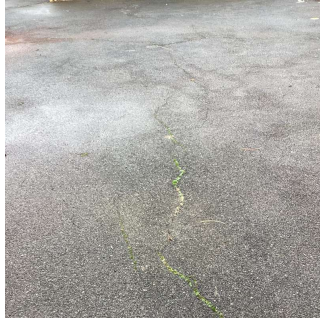
Question	Response
SITE	
PAVING	
Student Non-Use	
Asphalt	
Purpose of Action	LEVEL 2
Deficiency Photo1

Violations	Near Parking Lot No violations recorded.
Concrete	
Condition	Inspected 4 - Between Fair and Poor
Deficiency	CRACKS - MAJOR
Deficiency Location/Instance	Parking Lot
Deficiency Quantity	800
Quantity Uom	S.F.
Potential Action	REPLACE
Urgency of Action	PRIORITY 3
Purpose of Action	LEVEL 2
Deficiency Photo1

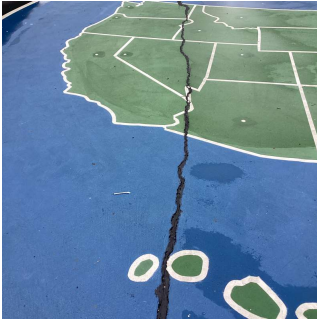
Question	Response
SITE	
PAVING	
Student Use	
Asphalt	
Deficiency Photo1

Violations	Schoolyard No violations recorded.
Concrete	Inspected
Condition	3 - Fair
Deficiency	CRACKS - MAJOR
Deficiency Location/Instance	Schoolyard
Deficiency Quantity	50
Quantity Uom	S.F.
Potential Action	REPLACE
Urgency of Action	PRIORITY 3
Purpose of Action	LEVEL 2
Deficiency Photo1

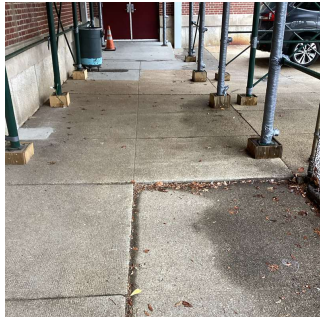
Question	Response
SITE	
PAVING	
Site Sidewalks & Walkways	
Concrete	
Deficiency Photo1

Violations	Near Exit 9 No violations recorded.
Deficiency	CRACKS - MAJOR
Deficiency Location/Instance	Near Exit 8
Deficiency Quantity	125
Quantity Uom	S.F.
Potential Action	REPLACE
Urgency of Action	PRIORITY 3
Purpose of Action	LEVEL 2
Deficiency Photo1
