NYC Department of Education
Building Condition Assessment Survey 2023 - 2024

Architectural Inspection

Asset: P.S. 197 - BROOKLYN, 1599 EAST 22 STREET, New York, 11210

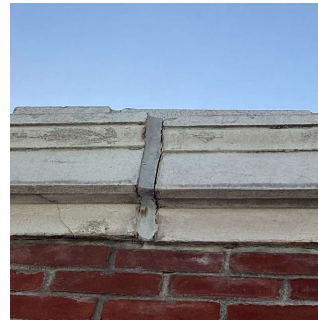
Roof 1 - Near BH1
No violations recorded.

| Question | Response |
|---|--|
| Deficiency | STONE: DETERIORATED TRANSVERSE JOINTS |

STONE: CRACKED/BROKEN PIECES

15
L.F.
MAINTENANCE
PRIORITY 3
LEVEL 2

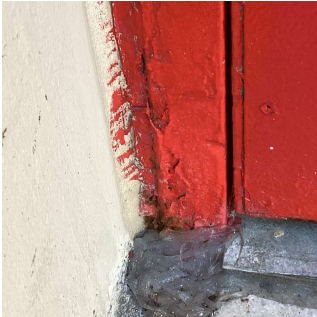
| Question | Response |
|---|---|
| Violations | Facade A - Main Entrance No violations recorded. |

| Question | Response |
|---|---|
| Deficiency | 3 - Fair METAL CLAD: DETERIORATED DOOR AND FRAME - MINOR DETERIORATION |

| Question | Response |
|---|---|
| Urgency of Action | PRIORITY 3 |

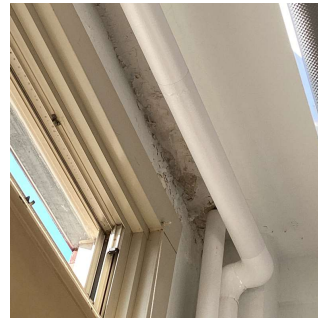
Facade H - Room 416

BRICK: WATER INFILTRATION IN INSTRUCTIONAL SPACE

REPAIR

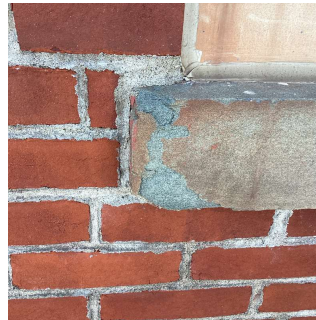
Roof 1 - BH1

BRICK: DETERIORATED MASONRY SILLS - MINOR

REPAIR

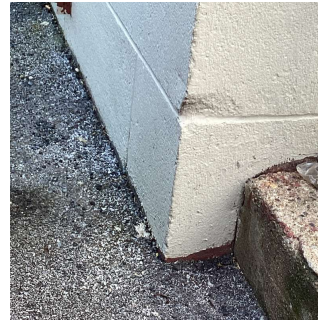
Corner of Facade B and Facade A

STONE: CRACKS AT BUILDING CORNERS

REPLACE

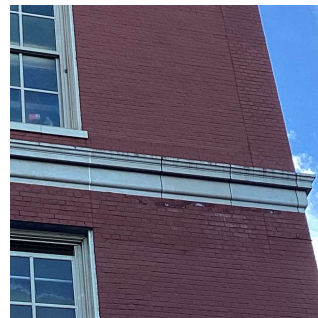
Facade B - Near Exit 2

BRICK: MINOR CRACKS AND SPALLING

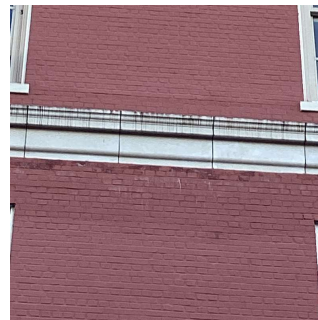
Facade B - Near Exit 2
No violations recorded.

| Deficiency | BRICK: EFFLORESCENCE |

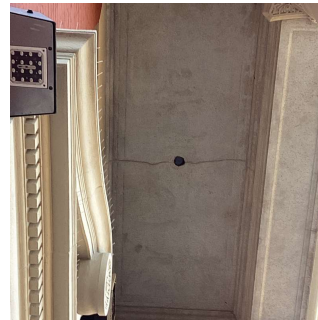
Facade A - Main Entrance

| Deficiency | STUCCO/PLASTER: MINOR CRACKS/SPALLING |

REPAIR

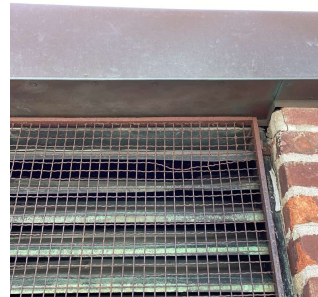
Roof 1 - Near BH1

MISSING/DAMAGED SCREEN

REPLACE

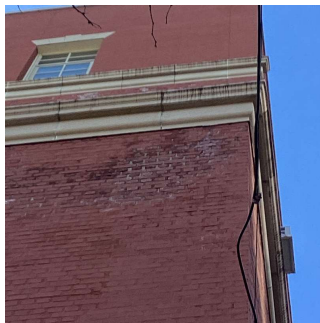
| Question | Response |
|---|---|
| Violations | Facade G No violations recorded. |

BRICK: DETERIORATED JOINTS

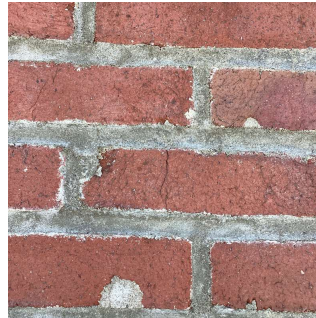
Roof 1 - BH1

| Question | Response |
|---|---|
| Deficiency | BULKHEAD/PENTHOUSE WALLS/EXTERIOR: CRACKS/SPALLING - MINOR |

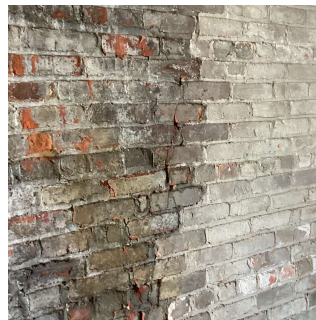
Roof 1 - PH

**BULKHEAD/PENTHOUSE WALLS/INTERIOR: BRICK
CRACKS/SPALLING**

REPLACE

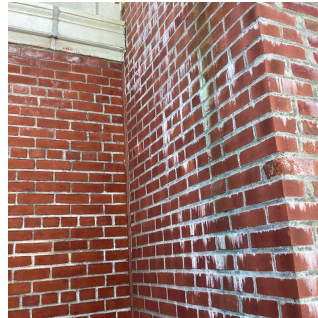
Roof 1 - BH1

Deficiency **BULKHEAD/PENTHOUSE WALLS/EXTERIOR: EFFLORESCENCE**

50
 S.F.
 MAINTENANCE
 PRIORITY 1
 LEVEL 1

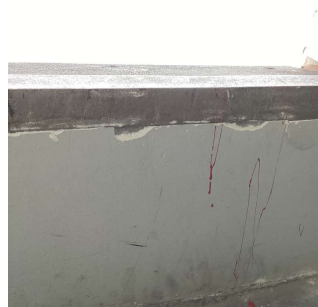
Roof 1 - BH1

**BULKHEAD/PENTHOUSE WALLS/INTERIOR: PLASTER
CRACKS/SPALLING**

REPLACE

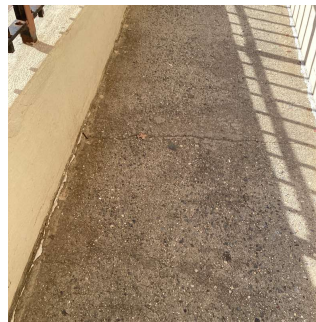
Facade H - HC Ramp

CONCRETE: CRACKS/SPALLING - MINOR

REPAIR

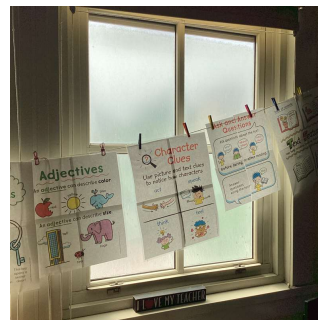
Facade H - Room 214

ALUMINUM - DOUBLE HUNG: HARDWARE POOR CONDITION/MISSING

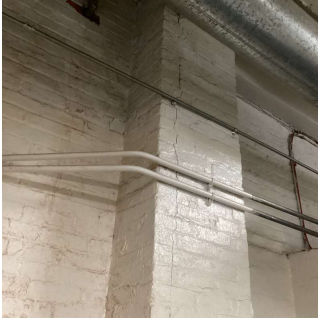
| Question | Response |
|---|--|
| Deficiency | STEEL COLUMNS/BEAMS: DETERIORATED MASONRY FIREPROOFING |
| Deficiency Location/Instance | Basement - Boiler Room |

| Question | Response |
|---|--|
| Potential Action | REPLACE |

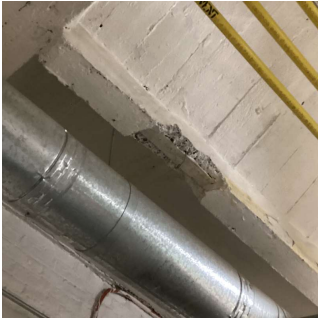
| Question | Response |
|---|--|
| Deficiency | STEEL COLUMNS/BEAMS: DETERIORATED CONCRETE FIREPROOFING |
| Deficiency Location/Instance | Basement - North, South Crawlspace, corridor near North Crawlspace, Boiler Room, Oil Tank Room |

| Question | Response |
|---|--|
| Potential Action | REPLACE |

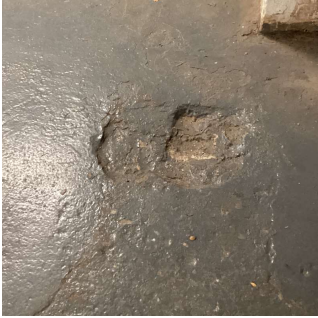
| Question | Response |
|---|--|
| | Basement - Boiler Room |

| Question | Response |
|---|--|
| Deficiency | CONCRETE SLAB ON GRADE: THRU CRACKS |
| Deficiency Location/Instance | Basement - Boiler Room |

| Question | Response |
|---|--|
| Potential Action | REPLACE |

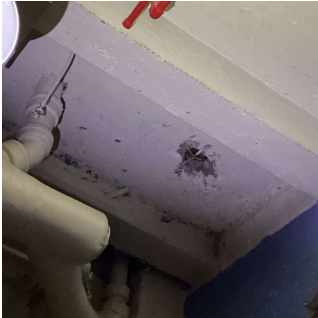
| Question | Response |
|---|--|
| | Basement - Storage Room |

| Question | Response |
|---|--|
| Deficiency | CONCRETE: CRACKS/SPALLED/REINFORCEMENT EXPOSED |
| Deficiency Location/Instance | Basement - Electrical Room, South Crawlspace, Storage Room |

| Question | Response |
|---|--|
| Potential Action | REPAIR |

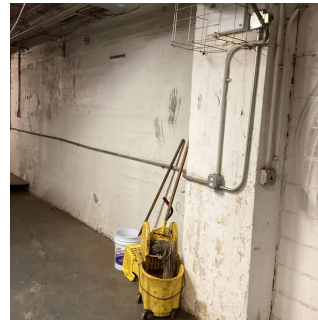
Basement - Boiler Room (near Crawlspace)

CONCRETE: WATER INFILTRATION IN NON- INSTRUCTIONAL SPACE

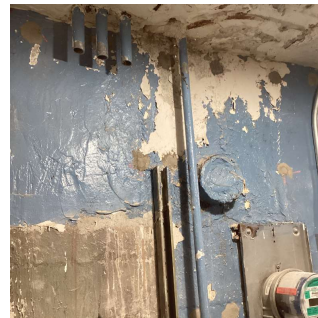
Basement - Electrical Room

CONCRETE: WATER INFILTRATION IN ELECTRICAL PANEL ROOM

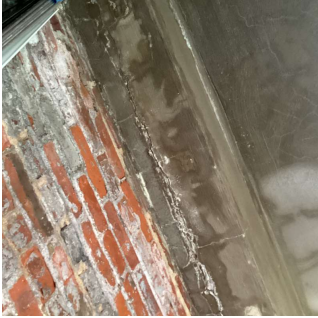
| Question | Response |
|---|--|
| Deficiency | STEEL COLUMNS/BEAMS: DETERIORATED CONCRETE FIREPROOFING |
| Deficiency Location/Instance | Roof 1 - BH1, PH |

| Question | Response |
|---|--|
| Potential Action | REPLACE |

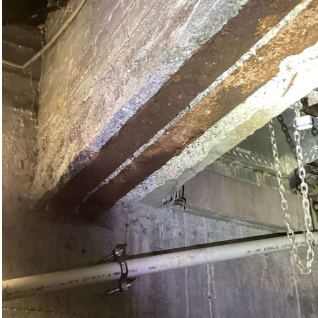
| Question | Response |
|---|--|
| Deficiency | STEEL COLUMNS/BEAMS: DETERIORATED CONCRETE FIREPROOFING |
| Deficiency Location/Instance | Basement - Ash Hoist Vault |

| Question | Response |
|---|--|
| Potential Action | REPAIR |

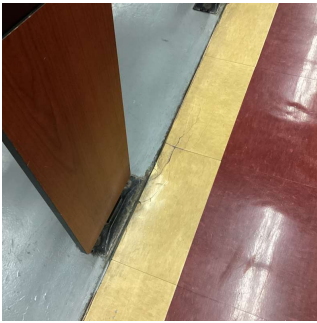
| Question | Response |
|---|--|
| Deficiency | VINYL TILES: DETERIORATED SUBSTRATE |

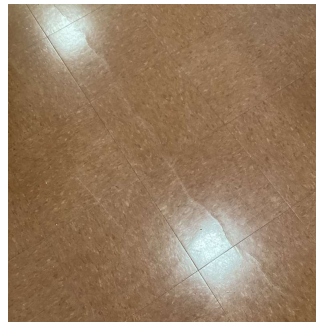
Center

CERAMIC TILE: DETERIORATED SUBSTRATE

REPLACE

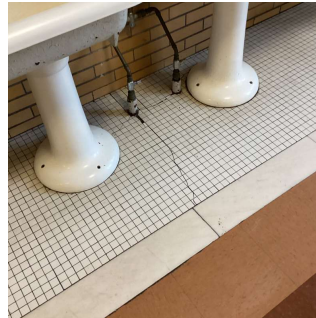
Near Drinking Fountain

CERAMIC TILE: BROKEN/MISSING TILES

REPLACE

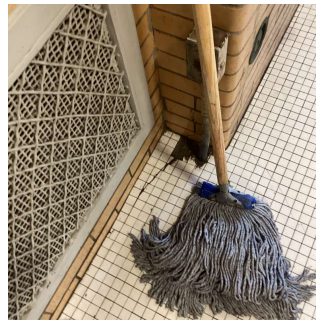
Near Drinking Fountain

| Question | Response |
|--|--|
| Deficiency | SALT GLAZED BRICK: CRACKS/SPALLING |
| Deficiency Location/Instance | Near Drinking Fountain, Near Servery |

| Question | Response |
|--|--|
| Potential Action | REPLACE |

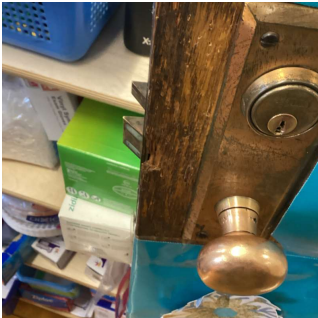
| Question | Response |
|--|--|
| Condition | 5 - Poor |
| Deficiency | WOOD: DETERIORATED DOOR |
| Deficiency Location/Instance | Room 305, 304, 303, 301,403,404,405 |

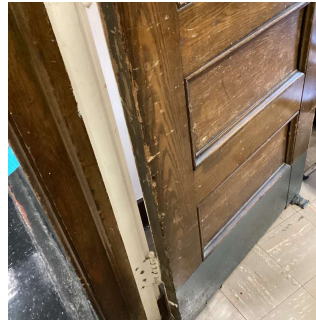
Room 252

| Question | Response |
|--|--|
| Deficiency | WOOD: DETERIORATED DOOR |
| Deficiency Location/Instance | Rooms 500,417, 252,206,203, 201 and others |

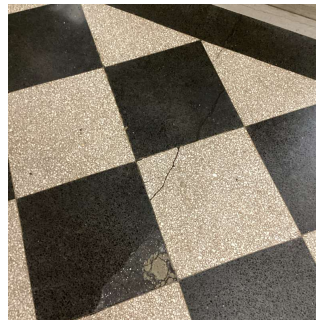
Corridor near Auditorium

TERRAZZO: CRACKS

REPLACE

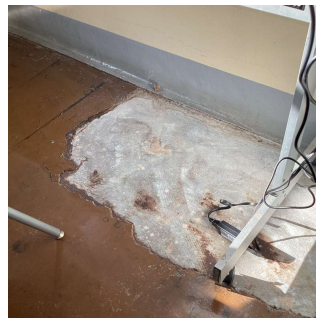
SHEET VINYL: BROKEN/DETERIORATED

REPLACE

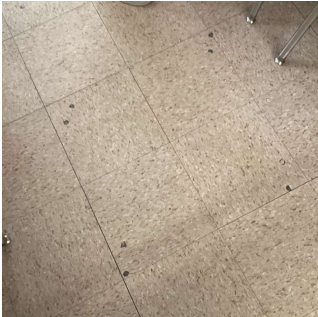
| Question | Response |
|--|--|
| | Room 314 |

| Question | Response |
|--|--|
| Deficiency | VINYL TILES: BROKEN/DETERIORATED/MISSING TILES |
| Deficiency Location/Instance | Room 505, 301, 314, 263, 252 and others |

| Question | Response |
|--|--|
| Potential Action | REPLACE |

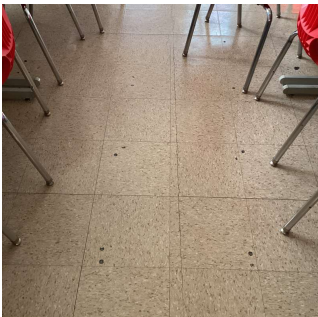
| Question | Response |
|--|--|
| | Room 314 |

| Question | Response |
|--|--|
| Deficiency | VINYL TILES: DETERIORATED SUBSTRATE |
| Deficiency Location/Instance | Rooms 420, 314, 301,206 |

| Question | Response |
|--|--|
| Potential Action | REPLACE |

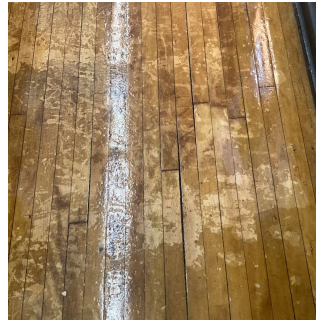
Room 416

| Question | Response |
|--|--|
| Deficiency | WOOD: DAMAGED/DETERIORATED |
| Deficiency Location/Instance | Rooms 509,506,416, 407, 402 and others |

| Question | Response |
|--|--|
| Potential Action | REPLACE |

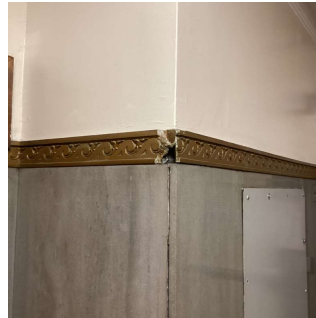
Auditorium Lobby

STONE MOLDINGS: CRACKS/SPALLING

REPLACE

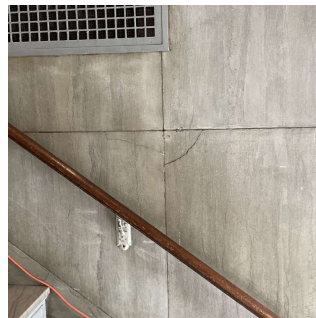
STONE: CRACKS/SPALLING

REPLACE

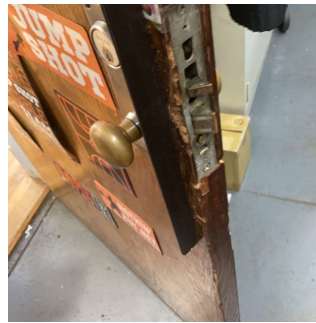
Office

| Question | Response |
|--|--|
| Deficiency | WOOD: DETERIORATED DOOR |
| Deficiency Location/Instance | Office, Storage Room |

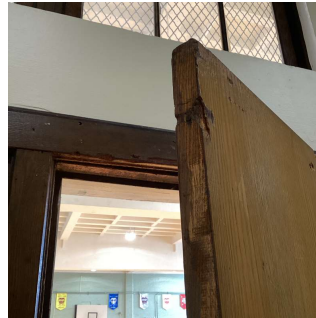
Entrance

WOOD: DETERIORATED DOOR AND FRAME

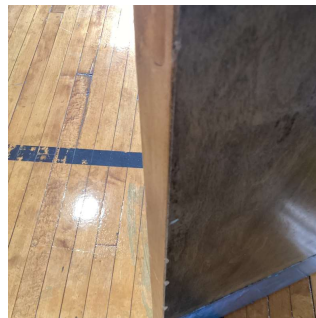
WOOD: DETERIORATED DOOR

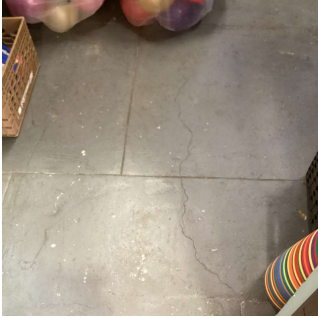
| Question | Response |
|---|--|
| Deficiency | CONCRETE: CRACKS |
| Deficiency Location/Instance | Storage Room |

| Question | Response |
|---|--|
| Potential Action | REPLACE |

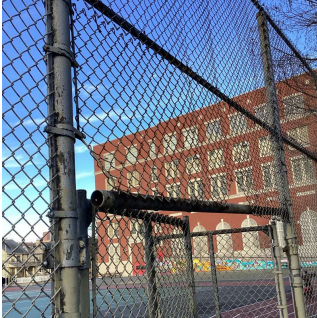
| Question | Response |
|---|--|
| Violations | E. 23rd Street No violations recorded. |

| Question | Response |
|---|--|
| Deficiency | CHAIN LINK: DAMAGED POST/RAIL |
| Deficiency Location/Instance | E.23rd Street |

| Question | Response |
|---|--|
| Potential Action | REPLACE |

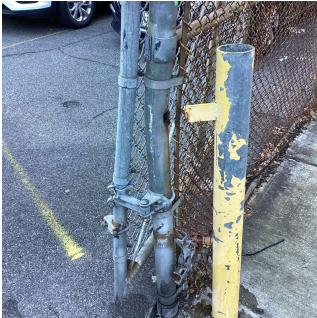
| Question | Response |
|---|--|
| Violations | E.22nd Street No violations recorded. |

| Question | Response |
|---|--|
| Deficiency | CHAIN LINK: DAMAGED POST/RAIL |
| Deficiency Location/Instance | E.22nd Street, E.23rd Street, Kings Hwy |

| Question | Response |
|---|--|
| Potential Action | REPLACE |

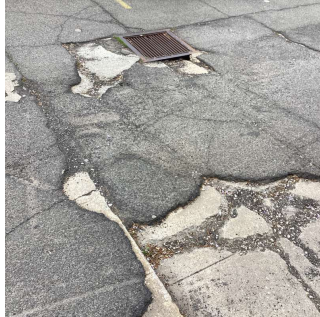
| Question | Response |
|---|--|
| Violations | Parking Lot No violations recorded. |

| Question | Response |
|---|--|
| Deficiency | POTHOLES |
| Deficiency Location/Instance | Parking Lot |

| Question | Response |
|---|--|
| Potential Action | REPAIR |

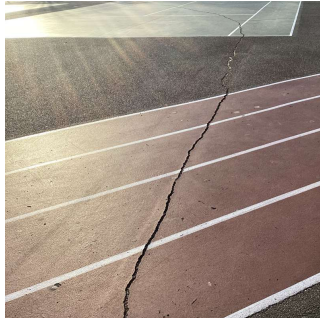
| Question | Response |
|---|--|
| Violations | Schoolyard No violations recorded. |

| Question | Response |
|---|--|
| Condition | 5 - Poor |
| Deficiency | CRACKS - MAJOR |
| Deficiency Location/Instance | Schoolyard, Courtyard |

| Question | Response |
|---|--|
| Potential Action | REPLACE |

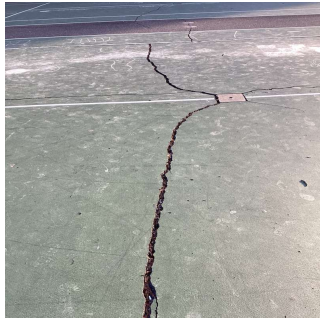
| Question | Response |
|---|--|
| Violations | Schoolyard No violations recorded. |

| Question | Response |
|---|--|
| Deficiency | CRACKS - MAJOR |
| Deficiency Location/Instance | Schoolyard |

| Question | Response |
|---|--|
| Potential Action | REPLACE |

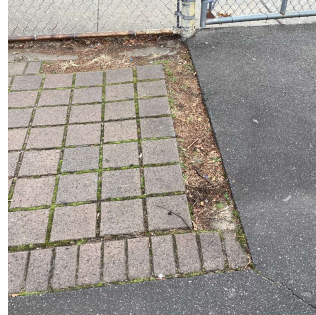
| Question | Response |
|---|--|
| Deficiency | DAMAGED/MISSING |
| Deficiency Location/Instance | Schoolyard |

| Question | Response |
|---|--|
| Potential Action | REPLACE |

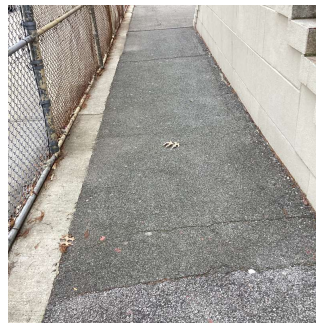
Near Exit 4

CRACKS - MAJOR

REPLACE

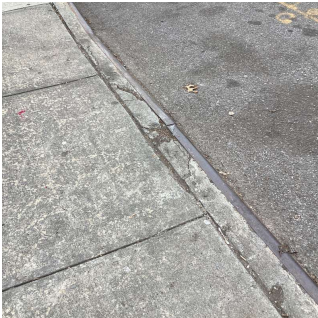
| Question | Response |
|---|--|
| | 22nd Street |

| Question | Response |
|---|--|
| Condition | 4 - Between Fair and Poor |
| Deficiency | DAMAGED CURBS |
| Deficiency Location/Instance | 22nd Street |

| Question | Response |
|---|--|
| Potential Action | REPLACE |
