**NYC Department of Education**  
**Building Condition Assessment Survey 2023 - 2024**

Architectural Inspection

**Asset: P.S. 200 - BROOKLYN, 1940 BENSON AVENUE, New York, 11214**

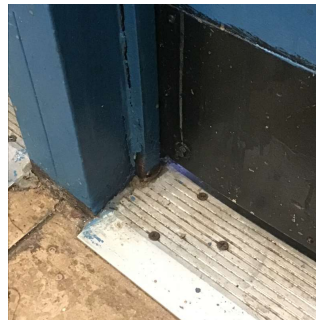
Facade C - Exit 10

**METAL CLAD: DETERIORATED DOOR AND FRAME - MAJOR DETERIORATION**

REPLACE

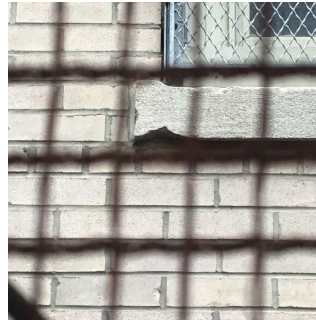
Facade D

Question	Response
<b>EXTERIOR</b>	
<b>DOORS</b>	
<b>TRANSOM/SIDE LIGHT</b>	
Urgency of Action	PRIORITY 4
Purpose of Action	LEVEL 2
Deficiency Photo1	 
	Facade G - Exit 8
Violations	No violations recorded.
<b>EXTERIOR WALLS</b>	
Material Type(s)	Inspected Masonry
Replacement Quantity	40,000
Replacement Uom	S.F.
Instance on All Facades	Inspected
Instance Condition	2 - Between Good and Fair
Instance Quantity	40,000
Instance Quantity Uom	S.F.
Deficiency	BRICK: DETERIORATED MASONRY SILLS - MINOR
Roof Plan reference	K200  
Elevation	 
Deficiency Quantity	20
Quantity Uom	L.F.
Potential Action	REPAIR
Urgency of Action	PRIORITY 3
Purpose of Action	LEVEL 2

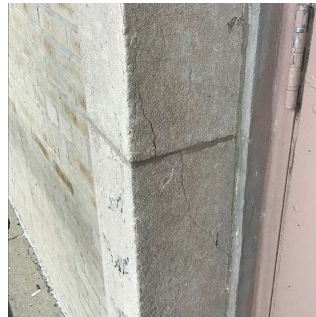
Facade C - Exit 10

STONE: CHIPPED/SPALLED/BROKEN PIECES - MINOR

REPAIR

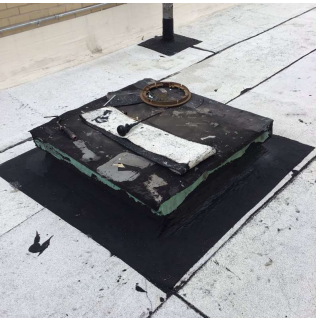
Question	Response
<b>EXTERIOR</b>	
<b>LOADING DOCK</b>	Does not Exist
<b>LOUVER</b>	Inspected
Condition	2 - Between Good and Fair
Deficiency	No deficiencies recorded
<b>PARAPETS</b>	Inspected
Material Type(s)	Concrete, Masonry, Metal
Replacement Quantity	7,000
Replacement Uom	C.F.
Instance on All Facades	Inspected
Instance Condition	2 - Between Good and Fair
Instance Quantity	7,000
Instance Quantity Uom	C.F.
Deficiency	No deficiencies recorded
<b>PLAZA DECK</b>	Does not Exist
<b>ROOF</b>	Inspected
<b>Roofing</b>	Inspected
Replacement Quantity	25,000
Replacement Uom	S.F.
<b>ROOF HATCH/SMOKE HATCH</b>	Inspected
Condition	5 - Poor
Deficiency	DETERIORATED
Roof Plan reference

Violations	Roof 4 - RH No violations recorded.
<b>LEADERS, GUTTERS, DOWNSPOUTS, SCUPPERS</b>	Under Construction

Deficiency Quantity	1
Quantity Uom	EACH
Potential Action	REPLACE
Urgency of Action	PRIORITY 4
Purpose of Action	LEVEL 2
Deficiency Photo1

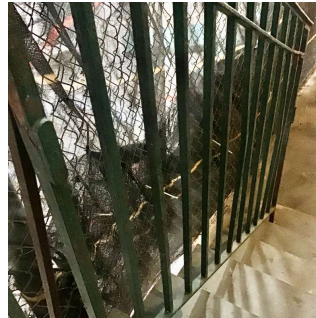
Facade E - Exit 5

MISSING RAILING

REPLACE

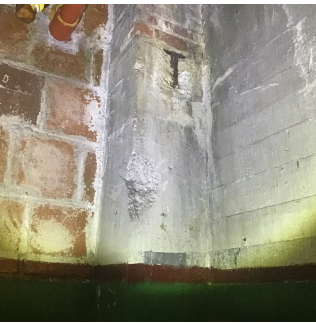
Deficiency Quantity	12
Quantity Uom	EACH
Potential Action	REPLACE BALANCES
Urgency of Action	PRIORITY 3
Purpose of Action	LEVEL 2
Deficiency Photo1	No photo recorded
Violations	No violations recorded.
<b>INTERIOR</b>	Inspected
<b>POOLS</b>	Does not Exist
<b>STRUCTURAL</b>	Inspected
<b>COLUMNS/BEAMS/BEARING WALLS</b>	Inspected
Condition	3 - Fair
Deficiency	CONCRETE COLUMNS/BEAMS: CRACKED/SPALLED/REINFORCEMENT EXPOSED
Deficiency Location/Instance	Basement - Boiler Room, Mechanical Equipment Room North, Crawlspace North
Deficiency Quantity	30
Quantity Uom	S.F.
Potential Action	REPLACE
Urgency of Action	PRIORITY 4
Purpose of Action	LEVEL 5

<p>Mechanical Equipment Room North</p> <p>No violations recorded.</p>
Deficiency  Deficiency Location/Instance Deficiency Quantity Quantity Uom Potential Action Urgency of Action Purpose of Action Deficiency Photo1           Violations	<p><b>STEEL COLUMNS/BEAMS: DETERIORATED CONCRETE FIREPROOFING</b></p> <p>Basement - Boiler Room, South Side Storage Area, Crawlspace North</p> <p>50</p> <p>S.F.</p> <p>REPLACE</p> <p>PRIORITY 3</p> <p>LEVEL 5</p>

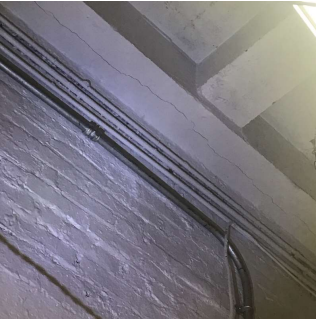
<p>Boiler Room</p> <p>No violations recorded.</p>
<b>FLOOR STRUCTURE</b>	
Condition	Inspected
Condition	3 - Fair
Deficiency Deficiency Location/Instance Deficiency Quantity Quantity Uom Potential Action Urgency of Action Purpose of Action	<p><b>CONCRETE SLAB ON GRADE: THRU CRACKS</b></p> <p>Basement - Crawlspace North, Mechanical Equipment Room North</p> <p>300</p> <p>S.F.</p> <p>REPAIR</p> <p>PRIORITY 3</p> <p>LEVEL 5</p>

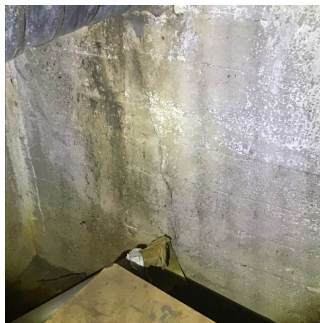
Basement - South Side Storage Area
Violations	No violations recorded.
<b>FOUNDATION WALLS</b>	
	Inspected
Material Type(s)	Concrete, Masonry
Condition	5 - Poor
Deficiency	CONCRETE: CRACKED/SPALLED/REINFORCEMENT EXPOSED
Deficiency Location/Instance	Basement - Boiler Room, Crawlspace North
Deficiency Quantity	30
Quantity Uom	S.F.
Potential Action	REPAIR
Urgency of Action	PRIORITY 3
Purpose of Action	LEVEL 5

Violations	Crawlspace North No violations recorded.
Deficiency	CONCRETE: WATER INFILTRATION IN NON- INSTRUCTIONAL SPACE
Deficiency Location/Instance	Basement - Room B20A, South Side Storage Area, Gas Meter Room, Oil Tank Room, Boiler Room,
Deficiency Quantity	500
Quantity Uom	S.F.
Potential Action	INSTALL WATERPROOFING
Urgency of Action	PRIORITY 5
Purpose of Action	LEVEL 5
Deficiency Photo1	 
Violations	Room B20A No violations recorded.
<b>ROOF STRUCTURE</b>	
Condition	Inspected
Deficiency	2 - Between Good and Fair
Deficiency	No deficiencies recorded
<b>VAULTS-BUNKERS</b>	
Condition	Inspected
Deficiency	2 - Between Good and Fair
Deficiency	No deficiencies recorded
<b>Slab Structure</b>	
Condition	Inspected
Deficiency	3 - Fair
Deficiency	CONCRETE SLAB ON GRADE: THRU CRACKS
Deficiency Location/Instance	Basement - Ash Hoist Vault

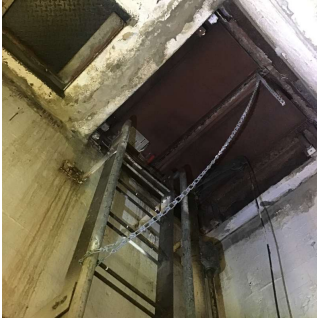
Question	Response
<b>INTERIOR</b>	
<b>STRUCTURAL</b>	
<b>VAULTS-BUNKERS</b>	
<b>Slab Structure</b>	
Deficiency Photo1	 
Violations	Ash Hoist Vault No violations recorded.
<b>Vault/Ash Hoist Doors and Framing</b>	Inspected
Condition	5 - Poor
Deficiency	WATER INFILTRATION
Deficiency Location/Instance	Basement - Ash Hoist Vault
Deficiency Quantity	10
Quantity Uom	S.F.
Potential Action	REPAIR
Urgency of Action	PRIORITY 5
Purpose of Action	LEVEL 2
Deficiency Photo1

Violations	Ash Hoist Vault No violations recorded.
<b>AUDITORIUM</b>	Inspected
Instance on 1st Floor (549 Seats)	Inspected
<b>Ceiling</b>	
Instance on 1st Floor (549 Seats)	Inspected
Condition	2 - Between Good and Fair
Deficiency	No deficiencies recorded
<b>Door(s)</b>	
Instance on 1st Floor (549 Seats)	Inspected
Condition	3 - Fair
Deficiency	METAL CLAD WOOD: DETERIORATED DOOR AND FRAME
Deficiency Location/Instance	Exit E
Deficiency Quantity	1
Quantity Uom	EACH

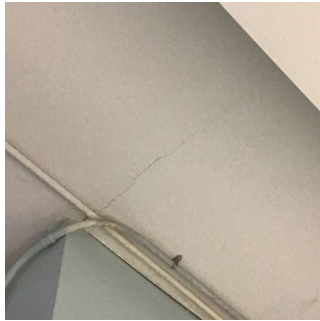
Question	Response
<b>INTERIOR</b>	
<b>CAFETERIA</b>	
<b>Ceiling</b>	
Deficiency Photo1

Violations	Near Right Side Windows No violations recorded.
<b>Door(s)</b>	
Instance on Basement	Inspected
Condition	4 - Between Fair and Poor
Deficiency	WOOD: DETERIORATED DOOR
Deficiency Location/Instance	Main Entrance
Deficiency Quantity	2
Quantity Uom	EACH
Potential Action	MAINTENANCE
Urgency of Action	PRIORITY 3
Purpose of Action	LEVEL 2
Deficiency Photo1

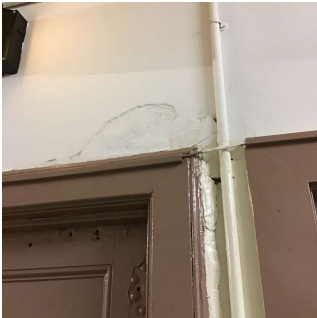
Question	Response
<b>INTERIOR</b>	
<b>CLASSROOMS/CORRIDORS/ADMIN SPACES</b>	
<b>Walls</b>	
Violations	Corridor near Room 303 No violations recorded.
Deficiency	PLASTER: CRACKS/SPALLING
Deficiency Location/Instance	Corridor near Stair CD/2, By Rooms 456,431,403,402 and others
Deficiency Quantity	180
Quantity Uom	S.F.
Potential Action	REPLACE
Urgency of Action	PRIORITY 3
Purpose of Action	LEVEL 2
Deficiency Photo1

Violations	Corridor near Stair CD/2 No violations recorded.
Deficiency	STONE MOLDINGS: CRACKS/SPALLING
Deficiency Location/Instance	Main Entrance Vestibule, Corridor near Stair CD/1, Exits 7,6 - Vestibules
Deficiency Quantity	40
Quantity Uom	L.F.
Potential Action	REPLACE
Urgency of Action	PRIORITY 3
Purpose of Action	LEVEL 2
Deficiency Photo1

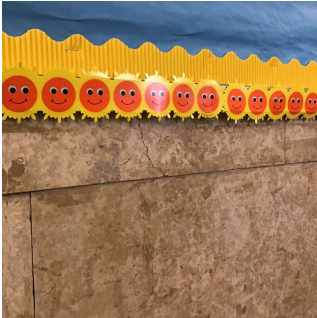
Violations	Main Entrance Vestibule No violations recorded.
Deficiency	STONE: CRACKS/SPALLING
Deficiency Location/Instance	Main Entrance Vestibule, Auditorium Vestibule, Exits 7,6 - Vestibules, Corridor near Multipurpose Room and others

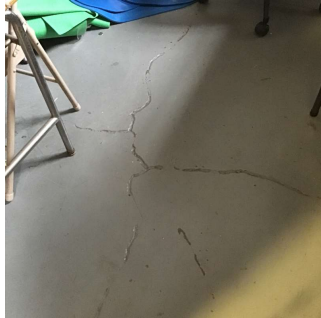
Question	Response
<b>INTERIOR</b>	
<b>GYMNASIUM</b>	
<b>Floor Finish</b>	
Deficiency Location/Instance	Office Room, Room 352
Deficiency Quantity	100
Quantity Uom	S.F.
Potential Action	REPLACE
Urgency of Action	PRIORITY 3
Purpose of Action	LEVEL 2
Deficiency Photo1

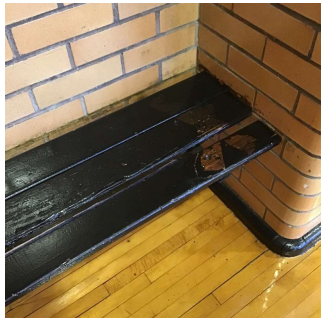
Violations	Office Room No violations recorded.
<b>Seating</b>	
Instance on 3rd Floor	Inspected
Condition	4 - Between Fair and Poor
Deficiency	DAMAGED FIXED SEATING
Deficiency Location/Instance	Right and Left Side
Deficiency Quantity	2
Quantity Uom	EACH
Potential Action	REPLACE
Urgency of Action	PRIORITY 3
Purpose of Action	LEVEL 2
Deficiency Photo1

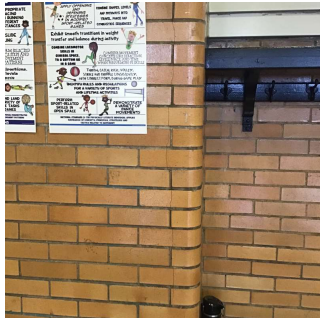
Violations	Left Side No violations recorded.
<b>Sliding-folding Partition</b>	
Instance on 3rd Floor	Does not Exist
<b>Stage</b>	
Instance on 3rd Floor	Does not Exist
<b>Walls</b>	
Instance on 3rd Floor	Inspected
Condition	2 - Between Good and Fair
Deficiency	SALT GLAZED BRICK: CRACKS/SPALLING
Deficiency Location/Instance	Left Side

Question	Response
<b>INTERIOR</b>	
<b>GYMNASIUM</b>	
<b>Walls</b>	
Deficiency Quantity	10
Quantity Uom	S.F.
Potential Action	REPLACE
Urgency of Action	PRIORITY 3
Purpose of Action	LEVEL 2
Deficiency Photo1

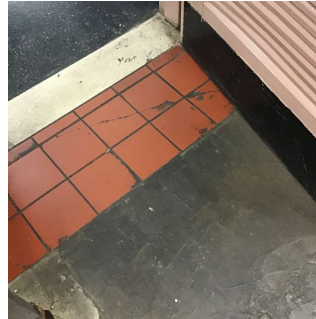
Near Servery

CERAMIC TILE: BROKEN/MISSING TILES

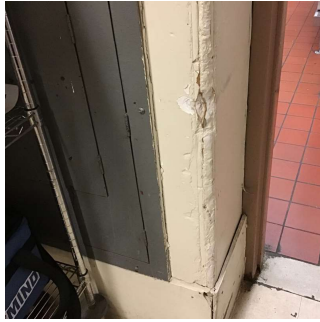
Question	Response
<b>INTERIOR</b>	
<b>KITCHEN</b>	
<b>Walls</b>	
Deficiency Photo1	 
	Near Exit Vestibule
Violations	No violations recorded.
Deficiency	GYPSUM BOARD: DETERIORATED
Deficiency Location/Instance	Storage Room
Deficiency Quantity	10
Quantity Uom	S.F.
Potential Action	REPLACE
Urgency of Action	PRIORITY 3
Purpose of Action	LEVEL 2
Deficiency Photo1

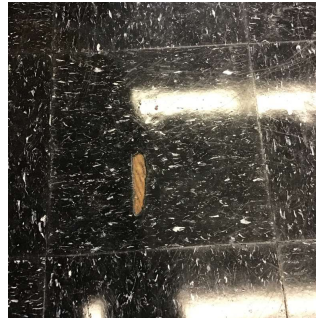
Deficiency	VINYL TILES: BROKEN/DETERIORATED/MISSING TILES
Deficiency Location/Instance	Right and Left Side
Deficiency Quantity	60
Quantity Uom	S.F.
Potential Action	REPLACE
Urgency of Action	PRIORITY 3
Purpose of Action	LEVEL 2
Deficiency Photo1

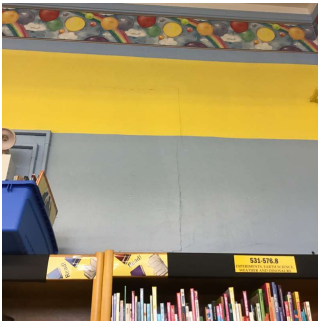
Instance on Room 309	Inspected
Condition	2 - Between Good and Fair
Deficiency	GYPSUM BOARD: DETERIORATED
Deficiency Location/Instance	Left Side
Deficiency Quantity	20
Quantity Uom	S.F.
Potential Action	REPLACE
Urgency of Action	PRIORITY 3
Purpose of Action	LEVEL 2

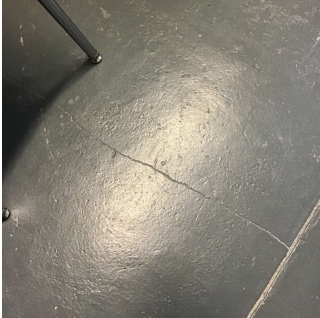
Entrance
Violations	No violations recorded.
<b>Floor Finish</b>	
Instance on 4th Floor	Inspected
Condition	2 - Between Good and Fair
Deficiency	CONCRETE: CRACKS
Deficiency Location/Instance	Center
Deficiency Quantity	10
Quantity Uom	S.F.
Potential Action	REPLACE

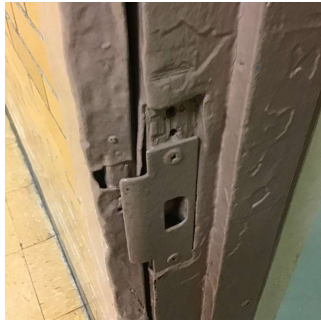
Condition	5 - Poor
Deficiency	METAL CLAD WOOD: DETERIORATED DOOR AND FRAME
Deficiency Location/Instance	Stair AB/1
Deficiency Quantity	1
Quantity Uom	EACH
Potential Action	MAINTENANCE
Urgency of Action	PRIORITY 3
Purpose of Action	LEVEL 2
Deficiency Photo1

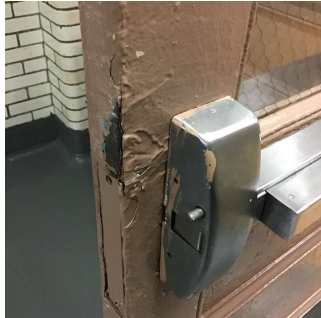
Exit 4 - Vestibule

Deficiency	METAL CLAD WOOD: DETERIORATED DOOR
Deficiency Location/Instance	Exit 4 - Vestibule, Stair AB/1
Deficiency Quantity	2
Quantity Uom	EACH
Potential Action	MAINTENANCE
Urgency of Action	PRIORITY 3
Purpose of Action	LEVEL 2
Deficiency Photo1

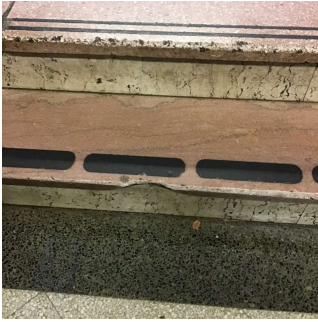
Stair CD/2
Violations	No violations recorded.
<b>Railings</b>	Inspected
Condition	2 - Between Good and Fair
Deficiency	No deficiencies recorded
<b>Stairs and Landings</b>	Inspected
Condition	3 - Fair
Deficiency	STONE: BROKEN/MISSING
Deficiency Location/Instance	Main Entrance Vestibule, Exits 6,2 - Vestibules
Deficiency Quantity	60
Quantity Uom	S.F.
Potential Action	REPLACE
Urgency of Action	PRIORITY 3
Purpose of Action	LEVEL 2
Deficiency Photo1

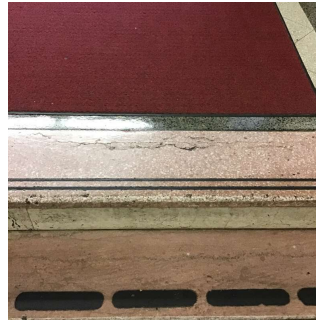
Main Entrance Vestibule
Violations	No violations recorded.
Deficiency	TERRAZZO: CRACKS
Deficiency Location/Instance	Main Entrance Vestibule, Stairs CD/2,1, Exit 10 - Vestibule
Deficiency Quantity	50
Quantity Uom	S.F.
Potential Action	REPLACE
Urgency of Action	PRIORITY 3
Purpose of Action	LEVEL 2

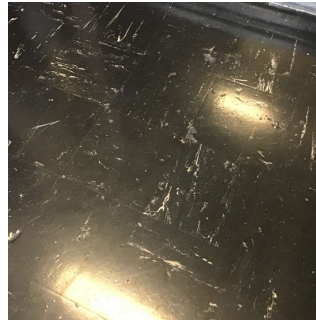
Stair F/3

**VINYL TILES: BROKEN/DETERIORATED/MISSING TILES**

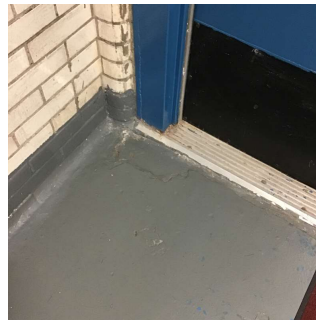
Exit 4 - Vestibule

**CONCRETE: CRACKS/SPALLING - MAJOR**

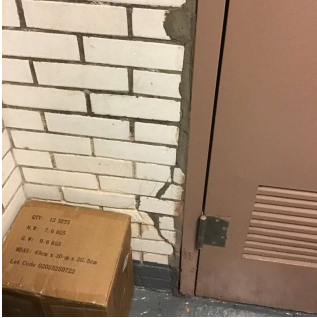
Question	Response
<b>INTERIOR</b>	
<b>STAIRS/RAMPS: INTERIOR</b>	
<b>Walls</b>	Inspected
Condition	2 - Between Good and Fair
Deficiency	CERAMIC TILE: BROKEN/ MISSING
Deficiency Location/Instance	Exits 9,4,5 - Vestibules
Deficiency Quantity	30
Quantity Uom	S.F.
Potential Action	REPLACE
Urgency of Action	PRIORITY 3
Purpose of Action	LEVEL 2
Deficiency Photo1

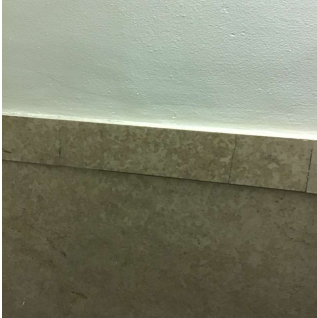
Violations	Exit 9 - Vestibule No violations recorded.
Deficiency	STONE MOLDINGS: CRACKS/SPALLING
Deficiency Location/Instance	Stairs CD/2,1
Deficiency Quantity	50
Quantity Uom	L.F.
Potential Action	REPLACE
Urgency of Action	PRIORITY 3
Purpose of Action	LEVEL 2
Deficiency Photo1

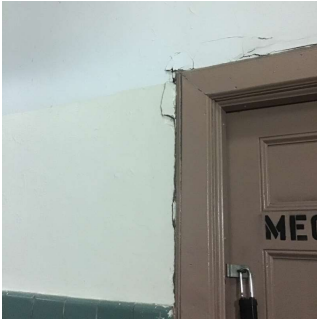
Question	Response
<b>INTERIOR</b>	
<b>STAIRS/RAMPS: INTERIOR</b>	
<b>Walls</b>	
Deficiency Photo1	 
Violations	Stair CD/2 No violations recorded.
Deficiency	PLASTER: CRACKS/SPALLING
Deficiency Location/Instance	Stairs AB/Basement, E/3,1
Deficiency Quantity	30
Quantity Uom	S.F.
Potential Action	REPLACE
Urgency of Action	PRIORITY 3
Purpose of Action	LEVEL 2
Deficiency Photo1

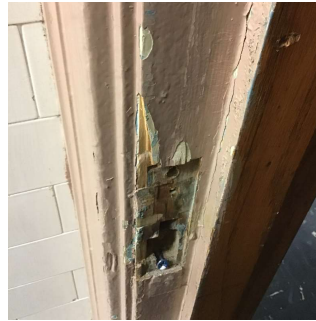
Violations	Stair AB/Basement No violations recorded.
<b>TOILET ROOMS - STAFF</b>	Inspected
<b>Ceiling</b>	Inspected
Condition	2 - Between Good and Fair
Deficiency	No deficiencies recorded
<b>Door(s)</b>	Inspected
Condition	5 - Poor
Deficiency	WOOD: DETERIORATED DOOR AND FRAME
Deficiency Location/Instance	Room 356
Deficiency Quantity	1
Quantity Uom	EACH
Potential Action	MAINTENANCE
Urgency of Action	PRIORITY 3
Purpose of Action	LEVEL 2

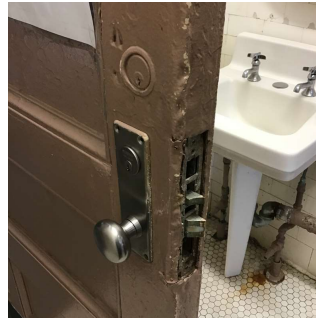
Room 451

METAL CLAD WOOD: DETERIORATED DOOR

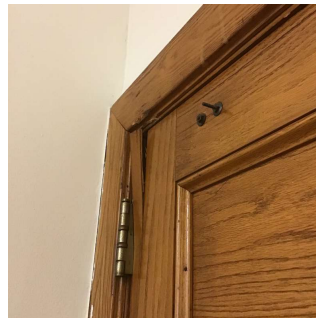
Room 101

WOOD: DETERIORATED DOOR

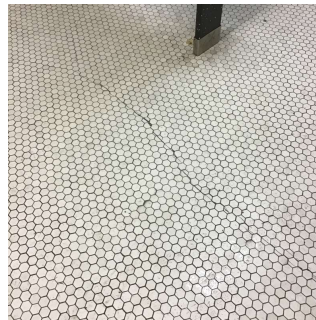
Room 459

CERAMIC TILE: DETERIORATED SUBSTRATE

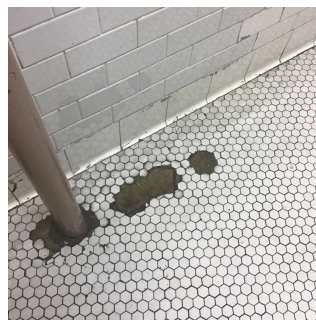
CERAMIC TILE: BROKEN/MISSING TILES

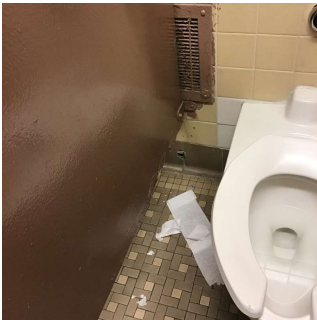
<b>Question</b>	<b>Response</b>
<b>INTERIOR</b>	
<b>TOILET ROOMS - STUDENTS</b>	
<b>Floor Finish</b>	Inspected
	Room 358
Violations	No violations recorded.
<b>Stalls</b>	Inspected
Condition	5 - Poor
Deficiency	RUST - MAJOR
Deficiency Location/Instance	Rooms 421,256,160
Deficiency Quantity	12
Quantity Uom	EACH
Potential Action	REPLACE
Urgency of Action	PRIORITY 3
Purpose of Action	LEVEL 2
Deficiency Photo1

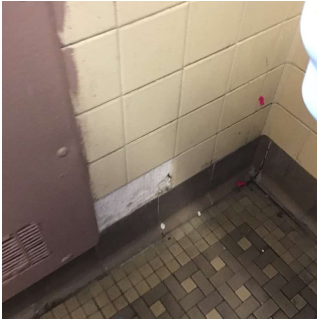
Room 421
Violations	No violations recorded.
<b>Walls</b>	Inspected
Condition	2 - Between Good and Fair
Deficiency	CERAMIC TILE: BROKEN/ MISSING
Deficiency Location/Instance	Rooms 459,421,358,321,221 and others
Deficiency Quantity	80
Quantity Uom	S.F.
Potential Action	REPLACE
Urgency of Action	PRIORITY 3
Purpose of Action	LEVEL 2
Deficiency Photo1

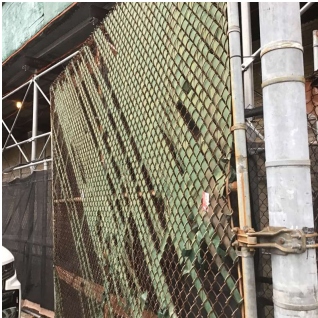
Violations	Bay 23rd Street No violations recorded.
Deficiency	CHAIN LINK: RUST - MAJOR
Deficiency Location/Instance	Bay 23rd Street
Deficiency Quantity	200
Quantity Uom	S.F.
Potential Action	REPLACE
Urgency of Action	PRIORITY 3
Purpose of Action	LEVEL 2
Deficiency Photo1

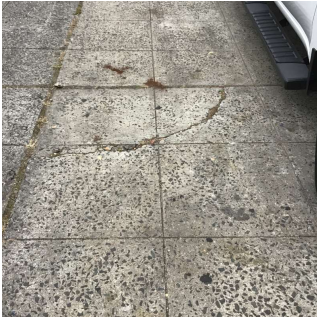
Violations	Bay 23rd Street No violations recorded.
<b>IRRIGATION SYSTEM</b>	Does not Exist
<b>PAVING</b>	Inspected
<b>Student Non-Use</b>	Inspected
Gravel Exists?	No
<b>Asphalt</b>	Does not Exist
<b>Concrete</b>	Inspected
Condition	3 - Fair
Deficiency	DAMAGED/DETERIORATED/MISSING SECTIONS
Deficiency Location/Instance	Bay 23rd Street
Deficiency Quantity	175
Quantity Uom	S.F.
Potential Action	REPLACE
Urgency of Action	PRIORITY 3
Purpose of Action	LEVEL 2

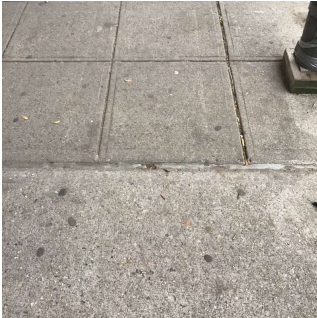
Violations	Bay 23rd Street No violations recorded.
<b>Pavers</b>	Does not Exist
<b>Student Use</b>	Inspected
Gravel Exists?	No
<b>Asphalt</b>	Inaccessible
<b>Concrete</b>	Does not Exist
<b>Pavers</b>	Does not Exist
<b>Site Sidewalks &amp; Walkways</b>	Inspected
<b>Asphalt</b>	Does not Exist
<b>Concrete</b>	Inspected
Condition	3 - Fair
Deficiency	DAMAGED/DETERIORATED/MISSING SECTIONS
Deficiency Location/Instance	Bay 23rd Street, Near Exit 10
Deficiency Quantity	150
Quantity Uom	S.F.
Potential Action	REPLACE
Urgency of Action	PRIORITY 3
Purpose of Action	LEVEL 2
Deficiency Photo1	 
Violations	Bay 23rd Street No violations recorded.
<b>Pavers</b>	Does not Exist
<b>DOT Sidewalk</b>	Inspected
<b>Asphalt</b>	Does not Exist
<b>Concrete</b>	Inspected
Condition	4 - Between Fair and Poor
Deficiency	HEAVING

Question	Response
<b>SITE</b>	
<b>PAVING</b>	
<b>DOT Sidewalk</b>	
<b>Concrete</b>	
Deficiency Location/Instance	Bay 22nd Street, Benson Avenue
Deficiency Quantity	100
Quantity Uom	S.F.
Potential Action	REPLACE
Urgency of Action	PRIORITY 3
Purpose of Action	LEVEL 2
Deficiency Photo1

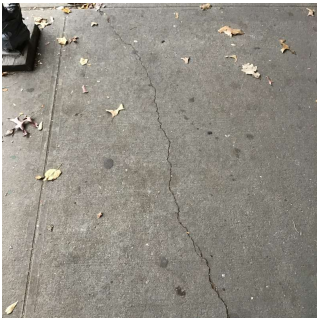
Violations	Bay 22nd Street No violations recorded.
Deficiency	DAMAGED/DETERIORATED/MISSING SECTIONS
Deficiency Location/Instance	Bay 23rd Street, Bay 22nd Street, Benson Avenue
Deficiency Quantity	575
Quantity Uom	S.F.
Potential Action	REPLACE
Urgency of Action	PRIORITY 3
Purpose of Action	LEVEL 2
Deficiency Photo1

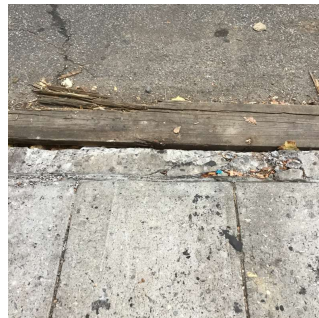
Violations	Bay 23rd Street No violations recorded.
Deficiency	DAMAGED CURBS
Deficiency Location/Instance	Benson Avenue, Bay 23rd Street, Bay 22nd Street
Deficiency Quantity	100
Quantity Uom	L.F.
Potential Action	REPLACE
Urgency of Action	PRIORITY 3
Purpose of Action	LEVEL 2
