NYC Department of Education
Building Condition Assessment Survey 2023 - 2024

Architectural Inspection

Asset: P.S. 207 - BROOKLYN, 4011 FILLMORE AVENUE, New York, 11234

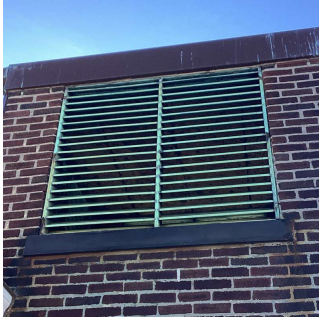
Question	Response
EXTERIOR	
EXTERIOR WALLS	
Material Type(s)	Masonry
Replacement Quantity	32,000
Replacement Uom	S.F.
Instance on All Facades	Under Construction
Instance Quantity	32,000
Instance Quantity Uom	S.F.
EXTERIOR SOFFITS	Does not Exist
LOADING DOCK	Does not Exist
LOUVER	Inspected
Condition	3 - Fair
Deficiency	MISSING/DAMAGED SCREEN
Roof Plan reference	K207
Elevation

Deficiency Quantity	40
Quantity Uom	S.F.
Potential Action	REPLACE
Urgency of Action	PRIORITY 4
Purpose of Action	LEVEL 2
Deficiency Photo1

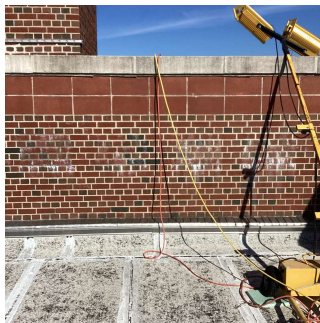
Deficiency	BRICK: EFFLORESCENCE
Roof Plan reference	K207

50
 S.F.
 MAINTENANCE
 PRIORITY 1

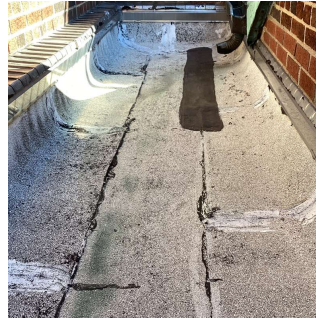
Roof 2 - Near BH2

Roof 1
Instance Quantity	24,000
Instance Quantity Uom	S.F.
Does the roof have major mechanical equipment sitting on Dunnage Steel less than 18" above the Roofing?	No
Does this roof instance have a Sustainable Roof System?	Yes
Sustainable Roof Type	White Roof
Sustainable Roof Location (Roof Number)	Roofs 1 - 6
Do solar panels exist on these roofs?	No
Is/Are the roof(s) suitable for Solar Panel installation?	Yes
Installation Year	2014
Source of Installation	Custodial Staff
Deficiency	MODIFIED BITUMEN: ROOFING: DELAMINATION
Roof Plan reference	K207

REPLACE ROOFING WITHOUT MAJOR EQUIPMENT REMOVAL

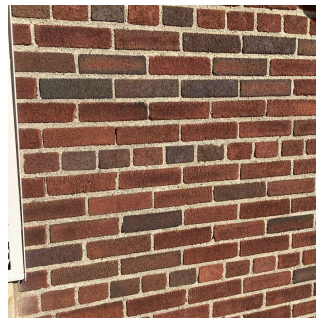
BULKHEAD/PENTHOUSE WALLS/EXTERIOR: DETERIORATED JOINTS

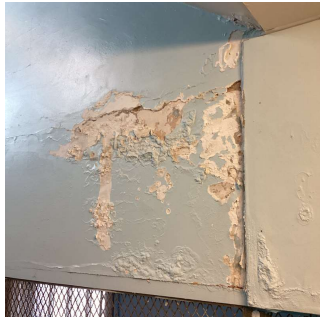
BULKHEAD/PENTHOUSE WALLS/EXTERIOR: WATER
INFILTRATION

REPAIR

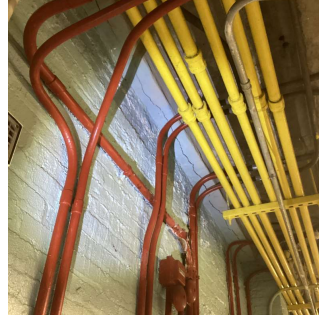
Question	Response
INTERIOR	
STRUCTURAL	
COLUMNS/BEAMS/BEARING WALLS	
Urgency of Action	PRIORITY 4
Purpose of Action	LEVEL 5
Deficiency Photo1

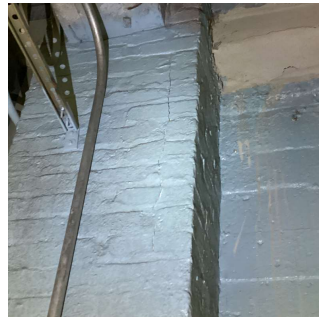
Violations	Boiler Room No violations recorded.
Deficiency	STEEL COLUMNS/BEAMS: DETERIORATED MASONRY FIREPROOFING
Deficiency Location/Instance	Basement - Near Paint Storage Room
Deficiency Quantity	10
Quantity Uom	S.F.
Potential Action	REPLACE
Urgency of Action	PRIORITY 3
Purpose of Action	LEVEL 5
Deficiency Photo1

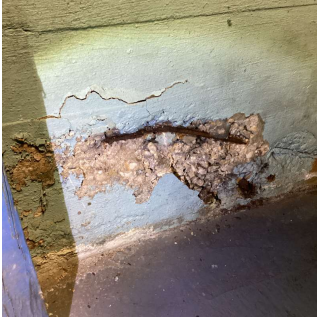
Question	Response
INTERIOR	
STRUCTURAL	
FLOOR STRUCTURE	Inspected
	Basement Staff Toilet Room
Violations	No violations recorded.
Deficiency	CONCRETE SLAB ON GRADE: THRU CRACKS
Deficiency Location/Instance	Basement - Boiler Room, NorthSide
Deficiency Quantity	300
Quantity Uom	S.F.
Potential Action	REPAIR
Urgency of Action	PRIORITY 3
Purpose of Action	LEVEL 5
Deficiency Photo1	 
	Boiler Room
Violations	No violations recorded.
FOUNDATION WALLS	Inspected
Material Type(s)	Concrete, Masonry
Condition	4 - Between Fair and Poor
Deficiency	CONCRETE: WATER INFILTRATION IN NON- INSTRUCTIONAL SPACE
Deficiency Location/Instance	Basement - East Side, Supply Room
Deficiency Quantity	200
Quantity Uom	S.F.
Potential Action	INSTALL WATERPROOFING
Urgency of Action	PRIORITY 5
Purpose of Action	LEVEL 5
Deficiency Photo1	 
	Basement - East Side
Violations	No violations recorded.
Deficiency	CONCRETE: CRACKED/SPALLED/REINFORCEMENT EXPOSED
Deficiency Location/Instance	Basement - Near Gas Meter Room

Question	Response
INTERIOR	
STRUCTURAL	
FOUNDATION WALLS	
Potential Action	REPAIR
Urgency of Action	PRIORITY 4
Purpose of Action	LEVEL 5
Deficiency Photo1

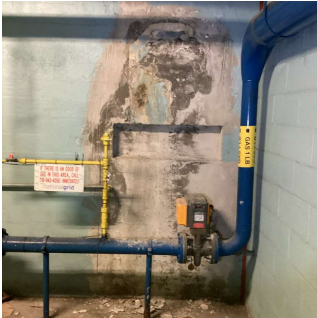
Basement - Near Gas Meter Room
Violations	No violations recorded.
Deficiency	CONCRETE: WATER INFILTRATION IN NON- INSTRUCTIONAL SPACE
Deficiency Location/Instance	Basement - Gas Meter Room
Deficiency Quantity	100
Quantity Uom	S.F.
Potential Action	INSTALL WATERPROOFING
Urgency of Action	PRIORITY 5
Purpose of Action	LEVEL 5
Deficiency Photo1

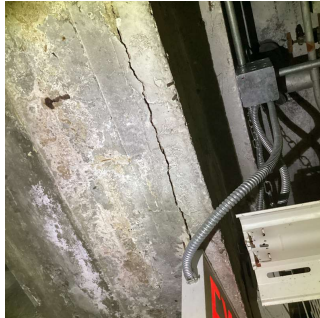
Violations	Storage Vault No violations recorded.
Slab Structure	Inspected
Condition	3 - Fair
Deficiency	STEEL COLUMNS/BEAMS: DETERIORATED CONCRETE FIREPROOFING
Deficiency Location/Instance	Basement - Ash Hoist Vault
Deficiency Quantity	20
Quantity Uom	S.F.
Potential Action	REPAIR
Urgency of Action	PRIORITY 5
Purpose of Action	LEVEL 6
Deficiency Photo1

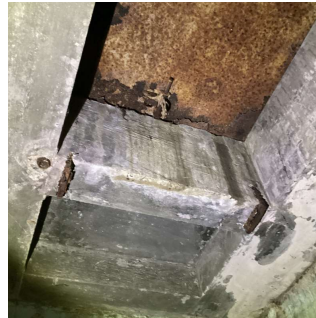
Violations	Ash Hoist Vault No violations recorded.
Vault/Ash Hoist Doors and Framing	Inspected
Condition	5 - Poor
Deficiency	WATER INFILTRATION
Deficiency Location/Instance	Basement - Ash Hoist Vault
Deficiency Quantity	10
Quantity Uom	S.F.
Potential Action	REPAIR
Urgency of Action	PRIORITY 5
Purpose of Action	LEVEL 2

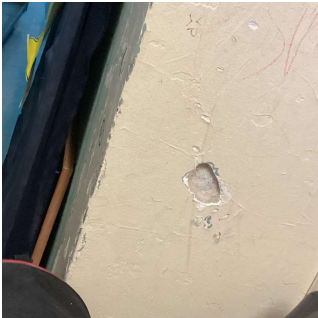
Question	Response
INTERIOR	
AUDITORIUM	
Stage	
Stage	Inspected
Instance on 1st Floor (431 Seats)	Inspected
Condition	2 - Between Good and Fair
Deficiency	No deficiencies recorded
Stage Curtain Rigging	Inspected
Instance on 1st Floor (431 Seats)	Inspected
Condition	1 - Good
Deficiency	No deficiencies recorded
Stage Curtains	Inspected
Instance on 1st Floor (431 Seats)	Inspected
Condition	1 - Good
Deficiency	No deficiencies recorded
Walls	
Instance on 1st Floor (431 Seats)	Inspected
Condition	2 - Between Good and Fair
Deficiency	PLASTER: CRACKS/SPALLING
Deficiency Location/Instance	Room by Right Stage
Deficiency Quantity	10
Quantity Uom	S.F.
Potential Action	REPLACE
Urgency of Action	PRIORITY 3
Purpose of Action	LEVEL 2
Deficiency Photo1

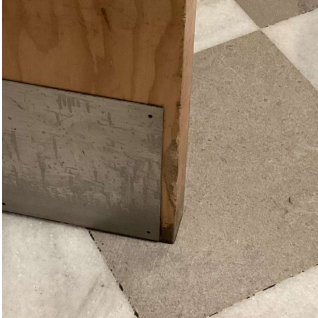
CAFETERIA	
Instance on 1st Floor	Inspected
Ceiling	
Instance on 1st Floor	Inspected
Condition	2 - Between Good and Fair
Deficiency	No deficiencies recorded
Door(s)	
Instance on 1st Floor	Inspected
Condition	3 - Fair
Deficiency	WOOD: DETERIORATED DOOR

Question	Response
INTERIOR	
CAFETERIA	
Door(s)	
Deficiency Location/Instance	Entrance leading to the Auditorium side
Deficiency Quantity	1
Quantity Uom	EACH
Potential Action	MAINTENANCE
Urgency of Action	PRIORITY 3
Purpose of Action	LEVEL 2
Deficiency Photo1

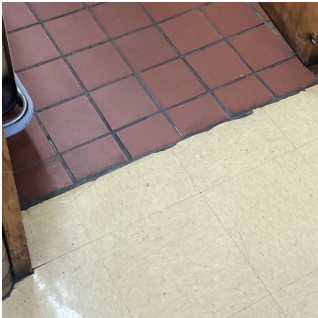
Violations	Entrance leading to the Auditorium side No violations recorded.
Fixed Equipment	
Instance on 1st Floor	Does not Exist
Floor Finish	
Instance on 1st Floor	Inspected
Condition	2 - Between Good and Fair
Deficiency	VINYL TILES: BROKEN/DETERIORATED/MISSING TILES
Deficiency Location/Instance	Near the Kitchen, by the Drinking Fountain
Deficiency Quantity	10
Quantity Uom	S.F.
Potential Action	REPLACE
Urgency of Action	PRIORITY 3
Purpose of Action	LEVEL 2
Deficiency Photo1

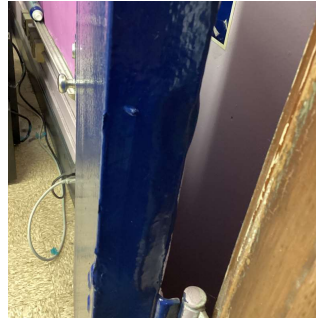
Exit AB Vestibule
Violations	No violations recorded.
Window Curtains/Shades/Blinds	
Instance on 1st Floor	Does not Exist
CLASSROOMS/CORRIDORS/ADMIN SPACES	
Ceiling	Inspected
Condition	2 - Between Good and Fair
Deficiency	No deficiencies recorded
Door(s)	Inspected
Condition	5 - Poor
Deficiency	METAL: DETERIORATED DOOR
Deficiency Location/Instance	Room 263

Quantity Uom	EACH
Potential Action	MAINTENANCE
Urgency of Action	PRIORITY 3
Purpose of Action	LEVEL 2
Deficiency Photo1

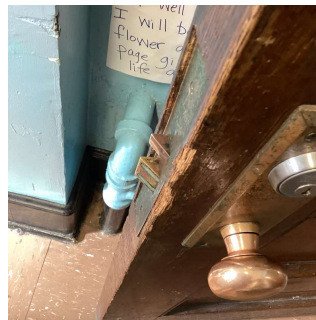
Room 313

Deficiency	WOOD: DETERIORATED DOOR
Deficiency Location/Instance	Rooms 105, 107, 201, 208, 313, and others
Deficiency Quantity	15
Quantity Uom	EACH
Potential Action	MAINTENANCE
Urgency of Action	PRIORITY 3
Purpose of Action	LEVEL 2
Deficiency Photo1

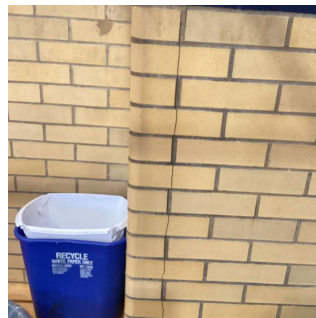
Near the windows

SALT GLAZED BRICK: CRACKS/SPALLING

REPLACE

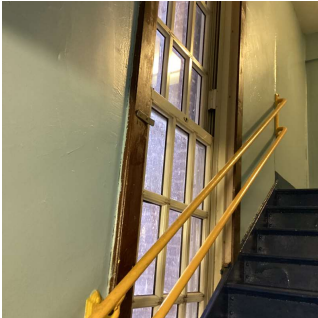
Question	Response
INTERIOR	
GYMNASIUM	Inspected
Walls	
Violations	No violations recorded.
Window Curtains/Shades/Blinds	
Instance on 3rd Floor	Does not Exist
INTERIOR DOOR HARDWARE	Inspected
Condition	3 - Fair
Deficiency	No deficiencies recorded
INTERIOR GUARDS	Inspected
Condition	3 - Fair
Deficiency	DETERIORATED/TORN-OUT/MISSING
Deficiency Location/Instance	Stairs EF/2, I/2
Deficiency Quantity	50
Quantity Uom	S.F.
Potential Action	REPLACE
Urgency of Action	PRIORITY 3
Purpose of Action	LEVEL 2
Deficiency Photo1

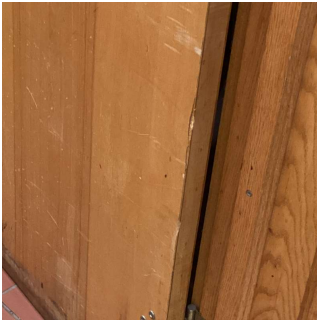
Violations	No violations recorded.
KITCHEN	Inspected
Instance on 1st Floor	Inspected
Ceiling	
Instance on 1st Floor	Inspected
Condition	2 - Between Good and Fair
Deficiency	No deficiencies recorded
Door(s)	
Instance on 1st Floor	Inspected
Condition	4 - Between Fair and Poor
Deficiency	WOOD: DETERIORATED DOOR
Deficiency Location/Instance	Main Entrance, Storage Room
Deficiency Quantity	2
Quantity Uom	EACH
Potential Action	MAINTENANCE

Main Entrance
Violations	No violations recorded.
Floor Finish	
Instance on 1st Floor	Inspected
Condition	2 - Between Good and Fair
Deficiency	QUARRY TILE: BROKEN/MISSING TILES
Deficiency Location/Instance	Food Preparation Area
Deficiency Quantity	10
Quantity Uom	S.F.
Potential Action	REPLACE
Urgency of Action	PRIORITY 3
Purpose of Action	LEVEL 2
Deficiency Photo1

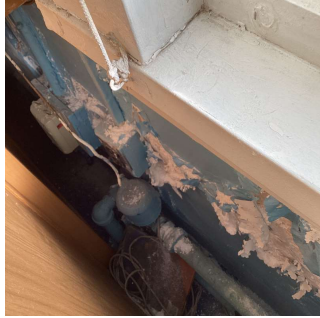
Question	Response
INTERIOR	
LIBRARY	
Floor Finish	
Instance on Room 315	Inspected
Condition	2 - Between Good and Fair
Deficiency	No deficiencies recorded
Walls	
Instance on Room 315	Inspected
Condition	2 - Between Good and Fair
Deficiency	PLASTER: CRACKS/SPALLING
Deficiency Location/Instance	Near the windows
Deficiency Quantity	30
Quantity Uom	S.F.
Potential Action	REPLACE
Urgency of Action	PRIORITY 3
Purpose of Action	LEVEL 2
Deficiency Photo1

Near the windows
Violations	No violations recorded.
LOCKER ROOM	Does not Exist
MULTI-PURPOSE ROOM	Does not Exist
SCIENCE DEMO ROOM	Does not Exist
SCIENCE LAB	Does not Exist
SCIENCE PREP ROOM	Does not Exist
SHOWER ROOM	Does not Exist
STAIRS/RAMPS: INTERIOR	Inspected
Do Letter Stair Signs Exist?	Partially
Ceiling	
Condition	2 - Between Good and Fair
Deficiency	PLASTER: CRACKS/SPALLING
Deficiency Location/Instance	Stairs CD/3, EF/1 Vestibule, I/1 Vestibule
Deficiency Quantity	30

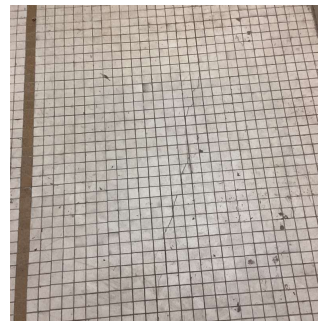
Stair I/1 Vestibule

CERAMIC TILE: BROKEN/MISSING

REPLACE

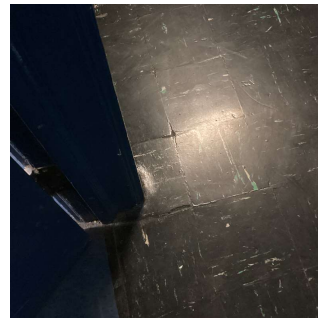
Stair EF/1

VINYL TILES: BROKEN/DETERIORATED/MISSING TILES

REPLACE

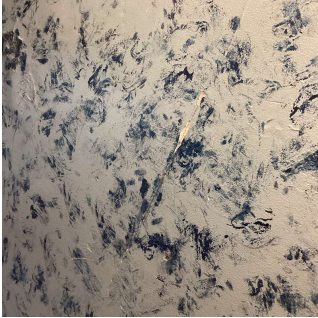
Question	Response
INTERIOR	
STAIRS/RAMPS: INTERIOR	
Walls	Inspected
Condition	2 - Between Good and Fair
Deficiency	GYPSUM BOARD: DETERIORATED
Deficiency Location/Instance	Stair CD/Between 2nd Floor and 3rd Floor
Deficiency Quantity	10
Quantity Uom	S.F.
Potential Action	REPLACE
Urgency of Action	PRIORITY 3
Purpose of Action	LEVEL 2
Deficiency Photo1

Violations	Stair CD/Between 2nd Floor and 3rd Floor No violations recorded.
Deficiency	BRICK: CRACKS/SPALLING
Deficiency Location/Instance	Stair I/1 Vestibule
Deficiency Quantity	10
Quantity Uom	S.F.
Potential Action	REPLACE
Urgency of Action	PRIORITY 3
Purpose of Action	LEVEL 2
Deficiency Photo1

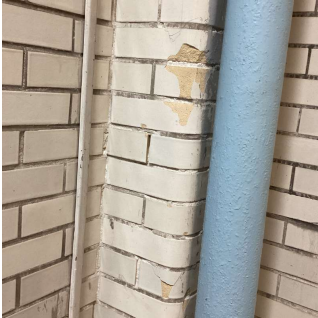
Violations	Stair I/1 Vestibule No violations recorded.
Deficiency	PLASTER: CRACKS/SPALLING
Deficiency Location/Instance	Stair I/1 Vestibule,3
Deficiency Quantity	50
Quantity Uom	S.F.
Potential Action	REPLACE
Urgency of Action	PRIORITY 3
Purpose of Action	LEVEL 2

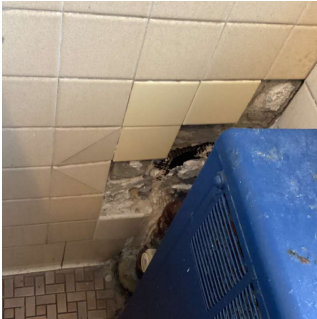
Room 256
Violations	No violations recorded.
Walls	Inspected
Condition	2 - Between Good and Fair
Deficiency	CERAMIC TILE: BROKEN/ MISSING
Deficiency Location/Instance	Rooms 256, 364, 4th Floor Men
Deficiency Quantity	20
Quantity Uom	S.F.
Potential Action	REPLACE
Urgency of Action	PRIORITY 3
Purpose of Action	LEVEL 2
Deficiency Photo1

4th Floor Men
Violations	No violations recorded.
TOILET ROOMS - STUDENTS	
Ceiling	Inspected
Condition	2 - Between Good and Fair
Deficiency	No deficiencies recorded
Door(s)	Inspected
Condition	5 - Poor
Deficiency	WOOD: DETERIORATED DOOR
Deficiency Location/Instance	1st Floor Boys
Deficiency Quantity	1
Quantity Uom	EACH
Potential Action	MAINTENANCE
Urgency of Action	PRIORITY 3
Purpose of Action	LEVEL 2

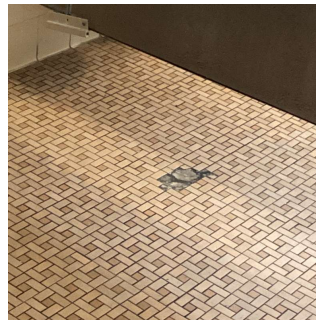
1st Floor Boys

CERAMIC TILE: BROKEN/MISSING TILES

REPLACE

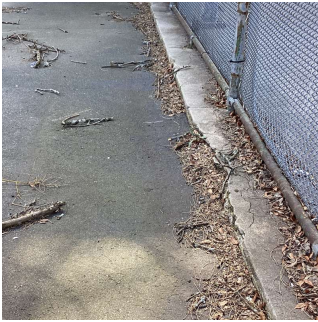
Question	Response
SITE	
Drainage System for Soil	Does not Exist
DRINKING FOUNTAINS	Does not Exist
FENCES	Inspected
Condition	4 - Between Fair and Poor
Deficiency	CONCRETE CURB: DAMAGED/DETERIORATED
Deficiency Location/Instance	Schoolyard
Deficiency Quantity	160
Quantity Uom	S.F.
Potential Action	REPLACE
Urgency of Action	PRIORITY 3
Purpose of Action	LEVEL 2
Deficiency Photo1

Violations	Schoolyard No violations recorded.
Deficiency	CHAIN LINK: DAMAGED POST/RAIL
Deficiency Location/Instance	Schoolyard
Deficiency Quantity	30
Quantity Uom	L.F.
Potential Action	REPLACE
Urgency of Action	PRIORITY 3
Purpose of Action	LEVEL 2
Deficiency Photo1

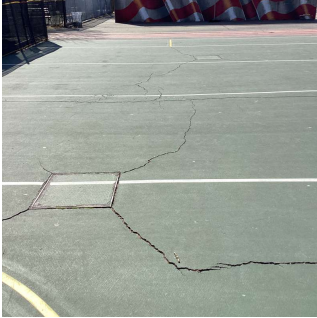
Violations	Schoolyard No violations recorded.
IRRIGATION SYSTEM	Does not Exist
PAVING	Inspected
Student Non-Use	Inspected
Gravel Exists?	No
Asphalt	Inaccessible
Concrete	Inaccessible
Pavers	Does not Exist
Student Use	Inspected
Gravel Exists?	No
Asphalt	Inspected
Condition	4 - Between Fair and Poor
Deficiency	CRACKS - MAJOR
Deficiency Location/Instance	Schoolyard
Deficiency Quantity	1,200
Quantity Uom	S.F.
Potential Action	REPLACE
Urgency of Action	PRIORITY 3
Purpose of Action	LEVEL 2
Deficiency Photo1

Violations	Schoolyard No violations recorded.
Concrete	Does not Exist
Pavers	Inspected
Condition	3 - Fair
Deficiency	HEAVING
Deficiency Location/Instance	Schoolyard
Deficiency Quantity	50
Quantity Uom	S.F.

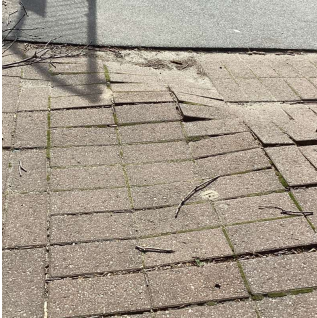
Question	Response
SITE	
PAVING	
Student Use	
Pavers	
Potential Action	REPLACE
Urgency of Action	PRIORITY 3
Purpose of Action	LEVEL 2
Deficiency Photo1

Schoolyard
Violations	No violations recorded.
Site Sidewalks & Walkways	Inspected
Asphalt	Does not Exist
Concrete	Inspected
Condition	2 - Between Good and Fair
Deficiency	No deficiencies recorded
Pavers	Does not Exist
DOT Sidewalk	Inspected
Asphalt	Does not Exist
Concrete	Inspected
Condition	4 - Between Fair and Poor
Deficiency	DAMAGED CURBS
Deficiency Location/Instance	Kimball Street, Coleman Street
Deficiency Quantity	60
Quantity Uom	L.F.
Potential Action	REPLACE
Urgency of Action	PRIORITY 3
Purpose of Action	LEVEL 2
Deficiency Photo1

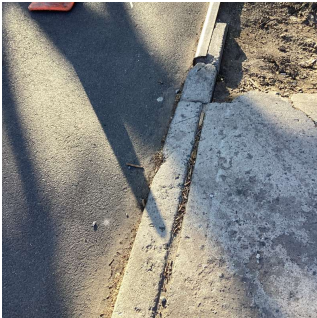
Coleman Street
Violations	No violations recorded.
Deficiency	HEAVING
Deficiency Location/Instance	Kimball Street
Deficiency Quantity	25

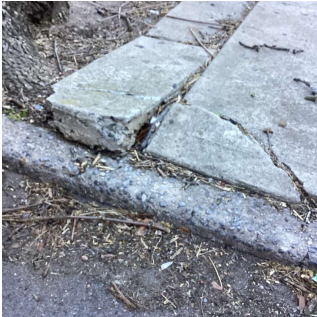
Question	Response
SITE	
PAVING	
DOT Sidewalk	
Concrete	
Quantity Uom	S.F.
Potential Action	REPLACE
Urgency of Action	PRIORITY 5
Purpose of Action	LEVEL 6
Deficiency Photo1

Kimball Street
Violations	No violations recorded.
Deficiency	HEAVING
Deficiency Location/Instance	Kimball Street, Fillmore Avenue, Coleman Street
Deficiency Quantity	100
Quantity Uom	S.F.
Potential Action	REPLACE
Urgency of Action	PRIORITY 3
Purpose of Action	LEVEL 2
Deficiency Photo1

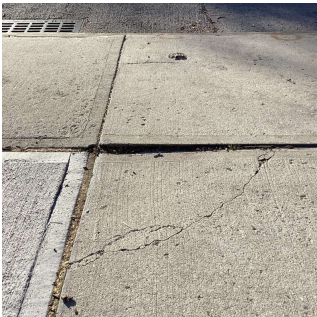
Fillmore Avenue
Violations	No violations recorded.
Deficiency	DAMAGED/DETERIORATED/MISSING SECTIONS
Deficiency Location/Instance	Kimball Street, Fillmore Avenue, Coleman Street
Deficiency Quantity	500
Quantity Uom	S.F.
Potential Action	REPLACE
Urgency of Action	PRIORITY 3
Purpose of Action	LEVEL 2

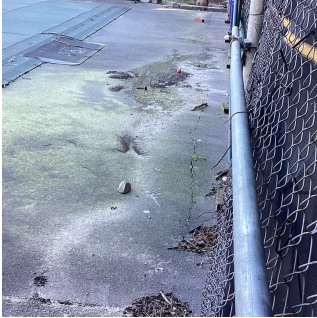
Question	Response
SITE	
PAVING	
DOT Sidewalk	
Concrete	
Deficiency Photo1	 
Violations	Coleman Street No violations recorded.
Pavers	Does not Exist
PLAYGROUNDS	Inspected
Instance on Schoolyard	Inspected
Benches	
Instance on Schoolyard	Inspected
Condition	2 - Between Good and Fair
Deficiency	No deficiencies recorded
Fence	
Instance on Schoolyard	Inspected
Condition	3 - Fair
Deficiency	CHAIN LINK: DAMAGED/DETERIORATED
Deficiency Location/Instance	Schoolyard
Deficiency Quantity	50
Quantity Uom	S.F.
Potential Action	REPLACE
Urgency of Action	PRIORITY 3
Purpose of Action	LEVEL 2
Deficiency Photo1	 
Violations	Schoolyard No violations recorded.
Pavement	
Instance on Schoolyard	Inspected
Condition	2 - Between Good and Fair
Deficiency	ASPHALT: CRACKS - MAJOR
Deficiency Location/Instance	Schoolyard
Deficiency Quantity	20
Quantity Uom	S.F.

Question	Response
SITE	
PLAYGROUNDS	
Pavement	
Potential Action	REPLACE
Urgency of Action	PRIORITY 3
Purpose of Action	LEVEL 2
Deficiency Photo1

Violations	Schoolyard No violations recorded.
Play Equipment	
Instance on Schoolyard	Inspected
Condition	2 - Between Good and Fair
Deficiency	No deficiencies recorded
Safety Surfacing	
Instance on Schoolyard	Inspected
Condition	3 - Fair
Deficiency	DETERIORATED/MISSING
Deficiency Location/Instance	Schoolyard
Deficiency Quantity	100
Quantity Uom	S.F.
Potential Action	REPLACE
Urgency of Action	PRIORITY 3
Purpose of Action	LEVEL 2
Deficiency Photo1

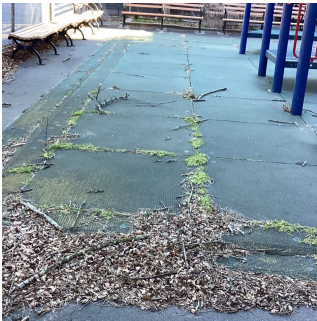
Violations	Schoolyard No violations recorded.
Unpaved Area	
Instance on Schoolyard	Inspected
Condition	2 - Between Good and Fair
Deficiency	No deficiencies recorded
PLAYING SURFACE	
	Does not Exist
RETAINING WALLS	
	Does not Exist
SEATING	
	Inspected
Benches	
	Inspected

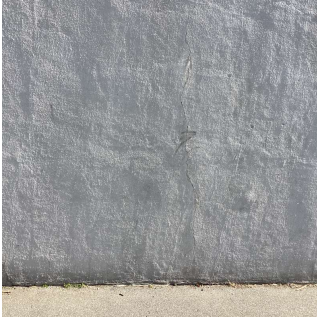
Question	Response
SITE	
SEATING	
Benches	
Concrete	Does not Exist
Metal/Wood/Plastic	Inspected
Condition	2 - Between Good and Fair
Deficiency	No deficiencies recorded
Bleachers	Does not Exist
SITE WALLS (NOT RETAINING WALLS)	Inspected
Condition	3 - Fair
Deficiency	CAST IN PLACE CONCRETE: CRACKS/SPALLING - MINOR
Deficiency Location/Instance	Schoolyard - Handball Wall
Deficiency Quantity	60
Quantity Uom	S.F.
Potential Action	REPAIR
Urgency of Action	PRIORITY 3
Purpose of Action	LEVEL 2
Deficiency Photo1

Schoolyard - Handball Wall
Violations	No violations recorded.
STAIRS/RAMPS: EXTERIOR	Does not Exist
ARTWORK	Does not Exist
