NYC Department of Education
Building Condition Assessment Survey 2023 - 2024

Architectural Inspection

Asset: P.S. 208 - BROOKLYN, 4801 AVENUE D, New York, 11203

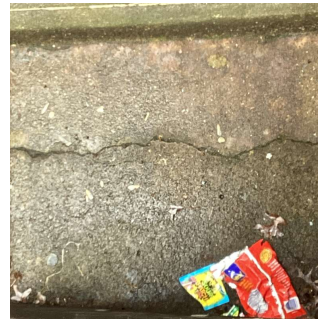
AW6

AREAWAY SLAB: CRACKS AND SPALLING

20

REPAIR

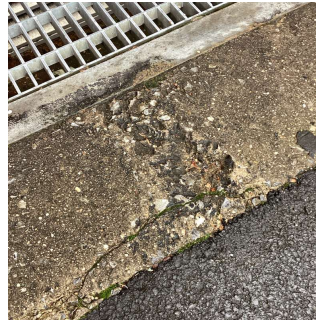
AW6
No violations recorded.

AREAWAY WALLS: CRACKS AND SPALLING

20

REPLACE

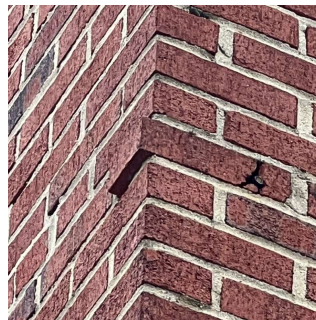
CH
No violations recorded.

BRICK: MAJOR / THRU CRACKS

10

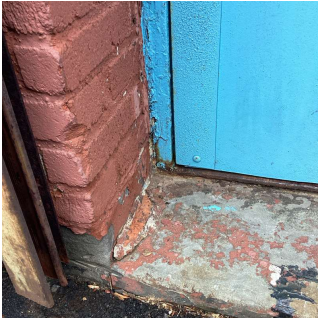
Violations	Roof 4 No violations recorded.
CORNICE	Inspected
Condition	2 - Between Good and Fair
Deficiency	No deficiencies recorded
DOORS	Inspected
DOORS AND FRAMES	Inspected
Condition	3 - Fair
Deficiency	METAL CLAD: DETERIORATED DOOR AND FRAME - MINOR DETERIORATION
Roof Plan reference	K208 EAST 49TH STREET

EAST 48TH STREET
Deficiency Quantity	1
Quantity Uom	EACH
Potential Action	MAINTENANCE
Urgency of Action	PRIORITY 3
Purpose of Action	LEVEL 2
Deficiency Photo1

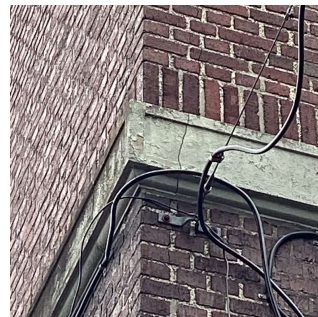
Facade B

STONE: CRACKS AT BUILDING CORNERS

10

REPLACE

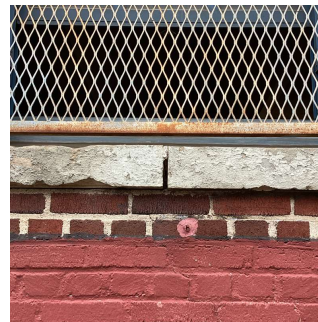
Facade F

BRICK: MASONRY SILLS - DETERIORATED JOINTS

10

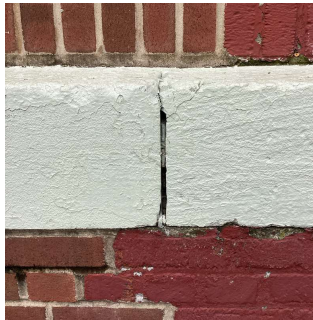
Facade C

STONE: DETERIORATED JOINTS

10

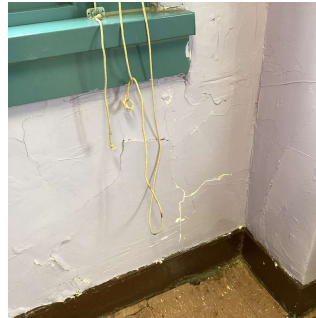
BRICK: WATER INFILTRATION IN INSTRUCTIONAL SPACE

Facade H - Room 315 (Facade A - Room 311, Facade B - Room 309, Facade G - Exit 11 Vestibule, Facade H - Rooms 215, 313, 316, Auditorium, Principal's Toilet Room similar)

REPAIR

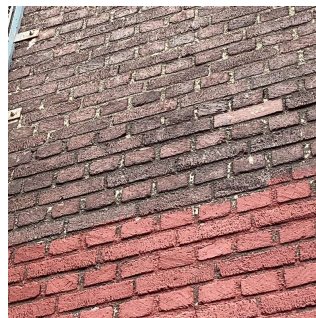
BRICK: DETERIORATED JOINTS

4,000
S.F.
REPOINT
PRIORITY 3
LEVEL 2

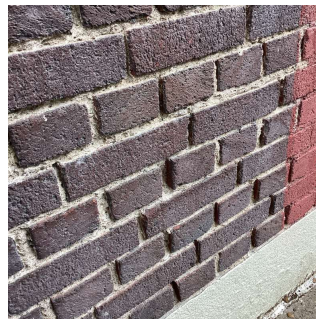
Deficiency
 BRICK: DETERIORATED JOINTS
 Roof Plan reference

80
 S.F.
 REPOINT
 PRIORITY 4
 LEVEL 2

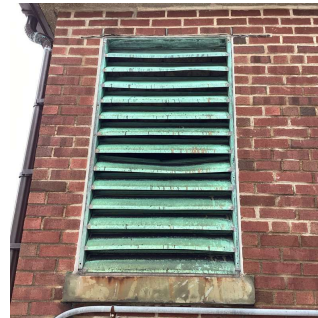
Roof 1 - by BH1

BROKEN/ DENTED BLADES

REPLACE

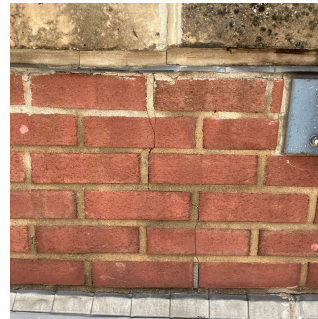
Roof 2

BRICK: MAJOR DETERIORATION/CRACKS

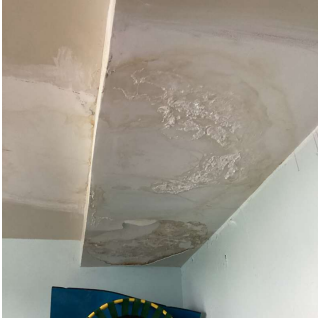
Deficiency MODIFIED BITUMEN: ROOFING: MAJOR ACTIVE ROOF LEAKS IN INSTRUCTIONAL SPACE

Deficiency Quantity	100
Quantity Uom	S.F.
Potential Action	REPLACE ROOFING WITHOUT MAJOR EQUIPMENT REMOVAL
Urgency of Action	PRIORITY 5
Purpose of Action	LEVEL 2
Deficiency Photo1

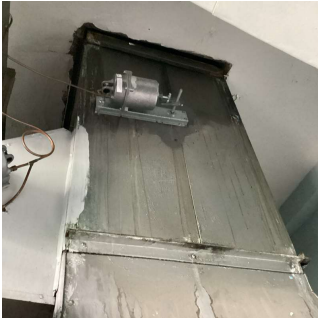
Question	Response
EXTERIOR	
ROOF	
Roofing	
ROOFING	
Violations	Roof 4 - Locker Room No violations recorded.
Deficiency	MODIFIED BITUMEN: ROOFING: MAJOR ACTIVE ROOF LEAKS IN NON-INSTRUCTIONAL SPACE
Roof Plan reference	K208

Deficiency Quantity	100
Quantity Uom	S.F.
Potential Action	REPLACE ROOFING WITHOUT MAJOR EQUIPMENT REMOVAL
Urgency of Action	PRIORITY 5
Purpose of Action	LEVEL 2
Deficiency Photo1

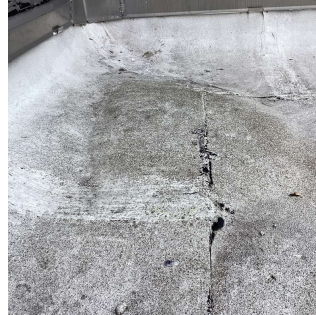
Roof 2

Violations	Roof 4 - Gymnasium Fan Room No violations recorded.
Deficiency	MODIFIED BITUMEN: ROOFING: DELAMINATION
Roof Plan reference	K208

Deficiency Quantity	30
Quantity Uom	S.F.
Potential Action	REPLACE ROOFING WITHOUT MAJOR EQUIPMENT REMOVAL
Urgency of Action	PRIORITY 4

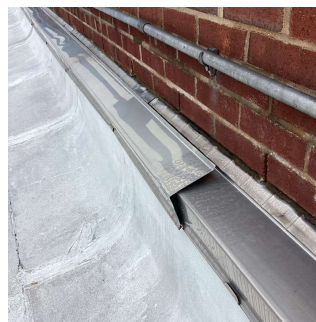
Roof 3

MODIFIED BITUMEN: FLASHING: CAP FLASHING DAMAGED

REPLACE

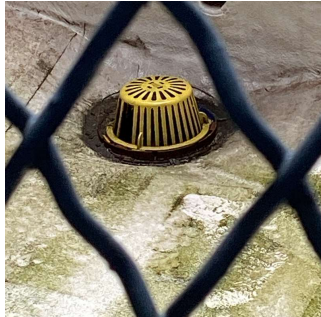
DETERIORATED

2
 EACH
 REPLACE
 PRIORITY 4
 LEVEL 2

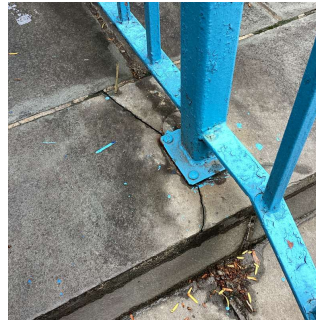
Facade A

STONE: CRACKS/SPALLING - MINOR

K208
 10
 S.F.
 REPAIR
 PRIORITY 3
 LEVEL 2

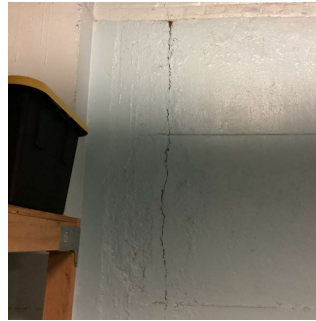
Question	Response
INTERIOR	
STRUCTURAL	
COLUMNS/BEAMS/BEARING WALLS	
Deficiency Photo1	 
Violations	Basement - Auditorium Fan Room No violations recorded.
Deficiency	STEEL COLUMNS/BEAMS: DETERIORATED CONCRETE FIREPROOFING
Deficiency Location/Instance	Basement - near Gas Meter Room
Deficiency Quantity	20
Quantity Uom	S.F.
Potential Action	REPLACE
Urgency of Action	PRIORITY 3
Purpose of Action	LEVEL 5
Deficiency Photo1	 
Violations	Basement - near Gas Meter Room No violations recorded.
FLOOR STRUCTURE	Inspected
Condition	2 - Between Good and Fair
Deficiency	No deficiencies recorded
FOUNDATION WALLS	Inspected
Material Type(s)	Concrete, Masonry
Condition	4 - Between Fair and Poor
Deficiency	CONCRETE: CRACKED/SPALLED/REINFORCEMENT EXPOSED
Deficiency Location/Instance	Basement - near Gas Meter Room
Deficiency Quantity	20
Quantity Uom	S.F.
Potential Action	REPAIR
Urgency of Action	PRIORITY 4
Purpose of Action	LEVEL 5

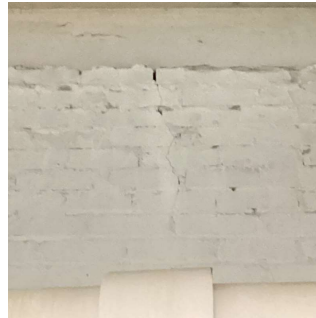
Basement - Auditorium Fan Room

BRICK: CRACKED/SPALLED

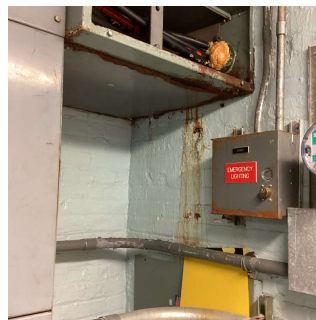
Basement - Electrical Panel Room

CONCRETE: WATER INFILTRATION IN ELECTRICAL PANEL ROOM

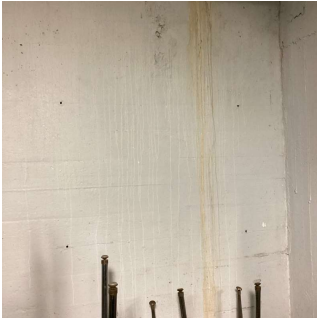
Question	Response
INTERIOR	
STRUCTURAL	
FOUNDATION WALLS	
Violations	No violations recorded.
Deficiency	CONCRETE: WATER INFILTRATION IN NON- INSTRUCTIONAL SPACE
Deficiency Location/Instance	Basement - Auditorium Fan Room
Deficiency Quantity	100
Quantity Uom	S.F.
Potential Action	INSTALL WATERPROOFING
Urgency of Action	PRIORITY 5
Purpose of Action	LEVEL 5
Deficiency Photo1

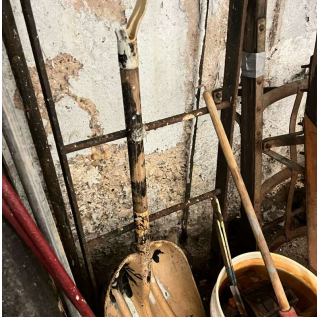
Violations	Basement - Auditorium Fan Room No violations recorded.
ROOF STRUCTURE	
Condition	Inspected 2 - Between Good and Fair
Deficiency	No deficiencies recorded
VAULTS-BUNKERS	
Foundation Walls	
Condition	Inspected 3 - Fair
Deficiency	CRACKS, SPALLING
Deficiency Location/Instance	Ash Hoist Vault
Deficiency Quantity	40
Quantity Uom	S.F.
Potential Action	REPAIR
Urgency of Action	PRIORITY 4
Purpose of Action	LEVEL 5
Deficiency Photo1

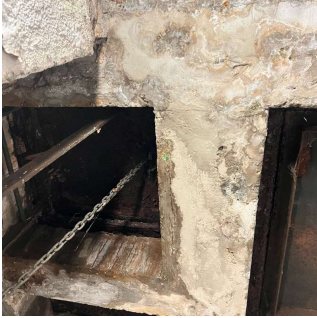
Question	Response
INTERIOR	
STRUCTURAL	
VAULTS-BUNKERS	
Slab Structure	
Deficiency	CONCRETE: WATER INFILTRATION IN NON- INSTRUCTIONAL SPACE
Deficiency Location/Instance	Ash Hoist Vault
Deficiency Quantity	100
Quantity Uom	S.F.
Potential Action	INSTALL WATERPROOFING
Urgency of Action	PRIORITY 5
Purpose of Action	LEVEL 5
Deficiency Photo1

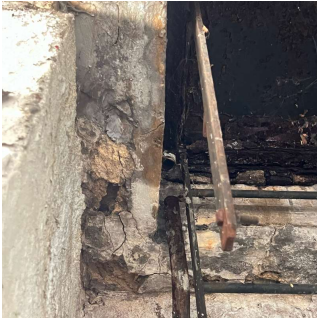
Violations	Ash Hoist Vault No violations recorded.
Deficiency	CONCRETE: CRACKS/SPALLED/REINFORCEMENT EXPOSED
Deficiency Location/Instance	Ash Hoist Vault
Deficiency Quantity	20
Quantity Uom	S.F.
Potential Action	REPAIR
Urgency of Action	PRIORITY 4
Purpose of Action	LEVEL 5
Deficiency Photo1

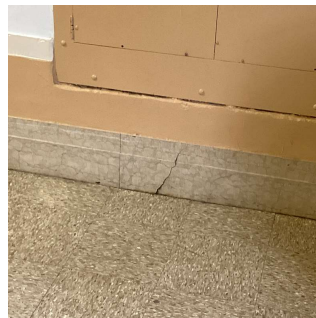
Along the entrance wall

STONE MOLDINGS: CRACKS/SPALLING

REPLACE

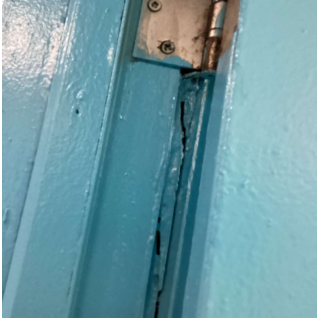
Question	Response
INTERIOR	
CAFETERIA	
Door(s)	
Instance on 1st Floor	Inspected
Condition	5 - Poor
Deficiency	METAL CLAD WOOD: DETERIORATED DOOR AND FRAME
Deficiency Location/Instance	Entrance near Stair A side
Deficiency Quantity	2
Quantity Uom	EACH
Potential Action	MAINTENANCE
Urgency of Action	PRIORITY 3
Purpose of Action	LEVEL 2
Deficiency Photo1

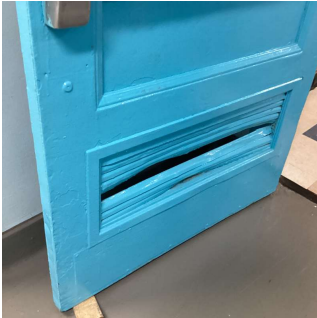
Violations	Entrance near Stair A side No violations recorded.
Deficiency	METAL CLAD WOOD: DAMAGED LOUVER
Deficiency Location/Instance	Entrance near Stair B side
Deficiency Quantity	2
Quantity Uom	EACH
Potential Action	MAINTENANCE
Urgency of Action	PRIORITY 3
Purpose of Action	LEVEL 2
Deficiency Photo1

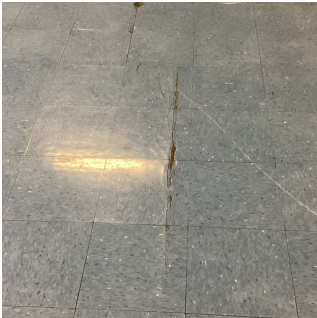
Violations	Entrance near Stair B side No violations recorded.
Fixed Equipment	
Instance on 1st Floor	Inspected
Condition	2 - Between Good and Fair
Deficiency	No deficiencies recorded
Floor Finish	
Instance on 1st Floor	Inspected
Condition	5 - Poor
Deficiency	VINYL TILES: DETERIORATED SUBSTRATE

Deficiency Location/Instance	Near the entrance, side, center

Question	Response
INTERIOR	
CAFETERIA	
Floor Finish	
Deficiency Quantity	500
Quantity Uom	S.F.
Potential Action	REPLACE
Urgency of Action	PRIORITY 3
Purpose of Action	LEVEL 2
Deficiency Photo1

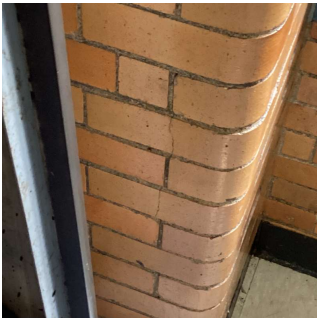
Violations	Near the center No violations recorded.
Sliding-folding Partition	
Instance on 1st Floor	Does not Exist
Stage	
Instance on 1st Floor	Does not Exist
Walls	
Instance on 1st Floor	Inspected
Condition	2 - Between Good and Fair
Deficiency	SALT GLAZED BRICK: CRACKS/SPALLING
Deficiency Location/Instance	Near the windows
Deficiency Quantity	10
Quantity Uom	S.F.
Potential Action	REPLACE
Urgency of Action	PRIORITY 3
Purpose of Action	LEVEL 2
Deficiency Photo1

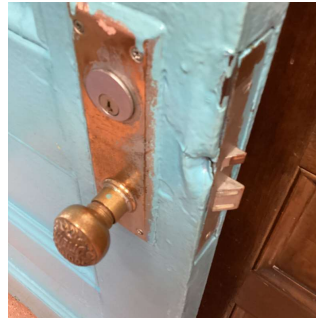
Room 315

METAL CLAD WOOD: DETERIORATED DOOR

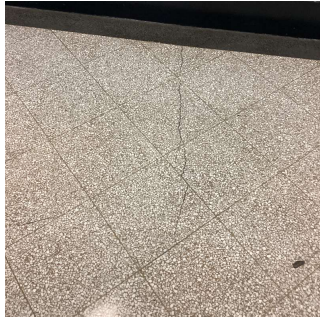
Question	Response
INTERIOR	
CLASSROOMS/CORRIDORS/ADMIN SPACES	
Floor Finish	
Violations	Room 309 No violations recorded.
Deficiency	TERRAZZO: CRACKS
Deficiency Location/Instance	Corridor near Room 110, by Stair E/1, in Exit 8, 9 Vestibule
Deficiency Quantity	30
Quantity Uom	S.F.
Potential Action	REPLACE
Urgency of Action	PRIORITY 3
Purpose of Action	LEVEL 2
Deficiency Photo1

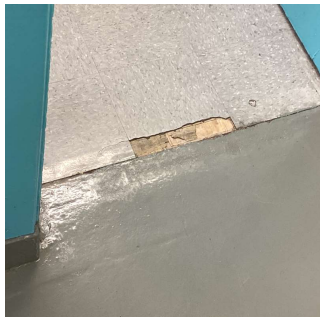
Violations	Corridor near Stair E/1 No violations recorded.
Deficiency	VINYL TILES: BROKEN/DETERIORATED/MISSING TILES
Deficiency Location/Instance	Rooms 206, 262, 264
Deficiency Quantity	40
Quantity Uom	S.F.
Potential Action	REPLACE
Urgency of Action	PRIORITY 3
Purpose of Action	LEVEL 2
Deficiency Photo1

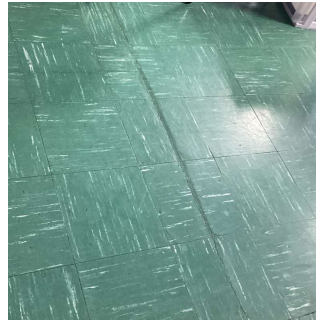
Room 103

Violations	Room 206 No violations recorded.
Deficiency	VINYL TILES: DETERIORATED SUBSTRATE
Deficiency Location/Instance	Rooms 103, 106, 110, 302, 315, and others
Deficiency Quantity	600
Quantity Uom	S.F.
Potential Action	REPLACE
Urgency of Action	PRIORITY 3

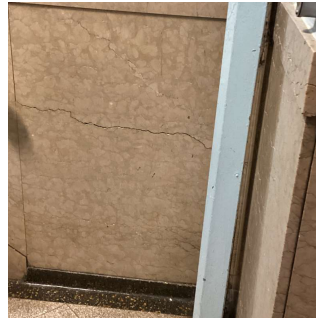
Exit 9 Vestibule (Main Entrance)

STONE: CRACKS/SPALLING

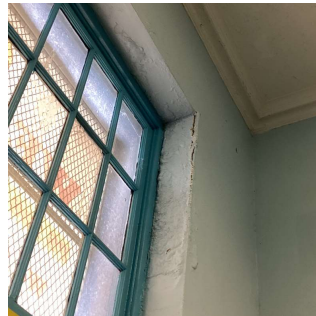
PLASTER: CRACKS/SPALLING

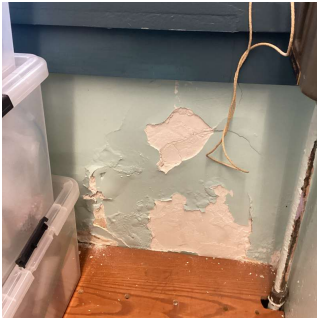
Question	Response
INTERIOR	
CLASSROOMS/CORRIDORS/ADMIN SPACES	
Walls	
Violations	Exit 9 Vestibule (Main Entrance) No violations recorded.
Deficiency	PLASTER: CRACKS/SPALLING - ACTIVE LEAK
Deficiency Location/Instance	Rooms 309, 311, 313, 315, 316
Deficiency Quantity	200
Quantity Uom	S.F.
Potential Action	REPLACE
Urgency of Action	PRIORITY 5
Purpose of Action	LEVEL 2
Deficiency Photo1

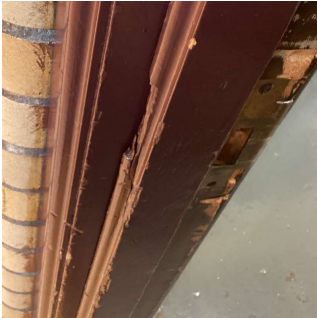
Violations	Room 316 No violations recorded.
Specialties	Does not Exist
GYMNASIUM	
Instance on 3rd Floor	Inspected
Ceiling	Inspected
Instance on 3rd Floor	Inspected
Condition	2 - Between Good and Fair
Deficiency	No deficiencies recorded
Door(s)	
Instance on 3rd Floor	Inspected
Condition	3 - Fair
Deficiency	WOOD: DETERIORATED DOOR AND FRAME
Deficiency Location/Instance	Office
Deficiency Quantity	1
Quantity Uom	EACH
Potential Action	MAINTENANCE
Urgency of Action	PRIORITY 3
Purpose of Action	LEVEL 2
Deficiency Photo1

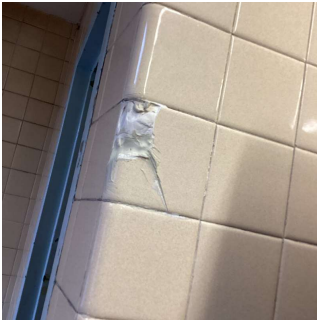
Violations	Office/Storage Room No violations recorded.
Walls	
Instance on 1st Floor	Inspected
Condition	2 - Between Good and Fair
Deficiency	CERAMIC TILE: BROKEN/ MISSING
Deficiency Location/Instance	Near the Storage Room
Deficiency Quantity	10
Quantity Uom	S.F.
Potential Action	REPLACE
Urgency of Action	PRIORITY 3
Purpose of Action	LEVEL 2
Deficiency Photo1

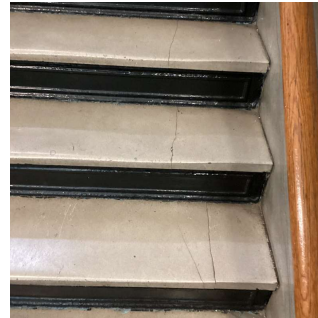
Stair A/1

STONE: BROKEN/MISSING

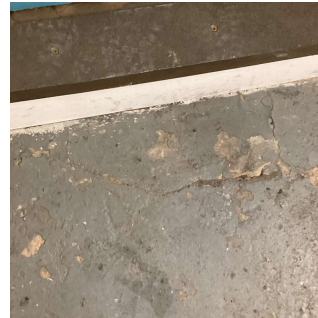
Stair E/Bulkhead

CONCRETE: CRACKS/SPALLING - MAJOR

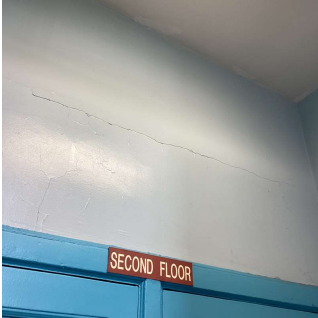
Question	Response
INTERIOR	
STAIRS/RAMPS: INTERIOR	
Walls	Inspected
Condition	2 - Between Good and Fair
Deficiency	PLASTER: CRACKS/SPALLING
Deficiency Location/Instance	Stair C/Vestibule, 1, 2
Deficiency Quantity	40
Quantity Uom	S.F.
Potential Action	REPLACE
Urgency of Action	PRIORITY 3
Purpose of Action	LEVEL 2
Deficiency Photo1

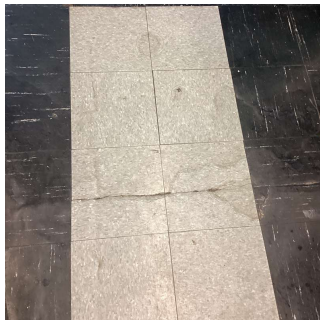
Room 258
Violations	No violations recorded.
Floor Finish	Inspected
Condition	4 - Between Fair and Poor
Deficiency	VINYL TILES: DETERIORATED SUBSTRATE
Deficiency Location/Instance	1st Floor Staff
Deficiency Quantity	10
Quantity Uom	S.F.
Potential Action	REPLACE
Urgency of Action	PRIORITY 3
Purpose of Action	LEVEL 2
Deficiency Photo1

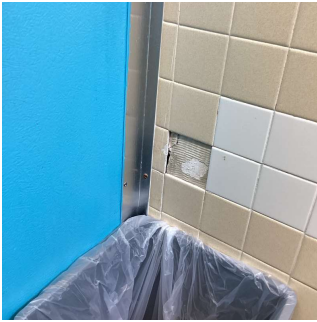
Room 353A
Violations	No violations recorded.
Stalls	Inspected
Condition	2 - Between Good and Fair
Deficiency	No deficiencies recorded
Walls	Inspected
Condition	2 - Between Good and Fair
Deficiency	CERAMIC TILE: BROKEN/ MISSING
Deficiency Location/Instance	Rooms 258, 315, 353A, 356, 1st Floor Staff
Deficiency Quantity	40
Quantity Uom	S.F.
Potential Action	REPLACE
Urgency of Action	PRIORITY 3
Purpose of Action	LEVEL 2
Deficiency Photo1

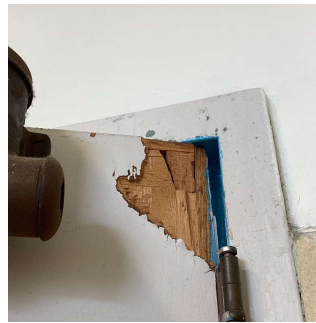
Room 353A
Violations	No violations recorded.
TOILET ROOMS - STUDENTS	
	Inspected
Ceiling	Inspected
Condition	2 - Between Good and Fair
Deficiency	No deficiencies recorded
Door(s)	Inspected
Condition	5 - Poor
Deficiency	WOOD: DETERIORATED DOOR
Deficiency Location/Instance	Room 254
Deficiency Quantity	1
Quantity Uom	EACH
Potential Action	MAINTENANCE
Urgency of Action	PRIORITY 3
Purpose of Action	LEVEL 2

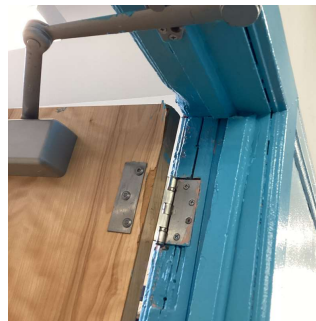
Room 354

WOOD: DETERIORATED DOOR AND FRAME

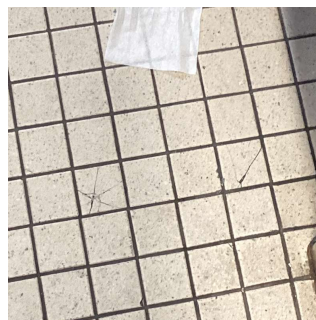
CERAMIC TILE: BROKEN/MISSING TILES

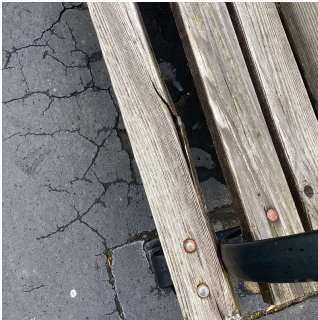
Question	Response
SITE	
PAVING	Inspected
DOT Sidewalk	
Concrete	Inspected
Violations	No violations recorded.
Pavers	Does not Exist
PLAYGROUNDS	Inspected
Instance on Courtyard	Inspected
Instance on North Side of Schoolyard	Inspected
Benches	
Instance on North Side of Schoolyard	Inspected
Condition	5 - Poor
Deficiency	DAMAGED/DETERIORATED
Deficiency Location/Instance	North Side of Schoolyard
Deficiency Quantity	3
Quantity Uom	EACH
Potential Action	REPLACE
Urgency of Action	PRIORITY 3
Purpose of Action	LEVEL 2
Deficiency Photo1

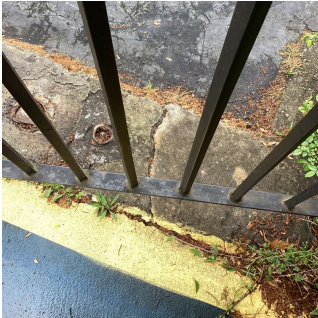
North Side of Schoolyard
Violations	No violations recorded.
Fence	
Instance on North Side of Schoolyard	Inspected
Condition	2 - Between Good and Fair
Deficiency	CONCRETE CURB: DAMAGED/DETERIORATED
Deficiency Location/Instance	North Side of Schoolyard
Deficiency Quantity	10
Quantity Uom	S.F.
Potential Action	REPLACE
Urgency of Action	PRIORITY 3
Purpose of Action	LEVEL 2
Deficiency Photo1

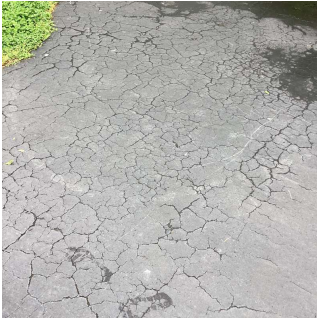
Question	Response
SITE	
PLAYGROUNDS	Inspected
Fence	
Violations	No violations recorded.
Pavement	
Instance on North Side of Schoolyard	Inspected
Condition	5 - Poor
Deficiency	ASPHALT: CRACKS - MAJOR
Deficiency Location/Instance	North Side of Schoolyard
Deficiency Quantity	500
Quantity Uom	S.F.
Potential Action	REPLACE
Urgency of Action	PRIORITY 3
Purpose of Action	LEVEL 2
Deficiency Photo1

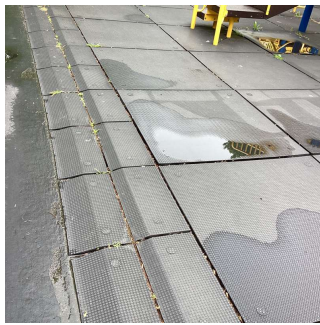
Violations	Courtyard No violations recorded.
Play Equipment	
Instance on North Side of Schoolyard	Inspected
Condition	2 - Between Good and Fair
Deficiency	No deficiencies recorded
Instance on Courtyard	Inspected
Condition	2 - Between Good and Fair
Deficiency	No deficiencies recorded
Safety Surfacing	
Instance on North Side of Schoolyard	Inspected
Condition	3 - Fair
Deficiency	DETERIORATED/MISSING
Deficiency Location/Instance	North Side of Schoolyard
Deficiency Quantity	200
Quantity Uom	S.F.
Potential Action	MAINTENANCE
Urgency of Action	PRIORITY 3
Purpose of Action	LEVEL 2
Deficiency Photo1
