NYC Department of Education
Building Condition Assessment Survey 2023 - 2024

Architectural Inspection

K209

Asset: P.S. 209 - BROOKLYN, 2609 EAST 7TH ST, New York, 11235

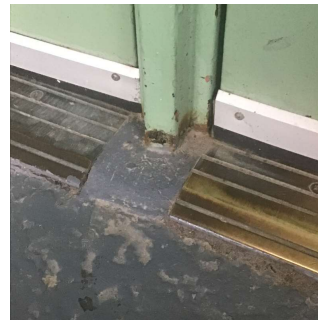
Facade D - Exit 5

METAL: DETERIORATED DOOR AND FRAME - MAJOR DETERIORATION

REPLACE

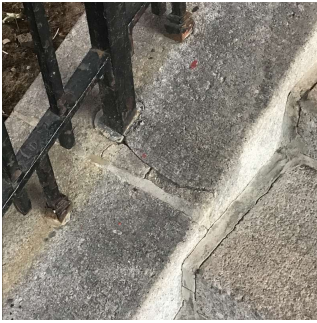
STONE: CRACKS/SPALLING - MINOR

10
S.F.
REPAIR
PRIORITY 3
LEVEL 2

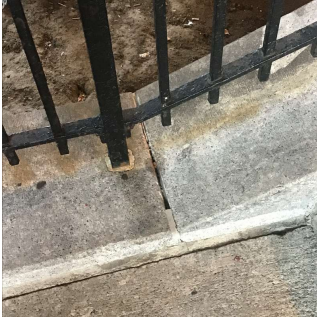
Violations	Facade A - Main Entrance No violations recorded.
Deficiency	STONE: DETERIORATED JOINTS
Roof Plan reference

Deficiency Quantity	10
Quantity Uom	S.F.
Potential Action	REPOINT
Urgency of Action	PRIORITY 4
Purpose of Action	LEVEL 2
Deficiency Photo1

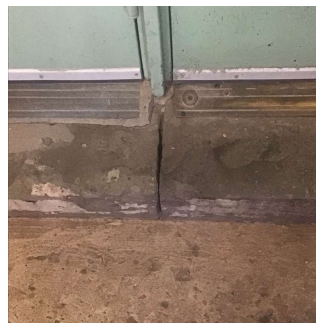
Facade C - Exit 3

STONE: DETERIORATED JOINTS

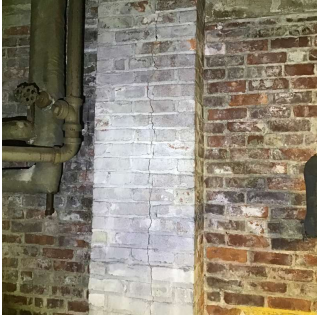
Question	Response
INTERIOR	
STRUCTURAL	
COLUMNS/BEAMS/BEARING WALLS	
Deficiency	STEEL COLUMNS/BEAMS: DETERIORATED MASONRY FIREPROOFING
Deficiency Location/Instance	Basement - South Crawlspace, Spiral Staircase Area
Deficiency Quantity	30
Quantity Uom	S.F.
Potential Action	REPLACE
Urgency of Action	PRIORITY 3
Purpose of Action	LEVEL 5
Deficiency Photo1

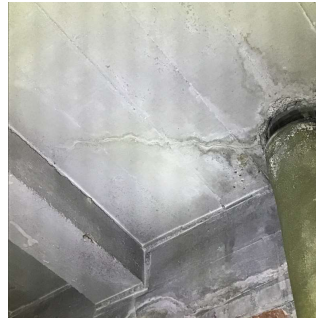
South Crawlspace

CONCRETE: CRACKS/SPALLED/REINFORCEMENT EXPOSED

REPAIR

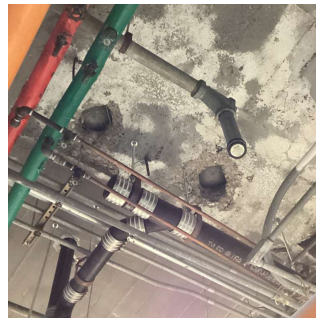
Boiler Room

CONCRETE: CRACKS/SPALLED/REINFORCEMENT EXPOSED

REPAIR

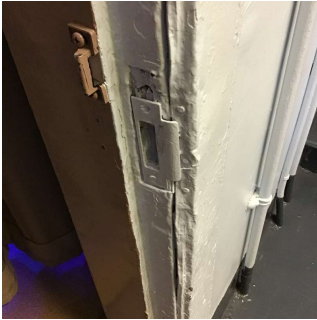
Question	Response
INTERIOR	
AUDITORIUM	
Ceiling	
Condition	2 - Between Good and Fair
Deficiency	No deficiencies recorded
Door(s)	
Instance on 1st Floor (502 Seats)	Inspected
Condition	5 - Poor
Deficiency	METAL: DETERIORATED DOOR AND FRAME
Deficiency Location/Instance	Right Side Backstage
Deficiency Quantity	1
Quantity Uom	EACH
Potential Action	MAINTENANCE
Urgency of Action	PRIORITY 3
Purpose of Action	LEVEL 2
Deficiency Photo1

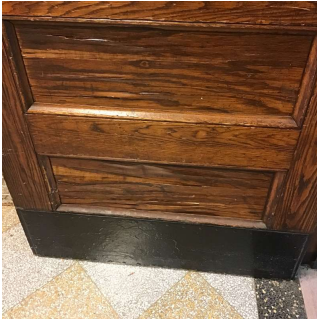
Violations	Right Side Backstage No violations recorded.
Deficiency	WOOD: DETERIORATED DOOR
Deficiency Location/Instance	Exit 7 - Vestibule
Deficiency Quantity	2
Quantity Uom	EACH
Potential Action	MAINTENANCE
Urgency of Action	PRIORITY 3
Purpose of Action	LEVEL 2
Deficiency Photo1

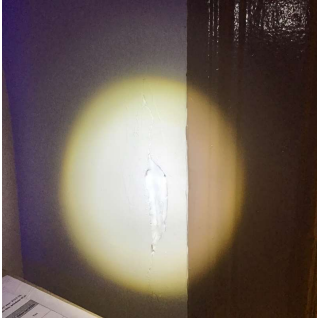
Question	Response
INTERIOR	
AUDITORIUM	
Walls	
Deficiency	PLASTER: CRACKS/SPALLING
Deficiency Location/Instance	Left Side Backstage
Deficiency Quantity	10
Quantity Uom	S.F.
Potential Action	REPLACE
Urgency of Action	PRIORITY 3
Purpose of Action	LEVEL 2
Deficiency Photo1

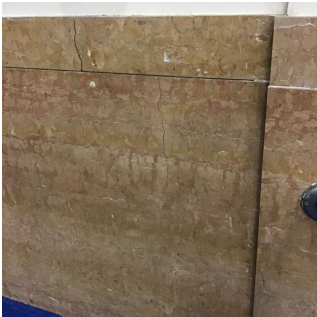
Violations	Left Side Backstage No violations recorded.
Deficiency	STONE: CRACKS/SPALLING
Deficiency Location/Instance	Right Side near Stage, By Windows
Deficiency Quantity	20
Quantity Uom	S.F.
Potential Action	REPLACE
Urgency of Action	PRIORITY 3
Purpose of Action	LEVEL 2
Deficiency Photo1

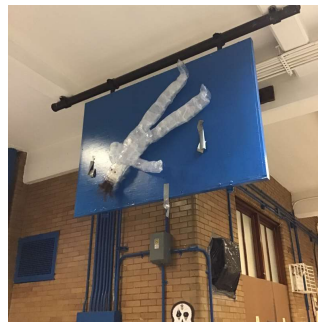
Instance on 1st Floor	Inspected
Condition	3 - Fair
Deficiency	DAMAGED/MISSING
Deficiency Location/Instance	Near Kitchen
Deficiency Quantity	1
Quantity Uom	EACH
Potential Action	MAINTENANCE
Urgency of Action	PRIORITY 3
Purpose of Action	LEVEL 2
Deficiency Photo1

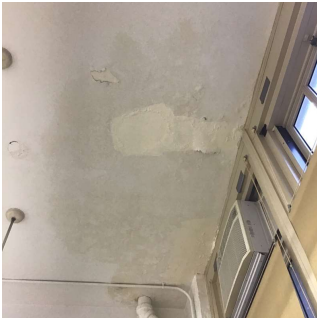
Corridor near Room 354
Violations	No violations recorded.
Deficiency	PLASTER: CRACKS/SPALLING
Deficiency Location/Instance	Room 402, Corridor near Room 451
Deficiency Quantity	60
Quantity Uom	S.F.
Potential Action	REPLACE
Urgency of Action	PRIORITY 3
Purpose of Action	LEVEL 2
Deficiency Photo1

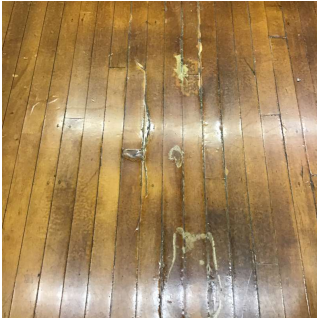
Question	Response
INTERIOR	
CLASSROOMS/CORRIDORS/ADMIN SPACES	
Floor Finish	
Deficiency	WOOD: DAMAGED/DETERIORATED
Deficiency Location/Instance	Rooms 413,402,305,302,301 and others
Deficiency Quantity	800
Quantity Uom	S.F.
Potential Action	REPLACE
Urgency of Action	PRIORITY 3
Purpose of Action	LEVEL 2
Deficiency Photo1

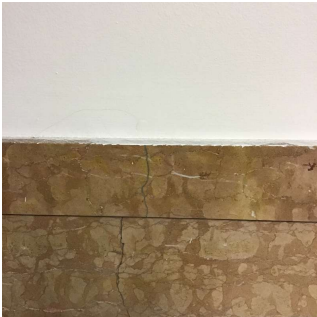
Corridor near Auditorium
Violations	No violations recorded.
Deficiency	STONE: CRACKS/SPALLING
Deficiency Location/Instance	Corridor near Auditorium, By Rooms 101A,105, Next to Cafeteria
Deficiency Quantity	50
Quantity Uom	S.F.
Potential Action	REPLACE
Urgency of Action	PRIORITY 3

Room 402
Violations	No violations recorded.
Walls	
Condition	Inspected
Condition	2 - Between Good and Fair
Deficiency	STONE MOLDINGS: CRACKS/SPALLING
Deficiency Location/Instance	Corridor near Auditorium
Deficiency Quantity	10
Quantity Uom	L.F.
Potential Action	REPLACE
Urgency of Action	PRIORITY 3
Purpose of Action	LEVEL 2
Deficiency Photo1

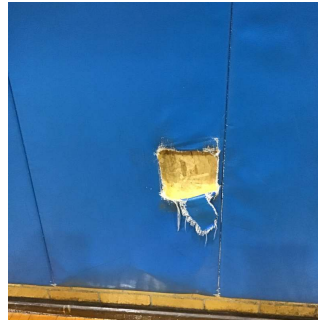
Rear Wall

WALL PADDING: DETERIORATED

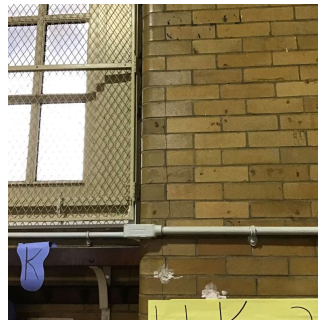
Near Right Side Windows

SALT GLAZED BRICK: CRACKS/SPALLING

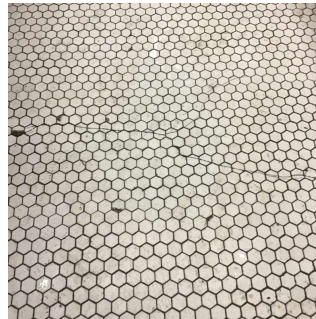
Near Sink

Deficiency CERAMIC TILE: DETERIORATED SUBSTRATE

Deficiency Location/Instance Near Sink, By Entrance

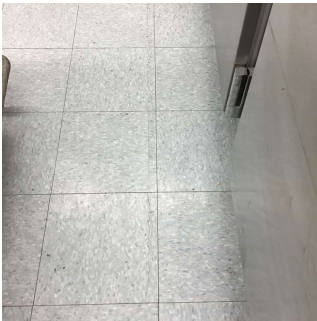
Deficiency VINYL TILES: DETERIORATED SUBSTRATE

Deficiency Location/Instance Near Entrance, By Fridges, Preparation Area

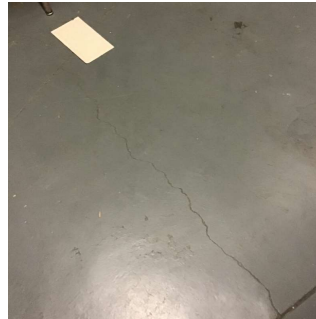
Deficiency	CONCRETE: CRACKS
------------	------------------

Deficiency Location/Instance	Center
------------------------------	--------

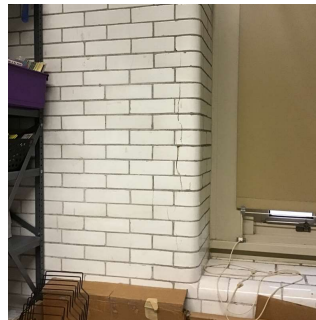
Deficiency	BRICK: CRACKS/SPALLING
------------	------------------------

Deficiency Location/Instance	Near Windows
------------------------------	--------------

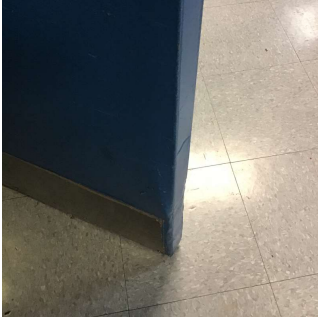
Question	Response
INTERIOR	
SHOWER ROOM	Inspected
Walls	
Violations	No violations recorded.
STAIRS/RAMPS: INTERIOR	Inspected
Do Letter Stair Signs Exist?	Partially
Ceiling	Inspected
Condition	2 - Between Good and Fair
Deficiency	No deficiencies recorded
Door(s)	Inspected
Condition	5 - Poor
Deficiency	METAL: DETERIORATED DOOR
Deficiency Location/Instance	Stair AB/1
Deficiency Quantity	1
Quantity Uom	EACH
Potential Action	MAINTENANCE
Urgency of Action	PRIORITY 3
Purpose of Action	LEVEL 2
Deficiency Photo1

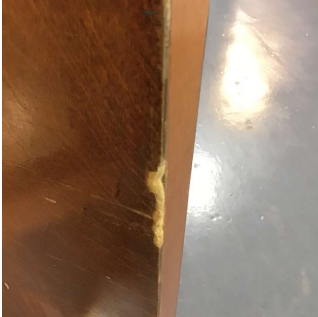
Stair AB/1
Violations	No violations recorded.
Deficiency	WOOD: DETERIORATED DOOR
Deficiency Location/Instance	Stair CD/1, Main Entrance Lobby
Deficiency Quantity	4
Quantity Uom	EACH
Potential Action	MAINTENANCE
Urgency of Action	PRIORITY 3
Purpose of Action	LEVEL 2
Deficiency Photo1

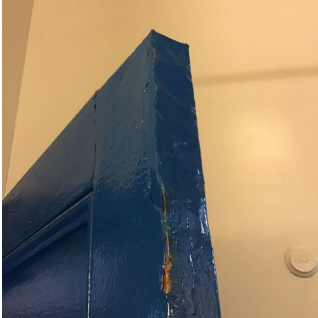
Stair CD/1
Violations	No violations recorded.
Deficiency	METAL CLAD WOOD: DETERIORATED DOOR
Deficiency Location/Instance	Stair AB/1, Exit 3 - Vestibule

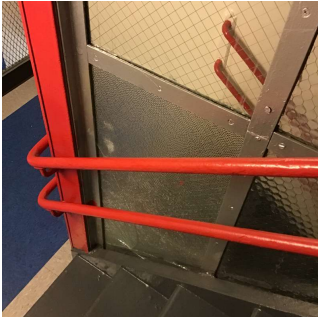
Violations	Stair AB/1 No violations recorded.
Partition	Inspected
Condition	2 - Between Good and Fair
Deficiency	GLASS PANEL: DAMAGED/DETERIORATED
Deficiency Location/Instance	Stair AB/3
Deficiency Quantity	10
Quantity Uom	S.F.
Potential Action	REPLACE
Urgency of Action	PRIORITY 3
Purpose of Action	LEVEL 2
Deficiency Photo1

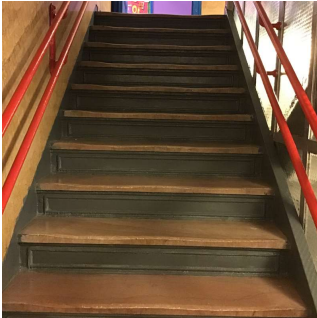
Question	Response
INTERIOR	
STAIRS/RAMPS: INTERIOR	
Stairs and Landings	
Deficiency	STONE: WORN-OUT TREAD/NOSINGS
Deficiency Location/Instance	Stair CD/1
Deficiency Quantity	150
Quantity Uom	S.F.
Potential Action	REPLACE
Urgency of Action	PRIORITY 3
Purpose of Action	LEVEL 2
Deficiency Photo1

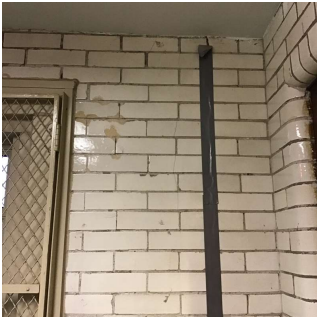
Violations	Stair CD/1 No violations recorded.
Walls	Inspected
Condition	2 - Between Good and Fair
Deficiency	BRICK: CRACKS/SPALLING
Deficiency Location/Instance	Exits 4,5 - Vestibules
Deficiency Quantity	40
Quantity Uom	S.F.
Potential Action	REPLACE
Urgency of Action	PRIORITY 3
Purpose of Action	LEVEL 2
Deficiency Photo1

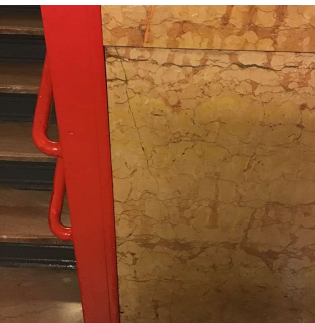
Violations	Exit 5 - Vestibule No violations recorded.
Deficiency	STONE: CRACKS/SPALLING
Deficiency Location/Instance	Stair CD/1
Deficiency Quantity	50
Quantity Uom	S.F.
Potential Action	REPLACE
Urgency of Action	PRIORITY 3
Purpose of Action	LEVEL 2

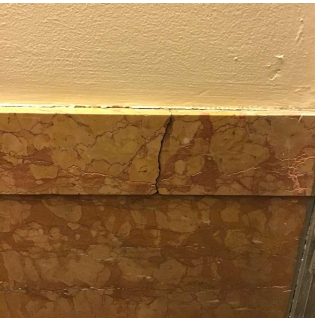
Stair CD/1 No violations recorded.
Deficiency Deficiency Location/Instance Deficiency Quantity Quantity Uom Potential Action Urgency of Action Purpose of Action Deficiency Photo1 Violations	STONE MOLDINGS: CRACKS/SPALLING Stair CD/1 20 L.F. REPLACE PRIORITY 3 LEVEL 2

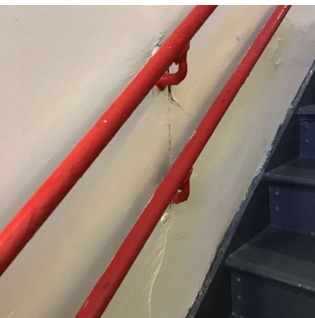
Stair E/4 No violations recorded.

Stair CD/1 No violations recorded.
Deficiency Deficiency Location/Instance Deficiency Quantity Quantity Uom Potential Action Urgency of Action Purpose of Action Deficiency Photo1 Violations	PLASTER: CRACKS/SPALLING Stair E/4 10 S.F. REPLACE PRIORITY 3 LEVEL 2

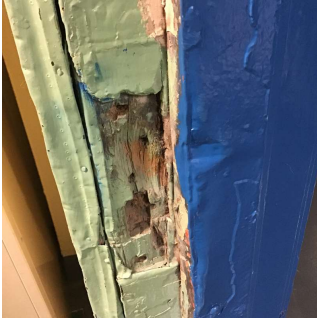
Question	Response
INTERIOR	
TOILET ROOMS - STAFF	Inspected
Ceiling	Inspected
Condition	2 - Between Good and Fair
Deficiency	No deficiencies recorded
Door(s)	Inspected
Condition	5 - Poor
Deficiency	METAL CLAD WOOD: DETERIORATED DOOR AND FRAME
Deficiency Location/Instance	Room 158
Deficiency Quantity	1
Quantity Uom	EACH
Potential Action	MAINTENANCE
Urgency of Action	PRIORITY 3
Purpose of Action	LEVEL 2
Deficiency Photo1

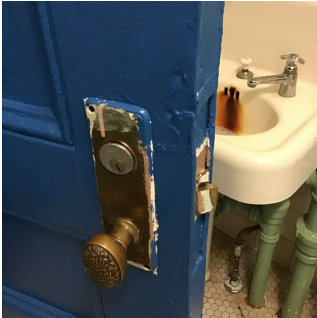
Violations	Room 158 No violations recorded.
Deficiency	WOOD: DETERIORATED DOOR
Deficiency Location/Instance	Rooms 451,356,351,258
Deficiency Quantity	4
Quantity Uom	EACH
Potential Action	MAINTENANCE
Urgency of Action	PRIORITY 3
Purpose of Action	LEVEL 2
Deficiency Photo1

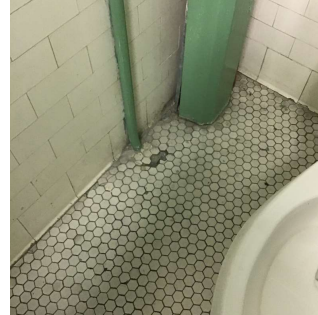
Violations	Room 451 No violations recorded.
Floor Finish	Inspected
Condition	5 - Poor
Deficiency	CERAMIC TILE: BROKEN/MISSING TILES
Deficiency Location/Instance	Room 351
Deficiency Quantity	10
Quantity Uom	S.F.
Potential Action	REPLACE

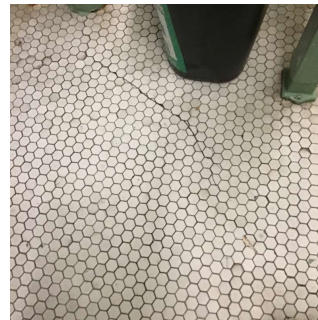
Room 451

CERAMIC TILE: DETERIORATED SUBSTRATE

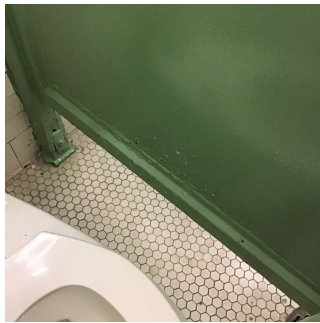
RUST - MAJOR

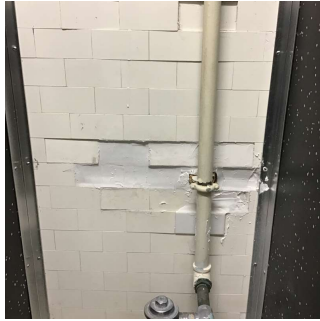
Violations	Room 451 No violations recorded.
Walls	Inspected
Condition	2 - Between Good and Fair
Deficiency	CERAMIC TILE: BROKEN/ MISSING
Deficiency Location/Instance	Rooms 356,351,258,257
Deficiency Quantity	50
Quantity Uom	S.F.
Potential Action	REPLACE
Urgency of Action	PRIORITY 3
Purpose of Action	LEVEL 2
Deficiency Photo1

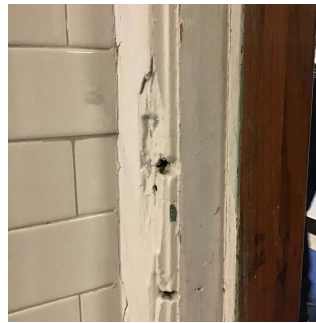
Violations	Room 356 No violations recorded.
TOILET ROOMS - STUDENTS	
Ceiling	Inspected
Condition	2 - Between Good and Fair
Deficiency	No deficiencies recorded
Door(s)	Inspected
Condition	5 - Poor
Deficiency	WOOD: DETERIORATED DOOR AND FRAME
Deficiency Location/Instance	Room 457
Deficiency Quantity	1
Quantity Uom	EACH
Potential Action	MAINTENANCE
Urgency of Action	PRIORITY 3
Purpose of Action	LEVEL 2

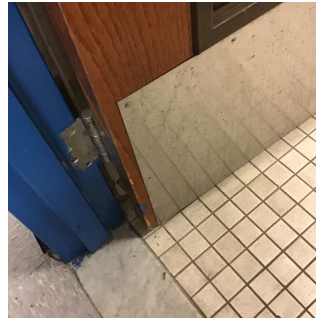
Room 459

WOOD: DETERIORATED DOOR

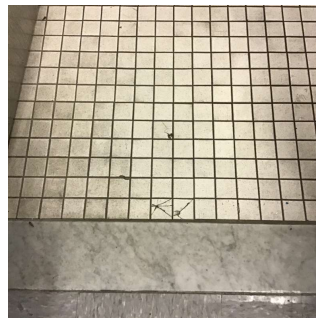
CERAMIC TILE: BROKEN/MISSING TILES

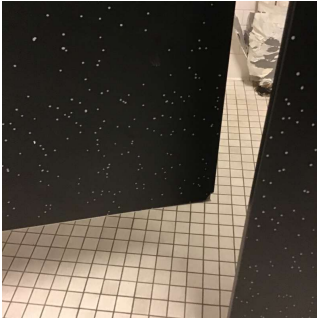
Question	Response
INTERIOR	
TOILET ROOMS - STUDENTS	
Floor Finish	Inspected
	Room 459
Violations	No violations recorded.
Stalls	Inspected
Condition	4 - Between Fair and Poor
Deficiency	BROKEN/MISSING
Deficiency Location/Instance	Rooms 358,260
Deficiency Quantity	2
Quantity Uom	EACH
Potential Action	REPLACE
Urgency of Action	PRIORITY 3
Purpose of Action	LEVEL 2
Deficiency Photo1

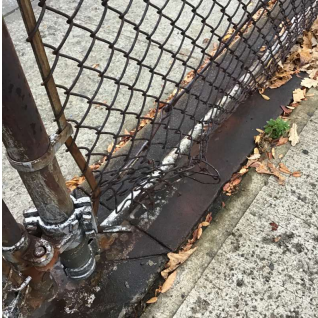
Question	Response
SITE	
FENCES	
Deficiency	CHAIN LINK: DAMAGED/DETERIORATED
Deficiency Location/Instance	Coney Island Avenue
Deficiency Quantity	50
Quantity Uom	S.F.
Potential Action	REPLACE
Urgency of Action	PRIORITY 5
Purpose of Action	LEVEL 6
Deficiency Photo1

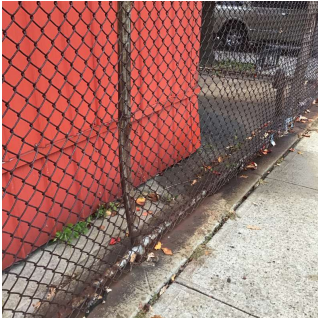
Violations	Coney Island Avenue No violations recorded.
Deficiency	CHAIN LINK: DAMAGED POST/RAIL
Deficiency Location/Instance	Manor Court, Coney Island Avenue
Deficiency Quantity	50
Quantity Uom	L.F.
Potential Action	REPLACE
Urgency of Action	PRIORITY 3
Purpose of Action	LEVEL 2
Deficiency Photo1

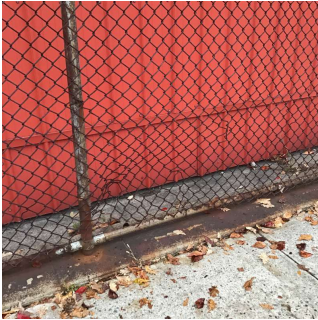
Violations	Manor Court No violations recorded.
Deficiency	CHAIN LINK: DAMAGED/DETERIORATED
Deficiency Location/Instance	Manor Court, Coney Island Avenue
Deficiency Quantity	150
Quantity Uom	S.F.
Potential Action	REPLACE
Urgency of Action	PRIORITY 3
Purpose of Action	LEVEL 2

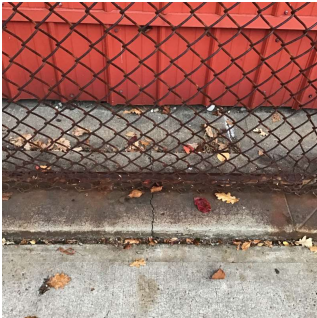
Manor Court
Violations	No violations recorded.
Deficiency	CONCRETE CURB: DAMAGED/DETERIORATED

Question	Response
SITE	
FENCES	
Deficiency Location/Instance	Manor Court, Coney Island Avenue
Deficiency Quantity	70
Quantity Uom	S.F.
Potential Action	REPLACE
Urgency of Action	PRIORITY 3
Purpose of Action	LEVEL 2
Deficiency Photo1

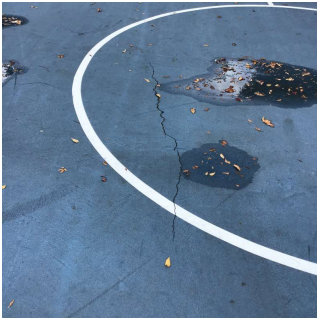
Violations	Manor Court No violations recorded.
IRRIGATION SYSTEM	Does not Exist
PAVING	Inspected
Student Non-Use	Inspected
Gravel Exists?	No
Asphalt	Does not Exist
Concrete	Inaccessible
Pavers	Does not Exist
Student Use	Inspected
Gravel Exists?	No
Asphalt	Inspected
Condition	3 - Fair
Deficiency	CRACKS - MAJOR
Deficiency Location/Instance	Schoolyard
Deficiency Quantity	150
Quantity Uom	S.F.
Potential Action	REPLACE
Urgency of Action	PRIORITY 3
Purpose of Action	LEVEL 2
Deficiency Photo1

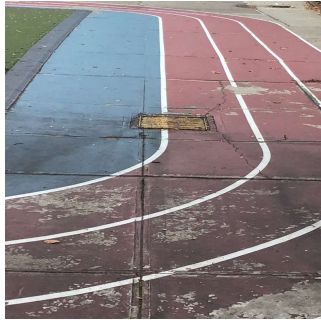
Condition	4 - Between Fair and Poor
Deficiency	DAMAGED/DETERIORATED/MISSING SECTIONS
Deficiency Location/Instance	Near Coney Island Avenue, Schoolyard
Deficiency Quantity	600
Quantity Uom	S.F.
Potential Action	REPLACE
Urgency of Action	PRIORITY 3
Purpose of Action	LEVEL 2
Deficiency Photo1

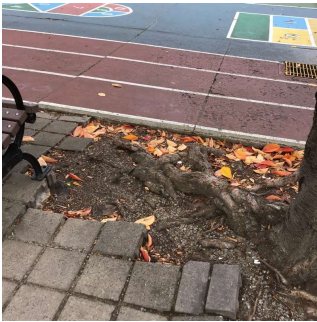
Question	Response
SITE	
PAVING	
Student Use	
Pavers	
Violations	Near TCU Units No violations recorded.
Deficiency	DAMAGED/MISSING
Deficiency Location/Instance	Schoolyard
Deficiency Quantity	150
Quantity Uom	S.F.
Potential Action	REPLACE
Urgency of Action	PRIORITY 3
Purpose of Action	LEVEL 2
Deficiency Photo1

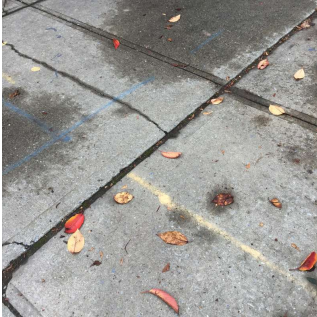
Violations	Schoolyard No violations recorded.
Site Sidewalks & Walkways	Inspected
Asphalt	Does not Exist
Concrete	Inspected
Condition	4 - Between Fair and Poor
Deficiency	HEAVING
Deficiency Location/Instance	Manor Court, Near TCU
Deficiency Quantity	300
Quantity Uom	S.F.
Potential Action	REPLACE
Urgency of Action	PRIORITY 3
Purpose of Action	LEVEL 2
Deficiency Photo1

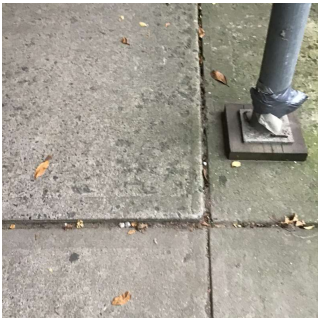
Question	Response
SITE	
PAVING	
Site Sidewalks & Walkways	
Concrete	
Quantity Uom	S.F.
Potential Action	REPLACE
Urgency of Action	PRIORITY 3
Purpose of Action	LEVEL 2
Deficiency Photo1	 
	Near T-2
Violations	No violations recorded.
Pavers	Does not Exist
DOT Sidewalk	Inspected
Asphalt	Does not Exist
Concrete	Inspected
Condition	4 - Between Fair and Poor
Deficiency	HEAVING
Deficiency Location/Instance	E. 7th Street, Coney Island Avenue
Deficiency Quantity	200
Quantity Uom	S.F.
Potential Action	REPLACE
Urgency of Action	PRIORITY 3
Purpose of Action	LEVEL 2
Deficiency Photo1

E. 7th Street
Violations	No violations recorded.
Deficiency	DAMAGED/DETERIORATED/MISSING SECTIONS
Deficiency Location/Instance	Avenue Z, E. 7th Street, Coney Island Avenue, Manor Court
Deficiency Quantity	2,000
Quantity Uom	S.F.
Potential Action	REPLACE
Urgency of Action	PRIORITY 3
Purpose of Action	LEVEL 2

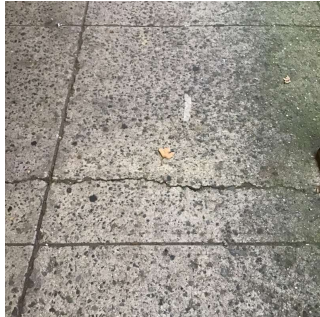
Violations	Avenue Z No violations recorded.
Deficiency	DAMAGED CURBS
Deficiency Location/Instance	Avenue Z, E. 7th Street, Manor Court, Coney Island Avenue
Deficiency Quantity	700
Quantity Uom	L.F.
Potential Action	REPLACE
Urgency of Action	PRIORITY 3
Purpose of Action	LEVEL 2
Deficiency Photo1

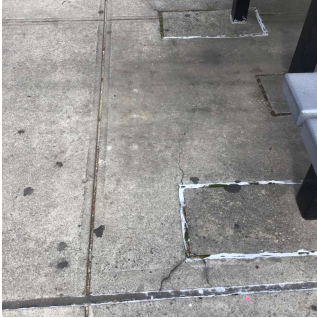
Violations	E. 7th Street No violations recorded.
Pavers	Does not Exist
PLAYGROUNDS	Inspected
Instance on Schoolyard	Inspected
Benches	
Instance on Schoolyard	Inspected
Condition	2 - Between Good and Fair
Deficiency	No deficiencies recorded
Fence	
Instance on Schoolyard	Inspected
Condition	2 - Between Good and Fair
Deficiency	No deficiencies recorded
Pavement	
Instance on Schoolyard	Inspected
Condition	4 - Between Fair and Poor
Deficiency	CONCRETE: CRACKS - MAJOR
Deficiency Location/Instance	Near Coney Island Avenue
Deficiency Quantity	250

Question	Response
SITE	
PLAYGROUNDS	
Pavement	
Quantity Uom	S.F.
Potential Action	REPLACE
Urgency of Action	PRIORITY 3
Purpose of Action	LEVEL 2
Deficiency Photo1

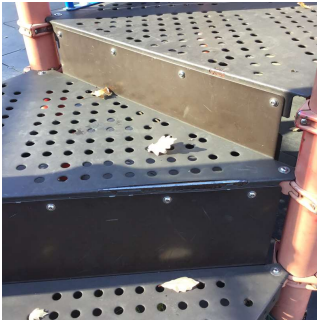
Stairs
Violations	No violations recorded.
Deficiency	BROKEN/DETERIORATED/MISSING
Deficiency Location/Instance	Bridge
Deficiency Quantity	1
Quantity Uom	EACH
Potential Action	REPLACE
Urgency of Action	PRIORITY 5
Purpose of Action	LEVEL 6

Near Coney Island Avenue
Violations	No violations recorded.
Play Equipment	
Instance on Schoolyard	Inspected
Condition	5 - Poor
Deficiency	BROKEN/DETERIORATED/MISSING
Deficiency Location/Instance	Stairs
Deficiency Quantity	1
Quantity Uom	EACH
Potential Action	REPLACE
Urgency of Action	PRIORITY 3
Purpose of Action	LEVEL 2
Deficiency Photo1

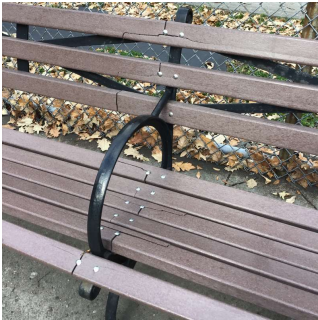
Question	Response
SITE	
SEATING	
Benches	
Metal/Wood/Plastic	Inspected
Condition	5 - Poor
Deficiency	DAMAGED/DETERIORATED
Deficiency Location/Instance	Near Handball Wall, By Playground, Next to Basketball Court
Deficiency Quantity	6
Quantity Uom	EACH
Potential Action	REPLACE
Urgency of Action	PRIORITY 3
Purpose of Action	LEVEL 2
Deficiency Photo1

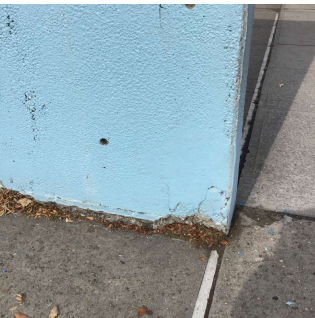
Handball Wall
Violations	No violations recorded.
STAIRS/RAMPS: EXTERIOR	
	Does not Exist
ARTWORK	
	Does not Exist

Violations	Near Handball Wall No violations recorded.
Bleachers	Does not Exist
SITE WALLS (NOT RETAINING WALLS)	
Condition	Inspected
Condition	3 - Fair
Deficiency	CAST IN PLACE CONCRETE: DETERIORATED CONTROL/EXPANSION JOINT
Deficiency Location/Instance	Near Playground
Deficiency Quantity	10
Quantity Uom	L.F.
Potential Action	REPLACE
Urgency of Action	PRIORITY 3
Purpose of Action	LEVEL 2
Deficiency Photo1	 
Violations	Near Playground No violations recorded.
Deficiency	CAST IN PLACE CONCRETE: CRACKS/SPALLING - MAJOR
Deficiency Location/Instance	Handball Wall
Deficiency Quantity	20

Quantity Uom	S.F.
Potential Action	REPLACE

Question	Response
SITE	
SITE WALLS (NOT RETAINING WALLS)	
Urgency of Action	PRIORITY 3
Purpose of Action	LEVEL 2
Deficiency Photo1
