**NYC Department of Education**  
**Building Condition Assessment Survey 2023 - 2024**

Architectural Inspection

**Asset: P.S. 219 - BROOKLYN, 1060 CLARKSON AVENUE, New York, 11212**

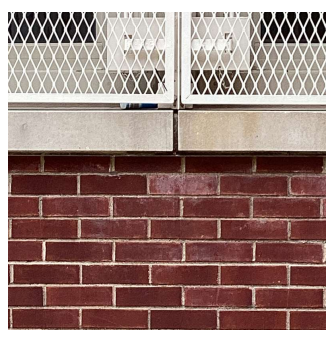
Question	Response
<b>EXTERIOR</b>	
<b>EXTERIOR WALLS</b>	
Material Type(s)	Masonry
Replacement Quantity	36,000
Replacement Uom	S.F.
Instance on All Facades	Inspected
Instance Condition	3 - Fair
Instance Quantity	36,000
Instance Quantity Uom	S.F.
Deficiency	BRICK: MASONRY SILLS - DETERIORATED JOINTS
Roof Plan reference	<p>K219</p>

Deficiency Quantity	10
Quantity Uom	L.F.
Potential Action	REPOINT
Urgency of Action	PRIORITY 3
Purpose of Action	LEVEL 2
Deficiency Photo1

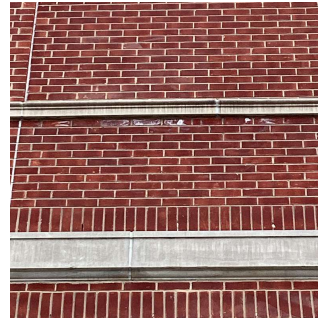
Facade A

BRICK: EFFLORESCENCE

Urgency of Action  
Purpose of Action  
Deficiency Photo1

PRIORITY 1  
LEVEL 1

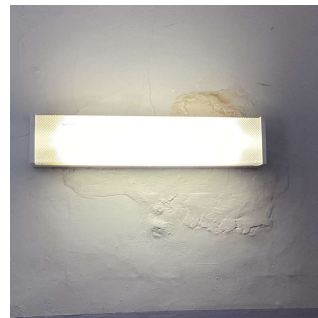
Facade G - Stairwell E/3

**BRICK: WATER INFILTRATION IN INSTRUCTIONAL SPACE**

REPAIR

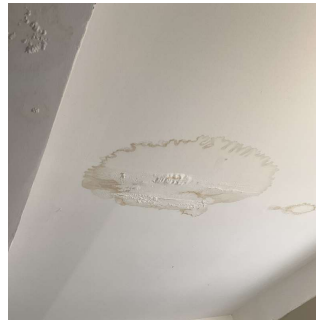
Roof 3 - Stairwell F/4+

MODIFIED BITUMEN: ROOFING: MAJOR ACTIVE ROOF  
LEAKS IN NON-INSTRUCTIONAL SPACE

REPLACE ROOFING WITHOUT MAJOR EQUIPMENT  
REMOVAL

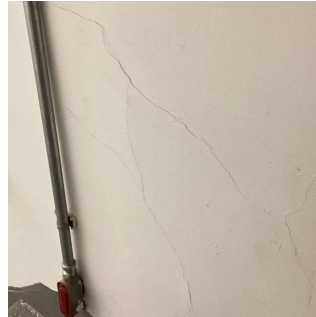
BH2

BULKHEAD/PENTHOUSE WALLS/INTERIOR: PLASTER  
CRACKS/SPALLING

Deficiency Quantity	25
Quantity Uom	S.F.
Potential Action	REPLACE
Urgency of Action	PRIORITY 3
Purpose of Action	LEVEL 2
Deficiency Photo1

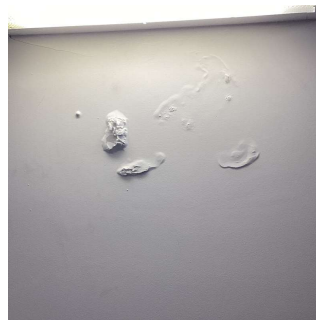
BH1

Deficiency	BULKHEAD/PENTHOUSE WALLS/EXTERIOR: WATER INFILTRATION
------------	---

Deficiency Quantity	100
Quantity Uom	S.F.
Potential Action	REPAIR
Urgency of Action	PRIORITY 5
Purpose of Action	LEVEL 2
Deficiency Photo1

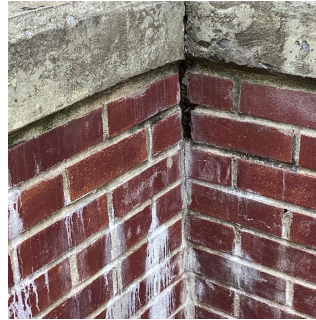
Facade C

BRICK: DETERIORATED JOINTS

S.F.  
 REPOINT  
 PRIORITY 3  
 LEVEL 2

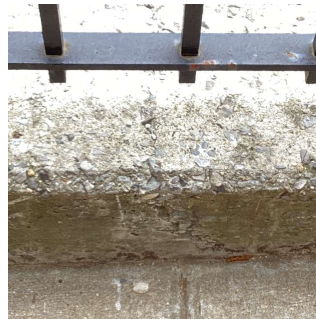
Facade C

CAST IN PLACE CONCRETE: CRACKS/SPALLING - MINOR

35  
 S.F.  
 REPAIR  
 PRIORITY 3  
 LEVEL 2

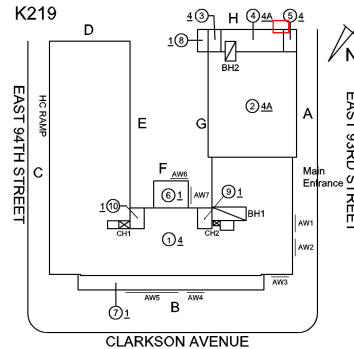
DAMAGED

10  
 L.F.  
 REPLACE  
 PRIORITY 4  
 LEVEL 2

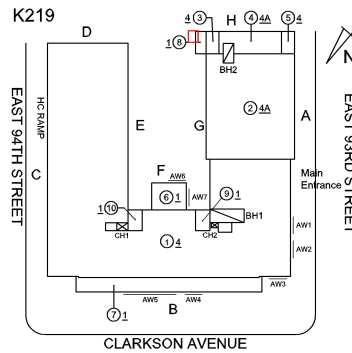
STONE: WORN-OUT TREAD/RISER/NOSING

REPLACE

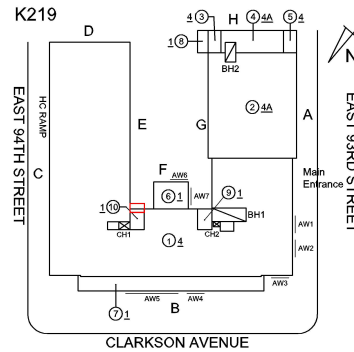
STONE: CRACKS/SPALLING - MAJOR

10  
S.F.  
REPLACE  
PRIORITY 4  
LEVEL 2

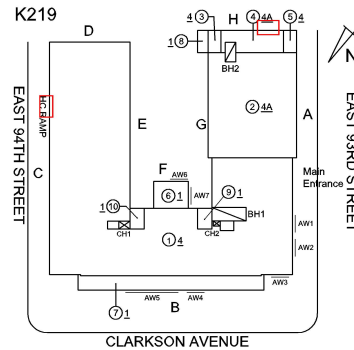
**CONCRETE: CRACKS/SPALLING - MAJOR**

30  
S.F.  
REPLACE  
PRIORITY 4  
LEVEL 2

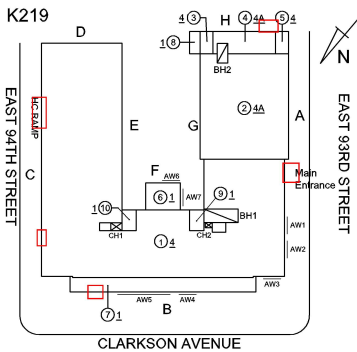
Violations	Facade C No violations recorded.
Deficiency	<b>CONCRETE: CRACKS/SPALLING - MINOR</b>
Roof Plan reference	K219

Deficiency Quantity	75
Quantity Uom	S.F.
Potential Action	REPAIR
Urgency of Action	PRIORITY 3
Purpose of Action	LEVEL 2
Deficiency Photo1

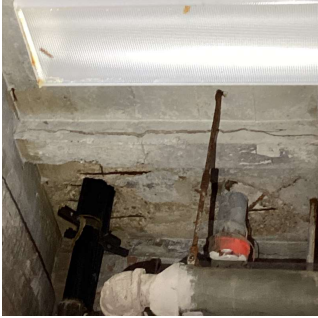
<b>Question</b>	<b>Response</b>
<b>EXTERIOR</b>	
<b>WINDOWS</b>	
<b>WINDOWS</b>	Inspected
Material Type(s)	Aluminum
Instance on Aluminum - Double Hung: All Facades	Inspected
Instance Condition	3 - Fair
Instance Quantity	8,500
Instance Quantity Uom	S.F.
Are these windows insulated	No
Installation Year	2000
Source of Installation	Custodial Staff
Deficiency	No deficiencies recorded
Instance on Aluminum - Other: All Facades	Inspected
Instance Condition	3 - Fair
Instance Quantity	1,500
Instance Quantity Uom	S.F.
Are these windows insulated	No
Installation Year	2000
Source of Installation	Custodial Staff
Deficiency	No deficiencies recorded
<b>INTERIOR</b>	Inspected
<b>POOLS</b>	Does not Exist
<b>STRUCTURAL</b>	Inspected
<b>COLUMNS/BEAMS/BEARING WALLS</b>	Inspected
Condition	3 - Fair
Deficiency	STEEL COLUMNS/BEAMS: DETERIORATED CONCRETE FIREPROOFING
Deficiency Location/Instance	Basement
Deficiency Quantity	25
Quantity Uom	S.F.

Potential Action	REPLACE
Urgency of Action	PRIORITY 5
Purpose of Action	LEVEL 6
Deficiency Photo1

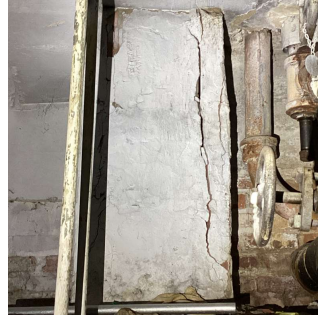
West Crawl Space (Basement Tile Storage Room similar)

Basement Tile Storage Room
Violations	No violations recorded.
Deficiency	STEEL COLUMNS/BEAMS: DETERIORATED CONCRETE FIREPROOFING
Deficiency Location/Instance	Basement
Deficiency Quantity	45
Quantity Uom	S.F.
Potential Action	REPLACE

PRIORITY 4  
LEVEL 5

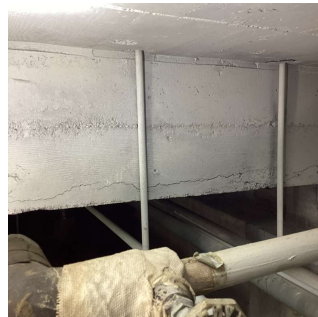
East Crawl Space (West Crawl Space, Boiler Room, Basement Corridor, Basement Fan Area, Basement Tile Storage Room similar)

STEEL COLUMNS/BEAMS: DETERIORATED CONCRETE FIREPROOFING

REPLACE

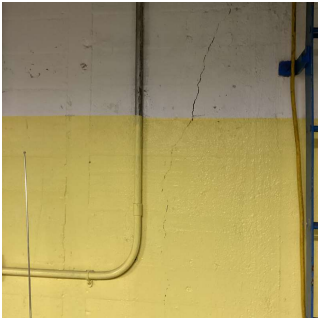
<b>Question</b>	<b>Response</b>
<b>INTERIOR</b>	
<b>STRUCTURAL</b>	
<b>FOUNDATION WALLS</b>	Inspected
Material Type(s)	Concrete
Condition	3 - Fair
Deficiency	CONCRETE: CRACKED/SPALLED/REINFORCEMENT EXPOSED
Deficiency Location/Instance	Basement
Deficiency Quantity	30
Quantity Uom	S.F.
Potential Action	REPAIR
Urgency of Action	PRIORITY 3
Purpose of Action	LEVEL 5
Deficiency Photo1

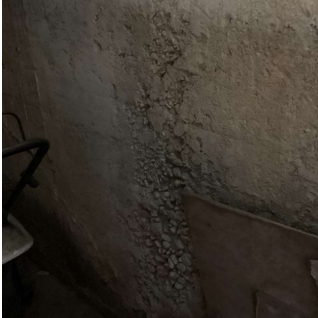
Violations	Basement Corridor No violations recorded.
<b>ROOF STRUCTURE</b>	Inspected
Condition	2 - Between Good and Fair
Deficiency	No deficiencies recorded
<b>VAULTS-BUNKERS</b>	Inspected
<b>Foundation Walls</b>	Inspected
Condition	3 - Fair
Deficiency	CRACKS, SPALLING
Deficiency Location/Instance	Vault
Deficiency Quantity	40
Quantity Uom	S.F.
Potential Action	REPAIR
Urgency of Action	PRIORITY 3
Purpose of Action	LEVEL 5
Deficiency Photo1

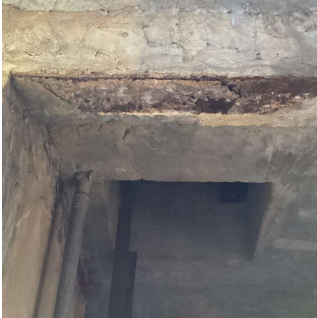
Question	Response
<b>INTERIOR</b>	
<b>STRUCTURAL</b>	
<b>VAULTS-BUNKERS</b>	
<b>Slab Structure</b>	
Deficiency	STEEL COLUMNS/BEAMS: MAJOR RUSTING
Deficiency Location/Instance	Vault
Deficiency Quantity	30
Quantity Uom	S.F.
Potential Action	REPLACE
Urgency of Action	PRIORITY 5
Purpose of Action	LEVEL 6
Deficiency Photo1

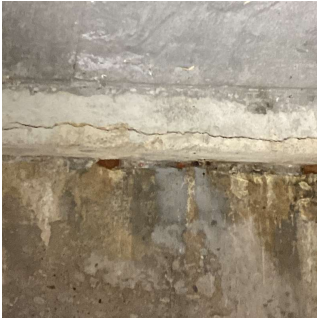
Violations	Vault No violations recorded.
Deficiency	STEEL COLUMNS/BEAMS: DETERIORATED CONCRETE FIREPROOFING
Deficiency Location/Instance	Vault
Deficiency Quantity	40
Quantity Uom	S.F.
Potential Action	REPAIR
Urgency of Action	PRIORITY 4
Purpose of Action	LEVEL 5
Deficiency Photo1

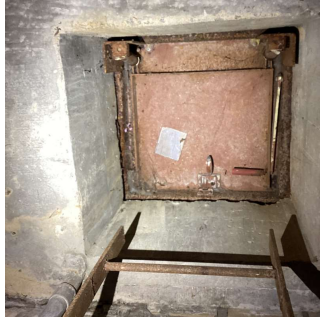
Violations	Vault No violations recorded.
<b>Vault/Ash Hoist Doors and Framing</b>	Inspected
Condition	5 - Poor
Deficiency	DETERIORATED/DAMAGED VAULT/ASH HOIST DOORS AND FRAMING
Deficiency Location/Instance	Vault
Deficiency Quantity	1
Quantity Uom	EACH
Potential Action	REPLACE
Urgency of Action	PRIORITY 4
Purpose of Action	LEVEL 2

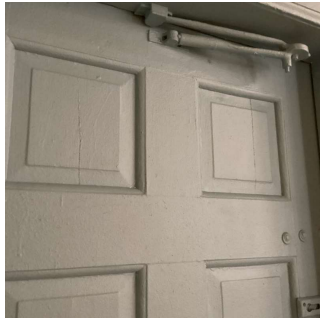
Violations	Vault No violations recorded.
<b>AUDITORIUM</b>	
Instance on 1st Floor (616 Seats)	Inspected
<b>Ceiling</b>	Inspected
Instance on 1st Floor (616 Seats)	Inspected
Condition	2 - Between Good and Fair
Deficiency	No deficiencies recorded
<b>Door(s)</b>	
Instance on 1st Floor (616 Seats)	Inspected
Condition	3 - Fair
Deficiency	WOOD: DETERIORATED DOOR
Deficiency Location/Instance	Left Side Stage
Deficiency Quantity	1
Quantity Uom	EACH
Potential Action	MAINTENANCE
Urgency of Action	PRIORITY 3
Purpose of Action	LEVEL 2
Deficiency Photo1

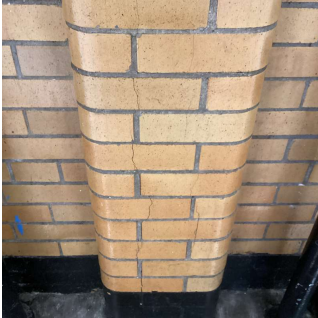
Question	Response
<b>INTERIOR</b>	
<b>CAFETERIA</b>	
<b>Walls</b>	
Condition	2 - Between Good and Fair
Deficiency	SALT GLAZED BRICK: CRACKS/SPALLING
Deficiency Location/Instance	Near Windows
Deficiency Quantity	70
Quantity Uom	S.F.
Potential Action	REPLACE
Urgency of Action	PRIORITY 3
Purpose of Action	LEVEL 2
Deficiency Photo1

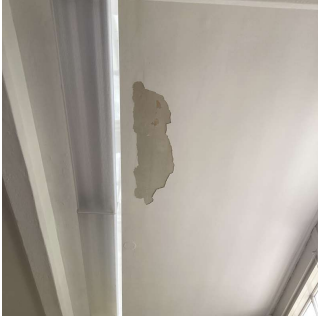
Near Windows
Violations	No violations recorded.
<b>Window Curtains/Shades/Blinds</b>	
Instance on 1st Floor	Does not Exist
<b>CLASSROOMS/CORRIDORS/ADMIN SPACES</b>	
<b>Ceiling</b>	Inspected
Condition	2 - Between Good and Fair
Deficiency	PLASTER: CRACKS/SPALLING
Deficiency Location/Instance	Room 312
Deficiency Quantity	20
Quantity Uom	S.F.
Potential Action	REPLACE
Urgency of Action	PRIORITY 3
Purpose of Action	LEVEL 2
Deficiency Photo1

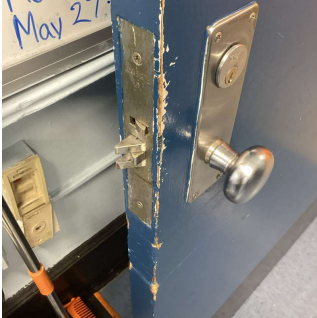
Room 312
Violations	No violations recorded.
<b>Door(s)</b>	
<b>Condition</b>	Inspected
Condition	5 - Poor
Deficiency	WOOD: DETERIORATED DOOR
Deficiency Location/Instance	Rooms 459, 417, 409, 408, 405 and others

Question	Response
<b>INTERIOR</b>	
<b>CLASSROOMS/CORRIDORS/ADMIN SPACES</b>	
<b>Door(s)</b>	
Quantity Uom	EACH
Potential Action	MAINTENANCE
Urgency of Action	PRIORITY 3
Purpose of Action	LEVEL 2
Deficiency Photo1

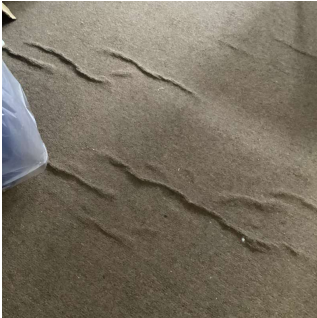
Room 417
Violations	No violations recorded.
<b>Floor Finish</b>	Inspected
Condition	3 - Fair
Deficiency	CARPET: WORN/DETERIORATED
Deficiency Location/Instance	Room 218
Deficiency Quantity	200
Quantity Uom	S.F.
Potential Action	REPLACE
Urgency of Action	PRIORITY 3
Purpose of Action	LEVEL 2
Deficiency Photo1

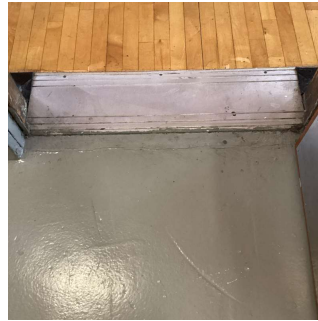
Room 218
Violations	No violations recorded.
Deficiency	CONCRETE: CRACKS
Deficiency Location/Instance	Corridor near 3rd Floor - Gymnasium
Deficiency Quantity	20
Quantity Uom	S.F.
Potential Action	REPLACE
Urgency of Action	PRIORITY 3
Purpose of Action	LEVEL 2

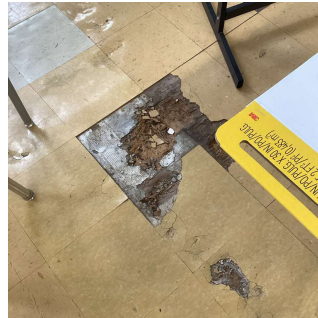
Room 413

VINYL TILES: DETERIORATED SUBSTRATE

REPLACE

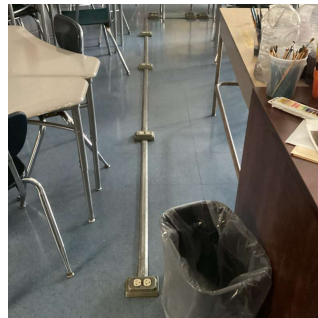
Room 302

VINYL TILES: TRIPPING HAZARD - ELECTRICAL OUTLET

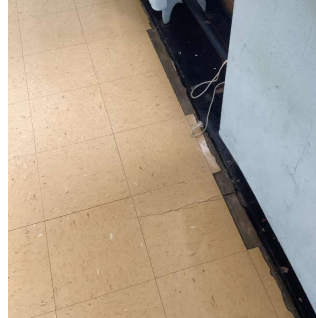
Room 413

Deficiency	VINYL TILES: DETERIORATED SUBSTRATE
Deficiency Location/Instance	Rooms 416, 413, 409, 307, 306 and others
Deficiency Quantity	3,000
Quantity Uom	S.F.
Potential Action	REPLACE
Urgency of Action	PRIORITY 3
Purpose of Action	LEVEL 2
Deficiency Photo1

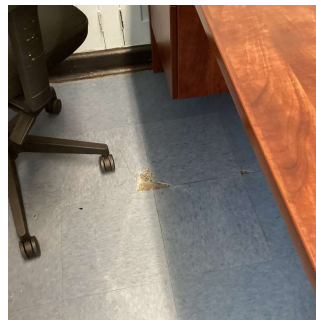
Room 417

Deficiency	VINYL TILES: BROKEN/DETERIORATED/MISSING TILES
Deficiency Location/Instance	Rooms 417, 315, 311, 203, 106 and others
Deficiency Quantity	300
Quantity Uom	S.F.
Potential Action	REPLACE
Urgency of Action	PRIORITY 3
Purpose of Action	LEVEL 2
Deficiency Photo1

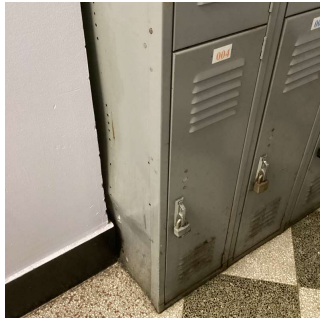
Exit 9 - Vestibule  No violations recorded.
<b>Specialties</b>	Inspected
<b>Classroom Locker(s)</b>	Inspected
Condition Deficiency Deficiency Location/Instance Deficiency Quantity Quantity Uom Potential Action Urgency of Action Purpose of Action	2 - Between Good and Fair DAMAGED UNITS Locker 004 (Corridor near Room 153) 1 EACH REPLACE PRIORITY 3 LEVEL 2

Locker 004 (Corridor near Room 153)
Violations	No violations recorded.
<b>Fixed Seating</b>	Does not Exist
<b>GYMNASIUM</b>	
Instance on 3rd Floor	Inspected
Instance on 4th Floor	Inspected
<b>Ceiling</b>	
Instance on 3rd Floor	Inspected
Condition	2 - Between Good and Fair
Deficiency	PLASTER: CRACKS/SPALLING
Deficiency Location/Instance	Office Room
Deficiency Quantity	10
Quantity Uom	S.F.
Potential Action	REPLACE
Urgency of Action	PRIORITY 3
Purpose of Action	LEVEL 2
Deficiency Photo1

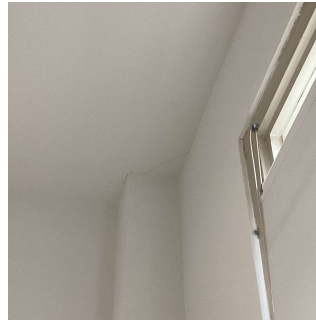
Office Room
Violations	No violations recorded.
Instance on 4th Floor	Inspected
Condition	2 - Between Good and Fair
Deficiency	PLASTER: CRACKS/SPALLING
Deficiency Location/Instance	Office Room
Deficiency Quantity	10
Quantity Uom	S.F.
Potential Action	REPLACE
Urgency of Action	PRIORITY 3

Purpose of Action	LEVEL 2

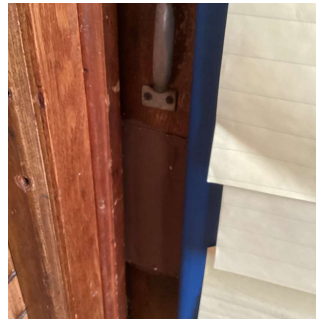
Instance on 3rd Floor	Inspected
Condition	5 - Poor
Deficiency	WOOD: DETERIORATED DOOR
Deficiency Location/Instance	Room 362
Deficiency Quantity	1
Quantity Uom	EACH
Potential Action	MAINTENANCE
Urgency of Action	PRIORITY 3
Purpose of Action	LEVEL 2
Deficiency Photo1

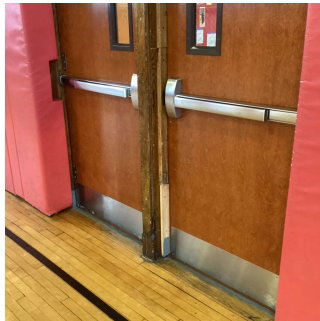
Instance on 4th Floor	Inspected
Condition	5 - Poor
Deficiency	WOOD: DETERIORATED DOOR AND FRAME
Deficiency Location/Instance	Main Entrance
Deficiency Quantity	2
Quantity Uom	EACH
Potential Action	MAINTENANCE
Urgency of Action	PRIORITY 3
Purpose of Action	LEVEL 2

Main Entrance
Violations	No violations recorded.
Instance on 3rd Floor	Inspected
Condition	5 - Poor
Deficiency	METAL: DETERIORATED DOOR
Deficiency Location/Instance	Room 361
Deficiency Quantity	1
Quantity Uom	EACH
Potential Action	MAINTENANCE
Urgency of Action	PRIORITY 3
Purpose of Action	LEVEL 2
Deficiency Photo1

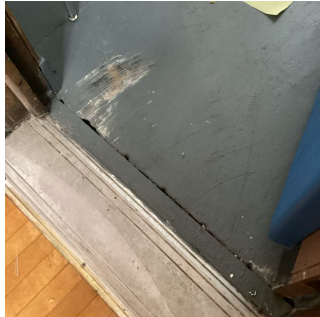
Question	Response
<b>INTERIOR</b>	
<b>GYMNASIUM</b>	
<b>Door(s)</b>	
Deficiency Photo1	 
	Office Room
Violations	No violations recorded.
Instance on 3rd Floor	Inspected
Condition	5 - Poor
Deficiency	WOOD: DETERIORATED DOOR AND FRAME
Deficiency Location/Instance	Office Room
Deficiency Quantity	1
Quantity Uom	EACH
Potential Action	MAINTENANCE
Urgency of Action	PRIORITY 3
Purpose of Action	LEVEL 2
Deficiency Photo1	 
	Office Room
Violations	No violations recorded.
<b>Fixed Equipment</b>	
Instance on 4th Floor	Inspected
Condition	2 - Between Good and Fair
Deficiency	No deficiencies recorded
Instance on 3rd Floor	Inspected
Condition	2 - Between Good and Fair
Deficiency	No deficiencies recorded
<b>Floor Finish</b>	
Instance on 3rd Floor	Inspected
Condition	2 - Between Good and Fair
Deficiency	CONCRETE: CRACKS
Deficiency Location/Instance	Office Room
Deficiency Quantity	10
Quantity Uom	S.F.
Potential Action	REPLACE
Urgency of Action	PRIORITY 3

Office Room
Violations	No violations recorded.
Instance on 4th Floor	Inspected
Condition	2 - Between Good and Fair
Deficiency	WOOD: DAMAGED/DETERIORATED
Deficiency Location/Instance	Near Right Side Windows
Deficiency Quantity	20
Quantity Uom	S.F.
Potential Action	REPLACE
Urgency of Action	PRIORITY 3
Purpose of Action	LEVEL 2
Deficiency Photo1

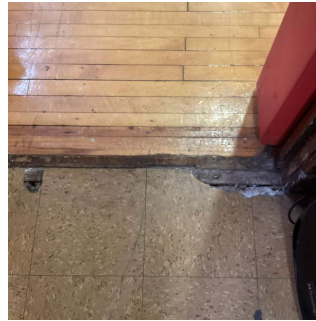
Near Right Side Windows
Violations	No violations recorded.
Deficiency	VINYL TILES: BROKEN/DETERIORATED/MISSING TILES
Deficiency Location/Instance	Office Room
Deficiency Quantity	20
Quantity Uom	S.F.
Potential Action	REPLACE
Urgency of Action	PRIORITY 3
Purpose of Action	LEVEL 2

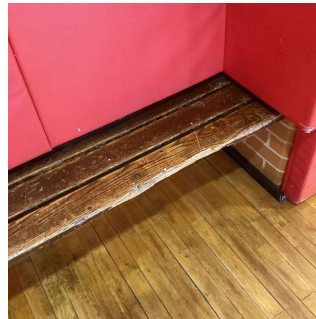
Instance on 4th Floor	Inspected
Condition	3 - Fair
Deficiency	DAMAGED FIXED SEATING
Deficiency Location/Instance	Near Left Side Windows
Deficiency Quantity	1
Quantity Uom	EACH
Potential Action	REPLACE
Urgency of Action	PRIORITY 3
Purpose of Action	LEVEL 2
Deficiency Photo1

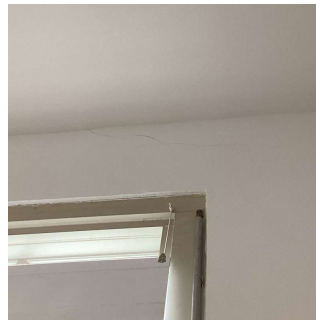
Office Room

PLASTER: CRACKS/SPALLING

REPLACE

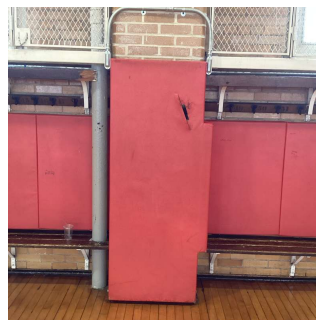
WALL PADDING: DETERIORATED

Question	Response
<b>INTERIOR</b>	
<b>GYMNASIUM</b>	
<b>Walls</b>	
Violations	Near Left Side Windows No violations recorded.
Instance on 3rd Floor	Inspected
Condition	2 - Between Good and Fair
Deficiency	SALT GLAZED BRICK: CRACKS/SPALLING
Deficiency Location/Instance	Near Right and Left Side Windows
Deficiency Quantity	40
Quantity Uom	S.F.
Potential Action	REPLACE
Urgency of Action	PRIORITY 3
Purpose of Action	LEVEL 2
Deficiency Photo1

REPLACE

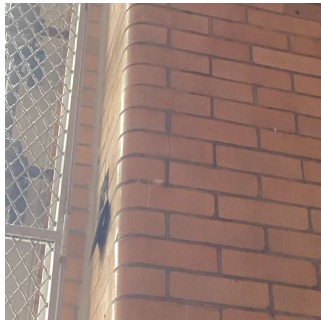
Violations	Near Right Side Windows No violations recorded.
Instance on 4th Floor	Inspected
Condition	3 - Fair
Deficiency	SALT GLAZED BRICK: CRACKS/SPALLING
Deficiency Location/Instance	Near Left Side Windows, by Main Entrance
Deficiency Quantity	30
Quantity Uom	S.F.
Potential Action	REPLACE
Urgency of Action	PRIORITY 3
Purpose of Action	LEVEL 2
Deficiency Photo1

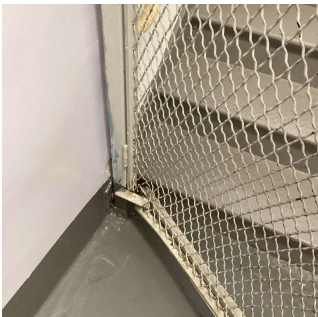
<b>Question</b>	<b>Response</b>
<b>INTERIOR</b>	
<b>INTERIOR DOOR HARDWARE</b>	Inspected
Condition	3 - Fair
Deficiency	No deficiencies recorded
<b>INTERIOR GUARDS</b>	Inspected
Condition	2 - Between Good and Fair
Deficiency	DETERIORATED/TORN-OUT/MISSING
Deficiency Location/Instance	Stairs E/Bulkhead, F/Bulkhead
Deficiency Quantity	40
Quantity Uom	S.F.
Potential Action	REPLACE
Urgency of Action	PRIORITY 3
Purpose of Action	LEVEL 2
Deficiency Photo1

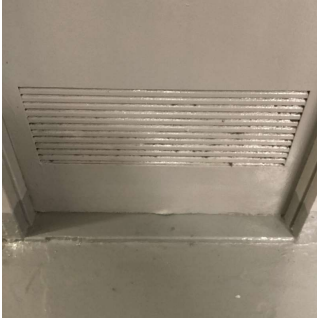
Question	Response
<b>INTERIOR</b>	
<b>KITCHEN</b>	
<b>Door(s)</b>	
Deficiency	METAL: DETERIORATED DOOR
Deficiency Location/Instance	Kitchen Locker Room
Deficiency Quantity	1
Quantity Uom	EACH
Potential Action	MAINTENANCE
Urgency of Action	PRIORITY 3
Purpose of Action	LEVEL 2
Deficiency Photo1

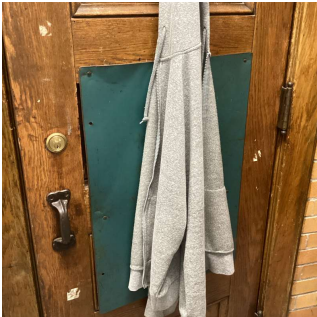
Violations	Kitchen Locker Room No violations recorded.
Deficiency	WOOD: DETERIORATED DOOR
Deficiency Location/Instance	Office Room Closet
Deficiency Quantity	1
Quantity Uom	EACH
Potential Action	MAINTENANCE
Urgency of Action	PRIORITY 3
Purpose of Action	LEVEL 2
Deficiency Photo1

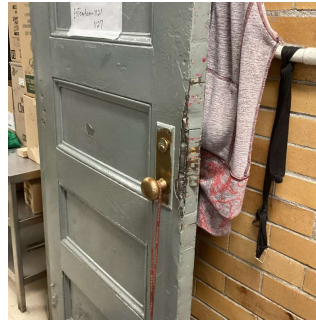
Violations	Office Room Closet No violations recorded.
Deficiency	METAL CLAD WOOD: DETERIORATED DOOR
Deficiency Location/Instance	Office Room
Deficiency Quantity	1
Quantity Uom	EACH
Potential Action	MAINTENANCE
Urgency of Action	PRIORITY 3
Purpose of Action	LEVEL 2

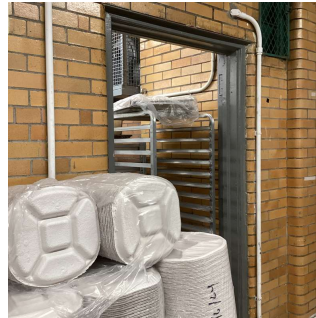
Preparation Area

WOOD: MISSING DOOR

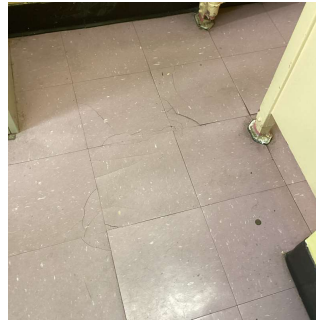
Kitchen Locker Room

VINYL TILES: BROKEN/DETERIORATED/MISSING TILES

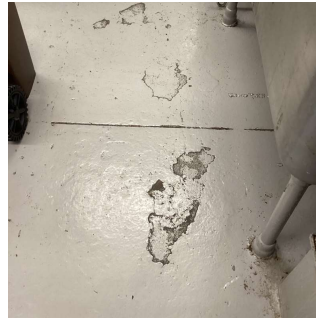
Near Sink

CONCRETE: CRACKS

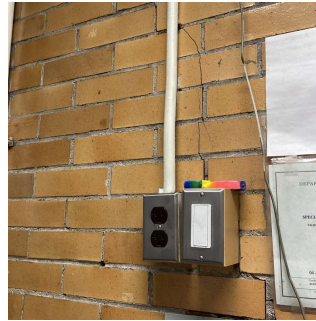
Office Room

SALT GLAZED BRICK: CRACKS/SPALLING

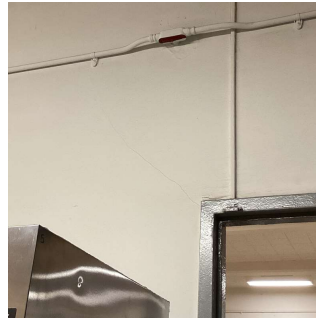
Servery

PLASTER: CRACKS/SPALLING

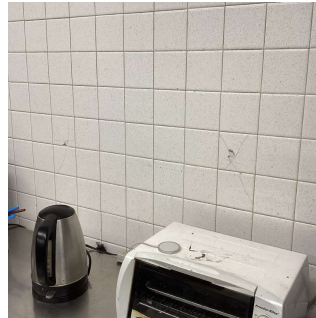
Preparation Area

CERAMIC TILE: BROKEN/ MISSING

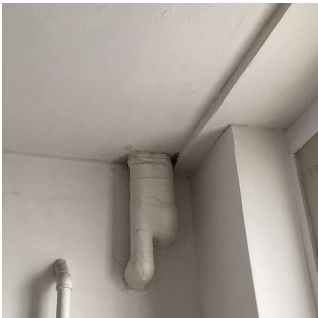
Question	Response
<b>INTERIOR</b>	
<b>LIBRARY</b>	Does not Exist
<b>LOCKER ROOM</b>	Inspected
Instance on 4th Floor	Inspected
Alternative use	Yes
<b>Ceiling</b>	
Instance on 4th Floor	Inspected
Condition	2 - Between Good and Fair
Deficiency	PLASTER: CRACKS/SPALLING
Deficiency Location/Instance	Near Windows
Deficiency Quantity	10
Quantity Uom	S.F.
Potential Action	REPLACE
Urgency of Action	PRIORITY 3
Purpose of Action	LEVEL 2
Deficiency Photo1

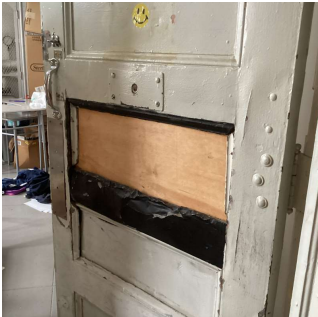
Violations	Near Windows No violations recorded.
<b>Door(s)</b>	
Instance on 4th Floor	Inspected
Condition	3 - Fair
Deficiency	METAL CLAD WOOD: DETERIORATED DOOR
Deficiency Location/Instance	Main Entrance
Deficiency Quantity	1
Quantity Uom	EACH
Potential Action	MAINTENANCE
Urgency of Action	PRIORITY 3
Purpose of Action	LEVEL 2
Deficiency Photo1

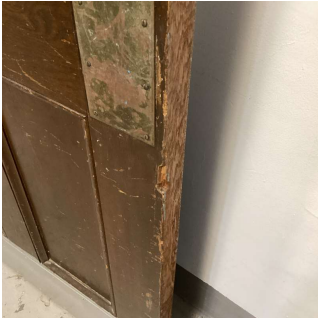
Violations	Stair A/4 No violations recorded.
<b>Door(s)</b>	Inspected
Condition	5 - Poor
Deficiency	WOOD: DETERIORATED DOOR
Deficiency Location/Instance	Exit 6 - Vestibule
Deficiency Quantity	2
Quantity Uom	EACH
Potential Action	MAINTENANCE
Urgency of Action	PRIORITY 3
Purpose of Action	LEVEL 2
Deficiency Photo1

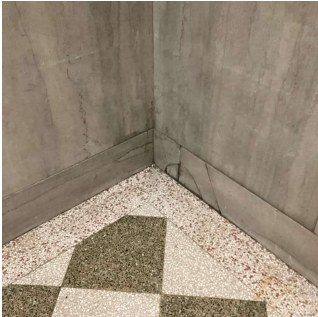
Question	Response
<b>INTERIOR</b>	
<b>STAIRS/RAMPS: INTERIOR</b>	
<b>Walls</b>	
Violations	Stair E/3 No violations recorded.
Deficiency	STONE MOLDINGS: CRACKS/SPALLING
Deficiency Location/Instance	Stair A/1
Deficiency Quantity	30
Quantity Uom	L.F.
Potential Action	REPLACE
Urgency of Action	PRIORITY 3
Purpose of Action	LEVEL 2
Deficiency Photo1

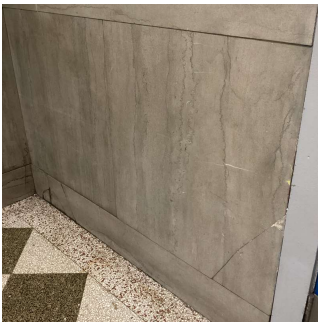
Violations	Stair E/3 No violations recorded.
Deficiency	STONE: CRACKS/SPALLING
Deficiency Location/Instance	Stair A/1
Deficiency Quantity	30
Quantity Uom	S.F.
Potential Action	REPLACE
Urgency of Action	PRIORITY 3
Purpose of Action	LEVEL 2

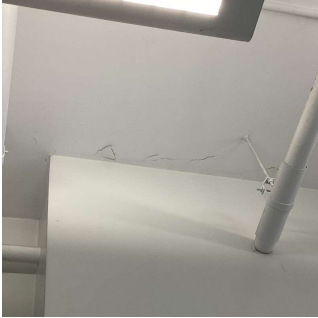
Question	Response
<b>INTERIOR</b>	
<b>TOILET ROOMS - STAFF</b>	
<b>Stalls</b>	Inspected
	Room 150
Violations	No violations recorded.
<b>Walls</b>	Inspected
Condition	2 - Between Good and Fair
Deficiency	PLASTER: CRACKS/SPALLING
Deficiency Location/Instance	Room 450
Deficiency Quantity	10
Quantity Uom	S.F.
Potential Action	REPLACE
Urgency of Action	PRIORITY 3
Purpose of Action	LEVEL 2
Deficiency Photo1	 
	Room 450
Violations	No violations recorded.
Deficiency	CERAMIC TILE: BROKEN/ MISSING
Deficiency Location/Instance	Room 150
Deficiency Quantity	10
Quantity Uom	S.F.
Potential Action	REPLACE
Urgency of Action	PRIORITY 3
Purpose of Action	LEVEL 2
Deficiency Photo1	 
	Room 150
Violations	No violations recorded.
<b>TOILET ROOMS - STUDENTS</b>	
	Inspected
<b>Ceiling</b>	Inspected
Condition	2 - Between Good and Fair
Deficiency	PLASTER: CRACKS/SPALLING
Deficiency Location/Instance	Room 356
Deficiency Quantity	10

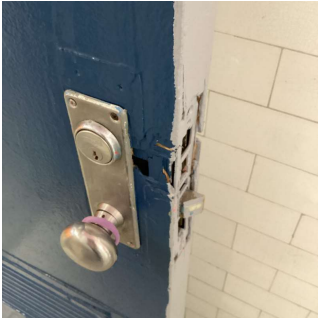
Room 356
Violations	No violations recorded.
<b>Door(s)</b>	Inspected
Condition	5 - Poor
Deficiency	WOOD: DETERIORATED DOOR
Deficiency Location/Instance	Rooms 456, 255, 152, In Room 204
Deficiency Quantity	4
Quantity Uom	EACH
Potential Action	MAINTENANCE
Urgency of Action	PRIORITY 3
Purpose of Action	LEVEL 2
Deficiency Photo1

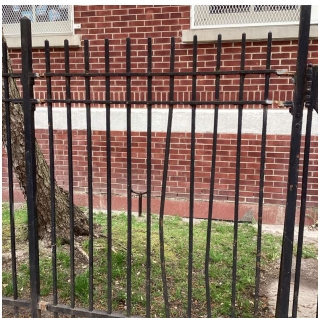
<b>Question</b>	<b>Response</b>
<b>SITE</b>	
<b>FENCES</b>	Inspected
Condition	4 - Between Fair and Poor
Deficiency	CHAIN LINK: DAMAGED POST/RAIL
Deficiency Location/Instance	E 93rd Street
Deficiency Quantity	10
Quantity Uom	L.F.
Potential Action	REPLACE
Urgency of Action	PRIORITY 3
Purpose of Action	LEVEL 2
Deficiency Photo1	 
Violations	E 93rd Street No violations recorded.
Deficiency	WROUGHT IRON: DAMAGED/DETERIORATED
Deficiency Location/Instance	E 94th Street, E 93rd Street, Clarkson Avenue
Deficiency Quantity	1,040
Quantity Uom	S.F.
Potential Action	REPLACE
Urgency of Action	PRIORITY 3
Purpose of Action	LEVEL 2
Deficiency Photo1

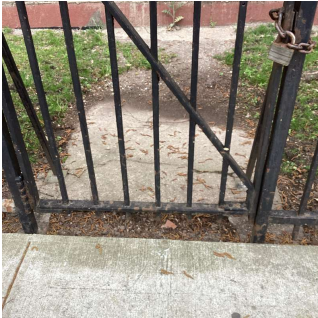
<b>Question</b>	<b>Response</b>
<b>SITE</b>	
<b>IRRIGATION SYSTEM</b>	Does not Exist
<b>PAVING</b>	Inspected
<b>Student Non-Use</b>	Inspected
Gravel Exists?	Yes
<b>Asphalt</b>	Does not Exist
<b>Concrete</b>	Inspected
Condition	2 - Between Good and Fair
Deficiency	DAMAGED/DETERIORATED/MISSING SECTIONS
Deficiency Location/Instance	E 94th Street
Deficiency Quantity	25
Quantity Uom	S.F.
Potential Action	REPLACE
Urgency of Action	PRIORITY 3
Purpose of Action	LEVEL 2
Deficiency Photo1

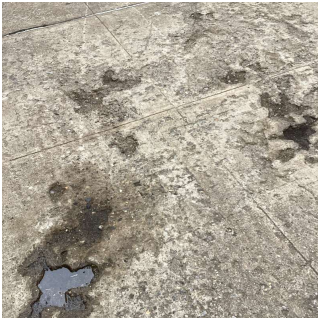
Near Exit 11

Violations	E 94th Street No violations recorded.
<b>Pavers</b>	Does not Exist
<b>Student Use</b>	Inspected
Gravel Exists?	No
<b>Asphalt</b>	Does not Exist
<b>Concrete</b>	Inspected
Condition	4 - Between Fair and Poor
Deficiency	DAMAGED/DETERIORATED/MISSING SECTIONS
Deficiency Location/Instance	Near Exits 9, 10, 11
Deficiency Quantity	675
Quantity Uom	S.F.
Potential Action	REPLACE
Urgency of Action	PRIORITY 3
Purpose of Action	LEVEL 2
Deficiency Photo1
