NYC Department of Education
Building Condition Assessment Survey 2023 - 2024

Architectural Inspection

Asset: I.S. 223 - BROOKLYN, 4200 16 AVENUE, New York, 11204

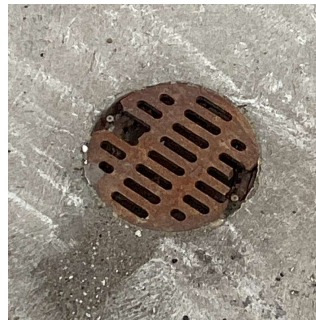
AW5	No violations recorded.
-----	-------------------------

Deficiency	AREAWAY DRAINS: DETERIORATED
Roof Plan reference	K223

Deficiency Quantity	3
Quantity Uom	EACH
Potential Action	REPLACE
Urgency of Action	PRIORITY 4
Purpose of Action	LEVEL 2
Deficiency Photo1

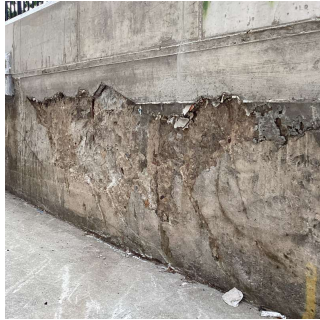
Deficiency	AREAWAY WALLS: CRACKS AND SPALLING
Roof Plan reference	K223

Deficiency Quantity	40
Quantity Uom	S.F.
Potential Action	REPLACE
Urgency of Action	PRIORITY 4
Purpose of Action	LEVEL 2

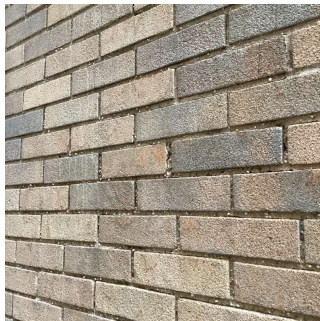
CH1
Violations	No violations recorded.
COPING	Inspected

AW5
Violations	No violations recorded.
Instance on AW1-AW4, AW6-AW15	Inspected
Instance Condition	2 - Between Good and Fair
Instance Quantity	11
Instance Quantity Uom	EACH
Deficiency	No deficiencies recorded
AWNINGS AND CANOPIES	Does not Exist
CHIMNEY	Inspected
Material Type(s)	Masonry
Condition	3 - Fair
Deficiency	BRICK: DETERIORATED JOINTS
Roof Plan reference

Deficiency Quantity	100
Quantity Uom	S.F.
Potential Action	REPOINT
Urgency of Action	PRIORITY 3
Purpose of Action	LEVEL 2
Deficiency Photo1

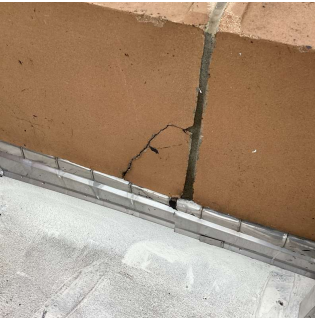
Question	Response
EXTERIOR	
COPING	
Condition	3 - Fair
Deficiency	TERRA COTTA: CRACKED/BROKEN PIECES
Roof Plan reference

Deficiency Quantity	10
Quantity Uom	L.F.
Potential Action	REPLACE-IN-KIND
Urgency of Action	PRIORITY 4
Purpose of Action	LEVEL 2
Deficiency Photo1

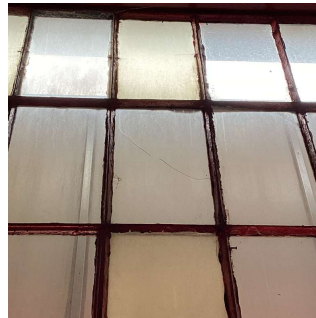
Facade A
No violations recorded.

METAL: BROKEN GLASS

20
S.F.
MAINTENANCE
PRIORITY 3
LEVEL 2

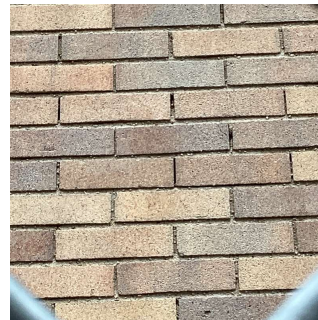
Facade D

BRICK: DETERIORATED JOINTS

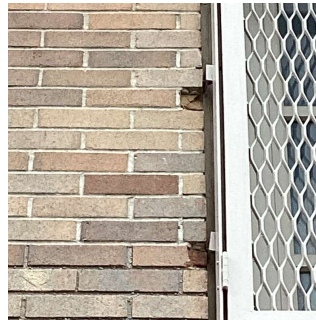
Facade D

BRICK: MAJOR / THRU CRACKS

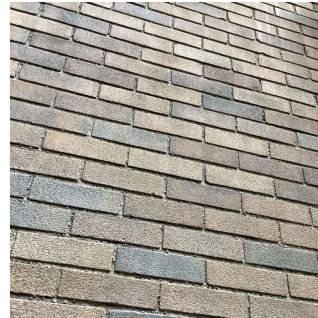
Facade D

BRICK: DETERIORATED JOINTS

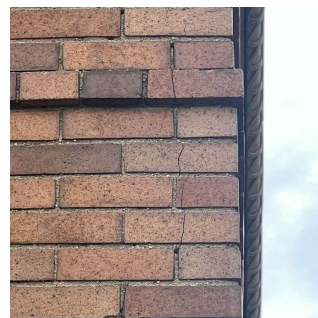
BRICK: CRACKS/DISPLACED/SPALLED BRICK AT BUILDING CORNERS

20
S.F.
REMOVE AND REBUILD
PRIORITY 4
LEVEL 2

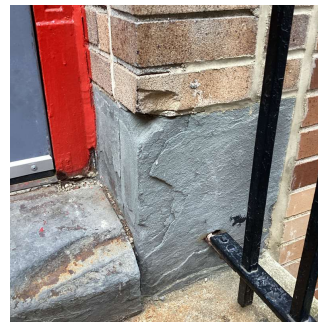
Facade D

STONE: CHIPPED/SPALLED/BROKEN PIECES - MINOR

20
 S.F.
 REPAIR
 PRIORITY 3
 LEVEL 2

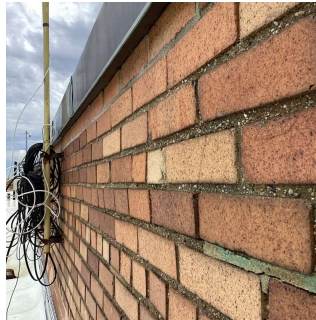
Roof 1

Deficiency	BRICK: OUT OF PLUMB
Roof Plan reference

Deficiency Quantity	20
Quantity Uom	C.F.
Potential Action	REMOVE AND REBUILD
Urgency of Action	PRIORITY 4
Purpose of Action	LEVEL 2
Deficiency Photo1

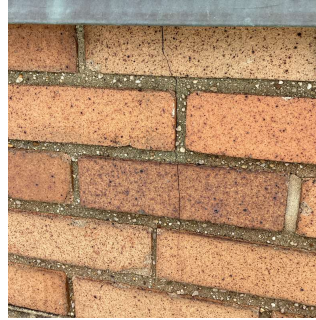
Roof 1

Deficiency	BRICK: MINOR CRACKS, SPALLING
Roof Plan reference

Deficiency Quantity	30
Quantity Uom	S.F.
Potential Action	REPAIR
Urgency of Action	PRIORITY 3
Purpose of Action	LEVEL 2

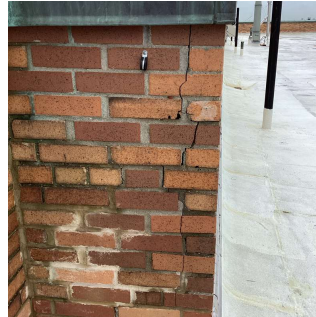
Roof 1

BRICK: MAJOR DETERIORATION/CRACKS

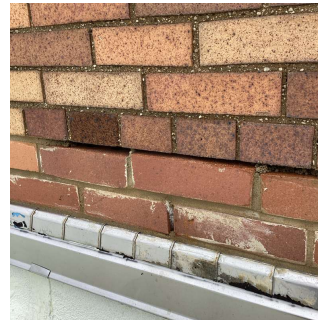
Roof 1

BRICK: DETERIORATED JOINTS

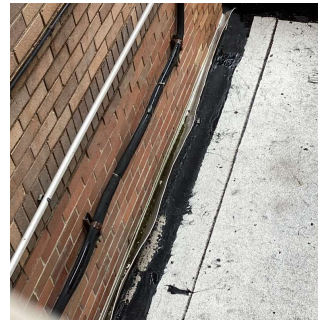
Roof 5
No violations recorded.

Deficiency	MODIFIED BITUMEN: FLASHING: CAP FLASHING DAMAGED
------------	--

Deficiency Quantity	80
---------------------	----

L.F.
REPLACE
PRIORITY 4
LEVEL 2

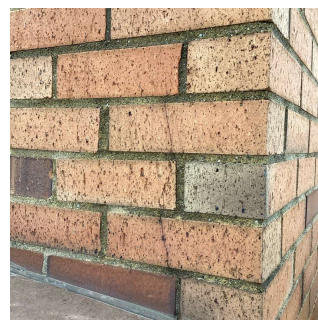
Inspected
3 - Fair
BULKHEAD/PENTHOUSE WALLS/EXTERIOR:
CRACKS/SPALLING - MINOR

10
S.F.
REPAIR
PRIORITY 3
LEVEL 2

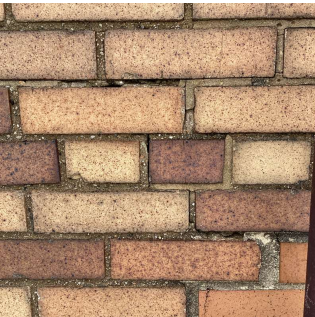
Question	Response
EXTERIOR	
ROOF	
Specialties	
BULKHEAD/PENTHOUSE	
Violations	PH No violations recorded.
Deficiency	BULKHEAD/PENTHOUSE WALLS/EXTERIOR: DETERIORATED JOINTS
Roof Plan reference

Deficiency Quantity	20
Quantity Uom	S.F.
Potential Action	REPOINT
Urgency of Action	PRIORITY 4
Purpose of Action	LEVEL 2
Deficiency Photo1

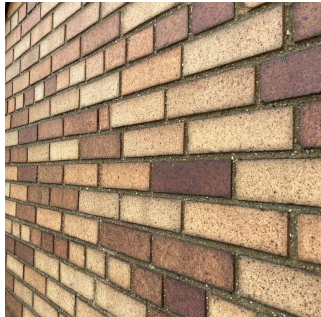
Violations	BH No violations recorded.
Deficiency	BULKHEAD/PENTHOUSE WALLS/EXTERIOR: DETERIORATED JOINTS
Roof Plan reference

Deficiency Quantity	100
Quantity Uom	S.F.
Potential Action	REPOINT
Urgency of Action	PRIORITY 3
Purpose of Action	LEVEL 2

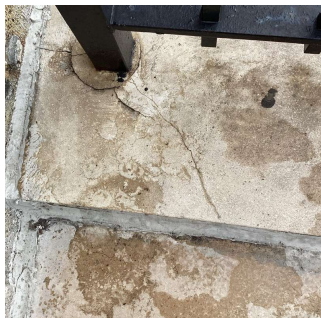
Violations	Facade A No violations recorded.

Violations	BH No violations recorded.
CUPOLA/ SPIRES/ TOWERS	Does not Exist
DORMER	Does not Exist
DUNNAGE STEEL	Does not Exist
SKYLIGHT/ROOF VENT	Does not Exist
ROOF/GRAVITY TANK	Does not Exist
STAIRS/RAMPS: EXTERIOR	Inspected
BUILDING CHEEK/FLANK WALLS	Inspected
Condition	3 - Fair
Deficiency	CAST IN PLACE CONCRETE: CRACKS/SPALLING - MINOR
Roof Plan reference

Deficiency Quantity	10
Quantity Uom	S.F.
Potential Action	REPAIR
Urgency of Action	PRIORITY 3
Purpose of Action	LEVEL 2
Deficiency Photo1

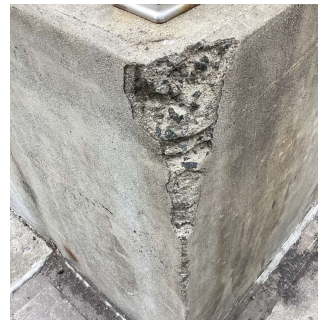
Facade C

CAST IN PLACE CONCRETE: CRACKS/SPALLING - MAJOR

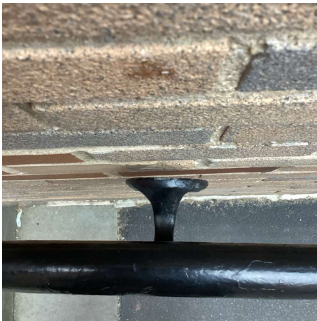
BROKEN BRACKET

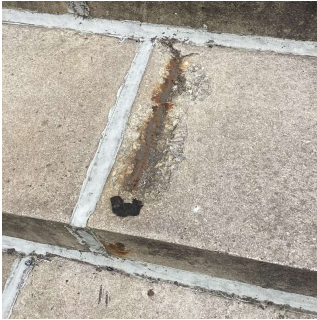
Violations	Facade E No violations recorded.
STAIRS/RAMPS	
Condition	Inspected 5 - Poor
Deficiency	CONCRETE: CRACKS/SPALLING - MAJOR
Roof Plan reference

Deficiency Quantity	20
Quantity Uom	S.F.
Potential Action	REPLACE
Urgency of Action	PRIORITY 4
Purpose of Action	LEVEL 2
Deficiency Photo1

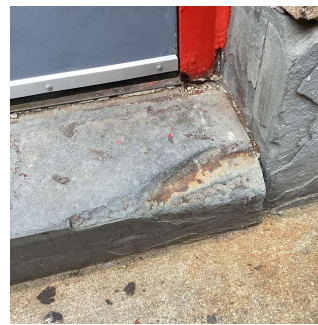
Facade D

Violations	Facade A No violations recorded.
Deficiency	STONE: CRACKS/SPALLING - MAJOR

30
S.F.
REPLACE
PRIORITY 4
LEVEL 2

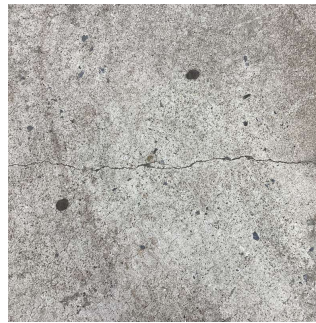
Facade C

CONCRETE: CRACKS/SPALLING - MINOR

20
S.F.
REPAIR
PRIORITY 3
LEVEL 2

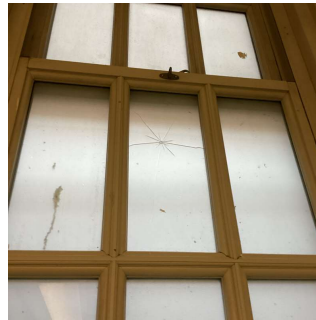
Facade D - Cafeteria Boy Toilet Room (Facade H - Auditorium similar throughout)

ALUMINUM - DOUBLE HUNG: BROKEN PANE

150
S.F.
MAINTENANCE
PRIORITY 3
LEVEL 2

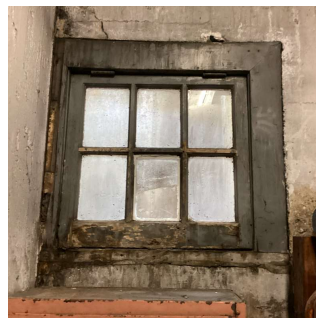
Deficiency	WOOD: DETERIORATED
------------	--------------------

Deficiency Quantity	100
---------------------	-----

Potential Action	REPLACE WINDOW
------------------	----------------

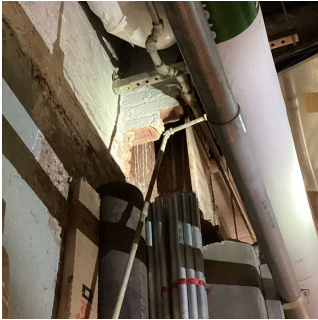
Question	Response
EXTERIOR	Inspected
WINDOWS	Inspected
WINDOWS	
Violations	Facade G - Basement No violations recorded.
INTERIOR	Inspected
POOLS	Does not Exist
STRUCTURAL	Inspected
COLUMNS/BEAMS/BEARING WALLS	Inspected
Condition	3 - Fair
Deficiency	STEEL COLUMNS/BEAMS: DETERIORATED MASONRY FIREPROOFING
Deficiency Location/Instance	Fan Room
Deficiency Quantity	20
Quantity Uom	S.F.
Potential Action	REPLACE
Urgency of Action	PRIORITY 4
Purpose of Action	LEVEL 5
Deficiency Photo1

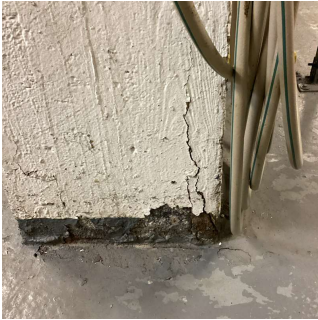
Violations	Boiler Room No violations recorded.
Deficiency	STEEL COLUMNS/BEAMS: DETERIORATED CONCRETE FIREPROOFING

Violations	Fan Room No violations recorded.
Deficiency	STEEL COLUMNS/BEAMS: DETERIORATED CONCRETE FIREPROOFING
Deficiency Location/Instance	Boiler Room
Deficiency Quantity	20
Quantity Uom	S.F.
Potential Action	REPLACE
Urgency of Action	PRIORITY 3
Purpose of Action	LEVEL 5
Deficiency Photo1

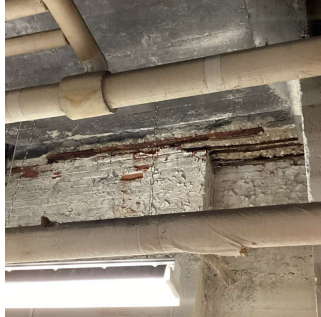
Boiler Room

Deficiency Location/Instance	Boiler Room, Fan Area
Deficiency Quantity	60
Quantity Uom	S.F.
Potential Action	REPLACE
Urgency of Action	PRIORITY 4
Purpose of Action	LEVEL 5
Deficiency Photo1

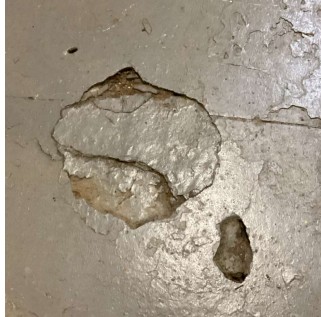
Condition	3 - Fair
Deficiency	CONCRETE SLAB ON GRADE: THRU CRACKS
Deficiency Location/Instance	Boiler Room
Deficiency Quantity	20
Quantity Uom	S.F.
Potential Action	REPLACE
Urgency of Action	PRIORITY 4
Purpose of Action	LEVEL 5
Deficiency Photo1

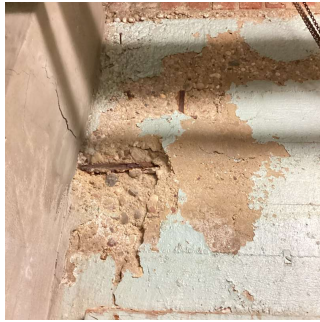
Violations	Boiler Room No violations recorded.
Deficiency	CONCRETE: CRACKED/SPALLED/REINFORCEMENT EXPOSED
Deficiency Location/Instance	Basement - Fan Room, Boiler Room
Deficiency Quantity	40
Quantity Uom	S.F.
Potential Action	REPAIR
Urgency of Action	PRIORITY 4
Purpose of Action	LEVEL 5
Deficiency Photo1

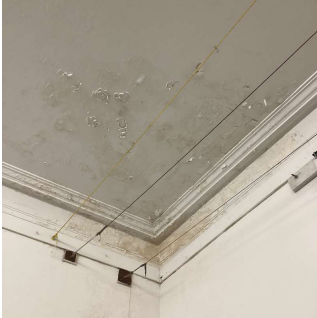
Question	Response
INTERIOR	
AUDITORIUM	
Ceiling	
Condition	2 - Between Good and Fair
Deficiency	PLASTER: CRACKS/SPALLING
Deficiency Location/Instance	Stage
Deficiency Quantity	30
Quantity Uom	S.F.
Potential Action	REPLACE
Urgency of Action	PRIORITY 3
Purpose of Action	LEVEL 2
Deficiency Photo1

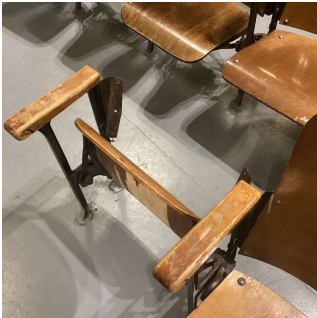
Violations	Seat B/4 No violations recorded.

Violations	Stage No violations recorded.
Door(s)	
Instance on 1st Floor (676 Seats)	Inspected
Condition	2 - Between Good and Fair
Deficiency	No deficiencies recorded
Fixed H/C Lift	
Instance on 1st Floor (676 Seats)	Does not Exist
Fixed Seating	
Instance on 1st Floor (676 Seats)	Inspected
Condition	5 - Poor
Deficiency	DAMAGED/BROKEN/INOPERABLE
Deficiency Location/Instance	Seats A/5, B/4, 7, 14, 16, 20, C/1, D/8, 24, E/18, F/1, 14, 20, G/14, H/2, 12, J/2, M/1, 2, 16, N/10, 16, O/10, P/14, 24, R/16, T/2, U/13, 20, X/2
Deficiency Quantity	30
Quantity Uom	EACH
Potential Action	REPLACE
Urgency of Action	PRIORITY 5
Purpose of Action	LEVEL 6

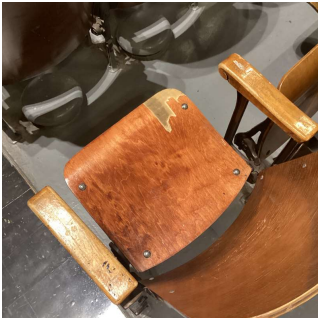
Question	Response
INTERIOR	
AUDITORIUM	
Fixed Seating	
Deficiency	DAMAGED/BROKEN/INOPERABLE
Deficiency Location/Instance	Seats L/2, 4, 6, 8, 10, and others
Deficiency Quantity	98
Quantity Uom	EACH
Potential Action	REPLACE
Urgency of Action	PRIORITY 3
Purpose of Action	LEVEL 2
Deficiency Photo1

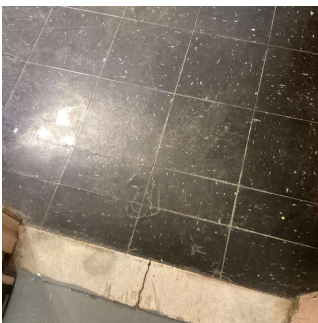
Violations	Seat L/2 No violations recorded.
Floor Finish	
Instance on 1st Floor (676 Seats)	Inspected
Condition	2 - Between Good and Fair
Deficiency	VINYL TILES: BROKEN/DETERIORATED/MISSING TILES
Deficiency Location/Instance	Center Aisle, Near Stair I
Deficiency Quantity	50
Quantity Uom	S.F.
Potential Action	REPLACE
Urgency of Action	PRIORITY 3
Purpose of Action	LEVEL 2
Deficiency Photo1

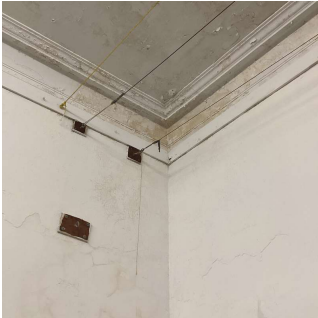
Question	Response
INTERIOR	
AUDITORIUM	
Walls	
Deficiency	PLASTER: CRACKS/SPALLING
Deficiency Location/Instance	Stage
Deficiency Quantity	20
Quantity Uom	S.F.
Potential Action	REPLACE
Urgency of Action	PRIORITY 3
Purpose of Action	LEVEL 2
Deficiency Photo1

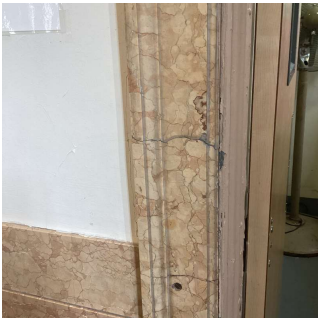
Violations	Stage No violations recorded.
Deficiency	STONE MOLDINGS: CRACKS/SPALLING
Deficiency Location/Instance	Near Exit 9, Near Entrance
Deficiency Quantity	20
Quantity Uom	L.F.
Potential Action	REPLACE
Urgency of Action	PRIORITY 3
Purpose of Action	LEVEL 2
Deficiency Photo1

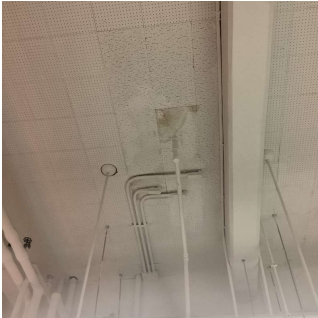
Violations	Near Exit 9 No violations recorded.
Window Curtains/Shades/Blinds	
Instance on 1st Floor (676 Seats)	Inspected
Condition	2 - Between Good and Fair
Deficiency	No deficiencies recorded
CAFETERIA	
Instance on Basement	Inspected
Ceiling	
Instance on Basement	Inspected
Condition	2 - Between Good and Fair
Deficiency	ACOUSTIC TILES ON PLASTER: DAMAGED/MISSING
Deficiency Location/Instance	Center

Question	Response
INTERIOR	
CAFETERIA	
Ceiling	
Deficiency Quantity	20
Quantity Uom	S.F.
Potential Action	REPLACE
Urgency of Action	PRIORITY 3
Purpose of Action	LEVEL 2
Deficiency Photo1

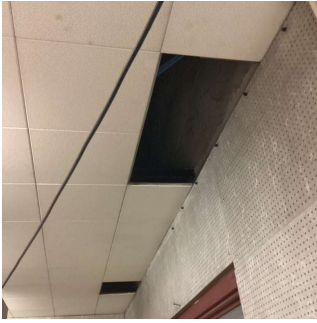
Violations	Near the Kitchen Staff Toilet No violations recorded.
Window Curtains/Shades/Blinds	
Instance on Basement	Does not Exist
CLASSROOMS/CORRIDORS/ADMIN SPACES	Inspected
Ceiling	Inspected
Condition	2 - Between Good and Fair
Deficiency	ACOUSTIC TILES: DAMAGED/MISSING
Deficiency Location/Instance	Room 203
Deficiency Quantity	10
Quantity Uom	S.F.
Potential Action	REPLACE
Urgency of Action	PRIORITY 3
Purpose of Action	LEVEL 2
Deficiency Photo1

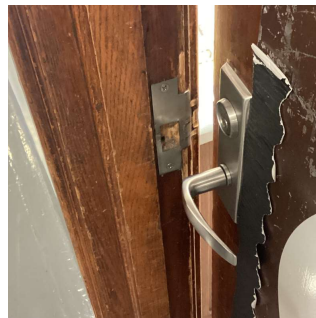
WOOD: DETERIORATED DOOR AND FRAME

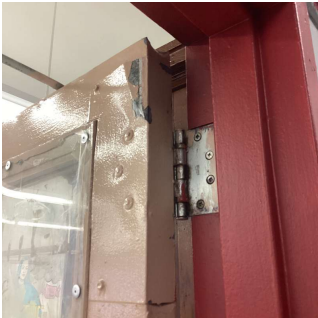
Question	Response
INTERIOR	
CLASSROOMS/CORRIDORS/ADMIN SPACES	
Door(s)	
	Room 228
Violations	No violations recorded.
Deficiency	METAL: DETERIORATED DOOR
Deficiency Location/Instance	Room 429
Deficiency Quantity	1
Quantity Uom	EACH
Potential Action	MAINTENANCE
Urgency of Action	PRIORITY 3
Purpose of Action	LEVEL 2
Deficiency Photo1

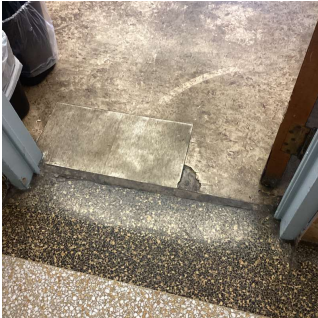
Room 429
Violations	No violations recorded.
Floor Finish	Inspected
Condition	2 - Between Good and Fair
Deficiency	SHEET VINYL: BROKEN/DETERIORATED
Deficiency Location/Instance	Rooms 109, 203
Deficiency Quantity	120
Quantity Uom	S.F.
Potential Action	REPLACE
Urgency of Action	PRIORITY 3
Purpose of Action	LEVEL 2
Deficiency Photo1

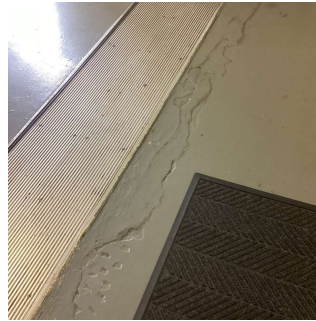
Room 109
Violations	No violations recorded.
Deficiency	CONCRETE: CRACKS
Deficiency Location/Instance	Corridor near Exit 10
Deficiency Quantity	20
Quantity Uom	S.F.
Potential Action	REPLACE
Urgency of Action	PRIORITY 3
Purpose of Action	LEVEL 2

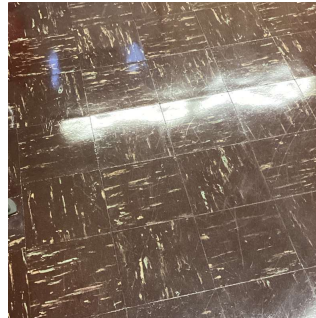
Room 107

VINYL TILES: BROKEN/DETERIORATED/MISSING TILES

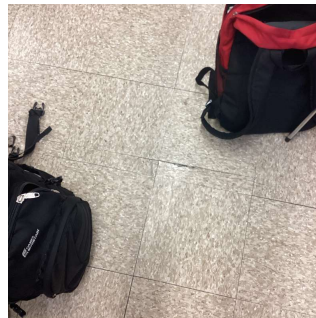
Room 427

VINYL TILES: DETERIORATED SUBSTRATE

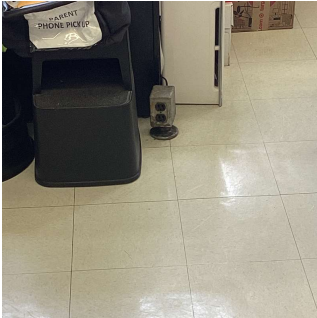
Question	Response
INTERIOR	
CLASSROOMS/CORRIDORS/ADMIN SPACES	
Floor Finish	
Deficiency	VINYL TILES: TRIPPING HAZARD - ELECTRICAL OUTLET
Deficiency Location/Instance	Room 203
Deficiency Quantity	10
Quantity Uom	S.F.
Potential Action	REMOVE
Urgency of Action	PRIORITY 5
Purpose of Action	LEVEL 6
Deficiency Photo1

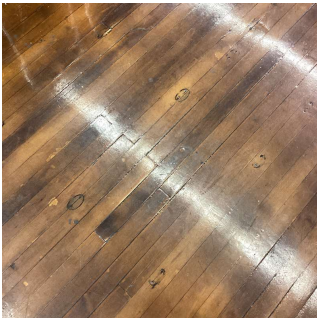
Room 203
Violations	No violations recorded.
Deficiency	WOOD: DAMAGED/DETERIORATED
Deficiency Location/Instance	Rooms 117, 125A, 219, 313, 420, and others
Deficiency Quantity	650
Quantity Uom	S.F.
Potential Action	REPLACE
Urgency of Action	PRIORITY 3
Purpose of Action	LEVEL 2
Deficiency Photo1

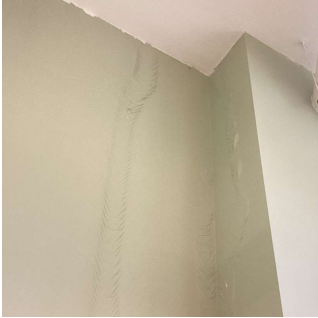
Question	Response
INTERIOR	
CLASSROOMS/CORRIDORS/ADMIN SPACES	
Walls	Inspected
Condition	2 - Between Good and Fair
Deficiency	GYPSUM BOARD: DETERIORATED
Deficiency Location/Instance	Room 413
Deficiency Quantity	20
Quantity Uom	S.F.
Potential Action	REPLACE
Urgency of Action	PRIORITY 3
Purpose of Action	LEVEL 2
Deficiency Photo1

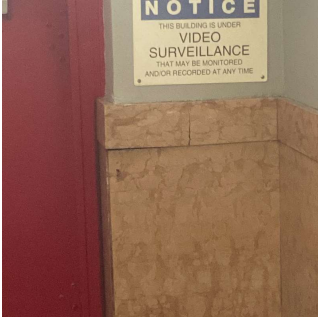
Violations	Room 413 No violations recorded.
Deficiency	STONE MOLDINGS: CRACKS/SPALLING
Deficiency Location/Instance	Near Main Entrance, Main Entrance Vestibule, Exit 5 Vestibule
Deficiency Quantity	30
Quantity Uom	L.F.
Potential Action	REPLACE
Urgency of Action	PRIORITY 3
Purpose of Action	LEVEL 2
Deficiency Photo1

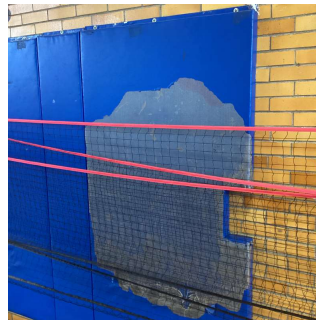
Near Office

WALL PADDING: DETERIORATED

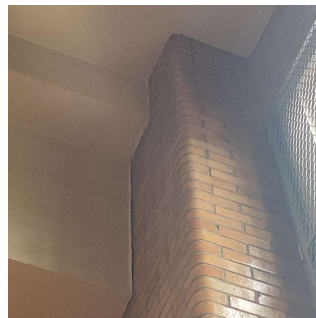
SALT GLAZED BRICK: CRACKS/SPALLING

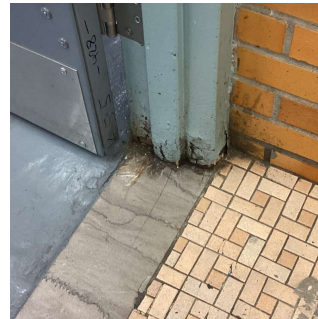
Serving Area

METAL: DETERIORATED DOOR AND FRAME

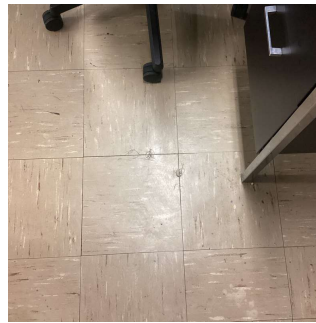
Office

VINYL TILES: BROKEN/DETERIORATED/MISSING TILES

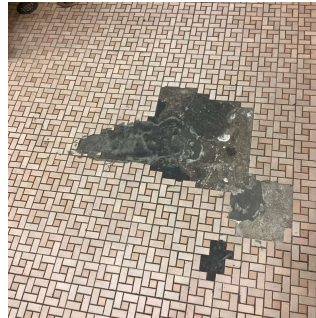
Near Hand Washing Sink

CERAMIC TILE: BROKEN/MISSING TILES

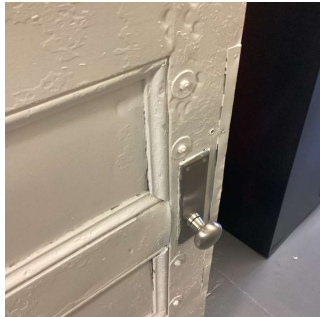
Question	Response
INTERIOR	
LOCKER ROOM	
Door(s)	
Purpose of Action	LEVEL 2
Deficiency Photo1

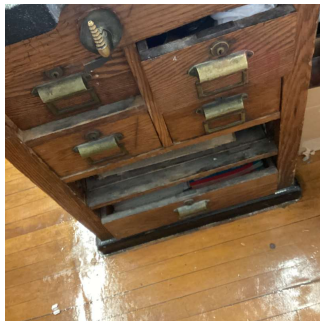
Room 313
Violations	No violations recorded.

Entrance
Violations	No violations recorded.
Floor Finish	
Instance on 4th Floor (36 Lockers)	Inspected
Condition	2 - Between Good and Fair
Deficiency	No deficiencies recorded
Locker Room Lockers	
Instance on 4th Floor (36 Lockers)	Does not Exist
Walls	
Instance on 4th Floor (36 Lockers)	Inspected
Condition	2 - Between Good and Fair
Deficiency	No deficiencies recorded
MULTI-PURPOSE ROOM	
	Does not Exist
SCIENCE DEMO ROOM	
	Inspected
Instance on Rooms 213, 313	Inspected
Alternative use	No
Fixed Equipment	
Instance on Rooms 213, 313	Inspected
Condition	3 - Fair
Deficiency	CABINETS: MISSING/DAMAGED
Deficiency Location/Instance	Rooms 213, 313
Deficiency Quantity	12
Quantity Uom	L.F.
Potential Action	REPLACE
Urgency of Action	PRIORITY 3
Purpose of Action	LEVEL 2
Deficiency Photo1

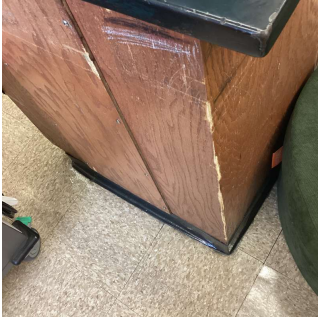
Question	Response
INTERIOR	
SCIENCE LAB	
Instance on Room 425	Inspected
Alternative use	No
Instance on Rooms 128, 411, 429	Inspected
Alternative use	No
Instance on Room 427	Inspected
Alternative use	No
Instance on Room 421	Inspected
Alternative use	Yes
Fixed Equipment	
Instance on Room 421	Inspected
Condition	3 - Fair
Deficiency	CABINETS: MISSING/DAMAGED
Deficiency Location/Instance	Room 421
Deficiency Quantity	10
Quantity Uom	L.F.
Potential Action	REPLACE
Urgency of Action	PRIORITY 3
Purpose of Action	LEVEL 2
Deficiency Photo1	No photo recorded
Violations	No violations recorded.
Instance on Room 427	Inspected
Condition	3 - Fair
Deficiency	CABINETS: MISSING/DAMAGED
Deficiency Location/Instance	Room 427
Deficiency Quantity	10
Quantity Uom	L.F.
Potential Action	REPLACE
Urgency of Action	PRIORITY 3
Purpose of Action	LEVEL 2
Deficiency Photo1

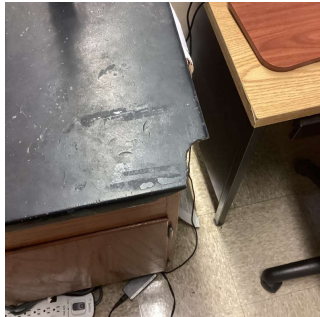
Violations	No violations recorded.
Instance on Room 425	Inspected
Condition	5 - Poor

Deficiency	DEMO TABLE: DAMAGED/DETERIORATED
Deficiency Location/Instance	Room 425
Deficiency Quantity	1
Quantity Uom	EACH
Potential Action	REPLACE
Urgency of Action	PRIORITY 3

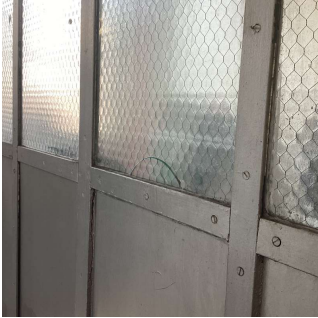
Question	Response
INTERIOR	
STAIRS/RAMPS: INTERIOR	
Partition	Inspected
Condition	3 - Fair
Deficiency	GLASS PANEL: DAMAGED/DETERIORATED
Deficiency Location/Instance	Stair EF/4
Deficiency Quantity	10
Quantity Uom	S.F.
Potential Action	REPLACE
Urgency of Action	PRIORITY 3
Purpose of Action	LEVEL 2
Deficiency Photo1

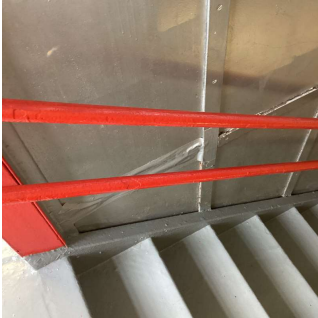
Violations	Stair EF/4 No violations recorded.
Deficiency	METAL FRAME: DAMAGED/DETERIORATED
Deficiency Location/Instance	Stairs EF/Basement,4, GH/1,2,3, and others
Deficiency Quantity	85
Quantity Uom	L.F.
Potential Action	REPLACE
Urgency of Action	PRIORITY 3
Purpose of Action	LEVEL 2
Deficiency Photo1

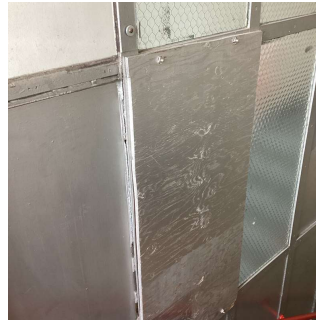
Stair GH/4

Violations	Stair GH/3 No violations recorded.
Deficiency	METAL PANEL: DAMAGED/DETERIORATED
Deficiency Location/Instance	Stairs AB/4, EF/Basement,4, GH/2,4, and others
Deficiency Quantity	50
Quantity Uom	S.F.
Potential Action	REPLACE
Urgency of Action	PRIORITY 3
Purpose of Action	LEVEL 2

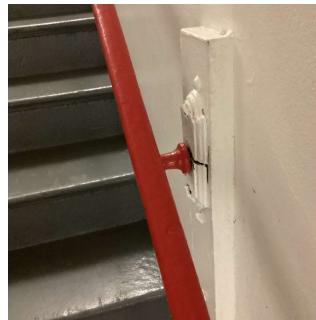
Stair CD/1

METAL: BROKEN BRACKET

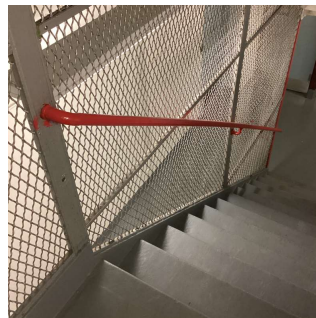
METAL: DAMAGED

Stair DC/1 (missing bottom rail)

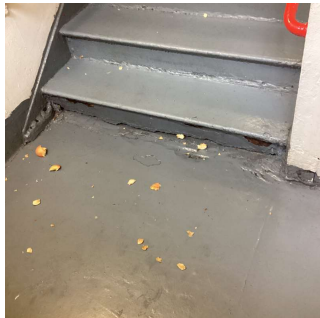
Question	Response
INTERIOR	
STAIRS/RAMPS: INTERIOR	
Railings	Inspected
	Stair CD/1
Violations	No violations recorded.
Stairs and Landings	Inspected
Condition	3 - Fair
Deficiency	TERRAZZO: CRACKS
Deficiency Location/Instance	Stair AB/1
Deficiency Quantity	20
Quantity Uom	S.F.
Potential Action	REPLACE
Urgency of Action	PRIORITY 3
Purpose of Action	LEVEL 2
Deficiency Photo1	 
	Stair AB/1
Violations	No violations recorded.
Deficiency	METAL: RUST - MAJOR
Deficiency Location/Instance	Stairs AB/2, GH/Basement
Deficiency Quantity	20
Quantity Uom	S.F.
Potential Action	REPLACE
Urgency of Action	PRIORITY 3
Purpose of Action	LEVEL 2
Deficiency Photo1

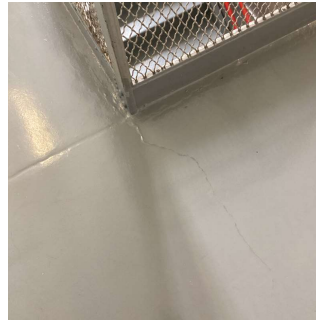
Stair GH/4

Stair GH/Basement
Violations	No violations recorded.
Deficiency	CONCRETE: CRACKS/SPALLING - MAJOR
Deficiency Location/Instance	Stairs EF/1, GH/2,3,4, I/1
Deficiency Quantity	75
Quantity Uom	S.F.
Potential Action	REPLACE
Urgency of Action	PRIORITY 3
Purpose of Action	LEVEL 2

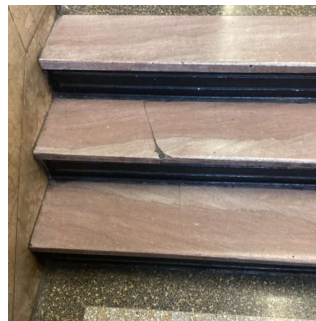
Main Entrance Vestibule

STONE: BROKEN/MISSING

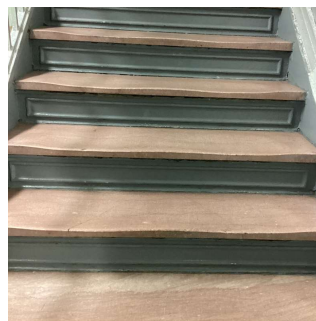
Stair AB/1

STONE: WORN-OUT TREAD/NOSINGS

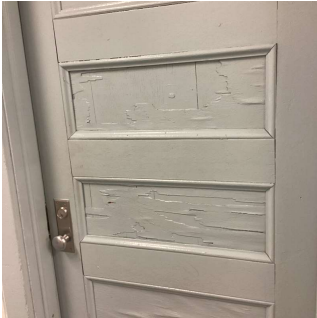
Question	Response
INTERIOR	
STAIRS/RAMPS: INTERIOR	
Walls	
Deficiency Photo1	 
Violations	Stair GH/Basement No violations recorded.
TOILET ROOMS - STAFF	
Ceiling	Inspected
Condition	2 - Between Good and Fair
Deficiency	No deficiencies recorded
Door(s)	Inspected
Condition	5 - Poor
Deficiency	WOOD: DETERIORATED DOOR
Deficiency Location/Instance	1st Floor Women, Rooms 210B, 312C, Kitchen
Deficiency Quantity	4
Quantity Uom	EACH
Potential Action	MAINTENANCE
Urgency of Action	PRIORITY 3
Purpose of Action	LEVEL 2
Deficiency Photo1

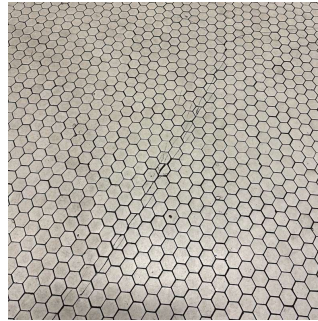
Room 210B

Violations	1st Floor Women No violations recorded.
Floor Finish	
Floor Finish	Inspected
Condition	5 - Poor
Deficiency	CERAMIC TILE: BROKEN/MISSING TILES
Deficiency Location/Instance	1st Floor Women, Rooms 210A, 210B,
Deficiency Quantity	40
Quantity Uom	S.F.
Potential Action	REPLACE
Urgency of Action	PRIORITY 3
Purpose of Action	LEVEL 2

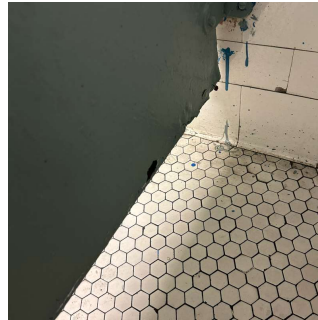
Room 210B

RUST - MAJOR

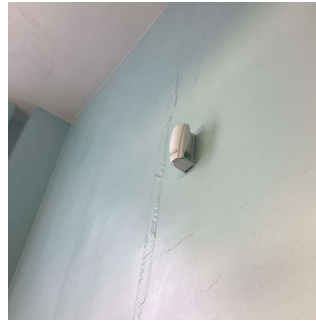
Room 312C

GYPSUM BOARD: DETERIORATED

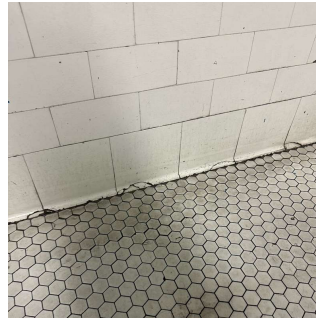
Room 210B

CERAMIC TILE: BROKEN/ MISSING

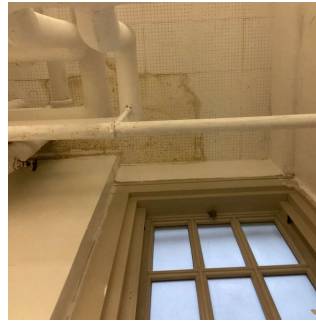
Cafeteria Boys

ACOUSTIC TILES ON PLASTER: DAMAGED/MISSING

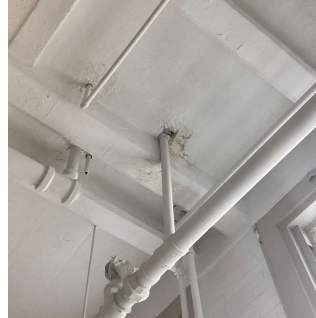
1st Floor Boys

PLASTER: CRACKS/SPALLING

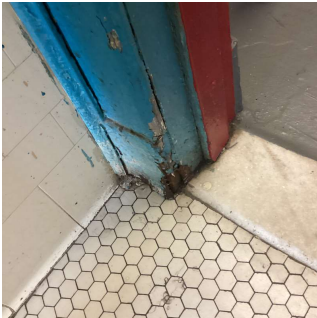
Question	Response
INTERIOR	
TOILET ROOMS - STUDENTS	
Door(s)	
Violations	Cafeteria Girls No violations recorded.
Deficiency	METAL CLAD WOOD: DETERIORATED DOOR AND FRAME
Deficiency Location/Instance	4th Floor Gymnasium
Deficiency Quantity	1
Quantity Uom	EACH
Potential Action	MAINTENANCE
Urgency of Action	PRIORITY 3
Purpose of Action	LEVEL 2
Deficiency Photo1

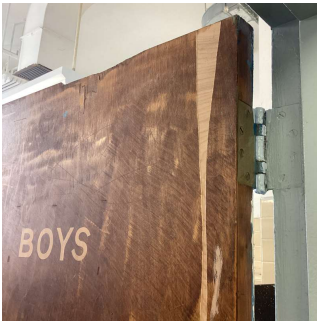
Violations	4th Floor Gymnasium No violations recorded.
Deficiency	WOOD: DETERIORATED DOOR
Deficiency Location/Instance	Rooms 212A, 312, 412A
Deficiency Quantity	3
Quantity Uom	EACH
Potential Action	MAINTENANCE
Urgency of Action	PRIORITY 3
Purpose of Action	LEVEL 2
Deficiency Photo1

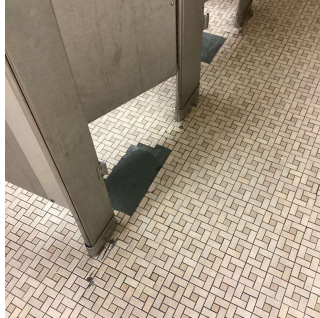
Violations	Room 312 No violations recorded.
Floor Finish	Inspected
Condition	3 - Fair
Deficiency	CERAMIC TILE: BROKEN/MISSING TILES
Deficiency Location/Instance	Cafeteria Girls, Cafeteria Boys, Rooms 412A, 412B, 4th Floor Gymnasium
Deficiency Quantity	80
Quantity Uom	S.F.
Potential Action	REPLACE

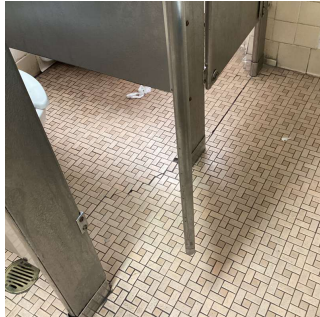
Violations	Cafeteria Girls No violations recorded.
Deficiency	CERAMIC TILE: DETERIORATED SUBSTRATE
Deficiency Location/Instance	Room 212A
Deficiency Quantity	20
Quantity Uom	S.F.
Potential Action	REPLACE
Urgency of Action	PRIORITY 3
Purpose of Action	LEVEL 2
Deficiency Photo1

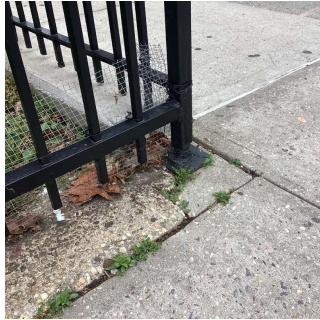
Question	Response
SITE	
Drainage System for Soil	Inspected
Catch Basins/Manhole - Surrounded by Soil	Inspected
Condition	2 - Between Good and Fair
Deficiency	No deficiencies recorded
Culverts - Soil Covering	Does not Exist
DRINKING FOUNTAINS	Does not Exist
FENCES	Inspected
Condition	4 - Between Fair and Poor
Deficiency	WROUGHT IRON: RUST - MAJOR
Deficiency Location/Instance	42nd Street
Deficiency Quantity	40
Quantity Uom	S.F.
Potential Action	REPLACE
Urgency of Action	PRIORITY 3
Purpose of Action	LEVEL 2
Deficiency Photo1

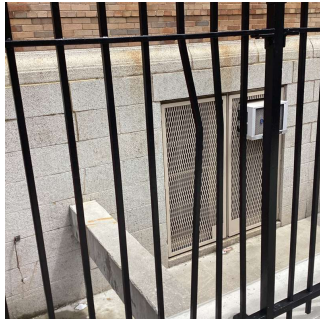
Violations	42nd Street No violations recorded.
Deficiency	WROUGHT IRON: DAMAGED/DETERIORATED
Deficiency Location/Instance	43rd Street, 16th Avenue, 42nd Street
Deficiency Quantity	320
Quantity Uom	S.F.
Potential Action	REPLACE
Urgency of Action	PRIORITY 3
Purpose of Action	LEVEL 2
Deficiency Photo1

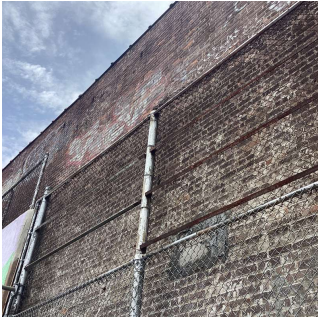
Question	Response
SITE	
FENCES	
Urgency of Action	PRIORITY 3
Purpose of Action	LEVEL 2
Deficiency Photo1	 
	Parking Lot
Violations	No violations recorded.
Deficiency	CHAIN LINK: RUST - MAJOR
Deficiency Location/Instance	Schoolyard
Deficiency Quantity	500
Quantity Uom	S.F.
Potential Action	REPLACE
Urgency of Action	PRIORITY 3
Purpose of Action	LEVEL 2
Deficiency Photo1

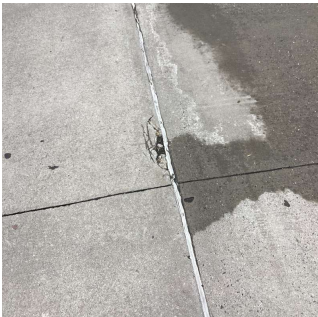
Question	Response
SITE	
FENCES	Inspected
Violations	No violations recorded.
IRRIGATION SYSTEM	Does not Exist
PAVING	Inspected
Student Non-Use	Inspected
Gravel Exists?	No
Asphalt	Does not Exist
Concrete	Inspected
Condition	3 - Fair
Deficiency	DAMAGED/DETERIORATED/MISSING SECTIONS
Deficiency Location/Instance	Parking Lot
Deficiency Quantity	425
Quantity Uom	S.F.
Potential Action	REPLACE
Urgency of Action	PRIORITY 3
Purpose of Action	LEVEL 2
Deficiency Photo1

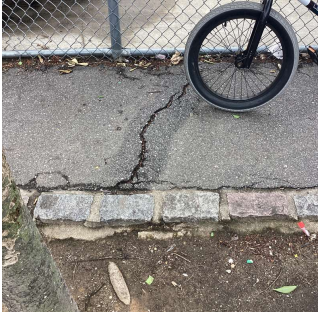
Violations	Parking Lot No violations recorded.
Pavers	Does not Exist
Student Use	Inspected
Gravel Exists?	No
Asphalt	Inspected
Condition	4 - Between Fair and Poor
Deficiency	HEAVING
Deficiency Location/Instance	Schoolyard
Deficiency Quantity	50
Quantity Uom	S.F.
Potential Action	REPLACE
Urgency of Action	PRIORITY 3
Purpose of Action	LEVEL 2
Deficiency Photo1

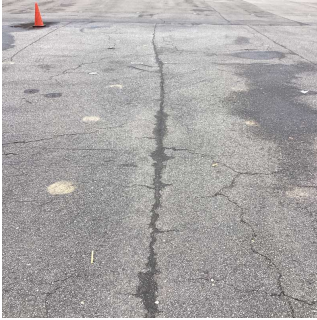
Question	Response
SITE	
PAVING	Inspected
Student Use	
Asphalt	
Violations	Schoolyard No violations recorded.
Deficiency	CRACKS - MAJOR
Deficiency Location/Instance	Schoolyard
Deficiency Quantity	4,500
Quantity Uom	S.F.
Potential Action	REPLACE
Urgency of Action	PRIORITY 3
Purpose of Action	LEVEL 2
Deficiency Photo1

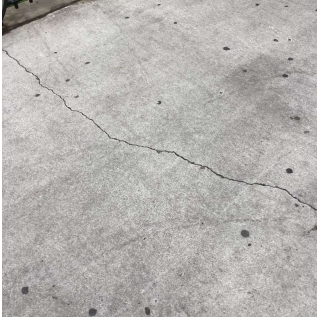
Violations	Schoolyard No violations recorded.
Concrete	Does not Exist
Pavers	Does not Exist
Site Sidewalks & Walkways	Inspected
Asphalt	Does not Exist
Concrete	Inspected
Condition	3 - Fair
Deficiency	DAMAGED/DETERIORATED/MISSING SECTIONS
Deficiency Location/Instance	16th Avenue
Deficiency Quantity	50
Quantity Uom	S.F.
Potential Action	REPLACE
Urgency of Action	PRIORITY 3
Purpose of Action	LEVEL 2
Deficiency Photo1
