**NYC Department of Education**  
**Building Condition Assessment Survey 2023 - 2024**

Architectural Inspection

**Asset: P.S. 229 - BROOKLYN, 1400 BENSON AVENUE, New York, 11228**

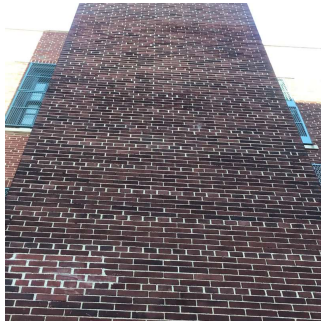
| Question | Response |
|---|--|
| Violations | Facade D<br>No violations recorded. |

| Question | Response |
|---|--|
| <b>CHIMNEY</b> | |

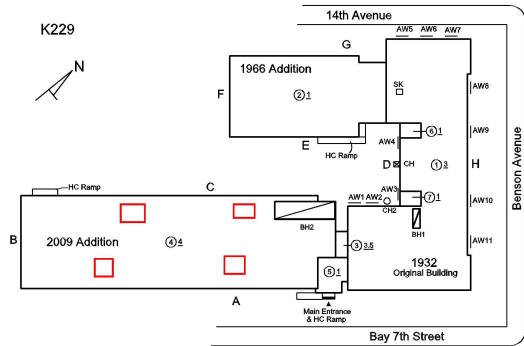
| Question | Response |
|---|---|
| Deficiency | 3 - Fair<br>BULKHEAD/PENTHOUSE WALLS/EXTERIOR:<br>EFFLORESCENCE |

60  
 S.F.  
 MAINTENANCE  
 PRIORITY 1  
 LEVEL 1

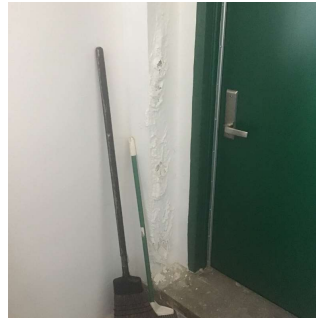
Roof 1 - BH1

**BULKHEAD/PENTHOUSE WALLS/INTERIOR: PLASTER  
 CRACKS/SPALLING**

20  
 S.F.  
 REPLACE  
 PRIORITY 3  
 LEVEL 2

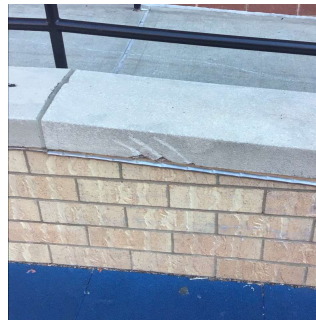
Facade C - Exit 2

| Deficiency | <b>BRICK: DETERIORATED COPING STONE</b> |

REPAIR

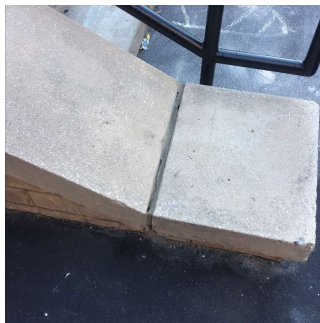
| Question | Response |
|---|--|
| Violations | Facade C - Exit 2<br>No violations recorded. |

| Deficiency | <b>BRICK: DETERIORATED JOINTS AT COPING STONES</b> |

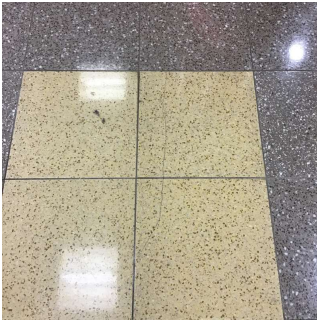
| Question | Response |
|--|--|
| Violations | Main Entrance Lobby<br>No violations recorded. |

| Question | Response |
|--|--|
| Deficiency | CERAMIC TILE: BROKEN/MISSING TILES |
| Deficiency Location/Instance | Main Entrance Lobby |

| Question | Response |
|--|--|
| Potential Action | REPLACE |

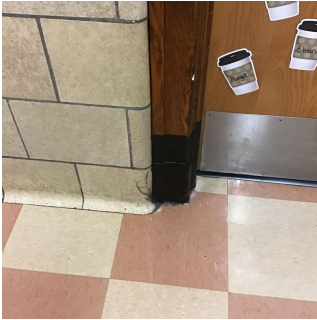
| Question | Response |
|--|--|
| Violations | Corridor near Room 323<br>No violations recorded. |

| Question | Response |
|--|--|
| Condition | Inspected<br>2 - Between Good and Fair |
| Deficiency | GLAZED BLOCK: CRACKS/SPALLING |
| Deficiency Location/Instance | Corridor near Rooms 459,466,323,228, Next Multipurpose Room and others |
| Urgency of Action | PRIORITY 3 |

| Question | Response |
|--|--|
| Potential Action | REPLACE |

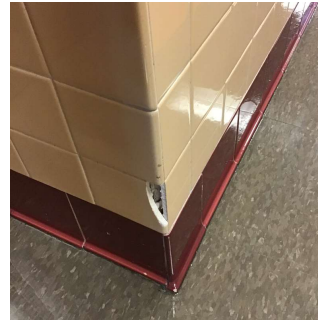
Corridor near Room 354

| Question | Response |
|--|--|
| Deficiency | CERAMIC TILE: BROKEN/ MISSING |
| Deficiency Location/Instance | Corridor near Rooms 364,354, By Stairs C/3,2, Next to Cafeteria |

| Question | Response |
|--|--|
| Potential Action | REPLACE |

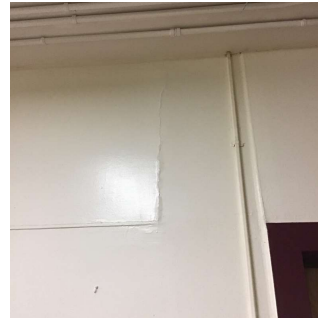
Corridor near Room 329

PLASTER: CRACKS/SPALLING

REPLACE

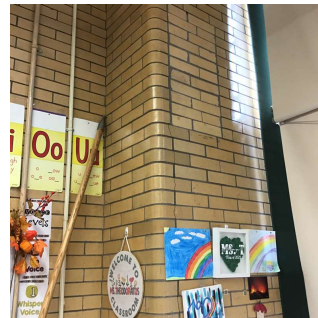
Room 129

SALT GLAZED BRICK: CRACKS/SPALLING

REPLACE

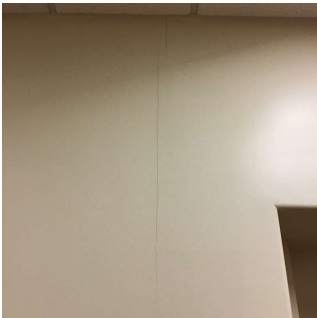
| Question | Response |
|--|--|
| | Corridor near Drinking Fountain - 1st Floor |

| Question | Response |
|--|--|
| Deficiency | GYPSUM BOARD: DETERIORATED |
| Deficiency Location/Instance | Main Entrance Lobby, Corridor near Drinking Fountain - 1st Floor, Room 132 |
| Urgency of Action | PRIORITY 3 |

| Question | Response |
|--|--|
| Potential Action | REPLACE |

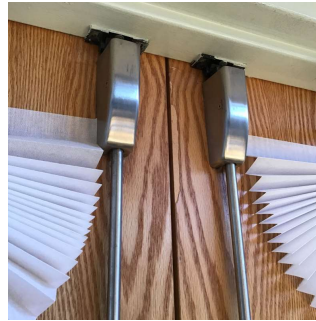
| Question | Response |
|--|--|
| Condition | 3 - Fair |
| Deficiency | WOOD: DETERIORATED DOOR |
| Deficiency Location/Instance | Main Entrance |

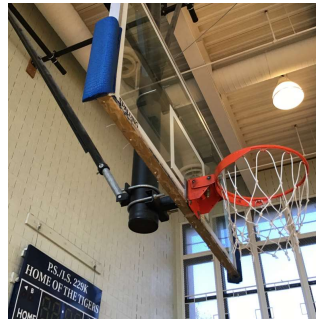
Rear Wall

| Condition | 5 - Poor |
| Deficiency | DAMAGED/MISSING |
| Deficiency Location/Instance | Rear Wall, near Entrance |

| Potential Action | REPLACE |

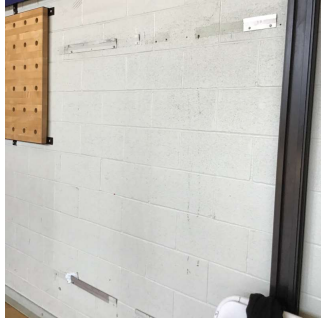
| Question | Response |
|---|--|
| Violations | Right Side<br>No violations recorded. |

| Question | Response |
|---|--|
| Deficiency | WALL PADDING: DETERIORATED |
| Deficiency Location/Instance | Right and Left Side |

| Question | Response |
|---|--|
| Urgency of Action | PRIORITY 3 |

| Question | Response |
|---|--|
| Potential Action | REPLACE |

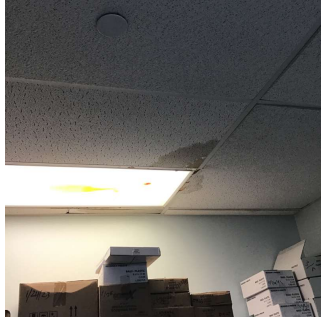
| Question | Response |
|---|--|
| Violations | Room C60F<br>No violations recorded. |

| Question | Response |
|---|--|
| Deficiency | ACOUSTIC TILES: DAMAGED/MISSING |
| Deficiency Location/Instance | Room C60F |
| Urgency of Action | PRIORITY 3 |

| Question | Response |
|---|--|
| Potential Action | REPLACE |

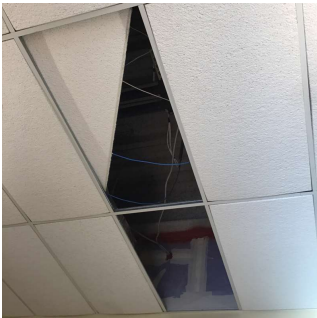
| Question | Response |
|---|--|
| Violations | Right Side<br>No violations recorded. |

| Question | Response |
|---|--|
| Deficiency | ACOUSTIC TILES: DAMAGED/MISSING - ACTIVE LEAK |
| Deficiency Location/Instance | Right Side, Near Entrance |
| Urgency of Action | PRIORITY 5 |

| Question | Response |
|---|--|
| Potential Action | REPLACE |

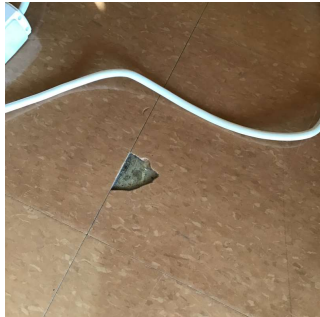
| Question | Response |
|--|--|
| | Room 469 |

| Question | Response |
|---|--|
| Deficiency | VINYL TILES: BROKEN/DETERIORATED/MISSING TILES |
| Deficiency Location/Instance | Room 469 |

| Question | Response |
|---|--|
| Potential Action | REPLACE |

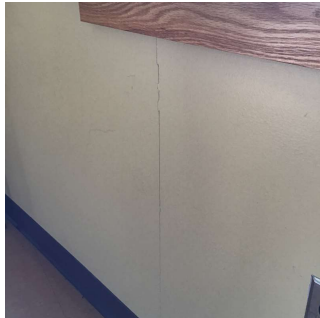
| Question | Response |
|--|--|
| | Room 469 |

| Question | Response |
|--|--|
| Deficiency | GYPSUM BOARD: DETERIORATED |
| Deficiency Location/Instance | Room 469, near Exit Door |
| Urgency of Action | PRIORITY 3 |

| Question | Response |
|--|--|
| Potential Action | REPLACE |

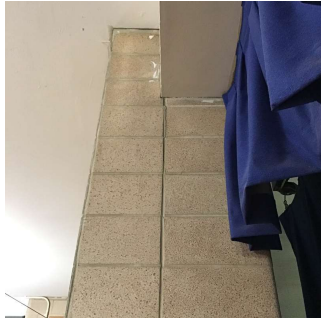
| <b>Walls</b> | |
|---|--|
| | Right Side |

| <b>Walls</b> | |
|---|--|
| Urgency of Action | PRIORITY 3 |

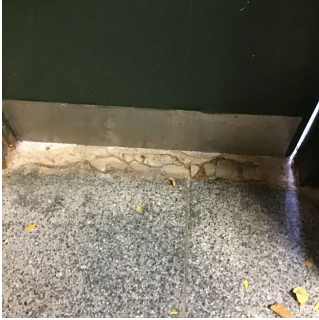
| Question | Response |
|---|--|
| Violations | Exit 11 - Vestibule<br>No violations recorded. |

| Question | Response |
|---|--|
| Urgency of Action | PRIORITY 3 |

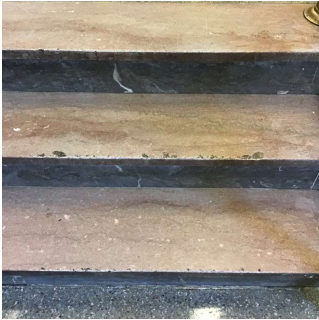
| Question | Response |
|---|--|
| Violations | Exit 9 -Vestibule<br>No violations recorded. |

| Question | Response |
|---|--|
| Deficiency | STONE: BROKEN/MISSING |
| Urgency of Action | PRIORITY 3 |

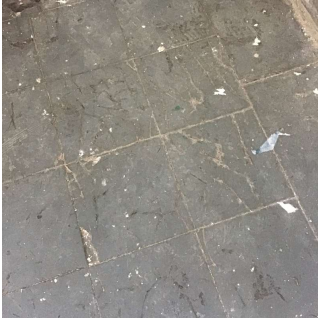
| Question | Response |
|---|--|
| | Stair DE/Bulkhead |

| Question | Response |
|---|--|
| Urgency of Action | PRIORITY 3 |

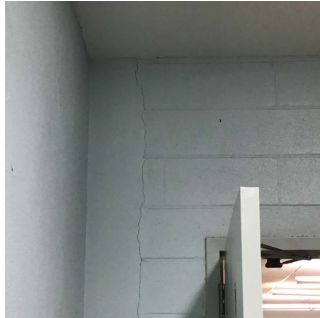
| Question | Response |
|---|--|
| | Stair C/Basement |

| Question | Response |
|---|--|
| Urgency of Action | PRIORITY 3 |

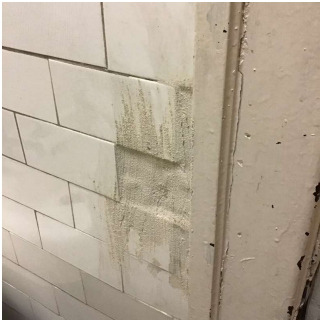
| Question | Response |
|---|--|
| Deficiency | CERAMIC TILE: BROKEN/ MISSING |
| Urgency of Action | PRIORITY 3 |

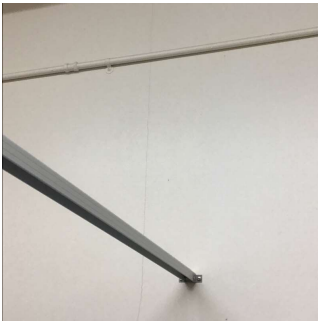
| Question | Response |
|---|--|
| Violations | Room 220<br>No violations recorded. |

| Question | Response |
|---|--|
| Urgency of Action | PRIORITY 3 |

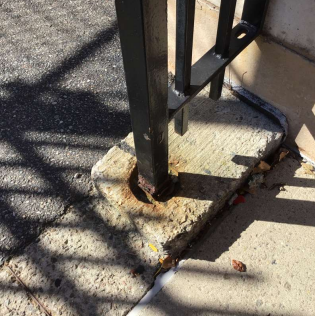
| Question | Response |
|---|--|
| Violations | <p>Bay 7th Street<br/>No violations recorded.</p> |

| Question | Response |
|---|--|
| Deficiency | <b>WROUGHT IRON: RUST - MAJOR</b> |
| Urgency of Action | PRIORITY 3 |

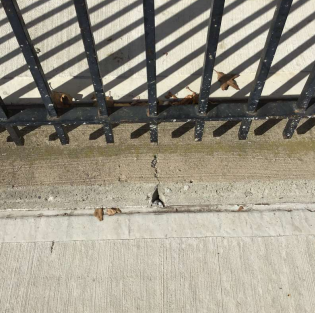
| Question | Response |
|---|--|
| Violations | <p>Bay 7th Street<br/>No violations recorded.</p> |

| Question | Response |
|---|--|
| Deficiency | <b>CONCRETE CURB: DAMAGED/DETERIORATED</b> |
| Urgency of Action | PRIORITY 3 |

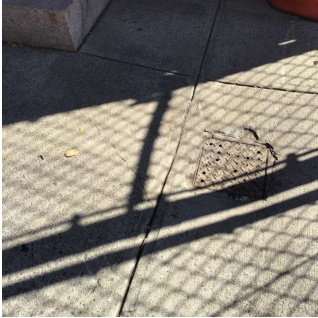
| Question | Response |
|---|--|
| Violations | 14th Avenue<br>No violations recorded. |

| Question | Response |
|---|--|
| Urgency of Action | PRIORITY 3 |

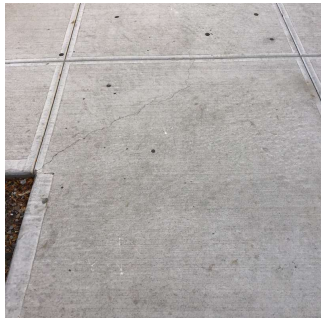
| Question | Response |
|---|--|
| Violations | Bay 7th Street<br>No violations recorded. |

| Question | Response |
|---|--|
| <b>Deficiency</b> | <b>DAMAGED/DETERIORATED/MISSING SECTIONS</b> |
| Urgency of Action | PRIORITY 3 |
