**NYC Department of Education**  
**Building Condition Assessment Survey 2023 - 2024**

Architectural Inspection

**Asset: P.S. 230 - BROOKLYN, 1 ALBEMARLE ROAD, New York, 11218**

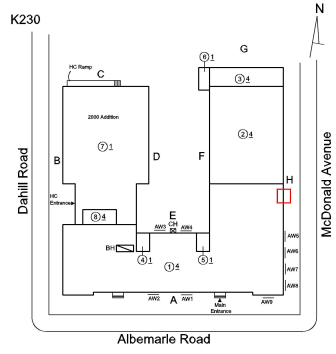
Question	Response
<b>EXTERIOR</b>	
<b>DOORS</b>	Inspected
<b>DOORS AND FRAMES</b>	Inspected
Condition	4 - Between Fair and Poor
Deficiency	METAL: DETERIORATED DOOR AND FRAME - MAJOR DETERIORATION
Roof Plan reference

Deficiency Quantity	2
Quantity Uom	EACH
Potential Action	REPLACE
Urgency of Action	PRIORITY 4
Purpose of Action	LEVEL 2
Deficiency Photo1

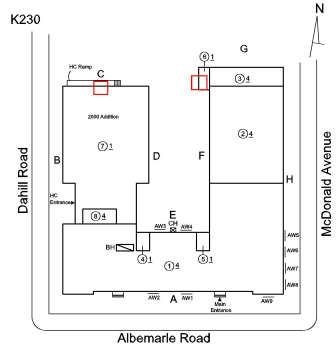
Violations	Facade H - Exit 8 No violations recorded.
Deficiency	METAL: DETERIORATED DOOR AND FRAME - MINOR DETERIORATION
Roof Plan reference

Deficiency Quantity	3
Quantity Uom	EACH
Potential Action	MAINTENANCE
Urgency of Action	PRIORITY 3
Purpose of Action	LEVEL 2

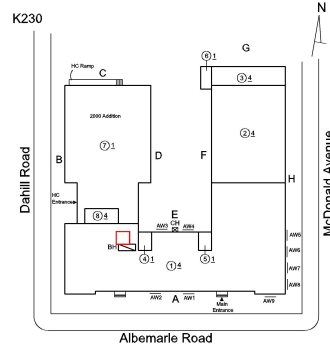
Condition	1 - Good
Deficiency	No deficiencies recorded
<b>LEADERS, GUTTERS, DOWNSPOUTS, SCUPPERS</b>	Inspected
Condition	3 - Fair
Deficiency	LOOSE

Deficiency Quantity  
Quantity Uom  
Potential Action  
Urgency of Action  
Purpose of Action  
Deficiency Photo1

1  
EACH  
MAINTENANCE  
PRIORITY 3  
LEVEL 2

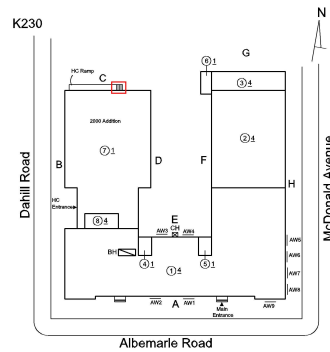
Question	Response
<b>EXTERIOR</b>	
<b>STAIRS/RAMPS: EXTERIOR</b>	Inspected
<b>BUILDING CHEEK/FLANK WALLS</b>	Inspected
Purpose of Action	LEVEL 2
Deficiency Photo1	 
	Facade A - Exit 2
Violations	No violations recorded.
<b>RAILINGS</b>	Inspected
Condition	3 - Fair
Deficiency	DAMAGED
Roof Plan reference	 
Deficiency Quantity	10
Quantity Uom	L.F.
Potential Action	REPLACE
Urgency of Action	PRIORITY 4
Purpose of Action	LEVEL 2
Deficiency Photo1	 
	Facade C - HC Ramp
Violations	No violations recorded.
Deficiency	BROKEN BRACKET

Deficiency Quantity  
Quantity Uom  
Potential Action  
Urgency of Action  
Purpose of Action  
Deficiency Photo1

1  
EACH  
REPLACE  
PRIORITY 4  
LEVEL 2

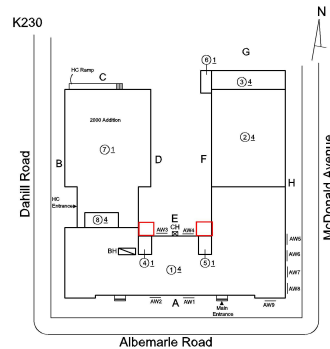
STONE: CRACKS/SPALLING - MAJOR

Deficiency Quantity  
Quantity Uom  
Potential Action  
Urgency of Action  
Purpose of Action

20  
S.F.  
REPLACE  
PRIORITY 4  
LEVEL 2

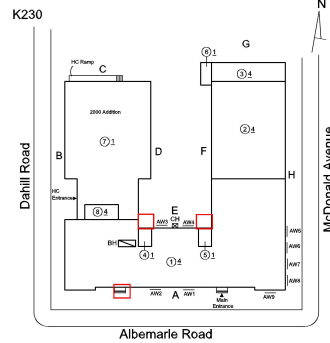
**STONE: DETERIORATED JOINTS**

100

L.F.

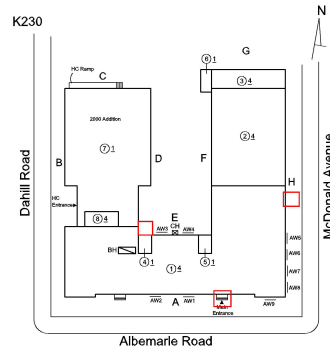
Deficiency Quantity  
 Quantity Uom  
 Potential Action  
 Urgency of Action  
 Purpose of Action  
 Deficiency Photo1

30  
 S.F.  
 REPAIR  
 PRIORITY 3  
 LEVEL 2

Facade A - Main Entrance  
 No violations recorded.

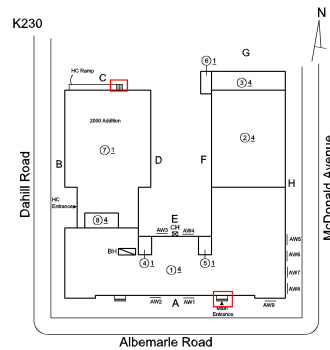
**CONCRETE: CRACKS/SPALLING - MINOR**

Deficiency Quantity  
 Quantity Uom  
 Potential Action  
 Urgency of Action  
 Purpose of Action

50  
 S.F.  
 REPAIR  
 PRIORITY 3  
 LEVEL 2

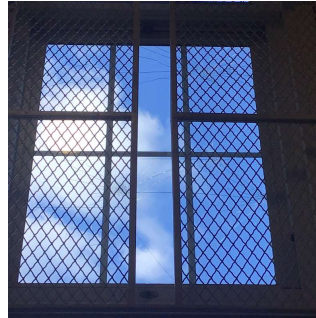
ALUMINUM - DOUBLE HUNG: BROKEN PANE

Facade F - Gymnasium shown, Facade E - Room 155 similar  
No violations recorded.

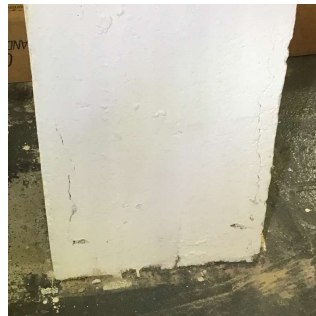
STEEL COLUMNS/BEAMS: DETERIORATED CONCRETE  
FIREPROOFING

<b>Question</b>	<b>Response</b>
<b>INTERIOR</b>	
<b>STRUCTURAL</b>	
<b>COLUMNS/BEAMS/BEARING WALLS</b>	
Violations	Shop Room No violations recorded.
Deficiency	<b>STEEL COLUMNS/BEAMS: DETERIORATED CONCRETE FIREPROOFING</b>
Deficiency Location/Instance	Basement - Gas Meter Room, Room C06, Shop Room
Deficiency Quantity	40
Quantity Uom	S.F.
Potential Action	REPLACE
Urgency of Action	PRIORITY 4
Purpose of Action	LEVEL 5
Deficiency Photo1

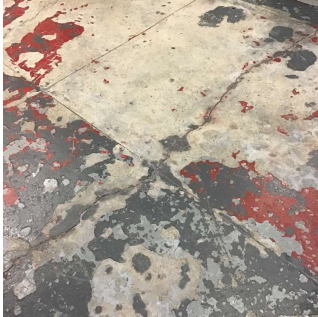
Violations	Boiler Room No violations recorded.
Deficiency	<b>CONCRETE SLAB ON GRADE: THRU CRACKS</b>
Deficiency Location/Instance	Basement - Boiler Room, Mechanical Equipment Room

Deficiency Quantity	100
Quantity Uom	S.F.
Potential Action	REPAIR
Urgency of Action	PRIORITY 3

Violations	Mechanical Equipment Room No violations recorded.
<b>FOUNDATION WALLS</b>	
	Under Construction
<b>ROOF STRUCTURE</b>	
Condition	Inspected
	2 - Between Good and Fair
Deficiency	No deficiencies recorded
<b>VAULTS-BUNKERS</b>	
	Under Construction
<b>AUDITORIUM</b>	
Instance on 1st Floor (507 Seats)	Inspected
	Inspected
<b>Ceiling</b>	
Instance on 1st Floor (507 Seats)	Inspected
Condition	2 - Between Good and Fair
Deficiency	No deficiencies recorded
<b>Door(s)</b>	
Instance on 1st Floor (507 Seats)	Inspected
Condition	2 - Between Good and Fair
Deficiency	No deficiencies recorded
<b>Fixed H/C Lift</b>	
Instance on 1st Floor (507 Seats)	Does not Exist
<b>Fixed Seating</b>	
Instance on 1st Floor (507 Seats)	Inspected
Condition	4 - Between Fair and Poor
Deficiency	DAMAGED/BROKEN/INOPERABLE
Deficiency Location/Instance	Seats D/19, E/13, F/8, H/13

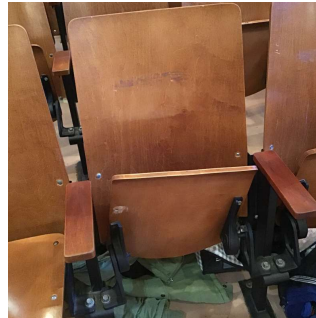
Seat C/16

DAMAGED/BROKEN/INOPERABLE

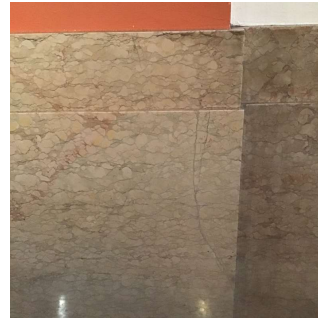
Left Side

STONE: CRACKS/SPALLING

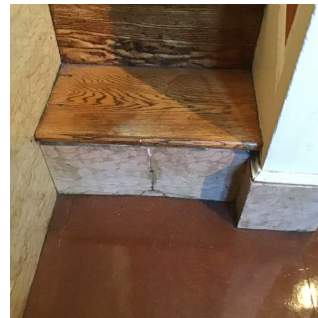
Right Side near Stage

STONE MOLDINGS: CRACKS/SPALLING

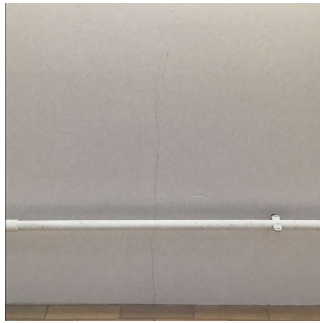
Question	Response
<b>INTERIOR</b>	
<b>AUDITORIUM</b>	
<b>Window Curtains/Shades/Blinds</b>	
Instance on 1st Floor (507 Seats)	Inspected
Condition	4 - Between Fair and Poor
Deficiency	WORN/DAMAGED CURTAINS
Deficiency Location/Instance	Right Side and Left Side
Deficiency Quantity	250
Quantity Uom	S.F.
Potential Action	MAINTENANCE
Urgency of Action	PRIORITY 3
Purpose of Action	LEVEL 2
Deficiency Photo1	 
Violations	Right Side No violations recorded.
<b>CAFETERIA</b>	
Instance on 1st Floor	Inspected
Condition	Inspected
<b>Ceiling</b>	
Instance on 1st Floor	Inspected
Condition	2 - Between Good and Fair
Deficiency	PLASTER: CRACKS/SPALLING
Deficiency Location/Instance	Near Room 157, By Entrance
Deficiency Quantity	20
Quantity Uom	S.F.
Potential Action	REPLACE
Urgency of Action	PRIORITY 3
Purpose of Action	LEVEL 2
Deficiency Photo1

Violations	Near Room 157 No violations recorded.
Deficiency	GYPSUM BOARD: DAMAGED/DETERIORATED

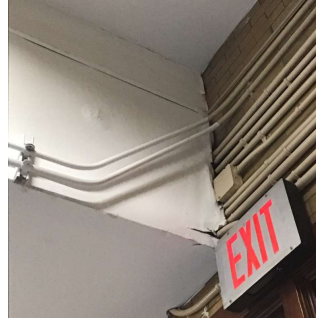
Deficiency Location/Instance	Near Main Entrance
Deficiency Quantity	10
Quantity Uom	S.F.

Potential Action	REPLACE
Urgency of Action	PRIORITY 3
Purpose of Action	LEVEL 2
Deficiency Photo1

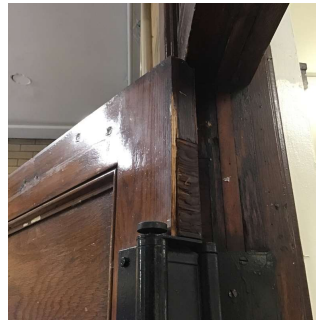
Instance on 1st Floor	Inspected
Condition	4 - Between Fair and Poor
Deficiency	WOOD: DETERIORATED DOOR
Deficiency Location/Instance	Main Entrance
Deficiency Quantity	2
Quantity Uom	EACH
Potential Action	MAINTENANCE
Urgency of Action	PRIORITY 3
Purpose of Action	LEVEL 2
Deficiency Photo1

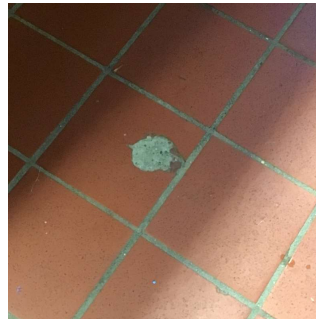
Condition	5 - Poor
-----------	----------

Deficiency QUARRY TILE: BROKEN/MISSING TILES

Deficiency Location/Instance Near Preparation Area

Deficiency Quantity 10

Potential Action REPLACE

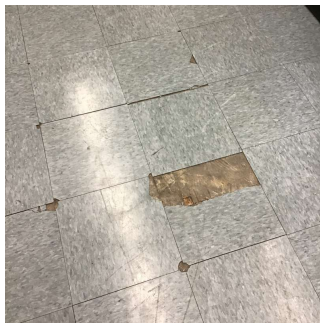
Deficiency VINYL TILES: BROKEN/DETERIORATED/MISSING TILES

Deficiency Location/Instance Office Room, Room 161

Deficiency Quantity 100

Potential Action REPLACE

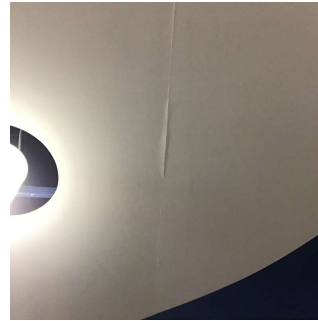
Left Side

**Ceiling**

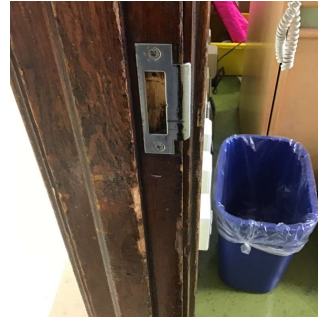
Instance on Room 309	Inspected
Condition	3 - Fair
Deficiency	WOOD: DETERIORATED DOOR AND FRAME
Deficiency Location/Instance	Entrance
Deficiency Quantity	1
Quantity Uom	EACH
Potential Action	MAINTENANCE
Urgency of Action	PRIORITY 3
Purpose of Action	LEVEL 2
Deficiency Photo1

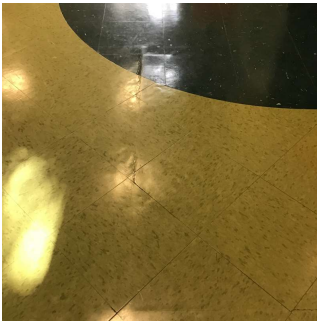
Instance on Room 309	Inspected
Condition	2 - Between Good and Fair
Deficiency	VINYL TILES: DETERIORATED SUBSTRATE
Deficiency Location/Instance	Near Entrance
Deficiency Quantity	20
Quantity Uom	S.F.
Potential Action	REPLACE
Urgency of Action	PRIORITY 3
Purpose of Action	LEVEL 2

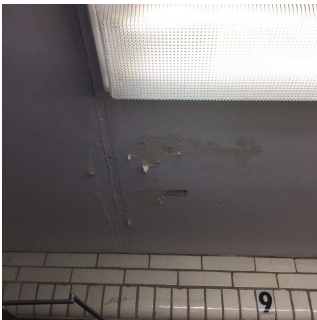
Near Entrance
Violations	No violations recorded.
<b>Walls</b>	
Instance on Room 309	Inspected
Condition	2 - Between Good and Fair
Deficiency	No deficiencies recorded
<b>LOCKER ROOM</b>	Does not Exist
<b>MULTI-PURPOSE ROOM</b>	Does not Exist
<b>SCIENCE DEMO ROOM</b>	Does not Exist
<b>SCIENCE LAB</b>	Does not Exist
<b>SCIENCE PREP ROOM</b>	Does not Exist
<b>SHOWER ROOM</b>	Does not Exist
<b>STAIRS/RAMPS: INTERIOR</b>	Inspected
Do Letter Stair Signs Exist?	Yes
<b>Ceiling</b>	
Condition	2 - Between Good and Fair
Deficiency	GYPSUM BOARD: DAMAGED/DETERIORATED
Deficiency Location/Instance	Exit 9 - Vestibule
Deficiency Quantity	20
Quantity Uom	S.F.
Potential Action	REPLACE
Urgency of Action	PRIORITY 3
Purpose of Action	LEVEL 2
Deficiency Photo1

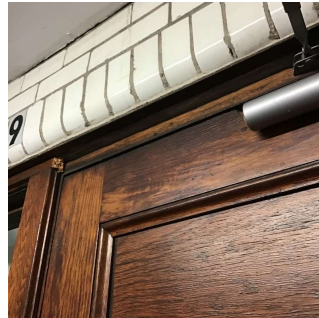
Deficiency	5 - Poor
	WOOD: DETERIORATED DOOR AND FRAME

Question	Response
<b>INTERIOR</b>	
<b>STAIRS/RAMPS: INTERIOR</b>	
<b>Door(s)</b>	
Deficiency Location/Instance	Exit 9 - Vestibule, Exit D - Vestibule
Deficiency Quantity	4
Quantity Uom	EACH
Potential Action	MAINTENANCE
Urgency of Action	PRIORITY 3
Purpose of Action	LEVEL 2
Deficiency Photo1

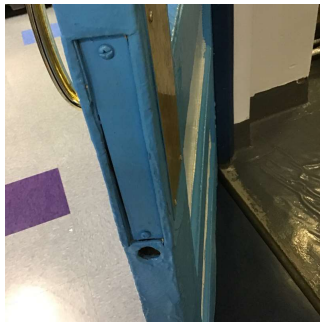
Violations	Exit 9 - Vestibule No violations recorded.
Deficiency	METAL CLAD WOOD: DETERIORATED DOOR
Deficiency Location/Instance	Stair CD/1
Deficiency Quantity	1
Quantity Uom	EACH
Potential Action	MAINTENANCE
Urgency of Action	PRIORITY 3
Purpose of Action	LEVEL 2

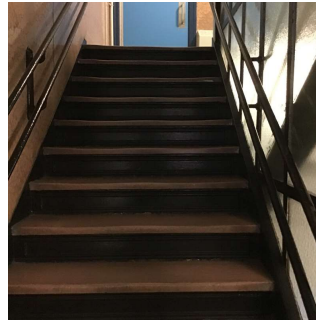
Stair EF/2

**Stairs and Landings**

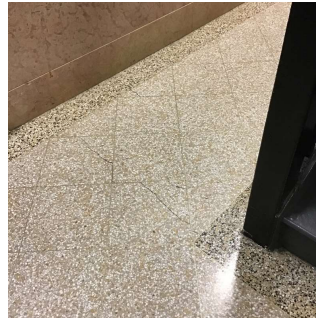
Stair EF/1

**TERRAZZO: CRACKS**

REPLACE

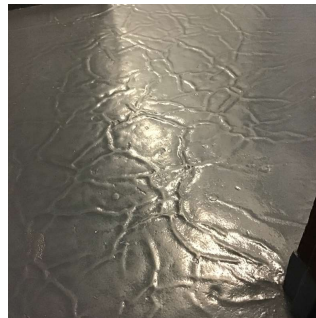
Stair CD/1

**ROLLED ASPHALT: CRACKS**

REPLACE

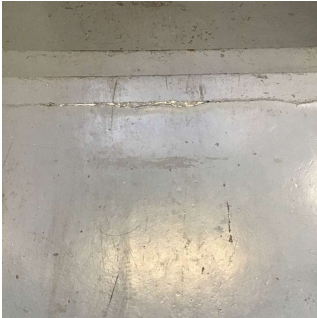
Question	Response
<b>INTERIOR</b>	
<b>STAIRS/RAMPS: INTERIOR</b>	
<b>Stairs and Landings</b>	
Deficiency	CONCRETE: CRACKS/SPALLING - MAJOR
Deficiency Location/Instance	Stair CD/Bulkhead, Exit 2 - Vestibule, Exits D,E - Vestibules
Deficiency Quantity	200
Quantity Uom	S.F.
Potential Action	REPLACE
Urgency of Action	PRIORITY 3
Purpose of Action	LEVEL 2
Deficiency Photo1

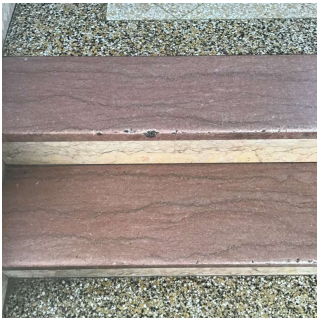
Violations	Exit 2 - Vestibule No violations recorded.
Deficiency	STONE: BROKEN/MISSING
Deficiency Location/Instance	Main Entrance Vestibule
Deficiency Quantity	10
Quantity Uom	S.F.
Potential Action	REPLACE
Urgency of Action	PRIORITY 3
Purpose of Action	LEVEL 2
Deficiency Photo1

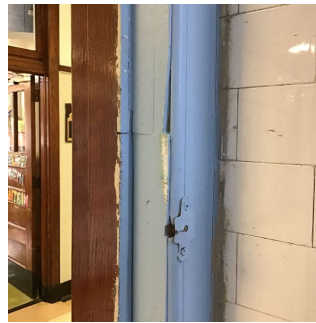
Room 356

Staff Toilet - 1st Floor
Violations	No violations recorded.
<b>Door(s)</b>	Inspected
Condition	5 - Poor
Deficiency	WOOD: DETERIORATED DOOR AND FRAME
Deficiency Location/Instance	Rooms 356,258
Deficiency Quantity	2
Quantity Uom	EACH
Potential Action	MAINTENANCE
Urgency of Action	PRIORITY 3
Purpose of Action	LEVEL 2

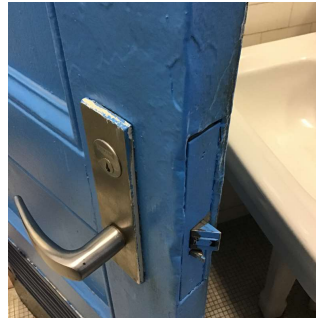
Room 451

METAL CLAD WOOD: DETERIORATED DOOR

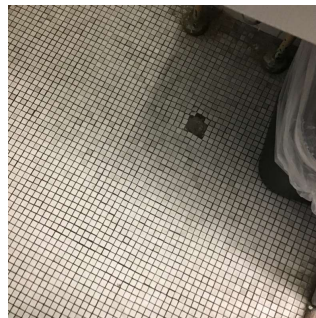
VINYL TILES: BROKEN/DETERIORATED/MISSING TILES

REPLACE

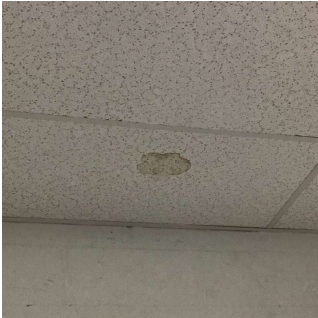
Question	Response
<b>INTERIOR</b>	
<b>TOILET ROOMS - STUDENTS</b>	
<b>Ceiling</b>	
Deficiency	ACOUSTIC TILES: DAMAGED/MISSING
Deficiency Location/Instance	Student Toilet - 4th Floor, Boys Toilet - 1st Floor New Wing
Deficiency Quantity	20
Quantity Uom	S.F.
Potential Action	REPLACE
Urgency of Action	PRIORITY 3
Purpose of Action	LEVEL 2
Deficiency Photo1

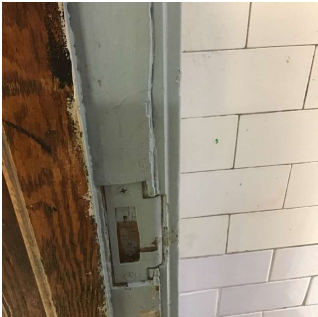
Violations	Student Toilet - 4th Floor No violations recorded.
<b>Door(s)</b>	Inspected
Condition	5 - Poor
Deficiency	WOOD: DETERIORATED DOOR AND FRAME
Deficiency Location/Instance	Room 358
Deficiency Quantity	1
Quantity Uom	EACH
Potential Action	MAINTENANCE
Urgency of Action	PRIORITY 3
Purpose of Action	LEVEL 2
Deficiency Photo1

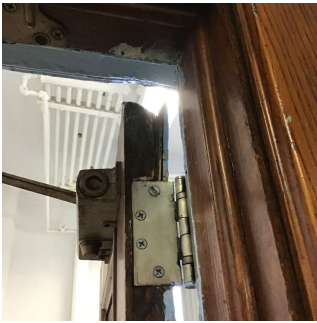
Violations	Room 358 No violations recorded.
Deficiency	WOOD: DETERIORATED DOOR
Deficiency Location/Instance	Boys Toilet - 1st Floor, Room 459
Deficiency Quantity	2
Quantity Uom	EACH
Potential Action	MAINTENANCE
Urgency of Action	PRIORITY 3

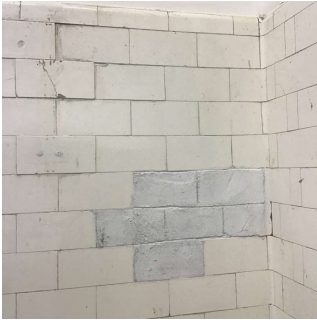
Room 459
Violations	No violations recorded.
<b>Floor Finish</b>	Inspected
Condition	2 - Between Good and Fair
Deficiency	No deficiencies recorded
<b>Stalls</b>	Inspected
Condition	2 - Between Good and Fair
Deficiency	No deficiencies recorded
<b>Walls</b>	Inspected
Condition	2 - Between Good and Fair
Deficiency	CERAMIC TILE: BROKEN/ MISSING
Deficiency Location/Instance	Boys Toilet -1st Floor, Rooms 459,457,358
Deficiency Quantity	40
Quantity Uom	S.F.
Potential Action	REPLACE
Urgency of Action	PRIORITY 3
Purpose of Action	LEVEL 2
Deficiency Photo1

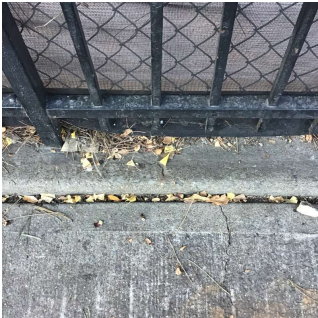
Question	Response
<b>SITE</b>	
<b>FENCES</b>	
Violations	Albemarle Road No violations recorded.
Deficiency	CONCRETE CURB: DAMAGED/DETERIORATED
Deficiency Location/Instance	McDonald Avenue, Albemarle Road, Dahill Road
Deficiency Quantity	120
Quantity Uom	S.F.
Potential Action	REPLACE
Urgency of Action	PRIORITY 3
Purpose of Action	LEVEL 2
Deficiency Photo1

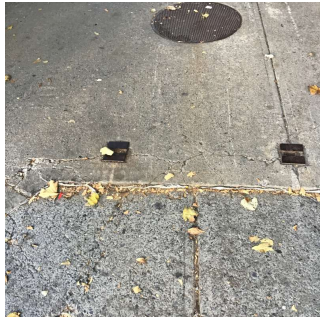
Deficiency	DAMAGED/DETERIORATED/MISSING SECTIONS
Deficiency Location/Instance	McDonald Avenue, Albemarle Road, Dahill Road
Deficiency Quantity	125
Quantity Uom	S.F.
Potential Action	REPLACE
Urgency of Action	PRIORITY 3
Purpose of Action	LEVEL 2

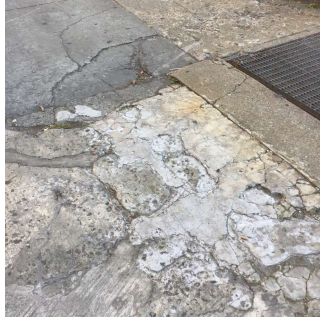
Violations	Albemarle Road No violations recorded.
Deficiency	DAMAGED/DETERIORATED/MISSING SECTIONS
Deficiency Location/Instance	McDonald Avenue, Albemarle Road, Dahill Road
Deficiency Quantity	2,000
Quantity Uom	S.F.
Potential Action	REPLACE
Urgency of Action	PRIORITY 3
Purpose of Action	LEVEL 2
