**NYC Department of Education**  
**Building Condition Assessment Survey 2023 - 2024**

Architectural Inspection

**Asset: P.S. 231 - BROOKLYN, 360 36TH STREET, New York, 11232**

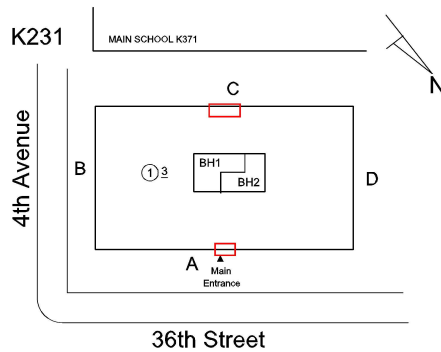
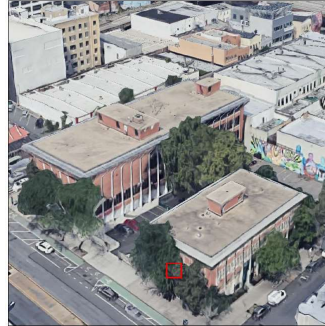
CAST IN PLACE / PRE-CAST CONCRETE: MAJOR CRACKS/SPALLING

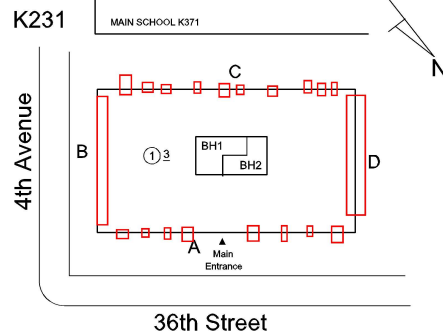
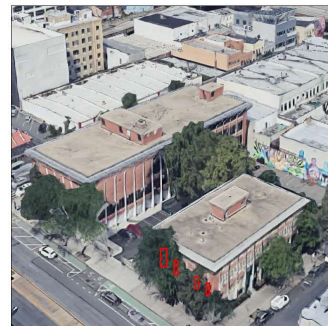
CAST IN PLACE / PRE-CAST CONCRETE: MINOR CRACKS/SPALLING

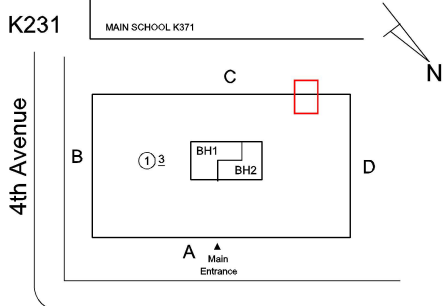
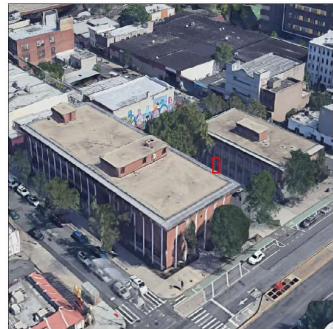
Violations	Facade A No violations recorded.
<b>EXTERIOR SOFFITS</b>	
Condition	Inspected 2 - Between Good and Fair
Deficiency	No deficiencies recorded
<b>LOADING DOCK</b>	
	Does not Exist
<b>LOUVER</b>	
Condition	Inspected 3 - Fair
Deficiency	BROKEN/ DENTED BLADES
Roof Plan reference	<p>K231 MAIN SCHOOL K371</p>

Deficiency Quantity	10
Quantity Uom	S.F.
Potential Action	REPLACE
Urgency of Action	PRIORITY 4
Purpose of Action	LEVEL 2

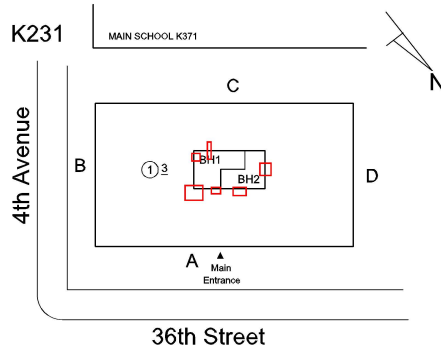
**BULKHEAD/PENTHOUSE WALLS/EXTERIOR:  
CRACKS/SPALLING - MINOR**

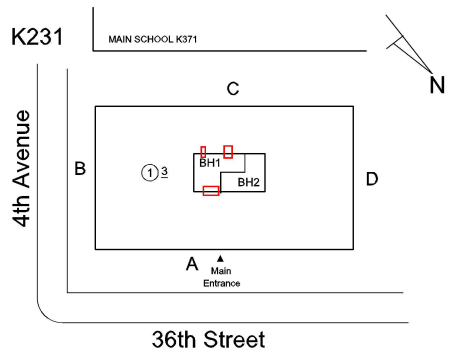
**BULKHEAD/PENTHOUSE WALLS/INTERIOR: CMU  
CRACKS/SPALLING**

Deficiency Quantity	40
Quantity Uom	S.F.
Potential Action	REPLACE
Urgency of Action	PRIORITY 4
Purpose of Action	LEVEL 2
Deficiency Photo1

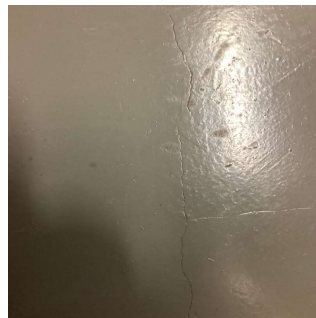
CONCRETE SLAB ON GRADE: THRU CRACKS

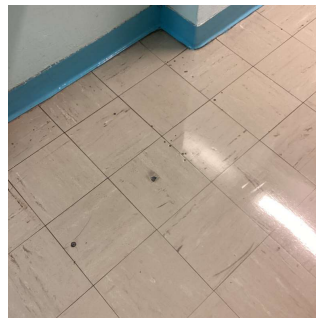
VINYL TILES: BROKEN/DETERIORATED/MISSING TILES

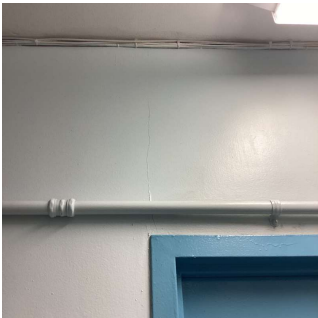
<b>Question</b>	<b>Response</b>
<b>INTERIOR</b>	
<b>CLASSROOMS/CORRIDORS/ADMIN SPACES</b>	
<b>Floor Finish</b>	Inspected
	Corridor near Room 209
Violations	No violations recorded.
<b>Walls</b>	Inspected
Condition	2 - Between Good and Fair
Deficiency	PLASTER: CRACKS/SPALLING
Deficiency Location/Instance	Corridor near Room B6
Deficiency Quantity	10
Quantity Uom	S.F.
Potential Action	REPLACE
Urgency of Action	PRIORITY 3
Purpose of Action	LEVEL 2
Deficiency Photo1

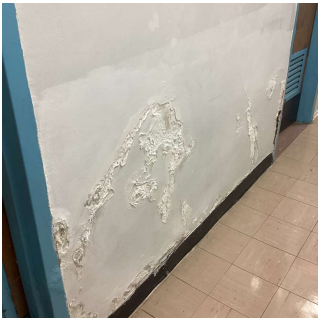
Violations	Corridor near Room B6 No violations recorded.
Deficiency	PLASTER: CRACKS/SPALLING - ACTIVE LEAK
Deficiency Location/Instance	Corridor near Rooms B13, B12, B11, B9, B1
Deficiency Quantity	130
Quantity Uom	S.F.
Potential Action	REPLACE
Urgency of Action	PRIORITY 5
Purpose of Action	LEVEL 2
Deficiency Photo1

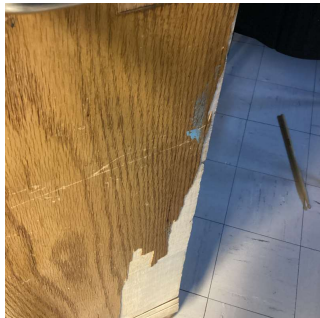
Question	Response
<b>INTERIOR</b>	
<b>LIBRARY</b>	
<b>Door(s)</b>	
Violations	No violations recorded.
<b>Floor Finish</b>	
Instance on Room 304/306	Inspected
Condition	2 - Between Good and Fair
Deficiency	No deficiencies recorded
<b>Walls</b>	
Instance on Room 304/306	Inspected
Condition	2 - Between Good and Fair
Deficiency	No deficiencies recorded
<b>LOCKER ROOM</b>	Does not Exist
<b>MULTI-PURPOSE ROOM</b>	Inspected
Instance on Basement - Room B11	Inspected
<b>Ceiling</b>	
Instance on Basement - Room B11	Inspected
Condition	2 - Between Good and Fair
Deficiency	No deficiencies recorded
<b>Door(s)</b>	
Instance on Basement - Room B11	Inspected
Condition	5 - Poor
Deficiency	WOOD: DETERIORATED DOOR
Deficiency Location/Instance	Main Entrance, Exit, Office Room
Deficiency Quantity	3
Quantity Uom	EACH
Potential Action	MAINTENANCE
Urgency of Action	PRIORITY 3
Purpose of Action	LEVEL 2
Deficiency Photo1

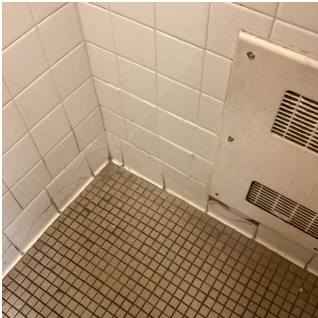
Question	Response
<b>INTERIOR</b>	
<b>STAIRS/RAMPS: INTERIOR</b>	
<b>Walls</b>	
Violations	Stair AB/Basement No violations recorded.
Deficiency	CERAMIC TILE: BROKEN/ MISSING
Deficiency Location/Instance	Room 203
Deficiency Quantity	10
Quantity Uom	S.F.
Potential Action	REPLACE
Urgency of Action	PRIORITY 3
Purpose of Action	LEVEL 2
Deficiency Photo1

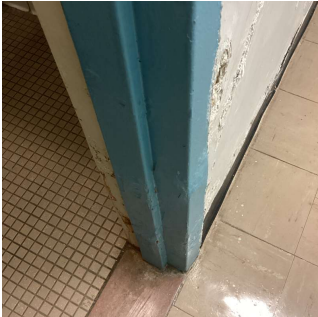
Violations	Room 203 No violations recorded.
<b>TOILET ROOMS - STAFF</b>	
<b>Ceiling</b>	Inspected
Condition	2 - Between Good and Fair
Deficiency	No deficiencies recorded
<b>Door(s)</b>	Inspected
Condition	5 - Poor
Deficiency	WOOD: DETERIORATED DOOR AND FRAME
Deficiency Location/Instance	Rooms B12, B13
Deficiency Quantity	2
Quantity Uom	EACH
Potential Action	MAINTENANCE
Urgency of Action	PRIORITY 3
Purpose of Action	LEVEL 2
Deficiency Photo1
