NYC Department of Education
Building Condition Assessment Survey 2023 - 2024

Architectural Inspection

Asset: I.S. 234 - BROOKLYN, 1875 E 17 STREET, New York, 11229

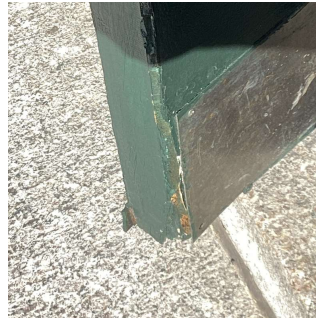
Facade A

METAL CLAD: DETERIORATED DOOR - MAJOR DETERIORATION

REPLACE

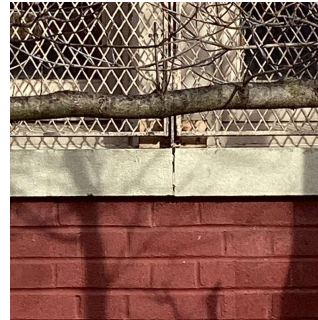
Violations	Facade A No violations recorded.
EXTERIOR WALLS	Inspected
Material Type(s)	Masonry
Replacement Quantity	67,000
Replacement Uom	S.F.
Instance on All Facades	Inspected
Instance Condition	3 - Fair
Instance Quantity	67,000
Instance Quantity Uom	S.F.
Deficiency	BRICK: MASONRY SILLS - DETERIORATED JOINTS
Roof Plan reference	K234

Deficiency Quantity	10
Quantity Uom	L.F.
Potential Action	REPOINT
Urgency of Action	PRIORITY 3
Purpose of Action	LEVEL 2

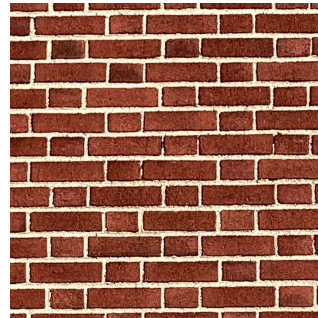
Facade A

BRICK: DETERIORATED JOINTS

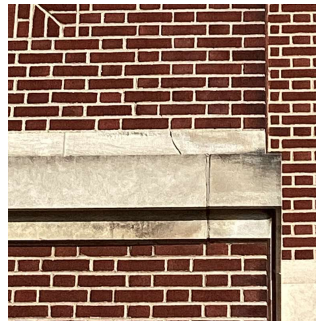
Facade A

STONE: CHIPPED/SPALLED/BROKEN PIECES - MINOR

25
S.F.
REPAIR
PRIORITY 3
LEVEL 2

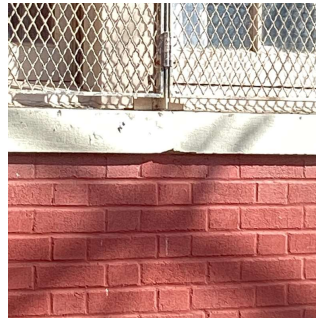
Facade A

BRICK: DETERIORATED MASONRY SILLS - MINOR

REPAIR

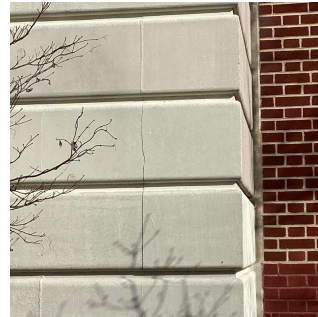
Facade A

STONE: CRACKS AT BUILDING CORNERS

REPLACE

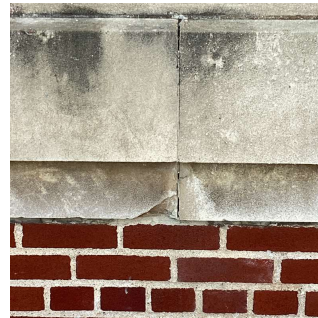
Facade L

STONE: DETERIORATED JOINTS

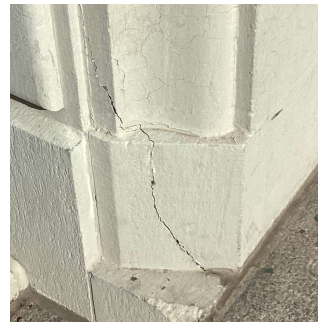
Facade A

STONE: CHIPPED/SPALLED/BROKEN PIECES - MAJOR

REPLACE

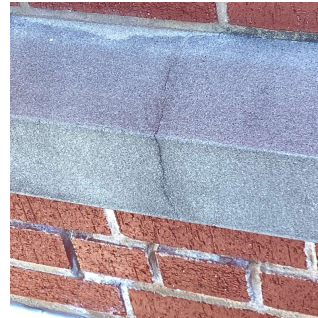
Roof 1

STONE: MINOR CRACKS, SPALLING

REPAIR

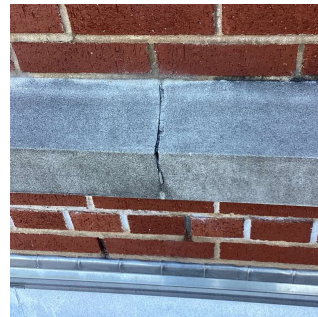
Roof 1

STONE: MAJOR DETERIORATION/CRACKS

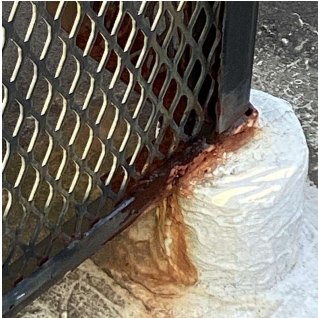
Question	Response
EXTERIOR	
ROOF	
Roofing	
LEADERS, GUTTERS, DOWNSPOUTS, SCUPPERS	Inspected
Condition	2 - Between Good and Fair
Deficiency	No deficiencies recorded
ROOF BARRIER/FENCE	Inspected
Condition	3 - Fair
Deficiency	RAILINGS/PANELS: DETERIORATED, MAJOR RUSTING
Roof Plan reference

Deficiency Quantity	40
Quantity Uom	S.F.
Potential Action	REPLACE
Urgency of Action	PRIORITY 4
Purpose of Action	LEVEL 2
Deficiency Photo1

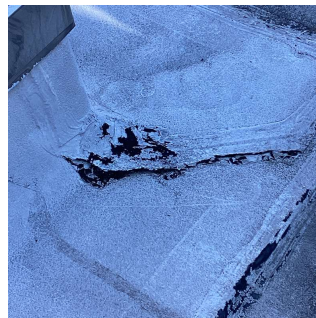
Roof 7

Deficiency	MODIFIED BITUMEN: ROOFING: DELAMINATION
------------	---

Potential Action	REPLACE ROOFING WITHOUT MAJOR EQUIPMENT REMOVAL
------------------	---

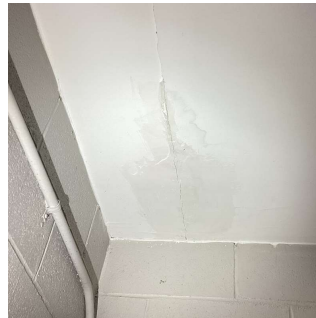
BH2
No violations recorded.

BH1
Violations	No violations recorded.
Deficiency	BULKHEAD/PENTHOUSE ROOF: MINOR LEAKAGE

50
S.F.
MAINTENANCE
PRIORITY 3
LEVEL 2

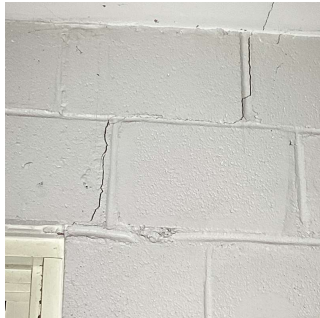
**BULKHEAD/PENTHOUSE WALLS/INTERIOR: CMU
CRACKS/SPALLING**

BH2
Violations	No violations recorded.
CUPOLA/ SPIRES/ TOWERS	Does not Exist
DORMER	Does not Exist
DUNNAGE STEEL	Inspected
Condition	2 - Between Good and Fair
Deficiency	No deficiencies recorded
SKYLIGHT/ROOF VENT	Inspected
Material Type(s)	Glass, Plastic
Condition	3 - Fair
Deficiency	DAMAGED GUARDS
Roof Plan reference

45
S.F.
REPLACE
PRIORITY 3
LEVEL 2

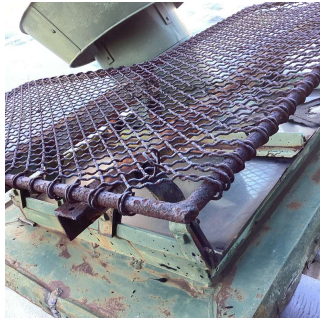
SK1
Violations	No violations recorded.
Deficiency	BROKEN GLASS

Deficiency Quantity	20
Quantity Uom	S.F.
Potential Action	MAINTENANCE
Urgency of Action	PRIORITY 3
Purpose of Action	LEVEL 2
Deficiency Photo1

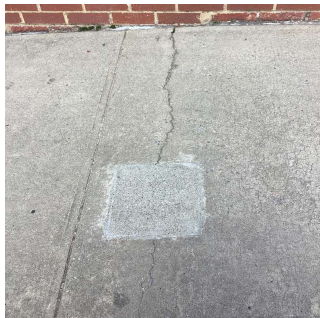
Violations	Facade K No violations recorded.
RAILINGS	Inspected
Condition	2 - Between Good and Fair
Deficiency	No deficiencies recorded
STAIRS/RAMPS	Inspected
Condition	3 - Fair
Deficiency	CONCRETE: CRACKS/SPALLING - MINOR
Roof Plan reference	<p>K234</p>

Violations	Facade K No violations recorded.
WINDOWS	Inspected
Replacement Quantity	26,000
Replacement Uom	S.F.
EXTERIOR GUARDS	Inspected
Condition	2 - Between Good and Fair
Deficiency	No deficiencies recorded

Deficiency Quantity	20
Quantity Uom	S.F.
Potential Action	REPAIR
Urgency of Action	PRIORITY 3
Purpose of Action	LEVEL 2
Deficiency Photo1

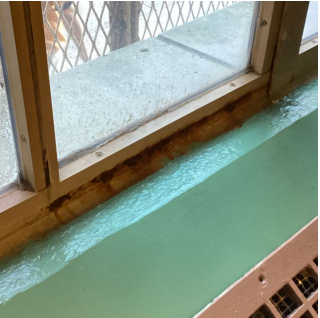
Question	Response
EXTERIOR	
WINDOWS	
WINDOWS	
Instance Condition	5 - Poor
Instance Quantity	400
Instance Quantity Uom	S.F.
Are these windows insulated	No
Installation Year	1985
Source of Installation	Custodial Staff
Deficiency	STEEL: DETERIORATED
Roof Plan reference	<p>K234</p>

Violations	Facade F - Auditorium No violations recorded.
Instance on Aluminum - Double Hung: 4th Floor Gymnasium and Cafeteria	Inspected
Instance Condition	2 - Between Good and Fair
Instance Quantity	750
Instance Quantity Uom	S.F.
Are these windows insulated	Yes
Installation Year	2014

Deficiency Quantity	400
Quantity Uom	S.F.
Potential Action	REPLACE WINDOW
Urgency of Action	PRIORITY 4
Purpose of Action	LEVEL 2
Deficiency Photo1

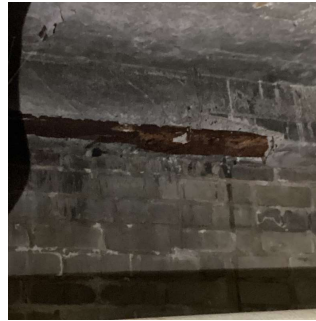
Crawl Space (Basement Storage Room similar)

Question	Response
EXTERIOR	
WINDOWS	
WINDOWS	
Source of Installation	Custodial Staff
Deficiency	No deficiencies recorded
Instance on Wood: Original Building	Inspected
Instance Condition	3 - Fair
Instance Quantity	18,000
Instance Quantity Uom	S.F.
Are these windows insulated	No
Installation Year	1998
Source of Installation	Custodial Staff
Deficiency	No deficiencies recorded
INTERIOR	Inspected
POOLS	Does not Exist
STRUCTURAL	Inspected
COLUMNS/BEAMS/BEARING WALLS	Inspected
Condition	4 - Between Fair and Poor
Deficiency	STEEL COLUMNS/BEAMS: DETERIORATED CONCRETE FIREPROOFING
Deficiency Location/Instance	Basement
Deficiency Quantity	65
Quantity Uom	S.F.
Potential Action	REPLACE
Urgency of Action	PRIORITY 4
Purpose of Action	LEVEL 5
Deficiency Photo1	 
	Basement Fan Room (Basement Storage Room, Crawl Space similar)
Violations	No violations recorded.
Deficiency	STEEL COLUMNS/BEAMS: MAJOR RUSTING
Deficiency Location/Instance	Basement

Deficiency Quantity	40
Quantity Uom	S.F.
Potential Action	REPLACE
Urgency of Action	PRIORITY 4
Purpose of Action	LEVEL 5

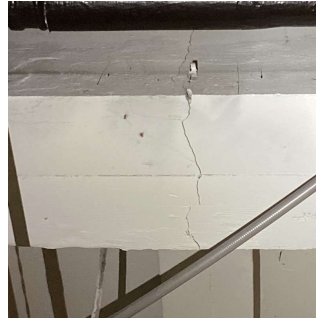
Boiler Room (Custodian Shop, Basement Fan Area, Oil Tank Room, Basement Storage Room, Crawl Space similar)

STEEL COLUMNS/BEAMS: DETERIORATED CONCRETE FIREPROOFING

REPLACE

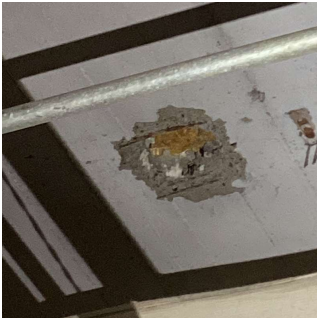
Question	Response
INTERIOR	
STRUCTURAL	
FLOOR STRUCTURE	
Violations	No violations recorded.
Deficiency	CONCRETE: CRACKS/SPALLED/REINFORCEMENT EXPOSED
Deficiency Location/Instance	Basement
Deficiency Quantity	60
Quantity Uom	S.F.
Potential Action	REPAIR
Urgency of Action	PRIORITY 4
Purpose of Action	LEVEL 5
Deficiency Photo1

Boiler Room (Basement Fan Area, Oil Tank Room, Crawl Space similar)
Violations	No violations recorded.
FOUNDATION WALLS	
Material Type(s)	Inspected Concrete
Condition	4 - Between Fair and Poor
Deficiency	CONCRETE: CRACKED/SPALLED/REINFORCEMENT EXPOSED
Deficiency Location/Instance	Basement
Deficiency Quantity	15
Quantity Uom	S.F.
Potential Action	REPAIR
Urgency of Action	PRIORITY 3
Purpose of Action	LEVEL 5
Deficiency Photo1

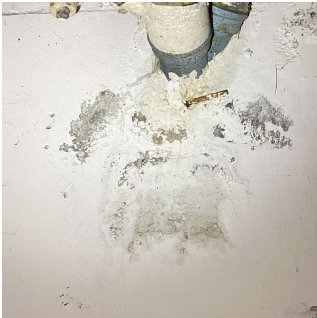
Gas Meter Room
Violations	No violations recorded.
Deficiency	CONCRETE: WATER INFILTRATION IN NON- INSTRUCTIONAL SPACE
Deficiency Location/Instance	Base
Deficiency Quantity	100

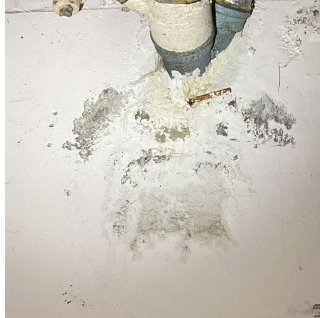
Violations	Gas Meter Room (Basement Storage Area similar) No violations recorded.
ROOF STRUCTURE	
Condition	Inspected 3 - Fair
Deficiency	CONCRETE: CRACKED/SPALLED/REINFORCEMENT EXPOSED
Deficiency Location/Instance	BH2
Deficiency Quantity	35
Quantity Uom	S.F.
Potential Action	REPAIR
Urgency of Action	PRIORITY 3
Purpose of Action	LEVEL 5
Deficiency Photo1

Quantity Uom	S.F.
Potential Action	INSTALL WATERPROOFING

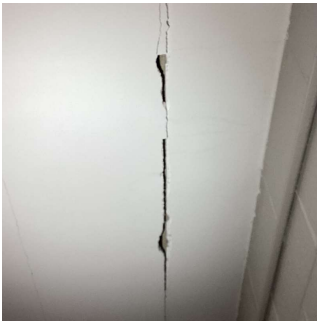
Violations	BH2 No violations recorded.
Deficiency	CONCRETE: CRACKED/SPALLED/REINFORCEMENT EXPOSED
Deficiency Location/Instance	BH
Deficiency Quantity	30
Quantity Uom	S.F.
Potential Action	REPAIR
Urgency of Action	PRIORITY 4
Purpose of Action	LEVEL 5

Violations	BH2 No violations recorded.
VAULTS-BUNKERS	Inspected
Foundation Walls	Inspected
Condition	3 - Fair
Deficiency	CRACKS, SPALLING
Deficiency Location/Instance	Vault
Deficiency Quantity	25
Quantity Uom	S.F.
Potential Action	REPAIR
Urgency of Action	PRIORITY 3
Purpose of Action	LEVEL 5
Deficiency Photo1

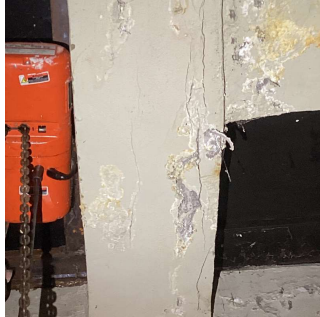
Violations	Vault No violations recorded.
Slab Structure	Inspected
Condition	3 - Fair
Deficiency	STEEL COLUMNS/BEAMS: DETERIORATED CONCRETE FIREPROOFING
Deficiency Location/Instance	Vault
Deficiency Quantity	20
Quantity Uom	S.F.
Potential Action	REPAIR
Urgency of Action	PRIORITY 4
Purpose of Action	LEVEL 5

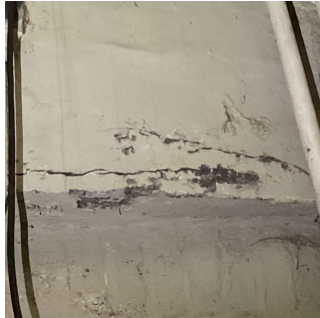
Violations	Vault No violations recorded.
Deficiency	CONCRETE: CRACKS/SPALLED/REINFORCEMENT EXPOSED
Deficiency Location/Instance	Vault
Deficiency Quantity	30
Quantity Uom	S.F.
Potential Action	REPAIR
Urgency of Action	PRIORITY 4
Purpose of Action	LEVEL 5
Deficiency Photo1

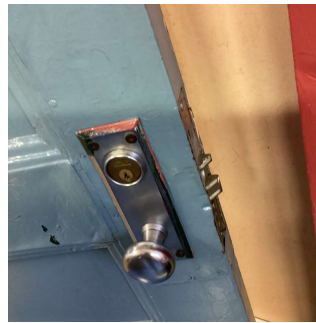
Office

WOOD: DETERIORATED DOOR

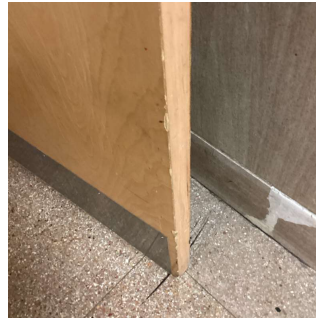
Entrance

DAMAGED/BROKEN/INOPERABLE

REPLACE

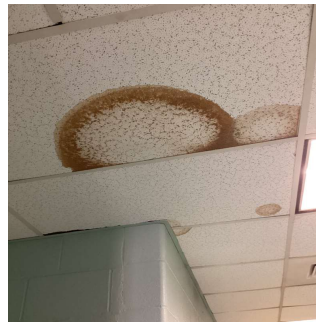
Corridor near room 305

ACOUSTIC TILES: DAMAGED/MISSING - ACTIVE LEAK

REPLACE

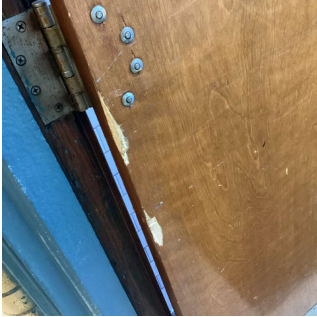
Question	Response
INTERIOR	
CLASSROOMS/CORRIDORS/ADMIN SPACES	
Door(s)	
	Room 408
Violations	No violations recorded.
Deficiency	WOOD: DETERIORATED DOOR
Deficiency Location/Instance	Main Entrance Vestibule (2 Doors), Rooms 310,311,407, 413,414 and others
Deficiency Quantity	33
Quantity Uom	EACH
Potential Action	MAINTENANCE
Urgency of Action	PRIORITY 3
Purpose of Action	LEVEL 2
Deficiency Photo1

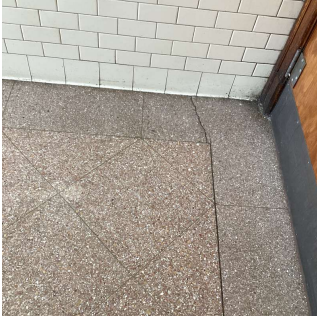
Main Entrance Vestibule
Violations	No violations recorded.
Floor Finish	Inspected
Condition	2 - Between Good and Fair
Deficiency	TERRAZZO: CRACKS
Deficiency Location/Instance	Exit 13, corridor near Auditorium
Deficiency Quantity	15
Quantity Uom	S.F.
Potential Action	REPLACE
Urgency of Action	PRIORITY 3
Purpose of Action	LEVEL 2
Deficiency Photo1

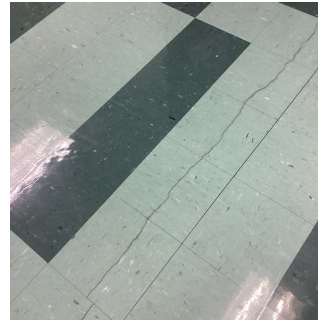
Corridor near room 312

Exit 13
Violations	No violations recorded.
Deficiency	VINYL TILES: DETERIORATED SUBSTRATE
Deficiency Location/Instance	Corridor near rooms 312, 211
Deficiency Quantity	20
Quantity Uom	S.F.

Potential Action	REPLACE
Urgency of Action	PRIORITY 4

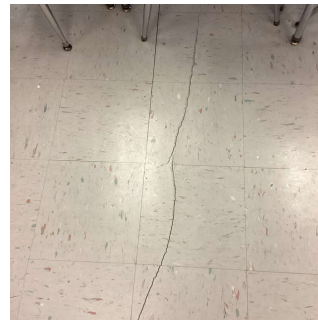
Room A303

VINYL TILES: DETERIORATED SUBSTRATE

REPLACE

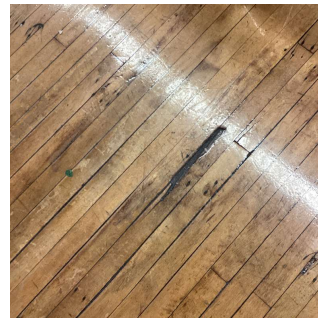
Room 310

WOOD: DAMAGED/DETERIORATED

REPLACE

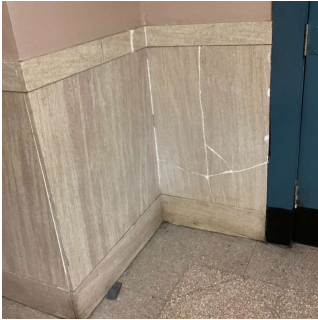
Question	Response
INTERIOR	
CLASSROOMS/CORRIDORS/ADMIN SPACES	
Floor Finish	Inspected
Violations	No violations recorded.
Walls	Inspected
Condition	2 - Between Good and Fair
Deficiency	STONE: CRACKS/SPALLING
Deficiency Location/Instance	Corridor near Auditorium
Deficiency Quantity	30
Quantity Uom	S.F.
Potential Action	REPLACE
Urgency of Action	PRIORITY 3
Purpose of Action	LEVEL 2
Deficiency Photo1

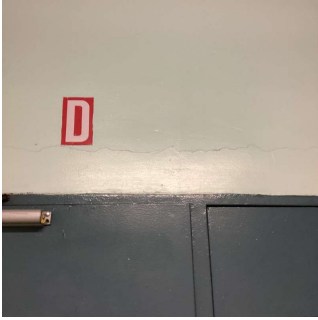
Violations	Corridor near Auditorium No violations recorded.
Deficiency	PLASTER: CRACKS/SPALLING
Deficiency Location/Instance	Corridor near Stair D/E 1
Deficiency Quantity	15
Quantity Uom	S.F.
Potential Action	REPLACE
Urgency of Action	PRIORITY 3
Purpose of Action	LEVEL 2
Deficiency Photo1

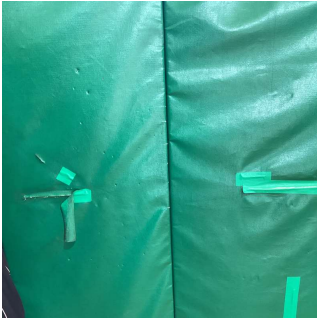
Question	Response
INTERIOR	
GYMNASIUM	
Walls	
Deficiency	WALL PADDING: DETERIORATED
Deficiency Location/Instance	Left Side, Right Side
Deficiency Quantity	100
Quantity Uom	S.F.
Potential Action	REPLACE
Urgency of Action	PRIORITY 3
Purpose of Action	LEVEL 2
Deficiency Photo1

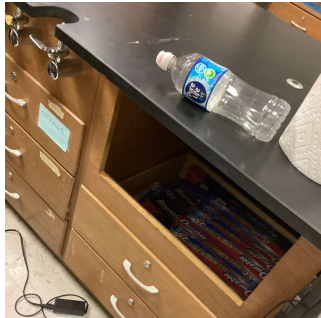
Question	Response
INTERIOR	
SCIENCE PREP ROOM	
Instance on Room 415	Inspected
Alternative use	No
Instance on Room A206	Inspected
Alternative use	No
Fixed Equipment	
Instance on Room A206	Inspected
Condition	3 - Fair
Deficiency	CABINETS: MISSING/DAMAGED
Deficiency Location/Instance	Room A206
Deficiency Quantity	10
Quantity Uom	L.F.
Potential Action	REPLACE
Urgency of Action	PRIORITY 3
Purpose of Action	LEVEL 2
Deficiency Photo1

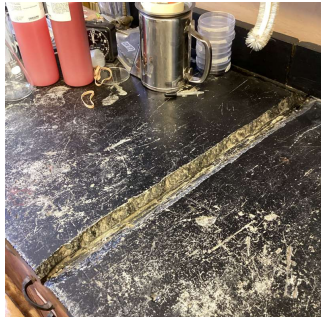
Violations	Room A206 No violations recorded.
Instance on Room 415	Inspected
Condition	5 - Poor
Deficiency	DEMO TABLE: DAMAGED/DETERIORATED
Deficiency Location/Instance	Room 415
Deficiency Quantity	1
Quantity Uom	EACH
Potential Action	REPLACE
Urgency of Action	PRIORITY 3
Purpose of Action	LEVEL 2
Deficiency Photo1

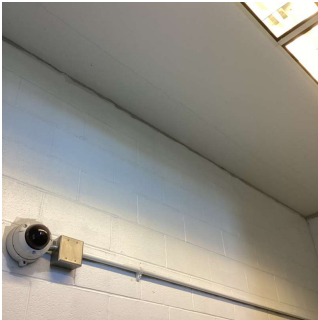
Question	Response
INTERIOR	
STAIRS/RAMPS: INTERIOR	Inspected
Do Letter Stair Signs Exist?	Partially
Ceiling	Inspected
Condition	2 - Between Good and Fair
Deficiency	GYPSUM BOARD: DAMAGED/DETERIORATED
Deficiency Location/Instance	Stairs A/2, 1
Deficiency Quantity	30
Quantity Uom	S.F.
Potential Action	REPLACE
Urgency of Action	PRIORITY 4
Purpose of Action	LEVEL 4
Deficiency Photo1

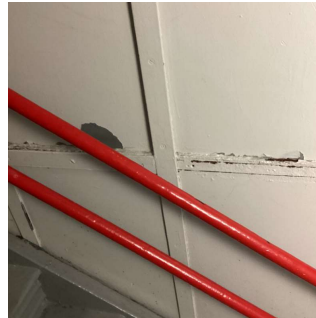
Stair D/E 1

METAL FRAME: DAMAGED/DETERIORATED

REPLACE

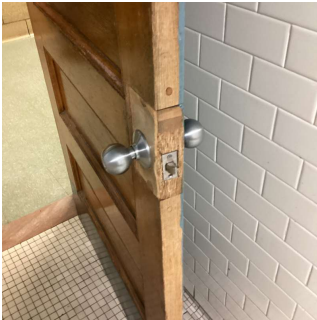
Question	Response
INTERIOR	
TOILET ROOMS - STAFF	
Ceiling	
Deficiency Photo1	 
	Kitchen Men Staff
Violations	No violations recorded.
Door(s)	Inspected
Condition	5 - Poor
Deficiency	WOOD: DETERIORATED DOOR
Deficiency Location/Instance	Rooms 353, 112
Deficiency Quantity	2
Quantity Uom	EACH
Potential Action	MAINTENANCE
Urgency of Action	PRIORITY 3
Purpose of Action	LEVEL 2
Deficiency Photo1

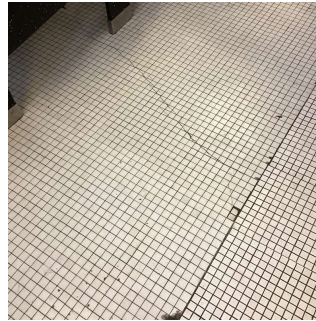
Room 353
Violations	No violations recorded.
Floor Finish	Inspected
Condition	2 - Between Good and Fair
Deficiency	CERAMIC TILE: DETERIORATED SUBSTRATE
Deficiency Location/Instance	Room 112
Deficiency Quantity	20
Quantity Uom	S.F.
Potential Action	REPLACE
Urgency of Action	PRIORITY 3
Purpose of Action	LEVEL 2

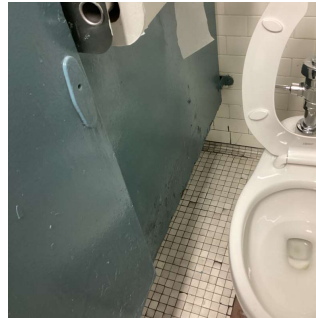
Room 353

RUST - MAJOR

REPLACE

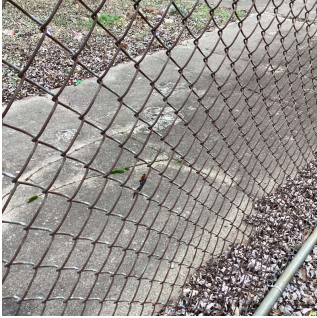
Question	Response
INTERIOR	
TOILET ROOMS - STUDENTS	
Walls	
Deficiency Photo1	 
Violations	Room 459 No violations recorded.
LIFE SAFETY	
F.D. HOLDING AREA	Inspected
F.D. HOLDING AREA	Does not Exist
STEEL STAIRS	Does not Exist
SITE	
CONTAINERIZATION	Inspected
CONTAINERIZATION	Does not Exist
Drainage System for Asphalt	Does not Exist
Drainage System for Concrete	Inspected
Catch Basins/Manhole - Surrounded by concrete	Inspected
Condition	3 - Fair
Deficiency	DAMAGED COVER
Deficiency Location/Instance	Near Exit 8
Deficiency Quantity	1
Quantity Uom	EACH
Potential Action	REPLACE
Urgency of Action	PRIORITY 3
Purpose of Action	LEVEL 2
Deficiency Photo1	 
Violations	Near Exit 8 No violations recorded.
Culverts - Concrete Covering	Does not Exist
Drainage System for Soil	Does not Exist
DRINKING FOUNTAINS	Does not Exist
FENCES	
Condition	Inspected
Condition	4 - Between Fair and Poor
Deficiency	CHAIN LINK: RUST - MAJOR
Deficiency Location/Instance	Walkway along E. 17th Street

Question	Response
SITE	
FENCES	
Quantity Uom	S.F.
Potential Action	REPLACE
Urgency of Action	PRIORITY 3
Purpose of Action	LEVEL 2
Deficiency Photo1

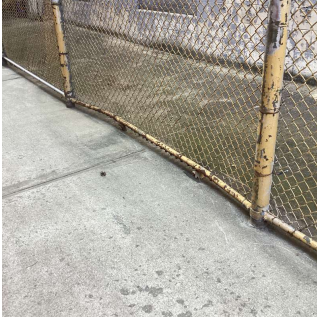
Violations	Walkway along E. 17th Street No violations recorded.
Deficiency	CHAIN LINK: DAMAGED POST/RAIL
Deficiency Location/Instance	Walkway along E. 17th Street
Deficiency Quantity	10
Quantity Uom	L.F.
Potential Action	REPLACE
Urgency of Action	PRIORITY 3
Purpose of Action	LEVEL 2
Deficiency Photo1

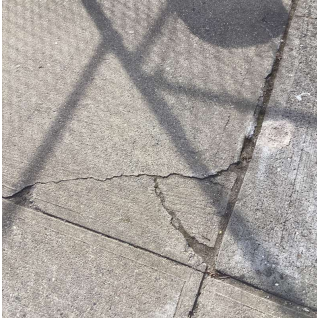
Question	Response
SITE	
PAVING	
Student Use	
Concrete	
Deficiency Quantity	700
Quantity Uom	S.F.
Potential Action	REPLACE
Urgency of Action	PRIORITY 3
Purpose of Action	LEVEL 2
Deficiency Photo1

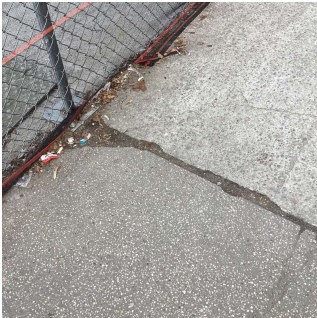
Schoolyard
Violations	No violations recorded.
Pavers	Does not Exist
Site Sidewalks & Walkways	Inspected
Asphalt	Does not Exist
Concrete	Inspected
Condition	3 - Fair
Deficiency	CRACKS - MAJOR
Deficiency Location/Instance	Near Exit 9, E.17th Street
Deficiency Quantity	125
Quantity Uom	S.F.
Potential Action	REPLACE
Urgency of Action	PRIORITY 3
Purpose of Action	LEVEL 2
Deficiency Photo1

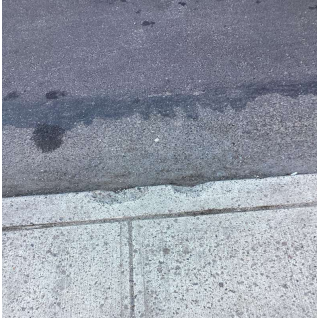
Near Exit 9
Violations	No violations recorded.
Pavers	Does not Exist
DOT Sidewalk	Inspected
Asphalt	Does not Exist
Concrete	Inspected
Condition	4 - Between Fair and Poor
Deficiency	DAMAGED CURBS

Question	Response
SITE	
PAVING	
DOT Sidewalk	
Concrete	
Deficiency Location/Instance	Avenue S, E. 17th Street
Deficiency Quantity	150
Quantity Uom	L.F.
Potential Action	REPLACE
Urgency of Action	PRIORITY 3
Purpose of Action	LEVEL 2
Deficiency Photo1

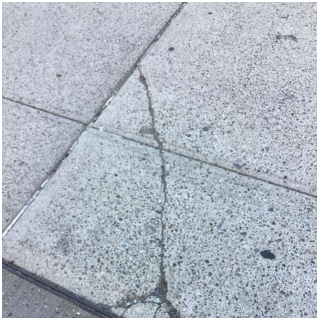
Violations	Avenue S No violations recorded.
Deficiency	DAMAGED/DETERIORATED/MISSING SECTIONS
Deficiency Location/Instance	Avenue S
Deficiency Quantity	1,700
Quantity Uom	S.F.
Potential Action	REPLACE
Urgency of Action	PRIORITY 3
Purpose of Action	LEVEL 2
Deficiency Photo1

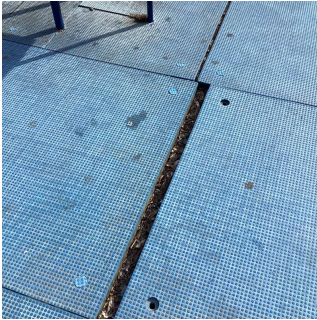
Question	Response
SITE	
PLAYGROUNDS	
Play Equipment	
Condition	2 - Between Good and Fair
Deficiency	No deficiencies recorded
Safety Surfacing	
Instance on Schoolyard	Inspected
Condition	2 - Between Good and Fair
Deficiency	DETERIORATED/MISSING
Deficiency Location/Instance	Near Entrance
Deficiency Quantity	15
Quantity Uom	S.F.
Potential Action	REPLACE
Urgency of Action	PRIORITY 3
Purpose of Action	LEVEL 2
Deficiency Photo1
