NYC Department of Education
Building Condition Assessment Survey 2023 - 2024

Architectural Inspection

K237

Asset: LUCRETIA MARCIGLIANO CAMPUS - K, 50 AVENUE P, New York, 11204

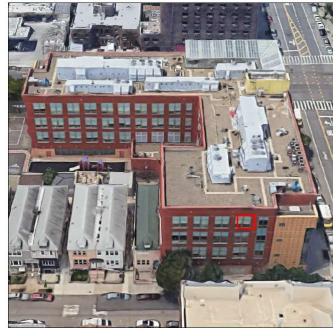
Question	Response
EXTERIOR	
STAIRS/RAMPS: EXTERIOR	Inspected
STAIRS/RAMPS	
Deficiency	No deficiencies recorded
WINDOWS	Inspected
Replacement Quantity	9,000
Replacement Uom	S.F.
EXTERIOR GUARDS	Inspected
Condition	2 - Between Good and Fair
Deficiency	No deficiencies recorded
LINTELS	Inspected
Condition	2 - Between Good and Fair
Deficiency	No deficiencies recorded
WINDOWS	Inspected
Material Type(s)	Aluminum
Instance on Aluminum - Other: All Facades	Inspected
Instance Condition	2 - Between Good and Fair
Instance Quantity	9,000
Instance Quantity Uom	S.F.
Are these windows insulated	Yes
Installation Year	2009
Source of Installation	Custodial Staff
Deficiency	ALUMINUM - OTHER: BROKEN PANE
Roof Plan reference

Deficiency Quantity	60
Quantity Uom	S.F.
Potential Action	MAINTENANCE
Urgency of Action	PRIORITY 3
Purpose of Action	LEVEL 2

Question	Response
EXTERIOR	
WINDOWS	Inspected
WINDOWS	
Deficiency Photo1	 
Violations	Facade B - Room 407 No violations recorded.
INTERIOR	Inspected
POOLS	Does not Exist
STRUCTURAL	Inspected
COLUMNS/BEAMS/BEARING WALLS	Inspected
Condition	2 - Between Good and Fair
Deficiency	No deficiencies recorded
FLOOR STRUCTURE	Inspected
Condition	2 - Between Good and Fair
Deficiency	CONCRETE SLAB ON GRADE: THRU CRACKS
Deficiency Location/Instance	Basement - Electrical Panel Room, Sump Pump Room
Deficiency Quantity	20
Quantity Uom	S.F.
Potential Action	REPAIR
Urgency of Action	PRIORITY 3
Purpose of Action	LEVEL 5
Deficiency Photo1	 
Violations	Basement - Electrical Panel Room No violations recorded.
FOUNDATION WALLS	Inspected
Material Type(s)	Concrete
Condition	4 - Between Fair and Poor
Deficiency	CONCRETE: WATER INFILTRATION IN ELECTRICAL PANEL ROOM
Deficiency Location/Instance	Basement - Electrical Panel Room
Deficiency Quantity	100

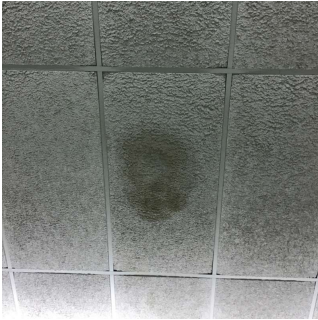
Question	Response
INTERIOR	
AUDITORIUM	Inspected
Walls	
Violations	No violations recorded.
Window Curtains/Shades/Blinds	
Instance on 1st Floor (344 Seats)	Does not Exist
CAFETERIA	Inspected
Instance on Basement	Inspected
Ceiling	
Instance on Basement	Inspected
Condition	3 - Fair
Deficiency	ACOUSTIC TILES: DAMAGED/MISSING
Deficiency Location/Instance	Near Room C05D, By Entrance
Deficiency Quantity	30
Quantity Uom	S.F.
Potential Action	REPLACE
Urgency of Action	PRIORITY 3
Purpose of Action	LEVEL 2
Deficiency Photo1

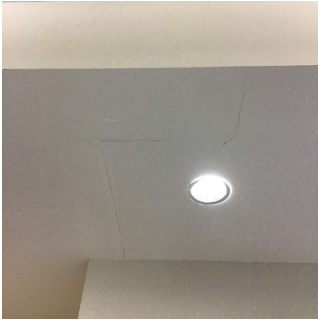
Violations	Near Room C05D No violations recorded.
Deficiency	GYPSUM BOARD: DAMAGED/DETERIORATED
Deficiency Location/Instance	Near Entrance, By Servery, Next Drinking Fountain, Center, Close Room C05D and others
Deficiency Quantity	250
Quantity Uom	S.F.
Potential Action	REPLACE
Urgency of Action	PRIORITY 3
Purpose of Action	LEVEL 2
Deficiency Photo1

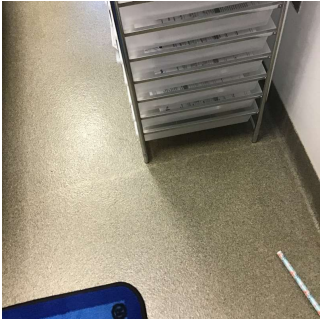
Question	Response
INTERIOR	
CLASSROOMS/CORRIDORS/ADMIN SPACES	
Door(s)	Inspected
Condition	2 - Between Good and Fair
Deficiency	No deficiencies recorded
Floor Finish	Inspected
Condition	2 - Between Good and Fair
Deficiency	EPOXY FLOORING: CRACKS/SPALLING
Deficiency Location/Instance	Room 320
Deficiency Quantity	10
Quantity Uom	S.F.
Potential Action	REPLACE
Urgency of Action	PRIORITY 3
Purpose of Action	LEVEL 2
Deficiency Photo1

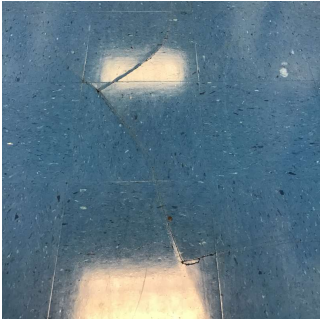
Corridor near Room C40	
Violations	No violations recorded.
Deficiency	VINYL TILES: BROKEN/DETERIORATED/MISSING TILES
Deficiency Location/Instance	Corridor near Exits 3,2, next Room C16, by Elevator A/1

Room 320	
Violations	No violations recorded.
Deficiency	VINYL TILES: DETERIORATED SUBSTRATE
Deficiency Location/Instance	Corridor near Rooms C40,C42,120, by Gymnasium, next Stair B/Basement and others
Deficiency Quantity	120
Quantity Uom	S.F.
Potential Action	REPLACE
Urgency of Action	PRIORITY 3
Purpose of Action	LEVEL 2
Deficiency Photo1

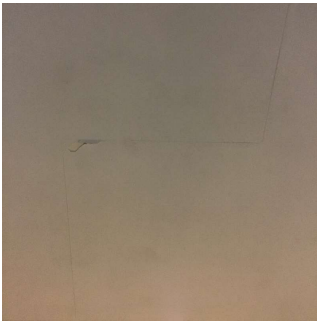
Question	Response
INTERIOR	
GYMNASIUM	
Ceiling	
Deficiency Photo1

Violations	Near Drinking Fountain No violations recorded.
Deficiency	ACOUSTIC TILES: DAMAGED/MISSING
Deficiency Location/Instance	Room C12
Deficiency Quantity	10
Quantity Uom	S.F.
Potential Action	REPLACE
Urgency of Action	PRIORITY 3
Purpose of Action	LEVEL 2
Deficiency Photo1	 
Violations	Room C12 No violations recorded.
Door(s)	
Instance on Basement	Inspected
Condition	2 - Between Good and Fair
Deficiency	No deficiencies recorded
Fixed Equipment	
Instance on Basement	Inspected
Condition	2 - Between Good and Fair
Deficiency	No deficiencies recorded
Floor Finish	
Instance on Basement	Inspected
Condition	3 - Fair
Deficiency	WOOD: DAMAGED/DETERIORATED
Deficiency Location/Instance	Near Sliding Folding Partition
Deficiency Quantity	20
Quantity Uom	S.F.
Potential Action	REPLACE
Urgency of Action	PRIORITY 5
Purpose of Action	LEVEL 6

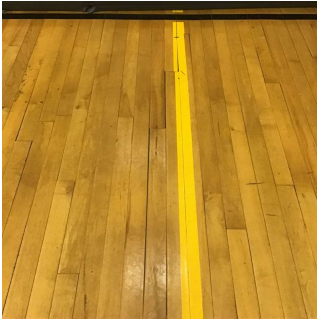
Violations	Near Sliding Folding Partition No violations recorded.
Deficiency	WOOD: DAMAGED/DETERIORATED
Deficiency Location/Instance	East and West Side, Center
Deficiency Quantity	140
Quantity Uom	S.F.
Potential Action	REPLACE
Urgency of Action	PRIORITY 3
Purpose of Action	LEVEL 2
Deficiency Photo1

Violations	Center No violations recorded.
Seating	
Instance on Basement	Inspected
Condition	2 - Between Good and Fair
Deficiency	No deficiencies recorded
Sliding-folding Partition	
Instance on Basement	Inspected
Condition	2 - Between Good and Fair
Deficiency	No deficiencies recorded
Stage	
Instance on Basement	Does not Exist
Walls	
Instance on Basement	Inspected
Condition	2 - Between Good and Fair
Deficiency	MASONRY: CRACKS/SPALLING
Deficiency Location/Instance	Near Stair A/Basement
Deficiency Quantity	10
Quantity Uom	S.F.
Potential Action	REPLACE

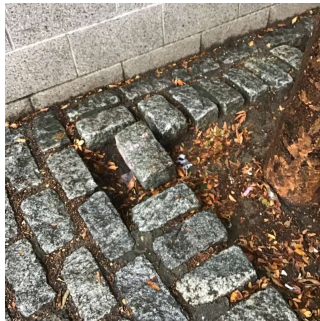
Violations	Schoolyard No violations recorded.
Concrete	Does not Exist
Pavers	Inspected
Condition	2 - Between Good and Fair
Deficiency	DAMAGED/MISSING
Deficiency Location/Instance	Schoolyard, near Emergency Generator Room
Deficiency Quantity	40
Quantity Uom	S.F.
Potential Action	REPLACE
Urgency of Action	PRIORITY 3
Purpose of Action	LEVEL 2
Deficiency Photo1

Violations	Schoolyard No violations recorded.
Site Sidewalks & Walkways	Inspected
Asphalt	Does not Exist
Concrete	Inspected
Condition	3 - Fair
Deficiency	CRACKS - MAJOR
Deficiency Location/Instance	Stillwell Avenue, Avenue P
Deficiency Quantity	250
Quantity Uom	S.F.
Potential Action	REPLACE
Urgency of Action	PRIORITY 3
Purpose of Action	LEVEL 2

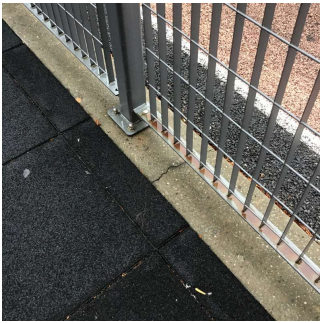
Question	Response
SITE	
PLAYGROUNDS	
Fence	
Deficiency Photo1

Violations	Near Schoolyard No violations recorded.
Pavement	
Instance on Schoolyard - Plaza Deck	Does not Exist
Play Equipment	
Instance on Schoolyard - Plaza Deck	Inspected
Condition	2 - Between Good and Fair
Deficiency	No deficiencies recorded
Safety Surfacing	
Instance on Schoolyard - Plaza Deck	Inspected
Condition	1 - Good
Deficiency	No deficiencies recorded
Unpaved Area	
Instance on Schoolyard - Plaza Deck	Does not Exist
PLAYING SURFACE	Does not Exist
RETAINING WALLS	Does not Exist
SEATING	Inspected
Benches	Inspected
Concrete	Does not Exist
Metal/Wood/Plastic	Inspected
Condition	2 - Between Good and Fair
Deficiency	No deficiencies recorded
Bleachers	Does not Exist
SITE WALLS (NOT RETAINING WALLS)	Inspected
Condition	3 - Fair
Deficiency	MASONRY UNIT: CRACKS/SPALLING - MAJOR
Deficiency Location/Instance	Schoolyard, near Playground
Deficiency Quantity	70

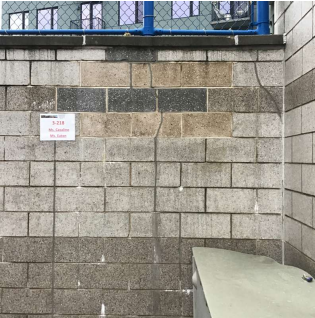
Schoolyard No violations recorded.
STAIRS/RAMPS: EXTERIOR	
ARTWORK	Inspected
Instance Instance Photo	Interior - Entrance Lobby - 30153

Question	Response
SITE	
SITE WALLS (NOT RETAINING WALLS)	
Deficiency Photo1 Violations
