NYC Department of Education
Building Condition Assessment Survey 2023 - 2024

Architectural Inspection

Asset: P.S. 238 - BROOKLYN, 1633 EAST 8 STREET, New York, 11223

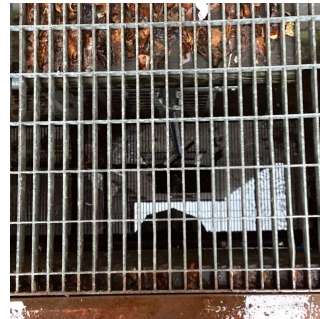
AW4

AREAWAY DRAINS: CLOGGED

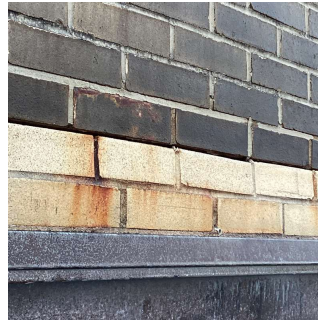
Chimney

BRICK: DETERIORATED JOINTS

20
S.F.
REPOINT
PRIORITY 4
LEVEL 2

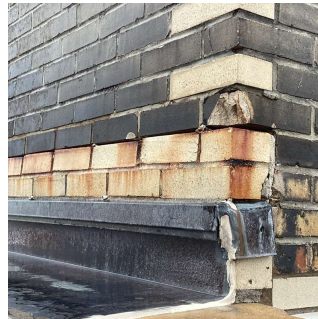
Chimney

BRICK: MAJOR / THRU CRACKS

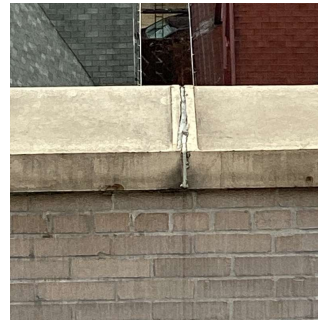
Roof 3

TERRA COTTA: DETERIORATED TRANSVERSE JOINTS

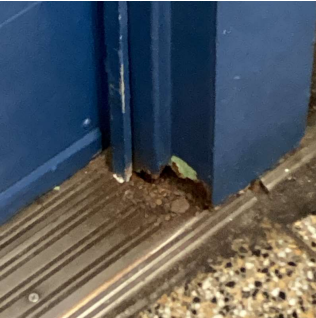
<p>Roof 1</p> <p>No violations recorded.</p>
Violations	<p>No violations recorded.</p>
CORNICE	
Condition	Inspected
Deficiency	2 - Between Good and Fair
Deficiency	No deficiencies recorded
DOORS	
DOORS AND FRAMES	
Condition	Inspected
Deficiency	5 - Poor
Deficiency	METAL: DETERIORATED DOOR AND FRAME - MAJOR DETERIORATION

Deficiency Quantity	12
Quantity Uom	EACH
Potential Action	REPLACE
Urgency of Action	PRIORITY 4
Purpose of Action	LEVEL 2
Deficiency Photo1

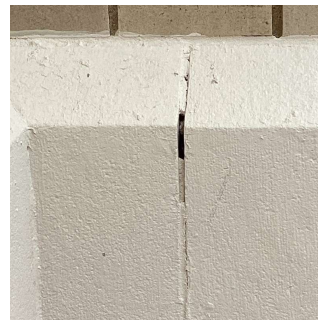
Facade H

Violations	<p>Facade A</p> <p>No violations recorded.</p>
DOOR HARDWARE	Inspected
Condition	3 - Fair
Deficiency	No deficiencies recorded
LINTELS	Inspected
Condition	2 - Between Good and Fair
Deficiency	No deficiencies recorded
TRANSOM/SIDE LIGHT	Inspected
Condition	2 - Between Good and Fair
Deficiency	No deficiencies recorded
EXTERIOR WALLS	Inspected
Material Type(s)	Masonry
Replacement Quantity	50,000
Replacement Uom	S.F.
Instance on All Facades	Inspected
Instance Condition	3 - Fair
Instance Quantity	50,000
Instance Quantity Uom	S.F.
Deficiency	STONE: DETERIORATED JOINTS

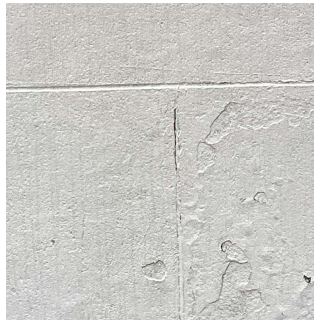
Facade H

STONE: DETERIORATED JOINTS

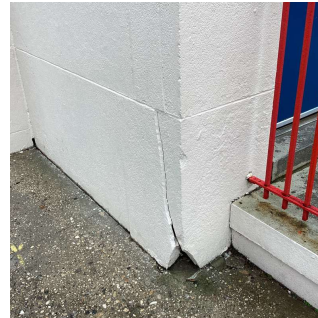
Facade F

STONE: CRACKS AT BUILDING CORNERS

REPLACE

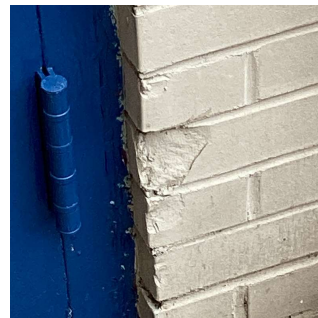
Facade C

BRICK: MAJOR / THRU CRACKS

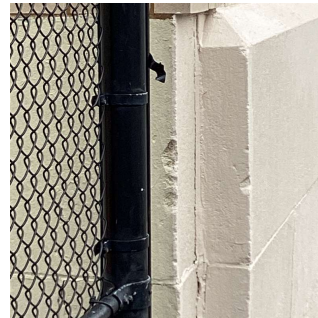
Facade B

STONE: CHIPPED/SPALLED/BROKEN PIECES - MINOR

REPAIR

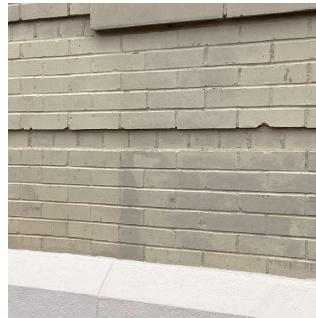
Facade B

BRICK: MINOR CRACKS AND SPALLING

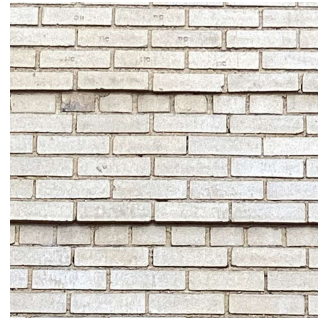
Facade A

BRICK: DETERIORATED JOINTS

PRIORITY 3
LEVEL 2

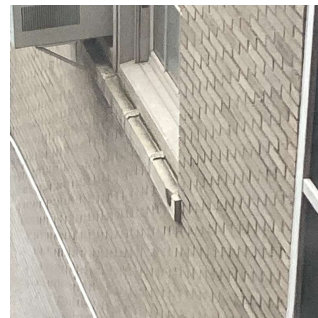
Facade F

BRICK: DETERIORATED MASONRY SILLS - MAJOR

30

REMOVE AND REPLACE

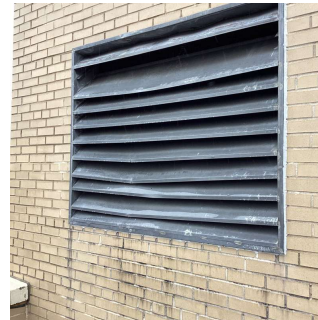
Roof 2

LOUVER

40

REPLACE

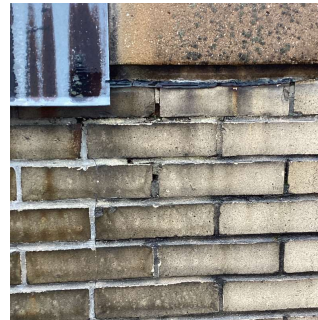
Roof 1

BRICK: DETERIORATED JOINTS

PARAPETS

10

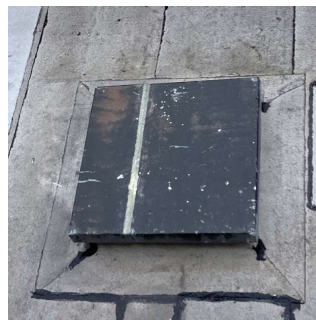
Roof 3
No violations recorded.

Violations	Roof 1 No violations recorded.
PLAZA DECK	Does not Exist
ROOF	Inspected
Roofing	Inspected
Replacement Quantity	23,000
Replacement Uom	S.F.
ROOF HATCH/SMOKE HATCH	Inspected
Condition	5 - Poor
Deficiency	INOPERABLE

ROOF HATCH/SMOKE HATCH

1
EACH
REPLACE
PRIORITY 4
LEVEL 2

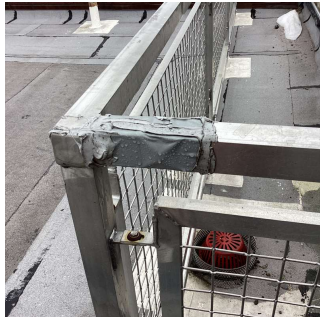
3 - Fair
RAILINGS/PANELS: DETERIORATED, MAJOR RUSTING

10
S.F.
REPLACE
PRIORITY 4
LEVEL 2

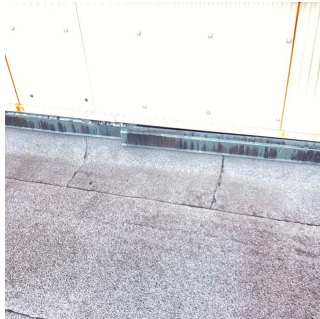
Violations	Roof 2 No violations recorded.
ROOF CAGE	Does not Exist
ROOFING	Inspected
Instance on Modified Bitumen: All Roofs	Inspected
Instance Condition	3 - Fair
Instance Photo	
	Roof 1
Instance Quantity	23,000
Instance Quantity Uom	S.F.
Does the roof have major mechanical equipment sitting on Dunnage Steel less than 18" above the Roofing?	No
Does this roof instance have a Sustainable Roof System?	No
Do solar panels exist on these roofs?	No
Is/Are the roof(s) suitable for Solar Panel installation?	Yes
Installation Year	2002
Source of Installation	Custodial Staff
Deficiency	MODIFIED BITUMEN: FLASHING: CAP FLASHING DAMAGED
Roof Plan reference	K238

Deficiency Quantity	10
Quantity Uom	L.F.
Potential Action	REPLACE
Urgency of Action	PRIORITY 4
Purpose of Action	LEVEL 2

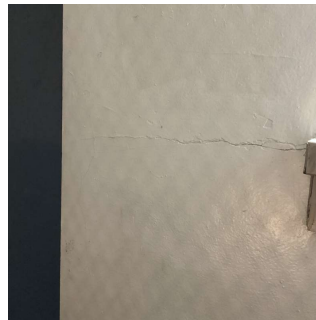
Violations	BH No violations recorded.
Deficiency	BULKHEAD/PENTHOUSE WALLS/INTERIOR: PLASTER CRACKS/SPALLING

BULKHEAD/PENTHOUSE

30
S.F.
REPLACE
PRIORITY 3
LEVEL 2

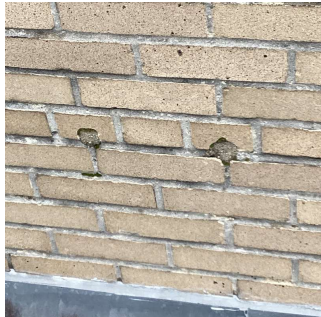
Deficiency **BULKHEAD/PENTHOUSE WALLS/EXTERIOR:
CRACKS/SPALLING - MINOR**

10
S.F.
REPAIR
PRIORITY 3
LEVEL 2

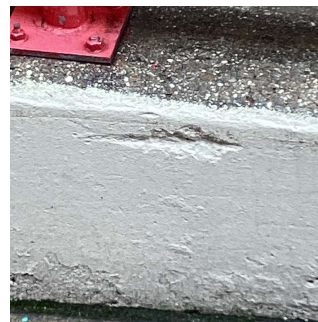
Facade D

CAST IN PLACE CONCRETE: CRACKS/SPALLING - MINOR

20

REPAIR

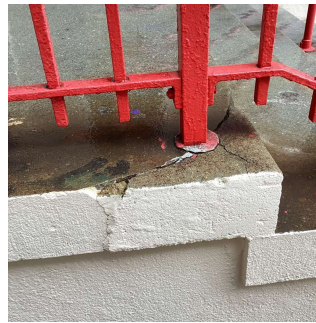
Facade E

STONE: CRACKS/SPALLING - MAJOR

25
S.F.
REPLACE
PRIORITY 4
LEVEL 2

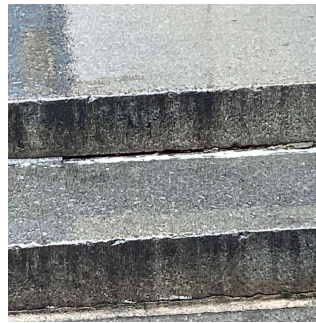
Facade A

STONE: DETERIORATED JOINTS

20
L.F.
REPOINT
PRIORITY 4
LEVEL 2

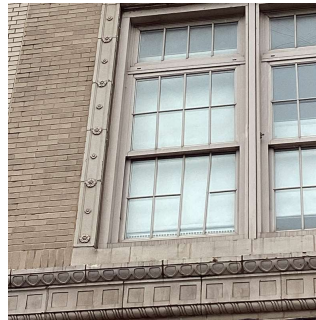
Facade H

ALUMINUM - DOUBLE HUNG: DETERIORATED

30
S.F.
REPLACE WINDOW
PRIORITY 4
LEVEL 2

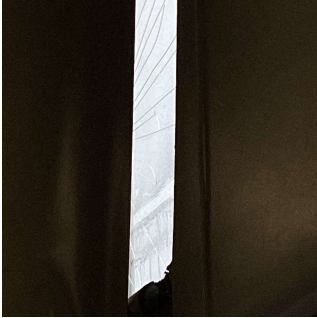
ALUMINUM - DOUBLE HUNG: BROKEN PANE

90
S.F.

Facade H - Room 254 (Facade H - Room 205, Facade A - Room 313 similar)
Violations	No violations recorded.
INTERIOR	
	Inspected
POOLS	
	Does not Exist
STRUCTURAL	
COLUMNS/BEAMS/BEARING WALLS	
Condition	4 - Between Fair and Poor
Deficiency	STEEL COLUMNS/BEAMS: MAJOR RUSTING
Deficiency Location/Instance	Basement
Deficiency Quantity	25
Quantity Uom	S.F.
Potential Action	REPLACE
Urgency of Action	PRIORITY 4
Purpose of Action	LEVEL 5
Deficiency Photo1

Question	Response
EXTERIOR	
WINDOWS	
WINDOWS	
Potential Action	MAINTENANCE
Urgency of Action	PRIORITY 3
Purpose of Action	LEVEL 2
Deficiency Photo1

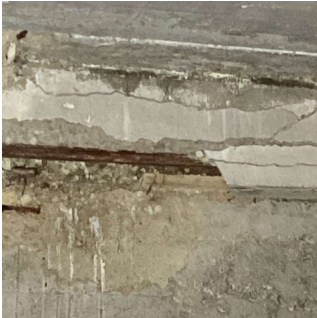
South Fan Area
Violations	No violations recorded.
Deficiency	STEEL COLUMNS/BEAMS: DETERIORATED CONCRETE FIREPROOFING
Deficiency Location/Instance	Basement
Deficiency Quantity	80
Quantity Uom	S.F.
Potential Action	REPLACE
Urgency of Action	PRIORITY 5
Purpose of Action	LEVEL 6

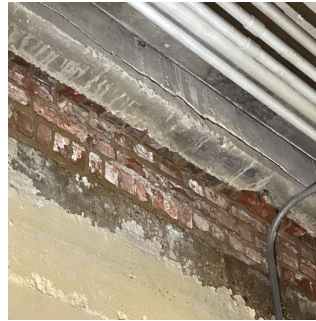
Room B-04 (South Fan Area similar)

STEEL COLUMNS/BEAMS: DETERIORATED CONCRETE FIREPROOFING

REPLACE

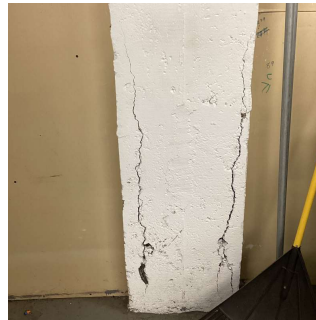
Basement Storage Room (Oil Tank Room, Boiler Room similar)

STEEL COLUMNS/BEAMS: DETERIORATED CONCRETE FIREPROOFING

REPLACE

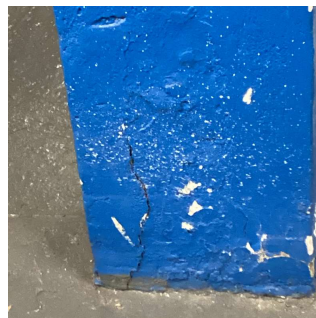
Boiler Room (Basement Storage Area, Oil Tank Room similar)

Question	Response
INTERIOR	
STRUCTURAL	
COLUMNS/BEAMS/BEARING WALLS	Inspected
Violations	No violations recorded.
FLOOR STRUCTURE	Inspected
Condition	3 - Fair
Deficiency	CONCRETE SLAB ON GRADE: THRU CRACKS
Deficiency Location/Instance	Basement
Deficiency Quantity	60
Quantity Uom	S.F.
Potential Action	REPLACE
Urgency of Action	PRIORITY 4
Purpose of Action	LEVEL 5
Deficiency Photo1

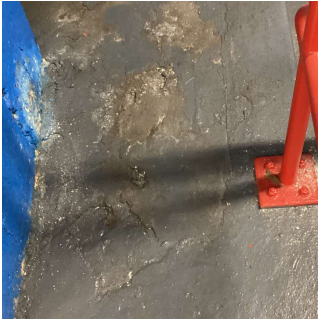
Violations	Boiler Room (Auditorium Crawl Space similar) No violations recorded.
Deficiency	CONCRETE SLAB ON GRADE: THRU CRACKS
Deficiency Location/Instance	Basement
Deficiency Quantity	350
Quantity Uom	S.F.
Potential Action	REPAIR
Urgency of Action	PRIORITY 3
Purpose of Action	LEVEL 5
Deficiency Photo1

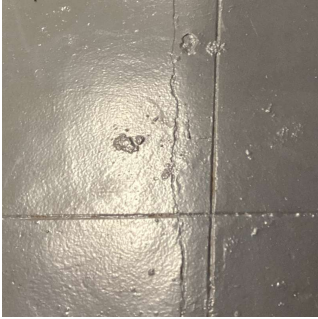
Violations	Basement Storage Area (South Fan Area, Boiler Room, Auditorium Crawl Space similar) No violations recorded.
FOUNDATION WALLS	Inspected
Material Type(s)	Concrete, Masonry
Condition	4 - Between Fair and Poor
Deficiency	CONCRETE: CRACKED/SPALLED/REINFORCEMENT EXPOSED

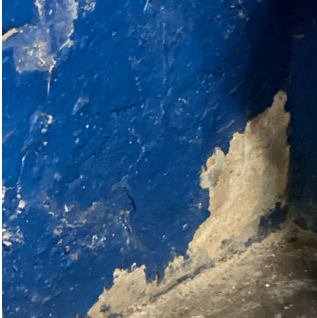
Violations	Boiler Room (Oil Tank Room similar) No violations recorded.
Deficiency	BRICK: CRACKED/SPALLED
Deficiency Location/Instance	Basement
Deficiency Quantity	30
Quantity Uom	S.F.
Potential Action	RESTITCH
Urgency of Action	PRIORITY 4
Purpose of Action	LEVEL 5
Deficiency Photo1

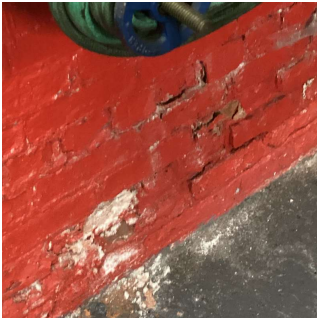
Violations	Boiler Room No violations recorded.
Deficiency	CONCRETE: CRACKED/SPALLED/REINFORCEMENT EXPOSED
Deficiency Location/Instance	Basement
Deficiency Quantity	60
Quantity Uom	S.F.
Potential Action	REPAIR
Urgency of Action	PRIORITY 4
Purpose of Action	LEVEL 5

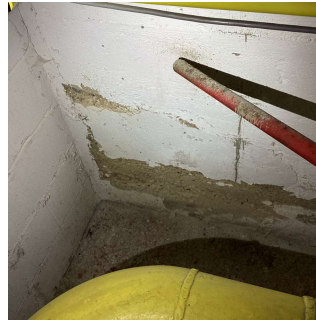
Gas Meter Room (Boiler Room, Basement Storage Area similar)

CONCRETE: WATER INFILTRATION IN NON- INSTRUCTIONAL SPACE

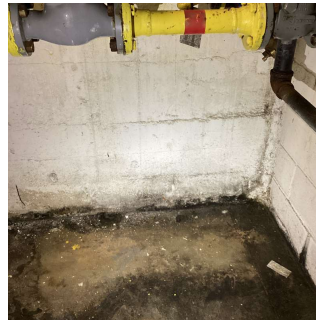
Gas Meter Room

CONCRETE: WATER INFILTRATION IN NON- INSTRUCTIONAL SPACE

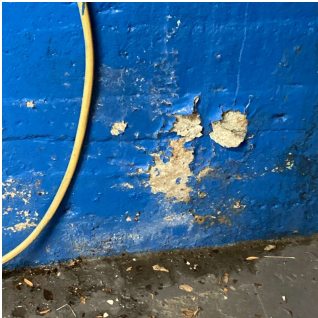
Violations	Vault No violations recorded.
Deficiency	CRACKS, SPALLING
Deficiency Location/Instance	Vault
Deficiency Quantity	30
Quantity Uom	S.F.
Potential Action	REPAIR
Urgency of Action	PRIORITY 3
Purpose of Action	LEVEL 5
Deficiency Photo1

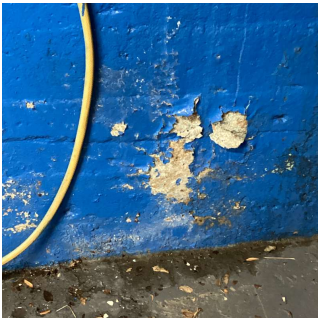
Violations	Vault No violations recorded.
Slab Structure	Inspected
Condition	3 - Fair
Deficiency	STEEL COLUMNS/BEAMS: DETERIORATED CONCRETE FIREPROOFING

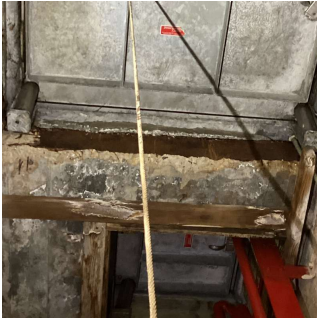
Violations	Vault No violations recorded.
Vault/Ash Hoist Doors and Framing	Inspected
Condition	5 - Poor
Deficiency	WATER INFILTRATION
Deficiency Location/Instance	Vault
Deficiency Quantity	10
Quantity Uom	S.F.
Potential Action	REPAIR
Urgency of Action	PRIORITY 5
Purpose of Action	LEVEL 2
Deficiency Photo1

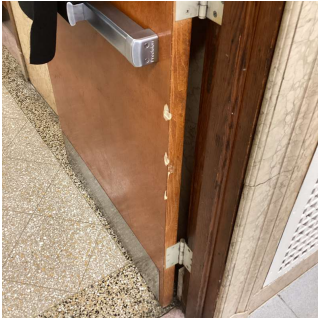
Question	Response
INTERIOR	
AUDITORIUM	
Door(s)	
Deficiency	WOOD: DETERIORATED DOOR
Deficiency Location/Instance	Entrance (4 Doors)
Deficiency Quantity	4
Quantity Uom	EACH
Potential Action	MAINTENANCE
Urgency of Action	PRIORITY 3
Purpose of Action	LEVEL 2
Deficiency Photo1

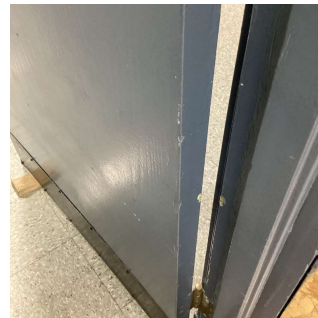
WOOD: DETERIORATED DOOR
Entrance (2 Doors)
2
EACH
MAINTENANCE
PRIORITY 3
LEVEL 2

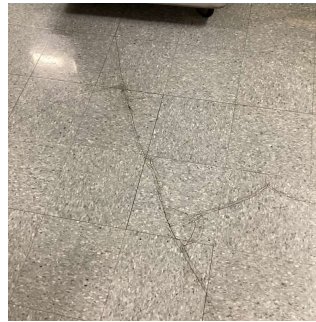
Near Kitchen Entrance
No violations recorded.

Instance on 1st Floor	Inspected
Condition	2 - Between Good and Fair
Deficiency	VINYL TILES: DETERIORATED SUBSTRATE
Deficiency Location/Instance	Near Kitchen Entrance, near Exit 2, Center, Entrance
Deficiency Quantity	70
Quantity Uom	S.F.
Potential Action	REPLACE
Urgency of Action	PRIORITY 3
Purpose of Action	LEVEL 2
Deficiency Photo1

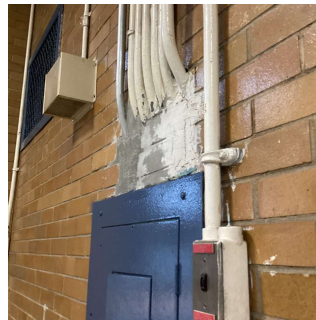
Near Exit 2
No violations recorded.

Instance on 1st Floor	Inspected
Condition	2 - Between Good and Fair
Deficiency	BRICK: CRACKS/SPALLING
Deficiency Location/Instance	Near Exit 2
Deficiency Quantity	10
Quantity Uom	S.F.
Potential Action	REPLACE
Urgency of Action	PRIORITY 3
Purpose of Action	LEVEL 2
Deficiency Photo1

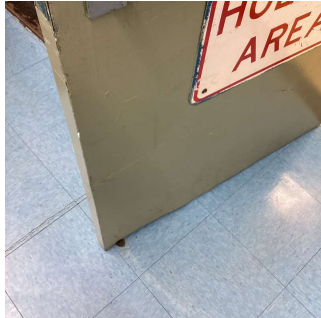
Question	Response
INTERIOR	
CLASSROOMS/CORRIDORS/ADMIN SPACES	Inspected
Ceiling	Inspected
Condition	2 - Between Good and Fair
Deficiency	No deficiencies recorded
Door(s)	Inspected
Condition	5 - Poor
Deficiency	METAL: DETERIORATED DOOR
Deficiency Location/Instance	Room 417
Deficiency Quantity	1
Quantity Uom	EACH
Potential Action	MAINTENANCE
Urgency of Action	PRIORITY 3
Purpose of Action	LEVEL 2
Deficiency Photo1

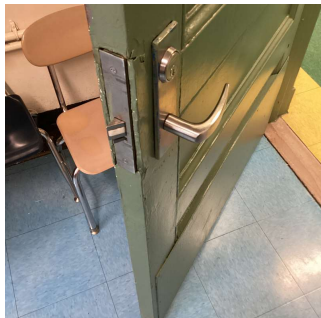
Room 417
Violations	No violations recorded.
Deficiency	METAL CLAD WOOD: DETERIORATED DOOR
Deficiency Location/Instance	Rooms 455, 419, 320,360
Deficiency Quantity	4
Quantity Uom	EACH
Potential Action	MAINTENANCE
Urgency of Action	PRIORITY 3
Purpose of Action	LEVEL 2
Deficiency Photo1

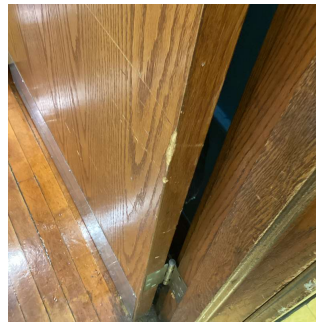
Room 423

Room 419
Violations	No violations recorded.
Deficiency	WOOD: DETERIORATED DOOR
Deficiency Location/Instance	Rooms 423, 420, 313, 307, 305 and others
Deficiency Quantity	11
Quantity Uom	EACH
Potential Action	MAINTENANCE
Urgency of Action	PRIORITY 3

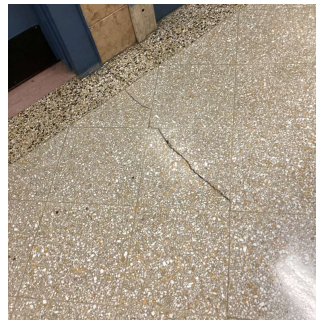
Corridor near room 101

TERRAZZO: CRACKS

REPLACE

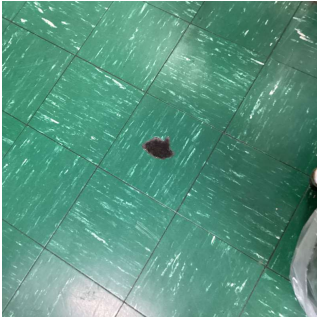
Question	Response
INTERIOR	
CLASSROOMS/CORRIDORS/ADMIN SPACES	
Floor Finish	
Violations	Room 455 No violations recorded.
Deficiency	VINYL TILES: BROKEN/DETERIORATED/MISSING TILES
Deficiency Location/Instance	Rooms 411, 265
Deficiency Quantity	400
Quantity Uom	S.F.
Potential Action	REPLACE
Urgency of Action	PRIORITY 3
Purpose of Action	LEVEL 2
Deficiency Photo1

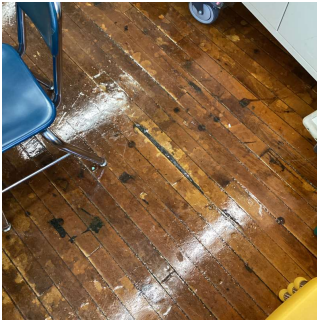
Violations	Room 411 No violations recorded.
Deficiency	WOOD: DAMAGED/DETERIORATED
Deficiency Location/Instance	Rooms 425, 423, 409, 407 405 and others
Deficiency Quantity	1,200
Quantity Uom	S.F.
Potential Action	REPLACE
Urgency of Action	PRIORITY 3
Purpose of Action	LEVEL 2
Deficiency Photo1

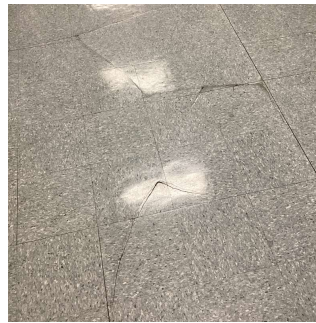
Corridor near room 120

Violations	Room 425 No violations recorded.
Deficiency	VINYL TILES: DETERIORATED SUBSTRATE
Deficiency Location/Instance	Corridor near rooms 120, 303,317, 321, Room 417 and others
Deficiency Quantity	500
Quantity Uom	S.F.
Potential Action	REPLACE
Urgency of Action	PRIORITY 3

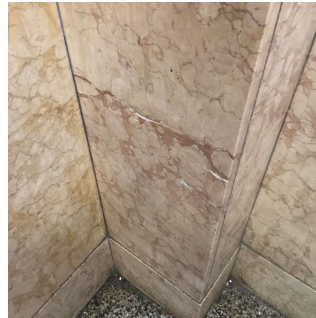
Main Entrance Vestibule

STONE: CRACKS/SPALLING

REPLACE

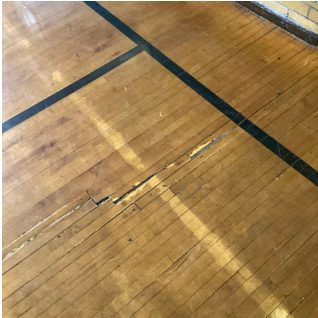
Question	Response
INTERIOR	
GYMNASIUM	
Floor Finish	
Deficiency	WOOD: DAMAGED/DETERIORATED
Deficiency Location/Instance	Near Entrance, near Storage Room
Deficiency Quantity	30
Quantity Uom	S.F.
Potential Action	REPLACE
Urgency of Action	PRIORITY 3
Purpose of Action	LEVEL 2
Deficiency Photo1

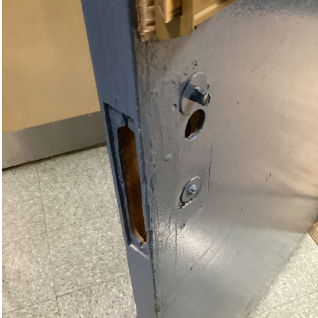
Violations	Near Windows No violations recorded.
Door(s)	
Instance on 1st Floor	Inspected
Condition	4 - Between Fair and Poor
Deficiency	WOOD: DETERIORATED DOOR
Deficiency Location/Instance	Entrance
Deficiency Quantity	1
Quantity Uom	EACH
Potential Action	MAINTENANCE
Urgency of Action	PRIORITY 3
Purpose of Action	LEVEL 2
Deficiency Photo1

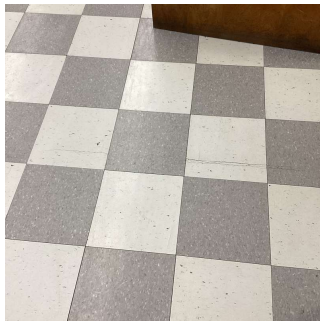
Question	Response
INTERIOR	
LIBRARY	
Door(s)	
Instance on Room 309	Inspected
Condition	2 - Between Good and Fair
Deficiency	No deficiencies recorded
Floor Finish	
Instance on Room 309	Inspected
Condition	2 - Between Good and Fair
Deficiency	VINYL TILES: DETERIORATED SUBSTRATE
Deficiency Location/Instance	Entrance
Deficiency Quantity	30
Quantity Uom	S.F.
Potential Action	REPLACE
Urgency of Action	PRIORITY 3
Purpose of Action	LEVEL 2
Deficiency Photo1

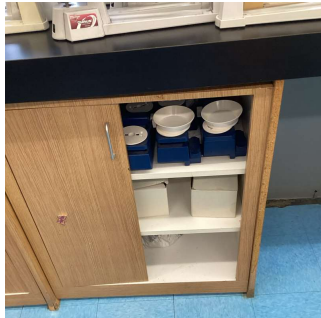
Question	Response
INTERIOR	
SCIENCE DEMO ROOM	
Fixed Equipment	
Deficiency Quantity	10
Quantity Uom	L.F.
Potential Action	REPLACE
Urgency of Action	PRIORITY 3
Purpose of Action	LEVEL 2
Deficiency Photo1

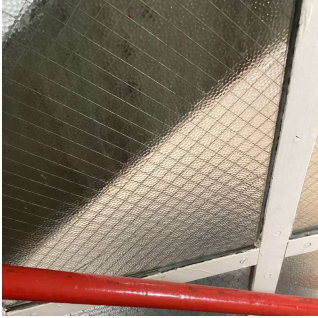
Question	Response
INTERIOR	
STAIRS/RAMPS: INTERIOR	
Ceiling	Inspected
Deficiency	No deficiencies recorded
Door(s)	Inspected
Condition	2 - Between Good and Fair
Deficiency	No deficiencies recorded
Partition	Inspected
Condition	2 - Between Good and Fair
Deficiency	GLASS PANEL: DAMAGED/DETERIORATED
Deficiency Location/Instance	Stair E/F 2, A/B 1, 3,4
Deficiency Quantity	20
Quantity Uom	S.F.
Potential Action	REPLACE
Urgency of Action	PRIORITY 3
Purpose of Action	LEVEL 2
Deficiency Photo1

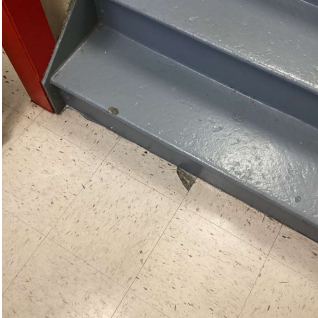
Violations	Stair E/F 2 No violations recorded.
Railings	Inspected
Condition	2 - Between Good and Fair
Deficiency	No deficiencies recorded
Stairs and Landings	Inspected
Condition	4 - Between Fair and Poor
Deficiency	VINYL TILES: BROKEN/DETERIORATED/MISSING TILES
Deficiency Location/Instance	Stair H/1
Deficiency Quantity	10
Quantity Uom	S.F.
Potential Action	REPLACE
Urgency of Action	PRIORITY 3
Purpose of Action	LEVEL 2
Deficiency Photo1

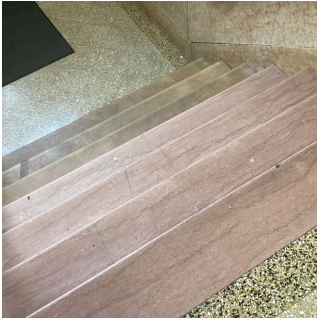
Question	Response
INTERIOR	
STAIRS/RAMPS: INTERIOR	
Stairs and Landings	
Deficiency	STONE: BROKEN/MISSING
Deficiency Location/Instance	Exits 5, 6
Deficiency Quantity	25
Quantity Uom	S.F.
Potential Action	REPLACE
Urgency of Action	PRIORITY 3
Purpose of Action	LEVEL 2
Deficiency Photo1

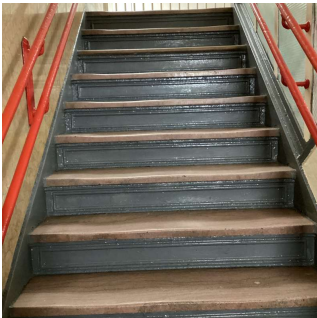
Violations	Exit 5 No violations recorded.
Deficiency	STONE: WORN-OUT TREAD/NOSINGS
Deficiency Location/Instance	Stair A/B 1
Deficiency Quantity	130
Quantity Uom	S.F.
Potential Action	REPLACE
Urgency of Action	PRIORITY 3
Purpose of Action	LEVEL 2
Deficiency Photo1

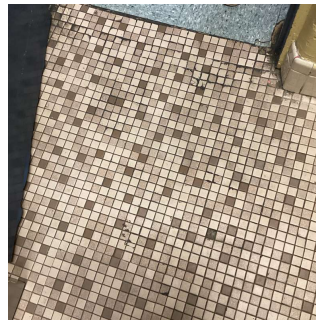
Kitchen Staff

CERAMIC TILE: BROKEN/MISSING TILES

REPLACE

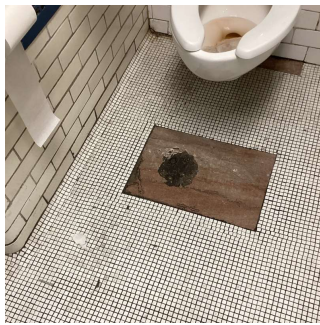
Question	Response
INTERIOR	
TOILET ROOMS - STUDENTS	
Floor Finish	
Deficiency Photo1

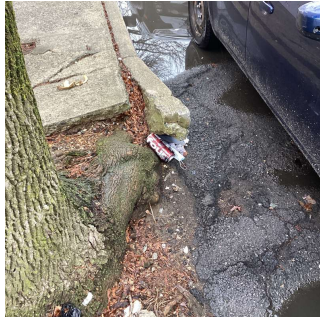
Question	Response
SITE	
PAVING	
DOT Sidewalk	
Concrete	
Deficiency Photo1

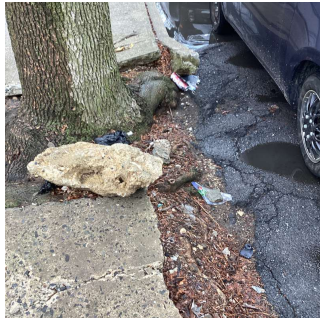
Violations	E. 9th Street 86296
Deficiency	DAMAGED/DETERIORATED/MISSING SECTIONS
Deficiency Location/Instance	E. 9th Street, E. 8th Street
Deficiency Quantity	2,500
Quantity Uom	S.F.
Potential Action	REPLACE
Urgency of Action	PRIORITY 4
Purpose of Action	LEVEL 4
Deficiency Photo1

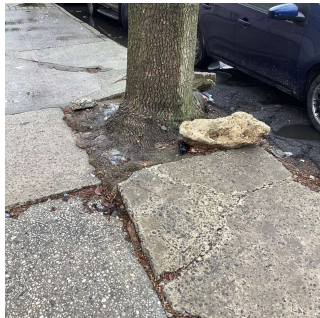
Violations	E. 9th Street 86296
Deficiency	HEAVING
Deficiency Location/Instance	E. 9th Street, E. 8th Street
Deficiency Quantity	1,000
Quantity Uom	S.F.
Potential Action	REPLACE
Urgency of Action	PRIORITY 4
Purpose of Action	LEVEL 4
Deficiency Photo1

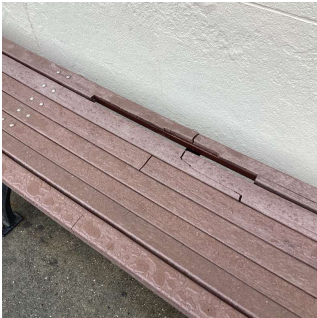
Deficiency	DAMAGED/DETERIORATED
Deficiency Location/Instance	Schoolyard
Deficiency Quantity	2

Question	Response
SITE	
SEATING	
Benches	
Metal/Wood/Plastic	
Quantity Uom	EACH
Potential Action	REPLACE
Urgency of Action	PRIORITY 5
Purpose of Action	LEVEL 6
Deficiency Photo1
