**NYC Department of Education**  
**Building Condition Assessment Survey 2023 - 2024**

Architectural Inspection

**Asset: P.S. 243 - BROOKLYN, 1580 DEAN STREET, New York, 11213**

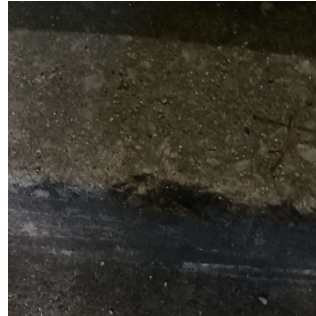
AW1

AREAWAY STAIRS: DETERIORATED  
TREADS/RISERS/NOSINGS

REPLACE

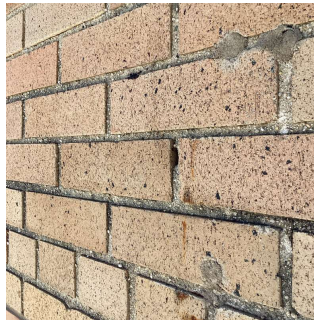
Roof 4  
No violations recorded.

Roof 4	
Violations	No violations recorded.
Deficiency	BRICK: DETERIORATED JOINTS

100  
S.F.  
REPOINT  
PRIORITY 3  
LEVEL 2

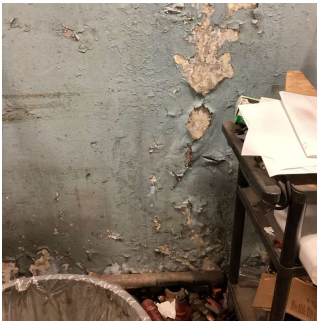
Question	Response
<b>INTERIOR</b>	
<b>STRUCTURAL</b>	
<b>FOUNDATION WALLS</b>	
Deficiency Photo1

Violations	Basement - Boiler Room Pit No violations recorded.
Deficiency	CONCRETE: CRACKED/SPALLED/REINFORCEMENT EXPOSED
Deficiency Location/Instance	Basement - Oil Tank Room
Deficiency Quantity	35
Quantity Uom	S.F.
Potential Action	REPAIR
Urgency of Action	PRIORITY 4
Purpose of Action	LEVEL 5
Deficiency Photo1

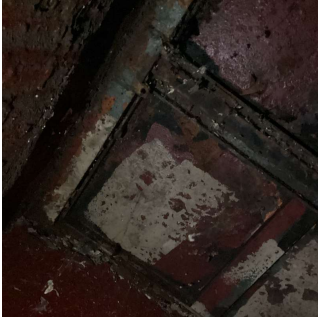
Violations	Basement - Oil Tank Room No violations recorded.
<b>ROOF STRUCTURE</b>	Inspected
Condition	2 - Between Good and Fair
Deficiency	No deficiencies recorded
<b>VAULTS-BUNKERS</b>	Inspected
<b>Foundation Walls</b>	Inspected
Condition	2 - Between Good and Fair
Deficiency	No deficiencies recorded
<b>Slab Structure</b>	Inspected
Condition	2 - Between Good and Fair
Deficiency	No deficiencies recorded
<b>Vault/Ash Hoist Doors and Framing</b>	Inspected
Condition	5 - Poor
Deficiency	WATER INFILTRATION
Deficiency Location/Instance	Basement - Ash Hoist Vault

Question	Response
<b>INTERIOR</b>	
<b>STRUCTURAL</b>	
<b>VAULTS-BUNKERS</b>	
<b>Vault/Ash Hoist Doors and Framing</b>	
Urgency of Action	PRIORITY 5
Purpose of Action	LEVEL 2
Deficiency Photo1

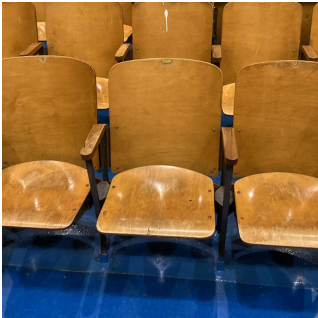
Violations	Seat A/112 No violations recorded.

Violations	Basement - Ash Hoist Vault No violations recorded.
<b>AUDITORIUM</b>	Inspected
Instance on 1st Floor (416 Seats)	Inspected
<b>Ceiling</b>	
Instance on 1st Floor (416 Seats)	Inspected
Condition	2 - Between Good and Fair
Deficiency	No deficiencies recorded
<b>Door(s)</b>	
Instance on 1st Floor (416 Seats)	Inspected
Condition	1 - Good
Deficiency	No deficiencies recorded
<b>Fixed H/C Lift</b>	
Instance on 1st Floor (416 Seats)	Does not Exist
<b>Fixed Seating</b>	
Instance on 1st Floor (416 Seats)	Inspected
Condition	2 - Between Good and Fair
Deficiency	DAMAGED/BROKEN/INOPERABLE
Deficiency Location/Instance	Seats A/105, 107, 110, 111, 112 and others
Deficiency Quantity	10
Quantity Uom	EACH
Potential Action	REPLACE
Urgency of Action	PRIORITY 3

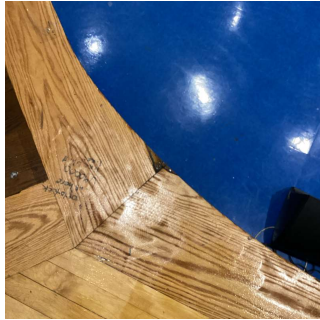
Question	Response
<b>INTERIOR</b>	
<b>AUDITORIUM</b>	
<b>Floor Finish</b>	
Instance on 1st Floor (416 Seats)	Inspected
Condition	2 - Between Good and Fair
Deficiency	No deficiencies recorded
<b>Sliding-folding Partition</b>	
Instance on 1st Floor (416 Seats)	Does not Exist
<b>Stage</b>	
Instance on 1st Floor (416 Seats)	Inspected
<b>Stage</b>	Inspected
Instance on 1st Floor (416 Seats)	Inspected
Condition	2 - Between Good and Fair
Deficiency	DAMAGED FLOOR
Deficiency Location/Instance	Left Side
Deficiency Quantity	10
Quantity Uom	S.F.
Potential Action	REPLACE
Urgency of Action	PRIORITY 3
Purpose of Action	LEVEL 2
Deficiency Photo1

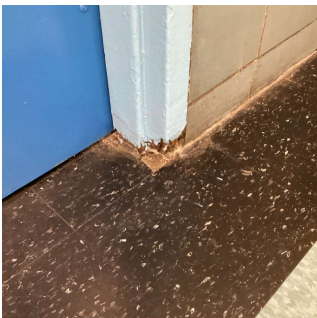
Violations	Main Entrance No violations recorded.
<b>Fixed Equipment</b>	
Instance on 1st Floor	Does not Exist
<b>Floor Finish</b>	
Instance on 1st Floor	Inspected
Condition	2 - Between Good and Fair
Deficiency	No deficiencies recorded

Violations	Near Entrance No violations recorded.
<b>Door(s)</b>	
Instance on 1st Floor	Inspected
Condition	4 - Between Fair and Poor
Deficiency	METAL: DETERIORATED DOOR AND FRAME
Deficiency Location/Instance	Main Entrance, Entrance Near kitchen
Deficiency Quantity	2
Quantity Uom	EACH
Potential Action	MAINTENANCE
Urgency of Action	PRIORITY 3
Purpose of Action	LEVEL 2
Deficiency Photo1

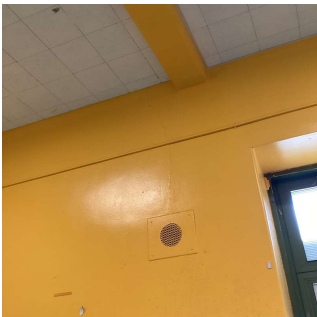
Violations	Near Entrance No violations recorded.
<b>Window Curtains/Shades/Blinds</b>	
Instance on 1st Floor	Does not Exist
<b>CLASSROOMS/CORRIDORS/ADMIN SPACES</b>	
<b>Ceiling</b>	Inspected
Condition	2 - Between Good and Fair
Deficiency	PLASTER: CRACKS/SPALLING

Question	Response
<b>INTERIOR</b>	
<b>CAFETERIA</b>	
<b>Stage</b>	
Instance on 1st Floor	Does not Exist
<b>Walls</b>	
Instance on 1st Floor	Inspected
Condition	2 - Between Good and Fair
Deficiency	GLAZED BLOCK: CRACKS/SPALLING
Deficiency Location/Instance	Near Windows
Deficiency Quantity	20
Quantity Uom	S.F.
Potential Action	REPLACE
Urgency of Action	PRIORITY 3
Purpose of Action	LEVEL 2
Deficiency Photo1	 
Violations	Near Windows No violations recorded.
Deficiency	PLASTER: CRACKS/SPALLING
Deficiency Location/Instance	Near Entrance, Near Kitchen
Deficiency Quantity	20
Quantity Uom	S.F.
Potential Action	REPLACE
Urgency of Action	PRIORITY 3
Purpose of Action	LEVEL 2
Deficiency Photo1

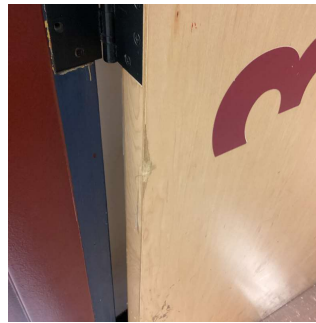
345

Violations	Corridor near Room 133 No violations recorded.
<b>Door(s)</b>	Inspected
Condition	5 - Poor
Deficiency	WOOD: DETERIORATED DOOR
Deficiency Location/Instance	Rooms 345, 343, 322, 307, 244 and others
Deficiency Quantity	12
Quantity Uom	EACH
Potential Action	MAINTENANCE
Urgency of Action	PRIORITY 3
Purpose of Action	LEVEL 2

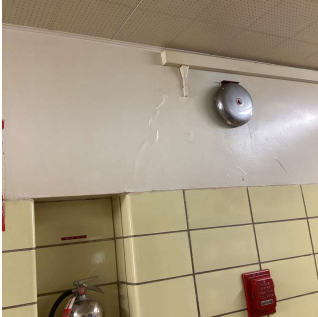
Question	Response
<b>INTERIOR</b>	
<b>CLASSROOMS/CORRIDORS/ADMIN SPACES</b>	
<b>Floor Finish</b>	Inspected
	Room 311
Violations	No violations recorded.
<b>Walls</b>	Inspected
Condition	2 - Between Good and Fair
Deficiency	PLASTER: CRACKS/SPALLING
Deficiency Location/Instance	Corridor near Rooms 244, 222, 106, 100
Deficiency Quantity	60
Quantity Uom	S.F.
Potential Action	REPLACE
Urgency of Action	PRIORITY 3
Purpose of Action	LEVEL 2
Deficiency Photo1

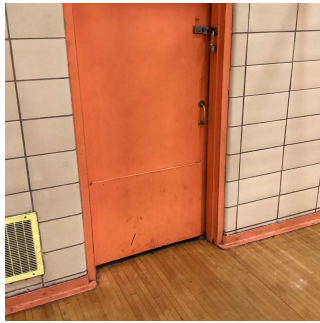
Violations	Corridor near Room 222 No violations recorded.
<b>Specialties</b>	Does not Exist
<b>GYMNASIUM</b>	Inspected
Instance on 1st Floor	Inspected
<b>Ceiling</b>	
Instance on 1st Floor	Inspected
Condition	2 - Between Good and Fair
Deficiency	No deficiencies recorded
<b>Door(s)</b>	
Instance on 1st Floor	Inspected
Condition	3 - Fair
Deficiency	METAL: DAMAGED LOUVER
Deficiency Location/Instance	Storage Room
Deficiency Quantity	1
Quantity Uom	EACH
Potential Action	MAINTENANCE

Urgency of Action	PRIORITY 3
Purpose of Action	LEVEL 2

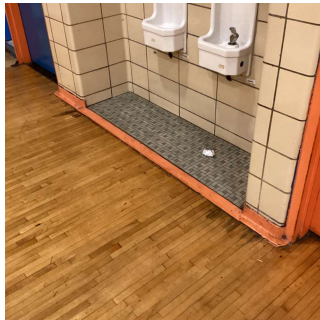
Storage Room
Violations	No violations recorded.
<b>Fixed Equipment</b>	
Instance on 1st Floor	Inspected
Condition	2 - Between Good and Fair
Deficiency	No deficiencies recorded
<b>Floor Finish</b>	
Instance on 1st Floor	Inspected
Condition	2 - Between Good and Fair
Deficiency	WOOD: DAMAGED/DETERIORATED
Deficiency Location/Instance	Near Drinking Fountain
Deficiency Quantity	10
Quantity Uom	S.F.
Potential Action	REPLACE
Urgency of Action	PRIORITY 3
Purpose of Action	LEVEL 2
Deficiency Photo1

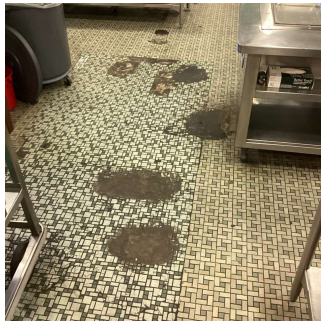
Violations	Center No violations recorded.

Instance on 1st Floor	Inspected
Condition	5 - Poor
Deficiency	CERAMIC TILE: BROKEN/MISSING TILES
Deficiency Location/Instance	Near Storage Room, Center, Near Entrance, Near Freezers
Deficiency Quantity	300
Quantity Uom	S.F.
Potential Action	REPLACE
Urgency of Action	PRIORITY 3
Purpose of Action	LEVEL 2
Deficiency Photo1

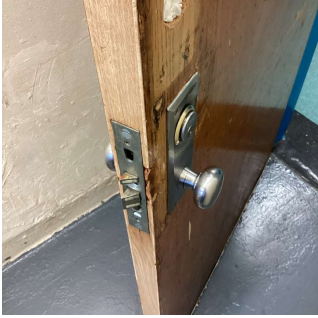
Question	Response
<b>INTERIOR</b>	
<b>LOCKER ROOM</b>	
<b>Ceiling</b>	
Instance on Room 140	Inspected
Condition	2 - Between Good and Fair
Deficiency	No deficiencies recorded
<b>Door(s)</b>	
Instance on Room 140	Inspected
Condition	3 - Fair
Deficiency	WOOD: DETERIORATED DOOR
Deficiency Location/Instance	Main Entrance
Deficiency Quantity	1
Quantity Uom	EACH
Potential Action	MAINTENANCE
Urgency of Action	PRIORITY 3
Purpose of Action	LEVEL 2
Deficiency Photo1

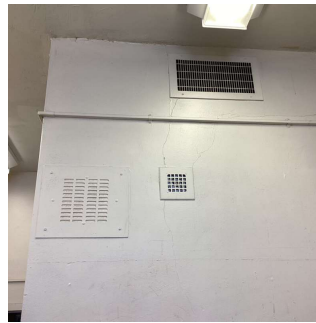
Main Entrance
Violations	No violations recorded.
<b>Floor Finish</b>	
Instance on Room 140	Inspected
Condition	2 - Between Good and Fair
Deficiency	No deficiencies recorded
<b>Locker Room Lockers</b>	
Instance on Room 140	Does not Exist
<b>Walls</b>	
Instance on Room 140	Inspected
Condition	2 - Between Good and Fair
Deficiency	PLASTER: CRACKS/SPALLING
Deficiency Location/Instance	Near Entrance
Deficiency Quantity	20
Quantity Uom	S.F.
Potential Action	REPLACE
Urgency of Action	PRIORITY 3

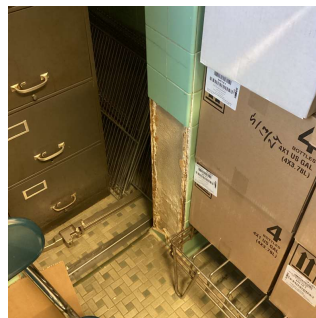
CERAMIC TILE: BROKEN/ MISSING

REPLACE

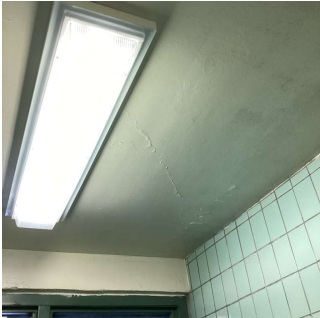
<b>Question</b>	<b>Response</b>
<b>INTERIOR</b>	
<b>SHOWER ROOM</b>	Inspected
<b>Walls</b>	
Violations	Right Side No violations recorded.
<b>STAIRS/RAMPS: INTERIOR</b>	Inspected
Do Letter Stair Signs Exist?	Yes
<b>Ceiling</b>	Inspected
Condition	2 - Between Good and Fair
Deficiency	PLASTER: CRACKS/SPALLING
Deficiency Location/Instance	Stair F/1 Vestibule
Deficiency Quantity	20
Quantity Uom	S.F.
Potential Action	REPLACE
Urgency of Action	PRIORITY 3
Purpose of Action	LEVEL 2
Deficiency Photo1

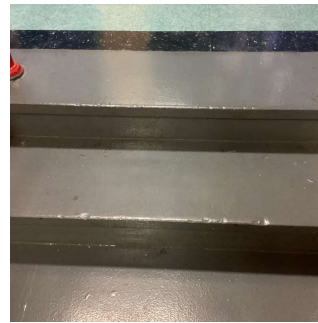
Stair BC/1

Violations	Stair GH/1 No violations recorded.
Deficiency	STONE: BROKEN/MISSING
Deficiency Location/Instance	Stairs BC/1, 2, GH/2
Deficiency Quantity	40
Quantity Uom	S.F.
Potential Action	REPLACE

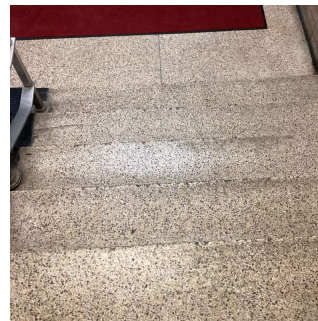
Main Entrance Vestibule

TERRAZZO: CRACKS

REPLACE

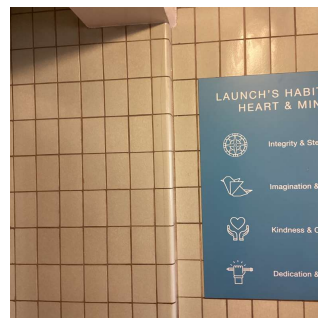
GLAZED BLOCK: CRACKS/SPALLING

REPLACE

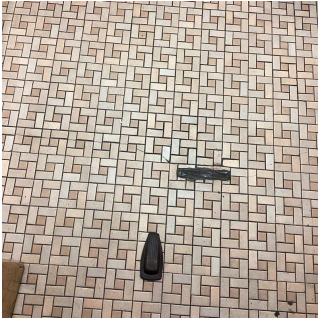
Question	Response
<b>INTERIOR</b>	
<b>TOILET ROOMS - STAFF</b>	
<b>Floor Finish</b>	
Deficiency	CERAMIC TILE: BROKEN/MISSING TILES
Deficiency Location/Instance	Rooms 326, 324, 117A
Deficiency Quantity	30
Quantity Uom	S.F.
Potential Action	REPLACE
Urgency of Action	PRIORITY 3
Purpose of Action	LEVEL 2
Deficiency Photo1

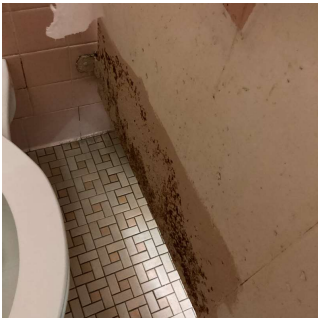
Room 324
Violations	No violations recorded.
<b>Stalls</b>	
Condition	Inspected
Deficiency	5 - Poor
Deficiency	RUST - MAJOR
Deficiency Location/Instance	Inside Kitchen
Deficiency Quantity	1
Quantity Uom	EACH
Potential Action	REPLACE
Urgency of Action	PRIORITY 3
Purpose of Action	LEVEL 2
Deficiency Photo1

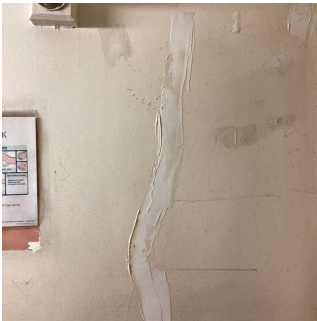
Inside Kitchen
Violations	No violations recorded.
<b>Walls</b>	
Condition	Inspected
Deficiency	2 - Between Good and Fair
Deficiency	PLASTER: CRACKS/SPALLING
Deficiency Location/Instance	Inside Kitchen, Rooms 326, 324, 133
Deficiency Quantity	40
Quantity Uom	S.F.
Potential Action	REPLACE
Urgency of Action	PRIORITY 3

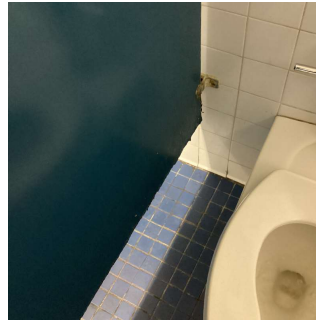
Violations	Inside Kitchen No violations recorded.
<b>TOILET ROOMS - STUDENTS</b>	
<b>Ceiling</b>	Inspected
Condition	2 - Between Good and Fair
Deficiency	No deficiencies recorded
<b>Door(s)</b>	Inspected
Condition	5 - Poor
Deficiency	WOOD: DETERIORATED DOOR
Deficiency Location/Instance	Rooms 347, 247, 139A, 104A, 102A and others
Deficiency Quantity	9
Quantity Uom	EACH
Potential Action	MAINTENANCE
Urgency of Action	PRIORITY 3
Purpose of Action	LEVEL 2
Deficiency Photo1	 
Violations	Room 139A No violations recorded.
<b>Floor Finish</b>	Inspected
Condition	2 - Between Good and Fair
Deficiency	No deficiencies recorded
<b>Stalls</b>	Inspected
Condition	4 - Between Fair and Poor
Deficiency	RUST - MAJOR
Deficiency Location/Instance	Room 347
Deficiency Quantity	4
Quantity Uom	EACH
Potential Action	REPLACE
Urgency of Action	PRIORITY 3

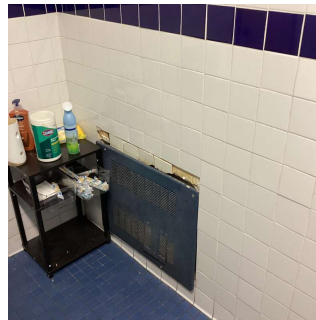
Room 346

CERAMIC TILE: BROKEN/ MISSING

REPLACE

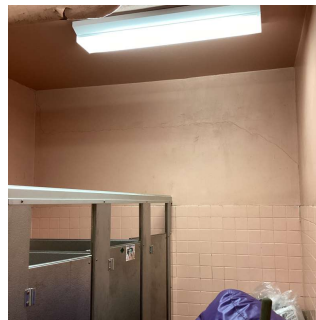
PLASTER: CRACKS/SPALLING

REPLACE

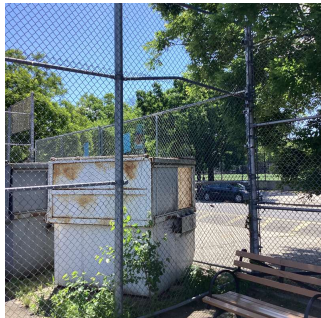
Question	Response
<b>INTERIOR</b>	Inspected
<b>TOILET ROOMS - STUDENTS</b>	Inspected
<b>Walls</b>	
Violations	Room 139A No violations recorded.
<b>LIFE SAFETY</b>	Inspected
<b>F.D. HOLDING AREA</b>	Does not Exist
<b>STEEL STAIRS</b>	Does not Exist
<b>SITE</b>	Inspected
<b>CONTAINERIZATION</b>	Inspected
Condition	5 - Poor
Deficiency	FENCING DAMAGED
Deficiency Location/Instance	Bergen Street
Deficiency Quantity	20
Quantity Uom	S.F.
Potential Action	REPAIR
Urgency of Action	PRIORITY 3
Purpose of Action	LEVEL 2
Deficiency Photo1

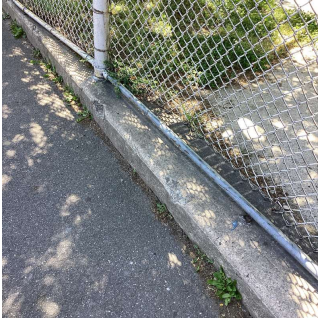
Question	Response
<b>SITE</b>	
<b>Drainage System for Asphalt</b>	Inspected
<b>Catch Basins/Manhole - Surrounded by asphalt</b>	Inspected
Condition	2 - Between Good and Fair
Deficiency	No deficiencies recorded
<b>Culverts - Asphalt Covering</b>	Does not Exist
<b>Drainage System for Concrete</b>	Inspected
<b>Catch Basins/Manhole - Surrounded by concrete</b>	Inspected
Condition	5 - Poor
Deficiency	BLOCKED
Deficiency Location/Instance	Near Exit 7
Deficiency Quantity	1
Quantity Uom	EACH
Potential Action	MAINTENANCE
Urgency of Action	PRIORITY 3
Purpose of Action	LEVEL 2
Deficiency Photo1	No photo recorded
Violations	No violations recorded.
<b>Culverts - Concrete Covering</b>	Does not Exist
<b>Drainage System for Soil</b>	Does not Exist
<b>DRINKING FOUNTAINS</b>	Does not Exist
<b>FENCES</b>	Inspected
Condition	4 - Between Fair and Poor
Deficiency	CONCRETE CURB: DAMAGED/DETERIORATED
Deficiency Location/Instance	Bergen Street

Deficiency Quantity	40
Quantity Uom	S.F.
Potential Action	REPLACE
Urgency of Action	PRIORITY 3
Purpose of Action	LEVEL 2
Deficiency Photo1

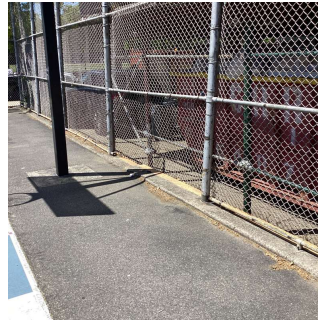
Schoolyard

**CHAIN LINK: DAMAGED POST/RAIL**

REPLACE

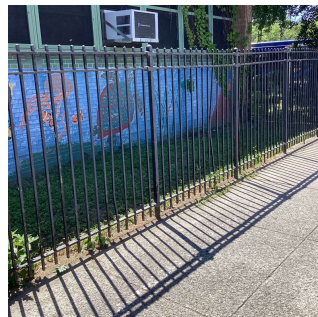
Troy Avenue

**WROUGHT IRON: DAMAGED/DETERIORATED**

REPLACE

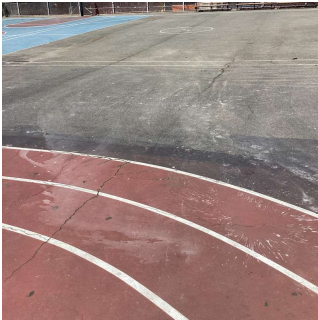
Question	Response
<b>SITE</b>	
<b>IRRIGATION SYSTEM</b>	Does not Exist
<b>PAVING</b>	Inspected
<b>Student Non-Use</b>	Inspected
Gravel Exists?	No
<b>Asphalt</b>	Inspected
Condition	2 - Between Good and Fair
Deficiency	No deficiencies recorded
<b>Concrete</b>	Inspected
Condition	2 - Between Good and Fair
Deficiency	No deficiencies recorded
<b>Pavers</b>	Inspected
Condition	2 - Between Good and Fair
Deficiency	No deficiencies recorded
<b>Student Use</b>	Inspected
Gravel Exists?	No
<b>Asphalt</b>	Inspected
Condition	4 - Between Fair and Poor
Deficiency	CRACKS - MAJOR
Deficiency Location/Instance	Schoolyard
Deficiency Quantity	2,000
Quantity Uom	S.F.
Potential Action	REPLACE
Urgency of Action	PRIORITY 3
Purpose of Action	LEVEL 2
Deficiency Photo1

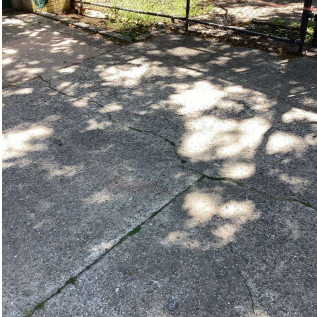
Question	Response
<b>SITE</b>	
<b>PAVING</b>	Inspected
<b>Student Use</b>	
<b>Pavers</b>	
Deficiency Photo1	 
Violations	Schoolyard No violations recorded.
<b>Site Sidewalks &amp; Walkways</b>	Inspected
<b>Asphalt</b>	Does not Exist
<b>Concrete</b>	Inspected
Condition	4 - Between Fair and Poor
Deficiency	HEAVING
Deficiency Location/Instance	Exits 7, 5
Deficiency Quantity	100
Quantity Uom	S.F.
Potential Action	REPLACE
Urgency of Action	PRIORITY 5
Purpose of Action	LEVEL 6
Deficiency Photo1	 
Violations	Exit 7 No violations recorded.
Deficiency	CRACKS - MAJOR
Deficiency Location/Instance	Exits 7, 6, 5, 4
Deficiency Quantity	1,200
Quantity Uom	S.F.
Potential Action	REPLACE
Urgency of Action	PRIORITY 3
Purpose of Action	LEVEL 2

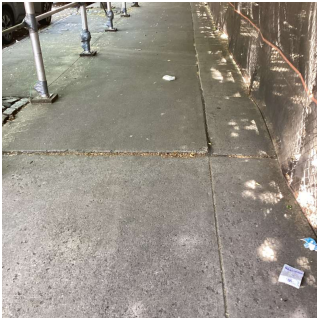
Violations	Exit 7 No violations recorded.
<b>Pavers</b>	Does not Exist
<b>DOT Sidewalk</b>	Inspected
<b>Asphalt</b>	Does not Exist
<b>Concrete</b>	Inspected
Condition	4 - Between Fair and Poor
Deficiency	HEAVING
Deficiency Location/Instance	Troy Avenue, Dean Street
Deficiency Quantity	150
Quantity Uom	S.F.
Potential Action	REPLACE
Urgency of Action	PRIORITY 3
Purpose of Action	LEVEL 2
Deficiency Photo1

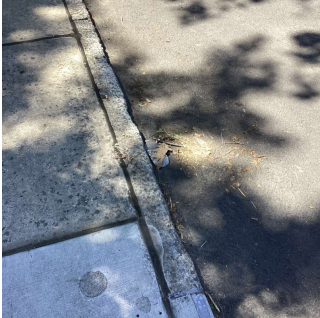
Violations	Dean Street No violations recorded.
Deficiency	DAMAGED CURBS
Deficiency Location/Instance	Troy Avenue, Dean Street, Bergen Street
Deficiency Quantity	60
Quantity Uom	L.F.
Potential Action	REPLACE
Urgency of Action	PRIORITY 3
Purpose of Action	LEVEL 2

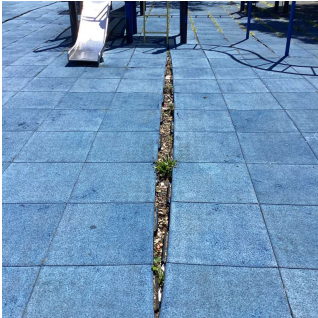
Question	Response
<b>SITE</b>	
<b>PLAYGROUNDS</b>	
<b>Safety Surfacing</b>	
Deficiency	DETERIORATED/MISSING
Deficiency Location/Instance	Right and Left Side, Center
Deficiency Quantity	400
Quantity Uom	S.F.
Potential Action	REPLACE
Urgency of Action	PRIORITY 5
Purpose of Action	LEVEL 6
Deficiency Photo1

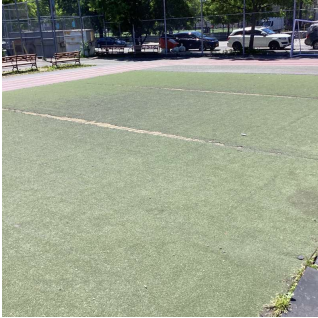
Violations	Right Side No violations recorded.
<b>Unpaved Area</b>	
Instance on Schoolyard	Does not Exist
<b>PLAYING SURFACE</b>	
<b>Playing Field</b>	
Instance on Schoolyard	Inspected
Instance Condition	Inspected
Instance Condition	5 - Poor
Deficiency	ARTIFICIAL TURF: DAMAGED/WORN OUT
Deficiency Location/Instance	Center
Deficiency Quantity	3,500
Quantity Uom	S.F.
Potential Action	REPLACE
Urgency of Action	PRIORITY 3
Purpose of Action	LEVEL 2
Deficiency Photo1

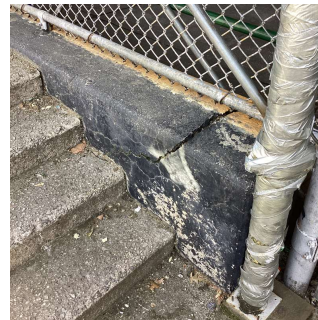
Near Exit 5

CAST IN PLACE CONCRETE: CRACKS/SPALLING - MAJOR

REPLACE

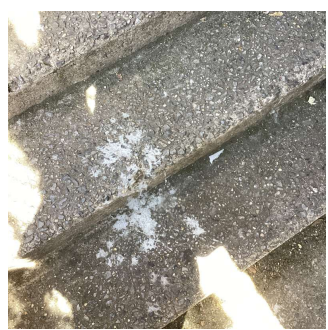
CAST IN PLACE CONCRETE: CRACKS/SPALLING - MAJOR

REPLACE
