**NYC Department of Education**  
**Building Condition Assessment Survey 2023 - 2024**

Architectural Inspection

**Asset: I.S. 246 - BROOKLYN, 72 VERONICA PLACE, New York, 11226**

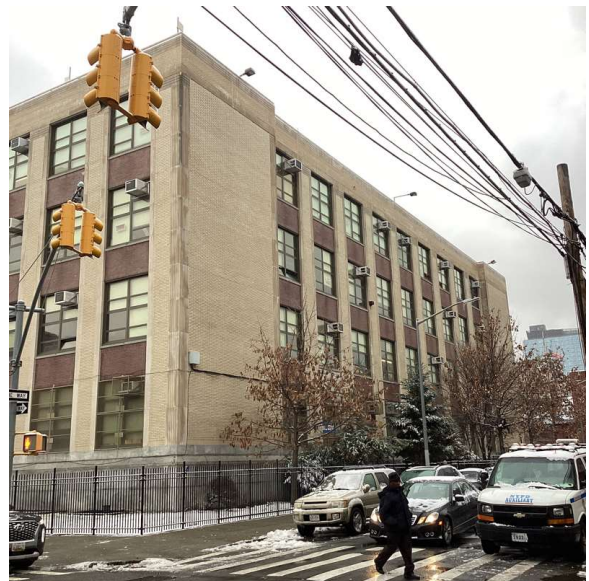
Corner of Veronica Place and Albemarle Road - West View

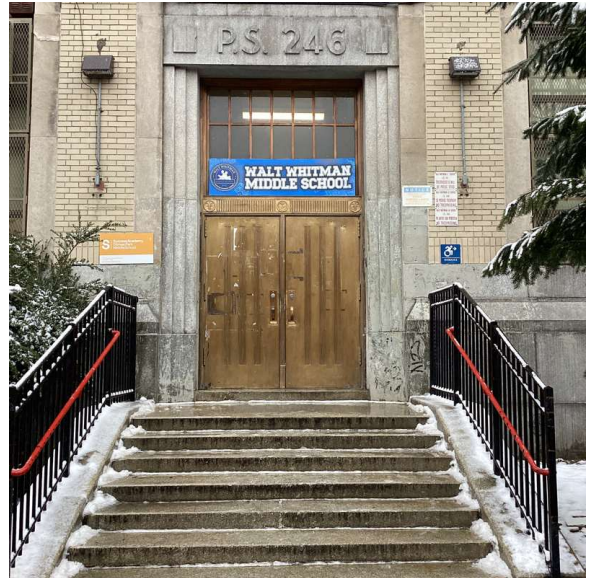
Facade A - Veronica Place

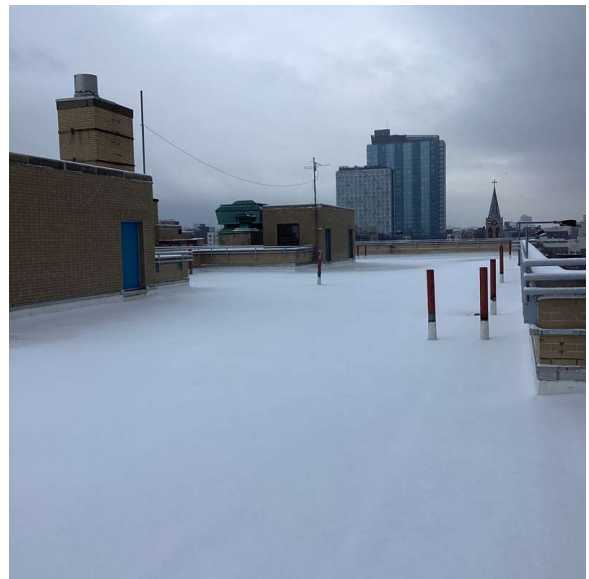
Roof 1 - Northwest View

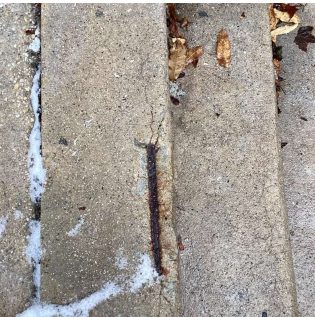
| Question | Response |
|---|--|
| Violations | AW4<br>No violations recorded. |

| Question | Response |
|---|--|
| Deficiency | AREAWAY STAIRS: DETERIORATED TREADS/RISERS/NOSINGS |

| Question | Response |
|---|--|
| Potential Action | REPLACE |

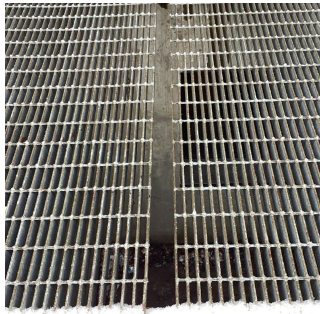
| Question | Response |
|---|--|
| Violations | AW7<br>No violations recorded. |

| Question | Response |
|---|--|
| Deficiency | <b>AREAWAY GRATINGS: MAJOR RUSTING / OR BROKEN</b> |

| Question | Response |
|---|--|
| Potential Action | REPLACE |

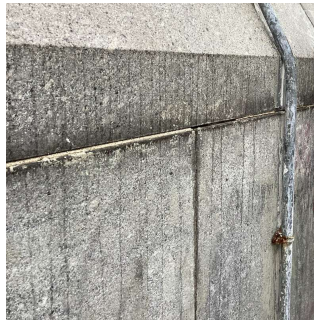
Facade A

**STONE: DETERIORATED JOINTS**

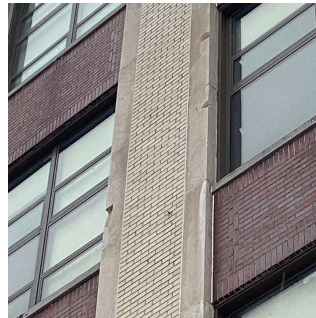
Facade B

STONE: CHIPPED/SPALLED/BROKEN PIECES - MAJOR

REPLACE

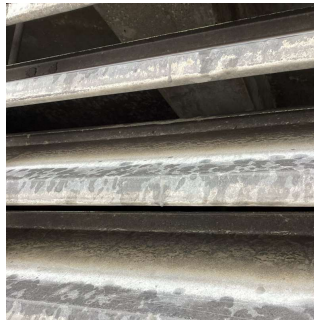
RV

MISSING/DAMAGED SCREEN

REPLACE

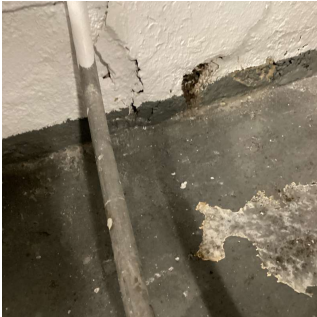
| Question | Response |
|---|--|
| Violations | Basement - Boiler Room<br>No violations recorded. |

| Question | Response |
|---|--|
| Deficiency | CONCRETE: CRACKED/SPALLED/REINFORCEMENT EXPOSED |

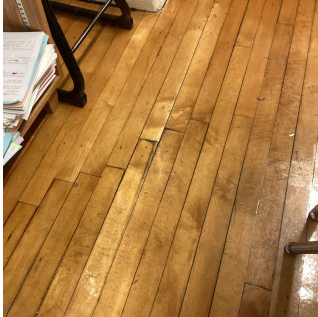
| Question | Response |
|--|--|
| Violations | Room 202 |

| Priority Condition Exist Last Year? | Priority Category | Condition Description | Component Affected | Location Description | Person(s) Notified | Person(s) Title | PhotoImage |
|---|---|---|---|---|---|---|--|
| Yes | Tripping Hazard | Severely heaving floor is a potential tripping hazard. | INTERIOR CLASSROOMS /CORRIDORS/ ADMIN SPACES Floor Finish | Room 202 | Jose Criollo | Cleaner | |

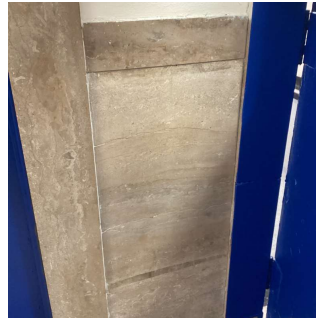
Corridor near Auditorium

STONE MOLDINGS: CRACKS/SPALLING

REPLACE

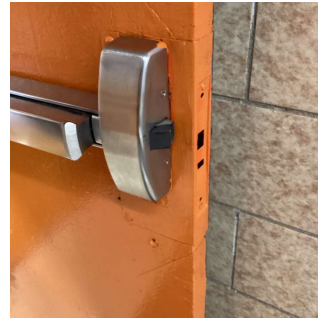
Main Entrance

WOOD: DETERIORATED DOOR

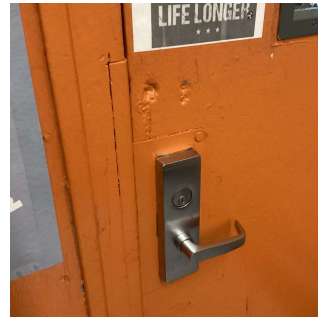
Main Entrance

DAMAGED/MISSING

REPLACE

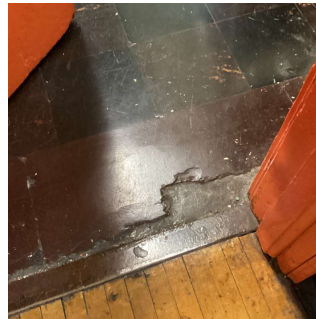
Office Room

| Deficiency | VINYL TILES: BROKEN/DETERIORATED/MISSING TILES |
| Deficiency Location/Instance | Office Room, Weight Room |

| Potential Action | REPLACE |

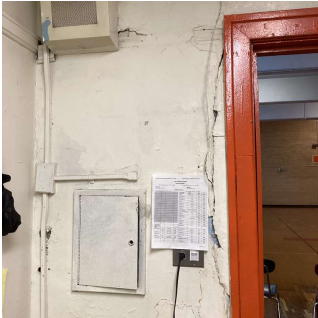
| Question | Response |
|---|--|
| Violations | Office Room<br>No violations recorded. |

| Question | Response |
|---|--|
| Deficiency | PLASTER: CRACKS/SPALLING |
| Deficiency Location/Instance | Office Room, Weight Room |

| Question | Response |
|---|--|
| Potential Action | REPLACE |

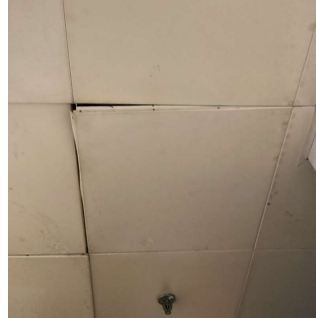
Near Windows

| Question | Response |
|---|--|
| Deficiency | METAL PAN: DAMAGED/MISSING |
| Deficiency Location/Instance | Near Windows, Room B15 |

| Potential Action | REPLACE |

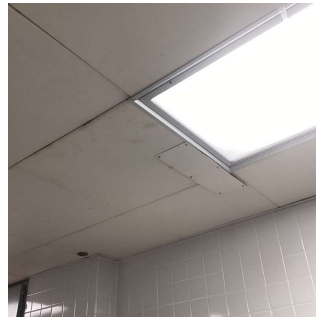
Near Sink

| Deficiency | METAL PAN: DAMAGED/MISSING |
| Deficiency Location/Instance | Near Sink, By Elevator B/Basement, Preparation Area |

| Potential Action | REPLACE |

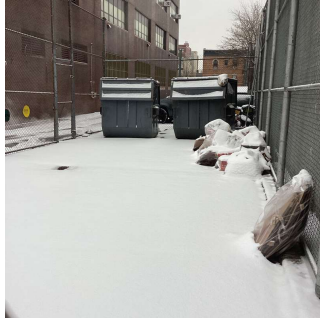
| Question | Response |
|--|--|
| Violations | Snyder Avenue<br>No violations recorded. |

| Question | Response |
|--|--|
| Deficiency | CHAIN LINK: DAMAGED POST/RAIL |

| Question | Response |
|--|--|
| Potential Action | REPLACE |

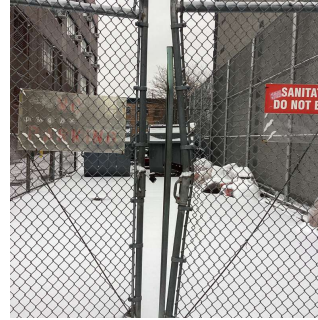
Snyder Avenue

CHAIN LINK: RUST - MAJOR

REPLACE

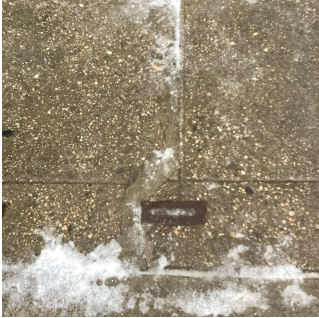
| Question | Response |
|---|--|
| | Veronica Place |

| Question | Response |
|---|--|
| Deficiency | DAMAGED/DETERIORATED/MISSING SECTIONS |

| Question | Response |
|---|--|
| Potential Action | REPLACE |

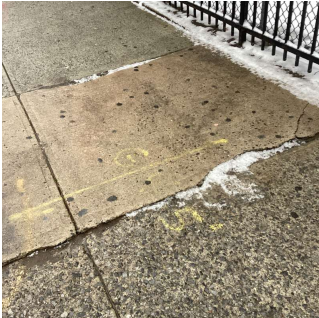
| Question | Response |
|---|--|
| | Veronica Place |

| Question | Response |
|---|--|
| Condition | 4 - Between Fair and Poor |
| Deficiency | DAMAGED/DETERIORATED/MISSING SECTIONS |

| Question | Response |
|---|--|
| Potential Action | REPLACE |

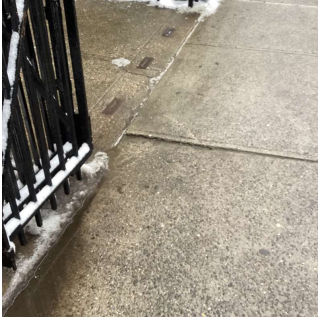
| Question | Response |
|---|--|
| Deficiency | HEAVING |

| Question | Response |
|---|--|
| Potential Action | REPLACE |

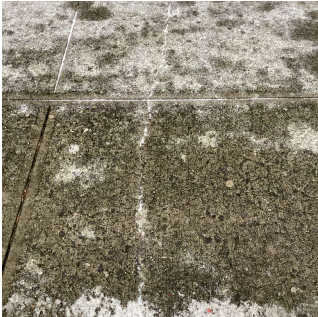
| Question | Response |
|---|--|
| Deficiency | DAMAGED/DETERIORATED/MISSING SECTIONS |

| Question | Response |
|---|--|
| Potential Action | REPLACE |

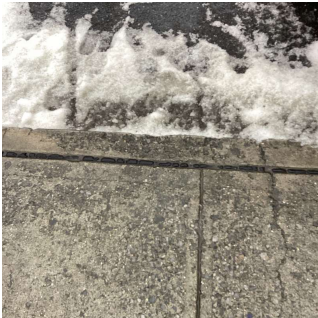
| Question | Response |
|---|--|
| | Albemarle Road |

| Question | Response |
|---|--|
| Deficiency | DAMAGED CURBS |

| Question | Response |
|---|--|
| Potential Action | REPLACE |
