NYC Department of Education
Building Condition Assessment Survey 2023 - 2024

Architectural Inspection

Asset: P.S. 247 - BROOKLYN, 7000 21 AVENUE, New York, 11204

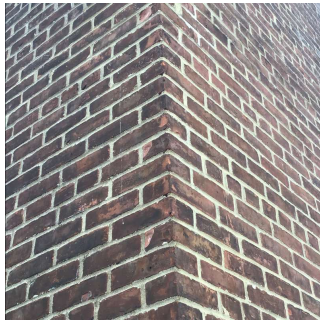
Violations	AW4 No violations recorded.
AWNINGS AND CANOPIES	
	Does not Exist
CHIMNEY	
Material Type(s)	Inspected Masonry
Condition	2 - Between Good and Fair
Deficiency	BRICK: DETERIORATED JOINTS
Roof Plan reference	K247
Deficiency Quantity	20
Quantity Uom	S.F.
Potential Action	REPOINT
Urgency of Action	PRIORITY 3
Purpose of Action	LEVEL 2
Deficiency Photo1

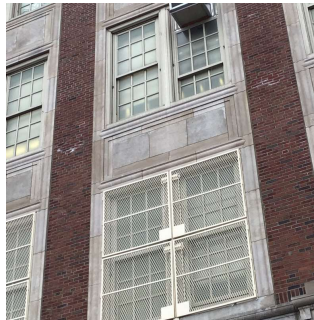
Facade A

STONE: EFFLORESCENCE

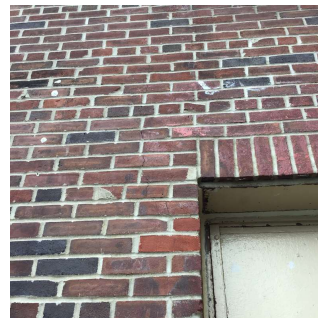
Facade E

BRICK: MINOR CRACKS AND SPALLING

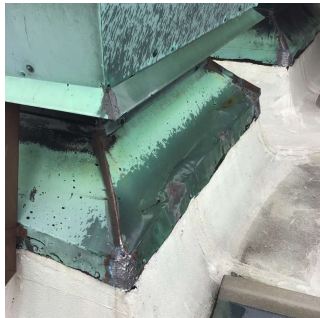
Violations	Roof 1 No violations recorded.
SKYLIGHT/ROOF VENT	Inspected
Material Type(s)	Other
Condition	2 - Between Good and Fair
Deficiency	DAMAGED FLASHING
Roof Plan reference	K247
Deficiency Quantity	10
Quantity Uom	L.F.
Potential Action	MAINTENANCE
Urgency of Action	PRIORITY 3
Purpose of Action	LEVEL 2
Deficiency Photo1

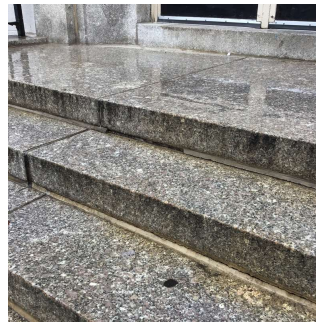
Facade A

STONE: DETERIORATED JOINTS

15
L.F.
REPOINT
PRIORITY 3
LEVEL 2

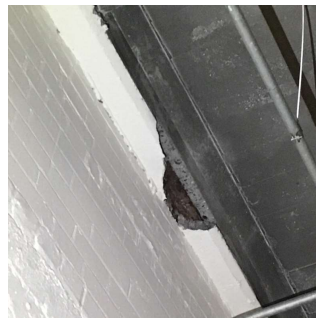
Boiler Room

STEEL COLUMNS/BEAMS: DETERIORATED
Basement
20
S.F.
REPAIR
PRIORITY 3
LEVEL 5

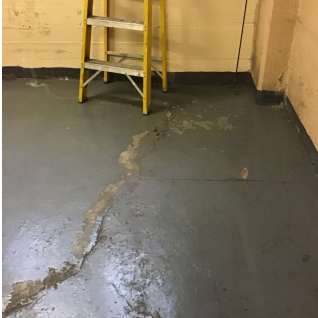
Boiler Room
Violations	No violations recorded.
Deficiency	CONCRETE: CRACKS/SPALLED/REINFORCEMENT EXPOSED
Deficiency Location/Instance	Basement Fan Room
Deficiency Quantity	50
Quantity Uom	S.F.
Potential Action	REPAIR
Urgency of Action	PRIORITY 3
Purpose of Action	LEVEL 5
Deficiency Photo1

Violations	Boiler Room No violations recorded.
FLOOR STRUCTURE	
Condition	Inspected 3 - Fair
Deficiency	CONCRETE SLAB ON GRADE: THRU CRACKS
Deficiency Location/Instance	Basement
Deficiency Quantity	40
Quantity Uom	S.F.
Potential Action	REPAIR
Urgency of Action	PRIORITY 3

Question	Response
INTERIOR	
STRUCTURAL	
FLOOR STRUCTURE	
Purpose of Action	LEVEL 5
Deficiency Photo1

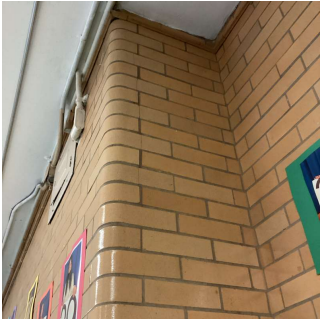
Question	Response
INTERIOR	
CAFETERIA	
Floor Finish	
Violations	No violations recorded.
Sliding-folding Partition	
Instance on 1st Floor	Does not Exist
Stage	
Instance on 1st Floor	Does not Exist
Walls	
Instance on 1st Floor	Inspected
Condition	2 - Between Good and Fair
Deficiency	SALT GLAZED BRICK: CRACKS/SPALLING
Deficiency Location/Instance	Near Drinking Fountain
Deficiency Quantity	10
Quantity Uom	S.F.
Potential Action	REPLACE
Urgency of Action	PRIORITY 3
Purpose of Action	LEVEL 2
Deficiency Photo1

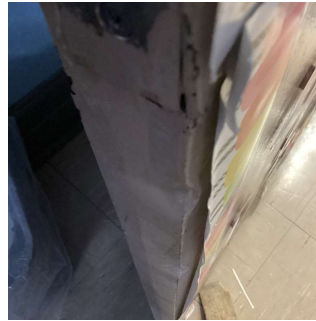
Violations	Near Drinking Fountain No violations recorded.
Window Curtains/Shades/Blinds	
Instance on 1st Floor	Does not Exist
CLASSROOMS/CORRIDORS/ADMIN SPACES	Inspected
Ceiling	Inspected
Condition	2 - Between Good and Fair
Deficiency	No deficiencies recorded
Door(s)	Inspected
Condition	5 - Poor
Deficiency	METAL: DETERIORATED DOOR
Deficiency Location/Instance	Room 420
Deficiency Quantity	1
Quantity Uom	EACH
Potential Action	MAINTENANCE

Urgency of Action	PRIORITY 3
Purpose of Action	LEVEL 2

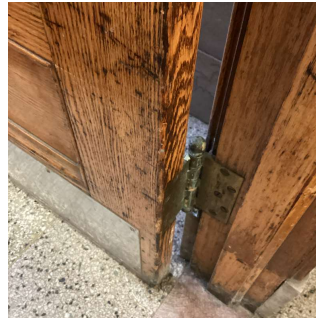
Main Entrance

WOOD: DETERIORATED DOOR

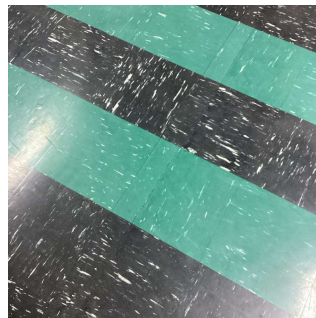
VINYL TILES: DETERIORATED SUBSTRATE

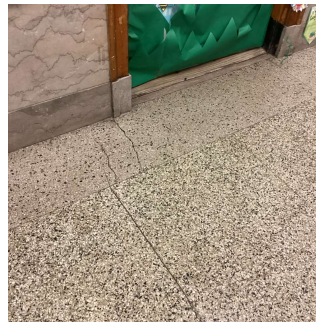
Corridor near Room 103

Question	Response
INTERIOR	
CLASSROOMS/CORRIDORS/ADMIN SPACES	
Floor Finish	
Violations	Corridor near Room 415 No violations recorded.
Deficiency	VINYL TILES: BROKEN/DETERIORATED/MISSING TILES
Deficiency Location/Instance	Rooms 460, 317, 315, 313, Corridor near Room 456 and others
Deficiency Quantity	1,060
Quantity Uom	S.F.
Potential Action	REPLACE
Urgency of Action	PRIORITY 3
Purpose of Action	LEVEL 2
Deficiency Photo1	 
Violations	Room 317 No violations recorded.
Deficiency	WOOD: DAMAGED/DETERIORATED
Deficiency Location/Instance	Rooms 311, 220, 219
Deficiency Quantity	30
Quantity Uom	S.F.
Potential Action	REPLACE
Urgency of Action	PRIORITY 3
Purpose of Action	LEVEL 2
Deficiency Photo1	 
Violations	Room 311 No violations recorded.
Deficiency	TERRAZZO: CRACKS
Deficiency Location/Instance	Main Entrance, Corridor near Rooms 103, 152, 153, by Cafeteria and others
Deficiency Quantity	60
Quantity Uom	S.F.
Potential Action	REPLACE

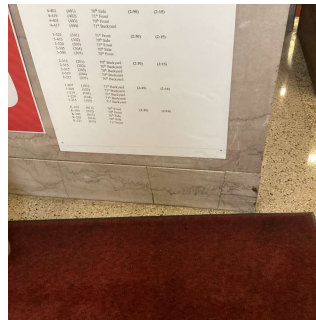
Main Entrance

STONE MOLDINGS: CRACKS/SPALLING

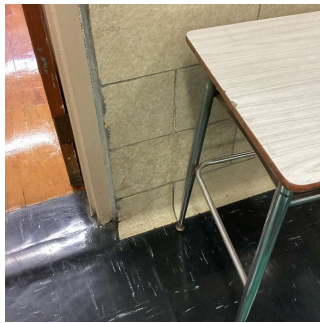
GLAZED BLOCK: CRACKS/SPALLING

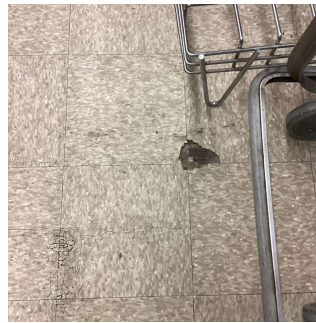
Violations	Corridor near Room 303A No violations recorded.
Specialties	Does not Exist
GYMNASIUM	Does not Exist
INTERIOR DOOR HARDWARE	Inspected
Condition	3 - Fair
Deficiency	No deficiencies recorded
INTERIOR GUARDS	Inspected
Condition	2 - Between Good and Fair
Deficiency	No deficiencies recorded
KITCHEN	Inspected
Instance on 1st Floor	Inspected
Ceiling	
Instance on 1st Floor	Inspected
Condition	2 - Between Good and Fair
Deficiency	No deficiencies recorded
Door(s)	
Instance on 1st Floor	Inspected
Condition	2 - Between Good and Fair
Deficiency	No deficiencies recorded
Floor Finish	
Instance on 1st Floor	Inspected
Condition	4 - Between Fair and Poor
Deficiency	VINYL TILES: DETERIORATED SUBSTRATE
Deficiency Location/Instance	Office Room
Deficiency Quantity	50
Quantity Uom	S.F.
Potential Action	REPLACE
Urgency of Action	PRIORITY 3

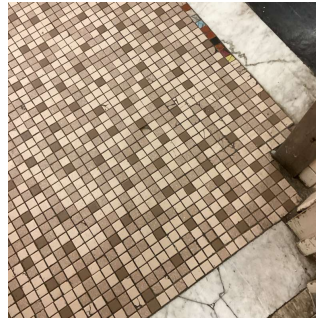
Near Main Entrance

CERAMIC TILE: BROKEN/MISSING TILES

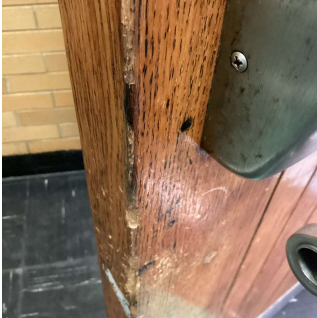
Question	Response
INTERIOR	
LIBRARY	
Door(s)	
Deficiency Photo1	 
	Main Entrance
Violations	No violations recorded.
Floor Finish	
Instance on Room 409	Inspected
Condition	2 - Between Good and Fair
Deficiency	WOOD: DAMAGED/DETERIORATED
Deficiency Location/Instance	Near Windows, by Main Entrance
Deficiency Quantity	20
Quantity Uom	S.F.
Potential Action	REPLACE
Urgency of Action	PRIORITY 3
Purpose of Action	LEVEL 2
Deficiency Photo1	 
	Near Windows
Violations	No violations recorded.
Walls	
Instance on Room 409	Inspected
Condition	2 - Between Good and Fair
Deficiency	No deficiencies recorded
LOCKER ROOM	
	Does not Exist
MULTI-PURPOSE ROOM	
Instance on 1st Floor	Inspected
Ceiling	
Instance on 1st Floor	Inspected
Condition	2 - Between Good and Fair
Deficiency	No deficiencies recorded
Door(s)	
Instance on 1st Floor	Inspected
Condition	4 - Between Fair and Poor
Deficiency	WOOD: DETERIORATED DOOR

Question	Response
INTERIOR	
MULTI-PURPOSE ROOM	
Door(s)	
Deficiency Location/Instance	Main Entrance
Deficiency Quantity	2
Quantity Uom	EACH
Potential Action	MAINTENANCE
Urgency of Action	PRIORITY 3
Purpose of Action	LEVEL 2
Deficiency Photo1

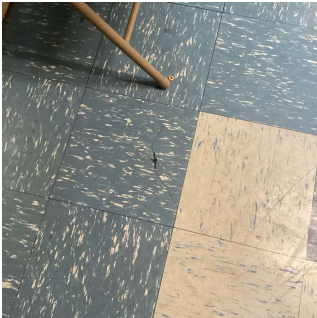
Violations	Right Side near Stage No violations recorded.
Sliding-folding Partition	
Instance on 1st Floor	Does not Exist
Stage	
Instance on 1st Floor	Inspected
Stage	
Instance on 1st Floor	Inspected
Condition	2 - Between Good and Fair

Violations	Main Entrance No violations recorded.
Fixed Equipment	
Instance on 1st Floor	Does not Exist
Floor Finish	
Instance on 1st Floor	Inspected
Condition	2 - Between Good and Fair
Deficiency	VINYL TILES: BROKEN/DETERIORATED/MISSING TILES
Deficiency Location/Instance	Right Side near Stage
Deficiency Quantity	10
Quantity Uom	S.F.
Potential Action	REPLACE
Urgency of Action	PRIORITY 3
Purpose of Action	LEVEL 2
Deficiency Photo1

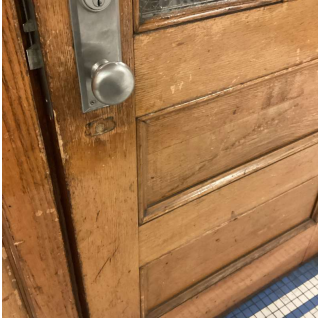
Question	Response
INTERIOR	
STAIRS/RAMPS: INTERIOR	
Door(s)	
Deficiency Location/Instance	Stairs CD/1, EF/1
Deficiency Quantity	4
Quantity Uom	EACH
Potential Action	MAINTENANCE
Urgency of Action	PRIORITY 3
Purpose of Action	LEVEL 2
Deficiency Photo1

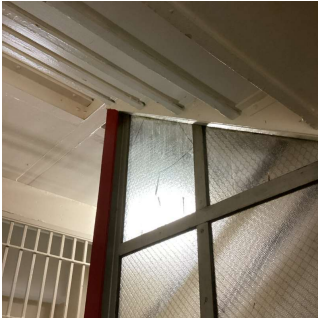
Violations	Stair EF/1 No violations recorded.
Partition	Inspected
Condition	2 - Between Good and Fair
Deficiency	GLASS PANEL: DAMAGED/DETERIORATED
Deficiency Location/Instance	Stairs EF/1, 2, 3
Deficiency Quantity	40
Quantity Uom	S.F.
Potential Action	REPLACE
Urgency of Action	PRIORITY 3
Purpose of Action	LEVEL 2
Deficiency Photo1

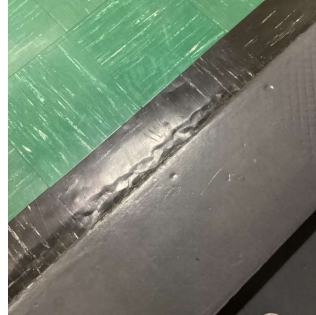
Stair EF/4

Violations	Stair EF/1 No violations recorded.
Railings	Inspected
Condition	2 - Between Good and Fair
Deficiency	No deficiencies recorded
Stairs and Landings	Inspected
Condition	3 - Fair
Deficiency	VINYL TILES: DETERIORATED SUBSTRATE
Deficiency Location/Instance	Stairs CD/1, EF/4
Deficiency Quantity	30
Quantity Uom	S.F.
Potential Action	REPLACE

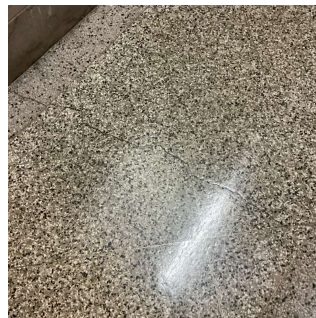
TERRAZZO: CRACKS
Stair EF/1
10
S.F.
REPLACE
PRIORITY 3
LEVEL 2

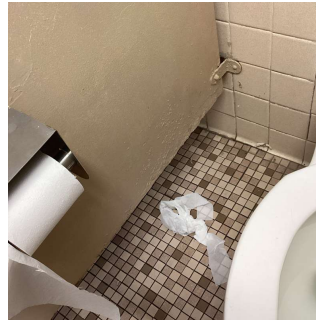
Room 257
Violations	No violations recorded.
Floor Finish	Inspected
Condition	2 - Between Good and Fair
Deficiency	No deficiencies recorded
Stalls	Inspected
Condition	2 - Between Good and Fair
Deficiency	No deficiencies recorded
Walls	Inspected
Condition	2 - Between Good and Fair
Deficiency	No deficiencies recorded
TOILET ROOMS - STUDENTS	Inspected
Ceiling	Inspected
Condition	2 - Between Good and Fair
Deficiency	No deficiencies recorded
Door(s)	Inspected
Condition	5 - Poor
Deficiency	WOOD: DETERIORATED DOOR
Deficiency Location/Instance	Rooms 459, 358, 260, Girls Toilet Room - 2nd Floor, In Room 103
Deficiency Quantity	5
Quantity Uom	EACH
Potential Action	MAINTENANCE

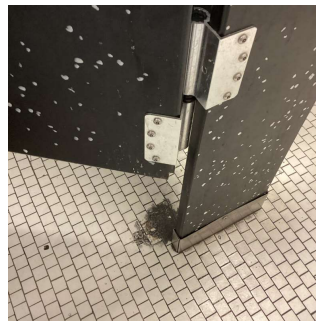
Room 358

BROKEN/MISSING

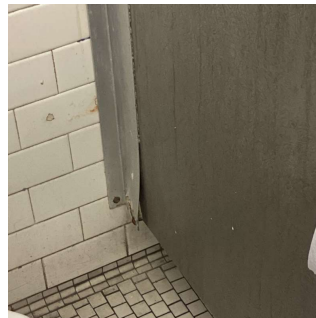
Room 459

BROKEN/MISSING

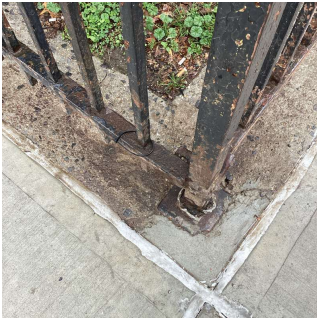
Violations	21st Avenue No violations recorded.
Deficiency	CHAIN LINK: DAMAGED POST/RAIL

Violations	Room 255 No violations recorded.
STEEL STAIRS	Does not Exist
SITE	Inspected
CONTAINERIZATION	Does not Exist
Drainage System for Asphalt	Inspected
Catch Basins/Manhole - Surrounded by asphalt	Inspected
Condition	2 - Between Good and Fair
Deficiency	No deficiencies recorded
Culverts - Asphalt Covering	Does not Exist
Drainage System for Concrete	Inspected
Catch Basins/Manhole - Surrounded by concrete	Inspected
Condition	2 - Between Good and Fair
Deficiency	No deficiencies recorded
Culverts - Concrete Covering	Does not Exist
Drainage System for Soil	Does not Exist
DRINKING FOUNTAINS	Does not Exist
FENCES	Inspected
Condition	3 - Fair
Deficiency	WROUGHT IRON: RUST - MAJOR
Deficiency Location/Instance	21st Avenue
Deficiency Quantity	40
Quantity Uom	S.F.
Potential Action	REPLACE
Urgency of Action	PRIORITY 3
Purpose of Action	LEVEL 2
Deficiency Photo1

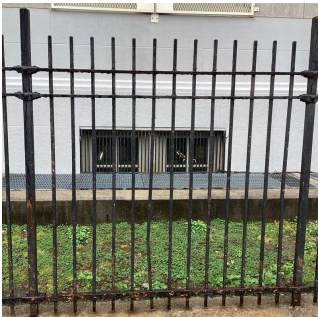
Violations	21st Avenue No violations recorded.
Deficiency	CONCRETE CURB: DAMAGED/DETERIORATED
Deficiency Location/Instance	21st Avenue, 70th Street, 71st Street, Schoolyard
Deficiency Quantity	250
Quantity Uom	S.F.
Potential Action	REPLACE
Urgency of Action	PRIORITY 3
Purpose of Action	LEVEL 2

Violations	Schoolyard No violations recorded.
Deficiency	WROUGHT IRON: DAMAGED/DETERIORATED
Deficiency Location/Instance	70th Street, 21st Avenue, 71st Street
Deficiency Quantity	160
Quantity Uom	S.F.
Potential Action	REPLACE
Urgency of Action	PRIORITY 3
Purpose of Action	LEVEL 2
Deficiency Photo1

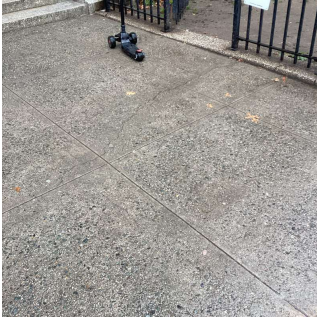
Question	Response
SITE	
PAVING	
Site Sidewalks & Walkways	
Asphalt	Inspected
Violations	No violations recorded.
Concrete	Inspected
Condition	3 - Fair
Deficiency	DAMAGED/DETERIORATED/MISSING SECTIONS
Deficiency Location/Instance	21st Avenue, 70th Street
Deficiency Quantity	150
Quantity Uom	S.F.
Potential Action	REPLACE
Urgency of Action	PRIORITY 3
Purpose of Action	LEVEL 2
Deficiency Photo1

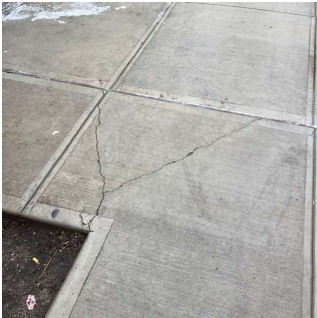
Violations	21st Avenue No violations recorded.
Pavers	Does not Exist
DOT Sidewalk	Inspected
Asphalt	Does not Exist
Concrete	Inspected
Condition	3 - Fair
Deficiency	DAMAGED/DETERIORATED/MISSING SECTIONS
Deficiency Location/Instance	70th Street, 71st Street
Deficiency Quantity	100
Quantity Uom	S.F.
Potential Action	REPLACE
Urgency of Action	PRIORITY 4
Purpose of Action	LEVEL 4
Deficiency Photo1

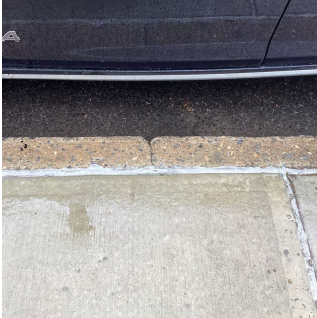
Violations	71st Street 52268
Deficiency	DAMAGED CURBS
Deficiency Location/Instance	70th Street

Question	Response
SITE	
PAVING	
DOT Sidewalk	
Concrete	
Deficiency Quantity	50
Quantity Uom	L.F.
Potential Action	REPLACE
Urgency of Action	PRIORITY 4
Purpose of Action	LEVEL 4
Deficiency Photo1
