NYC Department of Education
Building Condition Assessment Survey 2023 - 2024

Architectural Inspection

Asset: P.S. 250 - BROOKLYN, 108 MONTROSE AVENUE, New York, 11206

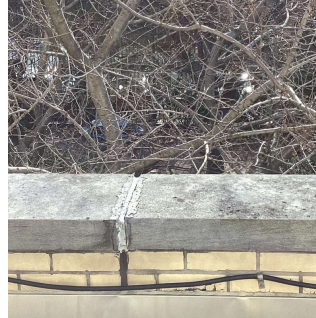
Roof 5

CAST STONE: DETERIORATED TRANSVERSE JOINTS

75
L.F.
MAINTENANCE
PRIORITY 3
LEVEL 2

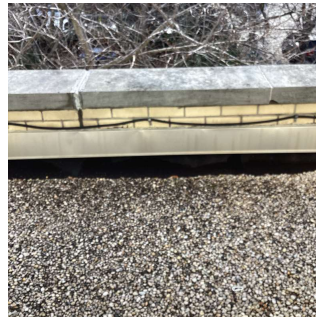
Facade F

CAST STONE: CRACKED/BROKEN PIECES

REPLACE-IN-KIND

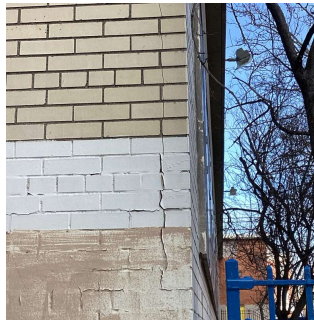
Facade C

Question	Response
EXTERIOR	
DOORS	
DOORS AND FRAMES	
Roof Plan reference	
Deficiency Quantity	1
Quantity Uom	EACH
Potential Action	MAINTENANCE
Urgency of Action	PRIORITY 3
Purpose of Action	LEVEL 2
Deficiency Photo1	
Violations	Cafeteria Exit No violations recorded.
DOOR HARDWARE	Inspected
Condition	2 - Between Good and Fair
Deficiency	No deficiencies recorded
LINTELS	Inspected
Condition	2 - Between Good and Fair
Deficiency	No deficiencies recorded
TRANSOM/SIDE LIGHT	Inspected
Condition	2 - Between Good and Fair
Deficiency	No deficiencies recorded
EXTERIOR WALLS	Inspected
Material Type(s)	Masonry, Other
Replacement Quantity	26,000
Replacement Uom	S.F.
Instance on All Facades	Inspected
Instance Condition	3 - Fair
Instance Quantity	26,000
Instance Quantity Uom	S.F.
Deficiency	BRICK: CRACKS/DISPLACED/SPALLED BRICK AT BUILDING CORNERS

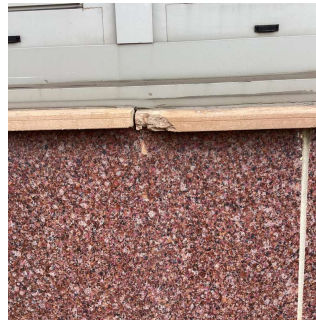
Facade F

BRICK: DETERIORATED MASONRY SILLS - MAJOR

REMOVE AND REPLACE

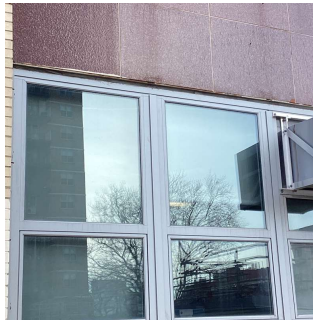
Facade F

CERAMIC TILE: DETERIORATED JOINTS

50
S.F.
REPOINT
PRIORITY 3
LEVEL 2

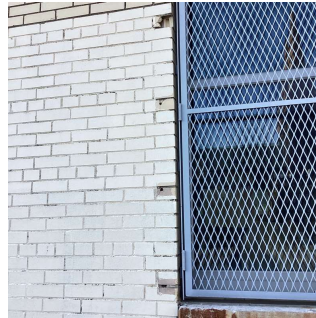
Facade B

BRICK: MAJOR / THRU CRACKS

10
S.F.
REMOVE AND REBUILD

PRIORITY 4
LEVEL 2

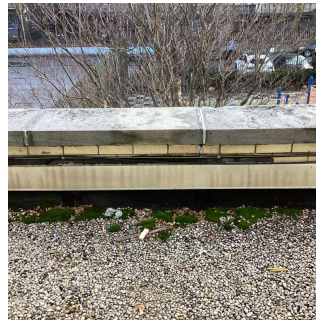
Roof 5
No violations recorded.

Question	Response
EXTERIOR	
LOUVER	
Deficiency Photo1	 
Violations	Facade B No violations recorded.
PARAPETS	Inspected
Material Type(s)	Masonry
Replacement Quantity	1,200
Replacement Uom	C.F.
Instance on Facades F, G	Inspected
Instance Condition	4 - Between Fair and Poor
Instance Quantity	1,200
Instance Quantity Uom	C.F.
Deficiency	BRICK: MAJOR DETERIORATION/CRACKS
Roof Plan reference	 
Deficiency Quantity	10
Quantity Uom	S.F.
Potential Action	REMOVE AND REBUILD
Urgency of Action	PRIORITY 4
Purpose of Action	LEVEL 2
Deficiency Photo1	 
Violations	Facade F No violations recorded.
Deficiency	BRICK: DETERIORATED JOINTS

10
S.F.
REPOINT
PRIORITY 4
LEVEL 2

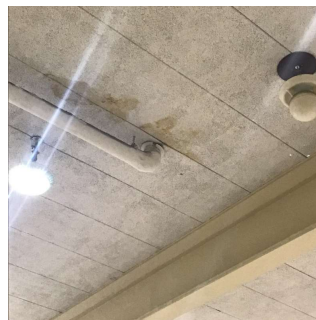
BUILT-UP: ROOFING: MAJOR ACTIVE ROOF LEAKS IN INSTRUCTIONAL SPACE

Roof 3 - Gymnasium, Roof 2 - Room 131 similar

REPLACE ROOFING WITHOUT MAJOR EQUIPMENT REMOVAL

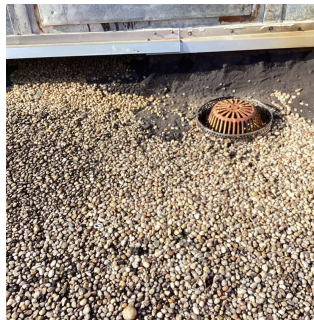
DETERIORATED

Roof Drain Flashing Leaks into Gymnasium

1
EACH
REPLACE
PRIORITY 4
LEVEL 2

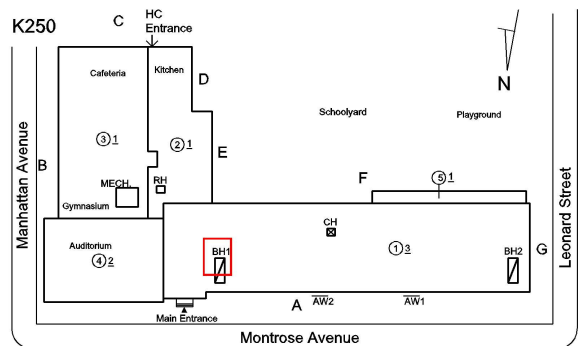
Roof Plan reference

**BULKHEAD/PENTHOUSE WALLS/EXTERIOR:
CRACKS/SPALLING - MINOR**

10
S.F.
REPAIR
PRIORITY 3
LEVEL 2

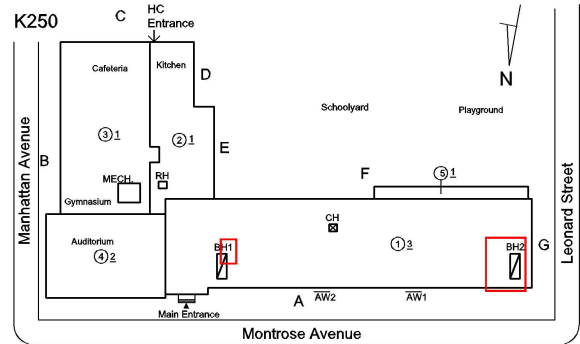
Roof Plan reference

**BULKHEAD/PENTHOUSE WALLS/INTERIOR: CMU
CRACKS/SPALLING**

REPLACE

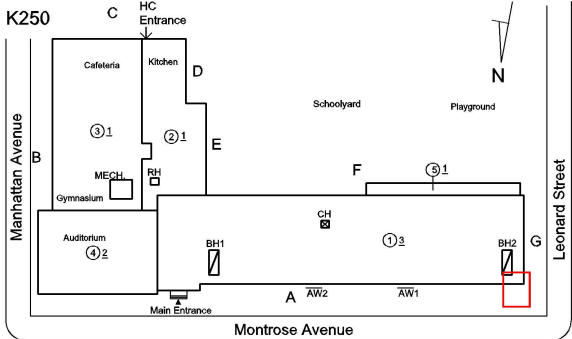
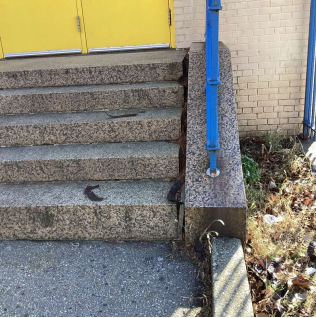
Question	Response
EXTERIOR	
STAIRS/RAMPS: EXTERIOR	Inspected
BUILDING CHEEK/FLANK WALLS	Inspected
Condition	5 - Poor
Deficiency	STONE: BULGING/DISPLACED
Roof Plan reference

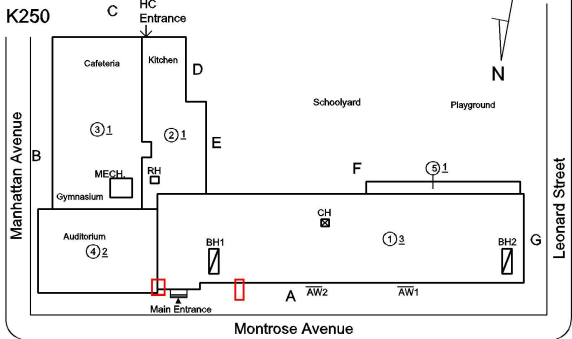
Violations	Facade A No violations recorded.
RAILINGS	Inspected
Condition	4 - Between Fair and Poor
Deficiency	DAMAGED
Roof Plan reference

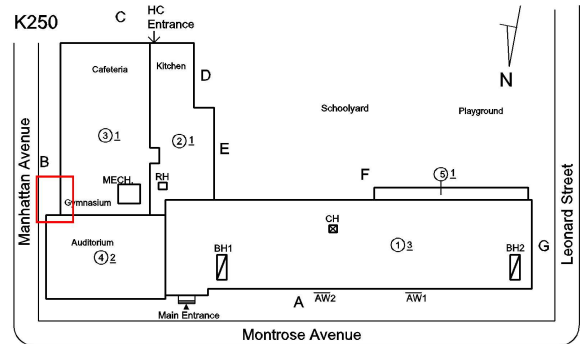
Roof Plan reference

MISSING RAILING

REPLACE

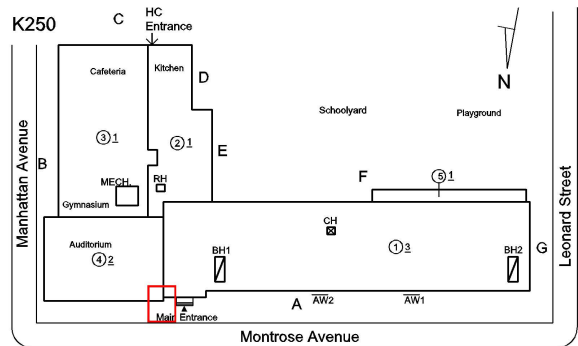
Roof Plan reference

STONE: CRACKS/SPALLING - MAJOR

10
 S.F.
 REPLACE
 PRIORITY 4
 LEVEL 2

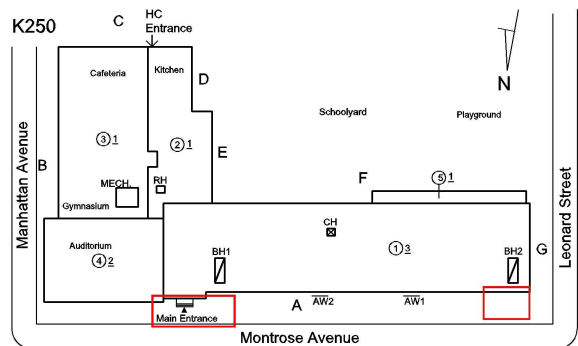
Roof Plan reference

STONE: DETERIORATED JOINTS

150
 L.F.
 REPOINT
 PRIORITY 3
 LEVEL 2

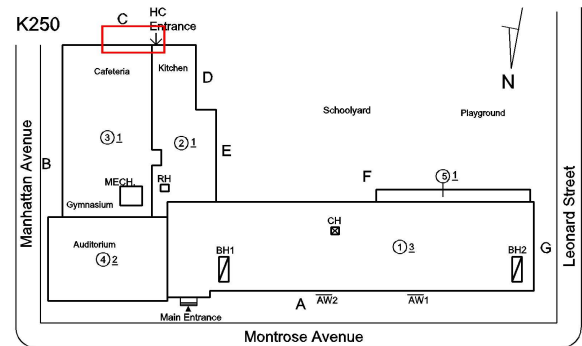
Roof Plan reference

CONCRETE: CRACKS/SPALLING - MAJOR

REPLACE

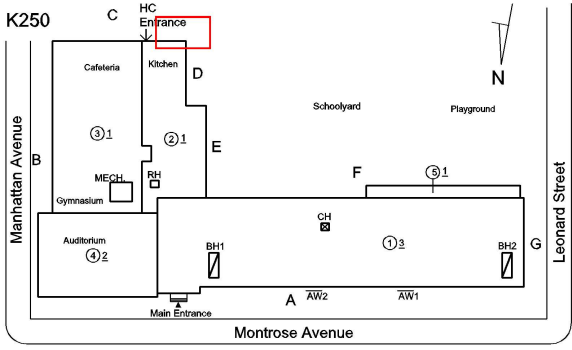
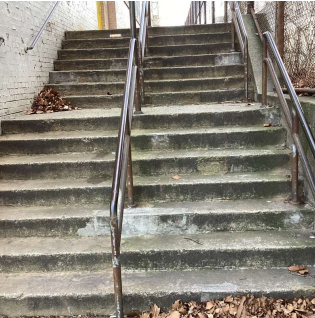
CONCRETE: CRACKS/SPALLING - MINOR

Deficiency Quantity	10
Quantity Uom	S.F.
Potential Action	REPAIR
Urgency of Action	PRIORITY 3
Purpose of Action	LEVEL 2
Deficiency Photo1

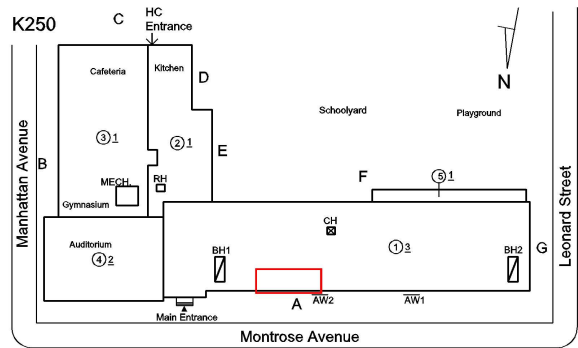
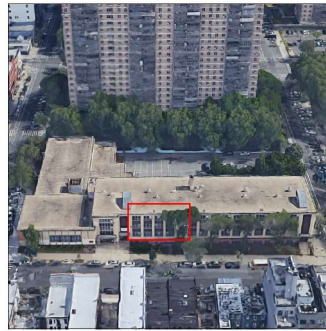
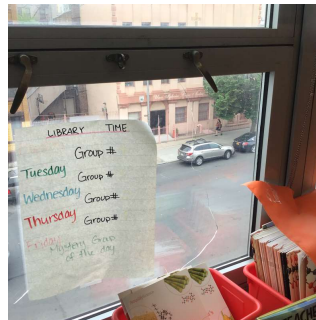
Room 324
No violations recorded.

Violations	Facade C No violations recorded.
WINDOWS	Inspected
Replacement Quantity	12,000
Replacement Uom	S.F.
EXTERIOR GUARDS	Inspected
Condition	2 - Between Good and Fair
Deficiency	No deficiencies recorded
LINTELS	Inspected
Condition	2 - Between Good and Fair
Deficiency	No deficiencies recorded
WINDOWS	Inspected
Material Type(s)	Aluminum
Instance on Aluminum - Other: All Facades	Inspected
Instance Condition	3 - Fair
Instance Quantity	11,500
Instance Quantity Uom	S.F.
Are these windows insulated	Yes
Installation Year	2014
Source of Installation	Custodial Staff
Deficiency	ALUMINUM - OTHER: BROKEN PANE

60
S.F.
MAINTENANCE
PRIORITY 3
LEVEL 2

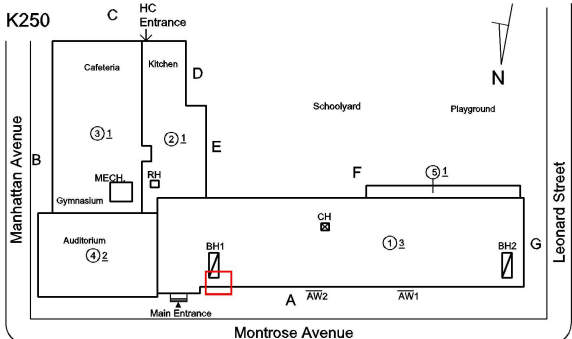
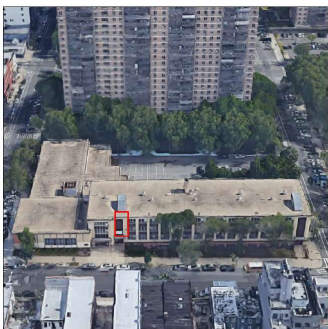
Instance on Aluminum - Other: Facade A	Inspected
Instance Condition	5 - Poor
Instance Quantity	500
Instance Quantity Uom	S.F.
Are these windows insulated	No
Installation Year	1964
Source of Installation	Custodial Staff
Deficiency	ALUMINUM - OTHER: DETERIORATED

Deficiency Quantity	180
Quantity Uom	S.F.
Potential Action	REPLACE WINDOW
Urgency of Action	PRIORITY 4
Purpose of Action	LEVEL 2
Deficiency Photo1

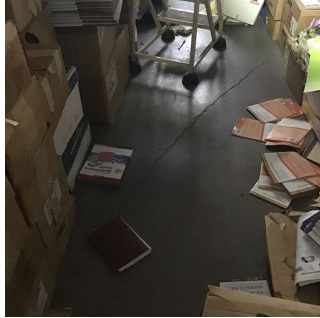
Violations	<p>Facade A - Stair E/F</p> <p>No violations recorded.</p>
INTERIOR	Inspected
POOLS	Does not Exist
STRUCTURAL	Inspected
COLUMNS/BEAMS/BEARING WALLS	Inspected
Condition	2 - Between Good and Fair
Deficiency	No deficiencies recorded
FLOOR STRUCTURE	Inspected
Condition	3 - Fair
Deficiency	CONCRETE SLAB ON GRADE: THRU CRACKS
Deficiency Location/Instance	Basement
Deficiency Quantity	40
Quantity Uom	S.F.

Question	Response
INTERIOR	
STRUCTURAL	
FLOOR STRUCTURE	
Potential Action	REPLACE
Urgency of Action	PRIORITY 4
Purpose of Action	LEVEL 5
Deficiency Photo1

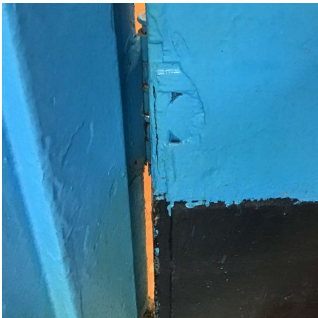
Question	Response
INTERIOR	
CAFETERIA	Inspected
Instance on 1st Floor	Inspected
Ceiling	
Instance on 1st Floor	Inspected
Condition	2 - Between Good and Fair
Deficiency	No deficiencies recorded
Door(s)	
Instance on 1st Floor	Inspected
Condition	5 - Poor
Deficiency	WOOD: DETERIORATED DOOR
Deficiency Location/Instance	Entrance
Deficiency Quantity	3
Quantity Uom	EACH
Potential Action	MAINTENANCE
Urgency of Action	PRIORITY 3
Purpose of Action	LEVEL 2
Deficiency Photo1

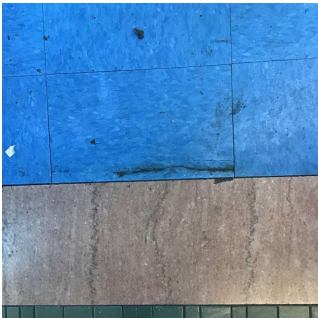
Violations	Entrance No violations recorded.
Fixed Equipment	
Instance on 1st Floor	Does not Exist
Floor Finish	
Instance on 1st Floor	Inspected
Condition	2 - Between Good and Fair
Deficiency	VINYL TILES: BROKEN/DETERIORATED/MISSING TILES
Deficiency Location/Instance	Near kitchen
Deficiency Quantity	10
Quantity Uom	S.F.
Potential Action	REPLACE
Urgency of Action	PRIORITY 3
Purpose of Action	LEVEL 2
Deficiency Photo1

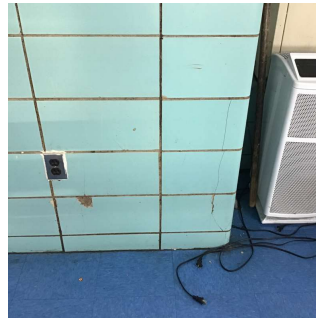
Near water fountain

Deficiency	GLAZED BLOCK: CRACKS/SPALLING
------------	-------------------------------

Potential Action	REPLACE
------------------	---------

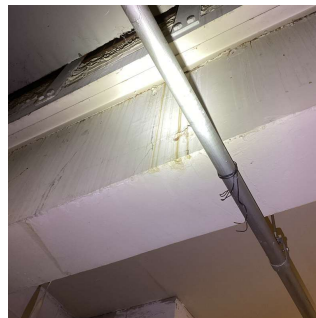
Deficiency	PLASTER: CRACKS/SPALLING - ACTIVE LEAK
------------	--

Potential Action	REPLACE
------------------	---------

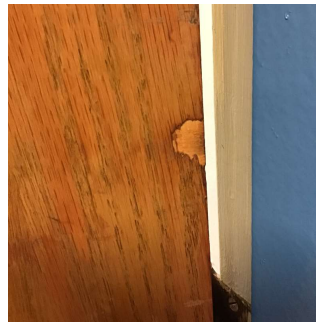
Room 323

Question	Response
INTERIOR	
CLASSROOMS/CORRIDORS/ADMIN SPACES	
Ceiling	
Violations	Room 131 No violations recorded.
Deficiency	ACOUSTIC TILES ON PLASTER: DAMAGED/MISSING
Deficiency Location/Instance	Corridor near Room 320,216,208,109
Deficiency Quantity	10
Quantity Uom	S.F.
Potential Action	REPLACE
Urgency of Action	PRIORITY 3
Purpose of Action	LEVEL 2
Deficiency Photo1	 
Violations	Corridor near Room 320 No violations recorded.
Deficiency	PLASTER: CRACKS/SPALLING
Deficiency Location/Instance	Exit 10, Room 304,216, Main Entrance Lobby
Deficiency Quantity	50
Quantity Uom	S.F.
Potential Action	REPLACE
Urgency of Action	PRIORITY 3
Purpose of Action	LEVEL 2
Deficiency Photo1	 
Violations	Exit 10 No violations recorded.
Door(s)	Inspected
Condition	5 - Poor
Deficiency	WOOD: DETERIORATED DOOR
Deficiency Location/Instance	Room 323,305,302,228,225,and others
Deficiency Quantity	12
Quantity Uom	EACH
Potential Action	MAINTENANCE

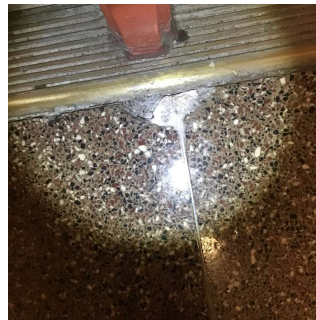
Exit 5

TERRAZZO: CRACKS

REPLACE

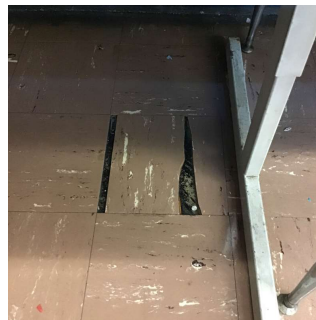
VINYL TILES: BROKEN/DETERIORATED/MISSING TILES

REPLACE

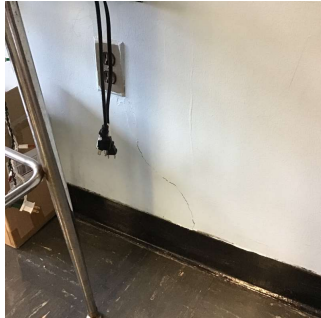
Question	Response
INTERIOR	
CLASSROOMS/CORRIDORS/ADMIN SPACES	
Floor Finish	Inspected
	Room 304
Violations	No violations recorded.
Walls	Inspected
Condition	2 - Between Good and Fair
Deficiency	PLASTER: CRACKS/SPALLING
Deficiency Location/Instance	Room 316, Corridor near Room 302,301,231,124, and others
Deficiency Quantity	40
Quantity Uom	S.F.
Potential Action	REPLACE
Urgency of Action	PRIORITY 3
Purpose of Action	LEVEL 2
Deficiency Photo1

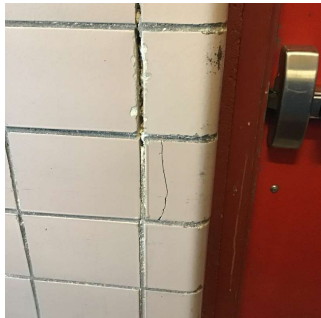
Violations	Room 316 No violations recorded.
Deficiency	GLAZED BLOCK: CRACKS/SPALLING
Deficiency Location/Instance	Exit 10, Corridor near Gymnasium, 101
Deficiency Quantity	10
Quantity Uom	S.F.
Potential Action	REPLACE
Urgency of Action	PRIORITY 3
Purpose of Action	LEVEL 2
Deficiency Photo1

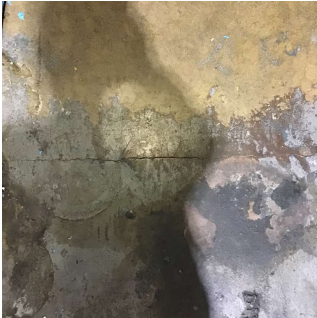
Question	Response
INTERIOR	
GYMNASIUM	
Floor Finish	
Deficiency	CONCRETE: CRACKS
Deficiency Location/Instance	Storage
Deficiency Quantity	10
Quantity Uom	S.F.
Potential Action	REPLACE
Urgency of Action	PRIORITY 3
Purpose of Action	LEVEL 2
Deficiency Photo1

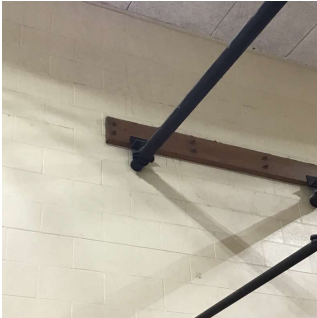
Violations	Storage No violations recorded.
Seating	
Instance on 1st Floor	Does not Exist
Sliding-folding Partition	
Instance on 1st Floor	Does not Exist
Stage	
Instance on 1st Floor	Does not Exist
Walls	
Instance on 1st Floor	Inspected
Condition	2 - Between Good and Fair
Deficiency	MASONRY: CRACKS/SPALLING
Deficiency Location/Instance	Near center, storage
Deficiency Quantity	50
Quantity Uom	S.F.
Potential Action	REPLACE
Urgency of Action	PRIORITY 3
Purpose of Action	LEVEL 2
Deficiency Photo1

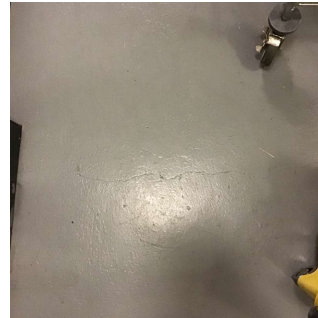
Question	Response
INTERIOR	
KITCHEN	
Door(s)	
Instance on 1st Floor	Inspected
Condition	3 - Fair
Deficiency	WOOD: DETERIORATED DOOR
Deficiency Location/Instance	Kitchen staff locker room
Deficiency Quantity	1
Quantity Uom	EACH
Potential Action	MAINTENANCE
Urgency of Action	PRIORITY 3
Purpose of Action	LEVEL 2
Deficiency Photo1	 
Violations	Kitchen staff locker room No violations recorded.
Floor Finish	
Instance on 1st Floor	Inspected
Condition	2 - Between Good and Fair
Deficiency	CERAMIC TILE: BROKEN/MISSING TILES
Deficiency Location/Instance	Near sink
Deficiency Quantity	10
Quantity Uom	S.F.
Potential Action	REPLACE
Urgency of Action	PRIORITY 3
Purpose of Action	LEVEL 2
Deficiency Photo1	 
Violations	Near sink No violations recorded.
Deficiency	CONCRETE: CRACKS
Deficiency Location/Instance	Storage
Deficiency Quantity	20
Quantity Uom	S.F.
Potential Action	REPLACE
Urgency of Action	PRIORITY 3

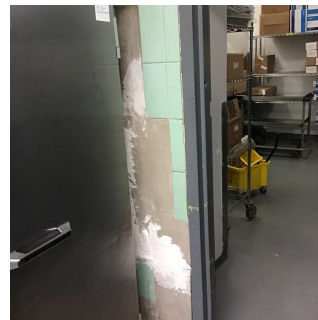
Near storage

Deficiency	CERAMIC TILE: BROKEN/ MISSING
Deficiency Location/Instance	Near Entrance, windows, storage
Deficiency Quantity	20
Quantity Uom	S.F.
Potential Action	REPLACE
Urgency of Action	PRIORITY 3
Purpose of Action	LEVEL 2
Deficiency Photo1

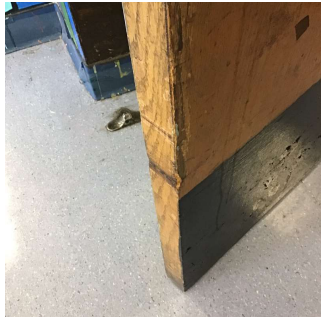
Question	Response
INTERIOR	
KITCHEN	
Walls	
Deficiency Photo1	 
Violations	Slop sink area No violations recorded.
LIBRARY	
Instance on Room 220/224	Inspected
Built-in Furnishing	Inspected
Instance on Room 220/224	Inspected
Condition	2 - Between Good and Fair
Deficiency	SINK/STORAGE CABINET - DAMAGED/DETERIORATED
Deficiency Location/Instance	Near bookshelves
Deficiency Quantity	10
Quantity Uom	L.F.
Potential Action	REPLACE
Urgency of Action	PRIORITY 3
Purpose of Action	LEVEL 2
Deficiency Photo1	 
Violations	Near bookshelves No violations recorded.
Ceiling	
Instance on Room 220/224	Inspected
Condition	2 - Between Good and Fair
Deficiency	No deficiencies recorded
Door(s)	
Instance on Room 220/224	Inspected
Condition	3 - Fair
Deficiency	WOOD: DETERIORATED DOOR
Deficiency Location/Instance	Entrance
Deficiency Quantity	1
Quantity Uom	EACH
Potential Action	MAINTENANCE
Urgency of Action	PRIORITY 3

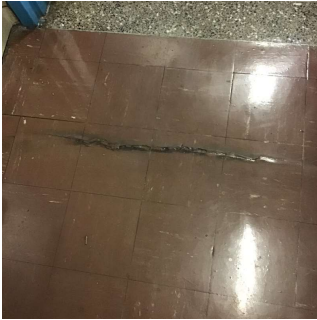
Question	Response
INTERIOR	
STAIRS/RAMPS: INTERIOR	
Ceiling	Inspected
Violations	No violations recorded.
Door(s)	Inspected
Condition	2 - Between Good and Fair
Deficiency	No deficiencies recorded
Partition	Does not Exist
Railings	Inspected
Condition	2 - Between Good and Fair
Deficiency	No deficiencies recorded
Stairs and Landings	Inspected
Condition	2 - Between Good and Fair
Deficiency	VINYL TILES: BROKEN/DETERIORATED/MISSING TILES
Deficiency Location/Instance	Stair CD/Basement, EF/1,3
Deficiency Quantity	20
Quantity Uom	S.F.
Potential Action	REPLACE
Urgency of Action	PRIORITY 3
Purpose of Action	LEVEL 2
Deficiency Photo1

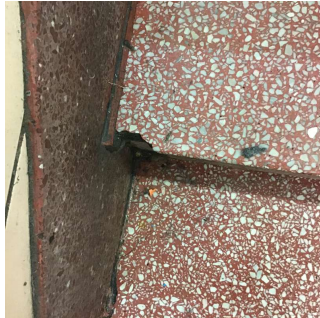
Question	Response
INTERIOR	
STAIRS/RAMPS: INTERIOR	
Stairs and Landings	
Deficiency	TERRAZZO: CRACKS
Deficiency Location/Instance	Main Entrance Lobby, Main Entrance Vestibule
Deficiency Quantity	120
Quantity Uom	S.F.
Potential Action	REPLACE
Urgency of Action	PRIORITY 3
Purpose of Action	LEVEL 2
Deficiency Photo1

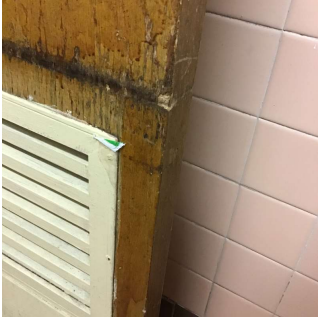
Violations	Stair AB/3 No violations recorded.
TOILET ROOMS - STAFF	
Inspected	
Ceiling	
Inspected	
Condition	2 - Between Good and Fair
Deficiency	No deficiencies recorded
Door(s)	
Inspected	
Condition	5 - Poor
Deficiency	WOOD: DETERIORATED DOOR
Deficiency Location/Instance	Kitchen staff locker room,321,221,127,B8

Question	Response
INTERIOR	
TOILET ROOMS - STAFF	
Door(s)	
Quantity Uom	EACH
Potential Action	MAINTENANCE
Urgency of Action	PRIORITY 3
Purpose of Action	LEVEL 2
Deficiency Photo1

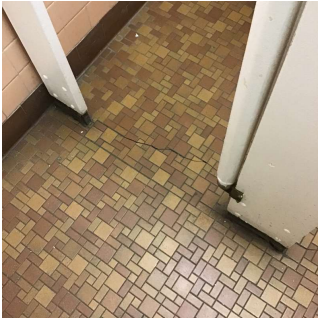
Violations	Kitchen staff locker room No violations recorded.
Floor Finish	Inspected
Condition	5 - Poor
Deficiency	CERAMIC TILE: BROKEN/MISSING TILES
Deficiency Location/Instance	Kitchen staff locker room,325,321,221,129, and others
Deficiency Quantity	50
Quantity Uom	S.F.
Potential Action	REPLACE
Urgency of Action	PRIORITY 3
Purpose of Action	LEVEL 2
Deficiency Photo1

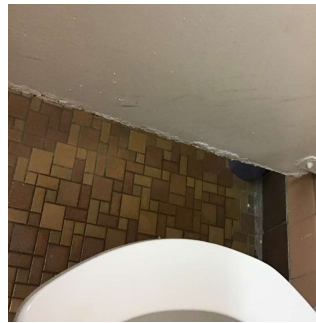
Violations	Kitchen staff locker room No violations recorded.
Stalls	Inspected
Condition	5 - Poor
Deficiency	RUST - MAJOR
Deficiency Location/Instance	Kitchen staff locker room,B8,127,129,
Deficiency Quantity	4
Quantity Uom	EACH
Potential Action	REPLACE
Urgency of Action	PRIORITY 3
Purpose of Action	LEVEL 2

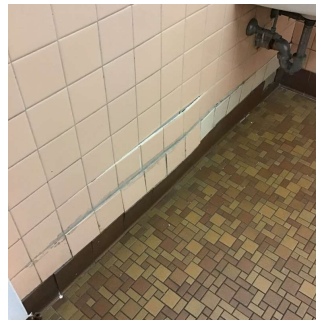
Room 129

CERAMIC TILE: BROKEN/ MISSING

REPLACE

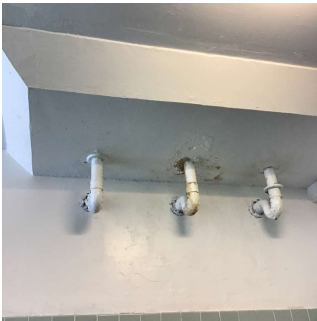
PLASTER: CRACKS/SPALLING - ACTIVE LEAK

REPLACE

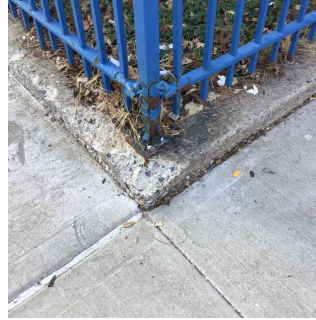
Violations	Along Montrose Avenue No violations recorded.
Deficiency	WROUGHT IRON: RUST - MAJOR
Deficiency Location/Instance	Along Montrose Avenue, Leonard Street, Manhattan Avenue
Deficiency Quantity	240
Quantity Uom	S.F.
Potential Action	REPLACE
Urgency of Action	PRIORITY 3
Purpose of Action	LEVEL 2

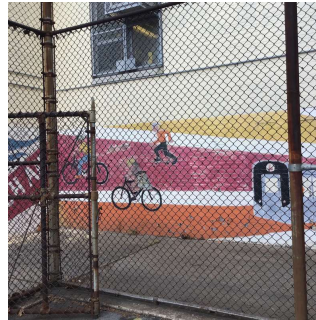
Schoolyard
No violations recorded.

Deficiency

CHAIN LINK: DAMAGED POST/RAIL

REPLACE

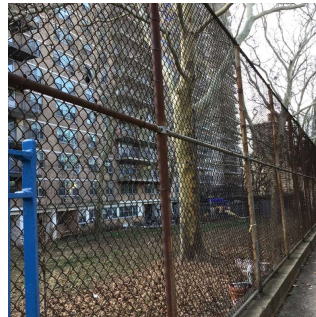
South-East Alleyway
No violations recorded.

Deficiency

CHAIN LINK: RUST - MAJOR

REPLACE

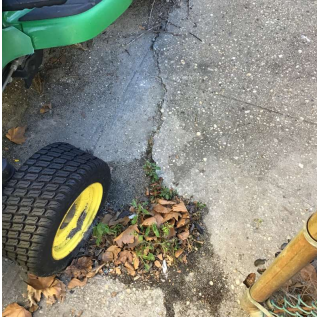
Question	Response
SITE	
IRRIGATION SYSTEM	Does not Exist
PAVING	Inspected
Student Non-Use	Inspected
Gravel Exists?	No
Asphalt	Does not Exist
Concrete	Inspected
Condition	3 - Fair
Deficiency	DAMAGED/DETERIORATED/MISSING SECTIONS
Deficiency Location/Instance	Near Schoolyard
Deficiency Quantity	225
Quantity Uom	S.F.
Potential Action	REPLACE
Urgency of Action	PRIORITY 3
Purpose of Action	LEVEL 2
Deficiency Photo1

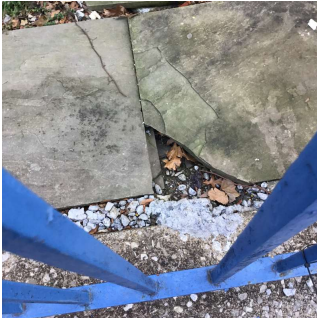
Violations	Near Schoolyard No violations recorded.
Pavers	Inspected
Condition	2 - Between Good and Fair
Deficiency	DAMAGED/MISSING
Deficiency Location/Instance	Along Montrose Avenue
Deficiency Quantity	10
Quantity Uom	S.F.
Potential Action	REPLACE
Urgency of Action	PRIORITY 3
Purpose of Action	LEVEL 2
Deficiency Photo1

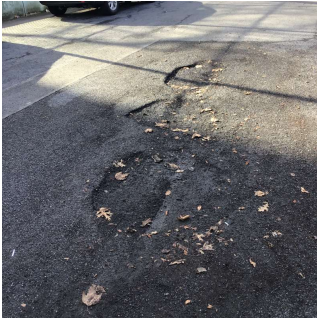
Question	Response
SITE	
PAVING	Inspected
Student Use	
Asphalt	
Deficiency	POTHOLES
Deficiency Location/Instance	Schoolyard
Deficiency Quantity	50
Quantity Uom	S.F.
Potential Action	REPAIR
Urgency of Action	PRIORITY 3
Purpose of Action	LEVEL 2
Deficiency Photo1

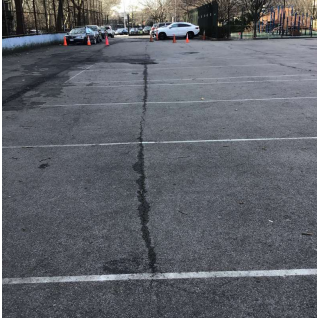
Violations	Schoolyard No violations recorded.
Deficiency	CRACKS - MAJOR
Deficiency Location/Instance	Schoolyard
Deficiency Quantity	2,000
Quantity Uom	S.F.
Potential Action	REPLACE
Urgency of Action	PRIORITY 3
Purpose of Action	LEVEL 2
Deficiency Photo1

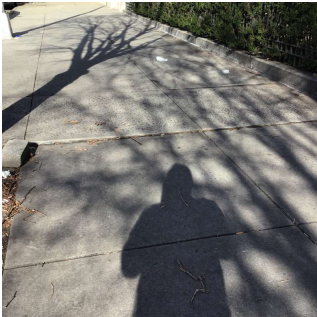
Question	Response
SITE	
PAVING	
DOT Sidewalk	
Concrete	
Deficiency Photo1

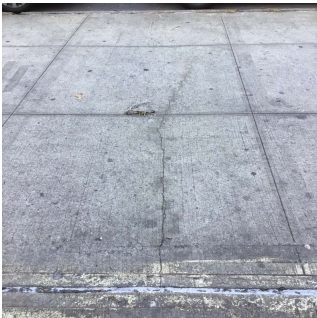
Violations	Along Leonard Street 48533, 52267
Deficiency	DAMAGED/DETERIORATED/MISSING SECTIONS
Deficiency Location/Instance	Along Montrose Avenue, Leonard Street, Manhattan Avenue
Deficiency Quantity	2,225
Quantity Uom	S.F.
Potential Action	REPLACE
Urgency of Action	PRIORITY 4
Purpose of Action	LEVEL 4
Deficiency Photo1

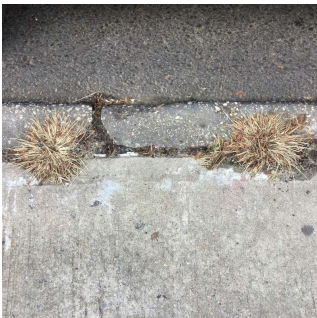
Violations	Along Montrose Avenue 48533, 52267
Deficiency	DAMAGED CURBS
Deficiency Location/Instance	Along Montrose Avenue, Leonard Street, Manhattan Avenue
Deficiency Quantity	345
Quantity Uom	L.F.
Potential Action	REPLACE
Urgency of Action	PRIORITY 4
Purpose of Action	LEVEL 4
Deficiency Photo1

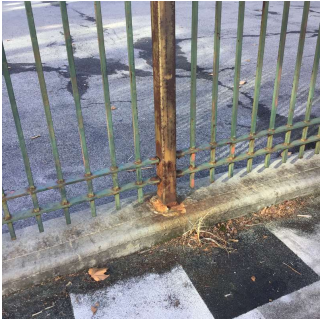
Question	Response
SITE	
PAVING	Inspected
DOT Sidewalk	Inspected
Pavers	Does not Exist
PLAYGROUNDS	Inspected
Instance on Schoolyard	Inspected
Benches	
Instance on Schoolyard	Inspected
Condition	2 - Between Good and Fair
Deficiency	No deficiencies recorded
Fence	
Instance on Schoolyard	Inspected
Condition	5 - Poor
Deficiency	WROUGHT IRON: RUST - MAJOR
Deficiency Location/Instance	Schoolyard
Deficiency Quantity	480
Quantity Uom	S.F.
Potential Action	REPLACE
Urgency of Action	PRIORITY 3
Purpose of Action	LEVEL 2
Deficiency Photo1

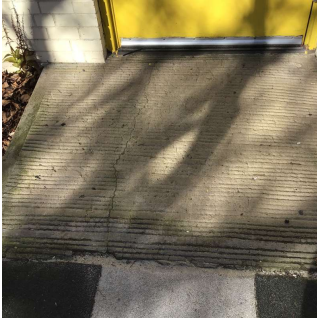
Question	Response
SITE	
PLAYGROUNDS	Inspected
Pavement	
Instance on Schoolyard	Inspected
Condition	2 - Between Good and Fair
Deficiency	CONCRETE: DAMAGED/DETERIORATED/MISSING SECTIONS
Deficiency Location/Instance	Schoolyard
Deficiency Quantity	25
Quantity Uom	S.F.
Potential Action	REPLACE
Urgency of Action	PRIORITY 3
Purpose of Action	LEVEL 2
Deficiency Photo1

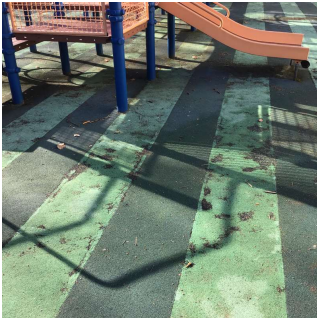
Violations	Schoolyard No violations recorded.
Play Equipment	
Instance on Schoolyard	Inspected
Condition	2 - Between Good and Fair
Deficiency	No deficiencies recorded
Safety Surfacing	
Instance on Schoolyard	Inspected
Condition	3 - Fair
Deficiency	DETERIORATED/MISSING
Deficiency Location/Instance	Schoolyard
Deficiency Quantity	100
Quantity Uom	S.F.
Potential Action	REPLACE
Urgency of Action	PRIORITY 3
Purpose of Action	LEVEL 2
Deficiency Photo1

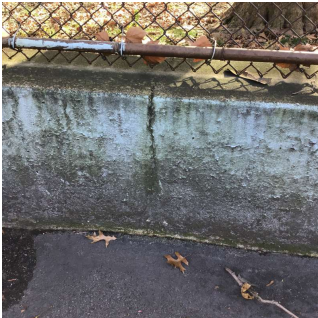
Question	Response
SITE	
PLAYGROUNDS	Inspected
Unpaved Area	
Condition	2 - Between Good and Fair
Deficiency	No deficiencies recorded
PLAYING SURFACE	Does not Exist
RETAINING WALLS	Inspected
Are there any Retaining Walls 6' OR higher facing public street/sidewalk?	No
Condition	3 - Fair
Deficiency	CAST IN PLACE CONCRETE: DETERIORATED CONTROL/EXPANSION JOINT
Deficiency Location/Instance	Schoolyard
Deficiency Quantity	30
Quantity Uom	L.F.
Potential Action	REPLACE
Urgency of Action	PRIORITY 3
Purpose of Action	LEVEL 2
Deficiency Photo1	 
Violations	Schoolyard No violations recorded.
Deficiency	CAST IN PLACE CONCRETE: CRACKS/SPALLING - MAJOR
Deficiency Location/Instance	Schoolyard
Deficiency Quantity	10
Quantity Uom	S.F.
Potential Action	REPLACE
Urgency of Action	PRIORITY 3
Purpose of Action	LEVEL 2
Deficiency Photo1
