NYC Department of Education
Building Condition Assessment Survey 2023 - 2024

Architectural Inspection

Asset: I.S. 252 - BROOKLYN, 1084 LENOX ROAD, New York, 11212

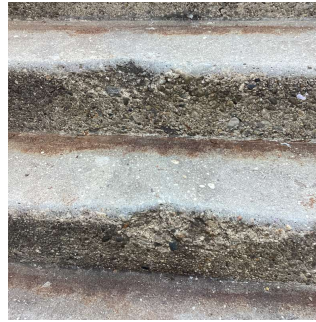
AW5

AREAWAY STAIRS: DETERIORATED TREADS/RISERS/NOSINGS

25
S.F.
REPLACE
PRIORITY 4
LEVEL 2

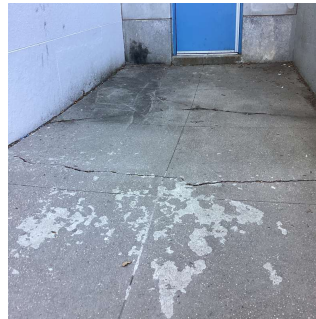
AW5

AREAWAY SLAB: DISPLACED

REPLACE

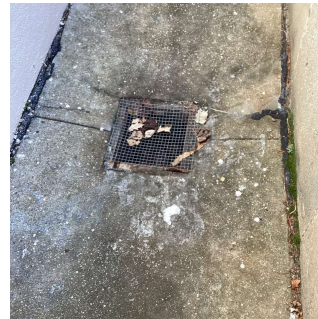
AW11

AREAWAY DRAINS: DETERIORATED

REPLACE

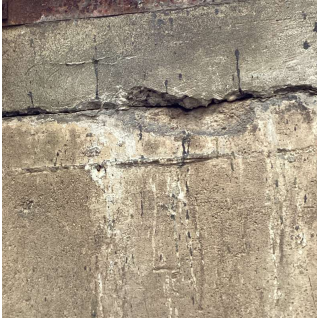
AREAWAY WALLS: CRACKS AND SPALLING

135
S.F.
REPLACE
PRIORITY 4
LEVEL 2

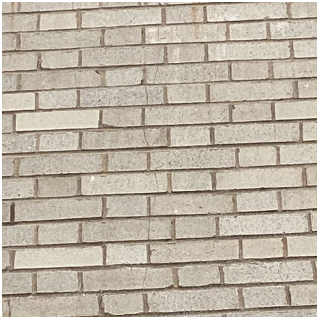
Violations	AW12 No violations recorded.
AWNINGS AND CANOPIES	
	Does not Exist
CHIMNEY	
Material Type(s)	Inspected Masonry
Condition	3 - Fair
Deficiency	BRICK: MINOR CRACKS AND SPALLING
Roof Plan reference	K252

Deficiency Quantity	30
Quantity Uom	S.F.
Potential Action	RESTITCH
Urgency of Action	PRIORITY 3
Purpose of Action	LEVEL 2
Deficiency Photo1

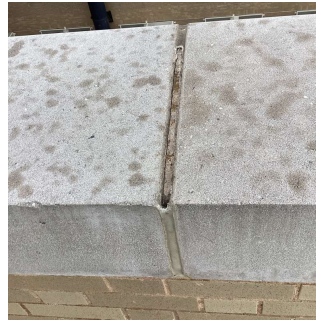
Roof 2

CAST STONE: DETERIORATED TRANSVERSE JOINTS

80
L.F.
MAINTENANCE
PRIORITY 3
LEVEL 2

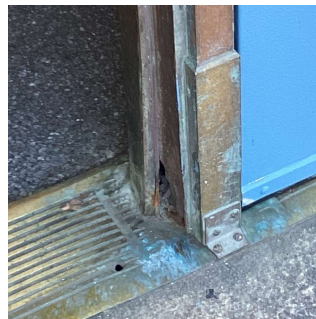
Facade A

METAL: DETERIORATED DOOR AND FRAME - MAJOR DETERIORATION

REPLACE

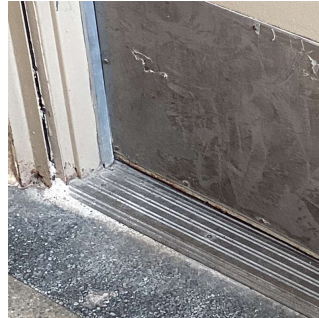
METAL CLAD: DETERIORATED DOOR AND FRAME - MINOR DETERIORATION

Deficiency Quantity	2
Quantity Uom	EACH
Potential Action	MAINTENANCE
Urgency of Action	PRIORITY 3
Purpose of Action	LEVEL 2
Deficiency Photo1

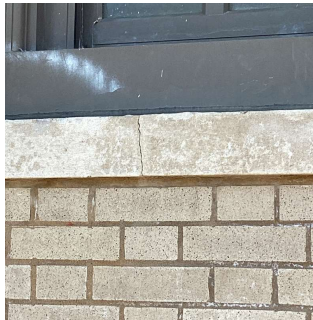
Facade G

BRICK: DETERIORATED MASONRY SILLS - MINOR

REPAIR

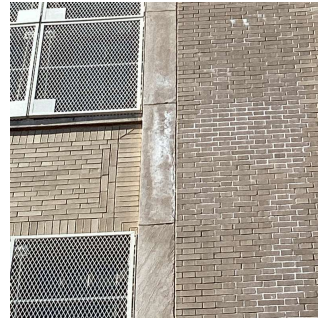
Facade C

STONE: EFFLORESCENCE

PRIORITY 1
LEVEL 1

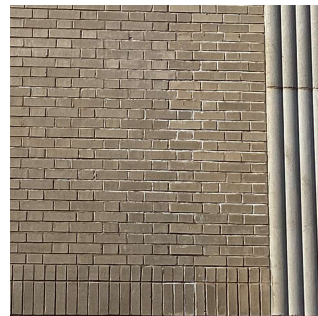
Facade C

BRICK: EFFLORESCENCE

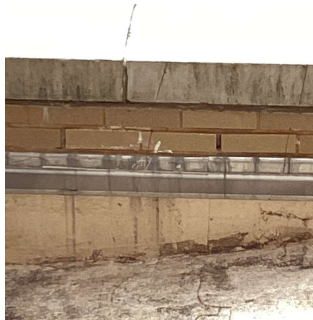
Roof 6

Deficiency **BRICK: MINOR CRACKS, SPALLING**

Deficiency Quantity **10**
 Quantity Uom **S.F.**
 Potential Action **REPAIR**
 Urgency of Action **PRIORITY 3**
 Purpose of Action **LEVEL 2**

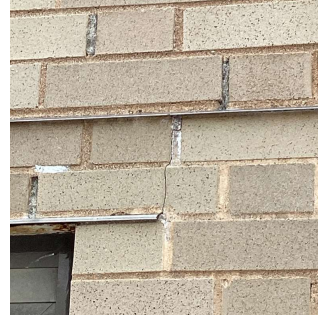
BH1

Deficiency	BULKHEAD/PENTHOUSE WALLS/EXTERIOR: CRACKS/SPALLING - MINOR
------------	---

Deficiency Quantity	10
Quantity Uom	S.F.
Potential Action	REPAIR
Urgency of Action	PRIORITY 3

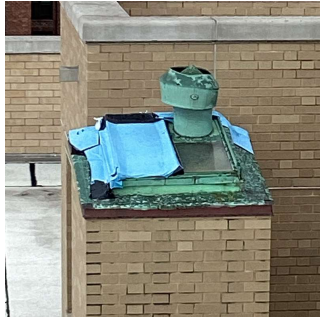
Violations	SK No violations recorded.
Deficiency	BROKEN GLASS
Roof Plan reference	K252

Deficiency Quantity	20
Quantity Uom	S.F.
Potential Action	MAINTENANCE
Urgency of Action	PRIORITY 3
Purpose of Action	LEVEL 2
Deficiency Photo1

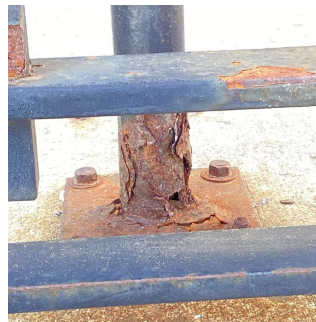
Facade C

RUST - MAJOR

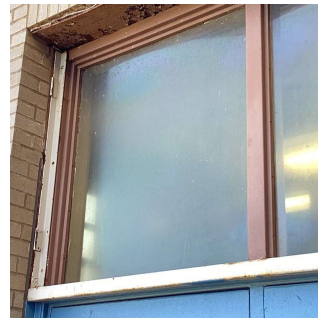
Facade F - Exit 6

Violations	Facade C No violations recorded.
WINDOWS	Inspected
Replacement Quantity	24,000
Replacement Uom	S.F.
EXTERIOR GUARDS	Inspected
Condition	3 - Fair
Deficiency	DETERIORATED/TORN-OUT/MISSING

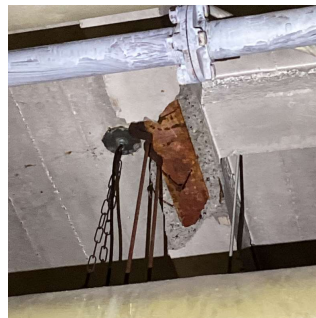
STEEL COLUMNS/BEAMS: DETERIORATED CONCRETE FIREPROOFING

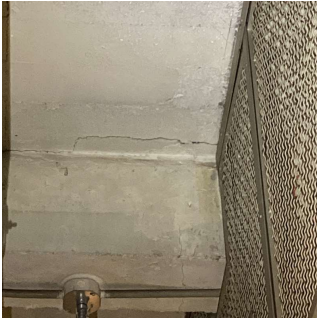
Question	Response
INTERIOR	
STRUCTURAL	
COLUMNS/BEAMS/BEARING WALLS	Inspected
Violations	Cafeteria Fan Room (Crawl Space under Auditorium similar) No violations recorded.
FLOOR STRUCTURE	Inspected
Condition	3 - Fair
Deficiency	CONCRETE: CRACKS/SPALLED/REINFORCEMENT EXPOSED
Deficiency Location/Instance	Basement
Deficiency Quantity	35
Quantity Uom	S.F.
Potential Action	REPAIR
Urgency of Action	PRIORITY 3
Purpose of Action	LEVEL 5
Deficiency Photo1

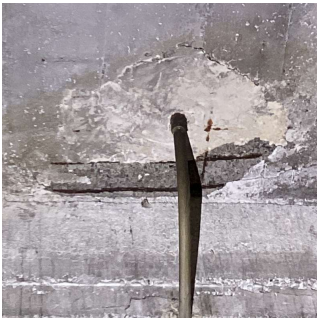
Violations	Basement Storage Room (Crawl Space under Auditorium similar) No violations recorded.
Deficiency	CONCRETE: CRACKS/SPALLED/REINFORCEMENT EXPOSED
Deficiency Location/Instance	Basement
Deficiency Quantity	20
Quantity Uom	S.F.
Potential Action	REPAIR
Urgency of Action	PRIORITY 4
Purpose of Action	LEVEL 5
Deficiency Photo1

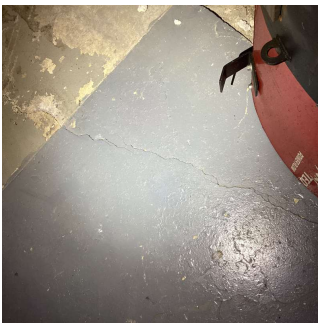
Violations	Custodian Shop No violations recorded.
Deficiency	CONCRETE SLAB ON GRADE: THRU CRACKS
Deficiency Location/Instance	Basement
Deficiency Quantity	200

Quantity Uom	S.F.
Potential Action	REPAIR
Urgency of Action	PRIORITY 3
Purpose of Action	LEVEL 5

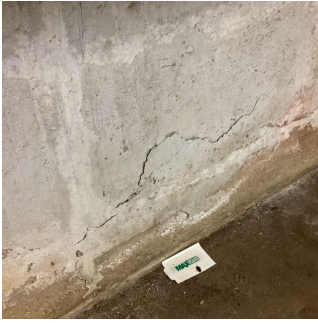
<p>Cafeteria Fan Room (Boiler Room, Custodian Shop, Basement Fan Area, Crawl Space under Auditorium similar)</p>
Violations	No violations recorded.
FOUNDATION WALLS	
Material Type(s)	Inspected Concrete, Masonry
Condition	5 - Poor
Deficiency	CONCRETE: CRACKED/SPALLED/REINFORCEMENT EXPOSED
Deficiency Location/Instance	Basement
Deficiency Quantity	60
Quantity Uom	S.F.
Potential Action	REPAIR
Urgency of Action	PRIORITY 3
Purpose of Action	LEVEL 5
Deficiency Photo1

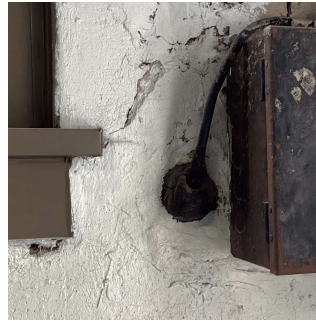
Basement Fan Area (Crawl Space under Auditorium similar)

<p>Crawl Space under Auditorium</p>
Violations	No violations recorded.
Deficiency	CONCRETE: CRACKED/SPALLED/REINFORCEMENT EXPOSED
Deficiency Location/Instance	Basement
Deficiency Quantity	30
Quantity Uom	S.F.
Potential Action	REPAIR
Urgency of Action	PRIORITY 4
Purpose of Action	LEVEL 5

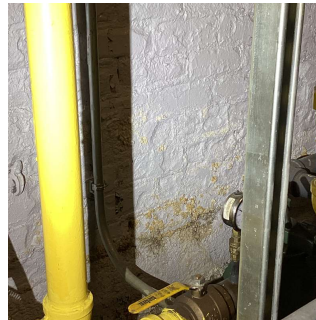
Boiler Room

BRICK: WATER INFILTRATION IN NON- INSTRUCTIONAL SPACE

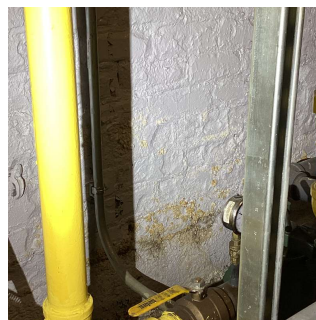
Boiler Room

BRICK: CRACKED/SPALLED

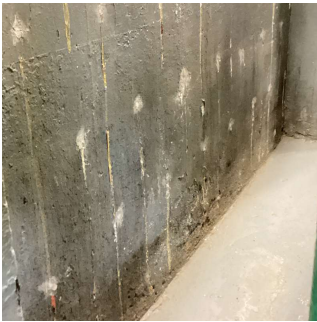
Question	Response
INTERIOR	
STRUCTURAL	
FOUNDATION WALLS	
Violations	No violations recorded.
Deficiency	CONCRETE: WATER INFILTRATION IN NON- INSTRUCTIONAL SPACE
Deficiency Location/Instance	Basement - Boiler Room, Room B2 (Crawl Space under Auditorium similar)
Deficiency Quantity	300
Quantity Uom	S.F.
Potential Action	INSTALL WATERPROOFING
Urgency of Action	PRIORITY 5
Purpose of Action	LEVEL 5
Deficiency Photo1

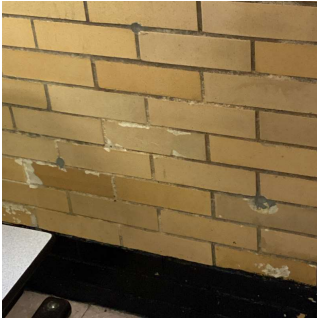
Violations	Boiler Room 35672513P
Deficiency	CONCRETE: WATER INFILTRATION IN INSTRUCTIONAL SPACE
Deficiency Location/Instance	Basement
Deficiency Quantity	100
Quantity Uom	S.F.
Potential Action	INSTALL WATERPROOFING
Urgency of Action	PRIORITY 5
Purpose of Action	LEVEL 5
Deficiency Photo1

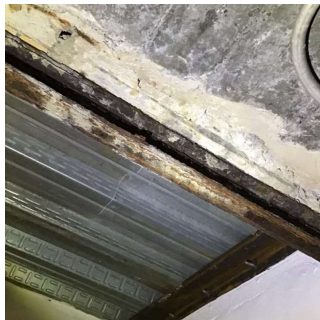
Question	Response
INTERIOR	
STRUCTURAL	
VAULTS-BUNKERS	
Slab Structure	
Condition	3 - Fair
Deficiency	STEEL COLUMNS/BEAMS: DETERIORATED CONCRETE FIREPROOFING
Deficiency Location/Instance	Basement
Deficiency Quantity	80
Quantity Uom	S.F.
Potential Action	REPAIR
Urgency of Action	PRIORITY 3
Purpose of Action	LEVEL 5
Deficiency Photo1

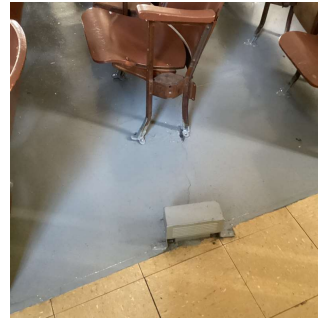
Seat L/26

CONCRETE: TRIPPING HAZARD - ELECTRICAL OUTLET

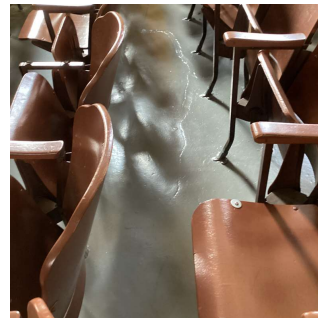
Near seat O/13

CONCRETE: CRACKS

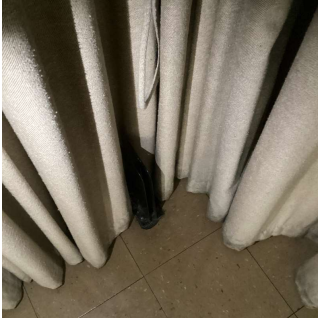
Question	Response
INTERIOR	
AUDITORIUM	
Sliding-folding Partition	
Instance on 1st Floor (560 Seats)	Does not Exist
Stage	
Instance on 1st Floor (560 Seats)	Inspected
Stage	
Instance on 1st Floor (560 Seats)	Inspected
Condition	3 - Fair
Deficiency	DAMAGED FASCIA
Deficiency Location/Instance	Right Side
Deficiency Quantity	10
Quantity Uom	S.F.
Potential Action	REPLACE
Urgency of Action	PRIORITY 3
Purpose of Action	LEVEL 2
Deficiency Photo1	 
	Right Side
Violations	No violations recorded.
Deficiency	DAMAGED FLOOR
Deficiency Location/Instance	Front
Deficiency Quantity	20
Quantity Uom	S.F.
Potential Action	REPLACE
Urgency of Action	PRIORITY 3
Purpose of Action	LEVEL 2
Deficiency Photo1	 
	Front
Violations	No violations recorded.
Stage Curtain Rigging	
Instance on 1st Floor (560 Seats)	Inspected
Instance on 1st Floor (560 Seats)	Inspected
Condition	5 - Poor
Deficiency	INOPERABLE
Deficiency Location/Instance	Left Rear

Question	Response
INTERIOR	
AUDITORIUM	
Stage	
Stage Curtain Rigging	
Deficiency Quantity	1
Quantity Uom	EACH
Potential Action	MAINTENANCE
Urgency of Action	PRIORITY 3
Purpose of Action	LEVEL 2
Deficiency Photo1

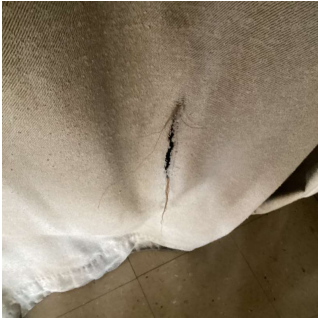
Violations	Left Rear No violations recorded.
Stage Curtains	Inspected
Instance on 1st Floor (560 Seats)	Inspected
Condition	3 - Fair
Deficiency	WORN/DETERIORATED
Deficiency Location/Instance	Right Side, Left Side
Deficiency Quantity	200
Quantity Uom	S.F.
Potential Action	REPLACE
Urgency of Action	PRIORITY 3
Purpose of Action	LEVEL 2
Deficiency Photo1

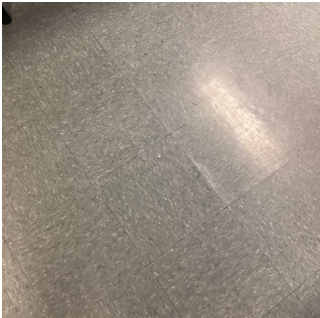
Question	Response
INTERIOR	
CAFETERIA	
Instance on Basement	Inspected
Ceiling	
Instance on Basement	Inspected
Condition	2 - Between Good and Fair
Deficiency	No deficiencies recorded
Door(s)	
Instance on Basement	Inspected
Condition	2 - Between Good and Fair
Deficiency	No deficiencies recorded
Fixed Equipment	
Instance on Basement	Does not Exist
Floor Finish	
Instance on Basement	Inspected
Condition	2 - Between Good and Fair
Deficiency	VINYL TILES: DETERIORATED SUBSTRATE
Deficiency Location/Instance	Center
Deficiency Quantity	15
Quantity Uom	S.F.
Potential Action	REPLACE
Urgency of Action	PRIORITY 3
Purpose of Action	LEVEL 2
Deficiency Photo1

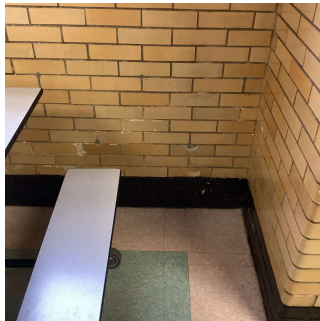
Center	Center
Violations	No violations recorded.
Sliding-folding Partition	
Instance on Basement	Does not Exist
Stage	
Instance on Basement	Does not Exist
Walls	
Instance on Basement	Inspected
Condition	2 - Between Good and Fair
Deficiency	BRICK: CRACKS/SPALLING - ACTIVE LEAK
Deficiency Location/Instance	Along Windows

Deficiency Quantity	30
Quantity Uom	S.F.
Potential Action	REPLACE
Urgency of Action	PRIORITY 5
Purpose of Action	LEVEL 2

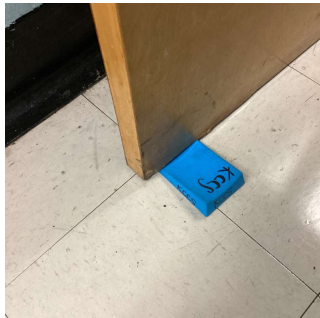
Violations	Along Windows No violations recorded.
Window Curtains/Shades/Blinds	
Instance on Basement	Does not Exist
CLASSROOMS/CORRIDORS/ADMIN SPACES	
Ceiling	
Condition	Inspected
Deficiency	2 - Between Good and Fair
Door(s)	
Condition	Inspected
Deficiency	5 - Poor
Deficiency	WOOD: DETERIORATED DOOR
Deficiency Location/Instance	Rooms 332, 319, 302, 228, 223 and others
Deficiency Quantity	10
Quantity Uom	EACH
Potential Action	MAINTENANCE
Urgency of Action	PRIORITY 3
Purpose of Action	LEVEL 2
Deficiency Photo1

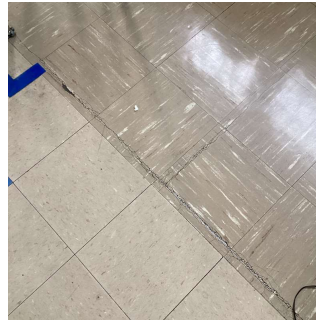
Room 319

Violations	Room 332 No violations recorded.
Floor Finish	
Condition	Inspected
Condition	2 - Between Good and Fair
Deficiency	VINYL TILES: DETERIORATED SUBSTRATE
Deficiency Location/Instance	Rooms 319, 128
Deficiency Quantity	25
Quantity Uom	S.F.
Potential Action	REPLACE
Urgency of Action	PRIORITY 3
Purpose of Action	LEVEL 2

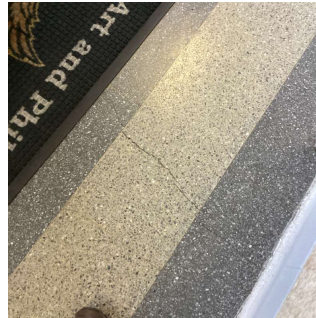
Main Entrance Vestibule

TERRAZZO: CRACKS

REPLACE

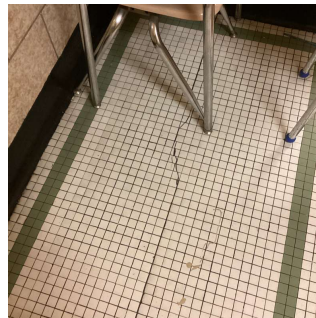
Corridor near room 320

CERAMIC TILE: DETERIORATED SUBSTRATE

REPLACE

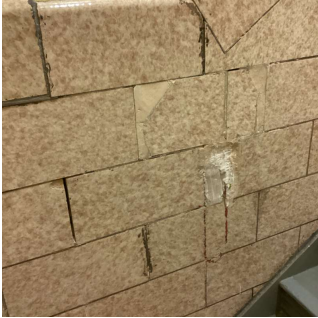
Question	Response
INTERIOR	
CLASSROOMS/CORRIDORS/ADMIN SPACES	
Walls	Inspected
Condition	2 - Between Good and Fair
Deficiency	GLAZED BLOCK: CRACKS/SPALLING
Deficiency Location/Instance	Corridor near 3rd Floor Gymnasium
Deficiency Quantity	15
Quantity Uom	S.F.
Potential Action	REPLACE
Urgency of Action	PRIORITY 3
Purpose of Action	LEVEL 2
Deficiency Photo1

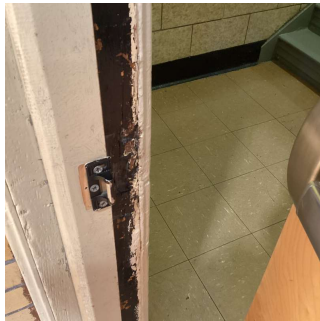
Deficiency	WOOD: DETERIORATED DOOR AND FRAME
Deficiency Location/Instance	Entrance (2 Doors)
Deficiency Quantity	2
Quantity Uom	EACH
Potential Action	MAINTENANCE
Urgency of Action	PRIORITY 3
Purpose of Action	LEVEL 2

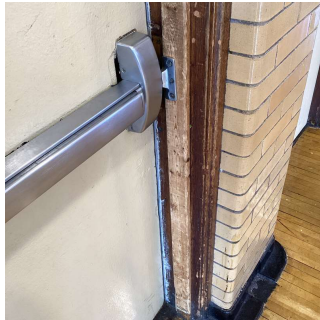
Entrance (2 Doors)
Violations	No violations recorded.
Instance on 4th Floor	Inspected
Condition	5 - Poor
Deficiency	WOOD: DETERIORATED DOOR AND FRAME
Deficiency Location/Instance	Entrance (2 Doors), Office
Deficiency Quantity	3
Quantity Uom	EACH
Potential Action	MAINTENANCE
Urgency of Action	PRIORITY 3
Purpose of Action	LEVEL 2
Deficiency Photo1

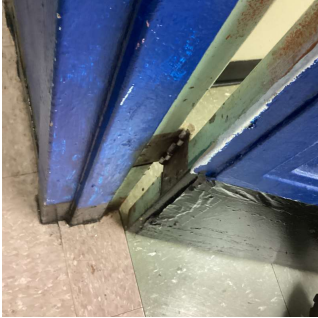
Locker Room

Condition	5 - Poor
Deficiency	METAL: DETERIORATED DOOR
Deficiency Location/Instance	Locker Room, Storage Room, Entrance
Deficiency Quantity	3
Quantity Uom	EACH
Potential Action	MAINTENANCE
Urgency of Action	PRIORITY 3
Purpose of Action	LEVEL 2
Deficiency Photo1

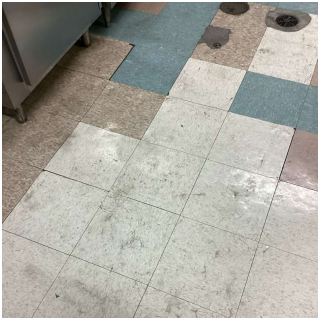
Instance on Basement	Inspected
Condition	2 - Between Good and Fair
Deficiency	SHEET VINYL: DETERIORATED SUBSTRATE
Deficiency Location/Instance	Room B-4
Deficiency Quantity	15
Quantity Uom	S.F.
Potential Action	REPLACE
Urgency of Action	PRIORITY 3
Purpose of Action	LEVEL 2
Deficiency Photo1

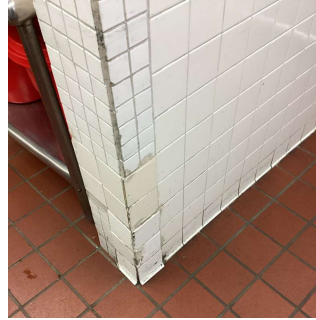
Instance on Basement	Inspected
Condition	2 - Between Good and Fair
Deficiency	CERAMIC TILE: BROKEN/ MISSING
Deficiency Location/Instance	Food Prep
Deficiency Quantity	15
Quantity Uom	S.F.

Potential Action	REPLACE
Urgency of Action	PRIORITY 3
Purpose of Action	LEVEL 2
Deficiency Photo1

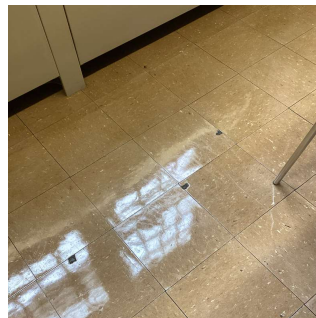
Instance on Room 313/315	Inspected
Condition	2 - Between Good and Fair
Deficiency	VINYL TILES: BROKEN/DETERIORATED/MISSING TILES
Deficiency Location/Instance	Rear
Deficiency Quantity	10
Quantity Uom	S.F.
Potential Action	REPLACE
Urgency of Action	PRIORITY 3
Purpose of Action	LEVEL 2
Deficiency Photo1

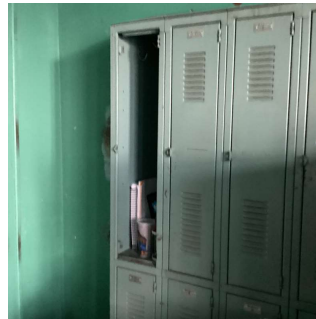
Instance on 3rd Floor (86 Lockers)	Inspected
Condition	2 - Between Good and Fair
Deficiency	DAMAGED UNITS
Deficiency Location/Instance	Locker 1
Deficiency Quantity	1
Quantity Uom	EACH
Potential Action	REPLACE
Urgency of Action	PRIORITY 3
Purpose of Action	LEVEL 2
Deficiency Photo1

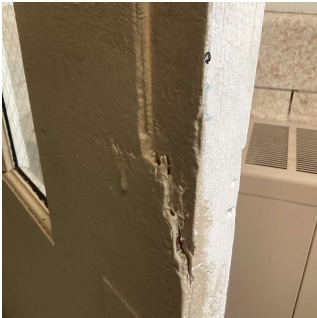
Instance on 1st Floor	Inspected
Condition	4 - Between Fair and Poor
Deficiency	WOOD: DETERIORATED DOOR
Deficiency Location/Instance	Exit 2 Vestibule (2 Doors)

Question	Response
INTERIOR	
MULTI-PURPOSE ROOM	
Door(s)	
Deficiency Quantity	2
Quantity Uom	EACH
Potential Action	MAINTENANCE
Urgency of Action	PRIORITY 3
Purpose of Action	LEVEL 2
Deficiency Photo1

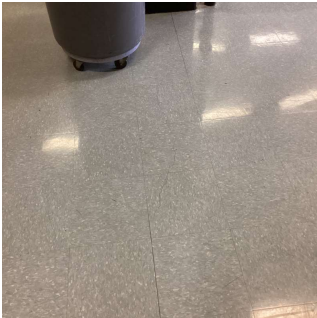
Violations	Exit 2 Vestibule (2 Doors) No violations recorded.
Fixed Equipment	
Instance on 1st Floor	Does not Exist
Floor Finish	
Instance on 1st Floor	Inspected
Condition	2 - Between Good and Fair
Deficiency	VINYL TILES: DETERIORATED SUBSTRATE
Deficiency Location/Instance	Near Stair C/D
Deficiency Quantity	20
Quantity Uom	S.F.
Potential Action	REPLACE
Urgency of Action	PRIORITY 3
Purpose of Action	LEVEL 2
Deficiency Photo1

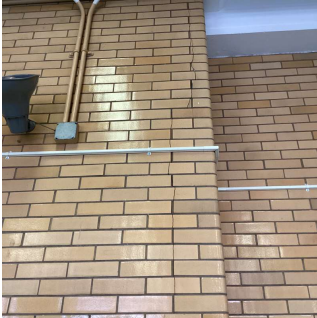
Violations	Near Stair C/D No violations recorded.
Sliding-folding Partition	
Instance on 1st Floor	Does not Exist
Stage	
Instance on 1st Floor	Does not Exist
Walls	
Instance on 1st Floor	Inspected
Condition	2 - Between Good and Fair
Deficiency	SALT GLAZED BRICK: CRACKS/SPALLING

Question	Response
INTERIOR	
MULTI-PURPOSE ROOM	
Walls	
Deficiency Location/Instance	Right Side
Deficiency Quantity	15
Quantity Uom	S.F.
Potential Action	REPLACE
Urgency of Action	PRIORITY 3
Purpose of Action	LEVEL 2
Deficiency Photo1

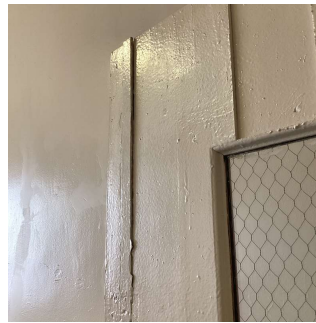
Exit 8 Vestibule (2 Doors)

Violations	Stair G/4 No violations recorded.
Deficiency	WOOD: DETERIORATED DOOR
Deficiency Location/Instance	Exit 8 Vestibule (2 Doors), Stair G/1
Deficiency Quantity	2
Quantity Uom	EACH

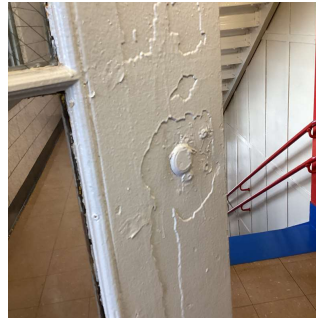
Stair EF/3 (2 Doors)

METAL: DETERIORATED DOOR

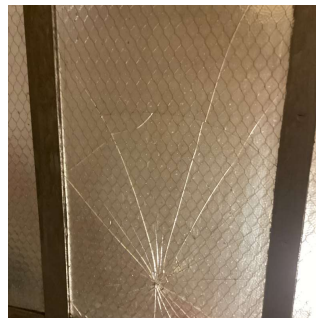
GLASS PANEL: DAMAGED/DETERIORATED

REPLACE

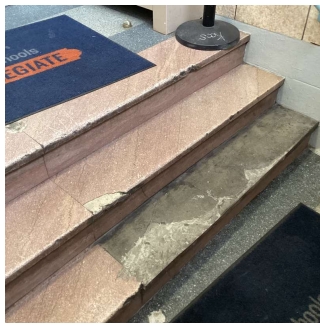
Question	Response
INTERIOR	
STAIRS/RAMPS: INTERIOR	
Partition	Inspected
	Stair CD/Bulkhead
Violations	No violations recorded.
Railings	Inspected
Condition	5 - Poor
Deficiency	METAL: MISSING
Deficiency Location/Instance	Exit 2 Vestibule, Corridor near Gymnasium, Main Entrance Vestibule
Deficiency Quantity	30
Quantity Uom	L.F.
Potential Action	REPLACE
Urgency of Action	PRIORITY 5
Purpose of Action	LEVEL 6
Deficiency Photo1	 
	Exit 2 Vestibule
Violations	No violations recorded.
Stairs and Landings	Inspected
Condition	5 - Poor
Deficiency	SHEET VINYL: BROKEN/DETERIORATED
Deficiency Location/Instance	Stair AB/ Bulkhead, CD/ Bulkhead, EF/ Bulkhead
Deficiency Quantity	600
Quantity Uom	S.F.
Potential Action	REPLACE
Urgency of Action	PRIORITY 3
Purpose of Action	LEVEL 2
Deficiency Photo1	No photo recorded
Violations	No violations recorded.
Deficiency	STONE: DETERIORATED SUBSTRATE
Deficiency Location/Instance	Exit 2 Vestibule (2 Doors)

Deficiency Quantity	30
Quantity Uom	S.F.
Potential Action	REPLACE
Urgency of Action	PRIORITY 3
Purpose of Action	LEVEL 2

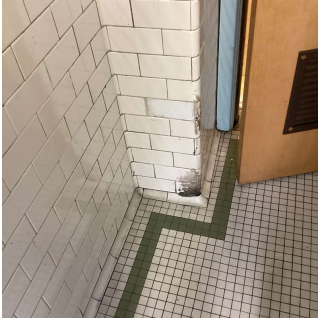
Violations	Kitchen Staff No violations recorded.
Walls	Inspected
Condition	2 - Between Good and Fair
Deficiency	CERAMIC TILE: BROKEN/ MISSING

Question	Response
INTERIOR	
TOILET ROOMS - STAFF	
Walls	
Deficiency Location/Instance	Room 214
Deficiency Quantity	10
Quantity Uom	S.F.
Potential Action	REPLACE
Urgency of Action	PRIORITY 3
Purpose of Action	LEVEL 2
Deficiency Photo1

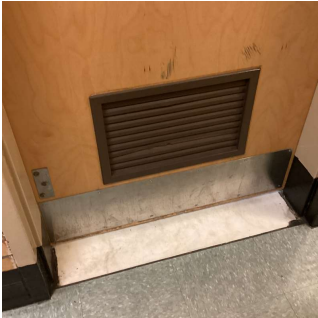
Room 214
Violations	No violations recorded.
TOILET ROOMS - STUDENTS	
Ceiling	Inspected
Condition	2 - Between Good and Fair
Deficiency	No deficiencies recorded
Door(s)	Inspected
Condition	5 - Poor
Deficiency	WOOD: DAMAGED LOUVER
Deficiency Location/Instance	Room 125B
Deficiency Quantity	1
Quantity Uom	EACH
Potential Action	MAINTENANCE
Urgency of Action	PRIORITY 3
Purpose of Action	LEVEL 2
Deficiency Photo1

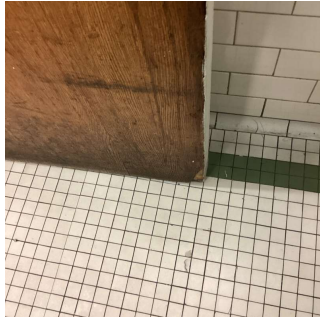
Room 125B
Violations	No violations recorded.
Deficiency	WOOD: DETERIORATED DOOR
Deficiency Location/Instance	Room 208
Deficiency Quantity	1
Quantity Uom	EACH
Potential Action	MAINTENANCE
Urgency of Action	PRIORITY 3

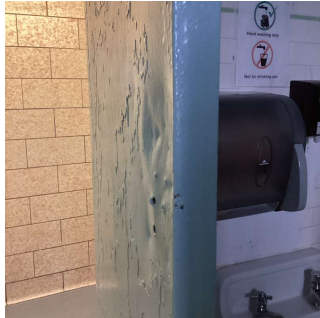
Violations	Room 208 No violations recorded.
Deficiency	METAL: DETERIORATED DOOR
Deficiency Location/Instance	Room 300,
Deficiency Quantity	1
Quantity Uom	EACH
Potential Action	MAINTENANCE
Urgency of Action	PRIORITY 3
Purpose of Action	LEVEL 2
Deficiency Photo1

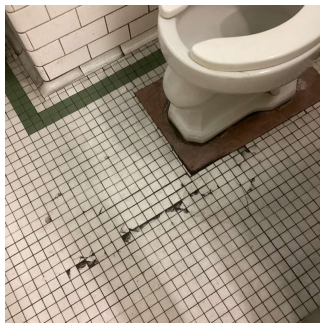
Violations	Room 300 No violations recorded.
Floor Finish	Inspected
Condition	2 - Between Good and Fair
Deficiency	CERAMIC TILE: DETERIORATED SUBSTRATE
Deficiency Location/Instance	Room 319, 208
Deficiency Quantity	20
Quantity Uom	S.F.
Potential Action	REPLACE
Urgency of Action	PRIORITY 3
Purpose of Action	LEVEL 2

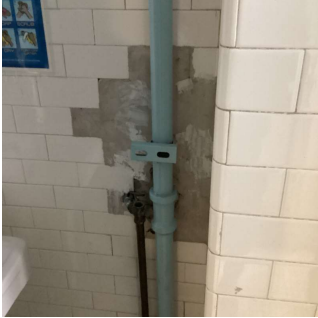
Violations	Room 300 No violations recorded.
Walls	Inspected
Condition	2 - Between Good and Fair
Deficiency	CERAMIC TILE: BROKEN/ MISSING
Deficiency Location/Instance	Rooms 300, 125
Deficiency Quantity	20
Quantity Uom	S.F.
Potential Action	REPLACE

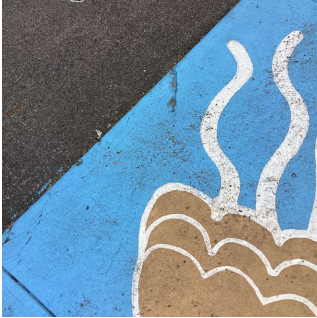
Question	Response
SITE	
PAVING	Inspected
Student Use	
Concrete	
Condition	3 - Fair
Deficiency	CRACKS - MAJOR
Deficiency Location/Instance	Schoolyard
Deficiency Quantity	150
Quantity Uom	S.F.
Potential Action	REPLACE
Urgency of Action	PRIORITY 3
Purpose of Action	LEVEL 2
Deficiency Photo1

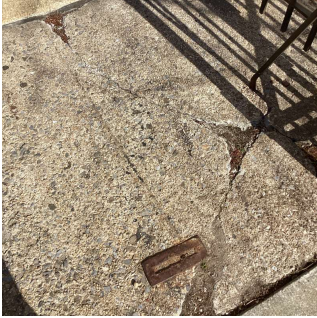
Violations	Schoolyard No violations recorded.
Pavers	Inspected
Condition	2 - Between Good and Fair
Deficiency	No deficiencies recorded
Site Sidewalks & Walkways	Inspected
Asphalt	Does not Exist
Concrete	Inspected
Condition	3 - Fair
Deficiency	CRACKS - MAJOR
Deficiency Location/Instance	Exit 8, Lenox Road
Deficiency Quantity	100
Quantity Uom	S.F.
Potential Action	REPLACE
Urgency of Action	PRIORITY 3
Purpose of Action	LEVEL 2
Deficiency Photo1

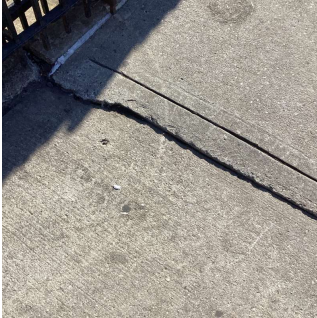
Question	Response
SITE	
PAVING	
DOT Sidewalk	
Asphalt	Does not Exist
Concrete	Inspected
Condition	4 - Between Fair and Poor
Deficiency	HEAVING
Deficiency Location/Instance	Lenox Road
Deficiency Quantity	25
Quantity Uom	S.F.
Potential Action	REPLACE
Urgency of Action	PRIORITY 4
Purpose of Action	LEVEL 4
Deficiency Photo1

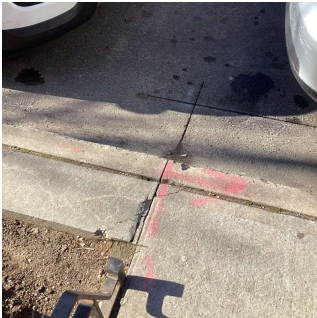
Violations	Lenox Road 52271
Deficiency	DAMAGED CURBS
Deficiency Location/Instance	Lenox Road, East 95th Street
Deficiency Quantity	100
Quantity Uom	L.F.
Potential Action	REPLACE
Urgency of Action	PRIORITY 4
Purpose of Action	LEVEL 4
Deficiency Photo1

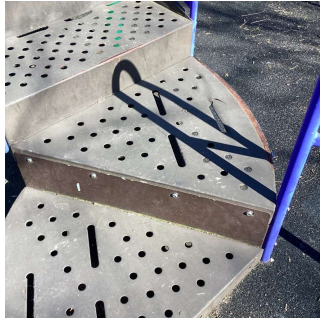
Question	Response
SITE	
PLAYGROUNDS	
Fence	
Violations	No violations recorded.
Pavement	
Instance on Schoolyard	Does not Exist
Play Equipment	
Instance on Schoolyard	Inspected
Condition	5 - Poor
Deficiency	BROKEN/DETERIORATED/MISSING
Deficiency Location/Instance	Center, Near Entrance
Deficiency Quantity	2
Quantity Uom	EACH
Potential Action	REPLACE
Urgency of Action	PRIORITY 3
Purpose of Action	LEVEL 2
Deficiency Photo1

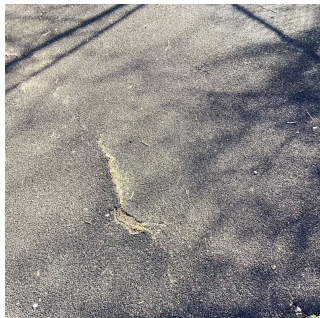
Violations	Center No violations recorded.
Safety Surfacing	
Instance on Schoolyard	Inspected
Condition	3 - Fair
Deficiency	DETERIORATED/MISSING
Deficiency Location/Instance	Throughout
Deficiency Quantity	150
Quantity Uom	S.F.
Potential Action	REPLACE
Urgency of Action	PRIORITY 3
Purpose of Action	LEVEL 2
Deficiency Photo1

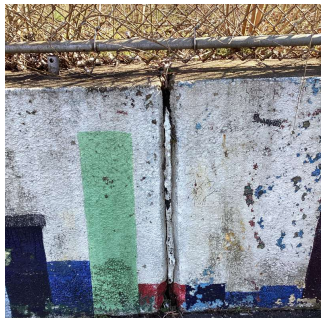
Violations	Near Entrance No violations recorded.
Unpaved Area	
Instance on Schoolyard	Does not Exist
PLAYING SURFACE	
Does not Exist	
RETAINING WALLS	
Inspected	
Are there any Retaining Walls 6' OR higher facing public street/sidewalk?	No
Condition	3 - Fair
Deficiency	CAST IN PLACE CONCRETE: DETERIORATED CONTROL/EXPANSION JOINT
Deficiency Location/Instance	Schoolyard
Deficiency Quantity	15
Quantity Uom	L.F.
Potential Action	REPLACE
Urgency of Action	PRIORITY 3
Purpose of Action	LEVEL 2
Deficiency Photo1

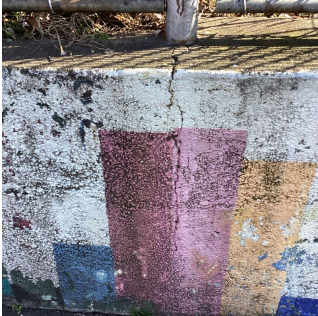
Violations	Schoolyard No violations recorded.
Deficiency	CAST IN PLACE CONCRETE: CRACKS/SPALLING - MAJOR
Deficiency Location/Instance	Schoolyard
Deficiency Quantity	20
Quantity Uom	S.F.

Question	Response
SITE	
RETAINING WALLS	
Potential Action	REPLACE
Urgency of Action	PRIORITY 3
Purpose of Action	LEVEL 2
Deficiency Photo1
