NYC Department of Education
Building Condition Assessment Survey 2023 - 2024

Architectural Inspection

K255

Asset: P.S. 255 - BROOKLYN, 1866 EAST 17 STREET, New York, 11229

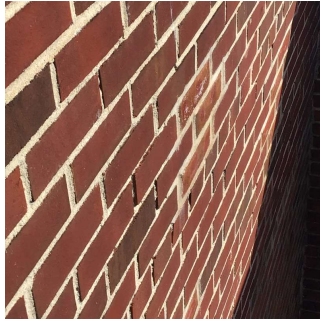
Question	Response
EXTERIOR	
CHIMNEY	
Deficiency Photo1

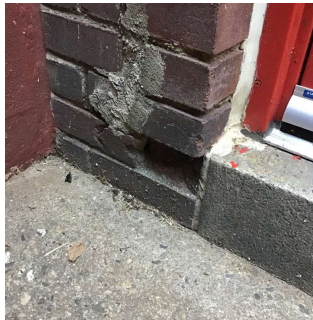
Facade A - AW1

EXTERIOR WALLS

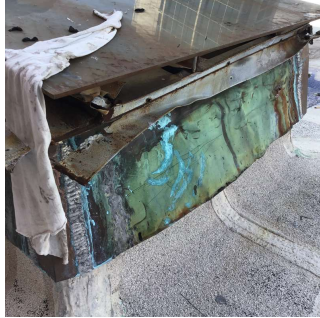
Roof 1
Violations	No violations recorded.
Deficiency	BROKEN GLASS
Roof Plan reference	K255

Question	Response
EXTERIOR	
ROOF	
Specialties	
SKYLIGHT/ROOF VENT	
Urgency of Action	PRIORITY 3
Purpose of Action	LEVEL 2
Deficiency Photo1

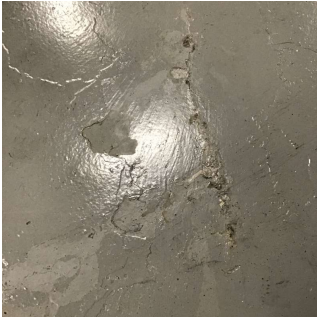
Question	Response
EXTERIOR	
WINDOWS	
WINDOWS	
Are these windows insulated	Yes
Installation Year	2023
Source of Installation	Custodial Staff
Deficiency	No deficiencies recorded
Instance on Aluminum - Double Hung: Facades A, E, J - Basement	Inspected
Instance Condition	3 - Fair
Instance Quantity	400
Instance Quantity Uom	S.F.
Are these windows insulated	Yes
Installation Year	1996
Source of Installation	Custodial Staff
Deficiency	No deficiencies recorded
INTERIOR	Inspected
POOLS	Does not Exist
STRUCTURAL	Inspected
COLUMNS/BEAMS/BEARING WALLS	Inspected
Condition	2 - Between Good and Fair
Deficiency	No deficiencies recorded
FLOOR STRUCTURE	Inspected
Condition	4 - Between Fair and Poor
Deficiency	CONCRETE SLAB ON GRADE: WATER INFILTRATION IN NON-INSTRUCTIONAL SPACE
Deficiency Location/Instance	Basement - Boiler Room Pit
Deficiency Quantity	100
Quantity Uom	S.F.
Potential Action	INSTALL WATERPROOFING
Urgency of Action	PRIORITY 5

Purpose of Action	LEVEL 5
Deficiency Photo1

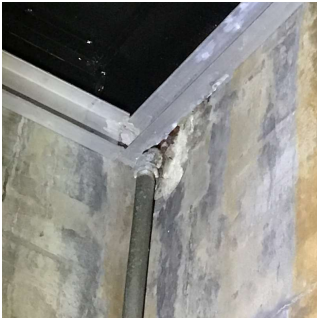
Basement- Ash Hoist Vault
Violations	No violations recorded.
Slab Structure	
	Inspected
Condition	2 - Between Good and Fair
Deficiency	No deficiencies recorded
Vault/Ash Hoist Doors and Framing	
	Inspected
Condition	1 - Good
Deficiency	No deficiencies recorded
AUDITORIUM	
	Inspected

Basement - Boiler Room Pit
Violations	No violations recorded.
ROOF STRUCTURE	
	Inspected
Condition	2 - Between Good and Fair
Deficiency	No deficiencies recorded
VAULTS-BUNKERS	
	Inspected
Foundation Walls	
	Inspected
Condition	2 - Between Good and Fair
Deficiency	CRACKS, SPALLING
Deficiency Location/Instance	Basement- Ash Hoist Vault
Deficiency Quantity	10
Quantity Uom	S.F.
Potential Action	REPAIR
Urgency of Action	PRIORITY 3
Purpose of Action	LEVEL 5
Deficiency Photo1

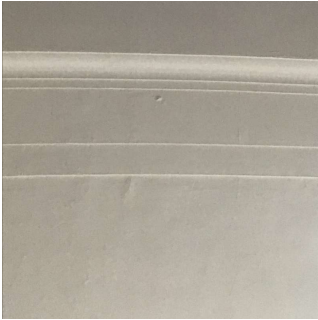
Question	Response
INTERIOR	
AUDITORIUM	
Ceiling	
Instance on 1st Floor (449 Seats)	Inspected
Condition	2 - Between Good and Fair
Deficiency	PLASTER: CRACKS/SPALLING
Deficiency Location/Instance	Near Stage
Deficiency Quantity	20
Quantity Uom	S.F.
Potential Action	REPLACE
Urgency of Action	PRIORITY 3
Purpose of Action	LEVEL 2
Deficiency Photo1

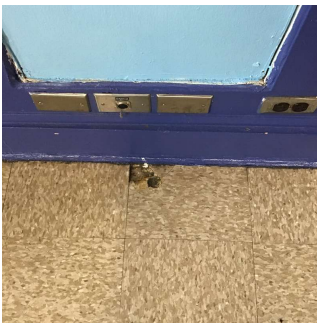
Violations	Near Stage No violations recorded.
Door(s)	
Instance on 1st Floor (449 Seats)	Inspected
Condition	2 - Between Good and Fair
Deficiency	No deficiencies recorded
Fixed H/C Lift	
Instance on 1st Floor (449 Seats)	Does not Exist
Fixed Seating	
Instance on 1st Floor (449 Seats)	Inspected
Condition	1 - Good
Deficiency	No deficiencies recorded
Floor Finish	
Instance on 1st Floor (449 Seats)	Inspected
Condition	2 - Between Good and Fair
Deficiency	VINYL TILES: BROKEN/DETERIORATED/MISSING TILES
Deficiency Location/Instance	Near Stage
Deficiency Quantity	10
Quantity Uom	S.F.
Potential Action	REPLACE

Urgency of Action	PRIORITY 3
Purpose of Action	LEVEL 2

Question	Response
INTERIOR	
AUDITORIUM	
Floor Finish	
Deficiency Photo1

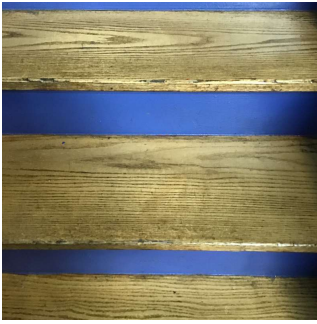
Near Stage
Violations	No violations recorded.
Sliding-folding Partition	
Instance on 1st Floor (449 Seats)	Does not Exist
Stage	
Instance on 1st Floor (449 Seats)	Inspected
Stage	Inspected
Instance on 1st Floor (449 Seats)	Inspected
Condition	2 - Between Good and Fair
Deficiency	DAMAGED STEPS
Deficiency Location/Instance	Right and Left Side
Deficiency Quantity	20
Quantity Uom	S.F.
Potential Action	REPLACE
Urgency of Action	PRIORITY 3
Purpose of Action	LEVEL 2
Deficiency Photo1

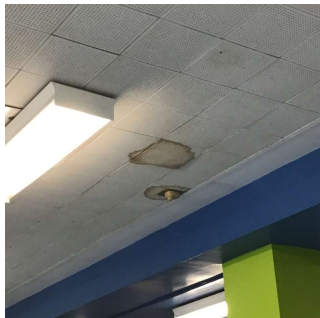
Question	Response
INTERIOR	
AUDITORIUM	
Walls	
Deficiency	No deficiencies recorded
Window Curtains/Shades/Blinds	
Instance on 1st Floor (449 Seats)	Inspected
Condition	1 - Good
Deficiency	No deficiencies recorded
CAFETERIA	
Instance on 1st Floor	Inspected
Ceiling	
Instance on 1st Floor	Inspected
Condition	2 - Between Good and Fair
Deficiency	ACOUSTIC TILES ON PLASTER: DAMAGED/MISSING
Deficiency Location/Instance	Center, near Windows, By Entrance
Deficiency Quantity	100
Quantity Uom	S.F.
Potential Action	REPLACE
Urgency of Action	PRIORITY 3
Purpose of Action	LEVEL 2
Deficiency Photo1

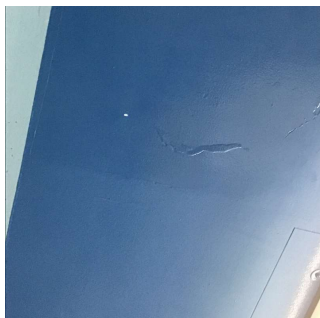
Center	
Violations	No violations recorded.
Deficiency	PLASTER: CRACKS/SPALLING
Deficiency Location/Instance	Center, near Windows
Deficiency Quantity	20
Quantity Uom	S.F.
Potential Action	REPLACE
Urgency of Action	PRIORITY 3
Purpose of Action	LEVEL 2
Deficiency Photo1

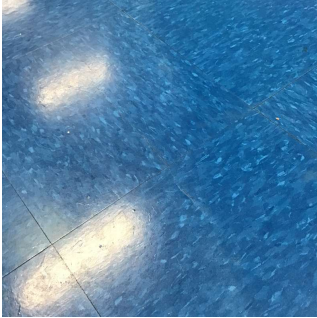
Question	Response
INTERIOR	
CAFETERIA	
Door(s)	
Instance on 1st Floor	Inspected
Condition	4 - Between Fair and Poor
Deficiency	WOOD: DETERIORATED DOOR
Deficiency Location/Instance	Entrance
Deficiency Quantity	2
Quantity Uom	EACH
Potential Action	MAINTENANCE
Urgency of Action	PRIORITY 3
Purpose of Action	LEVEL 2
Deficiency Photo1	 
Violations	Entrance No violations recorded.
Fixed Equipment	
Instance on 1st Floor	Does not Exist
Floor Finish	
Instance on 1st Floor	Inspected
Condition	2 - Between Good and Fair
Deficiency	VINYL TILES: BROKEN/DETERIORATED/MISSING TILES
Deficiency Location/Instance	Close Room 128A
Deficiency Quantity	10
Quantity Uom	S.F.
Potential Action	REPLACE
Urgency of Action	PRIORITY 3
Purpose of Action	LEVEL 2
Deficiency Photo1	 
Violations	Close Room 128A No violations recorded.
Deficiency	VINYL TILES: DETERIORATED SUBSTRATE
Deficiency Location/Instance	Near Servery, By Fridge
Deficiency Quantity	20
Quantity Uom	S.F.

Question	Response
INTERIOR	
CAFETERIA	
Floor Finish	
Potential Action	REPLACE
Urgency of Action	PRIORITY 3
Purpose of Action	LEVEL 2
Deficiency Photo1

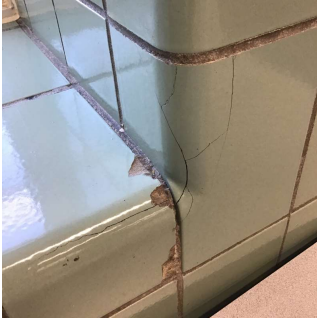
Near Servery
Violations	No violations recorded.
Sliding-folding Partition	
Instance on 1st Floor	Does not Exist
Stage	
Instance on 1st Floor	Does not Exist
Walls	
Instance on 1st Floor	Inspected
Condition	2 - Between Good and Fair
Deficiency	GLAZED BLOCK: CRACKS/SPALLING
Deficiency Location/Instance	Near Windows, Column, By Fridge, Next Servery
Deficiency Quantity	50
Quantity Uom	S.F.
Potential Action	REPLACE
Urgency of Action	PRIORITY 3
Purpose of Action	LEVEL 2
Deficiency Photo1

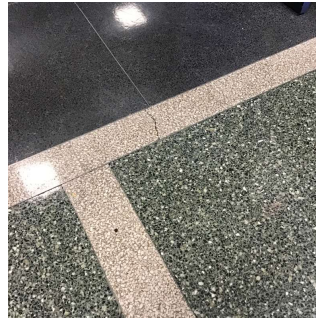
Main Entrance Lobby

TERRAZZO: CRACKS

REPLACE

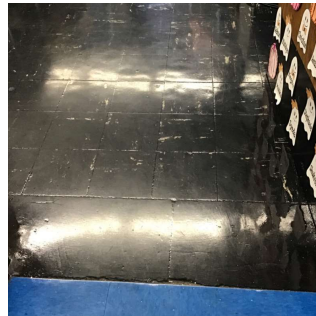
VINYL TILES: BROKEN/DETERIORATED/MISSING TILES

REPLACE

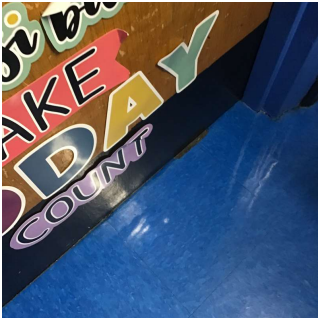
Question	Response
INTERIOR	
CLASSROOMS/CORRIDORS/ADMIN SPACES	
Floor Finish	
Violations	Room 330 No violations recorded.
Deficiency	VINYL TILES: DETERIORATED SUBSTRATE
Deficiency Location/Instance	Corridor near Room 106
Deficiency Quantity	10
Quantity Uom	S.F.
Potential Action	REPLACE
Urgency of Action	PRIORITY 3
Purpose of Action	LEVEL 2
Deficiency Photo1

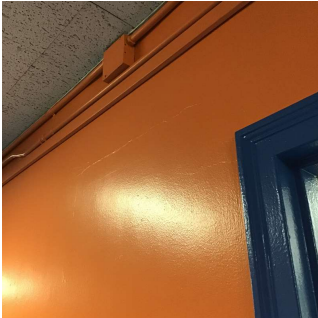
Violations	Corridor near Room 106 No violations recorded.
Walls	Inspected
Condition	2 - Between Good and Fair
Deficiency	PLASTER: CRACKS/SPALLING
Deficiency Location/Instance	Corridor near Room 122
Deficiency Quantity	10
Quantity Uom	S.F.
Potential Action	REPLACE
Urgency of Action	PRIORITY 3
Purpose of Action	LEVEL 2
Deficiency Photo1

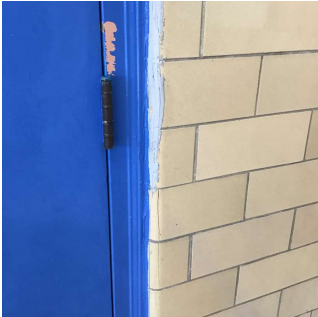
Violations	Storage Room No violations recorded.
Deficiency	GLAZED BLOCK: CRACKS/SPALLING
Deficiency Location/Instance	Near Storage Room, Next Windows, By Drinking Fountain
Deficiency Quantity	150
Quantity Uom	S.F.
Potential Action	REPLACE
Urgency of Action	PRIORITY 3
Purpose of Action	LEVEL 2
Deficiency Photo1

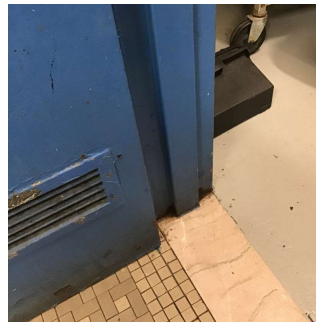
Storage Room

Door(s)

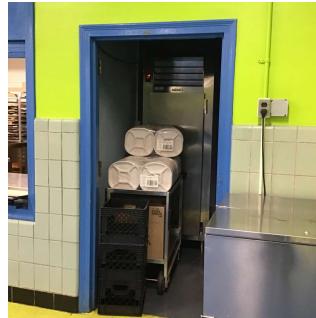
Room 128A

METAL: MISSING DOOR

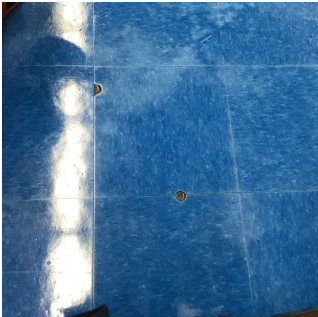
Instance on Room 227	Inspected
Condition	2 - Between Good and Fair
Deficiency	VINYL TILES: BROKEN/DETERIORATED/MISSING TILES
Deficiency Location/Instance	Near Windows
Deficiency Quantity	10
Quantity Uom	S.F.
Potential Action	REPLACE
Urgency of Action	PRIORITY 3
Purpose of Action	LEVEL 2
Deficiency Photo1

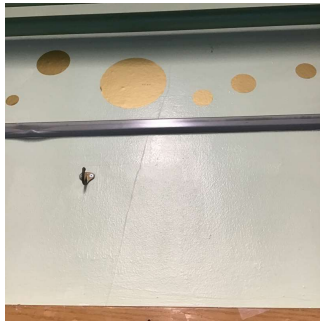
Instance on Room 227	Inspected
Condition	2 - Between Good and Fair
Deficiency	PLASTER: CRACKS/SPALLING
Deficiency Location/Instance	Left Side
Deficiency Quantity	10
Quantity Uom	S.F.
Potential Action	REPLACE
Urgency of Action	PRIORITY 3
Purpose of Action	LEVEL 2

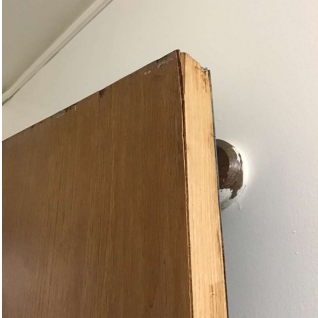
Violations	Room 332A No violations recorded.
Instance on 3rd Floor - Mezzanine	Inspected
Condition	4 - Between Fair and Poor
Deficiency	WOOD: DETERIORATED DOOR

Question	Response
INTERIOR	
LOCKER ROOM	
Door(s)	
Deficiency Location/Instance	Near Locker Room/3rd Floor Staff Bathroom, Entrance
Deficiency Quantity	2
Quantity Uom	EACH
Potential Action	MAINTENANCE
Urgency of Action	PRIORITY 3
Purpose of Action	LEVEL 2
Deficiency Photo1

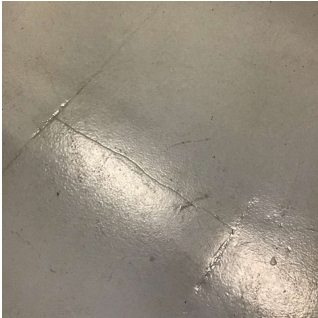
Near Locker Room/3rd Floor Staff Bathroom
Violations	No violations recorded.
Floor Finish	
Instance on 3rd Floor - Mezzanine	Inspected
Condition	2 - Between Good and Fair
Deficiency	CONCRETE: CRACKS
Deficiency Location/Instance	Near Drinking Fountain
Deficiency Quantity	10
Quantity Uom	S.F.
Potential Action	REPLACE
Urgency of Action	PRIORITY 3
Purpose of Action	LEVEL 2
Deficiency Photo1

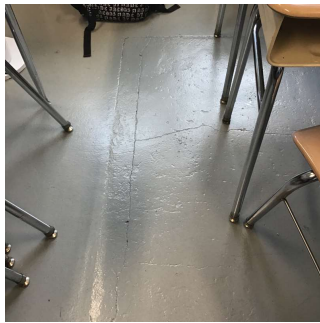
Near Drinking Fountain
Violations	No violations recorded.
Instance on 3rd Floor (10 Lockers)	Inspected
Condition	3 - Fair
Deficiency	CONCRETE: CRACKS
Deficiency Location/Instance	Center
Deficiency Quantity	50
Quantity Uom	S.F.
Potential Action	REPLACE
Urgency of Action	PRIORITY 3

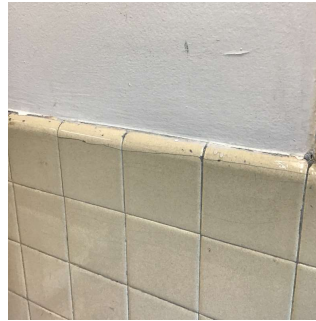
Near Entrance	Near Entrance
Violations	No violations recorded.
Deficiency	CERAMIC TILE: BROKEN/ MISSING
Deficiency Location/Instance	Near Drinking Fountain
Deficiency Quantity	10
Quantity Uom	S.F.
Potential Action	REPLACE
Urgency of Action	PRIORITY 3
Purpose of Action	LEVEL 2

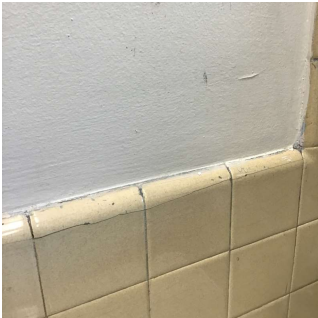
Walls	
Instance on 3rd Floor - Mezzanine	Inspected
Condition	2 - Between Good and Fair
Deficiency	CERAMIC TILE: BROKEN/ MISSING
Deficiency Location/Instance	Near Drinking Fountain
Deficiency Quantity	10
Quantity Uom	S.F.
Potential Action	REPLACE
Urgency of Action	PRIORITY 3
Purpose of Action	LEVEL 2
Deficiency Photo1

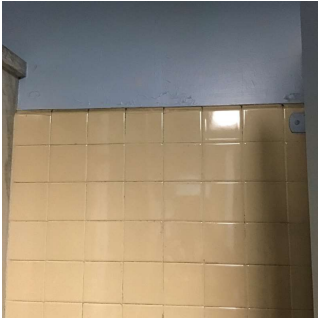
Question	Response
INTERIOR	
SHOWER ROOM	
Walls	
Violations	Near Drinking Fountain No violations recorded.
Instance on 3rd Floor	Inspected
Condition	2 - Between Good and Fair
Deficiency	CERAMIC TILE: BROKEN/ MISSING
Deficiency Location/Instance	Rear Wall
Deficiency Quantity	10
Quantity Uom	S.F.
Potential Action	REPLACE
Urgency of Action	PRIORITY 3
Purpose of Action	LEVEL 2
Deficiency Photo1

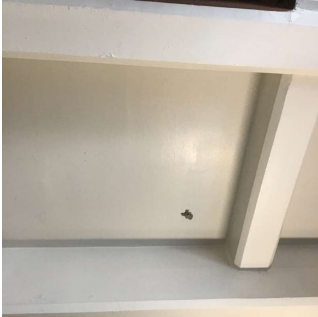
Violations	Rear Wall No violations recorded.
STAIRS/RAMPS: INTERIOR	
Do Letter Stair Signs Exist?	Inspected Yes
Ceiling	
Condition	Inspected 2 - Between Good and Fair
Deficiency	PLASTER: CRACKS/SPALLING
Deficiency Location/Instance	Stair G/4
Deficiency Quantity	10
Quantity Uom	S.F.
Potential Action	REPLACE
Urgency of Action	PRIORITY 3
Purpose of Action	LEVEL 2
Deficiency Photo1

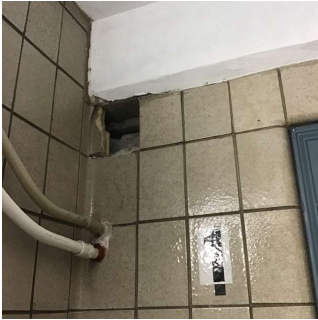
Question	Response
INTERIOR	
STAIRS/RAMPS: INTERIOR	
Stairs and Landings	Inspected
Violations	No violations recorded.
Walls	Inspected
Condition	2 - Between Good and Fair
Deficiency	GLAZED BLOCK: CRACKS/SPALLING
Deficiency Location/Instance	Stairs EF/Exit Vestibule, G/Exit Vestibule, H/1,Basement
Deficiency Quantity	40
Quantity Uom	S.F.
Potential Action	REPLACE
Urgency of Action	PRIORITY 3
Purpose of Action	LEVEL 2
Deficiency Photo1

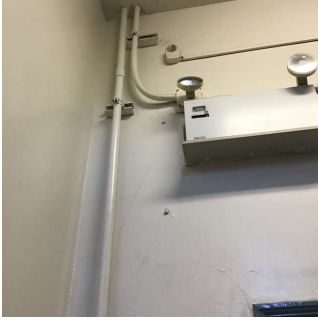
Violations	Stair H/1 No violations recorded.
Deficiency	PLASTER: CRACKS/SPALLING
Deficiency Location/Instance	Stairs BC/3, D/3,2, EF/1,3 and others
Deficiency Quantity	100
Quantity Uom	S.F.
Potential Action	REPLACE
Urgency of Action	PRIORITY 3
Purpose of Action	LEVEL 2
Deficiency Photo1

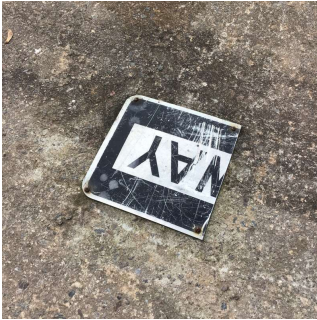
Near Park
Violations	No violations recorded.
Deficiency	DAMAGED COVER
Deficiency Location/Instance	Near Park
Deficiency Quantity	1
Quantity Uom	EACH
Potential Action	REPLACE
Urgency of Action	PRIORITY 3
Purpose of Action	LEVEL 2
Deficiency Photo1

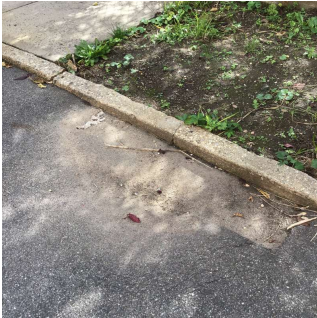
Question	Response
SITE	
PAVING	
Site Sidewalks & Walkways	
Asphalt	
Violations	No violations recorded.
Deficiency	POTHOLES
Deficiency Location/Instance	Near Playground
Deficiency Quantity	10
Quantity Uom	S.F.
Potential Action	REPAIR
Urgency of Action	PRIORITY 3
Purpose of Action	LEVEL 2
Deficiency Photo1

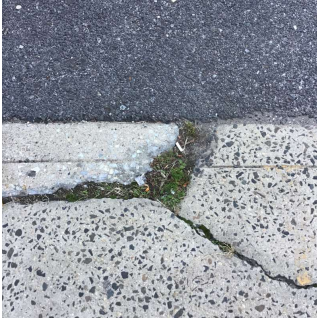
Near Playground
Violations	No violations recorded.
Concrete	
Condition	Inspected
	4 - Between Fair and Poor
Deficiency	DAMAGED CURBS
Deficiency Location/Instance	E. 17th Street, near Playground
Deficiency Quantity	280
Quantity Uom	L.F.
Potential Action	REPLACE
Urgency of Action	PRIORITY 3
Purpose of Action	LEVEL 2
Deficiency Photo1

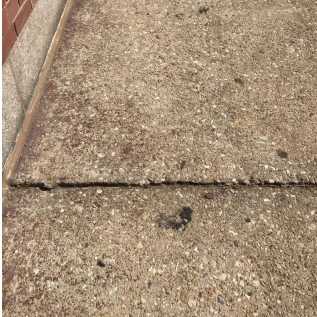
E. 17th Street
Violations	No violations recorded.
Deficiency	HEAVING
Deficiency Location/Instance	By the Park
Deficiency Quantity	125
Quantity Uom	S.F.
Potential Action	REPLACE
Urgency of Action	PRIORITY 3
Purpose of Action	LEVEL 2

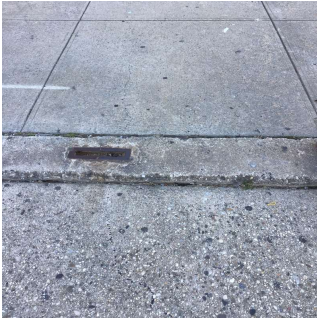
Violations	By the Park No violations recorded.
Deficiency	CRACKS - MAJOR
Deficiency Location/Instance	Moore Place, E. 17th Street, Near Playground, By Park, Avenue S
Deficiency Quantity	3,850
Quantity Uom	S.F.
Potential Action	REPLACE
Urgency of Action	PRIORITY 3
Purpose of Action	LEVEL 2
Deficiency Photo1

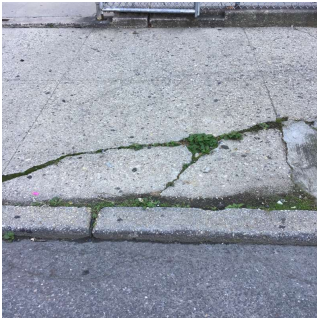
Violations	Moore Place 56243K255
Deficiency	HEAVING
Deficiency Location/Instance	Moore Place
Deficiency Quantity	50
Quantity Uom	S.F.
Potential Action	REPLACE
Urgency of Action	PRIORITY 5
Purpose of Action	LEVEL 6
Deficiency Photo1

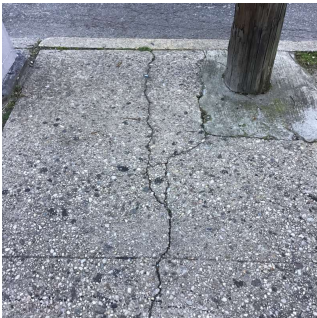
Violations	Moore Place 56243K255
Deficiency	DAMAGED/DETERIORATED/MISSING SECTIONS
Deficiency Location/Instance	Moore Place, E. 17th Street, Avenue S
Deficiency Quantity	925
Quantity Uom	S.F.
Potential Action	REPLACE
Urgency of Action	PRIORITY 4
Purpose of Action	LEVEL 4
Deficiency Photo1

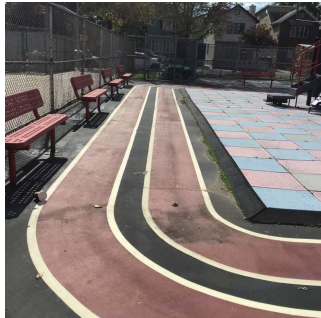
Instance on South of Building	Inspected
Condition	3 - Fair
Deficiency	ASPHALT: CRACKS - MAJOR
Deficiency Location/Instance	Playground
Deficiency Quantity	150
Quantity Uom	S.F.
Potential Action	REPLACE
Urgency of Action	PRIORITY 3
Purpose of Action	LEVEL 2
Deficiency Photo1
