NYC Department of Education
Building Condition Assessment Survey 2023 - 2024

Architectural Inspection

Asset: P.S. 256 - BROOKLYN, 114 KOSCIUSKO STREET, New York, 11216

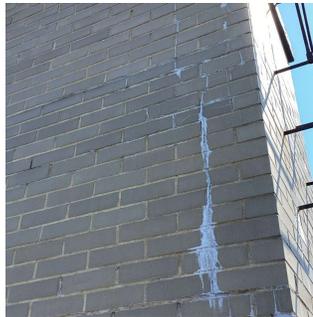
Deficiency	BRICK: MAJOR / THRU CRACKS
Roof Plan reference	K256

Deficiency Quantity	20
Quantity Uom	S.F.
Potential Action	REMOVE AND REBUILD
Urgency of Action	PRIORITY 4
Purpose of Action	LEVEL 2
Deficiency Photo1

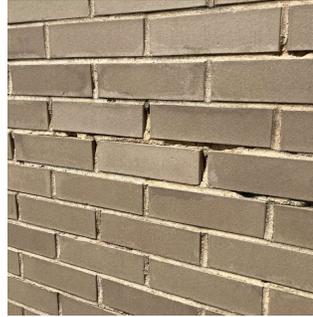
Violations	
Deficiency	BRICK: DETERIORATED JOINTS
Roof Plan reference	K256

Deficiency Quantity	60
Quantity Uom	S.F.
Potential Action	REPOINT
Urgency of Action	PRIORITY 4
Purpose of Action	LEVEL 2

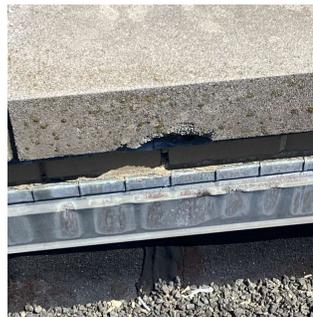
Roof 1
No violations recorded.

CAST STONE: CRACKED/BROKEN PIECES

REPLACE-IN-KIND

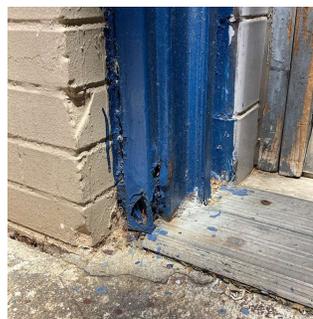
Facade C

METAL CLAD: DETERIORATED DOOR AND FRAME - MAJOR DETERIORATION

7
EACH
REPLACE
PRIORITY 4
LEVEL 2

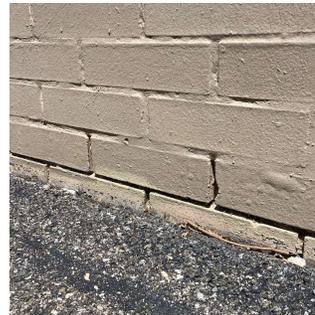
Facade C

BRICK: DETERIORATED JOINTS

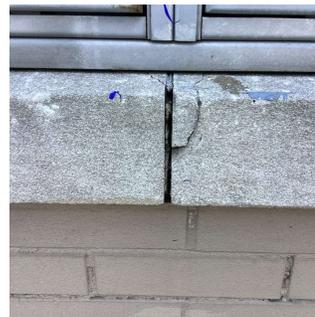
Facade A

BRICK: MASONRY SILLS - DETERIORATED JOINTS

PRIORITY 3

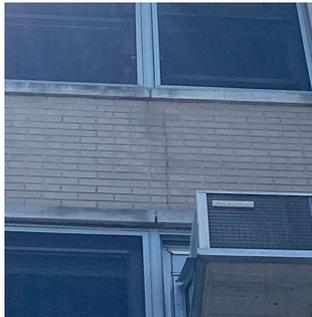
Facade A

BRICK: MAJOR / THRU CRACKS

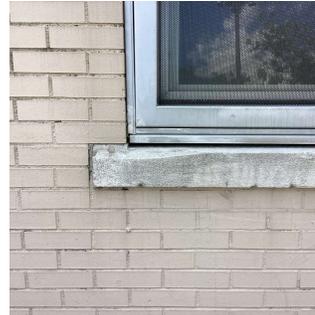
Facade A

BRICK: DETERIORATED MASONRY SILLS - MAJOR

PRIORITY 4
LEVEL 2

REMOVE AND REPLACE

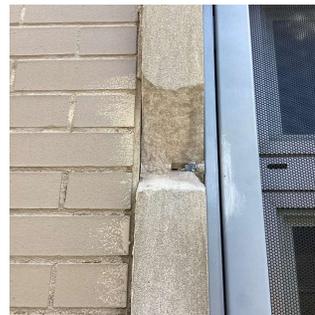
Facade F

STONE: CHIPPED/SPALLED/BROKEN PIECES - MAJOR
K256

REPLACE

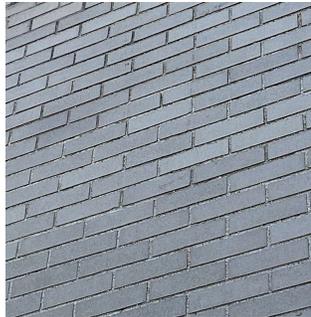
Facade F

BRICK: DETERIORATED JOINTS

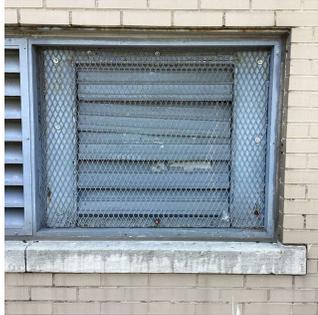
Deficiency Quantity	40
Quantity Uom	S.F.
Potential Action	MAINTENANCE
Urgency of Action	PRIORITY 1
Purpose of Action	LEVEL 1
Deficiency Photo	No photo recorded
Violations	No violations recorded.
EXTERIOR SOFFITS	Does not Exist
LOADING DOCK	Does not Exist
LOUVER	Inspected
Condition	3 - Fair
Deficiency	BROKEN/ DENTED BLADES
Roof Plan reference	K256
Elevation

Deficiency Quantity	10
Quantity Uom	S.F.
Potential Action	REPLACE
Urgency of Action	PRIORITY 4
Purpose of Action	LEVEL 2
Elevation

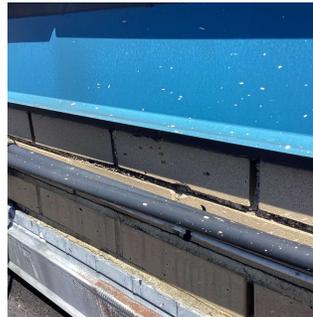
Violations	Roof 2 No violations recorded.
Deficiency	BRICK: DETERIORATED JOINTS

60
S.F.
REPOINT
PRIORITY 4
LEVEL 2

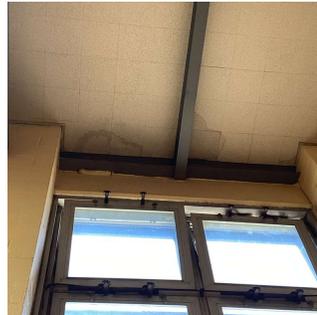
Violations	Roof 3 - Gymnasium No violations recorded.
Deficiency	BUILT-UP: FLASHING: PITCH POCKET DETERIORATED - MAJOR

Question	Response
EXTERIOR	
ROOF	
Roofing	
ROOFING	
	Roof 1
Instance Quantity	41,600
Instance Quantity Uom	S.F.
Does the roof have major mechanical equipment sitting on Dunnage Steel less than 18" above the Roofing?	No
Does this roof instance have a Sustainable Roof System?	No
Do solar panels exist on these roofs?	No
Is/Are the roof(s) suitable for Solar Panel installation?	Yes
Installation Year	1996
Source of Installation	Custodial Staff
Deficiency	BUILT-UP: ROOFING: MAJOR ACTIVE ROOF LEAKS IN INSTRUCTIONAL SPACE
Roof Plan reference	K256

Deficiency Quantity	200
Quantity Uom	S.F.
Potential Action	REPLACE ROOFING WITHOUT MAJOR EQUIPMENT REMOVAL
Urgency of Action	PRIORITY 5
Purpose of Action	LEVEL 2
Deficiency Photo1

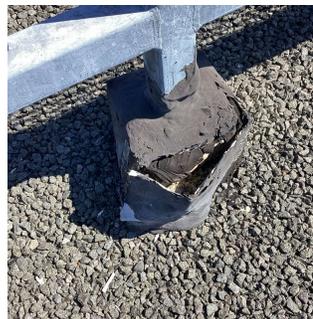
Roof 1

50
EACH
REPLACE
PRIORITY 4
LEVEL 2

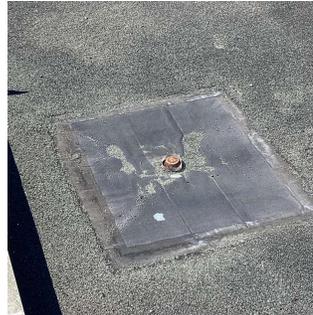
Roof 2

BUILT-UP: ROOFING: LOSS OF GRAVEL

150
S.F.
INSTALL NEW GRAVEL
PRIORITY 3
LEVEL 2

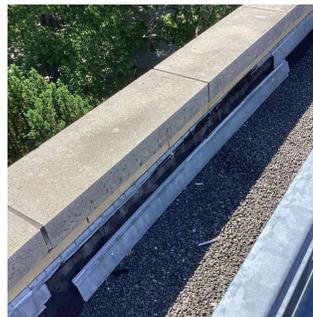
Roof 1

BUILT-UP: FLASHING: CAP FLASHING DAMAGED

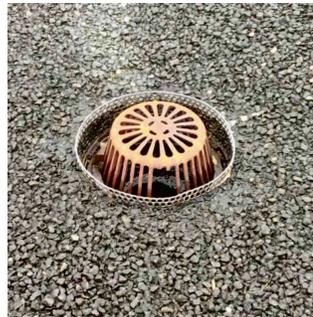
Roof 2
No violations recorded.

DETERIORATED

1
EACH
REPLACE
PRIORITY 4
LEVEL 2

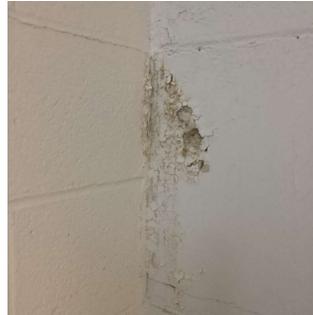
BH1

BULKHEAD/PENTHOUSE WALLS/INTERIOR: PLASTER CRACKS/SPALLING

10
S.F.
REPLACE
PRIORITY 4
LEVEL 2

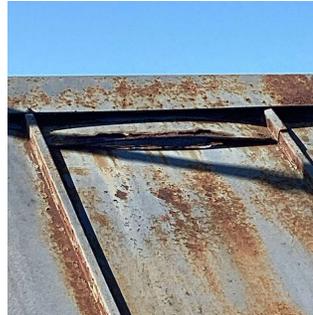
BH2

BULKHEAD/PENTHOUSE WALLS/EXTERIOR: DAMAGED METAL SIDING

20
S.F.
REPLACE
PRIORITY 4
LEVEL 2

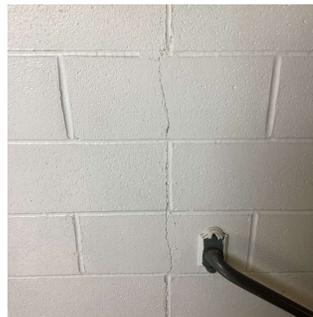
BH3

**BULKHEAD/PENTHOUSE WALLS/INTERIOR: CMU
CRACKS/SPALLING**

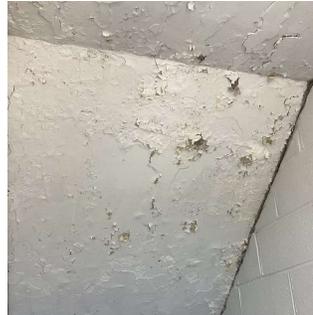
BH1

BULKHEAD/PENTHOUSE CEILING: PLASTER DAMAGED/DETERIORATED

40
S.F.
REPLACE
PRIORITY 3
LEVEL 2

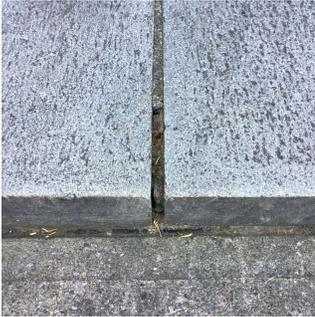
Violations	Facade F - Exit 5 No violations recorded.
STAIRS/RAMPS	
Condition	Inspected 5 - Poor
Deficiency	STONE: DETERIORATED JOINTS
Roof Plan reference	K256
Deficiency Quantity	40
Quantity Uom	L.F.
Potential Action	REPOINT
Urgency of Action	PRIORITY 4
Purpose of Action	LEVEL 2
Deficiency Photo1

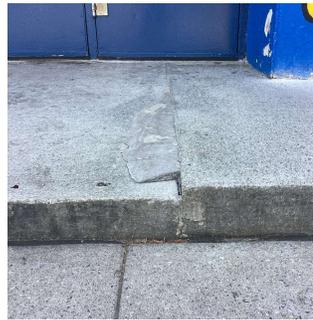
Facade A - Main Entrance

STONE: DETERIORATED SUBSTRATE

20
S.F.
REPLACE SUBSTRATE AND RESET
PRIORITY 4
LEVEL 2

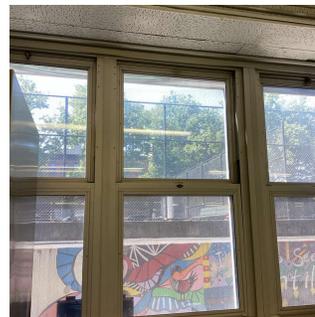
ALUMINUM - DOUBLE HUNG: HARDWARE POOR
CONDITION/MISSING

40
EACH
MAINTENANCE
PRIORITY 3
LEVEL 2

Facade C - Cafeteria (similar through)

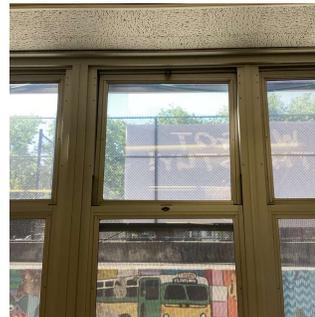
100
EACH
REPLACE BALANCES
PRIORITY 3
LEVEL 2

Facade C - Cafeteria (Facade B - Corridor near Room 201 similar throughout)

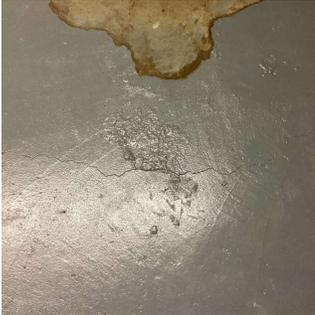
Question	Response
INTERIOR	
STRUCTURAL	Inspected
COLUMNS/BEAMS/BEARING WALLS	Inspected
Condition	2 - Between Good and Fair
Deficiency	No deficiencies recorded
FLOOR STRUCTURE	Inspected
Condition	3 - Fair
Deficiency	CONCRETE SLAB ON GRADE: THRU CRACKS
Deficiency Location/Instance	Sub-basement - Fan Room, Corridor
Deficiency Quantity	40
Quantity Uom	S.F.
Potential Action	REPAIR
Urgency of Action	PRIORITY 3
Purpose of Action	LEVEL 5
Deficiency Photo1

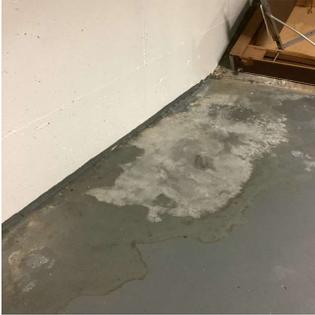
Sub-basement - Fan Room
Violations	No violations recorded.
FOUNDATION WALLS	Inspected
Material Type(s)	Concrete
Condition	4 - Between Fair and Poor
Deficiency	CONCRETE: WATER INFILTRATION IN NON- INSTRUCTIONAL SPACE
Deficiency Location/Instance	Sub-basement - Fan Room
Deficiency Quantity	100
Quantity Uom	S.F.
Potential Action	INSTALL WATERPROOFING
Urgency of Action	PRIORITY 5
Purpose of Action	LEVEL 5
Deficiency Photo1

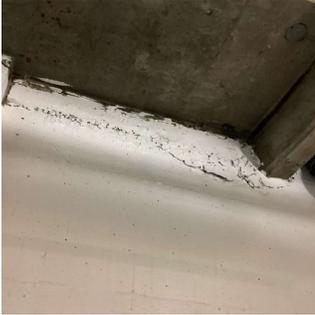
Deficiency	CONCRETE: CRACKED/SPALLED/REINFORCEMENT EXPOSED
Deficiency Location/Instance	Sub-basement - Fan Room
Deficiency Quantity	20

Question	Response
INTERIOR	
STRUCTURAL	
FOUNDATION WALLS	
Quantity Uom	S.F.
Potential Action	REPAIR
Urgency of Action	PRIORITY 4
Purpose of Action	LEVEL 5
Deficiency Photo1

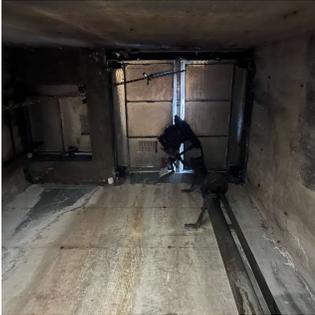
Violations	Sub-basement - Fan Room No violations recorded.
ROOF STRUCTURE	Inspected
Condition	2 - Between Good and Fair
Deficiency	No deficiencies recorded
VAULTS-BUNKERS	Inspected
Foundation Walls	Inspected
Condition	2 - Between Good and Fair
Deficiency	No deficiencies recorded
Slab Structure	Inspected
Condition	2 - Between Good and Fair
Deficiency	No deficiencies recorded
Vault/Ash Hoist Doors and Framing	Inspected
Condition	5 - Poor
Deficiency	WATER INFILTRATION
Deficiency Location/Instance	Ash Hoist Vault
Deficiency Quantity	10
Quantity Uom	S.F.
Potential Action	REPAIR
Urgency of Action	PRIORITY 5
Purpose of Action	LEVEL 2
Deficiency Photo1

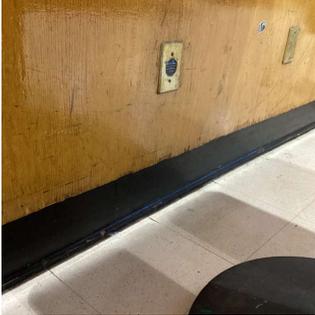
Near Exit 6
Violations	No violations recorded.
Sliding-folding Partition	
Instance on Basement (422 Seats)	Does not Exist
Stage	
Instance on Basement (422 Seats)	Inspected
Stage	Inspected
Instance on Basement (422 Seats)	Inspected
Condition	2 - Between Good and Fair
Deficiency	DAMAGED FASCIA
Deficiency Location/Instance	Center
Deficiency Quantity	10
Quantity Uom	S.F.
Potential Action	REPLACE
Urgency of Action	PRIORITY 3
Purpose of Action	LEVEL 2
Deficiency Photo1

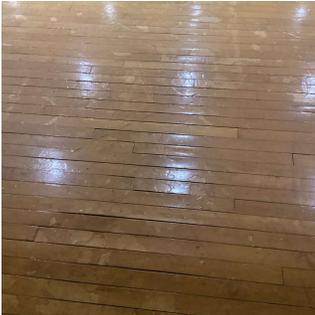
Center
Violations	No violations recorded.
Deficiency	DAMAGED FLOOR
Deficiency Location/Instance	Center
Deficiency Quantity	10
Quantity Uom	S.F.
Potential Action	REPLACE
Urgency of Action	PRIORITY 3
Purpose of Action	LEVEL 2

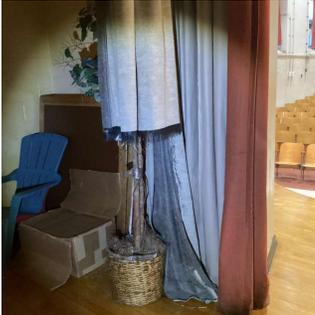
Center
Violations	No violations recorded.
Stage Curtain Rigging	Inspected
Instance on Basement (422 Seats)	Inspected
Condition	2 - Between Good and Fair
Deficiency	No deficiencies recorded
Stage Curtains	Inspected
Instance on Basement (422 Seats)	Inspected
Condition	5 - Poor
Deficiency	WORN/DETERIORATED
Deficiency Location/Instance	Left Side, Right Side
Deficiency Quantity	1,000
Quantity Uom	S.F.
Potential Action	REPLACE
Urgency of Action	PRIORITY 3
Purpose of Action	LEVEL 2
Deficiency Photo1

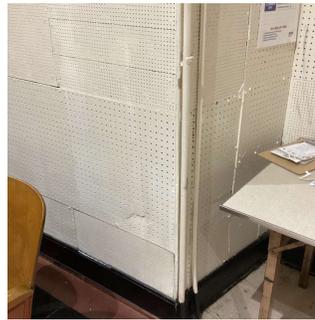
Left Side
Violations	No violations recorded.
Walls	
Instance on Basement (422 Seats)	Inspected
Condition	2 - Between Good and Fair
Deficiency	WOOD PANELING: DETERIORATED
Deficiency Location/Instance	Near Entrance
Deficiency Quantity	40
Quantity Uom	S.F.
Potential Action	REPLACE
Urgency of Action	PRIORITY 3
Purpose of Action	LEVEL 2

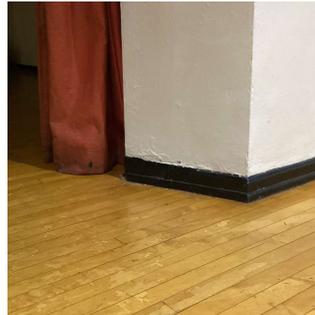
Stage Left

PLASTER: CRACKS/SPALLING

REPLACE

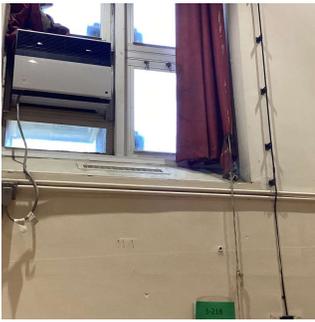
WORN/DAMAGED CURTAINS

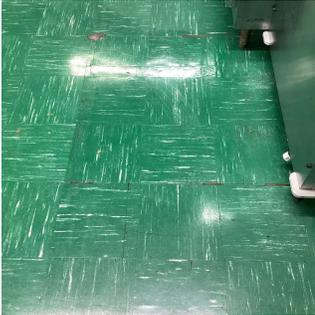
Violations	Near Stage No violations recorded.
CAFETERIA	Inspected
Instance on Basement	Inspected
Ceiling	
Instance on Basement	Inspected
Condition	2 - Between Good and Fair
Deficiency	No deficiencies recorded
Door(s)	
Instance on Basement	Inspected
Condition	2 - Between Good and Fair
Deficiency	No deficiencies recorded
Fixed Equipment	
Instance on Basement	Does not Exist
Floor Finish	
Instance on Basement	Inspected
Condition	2 - Between Good and Fair
Deficiency	VINYL TILES: DETERIORATED SUBSTRATE
Deficiency Location/Instance	Center, Near Kitchen Entrance
Deficiency Quantity	40
Quantity Uom	S.F.
Potential Action	REPLACE
Urgency of Action	PRIORITY 3
Purpose of Action	LEVEL 2
Deficiency Photo1

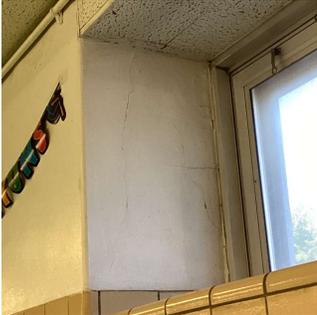
Question	Response
INTERIOR	
CAFETERIA	Inspected
Stage	
Instance on Basement	Does not Exist
Walls	
Instance on Basement	Inspected
Condition	2 - Between Good and Fair
Deficiency	PLASTER: CRACKS/SPALLING
Deficiency Location/Instance	Left Side
Deficiency Quantity	10
Quantity Uom	S.F.
Potential Action	REPLACE
Urgency of Action	PRIORITY 3
Purpose of Action	LEVEL 2
Deficiency Photo1

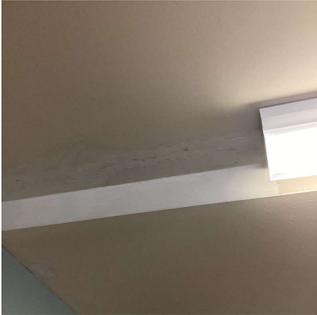
Room 201
Violations	No violations recorded.
Deficiency	ACOUSTIC TILES ON PLASTER: DAMAGED/MISSING

Left Side
Violations	No violations recorded.
Window Curtains/Shades/Blinds	
Instance on Basement	Does not Exist
CLASSROOMS/CORRIDORS/ADMIN SPACES	Inspected
Ceiling	Inspected
Condition	2 - Between Good and Fair
Deficiency	PLASTER: CRACKS/SPALLING - ACTIVE LEAK
Deficiency Location/Instance	Room 201
Deficiency Quantity	10
Quantity Uom	S.F.
Potential Action	REPLACE
Urgency of Action	PRIORITY 5
Purpose of Action	LEVEL 2
Deficiency Photo1

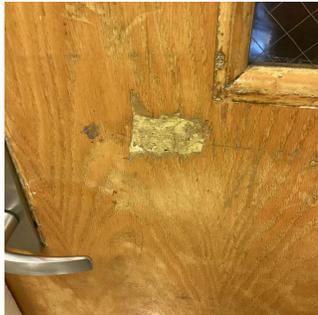
Room B3
Violations	No violations recorded.
Deficiency	METAL: DETERIORATED DOOR
Deficiency Location/Instance	Room B8
Deficiency Quantity	1
Quantity Uom	EACH
Potential Action	MAINTENANCE
Urgency of Action	PRIORITY 3
Purpose of Action	LEVEL 2

Room 117
Violations	No violations recorded.
Door(s)	Inspected
Condition	5 - Poor
Deficiency	WOOD: DETERIORATED DOOR
Deficiency Location/Instance	Rooms B3, B19, 117, 208, 303, and others
Deficiency Quantity	15
Quantity Uom	EACH
Potential Action	MAINTENANCE
Urgency of Action	PRIORITY 3
Purpose of Action	LEVEL 2
Deficiency Photo1

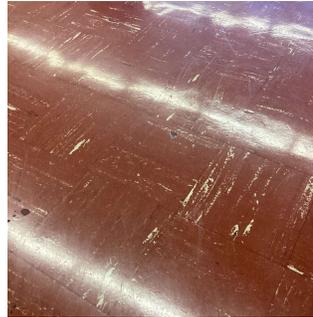
Room 220

VINYL TILES: BROKEN/DETERIORATED/MISSING TILES

REPLACE

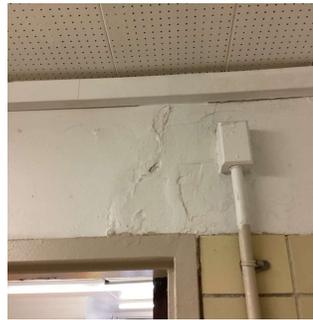
Corridor near Room B25

PLASTER: CRACKS/SPALLING

REPLACE

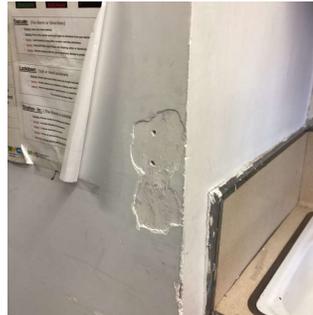
Room 319

PLASTER: CRACKS/SPALLING - ACTIVE LEAK

REPLACE

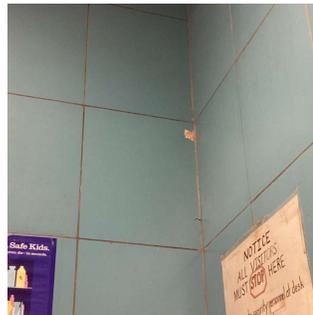
Main Entrance Vestibule

GLAZED BLOCK: CRACKS/SPALLING

REPLACE

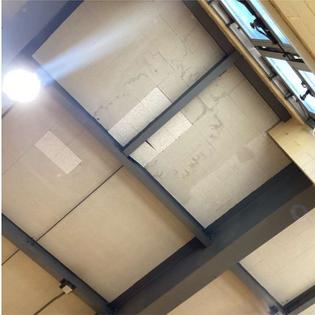
Question	Response
INTERIOR	
CLASSROOMS/CORRIDORS/ADMIN SPACES	Inspected
Walls	Inspected
Violations	No violations recorded.
Specialties	Does not Exist
GYMNASIUM	Inspected
Instance on Basement	Inspected
Ceiling	
Instance on Basement	Inspected
Condition	2 - Between Good and Fair
Deficiency	ACOUSTIC TILES ON PLASTER: DAMAGED/MISSING - ACTIVE LEAK
Deficiency Location/Instance	Near Windows
Deficiency Quantity	80
Quantity Uom	S.F.
Potential Action	REPLACE
Urgency of Action	PRIORITY 5
Purpose of Action	LEVEL 6
Deficiency Photo1

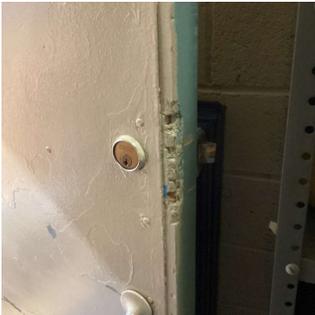
Violations	Near Windows No violations recorded.
Door(s)	
Instance on Basement	Inspected
Condition	4 - Between Fair and Poor
Deficiency	WOOD: DETERIORATED DOOR
Deficiency Location/Instance	Storage Room, Office
Deficiency Quantity	2
Quantity Uom	EACH
Potential Action	MAINTENANCE
Urgency of Action	PRIORITY 3
Purpose of Action	LEVEL 2
Deficiency Photo1

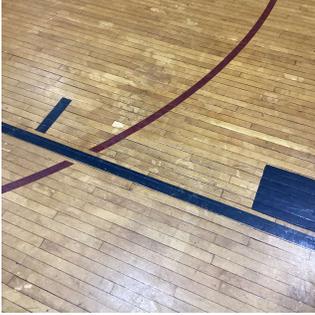
Question	Response
INTERIOR	
GYMNASIUM	Inspected
Fixed Equipment	
Instance on Basement	Inspected
Condition	2 - Between Good and Fair
Deficiency	No deficiencies recorded
Floor Finish	
Instance on Basement	Inspected
Condition	2 - Between Good and Fair
Deficiency	WOOD: DAMAGED/DETERIORATED
Deficiency Location/Instance	Center, Near Drinking Fountain
Deficiency Quantity	20
Quantity Uom	S.F.
Potential Action	REPLACE
Urgency of Action	PRIORITY 3
Purpose of Action	LEVEL 2
Deficiency Photo1

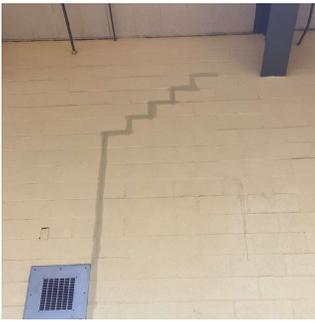
Center
Violations	No violations recorded.
Seating	
Instance on Basement	Inspected
Condition	2 - Between Good and Fair
Deficiency	No deficiencies recorded
Sliding-folding Partition	
Instance on Basement	Does not Exist
Stage	
Instance on Basement	Does not Exist
Walls	
Instance on Basement	Inspected
Condition	2 - Between Good and Fair
Deficiency	MASONRY: CRACKS/SPALLING
Deficiency Location/Instance	Opposite the Windows
Deficiency Quantity	30

Quantity Uom	S.F.
Potential Action	REPLACE
Urgency of Action	PRIORITY 3
Purpose of Action	LEVEL 2

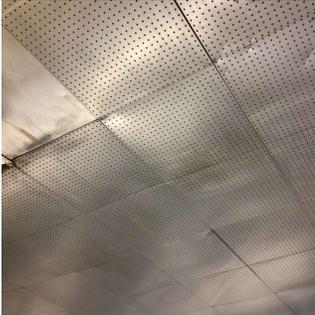
Violations	Opposite the Windows No violations recorded.
Window Curtains/Shades/Blinds	
Instance on Basement	Does not Exist
INTERIOR DOOR HARDWARE	
Condition	Inspected 3 - Fair
Deficiency	No deficiencies recorded
INTERIOR GUARDS	
Condition	Inspected 2 - Between Good and Fair
Deficiency	No deficiencies recorded
KITCHEN	
Instance on Basement	Inspected
Ceiling	
Instance on Basement	Inspected
Condition	2 - Between Good and Fair
Deficiency	METAL PAN: DAMAGED/MISSING
Deficiency Location/Instance	Near Exit to Exterior
Deficiency Quantity	10
Quantity Uom	S.F.
Potential Action	REPLACE
Urgency of Action	PRIORITY 3
Purpose of Action	LEVEL 2
Deficiency Photo1

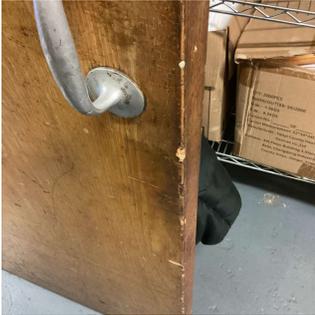
Storage Room
Violations	No violations recorded.

Violations	Near Exit to Exterior No violations recorded.
Door(s)	
Instance on Basement	Inspected
Condition	3 - Fair
Deficiency	WOOD: DETERIORATED DOOR
Deficiency Location/Instance	Storage Room

Question	Response
INTERIOR	
KITCHEN	
Door(s)	
Deficiency Quantity	1
Quantity Uom	EACH
Potential Action	MAINTENANCE
Urgency of Action	PRIORITY 3
Purpose of Action	LEVEL 2
Deficiency Photo1

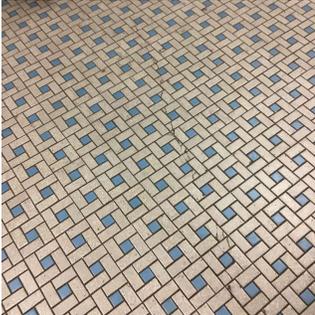
Left Side
Violations	No violations recorded.

Instance on Basement	Inspected
Condition	3 - Fair
Deficiency	CERAMIC TILE: DETERIORATED SUBSTRATE
Deficiency Location/Instance	Center, Left Side
Deficiency Quantity	40
Quantity Uom	S.F.
Potential Action	REPLACE
Urgency of Action	PRIORITY 3
Purpose of Action	LEVEL 2
Deficiency Photo1

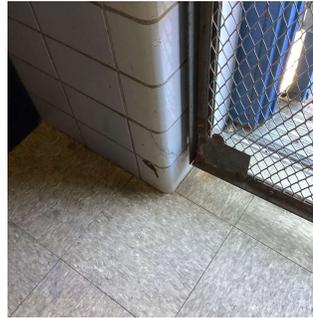
Instance on Basement	Inspected
Condition	2 - Between Good and Fair
Deficiency	GLAZED BLOCK: CRACKS/SPALLING
Deficiency Location/Instance	Exit Vestibule
Deficiency Quantity	10
Quantity Uom	S.F.
Potential Action	REPLACE
Urgency of Action	PRIORITY 3
Purpose of Action	LEVEL 2

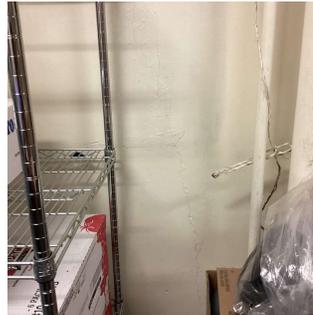
Storage Room

PLASTER: CRACKS/SPALLING

REPLACE

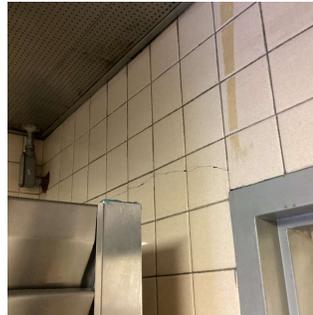
Near Storage Room

CERAMIC TILE: BROKEN/ MISSING

REPLACE

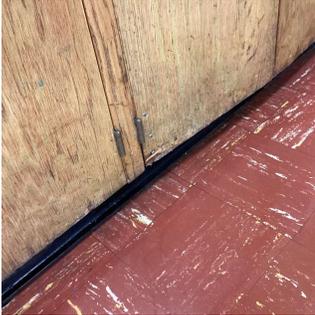
Question	Response
INTERIOR	
LIBRARY	Inspected
Instance on Room 222	Inspected
Built-in Furnishing	
Instance on Room 222	Inspected
Condition	2 - Between Good and Fair
Deficiency	SINK/STORAGE CABINET - DAMAGED/DETERIORATED
Deficiency Location/Instance	Left Side
Deficiency Quantity	10
Quantity Uom	L.F.
Potential Action	REPLACE
Urgency of Action	PRIORITY 3
Purpose of Action	LEVEL 2
Deficiency Photo1

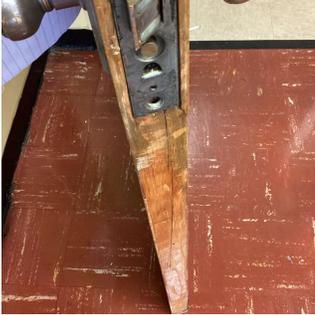
Left Side
Violations	No violations recorded.
Ceiling	
Instance on Room 222	Inspected
Condition	2 - Between Good and Fair
Deficiency	No deficiencies recorded
Door(s)	
Instance on Room 222	Inspected
Condition	3 - Fair
Deficiency	WOOD: DETERIORATED DOOR
Deficiency Location/Instance	Entrance
Deficiency Quantity	1
Quantity Uom	EACH
Potential Action	MAINTENANCE
Urgency of Action	PRIORITY 3
Purpose of Action	LEVEL 2
Deficiency Photo1

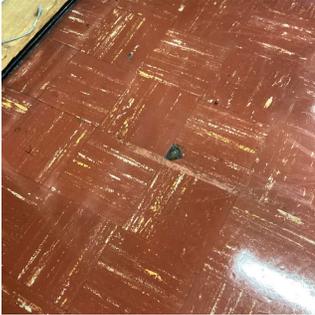
Question	Response
INTERIOR	
LIBRARY	
Floor Finish	
Instance on Room 222	Inspected
Condition	3 - Fair
Deficiency	VINYL TILES: BROKEN/DETERIORATED/MISSING TILES
Deficiency Location/Instance	Left Side, Near Entrance, Center, Right Side
Deficiency Quantity	40
Quantity Uom	S.F.
Potential Action	REPLACE
Urgency of Action	PRIORITY 3
Purpose of Action	LEVEL 2
Deficiency Photo1

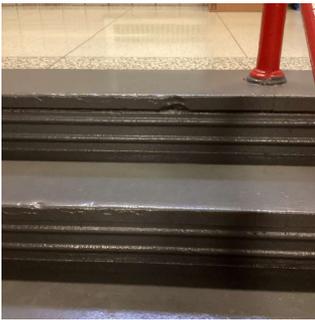
Deficiency	STONE: BROKEN/MISSING
Deficiency Location/Instance	Stair AB/Basement
Deficiency Quantity	10
Quantity Uom	S.F.
Potential Action	REPLACE
Urgency of Action	PRIORITY 3
Purpose of Action	LEVEL 2

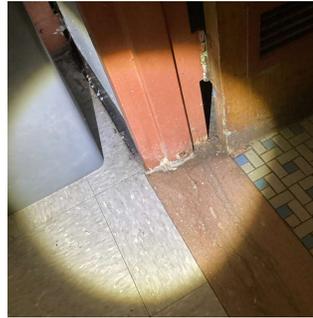
Violations	Stair CD/Bulkhead No violations recorded.
Walls	Inspected
Condition	2 - Between Good and Fair
Deficiency	No deficiencies recorded
TOILET ROOMS - STAFF	Inspected
Ceiling	Inspected
Condition	2 - Between Good and Fair
Deficiency	No deficiencies recorded
Door(s)	Inspected
Condition	5 - Poor
Deficiency	METAL: DETERIORATED DOOR AND FRAME
Deficiency Location/Instance	In Room B8
Deficiency Quantity	1
Quantity Uom	EACH
Potential Action	MAINTENANCE
Urgency of Action	PRIORITY 3
Purpose of Action	LEVEL 2

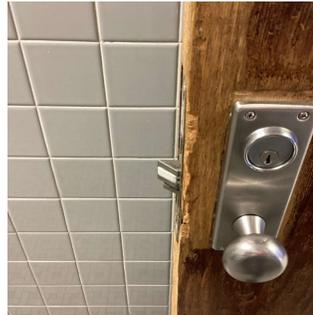
Room 301A

WOOD: DETERIORATED DOOR

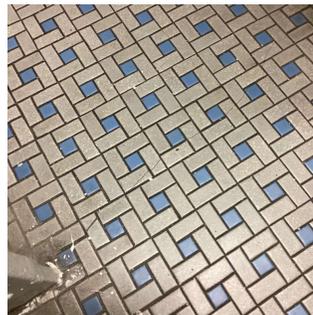
CERAMIC TILE: BROKEN/MISSING TILES

REPLACE

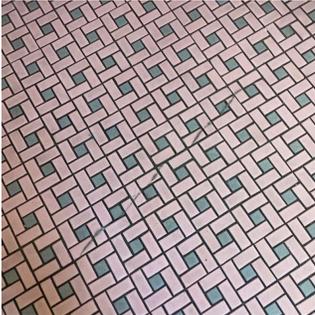
Question	Response
INTERIOR	
TOILET ROOMS - STAFF	
Floor Finish	
Violations	Room 301A No violations recorded.
Deficiency	CERAMIC TILE: DETERIORATED SUBSTRATE
Deficiency Location/Instance	Room B15
Deficiency Quantity	10
Quantity Uom	S.F.
Potential Action	REPLACE
Urgency of Action	PRIORITY 3
Purpose of Action	LEVEL 2
Deficiency Photo1

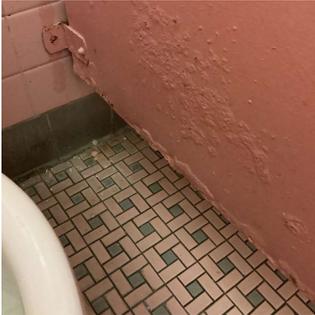
Violations	Room B15 No violations recorded.
Stalls	Inspected
Condition	5 - Poor
Deficiency	RUST - MAJOR
Deficiency Location/Instance	In Rooms B1, B8, Rooms B11, B15, 101A
Deficiency Quantity	5
Quantity Uom	EACH
Potential Action	REPLACE
Urgency of Action	PRIORITY 3
Purpose of Action	LEVEL 2
Deficiency Photo1

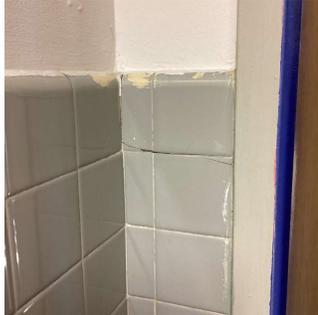
Violations	In Room B1 No violations recorded.
Walls	Inspected
Condition	2 - Between Good and Fair
Deficiency	CERAMIC TILE: BROKEN/ MISSING
Deficiency Location/Instance	In Room 117, Room 301A
Deficiency Quantity	10
Quantity Uom	S.F.
Potential Action	REPLACE

Question	Response
INTERIOR	
TOILET ROOMS - STAFF	
Walls	
Urgency of Action	PRIORITY 3
Purpose of Action	LEVEL 2
Deficiency Photo1

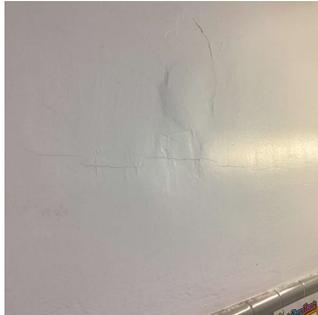
Room 301A
Violations	No violations recorded.
Deficiency	PLASTER: CRACKS/SPALLING
Deficiency Location/Instance	In Gymnasium Office, In Room 117, Room B11, 301A
Deficiency Quantity	40
Quantity Uom	S.F.
Potential Action	REPLACE
Urgency of Action	PRIORITY 3
Purpose of Action	LEVEL 2
Deficiency Photo1

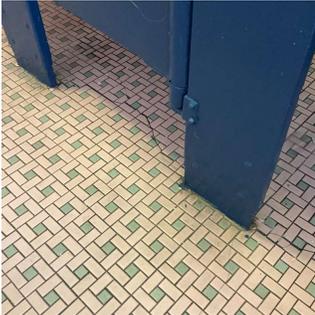
Question	Response
INTERIOR	
TOILET ROOMS - STUDENTS	
Floor Finish	
Violations	Room 316 No violations recorded.
Deficiency	CERAMIC TILE: DETERIORATED SUBSTRATE
Deficiency Location/Instance	Rooms 110, 116, 210, 310
Deficiency Quantity	90
Quantity Uom	S.F.
Potential Action	REPLACE
Urgency of Action	PRIORITY 3
Purpose of Action	LEVEL 2
Deficiency Photo1

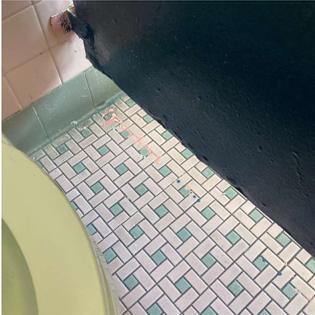
Violations	Room 310 No violations recorded.
Stalls	Inspected
Condition	5 - Poor
Deficiency	RUST - MAJOR
Deficiency Location/Instance	Rooms 110, 210, 310
Deficiency Quantity	12
Quantity Uom	EACH
Potential Action	REPLACE
Urgency of Action	PRIORITY 3
Purpose of Action	LEVEL 2
Deficiency Photo1

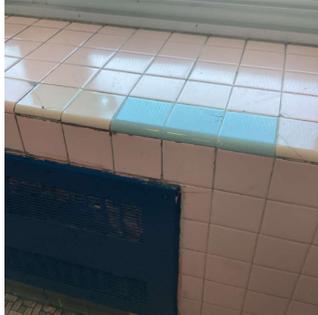
Violations	Room 310 No violations recorded.
Walls	Inspected
Condition	2 - Between Good and Fair
Deficiency	CERAMIC TILE: BROKEN/ MISSING
Deficiency Location/Instance	Rooms 110, 116, 210, 216, 310, 316
Deficiency Quantity	60
Quantity Uom	S.F.
Potential Action	REPLACE

Question	Response
INTERIOR	
TOILET ROOMS - STUDENTS	
Walls	
Urgency of Action	PRIORITY 3
Purpose of Action	LEVEL 2
Deficiency Photo1

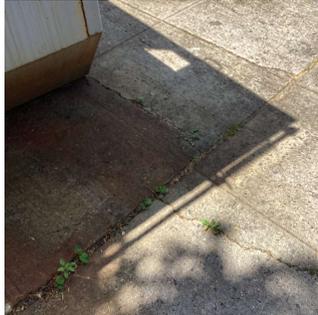
Room 310
Violations	No violations recorded.
LIFE SAFETY	Inspected
F.D. HOLDING AREA	Does not Exist
STEEL STAIRS	Does not Exist
SITE	Inspected
CONTAINERIZATION	Inspected
Condition	5 - Poor
Deficiency	CONCRETE PAD DAMAGED
Deficiency Location/Instance	Kosciuszko Street
Deficiency Quantity	100
Quantity Uom	S.F.
Potential Action	REPAIR
Urgency of Action	PRIORITY 3
Purpose of Action	LEVEL 2
Deficiency Photo1

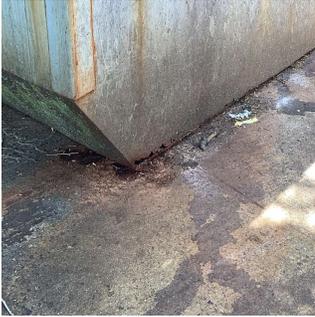
Kosciuszko Street
Violations	No violations recorded.
Deficiency	CONTAINER DAMAGED
Deficiency Location/Instance	Kosciuszko Street
Deficiency Quantity	1
Quantity Uom	EACH
Potential Action	REPLACE
Urgency of Action	PRIORITY 3
Purpose of Action	LEVEL 2

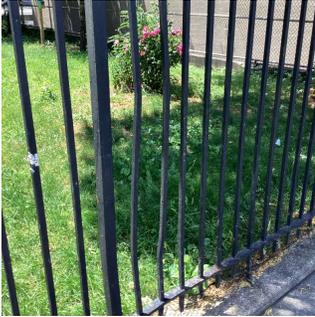
Violations	Kosciuszko Street No violations recorded.
Drainage System for Asphalt	Inspected
Catch Basins/Manhole - Surrounded by asphalt	Inspected
Condition	2 - Between Good and Fair
Deficiency	No deficiencies recorded
Culverts - Asphalt Covering	Does not Exist
Drainage System for Concrete	Inspected
Catch Basins/Manhole - Surrounded by concrete	Inspected
Condition	2 - Between Good and Fair
Deficiency	No deficiencies recorded
Culverts - Concrete Covering	Does not Exist
Drainage System for Soil	Does not Exist
DRINKING FOUNTAINS	Does not Exist
FENCES	Inspected
Condition	3 - Fair
Deficiency	WROUGHT IRON: DAMAGED/DETERIORATED
Deficiency Location/Instance	Kosciuszko Street
Deficiency Quantity	40
Quantity Uom	S.F.
Potential Action	REPLACE
Urgency of Action	PRIORITY 3
Purpose of Action	LEVEL 2
Deficiency Photo1

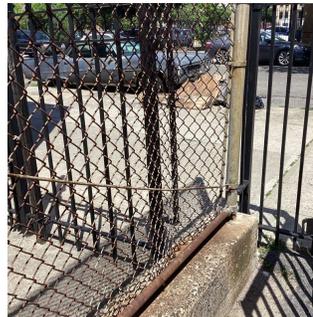
CHAIN LINK: DAMAGED/DETERIORATED
West Side of Building
100
S.F.
REPLACE
PRIORITY 3
LEVEL 2

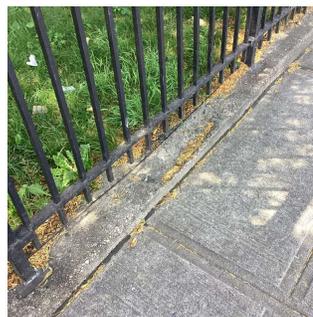
CONCRETE CURB: DAMAGED/DETERIORATED
West Side of Building, Kosciuszko Street
45
S.F.
REPLACE
PRIORITY 3
LEVEL 2

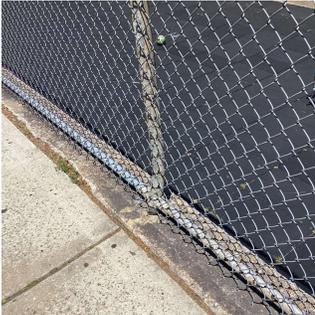
Question	Response
SITE	
FENCES	
Violations	Kosciuszko Street No violations recorded.
Deficiency	CHAIN LINK: DAMAGED POST/RAIL
Deficiency Location/Instance	Lafayette Avenue
Deficiency Quantity	10
Quantity Uom	L.F.
Potential Action	REPLACE
Urgency of Action	PRIORITY 3
Purpose of Action	LEVEL 2
Deficiency Photo1

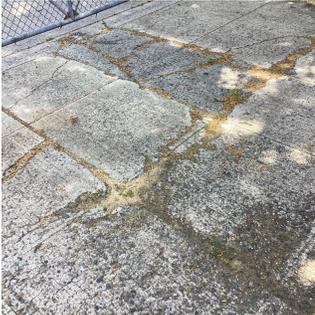
Violations	Lafayette Avenue No violations recorded.
IRRIGATION SYSTEM	Does not Exist
PAVING	Inspected
Student Non-Use	Inspected
Gravel Exists?	No
Asphalt	Does not Exist
Concrete	Inspected
Condition	3 - Fair
Deficiency	DAMAGED/DETERIORATED/MISSING SECTIONS
Deficiency Location/Instance	Kosciuszko Street
Deficiency Quantity	450
Quantity Uom	S.F.
Potential Action	REPLACE
Urgency of Action	PRIORITY 3
Purpose of Action	LEVEL 2
Deficiency Photo1

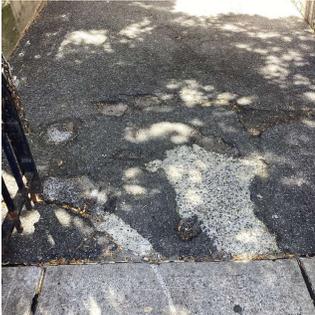
Question	Response
SITE	
PAVING	
Site Sidewalks & Walkways	Inspected
Asphalt	Inspected
Condition	4 - Between Fair and Poor
Deficiency	POTHOLES
Deficiency Location/Instance	East Side of Building
Deficiency Quantity	150
Quantity Uom	S.F.
Potential Action	REPAIR
Urgency of Action	PRIORITY 3
Purpose of Action	LEVEL 2
Deficiency Photo1

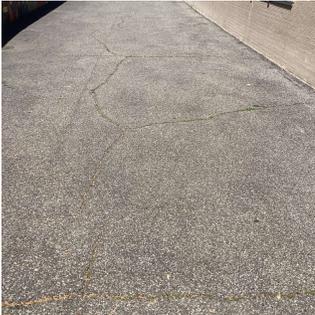
Violations	East Side of Building No violations recorded.
Deficiency	CRACKS - MAJOR
Deficiency Location/Instance	Rear of Building, West Side of Building
Deficiency Quantity	1,500
Quantity Uom	S.F.
Potential Action	REPLACE
Urgency of Action	PRIORITY 3
Purpose of Action	LEVEL 2
Deficiency Photo1

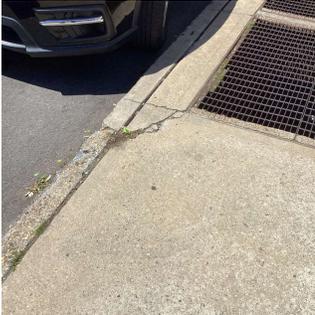
Question	Response
SITE	
PAVING	
DOT Sidewalk	
Concrete	
Deficiency Location/Instance	Lafayette Avenue, Kosciuszko Street
Deficiency Quantity	200
Quantity Uom	S.F.
Potential Action	REPLACE
Urgency of Action	PRIORITY 3
Purpose of Action	LEVEL 2
Deficiency Photo1

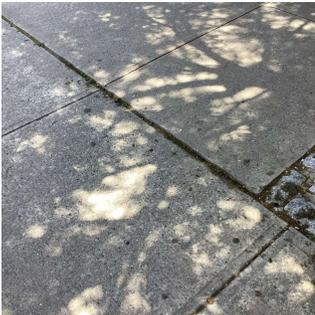
Violations	Lafayette Avenue No violations recorded.
Deficiency	HEAVING
Deficiency Location/Instance	Lafayette Avenue, Kosciuszko Street
Deficiency Quantity	75
Quantity Uom	S.F.
Potential Action	REPLACE
Urgency of Action	PRIORITY 3
Purpose of Action	LEVEL 2
Deficiency Photo1

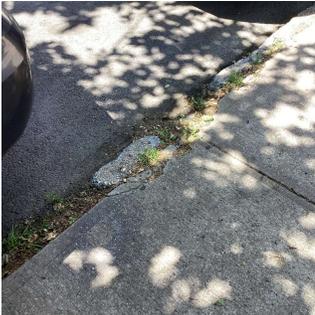
Violations	Lafayette Avenue No violations recorded.
Deficiency	DAMAGED CURBS
Deficiency Location/Instance	Lafayette Avenue, Kosciuszko Street
Deficiency Quantity	130
Quantity Uom	L.F.
Potential Action	REPLACE
Urgency of Action	PRIORITY 3
Purpose of Action	LEVEL 2

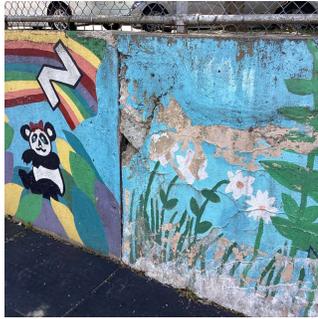
Violations	East Side No violations recorded.
Unpaved Area	
Instance on Along Lafayette Avenue	Does not Exist
PLAYING SURFACE	Does not Exist
RETAINING WALLS	Inspected
Are there any Retaining Walls 6' OR higher facing public street/sidewalk?	No
Condition	3 - Fair
Deficiency	CAST IN PLACE CONCRETE: CRACKS/SPALLING - MAJOR
Deficiency Location/Instance	Rear of Building, East Side of Building, Playground
Deficiency Quantity	200
Quantity Uom	S.F.
Potential Action	REPLACE
Urgency of Action	PRIORITY 3
Purpose of Action	LEVEL 2
Deficiency Photo1

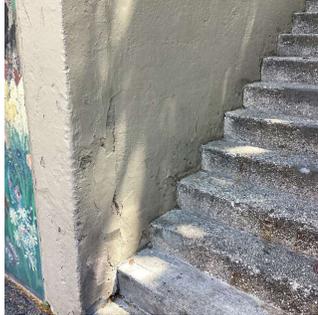
Violations	Playground No violations recorded.
SEATING	Does not Exist
SITE WALLS (NOT RETAINING WALLS)	Does not Exist
STAIRS/RAMPS: EXTERIOR	Inspected
Railings	Inspected
Condition	3 - Fair
Deficiency	MISSING
Deficiency Location/Instance	Stairway Leading to NYC Park
Deficiency Quantity	13
Quantity Uom	L.F.

Potential Action	REPLACE
Urgency of Action	PRIORITY 5

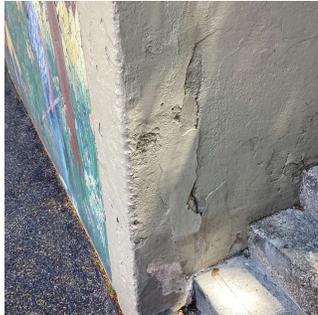
Violations	Stairway Leading to NYC Park No violations recorded.
Site Cheek/flank Walls	
Condition	Inspected
Deficiency	2 - Between Good and Fair
Deficiency Location/Instance	CAST IN PLACE CONCRETE: CRACKS/SPALLING - MAJOR Stairway Leading to NYC Park
Deficiency Quantity	30
Quantity Uom	S.F.
Potential Action	REPLACE
Urgency of Action	PRIORITY 3
Purpose of Action	LEVEL 2
Deficiency Photo1
