NYC Department of Education
Building Condition Assessment Survey 2023 - 2024

Architectural Inspection

Asset: P.S. 257 - BROOKLYN, 60 COOK STREET, New York, 11206

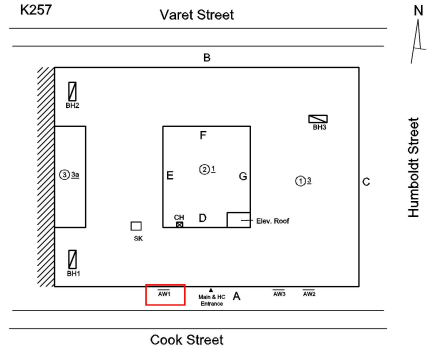
Violations	Areaway 1 No violations recorded.
Deficiency	AREAWAY GRATINGS: MAJOR RUSTING AND / OR BROKEN SUPPORTS
Roof Plan reference

Deficiency Quantity	10
Quantity Uom	L.F.
Potential Action	REPLACE
Urgency of Action	PRIORITY 4
Purpose of Action	LEVEL 2
Deficiency Photo1

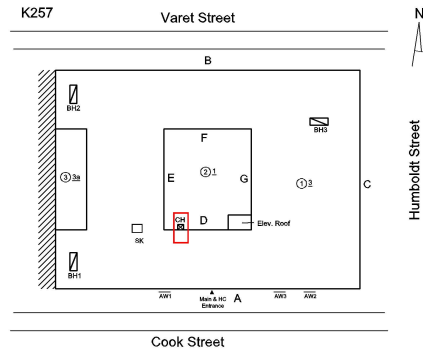
Roof Plan reference

Violations	Areaway 1 No violations recorded.
AWNINGS AND CANOPIES	Does not Exist
CHIMNEY	Inspected
Material Type(s)	Masonry
Condition	3 - Fair
Deficiency	BRICK: DETERIORATED JOINTS

100
S.F.
REPOINT
PRIORITY 3
LEVEL 2

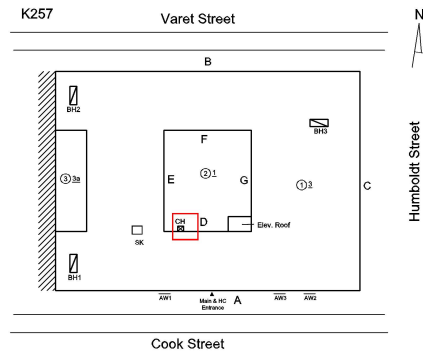
Roof Plan reference

BRICK: MAJOR / THRU CRACKS

10
S.F.
REMOVE AND REBUILD
PRIORITY 4
LEVEL 2

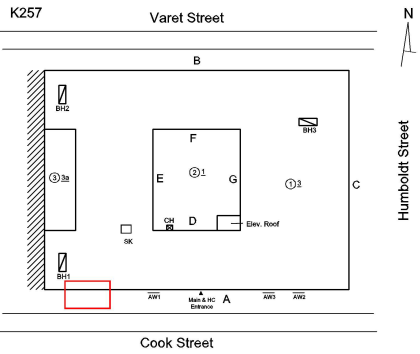
Question	Response
EXTERIOR	
DOORS	
DOORS AND FRAMES	
Roof Plan reference

Question	Response
EXTERIOR	
CHIMNEY	
Deficiency Photo1	 
Violations	Chimney No violations recorded.
COPING	Does not Exist
CORNICE	Does not Exist
DOORS	Inspected
DOORS AND FRAMES	Inspected
Condition	5 - Poor
Deficiency	METAL CLAD: DETERIORATED DOOR AND FRAME - MINOR DETERIORATION
Roof Plan reference	 
Deficiency Quantity	1
Quantity Uom	EACH
Potential Action	MAINTENANCE
Urgency of Action	PRIORITY 3
Purpose of Action	LEVEL 2
Deficiency Photo1	 
Violations	Facade B North View No violations recorded.
Deficiency	METAL: DETERIORATED DOOR - MAJOR DETERIORATION

Deficiency Quantity	5
Quantity Uom	EACH
Potential Action	REPLACE
Urgency of Action	PRIORITY 5
Purpose of Action	LEVEL 2
Deficiency Photo1

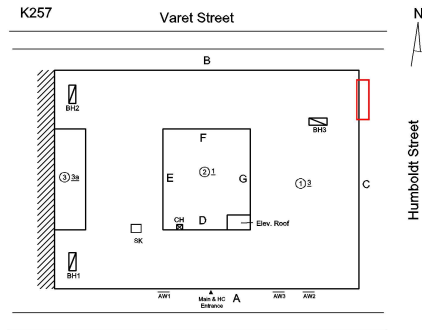
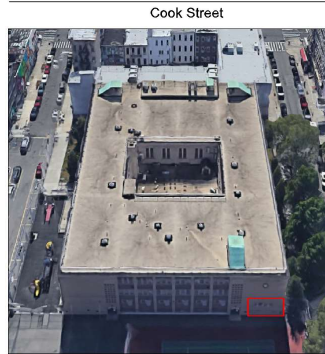
Roof Plan reference

Violations	Facade A - South view No violations recorded.
DOOR HARDWARE	Inspected
Condition	3 - Fair
Deficiency	No deficiencies recorded
LINTELS	Inspected
Condition	2 - Between Good and Fair
Deficiency	No deficiencies recorded
TRANSOM/SIDE LIGHT	Inspected
Condition	2 - Between Good and Fair
Deficiency	No deficiencies recorded
EXTERIOR WALLS	Inspected
Material Type(s)	Masonry
Replacement Quantity	17,000
Replacement Uom	S.F.
Instance on All Facades	Inspected
Instance Condition	3 - Fair
Instance Quantity	17,000
Instance Quantity Uom	S.F.
Deficiency	BRICK: DETERIORATED MASONRY SILLS - MAJOR

REMOVE AND REPLACE

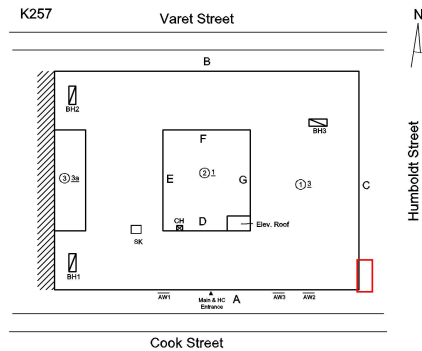
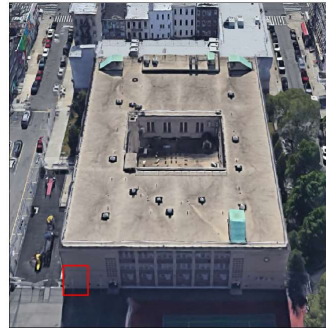
Roof Plan reference

BRICK: CRACKS/DISPLACED/SPALLED BRICK AT BUILDING CORNERS

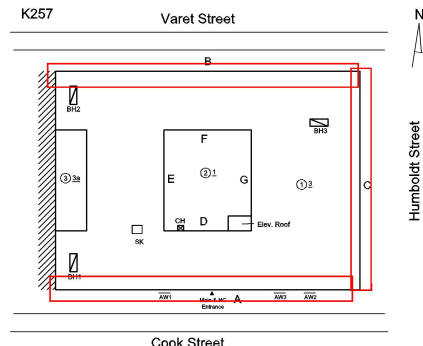
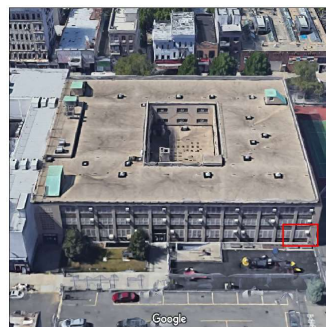
Roof Plan reference

BRICK: DETERIORATED JOINTS

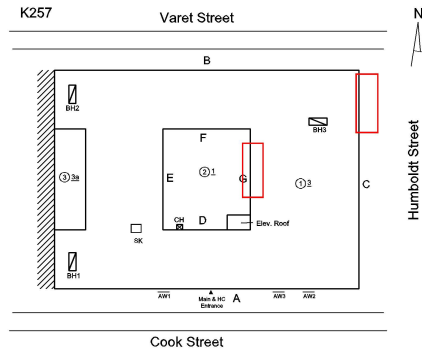
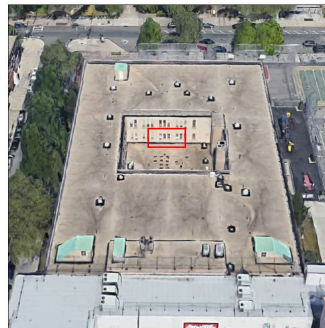
Roof Plan reference

BRICK: DETERIORATED MASONRY SILLS - MINOR

REPAIR

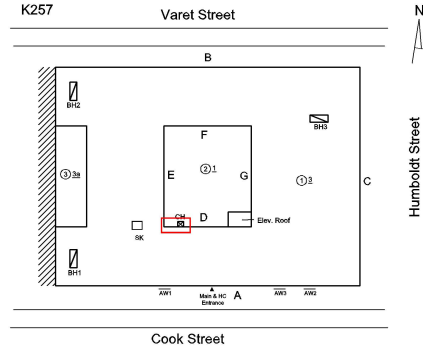
Roof Plan reference

BUILT-UP: FLASHING: DRIP EDGE/GRAVEL STOP DAMAGED

REPLACE

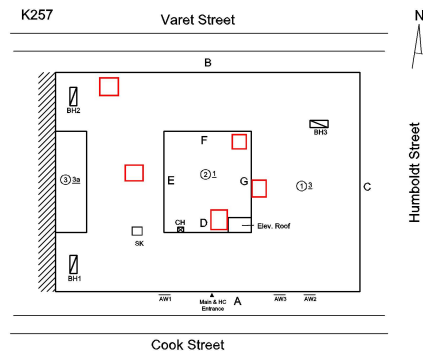
Roof Plan reference

BUILT-UP: ROOFING: MAJOR ACTIVE ROOF LEAKS IN INSTRUCTIONAL SPACE

REPLACE ROOFING WITHOUT MAJOR EQUIPMENT REMOVAL

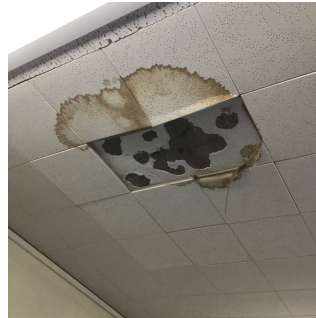
Roof 2 - Staff Cafeteria shown, Roof 1 - Gymnasium, Rooms 300,323, Roof 2 - Room 129

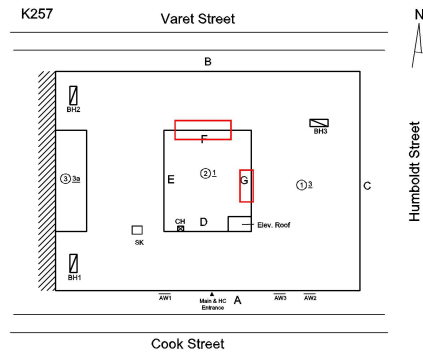
Roof Plan reference

BUILT-UP: FLASHING: CAP FLASHING MISSING

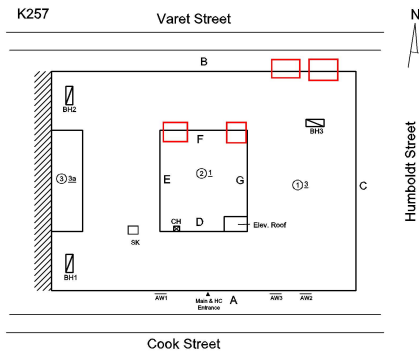
Roof Plan reference

BUILT-UP: ROOFING: DELAMINATION

10
S.F.
REPLACE ROOFING WITHOUT MAJOR EQUIPMENT
REMOVAL
PRIORITY 4
LEVEL 2

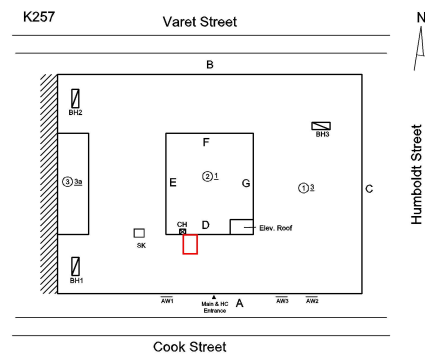
Roof Plan reference

DETERIORATED

REPLACE

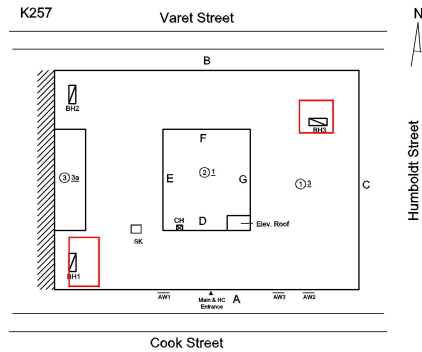
Roof Plan reference

BULKHEAD/PENTHOUSE WALLS/INTERIOR: CMU
CRACKS/SPALLING

20
S.F.
REPLACE
PRIORITY 3
LEVEL 2

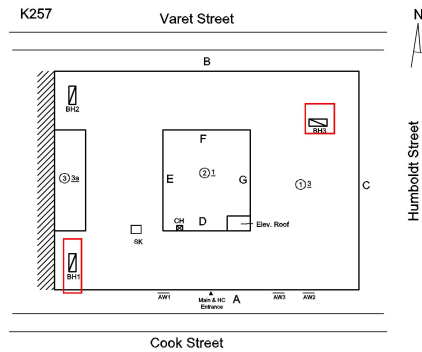
Roof Plan reference

BULKHEAD/PENTHOUSE WINDOWS: AIR/WATER INFILTRATION WITH DAMAGED CAULKING

10
L.F.
MAINTENANCE
PRIORITY 3
LEVEL 2

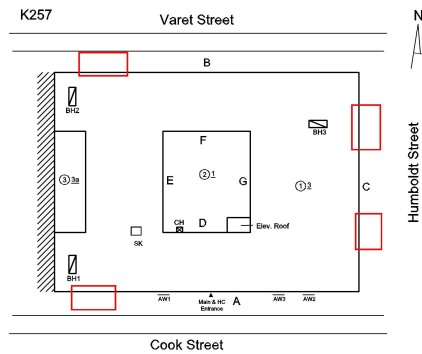
Question	Response
EXTERIOR	
ROOF	Inspected
Specialties	Inspected
SKYLIGHT/ROOF VENT	Inspected
Condition	2 - Between Good and Fair
Deficiency	No deficiencies recorded
ROOF/GRAVITY TANK	Does not Exist
STAIRS/RAMPS: EXTERIOR	Inspected
BUILDING CHEEK/FLANK WALLS	Does not Exist
RAILINGS	Inspected
Condition	3 - Fair
Deficiency	MISSING RAILING
Roof Plan reference	
Deficiency Quantity	30
Quantity Uom	L.F.
Potential Action	REPLACE
Urgency of Action	PRIORITY 5
Purpose of Action	LEVEL 6
Deficiency Photo1	
Violations	Facade A - South view No violations recorded.
STAIRS/RAMPS	Inspected
Condition	5 - Poor
Deficiency	STONE: DETERIORATED JOINTS

30
L.F.
REPOINT
PRIORITY 3
LEVEL 2

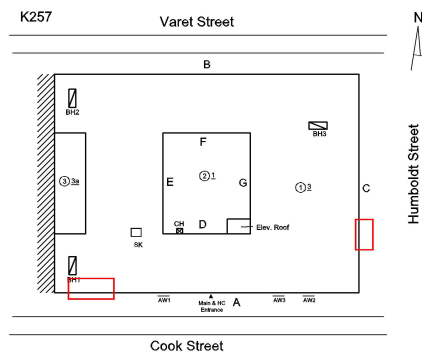
Roof Plan reference

STONE: CRACKS/SPALLING - MAJOR

100
S.F.
REPLACE
PRIORITY 4
LEVEL 2

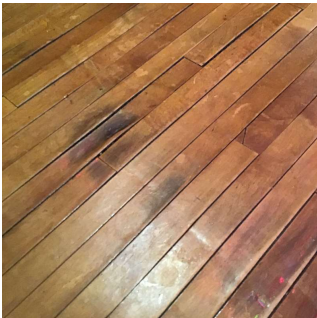
Violations	Near Entrance No violations recorded.
Sliding-folding Partition	
Instance on 1st Floor (400 Seats)	Does not Exist
Stage	
Instance on 1st Floor (400 Seats)	Inspected
Stage	Inspected
Instance on 1st Floor (400 Seats)	Inspected
Condition	2 - Between Good and Fair
Deficiency	DAMAGED FLOOR
Deficiency Location/Instance	Right Side, Center
Deficiency Quantity	20
Quantity Uom	S.F.
Potential Action	REPLACE
Urgency of Action	PRIORITY 3
Purpose of Action	LEVEL 2
Deficiency Photo1

Violations	Right Side No violations recorded.
Stage Curtain Rigging	
Instance on 1st Floor (400 Seats)	Inspected
Condition	2 - Between Good and Fair
Deficiency	No deficiencies recorded
Stage Curtains	
Instance on 1st Floor (400 Seats)	Inspected

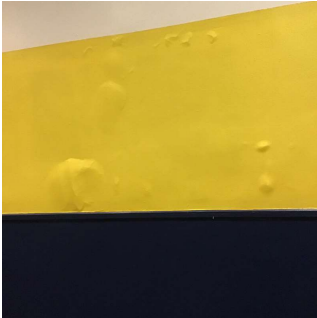
Violations	Left Side No violations recorded.
Walls	
Instance on 1st Floor (400 Seats)	Inspected
Condition	2 - Between Good and Fair
Deficiency	PLASTER: CRACKS/SPALLING
Deficiency Location/Instance	Left Side, Right Side near Stage
Deficiency Quantity	60
Quantity Uom	S.F.
Potential Action	REPLACE
Urgency of Action	PRIORITY 3
Purpose of Action	LEVEL 2
Deficiency Photo1

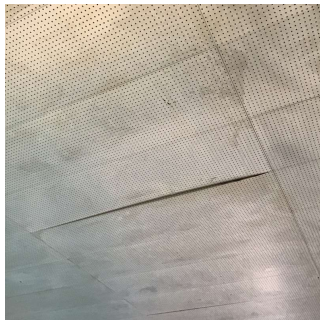
Storage Room
Violations	No violations recorded.
Window Curtains/Shades/Blinds	
Instance on 1st Floor (400 Seats)	Does not Exist
CAFETERIA	
	Inspected
Instance on 1st Floor - Staff (600 SF)	Inspected
Instance on 1st Floor - Students	Inspected
Ceiling	
Instance on 1st Floor - Students	Inspected
Condition	2 - Between Good and Fair
Deficiency	METAL PAN: DAMAGED/MISSING
Deficiency Location/Instance	Center, Near Entrance
Deficiency Quantity	20
Quantity Uom	S.F.
Potential Action	REPLACE
Urgency of Action	PRIORITY 3
Purpose of Action	LEVEL 2
Deficiency Photo1

Center
Violations	No violations recorded.
Instance on 1st Floor - Staff (600 SF)	Inspected
Condition	3 - Fair
Deficiency	ACOUSTIC TILES ON PLASTER: DAMAGED/MISSING
Deficiency Location/Instance	Near Entrance
Deficiency Quantity	10
Quantity Uom	S.F.
Potential Action	REPLACE
Urgency of Action	PRIORITY 3

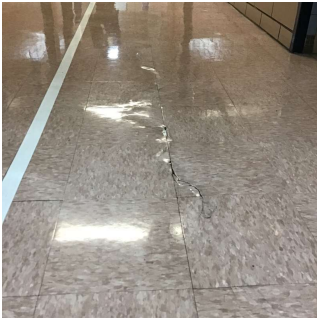
Question	Response
INTERIOR	
CLASSROOMS/CORRIDORS/ADMIN SPACES	
Floor Finish	
Violations	Corridor near Room 332 No violations recorded.
Deficiency	VINYL TILES: DETERIORATED SUBSTRATE
Deficiency Location/Instance	Corridor near Room 140
Deficiency Quantity	20
Quantity Uom	S.F.
Potential Action	REPLACE
Urgency of Action	PRIORITY 5
Purpose of Action	LEVEL 6
Deficiency Photo1

Violations	Corridor near Room 140 No violations recorded.
Walls	Inspected
Condition	2 - Between Good and Fair
Deficiency	GLAZED BLOCK: CRACKS/SPALLING
Deficiency Location/Instance	Corridor near Rooms 349, 338, 332, 319, 304 and others
Deficiency Quantity	400
Quantity Uom	S.F.
Potential Action	REPLACE
Urgency of Action	PRIORITY 3
Purpose of Action	LEVEL 2
Deficiency Photo1

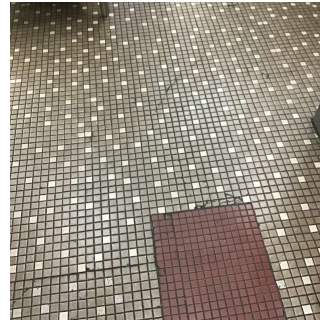
Prep area
No violations recorded.

Violations	Storage Room No violations recorded.
Floor Finish	
Instance on 1st Floor	Inspected
Condition	3 - Fair
Deficiency	CERAMIC TILE: BROKEN/MISSING TILES
Deficiency Location/Instance	Main Entrance, prep area, Near hallway Entrance
Deficiency Quantity	50
Quantity Uom	S.F.
Potential Action	REPLACE
Urgency of Action	PRIORITY 3

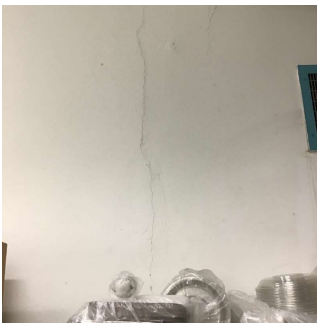
Deficiency	PLASTER: CRACKS/SPALLING
Deficiency Location/Instance	Storage Room
Deficiency Quantity	20
Quantity Uom	S.F.
Potential Action	REPLACE
Urgency of Action	PRIORITY 3
Purpose of Action	LEVEL 2

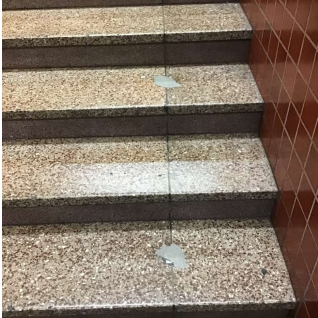
Question	Response
INTERIOR	
STAIRS/RAMPS: INTERIOR	
Door(s)	Inspected
Condition	2 - Between Good and Fair
Deficiency	No deficiencies recorded
Partition	Does not Exist
Railings	Inspected
Condition	2 - Between Good and Fair
Deficiency	No deficiencies recorded
Stairs and Landings	Inspected
Condition	2 - Between Good and Fair
Deficiency	VINYL TILES: BROKEN/DETERIORATED/MISSING TILES
Deficiency Location/Instance	Stairs B/1, C/3, 2
Deficiency Quantity	30
Quantity Uom	S.F.
Potential Action	REPLACE
Urgency of Action	PRIORITY 3
Purpose of Action	LEVEL 2
Deficiency Photo1	 
Violations	Stair C/3 No violations recorded.
Deficiency	STONE: BROKEN/MISSING
Deficiency Location/Instance	Stairs A/1, B/1, D/2
Deficiency Quantity	30
Quantity Uom	S.F.
Potential Action	REPLACE
Urgency of Action	PRIORITY 3
Purpose of Action	LEVEL 2
Deficiency Photo1	 
Violations	Stair D/2 No violations recorded.
Deficiency	TERRAZZO: CRACKS
Deficiency Location/Instance	Corridor near Auditorium, Corridor Near Stair A/1

Question	Response
INTERIOR	
STAIRS/RAMPS: INTERIOR	
Stairs and Landings	
Quantity Uom	S.F.
Potential Action	REPLACE
Urgency of Action	PRIORITY 3
Purpose of Action	LEVEL 2
Deficiency Photo1

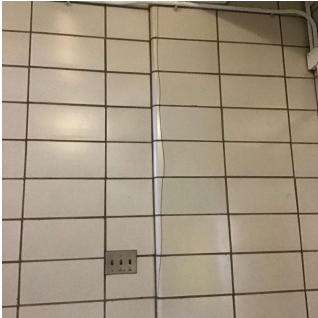
Corridor near Auditorium
Violations	No violations recorded.
Walls	Inspected
Condition	2 - Between Good and Fair
Deficiency	GLAZED BLOCK: CRACKS/SPALLING
Deficiency Location/Instance	Stairs A/1, 2, C/3, D/3
Deficiency Quantity	40
Quantity Uom	S.F.
Potential Action	REPLACE
Urgency of Action	PRIORITY 3
Purpose of Action	LEVEL 2
Deficiency Photo1

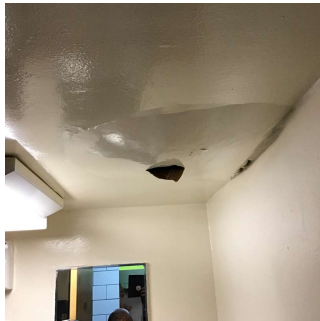
Stair A/1
Violations	No violations recorded.
TOILET ROOMS - STAFF	Inspected
Ceiling	Inspected
Condition	2 - Between Good and Fair
Deficiency	GYPSUM BOARD: DAMAGED/DETERIORATED - ACTIVE LEAK
Deficiency Location/Instance	Room 323
Deficiency Quantity	10
Quantity Uom	S.F.
Potential Action	REPLACE
Urgency of Action	PRIORITY 5
Purpose of Action	LEVEL 2

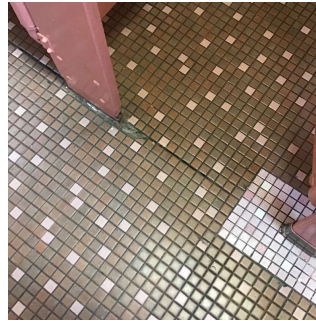
Violations	Room 142 No violations recorded.
Floor Finish	Inspected
Condition	2 - Between Good and Fair
Deficiency	CERAMIC TILE: DETERIORATED SUBSTRATE
Deficiency Location/Instance	Room 221
Deficiency Quantity	10
Quantity Uom	S.F.
Potential Action	REPLACE
Urgency of Action	PRIORITY 3
Purpose of Action	LEVEL 2

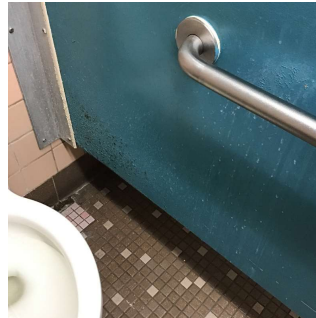
Room 142

RUST - MAJOR

REPLACE

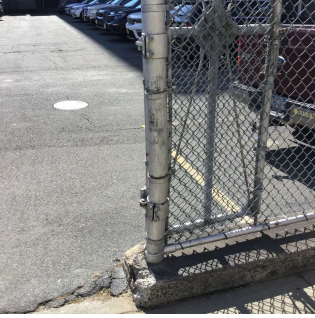
Question	Response
SITE	
CONTAINERIZATION	
Deficiency Photo1	 
Violations	Parking Lot No violations recorded.
Drainage System for Asphalt	Inspected
Catch Basins/Manhole - Surrounded by asphalt	Inspected
Condition	2 - Between Good and Fair
Deficiency	No deficiencies recorded
Culverts - Asphalt Covering	Does not Exist
Drainage System for Concrete	Inspected
Catch Basins/Manhole - Surrounded by concrete	Inspected
Condition	5 - Poor
Deficiency	BLOCKED
Deficiency Location/Instance	Veret Street
Deficiency Quantity	1
Quantity Uom	EACH
Potential Action	MAINTENANCE
Urgency of Action	PRIORITY 3
Purpose of Action	LEVEL 2
Deficiency Photo1	No photo recorded
Violations	No violations recorded.
Culverts - Concrete Covering	Does not Exist
Drainage System for Soil	Does not Exist
DRINKING FOUNTAINS	Does not Exist
FENCES	Inspected
Condition	3 - Fair
Deficiency	CHAIN LINK: DAMAGED POST/RAIL
Deficiency Location/Instance	Parking Lot
Deficiency Quantity	10

Quantity Uom	L.F.
Potential Action	REPLACE
Urgency of Action	PRIORITY 3
Purpose of Action	LEVEL 2

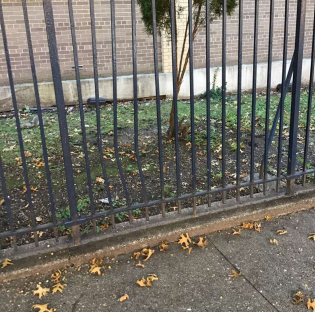
Violations	<p>Parking Lot No violations recorded.</p>
Deficiency	WROUGHT IRON: DAMAGED/DETERIORATED
Deficiency Location/Instance	Varet Street, Cook Street
Deficiency Quantity	320
Quantity Uom	S.F.
Potential Action	REPLACE
Urgency of Action	PRIORITY 3
Purpose of Action	LEVEL 2
Deficiency Photo1

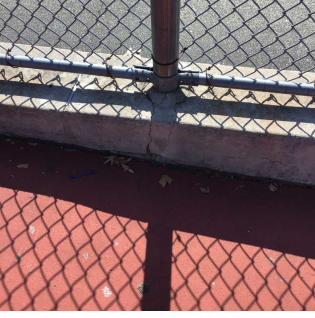
Violations	<p>Schoolyard No violations recorded.</p>
Deficiency	CONCRETE CURB: DAMAGED/DETERIORATED

Violations	<p>Varet Street No violations recorded.</p>
Deficiency	CONCRETE CURB: DAMAGED/DETERIORATED
Deficiency Location/Instance	Schoolyard, Cook Street, Varet Street, Humboldt Street
Deficiency Quantity	60
Quantity Uom	S.F.
Potential Action	REPLACE
Urgency of Action	PRIORITY 3
Purpose of Action	LEVEL 2
Deficiency Photo1

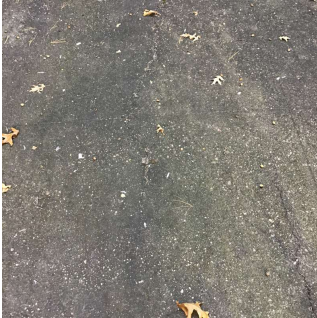
Question	Response
SITE	
PAVING	
Student Non-Use	
Asphalt	
Deficiency Photo1	 
Violations	Parking Lot No violations recorded.
Concrete	Does not Exist
Pavers	Does not Exist
Student Use	Inspected
Gravel Exists?	No
Asphalt	Inspected
Condition	4 - Between Fair and Poor
Deficiency	CRACKS - MAJOR
Deficiency Location/Instance	Schoolyard
Deficiency Quantity	900
Quantity Uom	S.F.
Potential Action	REPLACE
Urgency of Action	PRIORITY 3
Purpose of Action	LEVEL 2
Deficiency Photo1	 
Violations	Schoolyard No violations recorded.
Concrete	Does not Exist
Pavers	Does not Exist
Site Sidewalks & Walkways	Inspected
Asphalt	Does not Exist
Concrete	Inspected
Condition	3 - Fair
Deficiency	CRACKS - MAJOR
Deficiency Location/Instance	Varet Street, Exit 4
Deficiency Quantity	175
Quantity Uom	S.F.

Question	Response
SITE	
PAVING	
Site Sidewalks & Walkways	
Concrete	
Potential Action	REPLACE
Urgency of Action	PRIORITY 3
Purpose of Action	LEVEL 2
Deficiency Photo1

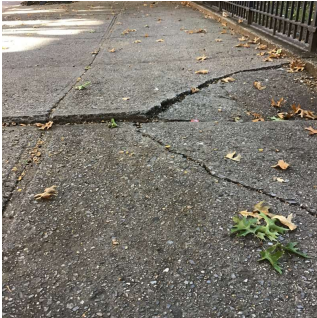
Varet Street
Violations	No violations recorded.
Deficiency	DAMAGED CURBS
Deficiency Location/Instance	Cook Street, Varet Street, Humboldt Street
Deficiency Quantity	60
Quantity Uom	L.F.
Potential Action	REPLACE
Urgency of Action	PRIORITY 3
Purpose of Action	LEVEL 2

Varet Street
Violations	No violations recorded.
Pavers	Does not Exist
DOT Sidewalk	Inspected
Asphalt	Does not Exist
Concrete	Inspected
Condition	4 - Between Fair and Poor
Deficiency	HEAVING
Deficiency Location/Instance	Varet Street
Deficiency Quantity	75
Quantity Uom	S.F.
Potential Action	REPLACE
Urgency of Action	PRIORITY 5
Purpose of Action	LEVEL 6
Deficiency Photo1

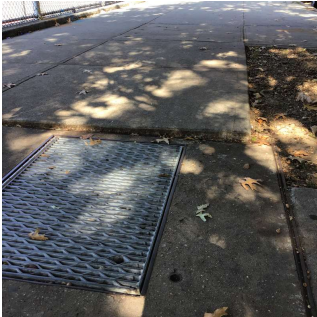
Violations	Varet Street No violations recorded.
Deficiency	HEAVING
Deficiency Location/Instance	Humboldt Street, Varet Street
Deficiency Quantity	250
Quantity Uom	S.F.
Potential Action	REPLACE
Urgency of Action	PRIORITY 3
Purpose of Action	LEVEL 2
Deficiency Photo1

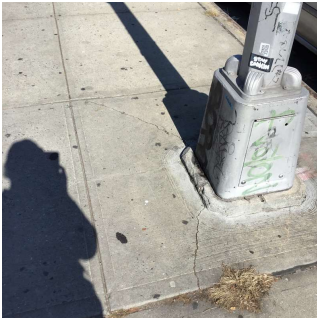
Violations	Humboldt Street No violations recorded.
Deficiency	DAMAGED/DETERIORATED/MISSING SECTIONS
Deficiency Location/Instance	Cook Street, Varet Street, Humboldt Street
Deficiency Quantity	825
Quantity Uom	S.F.
Potential Action	REPLACE
Urgency of Action	PRIORITY 3
Purpose of Action	LEVEL 2
Deficiency Photo1

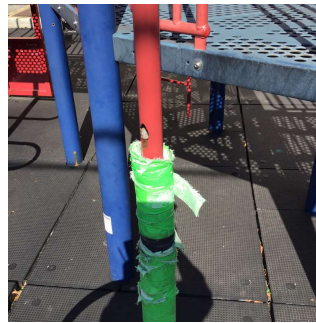
Violations	Main Entrance No violations recorded.
Pavement	
Instance on Near Main Entrance	Inspected
Condition	2 - Between Good and Fair
Deficiency	No deficiencies recorded
Play Equipment	
Instance on Near Main Entrance	Inspected
Condition	5 - Poor
Deficiency	BROKEN/DETERIORATED/MISSING
Deficiency Location/Instance	East side

Deficiency Quantity	1
Quantity Uom	EACH
Potential Action	REPLACE
Urgency of Action	PRIORITY 3
Purpose of Action	LEVEL 2

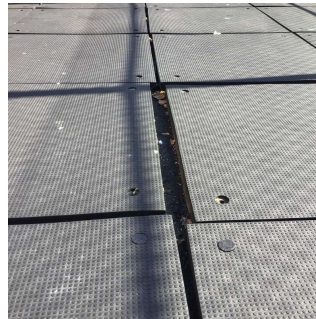
Center

DETERIORATED/MISSING

REPLACE
