**NYC Department of Education
Building Condition Assessment Survey 2023 - 2024**

Architectural Inspection

Asset: I.S. 259 - BROOKLYN, 7305 FT HAMILTON PKWY, New York, 11228

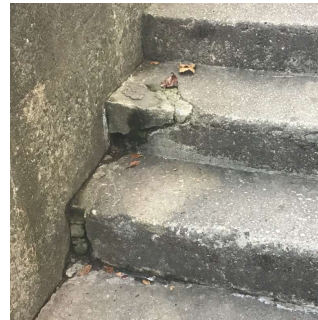
Facade A - AW8

Question	Response
Architectural	
EXTERIOR	Inspected
AREAWAY	Inspected
Instance on AW1 - AW8	Inspected
Instance Condition	4 - Between Fair and Poor
Instance Quantity	8
Instance Quantity Uom	EACH
Deficiency	AREAWAY STAIRS: DETERIORATED TREADS/RISERS/NOSINGS

10
S.F.
REPLACE
PRIORITY 4
LEVEL 2

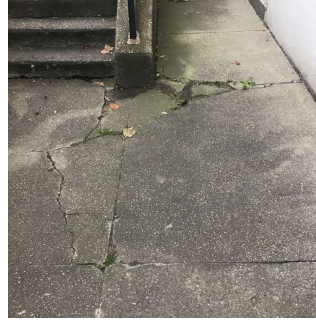
Facade A - AW8

AREAWAY SLAB: CRACKS AND SPALLING

300
S.F.
REPLACE
PRIORITY 4
LEVEL 2

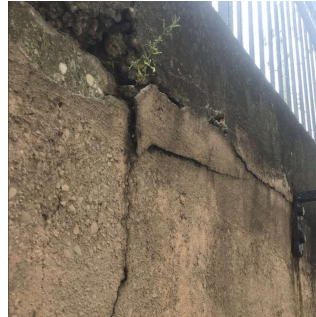
Facade A - AW8

AREAWAY WALLS: CRACKS AND SPALLING

10

REPLACE

LEVEL 6

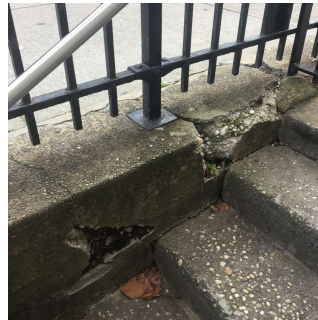
Facade A - AW8

AREAWAY WALLS: DETERIORATED COPING STONE

20
S.F.
REPLACE
PRIORITY 4
LEVEL 2

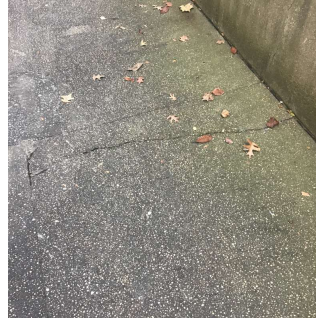
Facade A - AW7

AREAWAY SLAB: CRACKS AND SPALLING

10
S.F.
REPAIR
PRIORITY 3
LEVEL 2

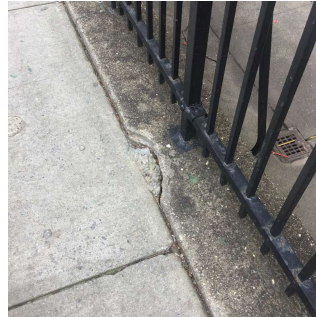
Facade A - AW7

AREAWAY WALLS: DETERIORATED COPING STONE

100

REPAIR

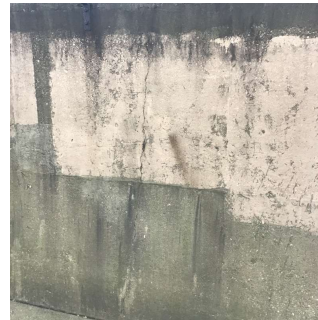
Facade A - AW8
 No violations recorded.

AREAWAY WALLS: CRACKS AND SPALLING

80
 S.F.
 REPAIR
 PRIORITY 3
 LEVEL 2

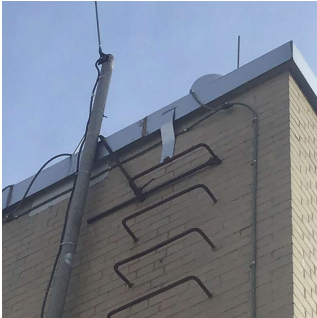
BRICK: DETERIORATED LADDER

1
 EACH
 REPLACE
 PRIORITY 3
 LEVEL 2

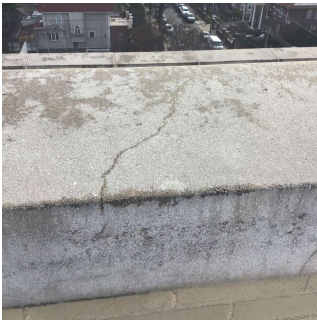
Violations	Roof 1 - CH No violations recorded.
COPING	
Condition	Inspected 3 - Fair
Deficiency	CAST STONE: CRACKED/BROKEN PIECES
Roof Plan reference

Deficiency Quantity	10
Quantity Uom	L.F.
Potential Action	REPLACE-IN-KIND
Urgency of Action	PRIORITY 4
Purpose of Action	LEVEL 2
Deficiency Photo1

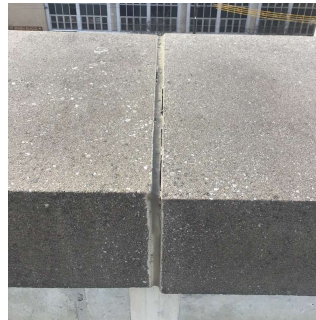
Roof 4 - Facade C
No violations recorded.

Violations	Roof 2 No violations recorded.
Deficiency	CAST STONE: DETERIORATED TRANSVERSE JOINTS

10
L.F.
MAINTENANCE
PRIORITY 3
LEVEL 2

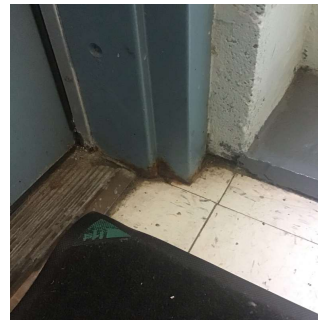
Facade A - Exit 3

METAL: DETERIORATED DOOR AND FRAME - MINOR DETERIORATION

6

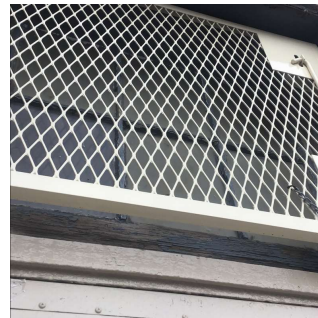
Facade F - Near Exit 9

WOOD: EXCESSIVELY WEATHERED

10
 S.F.
 REPLACE
 PRIORITY 4
 LEVEL 2

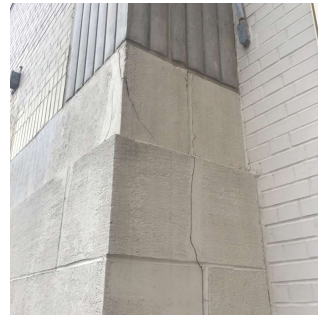
Corner of Facades E and F

CAST IN PLACE / PRE-CAST CONCRETE: MAJOR CRACKS/SPALLING

80

REPLACE

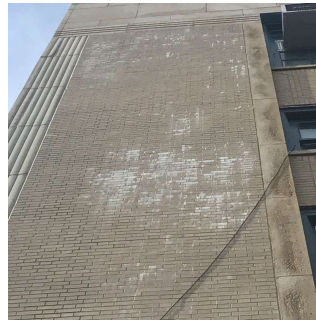
Facade F

BRICK: EFFLORESCENCE

300

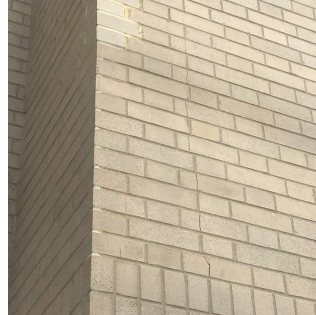
Facade G - Near Exit 8

BRICK: CRACKS/DISPLACED/SPALLED BRICK AT BUILDING CORNERS

Deficiency Quantity

30

REMOVE AND REBUILD
PRIORITY 4
LEVEL 2

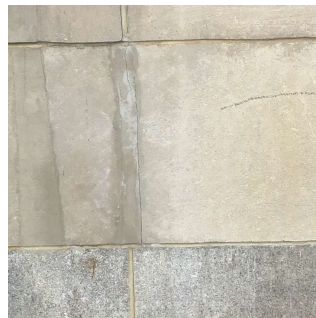
STONE: CRACKS AT BUILDING CORNERS

10
S.F.
REPLACE
PRIORITY 4
LEVEL 2

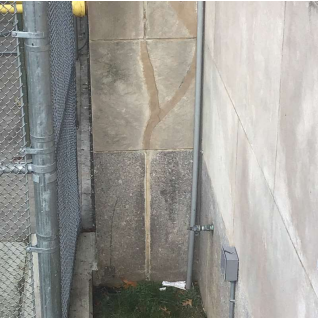
Question	Response
EXTERIOR	
EXTERIOR WALLS	
Violations	Corner of Facades G and H No violations recorded.
Deficiency	STONE: CHIPPED/SPALLED/BROKEN PIECES - MINOR
Roof Plan reference

Deficiency Quantity	30
Quantity Uom	S.F.
Potential Action	REPAIR
Urgency of Action	PRIORITY 3
Purpose of Action	LEVEL 2
Deficiency Photo1

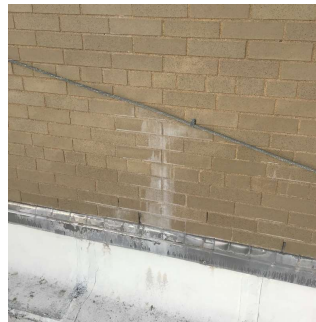
Roof 1 - Facade H

Deficiency	BRICK: EFFLORESCENCE
------------	----------------------

Deficiency Quantity	50
Quantity Uom	S.F.
Potential Action	MAINTENANCE
Urgency of Action	PRIORITY 1
Purpose of Action	LEVEL 1
Deficiency Photo1

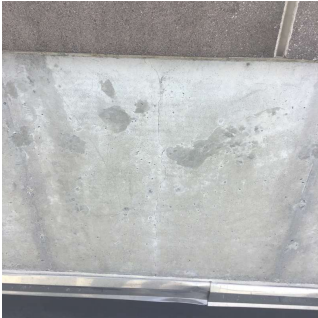
Deficiency	CONCRETE: MINOR CRACKS, SPALLING
------------	----------------------------------

Deficiency Quantity	10
Quantity Uom	S.F.
Potential Action	REPAIR
Urgency of Action	PRIORITY 3
Purpose of Action	LEVEL 2

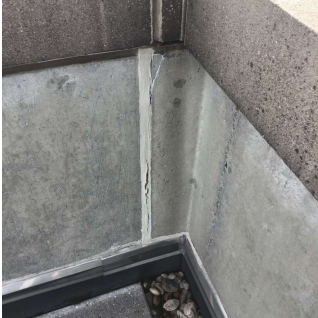
Violations	Roof 4 - Facade B No violations recorded.
Deficiency	CONCRETE: DETERIORATED CONTROL/EXPANSION JOINT
Roof Plan reference

Deficiency Quantity	10
Quantity Uom	L.F.
Potential Action	MAINTENANCE
Urgency of Action	PRIORITY 3
Purpose of Action	LEVEL 2
Deficiency Photo1

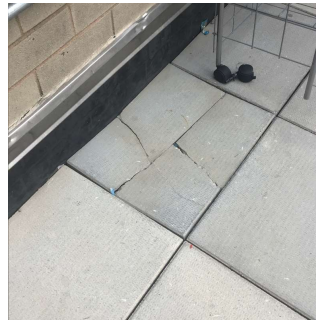
Plaza Deck - Near AW1
 No violations recorded.

Violations	Roof 4 - Facade B No violations recorded.
PLAZA DECK	Inspected
Instance on Pavers: Courtyard	Inspected
Instance Condition	4 - Between Fair and Poor
Instance Quantity	5,000
Instance Quantity Uom	S.F.
Installation Year	2010
Source of Installation	Custodial Staff
Deficiency	PAVERS: PAVERS IN POOR CONDITION

60
 S.F.
 REPLACE
 PRIORITY 4
 LEVEL 2

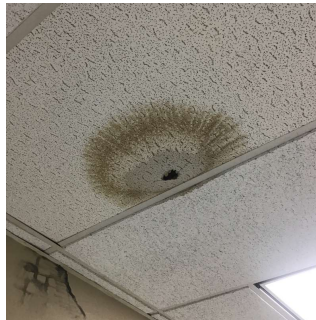
Deficiency	IRMA: ROOFING: MAJOR ACTIVE ROOF LEAKS IN INSTRUCTIONAL SPACE
------------	---

Roof 4 - Corridor near Room 432D shown, Roof 4 - Corridor near Room 437 similar

Deficiency Quantity	200
Quantity Uom	S.F.
Potential Action	REPLACE ROOFING WITHOUT MAJOR EQUIPMENT REMOVAL
Urgency of Action	PRIORITY 5
Purpose of Action	LEVEL 2

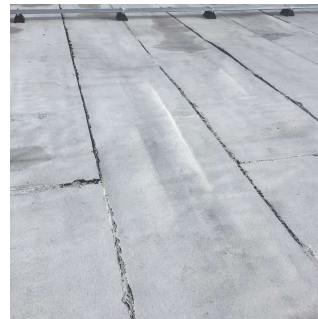
Roof 2
No violations recorded.

Violations	Roof 1 - Room 426 shown, Roof 2 - 4th Floor Gymnasium No violations recorded.
Deficiency	MODIFIED BITUMEN: ROOFING: DELAMINATION

20
S.F.
REPLACE ROOFING WITHOUT MAJOR EQUIPMENT
REMOVAL
PRIORITY 4
LEVEL 2

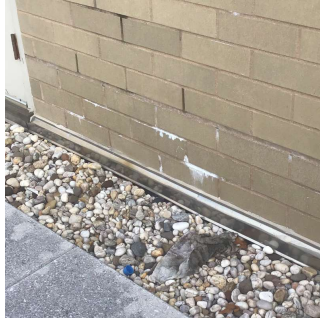
BULKHEAD/PENTHOUSE WALLS/EXTERIOR:
EFFLORESCENCE

Question	Response
EXTERIOR	
ROOF	
Specialties	
BULKHEAD/PENTHOUSE	
Potential Action	MAINTENANCE
Urgency of Action	PRIORITY 1
Purpose of Action	LEVEL 1
Deficiency Photo1

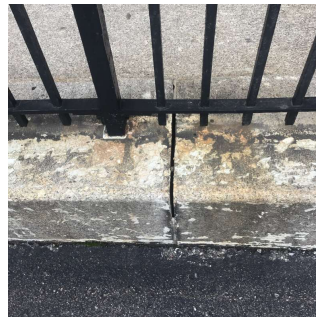
Facade F - Exit 9

STONE: DETERIORATED JOINTS

10
 S.F.
 REPOINT
 PRIORITY 4
 LEVEL 2

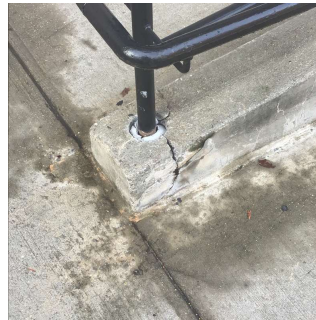
Facade A - HC Ramp

CAST IN PLACE CONCRETE: CRACKS/SPALLING - MAJOR

Deficiency Quantity	10
Quantity Uom	S.F.
Potential Action	REPLACE
Urgency of Action	PRIORITY 4
Purpose of Action	LEVEL 2
Deficiency Photo1

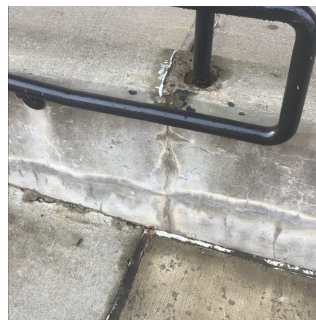
Facade A - HC Ramp

Deficiency	CAST IN PLACE CONCRETE: CRACKS/SPALLING - MINOR
------------	---

Deficiency Quantity	20
Quantity Uom	S.F.
Potential Action	REPAIR
Urgency of Action	PRIORITY 3
Purpose of Action	LEVEL 2
Deficiency Photo1

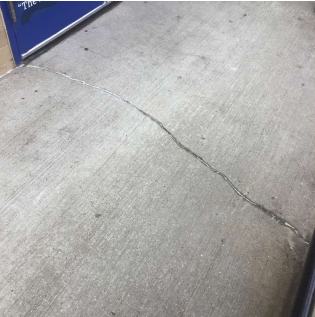
CONCRETE: CRACKS/SPALLING - MAJOR

Violations	<p>Facade A - Main Entrance</p> <p>No violations recorded.</p>
WINDOWS	Inspected
Replacement Quantity	14,000
Replacement Uom	S.F.
EXTERIOR GUARDS	Inspected
Condition	2 - Between Good and Fair
Deficiency	No deficiencies recorded
LINTELS	Inspected
Condition	2 - Between Good and Fair
Deficiency	No deficiencies recorded
WINDOWS	Inspected
Material Type(s)	Aluminum
Instance on Aluminum - Other: 2010 Addition	Inspected
Instance Condition	2 - Between Good and Fair
Instance Quantity	4,000
Instance Quantity Uom	S.F.
Are these windows insulated	Yes
Installation Year	2010
Source of Installation	Custodial Staff
Deficiency	No deficiencies recorded
Instance on Aluminum - Double Hung: Original Building	Inspected

Deficiency Quantity	30
Quantity Uom	S.F.
Potential Action	REPLACE
Urgency of Action	PRIORITY 4
Purpose of Action	LEVEL 2
Deficiency Photo1

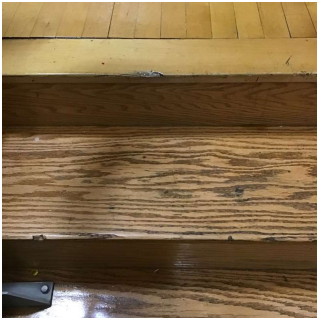
Violations	Left Side No violations recorded.
Sliding-folding Partition	
Instance on 1st Floor (525 Seats)	Does not Exist
Stage	
Instance on 1st Floor (525 Seats)	Inspected
Stage	
Instance on 1st Floor (525 Seats)	Inspected
Condition	2 - Between Good and Fair
Deficiency	DAMAGED STEPS
Deficiency Location/Instance	Left Side
Deficiency Quantity	10

Left Side
Violations	No violations recorded.
Stage Curtain Rigging	Inspected
Instance on 1st Floor (525 Seats)	Inspected
Condition	1 - Good
Deficiency	No deficiencies recorded
Stage Curtains	Inspected
Instance on 1st Floor (525 Seats)	Inspected
Condition	2 - Between Good and Fair
Deficiency	No deficiencies recorded
Walls	
Instance on 1st Floor (525 Seats)	Inspected
Condition	2 - Between Good and Fair
Deficiency	STONE MOLDINGS: CRACKS/SPALLING
Deficiency Location/Instance	Left Side
Deficiency Quantity	20
Quantity Uom	L.F.
Potential Action	REPLACE
Urgency of Action	PRIORITY 3
Purpose of Action	LEVEL 2
Deficiency Photo1

Question	Response
INTERIOR	
AUDITORIUM	
Stage	
Stage	
Quantity Uom	S.F.
Potential Action	REPLACE
Urgency of Action	PRIORITY 3
Purpose of Action	LEVEL 2
Deficiency Photo1

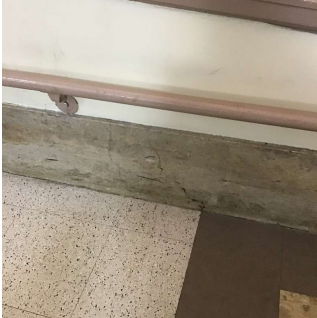
Left Side
Violations	No violations recorded.
Deficiency	PLASTER: CRACKS/SPALLING
Deficiency Location/Instance	Right and Left Side

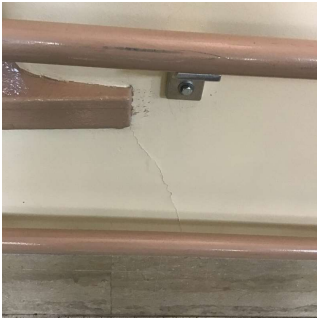
Question	Response
INTERIOR	
AUDITORIUM	
Walls	
Deficiency Quantity	50
Quantity Uom	S.F.
Potential Action	REPLACE
Urgency of Action	PRIORITY 3
Purpose of Action	LEVEL 2
Deficiency Photo1

Right Side
Violations	No violations recorded.
Window Curtains/Shades/Blinds	
Instance on 1st Floor (525 Seats)	Inspected
Condition	2 - Between Good and Fair
Deficiency	No deficiencies recorded
CAFETERIA	
Instance on Basement	Inspected
Ceiling	
Instance on Basement	Inspected
Condition	2 - Between Good and Fair
Deficiency	ACOUSTIC TILES: DAMAGED/MISSING
Deficiency Location/Instance	Near Servery
Deficiency Quantity	10
Quantity Uom	S.F.
Potential Action	REPLACE
Urgency of Action	PRIORITY 3
Purpose of Action	LEVEL 2
Deficiency Photo1

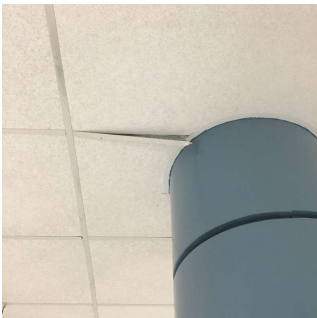
Near Servery
Violations	No violations recorded.
Door(s)	
Instance on Basement	Inspected
Condition	2 - Between Good and Fair
Deficiency	No deficiencies recorded

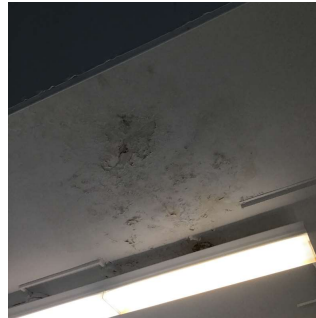
Question	Response
INTERIOR	
CAFETERIA	
Walls	
Deficiency	CERAMIC TILE: BROKEN/ MISSING
Deficiency Location/Instance	Near Servery, By Kitchen Door, Close to Exit, Next to Room C08
Deficiency Quantity	40
Quantity Uom	S.F.
Potential Action	REPLACE
Urgency of Action	PRIORITY 3
Purpose of Action	LEVEL 2
Deficiency Photo1	 
Violations	Near Servery No violations recorded.
Window Curtains/Shades/Blinds	
Instance on Basement	Does not Exist
CLASSROOMS/CORRIDORS/ADMIN SPACES	
Ceiling	Inspected
Condition	2 - Between Good and Fair
Deficiency	ACOUSTIC TILES ON PLASTER: DAMAGED/MISSING
Deficiency Location/Instance	Corridor near Stair C/1
Deficiency Quantity	10
Quantity Uom	S.F.
Potential Action	REPLACE
Urgency of Action	PRIORITY 3
Purpose of Action	LEVEL 2
Deficiency Photo1	 
Violations	Corridor near Stair C/1 No violations recorded.
Deficiency	PLASTER: CRACKS/SPALLING - ACTIVE LEAK
Deficiency Location/Instance	Room 426
Deficiency Quantity	20

Quantity Uom	S.F.
Potential Action	REPLACE
Urgency of Action	PRIORITY 5

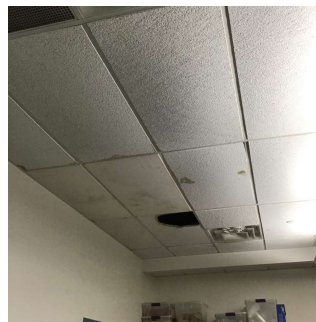
Room 438

ACOUSTIC TILES: DAMAGED/MISSING

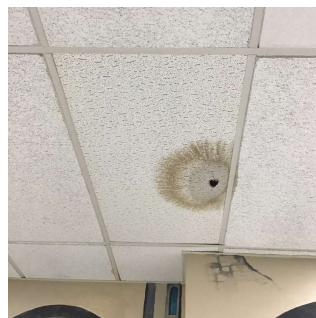
ACOUSTIC TILES: DAMAGED/MISSING - ACTIVE LEAK

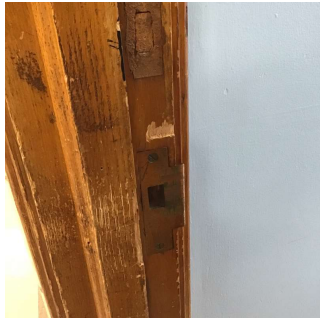
Question	Response
INTERIOR	
CLASSROOMS/CORRIDORS/ADMIN SPACES	
Ceiling	Inspected
Violations	Corridor near Room 432D No violations recorded.
Door(s)	Inspected
Condition	5 - Poor
Deficiency	WOOD: DETERIORATED DOOR AND FRAME
Deficiency Location/Instance	Room 322
Deficiency Quantity	1
Quantity Uom	EACH
Potential Action	MAINTENANCE
Urgency of Action	PRIORITY 3
Purpose of Action	LEVEL 2
Deficiency Photo1

Violations	Room 322 No violations recorded.
Deficiency	METAL: DETERIORATED DOOR AND FRAME
Deficiency Location/Instance	Rooms 419,223
Deficiency Quantity	2
Quantity Uom	EACH
Potential Action	MAINTENANCE
Urgency of Action	PRIORITY 3
Purpose of Action	LEVEL 2
Deficiency Photo1

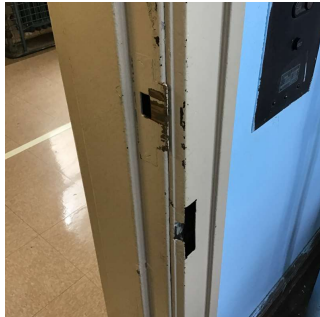
Violations	Room 419 No violations recorded.
Deficiency	METAL CLAD WOOD: DETERIORATED DOOR
Deficiency Location/Instance	Room 426
Deficiency Quantity	1
Quantity Uom	EACH
Potential Action	MAINTENANCE
Urgency of Action	PRIORITY 3
Purpose of Action	LEVEL 2

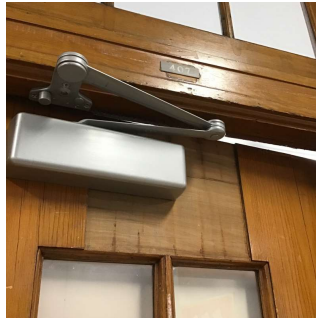
Room 407

WOOD: DETERIORATED DOOR

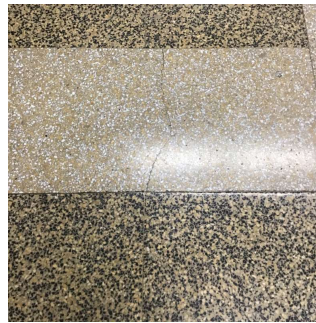
Corridor near Auditorium

Question	Response
INTERIOR	
CLASSROOMS/CORRIDORS/ADMIN SPACES	
Floor Finish	
Violations	Room 415 No violations recorded.
Deficiency	VINYL TILES: DETERIORATED SUBSTRATE
Deficiency Location/Instance	Room 320, Corridor near Room C01, By Elevator A/Basement
Deficiency Quantity	30
Quantity Uom	S.F.
Potential Action	REPLACE
Urgency of Action	PRIORITY 3
Purpose of Action	LEVEL 2
Deficiency Photo1	 
Violations	Corridor near Room C01 No violations recorded.
Deficiency	VINYL TILES: BROKEN/DETERIORATED/MISSING TILES
Deficiency Location/Instance	Rooms 430,426,330,215, Corridor near Stair C/Basement and others
Deficiency Quantity	1,600
Quantity Uom	S.F.
Potential Action	REPLACE
Urgency of Action	PRIORITY 3
Purpose of Action	LEVEL 2
Deficiency Photo1	 
Violations	Room 330 No violations recorded.
Deficiency	TERRAZZO: CRACKS
Deficiency Location/Instance	Corridor near Auditorium, Exit 6 - Vestibule, Corridor near Stair C/1
Deficiency Quantity	70

Quantity Uom	S.F.
Potential Action	REPLACE
Urgency of Action	PRIORITY 3
Purpose of Action	LEVEL 2

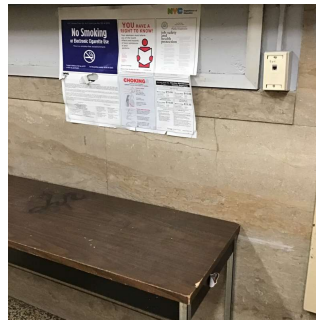
Corridor near Auditorium

STONE: CRACKS/SPALLING

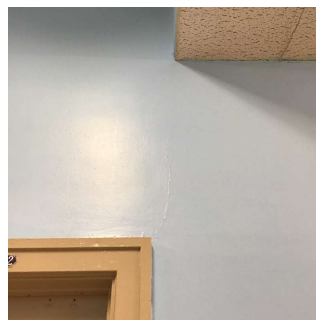
PLASTER: CRACKS/SPALLING

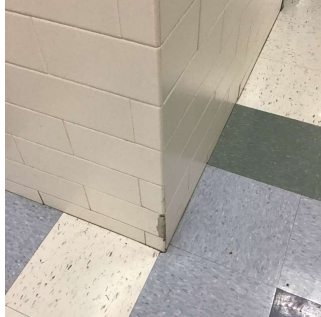
Question	Response
INTERIOR	
CLASSROOMS/CORRIDORS/ADMIN SPACES	
Walls	
Violations	Corridor near Room 432 No violations recorded.
Deficiency	GYPSUM BOARD: DETERIORATED
Deficiency Location/Instance	Corridor near Stairs A/4, C/1, By Room C29
Deficiency Quantity	30
Quantity Uom	S.F.
Potential Action	REPLACE
Urgency of Action	PRIORITY 3
Purpose of Action	LEVEL 2
Deficiency Photo1	 
Violations	Corridor near Stair C/1 No violations recorded.
Deficiency	CERAMIC TILE: BROKEN/ MISSING
Deficiency Location/Instance	Corridor near Elevator A/4, By Stairs C/Basement, D/Basement, Next to Rooms 432,C20 and others
Deficiency Quantity	80
Quantity Uom	S.F.
Potential Action	REPLACE
Urgency of Action	PRIORITY 3
Purpose of Action	LEVEL 2
Deficiency Photo1

Violations	Corridor near Elevator A/4 No violations recorded.
Deficiency	GLAZED BLOCK: CRACKS/SPALLING
Deficiency Location/Instance	Room 431, Exit 4 - Vestibule, Corridor near Rooms 328,321,111 and others

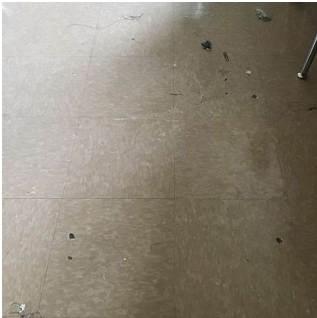
Question	Response
INTERIOR	
GYMNASIUM	
Floor Finish	
Purpose of Action	LEVEL 2
Deficiency Photo1	 
	Office Room
Violations	No violations recorded.
Instance on 3rd Floor	Inspected
Condition	2 - Between Good and Fair
Deficiency	VINYL TILES: BROKEN/DETERIORATED/MISSING TILES
Deficiency Location/Instance	Room 301R
Deficiency Quantity	10
Quantity Uom	S.F.
Potential Action	REPLACE
Urgency of Action	PRIORITY 3
Purpose of Action	LEVEL 2
Deficiency Photo1

Room 301R
Violations	No violations recorded.
Seating	
Instance on 3rd Floor	Inspected
Condition	2 - Between Good and Fair
Deficiency	No deficiencies recorded
Instance on 4th Floor	Inspected
Condition	2 - Between Good and Fair
Deficiency	No deficiencies recorded
Sliding-folding Partition	
Instance on 3rd Floor	Does not Exist
Instance on 4th Floor	Does not Exist
Stage	
Instance on 3rd Floor	Does not Exist
Instance on 4th Floor	Does not Exist
Walls	
Instance on 3rd Floor	Inspected

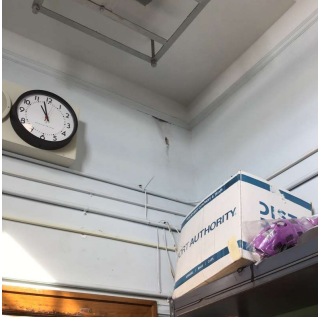
Question	Response
INTERIOR	
GYMNASIUM	
Walls	
Condition	2 - Between Good and Fair
Deficiency	WALL PADDING: DETERIORATED
Deficiency Location/Instance	Right Side
Deficiency Quantity	20
Quantity Uom	S.F.
Potential Action	REPLACE
Urgency of Action	PRIORITY 3
Purpose of Action	LEVEL 2
Deficiency Photo1	 
Violations	Right Side No violations recorded.
Instance on 4th Floor	Inspected
Condition	2 - Between Good and Fair
Deficiency	PLASTER: CRACKS/SPALLING
Deficiency Location/Instance	Office Room
Deficiency Quantity	10
Quantity Uom	S.F.
Potential Action	REPLACE
Urgency of Action	PRIORITY 3
Purpose of Action	LEVEL 2
Deficiency Photo1

Violations	Office Room No violations recorded.
Deficiency	WALL PADDING: DETERIORATED
Deficiency Location/Instance	Near Main Entrance
Deficiency Quantity	20
Quantity Uom	S.F.
Potential Action	REPLACE
Urgency of Action	PRIORITY 3
Purpose of Action	LEVEL 2

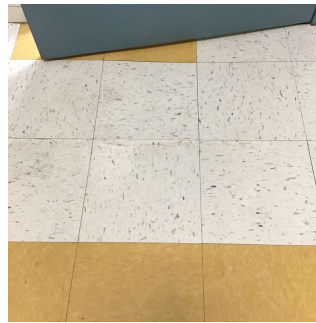
Near Room C17

Floor Finish

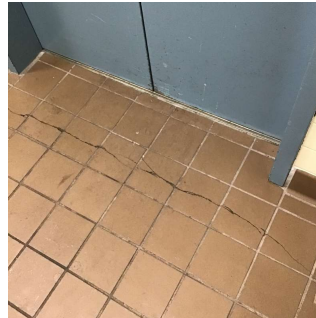
Near Elevator B/Basement

QUARRY TILE: BROKEN/MISSING TILES

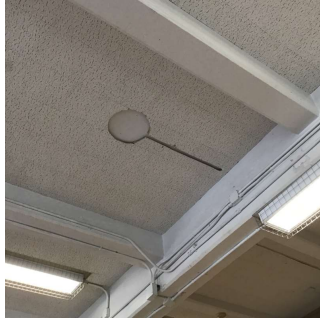
Question	Response
INTERIOR	
MULTI-PURPOSE ROOM	
Ceiling	
Urgency of Action	PRIORITY 3
Purpose of Action	LEVEL 2
Deficiency Photo1

Violations	Near Exit 12 No violations recorded.
Door(s)	
Instance on 1st Floor	Inspected
Condition	5 - Poor
Deficiency	WOOD: DETERIORATED DOOR
Deficiency Location/Instance	Main Entrance, Exit 5 - Vestibule
Deficiency Quantity	4
Quantity Uom	EACH
Potential Action	MAINTENANCE
Urgency of Action	PRIORITY 3
Purpose of Action	LEVEL 2
Deficiency Photo1

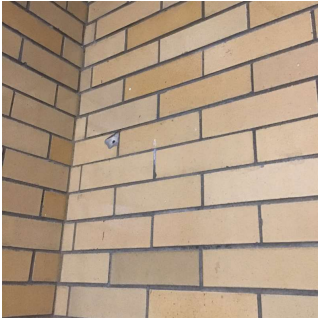
Question	Response
INTERIOR	
MULTI-PURPOSE ROOM	
Walls	
Deficiency	SALT GLAZED BRICK: CRACKS/SPALLING
Deficiency Location/Instance	Near Stair E/1
Deficiency Quantity	10
Quantity Uom	S.F.
Potential Action	REPLACE
Urgency of Action	PRIORITY 3
Purpose of Action	LEVEL 2
Deficiency Photo1

Violations	Near Stair E/1 No violations recorded.
Window Curtains/Shades/Blinds	
Instance on 1st Floor	Does not Exist
SCIENCE DEMO ROOM	
Instance on Room 411	Inspected
Alternative use	No
Instance on Room 321	Inspected
Alternative use	Yes
Instance on Room 419	Inspected
Alternative use	Yes
Instance on Rooms 421,325	Inspected
Alternative use	Yes
Fixed Equipment	
Instance on Room 321	Inspected
Condition	3 - Fair
Deficiency	CABINETS: MISSING/DAMAGED
Deficiency Location/Instance	Room 321
Deficiency Quantity	10
Quantity Uom	L.F.
Potential Action	REPLACE
Urgency of Action	PRIORITY 3
Purpose of Action	LEVEL 2
Deficiency Photo1	No photo recorded
Violations	No violations recorded.

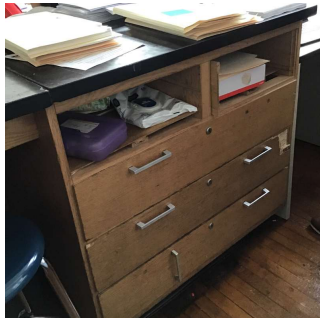
Question	Response
INTERIOR	
SCIENCE DEMO ROOM	
Fixed Equipment	
Potential Action	REPLACE
Urgency of Action	PRIORITY 3
Purpose of Action	LEVEL 2
Deficiency Photo1	No photo recorded
Violations	No violations recorded.
Instance on Rooms 421,325	Inspected
Condition	3 - Fair
Deficiency	CABINETRY: MISSING/DAMAGED
Deficiency Location/Instance	Rooms 421,325
Deficiency Quantity	14
Quantity Uom	L.F.
Potential Action	REPLACE
Urgency of Action	PRIORITY 3
Purpose of Action	LEVEL 2
Deficiency Photo1

Violations	Room 421 No violations recorded.
SCIENCE LAB	
Instance on Rooms 434,438	Inspected
Alternative use	No
Fixed Equipment	
Instance on Rooms 434,438	Inspected
Condition	2 - Between Good and Fair
Deficiency	No deficiencies recorded
SCIENCE PREP ROOM	
Instance on Room 415	Inspected
Alternative use	Yes
Instance on Room 436	Inspected
Alternative use	No
Fixed Equipment	
Instance on Room 436	Inspected
Condition	2 - Between Good and Fair

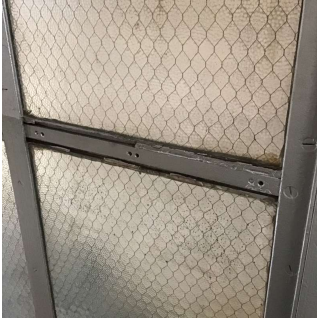
Question	Response
INTERIOR	
STAIRS/RAMPS: INTERIOR	
Partition	Inspected
Condition	2 - Between Good and Fair
Deficiency	METAL FRAME: DAMAGED/DETERIORATED
Deficiency Location/Instance	Stair C/Bulkhead
Deficiency Quantity	10
Quantity Uom	L.F.
Potential Action	REPLACE
Urgency of Action	PRIORITY 3
Purpose of Action	LEVEL 2
Deficiency Photo1

Violations	Stair C/Bulkhead No violations recorded.
Deficiency	GLASS PANEL: DAMAGED/DETERIORATED
Deficiency Location/Instance	Stairs B/Bulkhead, C/Bulkhead
Deficiency Quantity	40
Quantity Uom	S.F.
Potential Action	REPLACE
Urgency of Action	PRIORITY 3
Purpose of Action	LEVEL 2
Deficiency Photo1

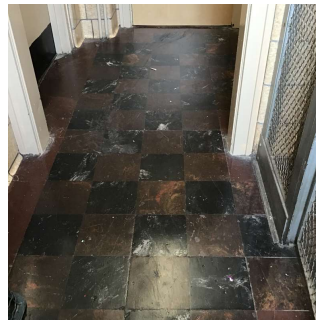
Stair F/4

VINYL TILES: BROKEN/DETERIORATED/MISSING TILES

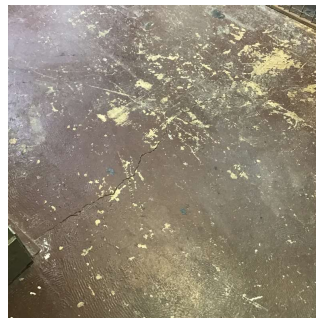
CONCRETE: CRACKS/SPALLING - MAJOR

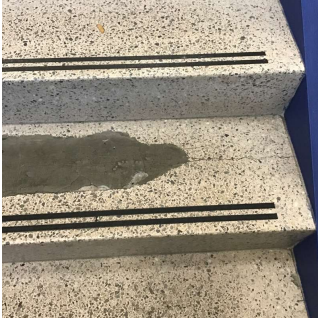
Question	Response
INTERIOR	
STAIRS/RAMPS: INTERIOR	
Stairs and Landings	
Violations	Stair C/Bulkhead No violations recorded.
Deficiency	STONE: BROKEN/MISSING
Deficiency Location/Instance	Exits 9,8,6,5 - Vestibules, Stair F/1
Deficiency Quantity	200
Quantity Uom	S.F.
Potential Action	REPLACE
Urgency of Action	PRIORITY 3
Purpose of Action	LEVEL 2
Deficiency Photo1	 
Violations	Exit 8 - Vestibule No violations recorded.
Deficiency	TERRAZZO: CRACKS
Deficiency Location/Instance	Main Entrance Lobby, Exits 10,9,5 - Vestibules
Deficiency Quantity	80
Quantity Uom	S.F.
Potential Action	REPLACE
Urgency of Action	PRIORITY 3
Purpose of Action	LEVEL 2
Deficiency Photo1

Violations	Main Entrance Lobby No violations recorded.
Walls	Inspected
Condition	2 - Between Good and Fair
Deficiency	MASONRY: CRACKS/SPALLING
Deficiency Location/Instance	Stair B/4
Deficiency Quantity	10
Quantity Uom	S.F.
Potential Action	REPLACE
Urgency of Action	PRIORITY 3

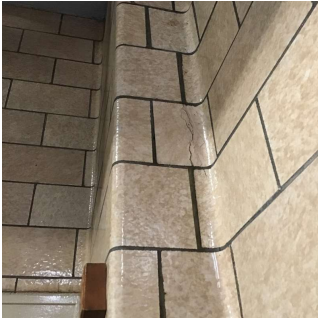
Question	Response
INTERIOR	
STAIRS/RAMPS: INTERIOR	
Walls	
Deficiency	GLAZED BLOCK: CRACKS/SPALLING
Deficiency Location/Instance	Stairs C/4,3, F/4,3, Exit 10 - Vestibule and others
Deficiency Quantity	140
Quantity Uom	S.F.
Potential Action	REPLACE
Urgency of Action	PRIORITY 3
Purpose of Action	LEVEL 2
Deficiency Photo1

Violations	Stair C/4 No violations recorded.
TOILET ROOMS - STAFF	Inspected
Ceiling	Inspected
Condition	2 - Between Good and Fair
Deficiency	GYPSON BOARD: DAMAGED/DETERIORATED
Deficiency Location/Instance	Room 432A
Deficiency Quantity	10
Quantity Uom	S.F.
Potential Action	REPLACE
Urgency of Action	PRIORITY 3
Purpose of Action	LEVEL 2
Deficiency Photo1

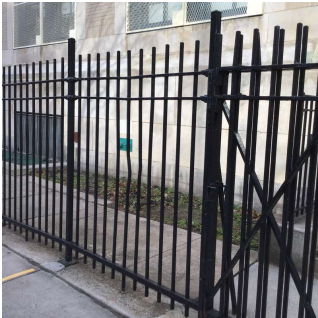
Question	Response
SITE	
FENCES	
Violations	73rd Street No violations recorded.
Deficiency	WROUGHT IRON: DAMAGED/DETERIORATED
Deficiency Location/Instance	74th Street, Fort Hamilton Parkway
Deficiency Quantity	540
Quantity Uom	S.F.
Potential Action	REPLACE
Urgency of Action	PRIORITY 3
Purpose of Action	LEVEL 2
Deficiency Photo1

Violations	74th Street No violations recorded.
Deficiency	CONCRETE CURB: DAMAGED/DETERIORATED
Deficiency Location/Instance	74th Street, Fort Hamilton Parkway, 73rd Street
Deficiency Quantity	350
Quantity Uom	S.F.
Potential Action	REPLACE
Urgency of Action	PRIORITY 3
Purpose of Action	LEVEL 2
Deficiency Photo1

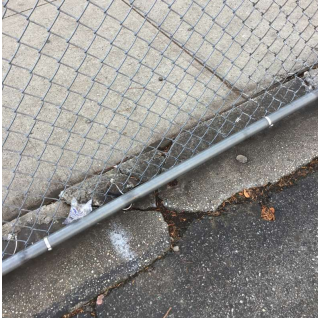
Violations	74th Street No violations recorded.
IRRIGATION SYSTEM	
	Does not Exist
PAVING	
	Inspected
Student Non-Use	
Gravel Exists?	Inspected No
Asphalt	
	Does not Exist
Concrete	
Condition	Inspected 3 - Fair
Deficiency	DAMAGED/DETERIORATED/MISSING SECTIONS
Deficiency Location/Instance	74th Street, Fort Hamilton Parkway

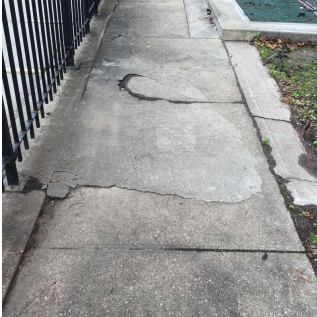
Question	Response
SITE	
PAVING	
Student Non-Use	
Concrete	
Deficiency Quantity	225
Quantity Uom	S.F.
Potential Action	REPLACE
Urgency of Action	PRIORITY 3
Purpose of Action	LEVEL 2
Deficiency Photo1

74th Street
Violations	No violations recorded.
Pavers	Does not Exist
Student Use	Inspected
Gravel Exists?	No
Asphalt	Inspected
Condition	4 - Between Fair and Poor
Deficiency	CRACKS - MAJOR
Deficiency Location/Instance	Schoolyard
Deficiency Quantity	1,000
Quantity Uom	S.F.
Potential Action	REPLACE
Urgency of Action	PRIORITY 3
Purpose of Action	LEVEL 2
Deficiency Photo1

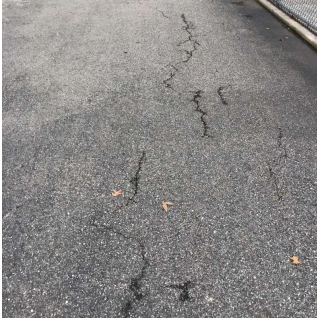
Schoolyard
Violations	No violations recorded.
Concrete	Does not Exist
Pavers	Does not Exist
Site Sidewalks & Walkways	Inspected
Asphalt	Inspected
Condition	3 - Fair
Deficiency	CRACKS - MAJOR
Deficiency Location/Instance	74th Street

Question	Response
SITE	
PAVING	
Site Sidewalks & Walkways	
Asphalt	
Deficiency Quantity	60
Quantity Uom	S.F.
Potential Action	REPLACE
Urgency of Action	PRIORITY 3
Purpose of Action	LEVEL 2
Deficiency Photo1

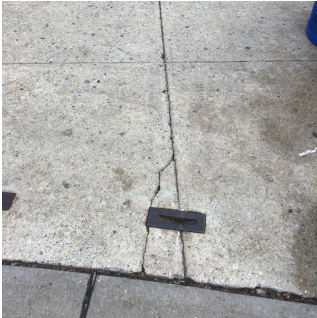
Fort Hamilton
Violations	No violations recorded.
Pavers	Does not Exist
DOT Sidewalk	Inspected
Asphalt	Does not Exist
Concrete	Inspected
Condition	4 - Between Fair and Poor
Deficiency	HEAVING
Deficiency Location/Instance	74th Street
Deficiency Quantity	150
Quantity Uom	S.F.
Potential Action	REPLACE

74th Street
Violations	No violations recorded.
Concrete	Inspected
Condition	3 - Fair
Deficiency	DAMAGED/DETERIORATED/MISSING SECTIONS
Deficiency Location/Instance	73rd Street, Fort Hamilton Parkway
Deficiency Quantity	100
Quantity Uom	S.F.
Potential Action	REPLACE
Urgency of Action	PRIORITY 3
Purpose of Action	LEVEL 2
Deficiency Photo1

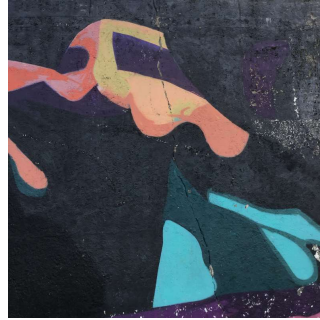
Schoolyard

SITE WALLS (NOT RETAINING WALLS)
