NYC Department of Education
Building Condition Assessment Survey 2023 - 2024

Architectural Inspection

Asset: P.S./I.S. 323 - BROOKLYN, 210 CHESTER STREET, New York, 11212

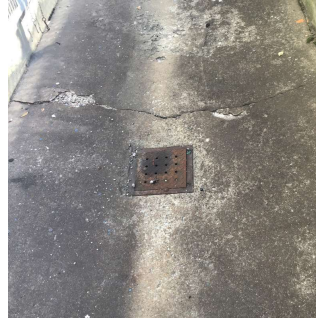
AW6
No violations recorded.

Question	Response
Architectural	
EXTERIOR	Inspected
AREAWAY	Inspected
Instance on AW1-AW9	Inspected
Instance Condition	3 - Fair
Instance Quantity	9
Instance Quantity Uom	EACH
Deficiency	AREAWAY SLAB: CRACKS AND SPALLING
Roof Plan reference	K263
Deficiency Quantity	60
Quantity Uom	S.F.
Potential Action	REPAIR
Urgency of Action	PRIORITY 3
Purpose of Action	LEVEL 2

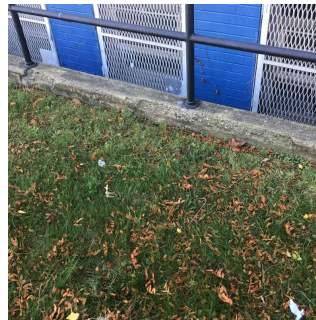
AW4, AW5
No violations recorded.

AREAWAY WALLS: CRACKS AND SPALLING

16
S.F.
REPAIR
PRIORITY 3
LEVEL 2

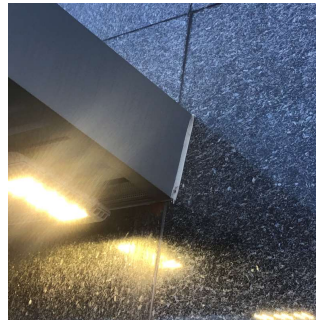
Main Entrance Canopy
No violations recorded.

20
S.F.
REPAIR
PRIORITY 5
LEVEL 2

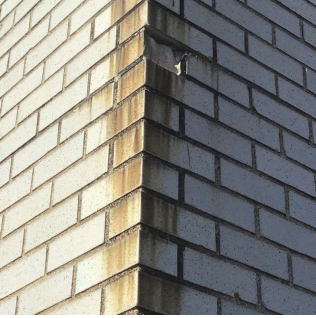
Facade A - South No violations recorded.
CHIMNEY	
Material Type(s)	Masonry
Condition	3 - Fair
Deficiency	BRICK: MAJOR / THRU CRACKS
Roof Plan reference	K263

Deficiency Quantity	15
Quantity Uom	S.F.
Potential Action	REMOVE AND REBUILD
Urgency of Action	PRIORITY 4
Purpose of Action	LEVEL 4
Deficiency Photo1

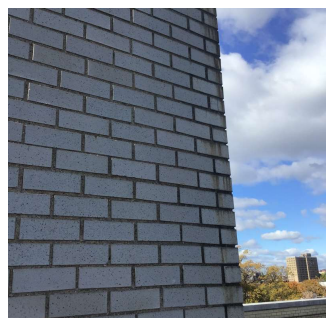
Violations	Chimney 35674680L
Deficiency	BRICK: DETERIORATED JOINTS

Deficiency Quantity	150
Quantity Uom	S.F.
Potential Action	REPOINT
Urgency of Action	PRIORITY 3
Purpose of Action	LEVEL 2
Deficiency Photo1

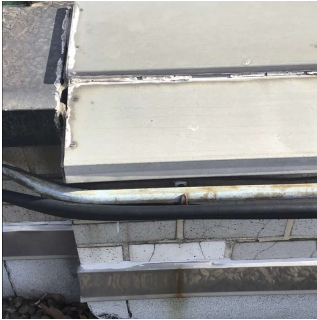
COPING	Inspected
Condition	3 - Fair
Deficiency	METAL: DETERIORATED JOINTS
Roof Plan reference	K263

Deficiency Quantity	25
Quantity Uom	L.F.
Potential Action	REPAIR
Urgency of Action	PRIORITY 3
Purpose of Action	LEVEL 2

Violations	Facade A - Above Main Entry No violations recorded.
Deficiency	CAST STONE: DETERIORATED TRANSVERSE JOINTS
Roof Plan reference	K263

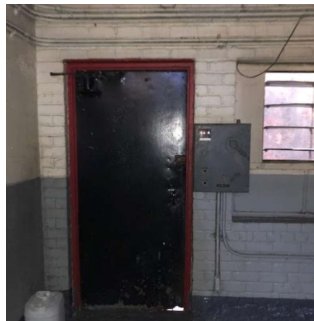
Boiler Room Door

Violations	Roof 1 - Facade A No violations recorded.
CORNICE	Does not Exist
DOORS	Inspected
DOORS AND FRAMES	Inspected
Condition	3 - Fair
Deficiency	METAL: DETERIORATED DOOR - MAJOR DETERIORATION

1
EACH
REPLACE
PRIORITY 4
LEVEL 2

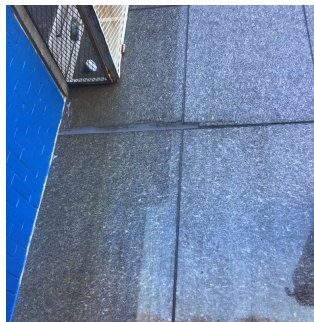
Facade A = Main Entry

DOOR HARDWARE	Inspected
Condition	3 - Fair
Deficiency	No deficiencies recorded
LINTELS	Inspected
Condition	2 - Between Good and Fair
Deficiency	No deficiencies recorded
TRANSOM/SIDE LIGHT	Inspected
Condition	2 - Between Good and Fair
Deficiency	No deficiencies recorded
EXTERIOR WALLS	Inspected
Material Type(s)	Masonry
Replacement Quantity	32,400
Replacement Uom	S.F.
Instance on All Facades	Inspected
Instance Condition	3 - Fair
Instance Quantity	32,400
Instance Quantity Uom	S.F.
Deficiency	STONE: CHIPPED/SPALLED/BROKEN PIECES - MAJOR

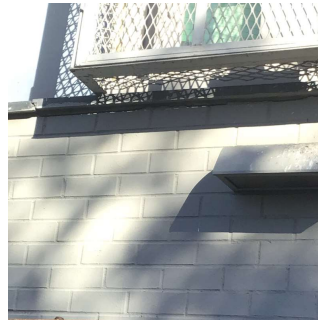
Facade C

BRICK: MASONRY SILLS - DETERIORATED JOINTS

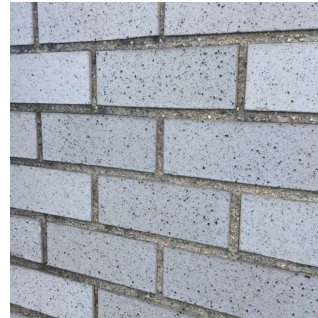
Facade E

BRICK: DETERIORATED JOINTS

PRIORITY 3
LEVEL 2

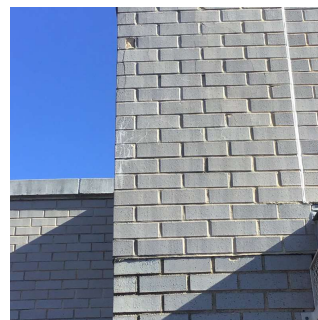
Facade E

BRICK: MAJOR / THRU CRACKS

100
S.F.
REMOVE AND REBUILD
PRIORITY 4
LEVEL 4

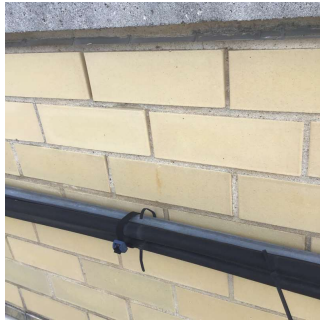
Question	Response
EXTERIOR	
EXTERIOR SOFFITS	Does not Exist
LOADING DOCK	Does not Exist
LOUVER	Inspected
Condition	2 - Between Good and Fair
Deficiency	No deficiencies recorded
PARAPETS	Inspected
Material Type(s)	Masonry
Replacement Quantity	9,000
Replacement Uom	C.F.
Instance on All Facades	Inspected
Instance Condition	3 - Fair
Instance Quantity	9,000
Instance Quantity Uom	C.F.
Deficiency	BRICK: DETERIORATED JOINTS
Roof Plan reference	K263
Deficiency Quantity	2,000
Quantity Uom	S.F.
Potential Action	REPOINT
Urgency of Action	PRIORITY 3
Purpose of Action	LEVEL 2
Deficiency Photo1

Violations	Facade A - Roof 1 No violations recorded.
Deficiency	BRICK: MINOR CRACKS, SPALLING

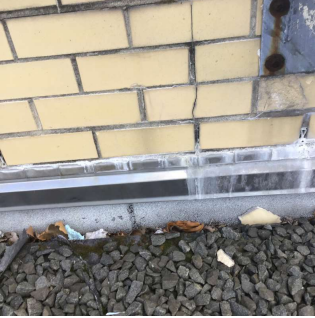
Deficiency Quantity	100
Quantity Uom	S.F.
Potential Action	REPAIR
Urgency of Action	PRIORITY 3
Purpose of Action	LEVEL 2
Deficiency Photo1

Violations	Roof 1 No violations recorded.
PLAZA DECK	Does not Exist
ROOF	Inspected
Roofing	Inspected
Replacement Quantity	45,000
Replacement Uom	S.F.
ROOF HATCH/SMOKE HATCH	Does not Exist
LEADERS, GUTTERS, DOWNSPOUTS, SCUPPERS	Inspected
Condition	2 - Between Good and Fair
Deficiency	No deficiencies recorded
ROOF BARRIER/FENCE	Does not Exist
ROOF CAGE	Does not Exist
ROOFING	Inspected
Instance on IRMA: All Roofs	Inspected
Instance Condition	3 - Fair
Instance Photo

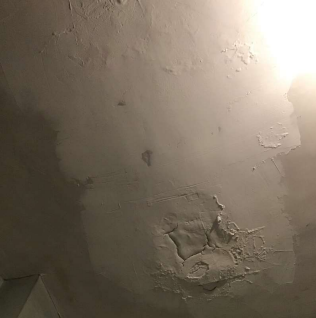
Roof 1 - Closet in Room 330 (shown), Room 312

Deficiency IRMA: ROOFING: MAJOR ACTIVE ROOF LEAKS IN INSTRUCTIONAL SPACE

Deficiency Quantity	200
Quantity Uom	S.F.
Potential Action	REPLACE ROOFING WITHOUT MAJOR EQUIPMENT REMOVAL
Urgency of Action	PRIORITY 5
Purpose of Action	LEVEL 2
Deficiency Photo1

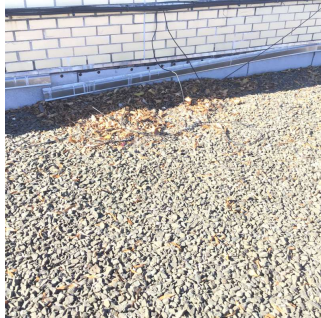
Deficiency IRMA: FLASHING: CAP FLASHING DAMAGED

Deficiency Quantity	10
Quantity Uom	L.F.

Question	Response
EXTERIOR	
ROOF	
Roofing	
ROOFING	
Potential Action	REPLACE
Urgency of Action	PRIORITY 4
Purpose of Action	LEVEL 2
Deficiency Photo1

Violations	Roof 2 - Facade E No violations recorded.
Deficiency	IRMA: ROOFING: DAMAGED INSULATION
Roof Plan reference	K263

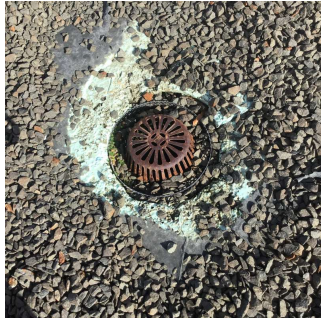
Deficiency Quantity	10
Quantity Uom	S.F.
Potential Action	REPLACE
Urgency of Action	PRIORITY 4
Purpose of Action	LEVEL 2
Deficiency Photo1

Violations	Roof 1 - South No violations recorded.
ROOFING DRAINS	Inspected
Condition	2 - Between Good and Fair
Deficiency	No deficiencies recorded
Specialties	Inspected
BULKHEAD/PENTHOUSE	Inspected
Condition	4 - Between Fair and Poor

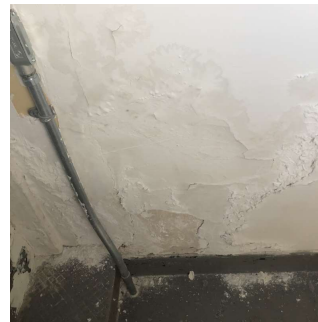
BH2

BULKHEAD/PENTHOUSE WALLS/EXTERIOR: WATER INFILTRATION

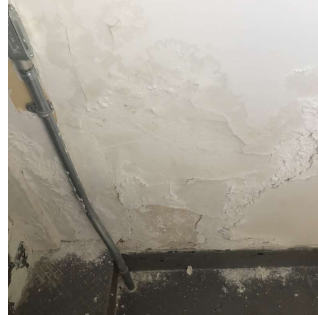
Bulkhead 2

BULKHEAD/PENTHOUSE WALLS/INTERIOR: PLASTER CRACKS/SPALLING

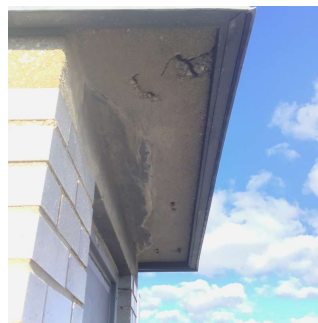
Bulkhead 2, 3

BULKHEAD/PENTHOUSE ROOF: DETERIORATED

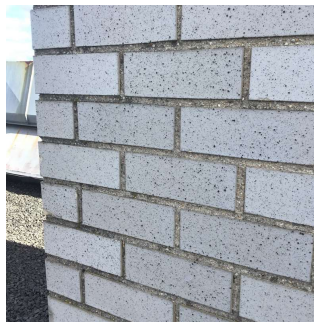
BULKHEAD/PENTHOUSE WALLS/EXTERIOR: DETERIORATED JOINTS

500
S.F.
REPOINT
PRIORITY 3
LEVEL 2

Bulkhead 3
No violations recorded.

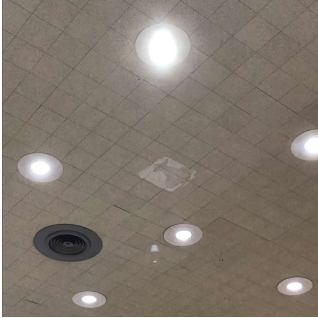
Question	Response
INTERIOR	
AUDITORIUM	
Ceiling	
Condition	2 - Between Good and Fair
Deficiency	ACOUSTIC TILES ON PLASTER: DAMAGED/MISSING
Deficiency Location/Instance	Center
Deficiency Quantity	10
Quantity Uom	S.F.
Potential Action	REPLACE
Urgency of Action	PRIORITY 3
Purpose of Action	LEVEL 2
Deficiency Photo1

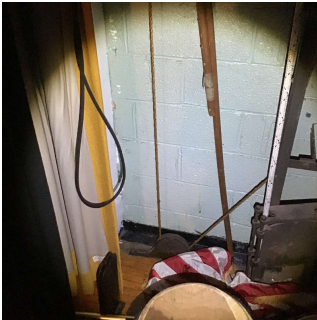
Question	Response
INTERIOR	
AUDITORIUM	
Stage	
Stage	
Deficiency Photo1	 
	Right Side
Violations	No violations recorded.
Stage Curtain Rigging	Inspected
Instance on 1st Floor (490 Seats)	Inspected
Condition	3 - Fair
Deficiency	DAMAGED/DETERIORATED
Deficiency Location/Instance	Right Side
Deficiency Quantity	1
Quantity Uom	EACH
Potential Action	REPLACE
Urgency of Action	PRIORITY 3
Purpose of Action	LEVEL 2
Deficiency Photo1

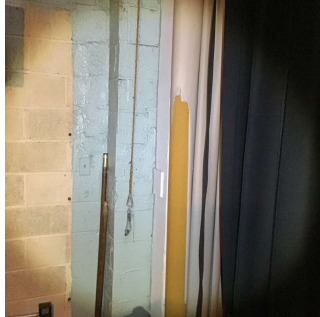
Right Side
Violations	No violations recorded.
Stage Curtains	Inspected
Instance on 1st Floor (490 Seats)	Inspected
Condition	3 - Fair
Deficiency	WORN/DETERIORATED
Deficiency Location/Instance	Left Side
Deficiency Quantity	100
Quantity Uom	S.F.
Potential Action	REPLACE
Urgency of Action	PRIORITY 3
Purpose of Action	LEVEL 2

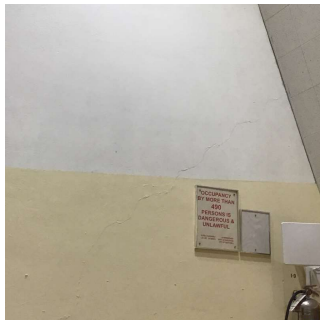
Left Side
Violations	No violations recorded.
Walls	
Instance on 1st Floor (490 Seats)	Inspected
Condition	2 - Between Good and Fair
Deficiency	PLASTER: CRACKS/SPALLING
Deficiency Location/Instance	Near Entrance, Near Stair F
Deficiency Quantity	30
Quantity Uom	S.F.
Potential Action	REPLACE
Urgency of Action	PRIORITY 3
Purpose of Action	LEVEL 2
Deficiency Photo1

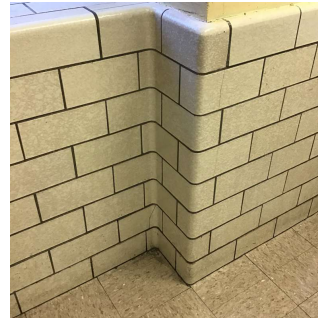
Near Windows

GLAZED BLOCK: CRACKS/SPALLING

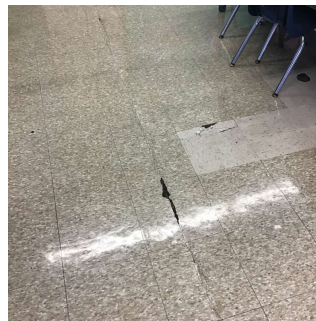
Room 102

VINYL TILES: DETERIORATED SUBSTRATE

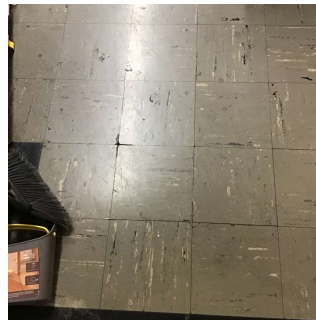
Room 337

VINYL TILES: BROKEN/DETERIORATED/MISSING TILES

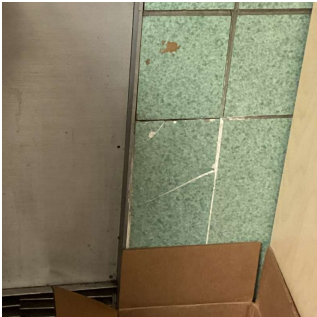
Question	Response
INTERIOR	
CLASSROOMS/CORRIDORS/ADMIN SPACES	
Floor Finish	
Deficiency	TERRAZZO: CRACKS
Deficiency Location/Instance	Main Entrance Lobby
Deficiency Quantity	30
Quantity Uom	S.F.
Potential Action	REPLACE
Urgency of Action	PRIORITY 3
Purpose of Action	LEVEL 2
Deficiency Photo1	 
Violations	Main Entrance Lobby No violations recorded.
Walls	
Condition	Inspected
Deficiency	2 - Between Good and Fair
Deficiency	GLAZED BLOCK: CRACKS/SPALLING
Deficiency Location/Instance	Corridor near Room 125
Deficiency Quantity	10
Quantity Uom	S.F.
Potential Action	REPLACE
Urgency of Action	PRIORITY 3
Purpose of Action	LEVEL 2
Deficiency Photo1

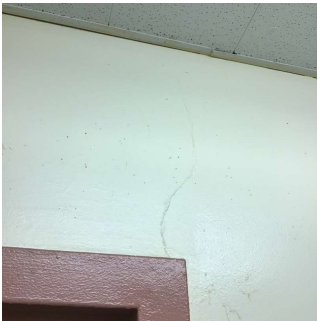
Violations	Corridor near Room 125 No violations recorded.
Deficiency	PLASTER: CRACKS/SPALLING
Deficiency Location/Instance	Corridor near Rooms B14, B19, 105, 310, Room 133, and others
Deficiency Quantity	100
Quantity Uom	S.F.
Potential Action	REPLACE
Urgency of Action	PRIORITY 3
Purpose of Action	LEVEL 2

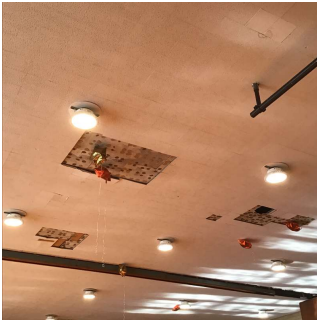
Violations	Corridor near Room B14 No violations recorded.
Specialties	Does not Exist
GYMNASIUM	
Instance on 1st Floor	Inspected
Instance on 1st Floor	Inspected
Ceiling	
Instance on 1st Floor	Inspected
Condition	3 - Fair
Deficiency	ACOUSTIC TILES ON PLASTER: DAMAGED/MISSING
Deficiency Location/Instance	Center, Near Windows
Deficiency Quantity	160
Quantity Uom	S.F.
Potential Action	REPLACE
Urgency of Action	PRIORITY 3
Purpose of Action	LEVEL 2
Deficiency Photo1

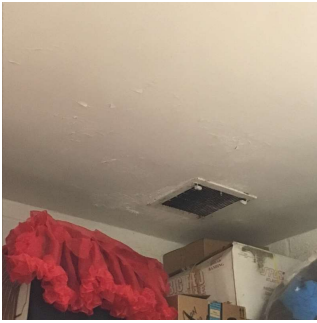
Violations	Center No violations recorded.
Deficiency	PLASTER: CRACKS/SPALLING
Deficiency Location/Instance	Store Room
Deficiency Quantity	10
Quantity Uom	S.F.
Potential Action	REPLACE
Urgency of Action	PRIORITY 3
Purpose of Action	LEVEL 2

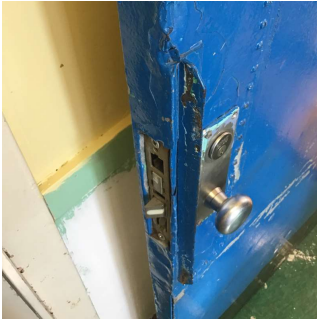
Store Room
Violations	No violations recorded.
Door(s)	
Instance on 1st Floor	Inspected
Condition	5 - Poor
Deficiency	METAL: DETERIORATED DOOR
Deficiency Location/Instance	Office 2, Store Room
Deficiency Quantity	2
Quantity Uom	EACH
Potential Action	MAINTENANCE
Urgency of Action	PRIORITY 3
Purpose of Action	LEVEL 2
Deficiency Photo1

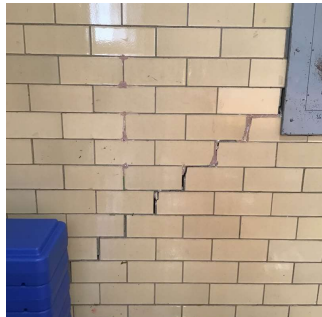
Deficiency	GLAZED BLOCK: CRACKS/SPALLING
Deficiency Location/Instance	Near Entrance, Near Office 2
Deficiency Quantity	30
Quantity Uom	S.F.
Potential Action	REPLACE
Urgency of Action	PRIORITY 3
Purpose of Action	LEVEL 2

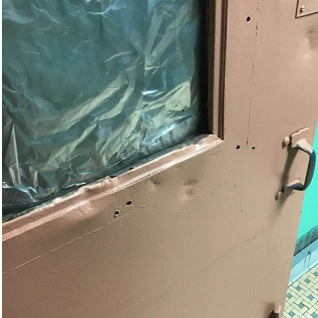
Question	Response
INTERIOR	
KITCHEN	
Door(s)	
Instance on Basement	Inspected
Condition	5 - Poor
Deficiency	METAL: DETERIORATED DOOR
Deficiency Location/Instance	Staff Serving Area
Deficiency Quantity	1
Quantity Uom	EACH
Potential Action	MAINTENANCE
Urgency of Action	PRIORITY 3
Purpose of Action	LEVEL 2
Deficiency Photo1

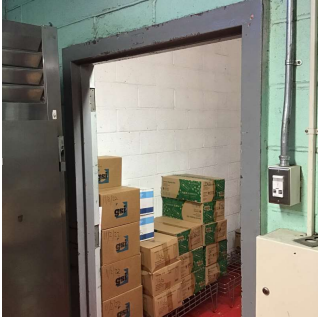
Violations	Staff Serving Area No violations recorded.
Deficiency	METAL: MISSING DOOR
Deficiency Location/Instance	Store Room, Students Serving Area
Deficiency Quantity	3
Quantity Uom	EACH
Potential Action	MAINTENANCE
Urgency of Action	PRIORITY 3
Purpose of Action	LEVEL 2
Deficiency Photo1

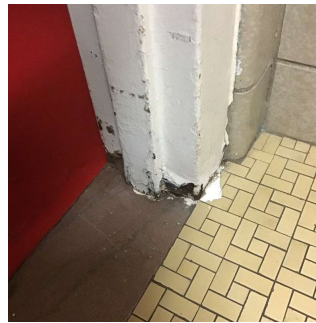
Violations	Store Room No violations recorded.
Deficiency	METAL: DETERIORATED DOOR AND FRAME
Deficiency Location/Instance	Store Room, Mop Room, Students Serving Area
Deficiency Quantity	3
Quantity Uom	EACH
Potential Action	MAINTENANCE
Urgency of Action	PRIORITY 3
Purpose of Action	LEVEL 2

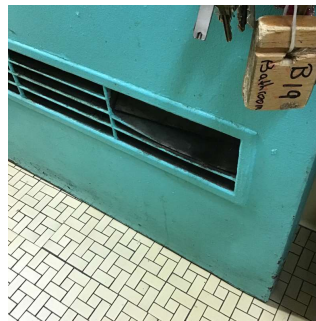
Office

METAL: DAMAGED LOUVER

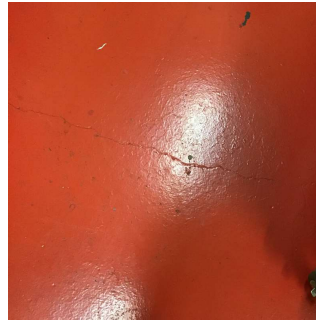
Store Room

CONCRETE: CRACKS

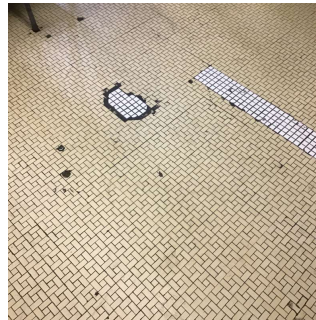
Center

CERAMIC TILE: BROKEN/MISSING TILES

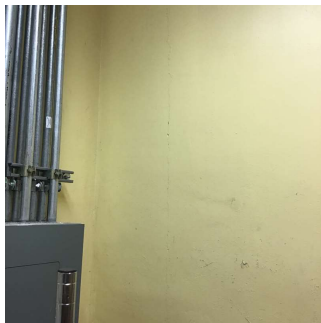
PLASTER: CRACKS/SPALLING

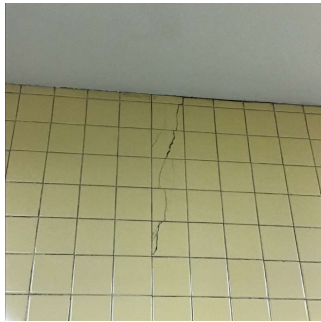
Store Room
Violations	No violations recorded.
Deficiency	CERAMIC TILE: BROKEN/ MISSING
Deficiency Location/Instance	Near Windows, Mop Room, Students Serving Area
Deficiency Quantity	25
Quantity Uom	S.F.
Potential Action	REPLACE
Urgency of Action	PRIORITY 3
Purpose of Action	LEVEL 2
Deficiency Photo1

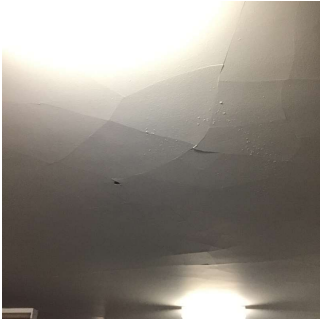
Question	Response
INTERIOR	
LIBRARY	Inspected
Walls	
Condition	2 - Between Good and Fair
Deficiency	No deficiencies recorded
LOCKER ROOM	Inspected
Instance on Basement - Boys (975 Lockers)	Inspected
Alternative use	Yes
Instance on Basement - Girls (975 Lockers)	Inspected
Alternative use	Yes
Ceiling	
Instance on Basement - Girls (975 Lockers)	Inspected
Condition	3 - Fair
Deficiency	PLASTER: CRACKS/SPALLING
Deficiency Location/Instance	Near Entrance
Deficiency Quantity	50
Quantity Uom	S.F.
Potential Action	REPLACE
Urgency of Action	PRIORITY 3
Purpose of Action	LEVEL 2
Deficiency Photo1

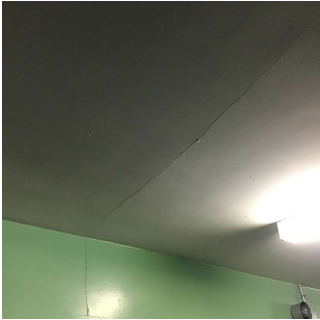
Near Entrance
Violations	No violations recorded.
Instance on Basement - Boys (975 Lockers)	Inspected
Condition	2 - Between Good and Fair
Deficiency	PLASTER: CRACKS/SPALLING
Deficiency Location/Instance	Center
Deficiency Quantity	20
Quantity Uom	S.F.
Potential Action	REPLACE
Urgency of Action	PRIORITY 3
Purpose of Action	LEVEL 2
Deficiency Photo1

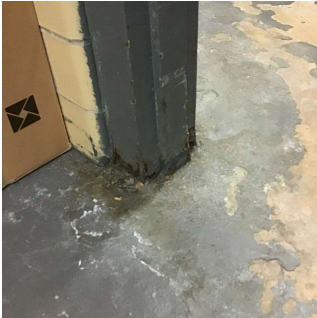
Question	Response
INTERIOR	
LOCKER ROOM	Inspected
Ceiling	
Violations	No violations recorded.
Door(s)	
Instance on Basement - Girls (975 Lockers)	Inspected
Condition	3 - Fair
Deficiency	METAL: DETERIORATED DOOR AND FRAME
Deficiency Location/Instance	Entrance
Deficiency Quantity	1
Quantity Uom	EACH
Potential Action	MAINTENANCE
Urgency of Action	PRIORITY 3
Purpose of Action	LEVEL 2
Deficiency Photo1

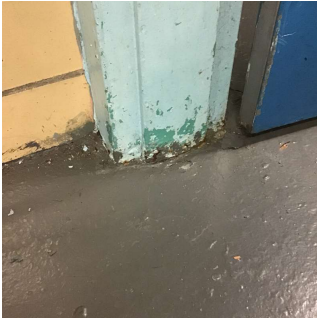
Violations	Entrance No violations recorded.
Instance on Basement - Boys (975 Lockers)	Inspected
Condition	3 - Fair
Deficiency	METAL: DETERIORATED DOOR AND FRAME
Deficiency Location/Instance	Entrance
Deficiency Quantity	1
Quantity Uom	EACH
Potential Action	MAINTENANCE
Urgency of Action	PRIORITY 3
Purpose of Action	LEVEL 2
Deficiency Photo1

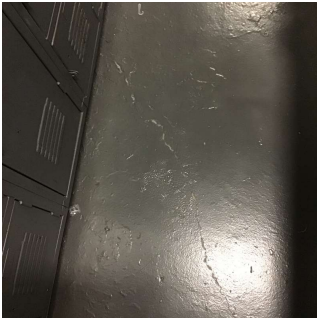
Violations	Entrance No violations recorded.
Floor Finish	
Instance on Basement - Girls (975 Lockers)	Inspected
Condition	3 - Fair
Deficiency	CONCRETE: CRACKS
Deficiency Location/Instance	Center, Near Exit to Exterior

Question	Response
INTERIOR	
LOCKER ROOM	
Floor Finish	
Deficiency Quantity	75
Quantity Uom	S.F.
Potential Action	REPLACE
Urgency of Action	PRIORITY 3
Purpose of Action	LEVEL 2
Deficiency Photo1

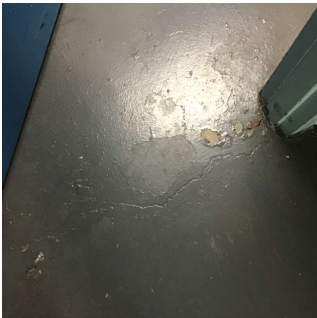
Center	
Violations	No violations recorded.
Instance on Basement - Boys (975 Lockers)	Inspected
Condition	2 - Between Good and Fair
Deficiency	CONCRETE: CRACKS
Deficiency Location/Instance	Near Exit to Exterior
Deficiency Quantity	10
Quantity Uom	S.F.
Potential Action	REPLACE
Urgency of Action	PRIORITY 3
Purpose of Action	LEVEL 2
Deficiency Photo1

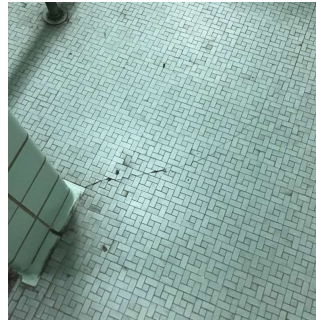
Door(s)	
Instance on Basement - Boys	Does not Exist
Floor Finish	
Instance on Basement - Boys	Inspected
Condition	5 - Poor
Deficiency	CERAMIC TILE: DETERIORATED SUBSTRATE
Deficiency Location/Instance	Center
Deficiency Quantity	30
Quantity Uom	S.F.
Potential Action	REPLACE
Urgency of Action	PRIORITY 3
Purpose of Action	LEVEL 2

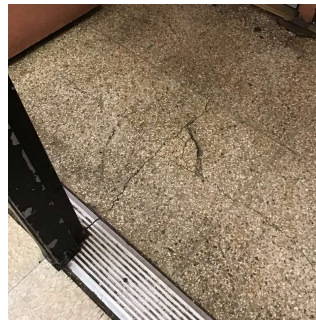
Deficiency TERRAZZO: CRACKS

Deficiency Location/Instance Stair B/1 Vestibule

Potential Action REPLACE

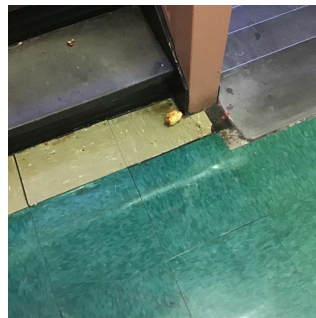
Deficiency VINYL TILES: DETERIORATED SUBSTRATE

Deficiency Location/Instance Stairs A/2,3, E/2

Potential Action REPLACE

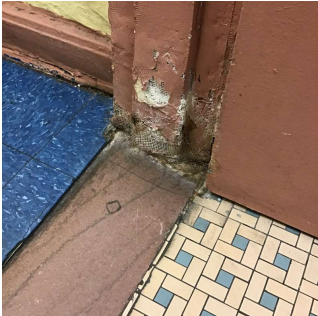
Violations	Kitchen Staff Men No violations recorded.
Deficiency	METAL: DETERIORATED DOOR AND FRAME
Deficiency Location/Instance	Room 121
Deficiency Quantity	1
Quantity Uom	EACH
Potential Action	MAINTENANCE
Urgency of Action	PRIORITY 3
Purpose of Action	LEVEL 2
Deficiency Photo1

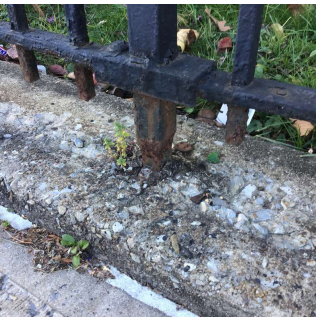
Violations	Near Exit 9 35674679Y
Deficiency	WROUGHT IRON: RUST - MAJOR
Deficiency Location/Instance	Chester Street, Sutter Avenue
Deficiency Quantity	160
Quantity Uom	S.F.
Potential Action	REPLACE

Question	Response
SITE	
FENCES	
Urgency of Action	PRIORITY 3
Purpose of Action	LEVEL 2
Deficiency Photo1

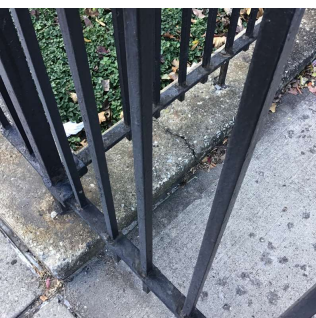
Violations	Chester Street No violations recorded.
Deficiency	CONCRETE CURB: DAMAGED/DETERIORATED
Deficiency Location/Instance	Chester Street, Blake Avenue, Bristol Street, Sutter Avenue
Deficiency Quantity	240
Quantity Uom	S.F.
Potential Action	REPLACE
Urgency of Action	PRIORITY 3
Purpose of Action	LEVEL 2
Deficiency Photo1

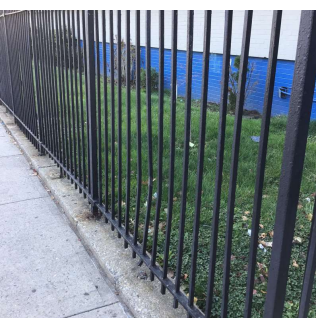
Violations	Chester Street No violations recorded.
Deficiency	WROUGHT IRON: DAMAGED/DETERIORATED
Deficiency Location/Instance	Chester Street, Blake Avenue, Bristol Street, Sutter Avenue
Deficiency Quantity	1,160
Quantity Uom	S.F.
Potential Action	REPLACE
Urgency of Action	PRIORITY 3
Purpose of Action	LEVEL 2
Deficiency Photo1

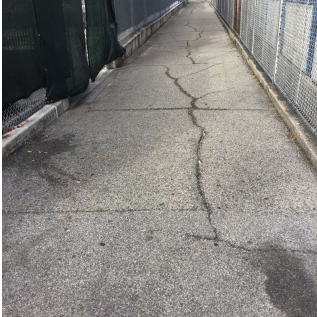
Question	Response
SITE	
PAVING	Inspected
Student Use	
Gravel Exists?	No
Asphalt	Inaccessible
Concrete	Inaccessible
Pavers	Does not Exist
Site Sidewalks & Walkways	Inspected
Asphalt	Inspected
Condition	4 - Between Fair and Poor
Deficiency	CRACKS - MAJOR
Deficiency Location/Instance	West Side of Building
Deficiency Quantity	675
Quantity Uom	S.F.
Potential Action	REPLACE
Urgency of Action	PRIORITY 3
Purpose of Action	LEVEL 2
Deficiency Photo1

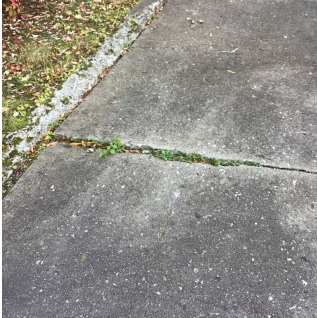
Sutter Avenue
Violations	No violations recorded.
Deficiency	DAMAGED/DETERIORATED/MISSING SECTIONS

West Side of Building
Violations	No violations recorded.
Concrete	Inspected
Condition	4 - Between Fair and Poor
Deficiency	HEAVING
Deficiency Location/Instance	Sutter Avenue
Deficiency Quantity	50
Quantity Uom	S.F.
Potential Action	REPLACE
Urgency of Action	PRIORITY 3
Purpose of Action	LEVEL 2
Deficiency Photo1

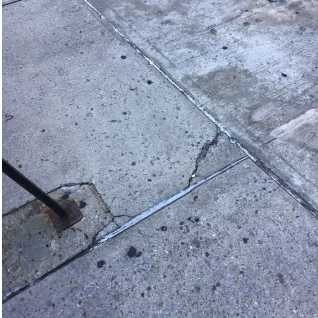
Violations	Blake Avenue Near Exit 3 No violations recorded.
Deficiency	DAMAGED/DETERIORATED/MISSING SECTIONS
Deficiency Location/Instance	Chester Street, Blake Avenue, West Side of Building, Bristol Street, Sutter Avenue
Deficiency Quantity	1,150
Quantity Uom	S.F.
Potential Action	REPLACE
Urgency of Action	PRIORITY 3
Purpose of Action	LEVEL 2
Deficiency Photo1

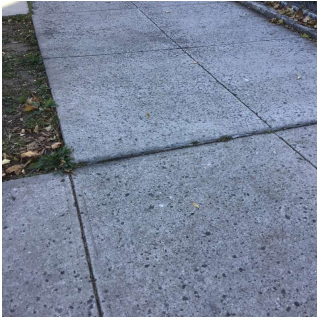
Violations	Chester Street No violations recorded.
Pavers	Inspected
Condition	2 - Between Good and Fair
Deficiency	No deficiencies recorded
DOT Sidewalk	Inspected
Asphalt	Does not Exist
Concrete	Inspected
Condition	4 - Between Fair and Poor
Deficiency	HEAVING
Deficiency Location/Instance	Bristol Street, Sutter Avenue

Deficiency Quantity	200

Question	Response
SITE	
PAVING	
DOT Sidewalk	
Concrete	
Quantity Uom	S.F.
Potential Action	REPLACE
Urgency of Action	PRIORITY 3
Purpose of Action	LEVEL 2
Deficiency Photo1

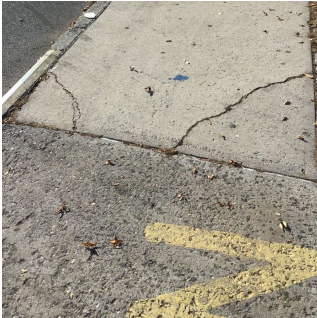
Blake Avenue
Violations	No violations recorded.
Deficiency	HEAVING
Deficiency Location/Instance	Chester Street, Bristol Street
Deficiency Quantity	300
Quantity Uom	S.F.
Potential Action	REPLACE
Urgency of Action	PRIORITY 5
Purpose of Action	LEVEL 6

Bristol Street
Violations	No violations recorded.
Deficiency	DAMAGED/DETERIORATED/MISSING SECTIONS
Deficiency Location/Instance	Chester Street, Blake Avenue, Bristol Street, Sutter Avenue
Deficiency Quantity	575
Quantity Uom	S.F.
Potential Action	REPLACE
Urgency of Action	PRIORITY 3
Purpose of Action	LEVEL 2
Deficiency Photo1

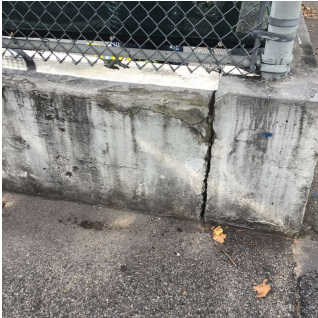
Question	Response
SITE	
PLAYGROUNDS	
Safety Surfacing	
Instance on Schoolyard	Inspected
Condition	2 - Between Good and Fair
Deficiency	No deficiencies recorded
Unpaved Area	
Instance on Schoolyard	Does not Exist
PLAYING SURFACE	
	Does not Exist
RETAINING WALLS	
Are there any Retaining Walls 6' OR higher facing public street/sidewalk?	Inspected
	No
Condition	3 - Fair
Deficiency	CAST IN PLACE CONCRETE: CRACKS/SPALLING - MAJOR
Deficiency Location/Instance	Near Exit 11, Near Playground
Deficiency Quantity	30
Quantity Uom	S.F.
Potential Action	REPLACE
Urgency of Action	PRIORITY 3
Purpose of Action	LEVEL 2
Deficiency Photo1

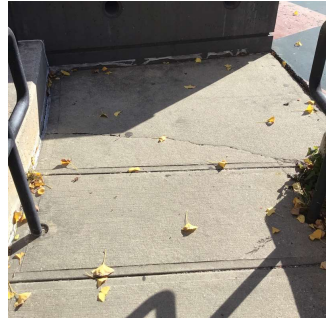
Near Playground
Violations	No violations recorded.
ARTWORK	
Instance	Inspected
Instance ID	Interior - Lobby (missing) - 11212
Artwork exist at stated location?	No

Deficiency	No deficiencies recorded
Site Cheek/flank Walls	
	Inspected
Condition	2 - Between Good and Fair
Deficiency	No deficiencies recorded
Stairs/ramps	
	Inspected
Condition	2 - Between Good and Fair
Deficiency	CAST IN PLACE CONCRETE: CRACKS/SPALLING - MAJOR
Deficiency Location/Instance	Near Playground
Deficiency Quantity	25
Quantity Uom	S.F.

Question	Response
SITE	
STAIRS/RAMPS: EXTERIOR	
Stairs/ramps	
Potential Action	REPLACE
Urgency of Action	PRIORITY 3
Purpose of Action	LEVEL 2
Deficiency Photo1
