**NYC Department of Education**  
**Building Condition Assessment Survey 2023 - 2024**

Architectural Inspection

**Asset: I.S. 265 - BROOKLYN, 101 PARK AVENUE, New York, 11205**

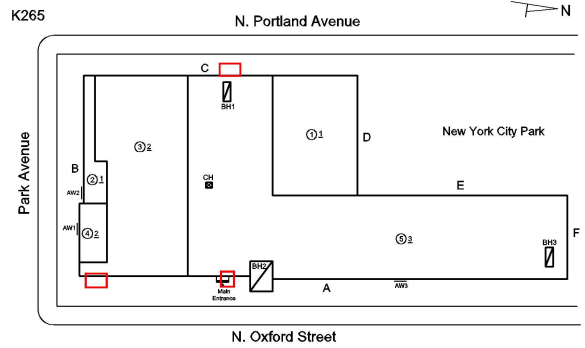
Question	Response
<b>EXTERIOR</b>	
<b>ROOF</b>	Inspected
<b>Specialties</b>	Inspected
<b>SKYLIGHT/ROOF VENT</b>	Does not Exist
<b>ROOF/GRAVITY TANK</b>	Does not Exist
<b>STAIRS/RAMPS: EXTERIOR</b>	Inspected
<b>BUILDING CHEEK/FLANK WALLS</b>	Inaccessible
<b>RAILINGS</b>	Inspected
Condition	5 - Poor

Deficiency RUST - MAJOR

40  
L.F.  
REPLACE  
PRIORITY 4  
LEVEL 2

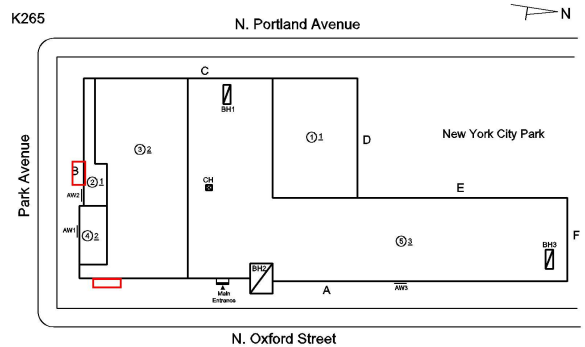
<b>STAIRS/RAMPS</b>	Inspected
Condition	5 - Poor

STONE: DETERIORATED JOINTS

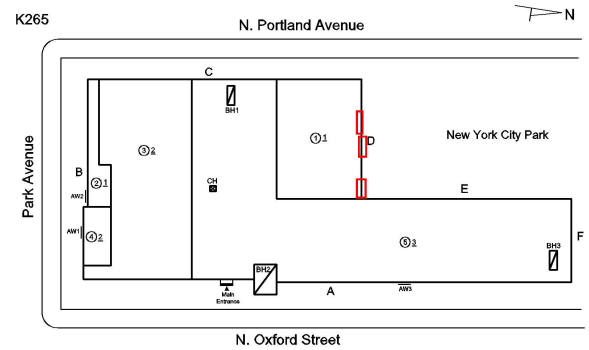
ALUMINUM - DOUBLE HUNG: INOPERABLE BALANCE

150  
EACH  
REPLACE BALANCES  
PRIORITY 3  
LEVEL 2

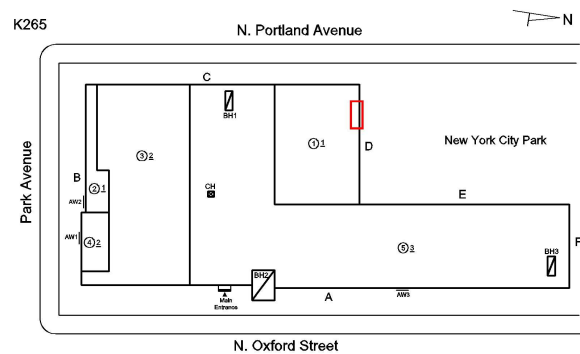
Instance on Aluminum - Other: Staircases, Corridors, Boys and Girls Locker Rooms	Inspected
Instance Condition	4 - Between Fair and Poor
Instance Quantity	1,000
Instance Quantity Uom	S.F.
Are these windows insulated	No
Installation Year	1957
Source of Installation	Custodial Staff
Deficiency	ALUMINUM - OTHER: DETERIORATED
Roof Plan reference	K265

Question	Response
<b>EXTERIOR</b>	
<b>WINDOWS</b>	
<b>WINDOWS</b>	
Elevation	 
Deficiency Quantity	100
Quantity Uom	S.F.
Potential Action	REPLACE WINDOW
Urgency of Action	PRIORITY 4
Purpose of Action	LEVEL 2
Deficiency Photo1	 
Violations	Facade D - Staff Cafeteria No violations recorded.
<b>INTERIOR</b>	Inspected
<b>POOLS</b>	Does not Exist
<b>STRUCTURAL</b>	Inspected
<b>COLUMNS/BEAMS/BEARING WALLS</b>	Inspected
Condition	2 - Between Good and Fair
Deficiency	No deficiencies recorded
<b>FLOOR STRUCTURE</b>	Inspected
Condition	3 - Fair
Deficiency	CONCRETE SLAB ON GRADE: THRU CRACKS
Deficiency Location/Instance	Basement - Boiler Room, Electrical Panel Room, Gas Meter Room
Deficiency Quantity	60
Quantity Uom	S.F.
Potential Action	REPAIR
Urgency of Action	PRIORITY 3
Purpose of Action	LEVEL 5

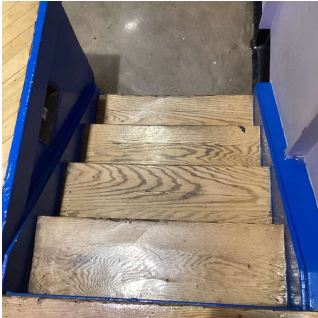
Question	Response
<b>INTERIOR</b>	
<b>AUDITORIUM</b>	
<b>Stage</b>	
Instance on 1st Floor (500 Seats)	Inspected
<b>Stage</b>	Inspected
Instance on 1st Floor (500 Seats)	Inspected
Condition	2 - Between Good and Fair
Deficiency	DAMAGED STEPS
Deficiency Location/Instance	Right Side, Left Side
Deficiency Quantity	15
Quantity Uom	S.F.
Potential Action	REPLACE
Urgency of Action	PRIORITY 3
Purpose of Action	LEVEL 2
Deficiency Photo1

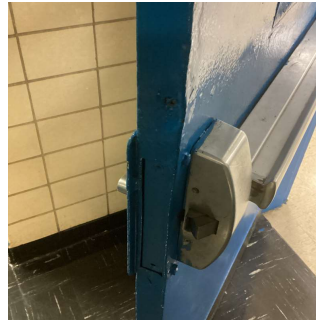
Question	Response
<b>INTERIOR</b>	
<b>CAFETERIA</b>	
<b>Ceiling</b>	
Quantity Uom	S.F.
Potential Action	REPLACE
Urgency of Action	PRIORITY 3
Purpose of Action	LEVEL 2
Deficiency Photo1	 
Center	Center
Violations	No violations recorded.
<b>Door(s)</b>	
Instance on Basement - Staff (600 Seats)	Inspected
Condition	3 - Fair
Deficiency	METAL: DETERIORATED DOOR
Deficiency Location/Instance	Entrance
Deficiency Quantity	1
Quantity Uom	EACH
Potential Action	MAINTENANCE
Urgency of Action	PRIORITY 3
Purpose of Action	LEVEL 2
Deficiency Photo1	 
Entrance	Entrance
Violations	No violations recorded.
Instance on Basement - Students	Inspected
Condition	3 - Fair
Deficiency	METAL: DETERIORATED DOOR
Deficiency Location/Instance	Main Entrance
Deficiency Quantity	1
Quantity Uom	EACH
Potential Action	MAINTENANCE
Urgency of Action	PRIORITY 3
Purpose of Action	LEVEL 2

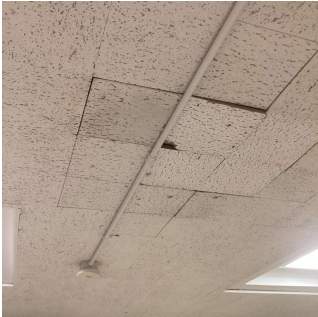
Question	Response
<b>INTERIOR</b>	
<b>CAFETERIA</b>	
<b>Walls</b>	
Violations	No violations recorded.
<b>Window Curtains/Shades/Blinds</b>	
Instance on Basement - Staff (600 Seats)	Does not Exist
Instance on Basement - Students	Does not Exist
<b>CLASSROOMS/CORRIDORS/ADMIN SPACES</b>	
<b>Ceiling</b>	
Condition	2 - Between Good and Fair
Deficiency	ACOUSTIC TILES ON PLASTER: DAMAGED/MISSING
Deficiency Location/Instance	Main Lobby, Corridor near rooms 131, 141
Deficiency Quantity	25
Quantity Uom	S.F.
Potential Action	REPLACE
Urgency of Action	PRIORITY 3
Purpose of Action	LEVEL 2
Deficiency Photo1

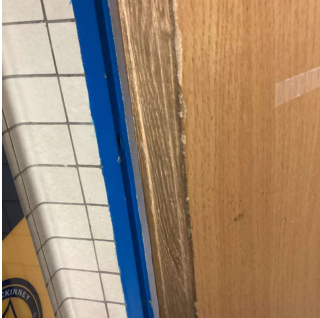
Question	Response
<b>INTERIOR</b>	
<b>LIBRARY</b>	
<b>Door(s)</b>	
Urgency of Action	PRIORITY 3
Purpose of Action	LEVEL 2
Deficiency Photo1

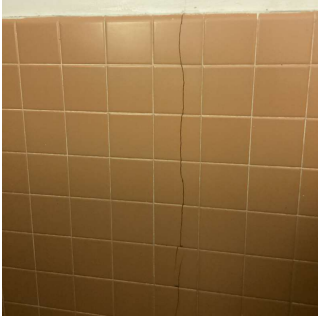
Question	Response
<b>INTERIOR</b>	
<b>TOILET ROOMS - STAFF</b>	Inspected
<b>Stalls</b>	Inspected
	Room B47
Violations	No violations recorded.
<b>Walls</b>	Inspected
Condition	2 - Between Good and Fair
Deficiency	CERAMIC TILE: BROKEN/ MISSING
Deficiency Location/Instance	Rooms 240, 209
Deficiency Quantity	15
Quantity Uom	S.F.
Potential Action	REPLACE
Urgency of Action	PRIORITY 3
Purpose of Action	LEVEL 2
Deficiency Photo1

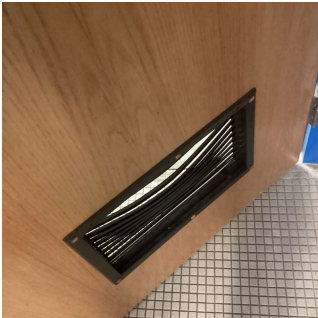
Room B15
Violations	No violations recorded.

Room 209
Violations	No violations recorded.
<b>TOILET ROOMS - STUDENTS</b>	Inspected
<b>Ceiling</b>	Inspected
Condition	2 - Between Good and Fair
Deficiency	No deficiencies recorded
<b>Door(s)</b>	Inspected
Condition	5 - Poor
Deficiency	WOOD: DAMAGED LOUVER
Deficiency Location/Instance	Room B15
Deficiency Quantity	1
Quantity Uom	EACH
Potential Action	MAINTENANCE
Urgency of Action	PRIORITY 3
Purpose of Action	LEVEL 2
Deficiency Photo1

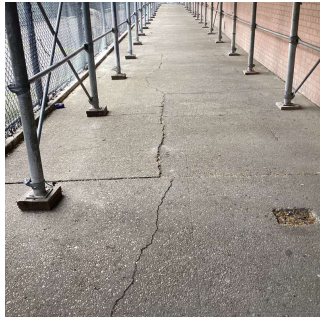
<b>IRRIGATION SYSTEM</b>	Does not Exist
<b>PAVING</b>	Inspected
<b>Student Non-Use</b>	Inspected
Gravel Exists?	No
<b>Asphalt</b>	Does not Exist
<b>Concrete</b>	Inspected
Condition	3 - Fair
Deficiency	HEAVING
Deficiency Location/Instance	Park Avenue
Deficiency Quantity	50
Quantity Uom	S.F.
Potential Action	REPLACE
Urgency of Action	PRIORITY 3
Purpose of Action	LEVEL 2

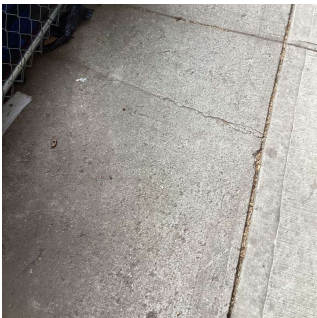
Violations	Along Exit 4 No violations recorded.
<b>Pavers</b>	Does not Exist
<b>DOT Sidewalk</b>	Inspected
<b>Asphalt</b>	Does not Exist
<b>Concrete</b>	Inspected
Condition	4 - Between Fair and Poor
Deficiency	DAMAGED CURBS
Deficiency Location/Instance	N. Oxford Street, Park Avenue
Deficiency Quantity	125
Quantity Uom	L.F.
Potential Action	REPLACE
Urgency of Action	PRIORITY 3
Purpose of Action	LEVEL 2
Deficiency Photo1
