**NYC Department of Education
Building Condition Assessment Survey 2023 - 2024**

Architectural Inspection

Asset: P.S. 269 - BROOKLYN, 1957 NOSTRAND AVENUE, New York, 11210

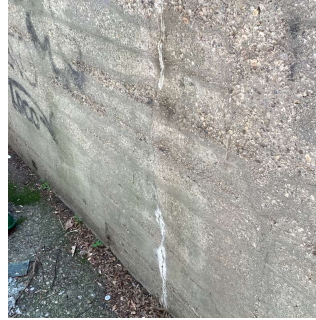
AW2

Question	Response
Architectural	
EXTERIOR	Inspected
AREAWAY	Inspected
Instance on AW1 - AW3	Inspected
Instance Condition	5 - Poor
Instance Quantity	3
Instance Quantity Uom	EACH
Deficiency	AREAWAY WALLS: CRACKS AND SPALLING
Roof Plan reference	
Deficiency Quantity	20
Quantity Uom	S.F.
Potential Action	REPAIR
Urgency of Action	PRIORITY 3
Purpose of Action	LEVEL 2

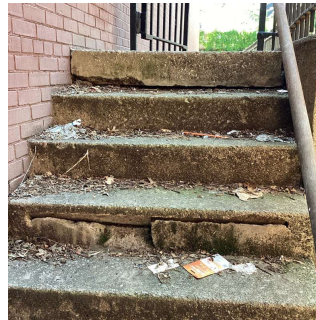
AW2

AREAWAY STAIRS: DETERIORATED
TREADS/RISERS/NOSINGS

REPLACE

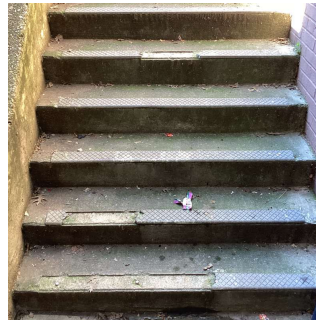
AW3
No violations recorded.

AREAWAY STAIRS: DETERIORATED
TREADS/RISERS/NOSINGS

20
S.F.
REPLACE
PRIORITY 5
LEVEL 6

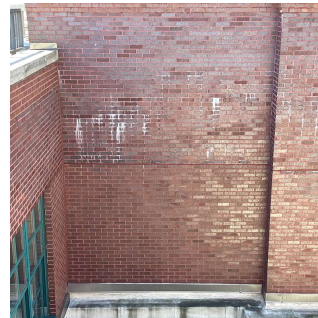
Facade A - Near Roof 2B

BRICK: EFFLORESCENCE

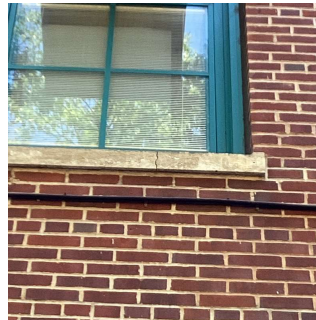
Facade A

BRICK: DETERIORATED MASONRY SILLS - MINOR

15
L.F.
REPAIR
PRIORITY 3
LEVEL 2

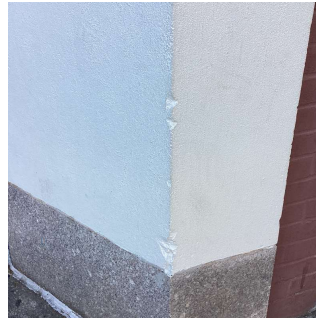
Facade A - Main Entrance

STONE: CHIPPED/SPALLED/BROKEN PIECES - MINOR

10
S.F.
REPAIR

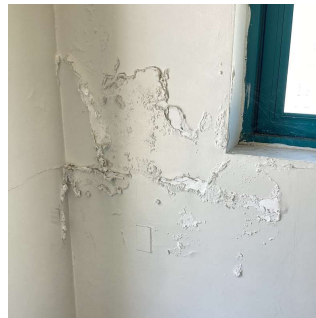
BH1
 No violations recorded.

Violations	BH2 No violations recorded.
Deficiency	BULKHEAD/PENTHOUSE WALLS/INTERIOR: PLASTER CRACKS/SPALLING

50
 S.F.
 REPLACE
 PRIORITY 3
 LEVEL 2

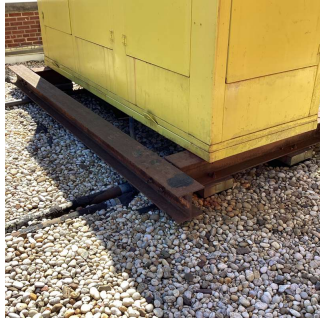
HEIGHT LESS THAN 18"

40
 L.F.
 REPLACE
 PRIORITY 3
 LEVEL 2

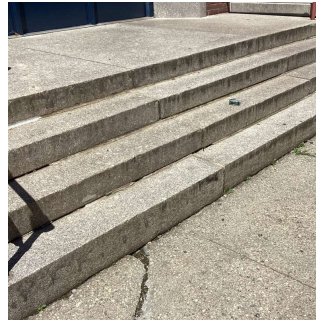
Facade G - Exit F

STAIRS/RAMPS

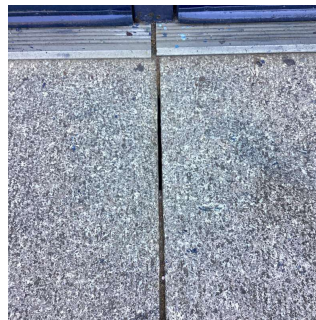
Facade A - Exit 5/6

STONE: DETERIORATED JOINTS

PRIORITY 4

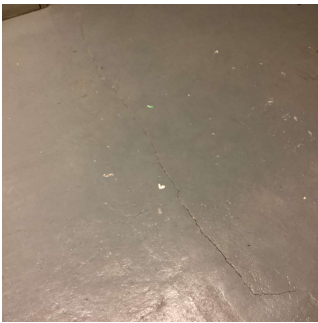
Question	Response
INTERIOR	Inspected
POOLS	Does not Exist
STRUCTURAL	Inspected
COLUMNS/BEAMS/BEARING WALLS	Inspected
Condition	2 - Between Good and Fair
Deficiency	No deficiencies recorded
FLOOR STRUCTURE	Inspected
Condition	3 - Fair
Deficiency	CONCRETE SLAB ON GRADE: THRU CRACKS
Deficiency Location/Instance	Basement - Electrical Panel Room
Deficiency Quantity	30
Quantity Uom	S.F.
Potential Action	REPAIR
Urgency of Action	PRIORITY 3
Purpose of Action	LEVEL 5
Deficiency Photo1

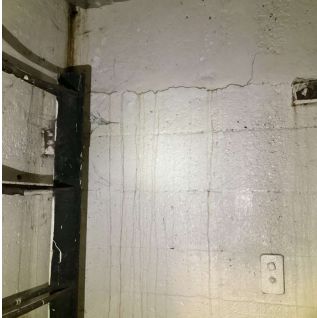
Question	Response
INTERIOR	
STRUCTURAL	
ROOF STRUCTURE	Inspected
Deficiency	No deficiencies recorded
VAULTS-BUNKERS	Inspected
Foundation Walls	Inspected
Condition	4 - Between Fair and Poor
Deficiency	WATER INFILTRATION IN NON- INSTRUCTIONAL SPACE
Deficiency Location/Instance	Basement - Ash Hoist Vault
Deficiency Quantity	100
Quantity Uom	S.F.
Potential Action	INSTALL WATERPROOFING
Urgency of Action	PRIORITY 5
Purpose of Action	LEVEL 5
Deficiency Photo1

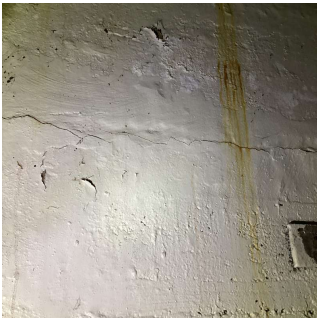
Violations	Ash Hoist Vault No violations recorded.
Deficiency	CRACKS, SPALLING
Deficiency Location/Instance	Basement - Ash Hoist Vault
Deficiency Quantity	10
Quantity Uom	S.F.
Potential Action	REPAIR
Urgency of Action	PRIORITY 3
Purpose of Action	LEVEL 5
Deficiency Photo1

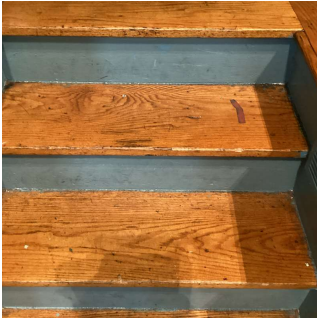
Instance on 1st Floor (412 Seats)	Inspected
Stage	Inspected
Instance on 1st Floor (412 Seats)	Inspected
Condition	2 - Between Good and Fair
Deficiency	DAMAGED STEPS

Question	Response
INTERIOR	
AUDITORIUM	
Stage	
Stage	
Deficiency Location/Instance	Right and Left Side
Deficiency Quantity	20
Quantity Uom	S.F.
Potential Action	REPLACE
Urgency of Action	PRIORITY 3
Purpose of Action	LEVEL 2
Deficiency Photo1

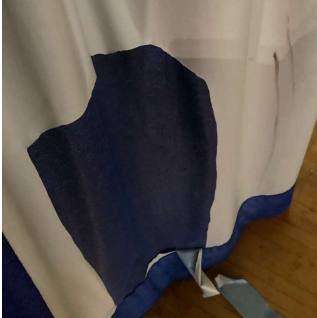
Right Side
Violations	No violations recorded.
Stage Curtain Rigging	Inspected
Instance on 1st Floor (412 Seats)	Inspected
Condition	2 - Between Good and Fair
Deficiency	No deficiencies recorded
Stage Curtains	Inspected
Instance on 1st Floor (412 Seats)	Inspected
Condition	4 - Between Fair and Poor
Deficiency	WORN/DETERIORATED
Deficiency Location/Instance	Right and Left Side
Deficiency Quantity	300
Quantity Uom	S.F.
Potential Action	REPLACE
Urgency of Action	PRIORITY 3
Purpose of Action	LEVEL 2
Deficiency Photo1

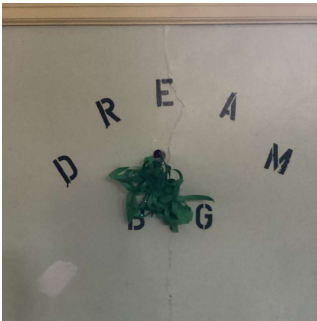
Question	Response
INTERIOR	
AUDITORIUM	
Walls	
Deficiency Location/Instance	Near Exit I
Deficiency Quantity	20
Quantity Uom	S.F.
Potential Action	REPLACE
Urgency of Action	PRIORITY 4
Purpose of Action	LEVEL 4
Deficiency Photo1	 
Violations	Near Exit I 35673079X
Deficiency	GYPSON BOARD: DETERIORATED
Deficiency Location/Instance	Near Main Entrance
Deficiency Quantity	20
Quantity Uom	S.F.
Potential Action	REPLACE
Urgency of Action	PRIORITY 3
Purpose of Action	LEVEL 2
Deficiency Photo1	 
Violations	Near Main Entrance No violations recorded.
Deficiency	PLASTER: CRACKS/SPALLING
Deficiency Location/Instance	Near Stair I
Deficiency Quantity	20
Quantity Uom	S.F.
Potential Action	REPLACE
Urgency of Action	PRIORITY 3
Purpose of Action	LEVEL 2

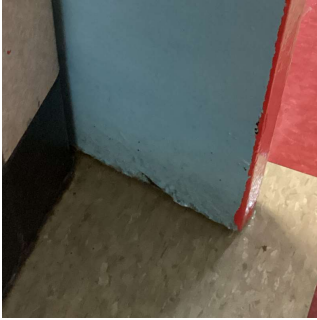
Violations	Near Windows No violations recorded.
Door(s)	
Instance on 1st Floor - Staff(600 SF)	Inspected
Condition	3 - Fair
Deficiency	METAL: DETERIORATED DOOR
Deficiency Location/Instance	Entrance
Deficiency Quantity	1
Quantity Uom	EACH
Potential Action	MAINTENANCE
Urgency of Action	PRIORITY 3
Purpose of Action	LEVEL 2
Deficiency Photo1

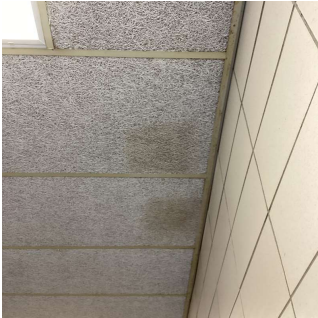
Question	Response
INTERIOR	
CAFETERIA	
Walls	
Deficiency	GLAZED BLOCK: CRACKS/SPALLING
Deficiency Location/Instance	Near Main Entrance, by Windows
Deficiency Quantity	20
Quantity Uom	S.F.
Potential Action	REPLACE
Urgency of Action	PRIORITY 3
Purpose of Action	LEVEL 2
Deficiency Photo1	 
	Near Main Entrance
Violations	No violations recorded.
Window Curtains/Shades/Blinds	
Instance on 1st Floor - Staff(600 SF)	Does not Exist
Instance on 1st Floor - Students	Does not Exist
CLASSROOMS/CORRIDORS/ADMIN SPACES	
Ceiling	Inspected
Condition	2 - Between Good and Fair
Deficiency	TECTUM: DAMAGED/MISSING
Deficiency Location/Instance	Corridor near Rooms 347, 354, 356
Deficiency Quantity	40
Quantity Uom	S.F.
Potential Action	REPLACE
Urgency of Action	PRIORITY 3
Purpose of Action	LEVEL 2
Deficiency Photo1

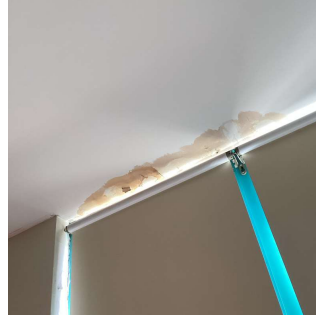
Corridor near Room 347
Violations	No violations recorded.
Deficiency	GYPSUM BOARD: DAMAGED/DETERIORATED
Deficiency Location/Instance	Room 354

Deficiency Quantity	20
Quantity Uom	S.F.
Potential Action	REPLACE

PRIORITY 3
LEVEL 2

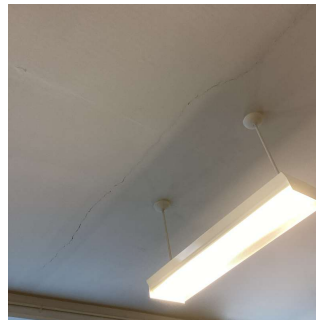
Room 217

PLASTER: CRACKS/SPALLING
Rooms 133, 217, Corridor near Room 107
60
S.F.
REPLACE
PRIORITY 3
LEVEL 2

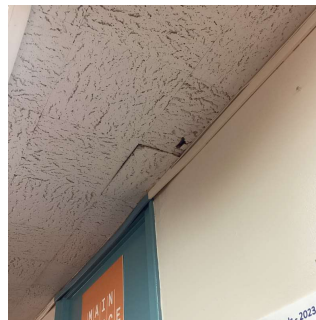
ACOUSTIC TILES ON PLASTER: DAMAGED/MISSING
Corridor near Rooms 105, 112
20
S.F.
REPLACE
PRIORITY 3
LEVEL 2

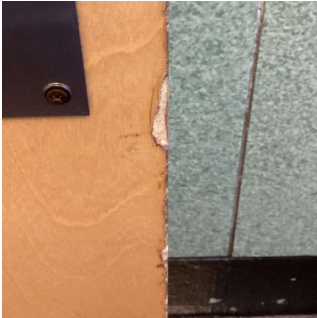
Question	Response
INTERIOR	
CLASSROOMS/CORRIDORS/ADMIN SPACES	
Ceiling	Inspected
Violations	Corridor near Room 105 No violations recorded.
Door(s)	Inspected
Condition	5 - Poor
Deficiency	WOOD: DETERIORATED DOOR
Deficiency Location/Instance	Main Entrance - Vestibule, Rooms 105, 142, 144, 146 and others
Deficiency Quantity	11
Quantity Uom	EACH
Potential Action	MAINTENANCE
Urgency of Action	PRIORITY 3
Purpose of Action	LEVEL 2
Deficiency Photo1

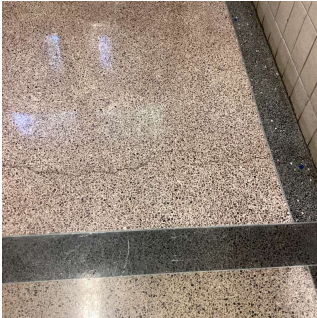
Violations	Main Entrance - Vestibule No violations recorded.
Floor Finish	Inspected
Condition	2 - Between Good and Fair
Deficiency	TERRAZZO: CRACKS
Deficiency Location/Instance	Exit Vestibule near Room 119
Deficiency Quantity	50
Quantity Uom	S.F.
Potential Action	REPLACE
Urgency of Action	PRIORITY 3
Purpose of Action	LEVEL 2
Deficiency Photo1

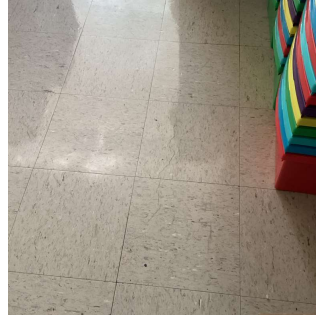
Room 352

Violations	Exit Vestibule near Room 119 No violations recorded.
Deficiency	VINYL TILES: DETERIORATED SUBSTRATE
Deficiency Location/Instance	Rooms 352, 147, 116, Corridor near Rooms 346, 246 and others

Deficiency Quantity	220
Quantity Uom	S.F.
Potential Action	REPLACE

PRIORITY 3
 LEVEL 2

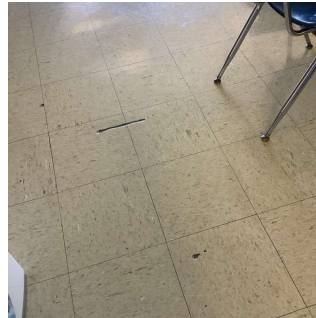
Room 347

VINYL TILES: BROKEN/DETERIORATED/MISSING TILES
 Rooms 250, 341, 347, 350, Corridor near Room 140 and others
 140
 S.F.
 REPLACE
 PRIORITY 3
 LEVEL 2

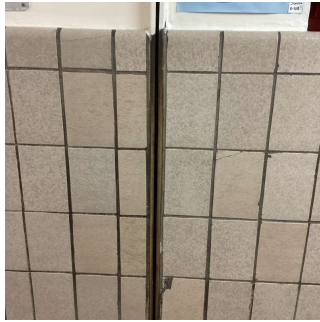
Question	Response
INTERIOR	
CLASSROOMS/CORRIDORS/ADMIN SPACES	
Walls	
Deficiency Photo1	 
Violations	Corridor near Room 212 No violations recorded.
Deficiency	GLAZED BLOCK: CRACKS/SPALLING
Deficiency Location/Instance	Main Entrance Lobby, Corridor near Rooms 133, 122, Exit K - Vestibule
Deficiency Quantity	40
Quantity Uom	S.F.
Potential Action	REPLACE
Urgency of Action	PRIORITY 3
Purpose of Action	LEVEL 2
Deficiency Photo1

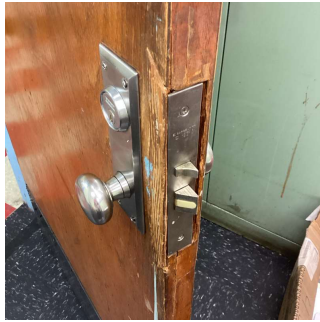
Question	Response
INTERIOR	
GYMNASIUM	
Ceiling	
Deficiency Photo1	 
	Near Left Side Windows
Violations	No violations recorded.
Door(s)	
Instance on 1st Floor	Inspected
Condition	5 - Poor
Deficiency	WOOD: DETERIORATED DOOR
Deficiency Location/Instance	Office Room, near Exit K, Storage Room
Deficiency Quantity	3
Quantity Uom	EACH
Potential Action	MAINTENANCE
Urgency of Action	PRIORITY 3
Purpose of Action	LEVEL 2
Deficiency Photo1

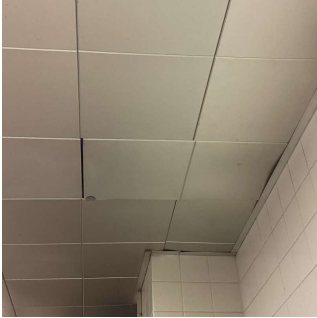
Question	Response
INTERIOR	
GYMNASIUM	
Walls	
Deficiency Photo1	 
	Near Left Side Windows
Violations	No violations recorded.
Deficiency	PLASTER: CRACKS/SPALLING
Deficiency Location/Instance	Right and Left Side near Windows, Office Room, by Main Entrance
Deficiency Quantity	60
Quantity Uom	S.F.
Potential Action	REPLACE
Urgency of Action	PRIORITY 3
Purpose of Action	LEVEL 2
Deficiency Photo1	 
	Left Side near Windows
Violations	No violations recorded.
Window Curtains/Shades/Blinds	
Instance on 1st Floor	Does not Exist
INTERIOR DOOR HARDWARE	
Condition	Inspected
Deficiency	3 - Fair
Deficiency	No deficiencies recorded
INTERIOR GUARDS	
Condition	Inspected
Deficiency	2 - Between Good and Fair
Deficiency	No deficiencies recorded
KITCHEN	
Instance on 1st Floor	Inspected
Ceiling	
Instance on 1st Floor	Inspected
Condition	2 - Between Good and Fair
Deficiency	METAL PAN: DAMAGED/MISSING
Deficiency Location/Instance	Servery
Deficiency Quantity	10

Quantity Uom	S.F.
Potential Action	REPLACE

Question	Response
INTERIOR	
KITCHEN	
Ceiling	
Urgency of Action	PRIORITY 3
Purpose of Action	LEVEL 2
Deficiency Photo1

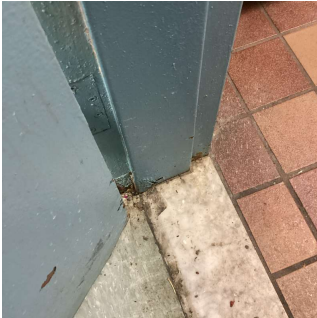
Violations	Servery No violations recorded.
Door(s)	
Instance on 1st Floor	Inspected
Condition	4 - Between Fair and Poor
Deficiency	METAL: DETERIORATED DOOR AND FRAME
Deficiency Location/Instance	Servery, Sinks Room
Deficiency Quantity	2
Quantity Uom	EACH
Potential Action	MAINTENANCE
Urgency of Action	PRIORITY 3
Purpose of Action	LEVEL 2
Deficiency Photo1

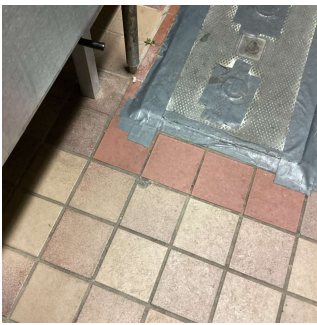
Violations	Sinks Room No violations recorded.
Floor Finish	
Instance on 1st Floor	Inspected
Condition	2 - Between Good and Fair
Deficiency	QUARRY TILE: BROKEN/MISSING TILES
Deficiency Location/Instance	Sinks Room
Deficiency Quantity	10
Quantity Uom	S.F.
Potential Action	REPLACE
Urgency of Action	PRIORITY 3
Purpose of Action	LEVEL 2

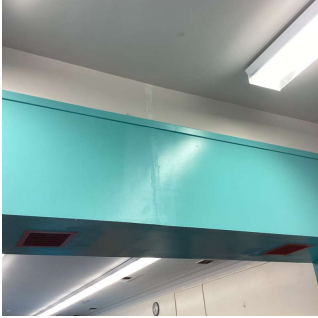
Question	Response
INTERIOR	
LIBRARY	
Floor Finish	
Instance on Room 113/117	Inspected
Condition	2 - Between Good and Fair
Deficiency	No deficiencies recorded
Walls	
Instance on Room 113/117	Inspected
Condition	2 - Between Good and Fair
Deficiency	GYPSUM BOARD: DETERIORATED
Deficiency Location/Instance	Center
Deficiency Quantity	20
Quantity Uom	S.F.
Potential Action	REPLACE
Urgency of Action	PRIORITY 3
Purpose of Action	LEVEL 2
Deficiency Photo1

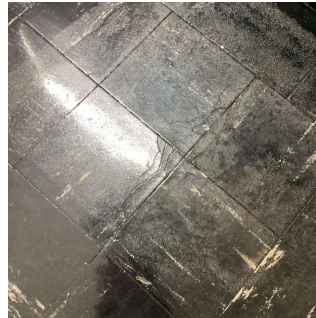
Stair I/1

VINYL TILES: DETERIORATED SUBSTRATE

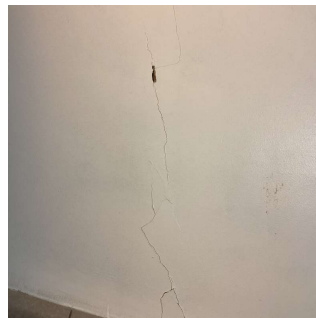
PLASTER: CRACKS/SPALLING

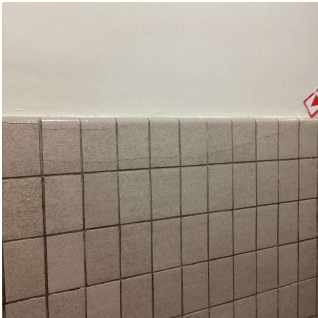
Question	Response
INTERIOR	
STAIRS/RAMPS: INTERIOR	
Walls	
Violations	Stair I/1 No violations recorded.
Deficiency	GLAZED BLOCK: CRACKS/SPALLING
Deficiency Location/Instance	Stairs BC/1, 2, 3, H/1, Basement and others
Deficiency Quantity	110
Quantity Uom	S.F.
Potential Action	REPLACE
Urgency of Action	PRIORITY 3
Purpose of Action	LEVEL 2
Deficiency Photo1

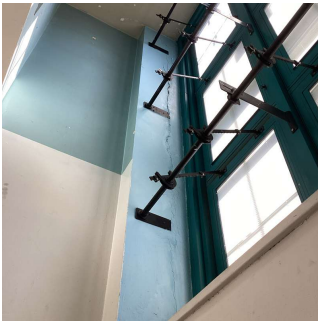
Violations	Stair BC/1 No violations recorded.
Deficiency	PLASTER: CRACKS/SPALLING
Deficiency Location/Instance	Stair H/1
Deficiency Quantity	40
Quantity Uom	S.F.
Potential Action	REPLACE
Urgency of Action	PRIORITY 4
Purpose of Action	LEVEL 4
Deficiency Photo1

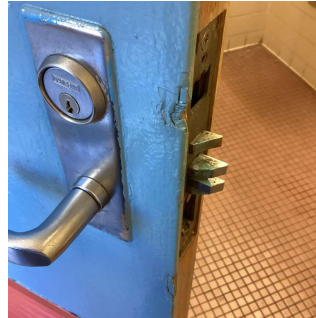
Room 340

Violations	Stair H/1 35673079X
TOILET ROOMS - STAFF	
Ceiling	Inspected
Condition	2 - Between Good and Fair
Deficiency	No deficiencies recorded
Door(s)	Inspected
Condition	5 - Poor
Deficiency	WOOD: DETERIORATED DOOR
Deficiency Location/Instance	Rooms 340, 244, 126
Deficiency Quantity	3

Quantity Uom	EACH
Potential Action	MAINTENANCE
Urgency of Action	PRIORITY 3
Purpose of Action	LEVEL 2
Deficiency Photo1

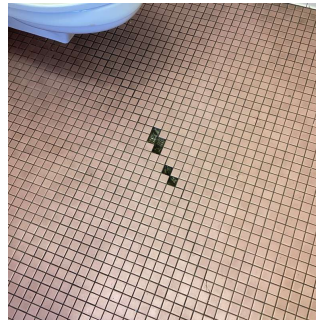
Deficiency	CERAMIC TILE: BROKEN/MISSING TILES
Deficiency Location/Instance	Room 344
Deficiency Quantity	10
Quantity Uom	S.F.
Potential Action	REPLACE
Urgency of Action	PRIORITY 3
Purpose of Action	LEVEL 2
Deficiency Photo1

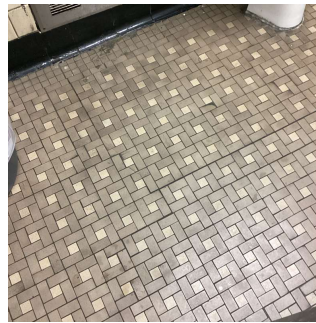
Deficiency	CERAMIC TILE: DETERIORATED SUBSTRATE
Deficiency Location/Instance	Men Toilet Room - 1st Floor
Deficiency Quantity	10
Quantity Uom	S.F.
Potential Action	REPLACE
Urgency of Action	PRIORITY 3
Purpose of Action	LEVEL 2

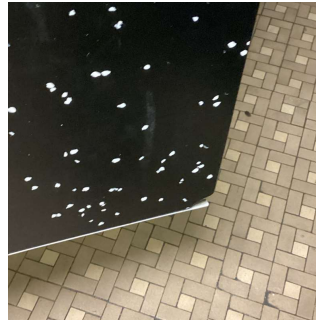
Women Toilet Room - 1st Floor

BROKEN/MISSING

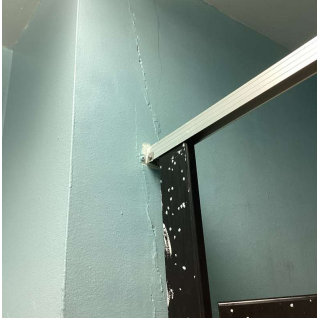
Question	Response
INTERIOR	
TOILET ROOMS - STAFF	
Stalls	Inspected
	In Room 133
Violations	No violations recorded.
Walls	Inspected
Condition	2 - Between Good and Fair
Deficiency	PLASTER: CRACKS/SPALLING
Deficiency Location/Instance	Men Toilet Room - 1st Floor, Women Toilet Room - 1st Floor, Room 126
Deficiency Quantity	30
Quantity Uom	S.F.
Potential Action	REPLACE
Urgency of Action	PRIORITY 3
Purpose of Action	LEVEL 2
Deficiency Photo1

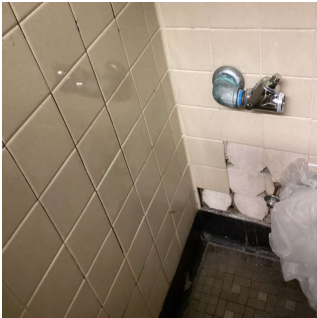
Violations	Men Toilet Room - 1st Floor No violations recorded.
Deficiency	CERAMIC TILE: BROKEN/ MISSING
Deficiency Location/Instance	Men Toilet Room - 1st Floor, Women Toilet Room - 1st Floor, Rooms 344, 244
Deficiency Quantity	40
Quantity Uom	S.F.
Potential Action	REPLACE
Urgency of Action	PRIORITY 3
Purpose of Action	LEVEL 2
Deficiency Photo1

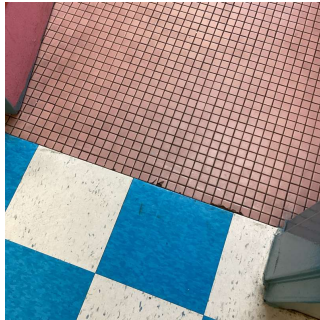
In Room 149
Violations	No violations recorded.
Floor Finish	Inspected
Condition	2 - Between Good and Fair
Deficiency	CERAMIC TILE: BROKEN/MISSING TILES
Deficiency Location/Instance	Room 246
Deficiency Quantity	10
Quantity Uom	S.F.
Potential Action	REPLACE
Urgency of Action	PRIORITY 3
Purpose of Action	LEVEL 2
Deficiency Photo1

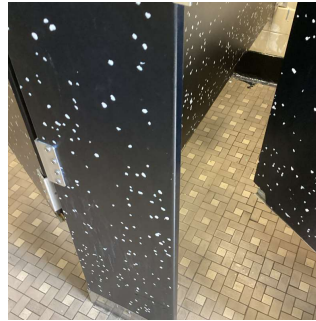
Room 246
Violations	No violations recorded.
Stalls	Inspected
Condition	5 - Poor
Deficiency	BROKEN/MISSING
Deficiency Location/Instance	Room 210
Deficiency Quantity	2
Quantity Uom	EACH
Potential Action	REPLACE
Urgency of Action	PRIORITY 3
Purpose of Action	LEVEL 2

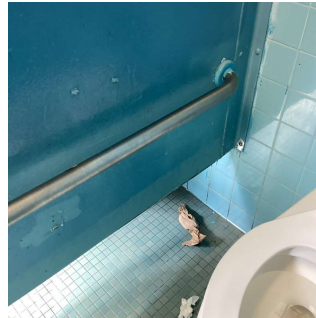
Room 342

RUST - MAJOR

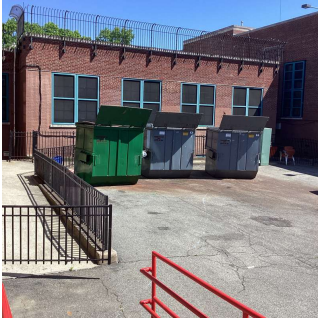
Question	Response
INTERIOR	Inspected
TOILET ROOMS - STUDENTS	Inspected
Walls	
Violations	Room 122 No violations recorded.
LIFE SAFETY	Inspected
F.D. HOLDING AREA	Does not Exist
STEEL STAIRS	Does not Exist
SITE	Inspected
CONTAINERIZATION	Inspected
Condition	5 - Poor
Deficiency	CONTAINER DAMAGED
Deficiency Location/Instance	Near Exit L
Deficiency Quantity	1
Quantity Uom	EACH
Potential Action	REPLACE
Urgency of Action	PRIORITY 3
Purpose of Action	LEVEL 2
Deficiency Photo1	 
Violations	Near Exit L No violations recorded.
Deficiency	FENCING MISSING
Deficiency Location/Instance	Near Exit L
Deficiency Quantity	750
Quantity Uom	S.F.
Potential Action	INSTALL NEW
Urgency of Action	PRIORITY 3
Purpose of Action	LEVEL 2
Deficiency Photo1	 
Violations	Near Exit L No violations recorded.
Deficiency	CONCRETE PAD DAMAGED
Deficiency Location/Instance	Near Exit L

Question	Response
SITE	
CONTAINERIZATION	
Deficiency Quantity	300
Quantity Uom	S.F.
Potential Action	REPAIR
Urgency of Action	PRIORITY 3
Purpose of Action	LEVEL 2
Deficiency Photo1

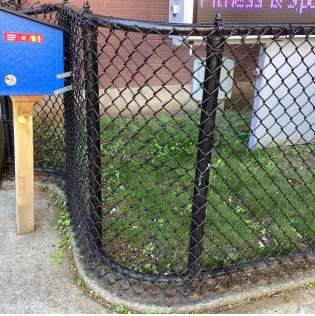
Question	Response
SITE	
Drainage System for Soil	Inspected
Culverts - Soil Covering	
DRINKING FOUNTAINS	Does not Exist
FENCES	Inspected
Condition	4 - Between Fair and Poor
Deficiency	CHAIN LINK: RUST - MAJOR
Deficiency Location/Instance	E 31st Street
Deficiency Quantity	600
Quantity Uom	S.F.
Potential Action	REPLACE
Urgency of Action	PRIORITY 3
Purpose of Action	LEVEL 2
Deficiency Photo1	 
	E 31st Street
Violations	No violations recorded.
Deficiency	WROUGHT IRON: MISSING SECTIONS
Deficiency Location/Instance	Near Dumpsters, Meditation Garden
Deficiency Quantity	400
Quantity Uom	S.F.
Potential Action	REPLACE
Urgency of Action	PRIORITY 3
Purpose of Action	LEVEL 2
Deficiency Photo1	 
	Meditation Garden
Violations	No violations recorded.
Deficiency	CHAIN LINK: DAMAGED/DETERIORATED
Deficiency Location/Instance	Nostrand Avenue
Deficiency Quantity	50
Quantity Uom	S.F.
Potential Action	REPLACE
Urgency of Action	PRIORITY 3
Purpose of Action	LEVEL 2

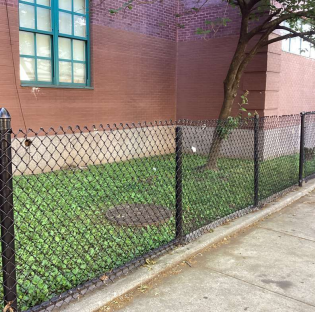
Violations	<p>Nostrand Avenue No violations recorded.</p>
Deficiency	CHAIN LINK: DAMAGED POST/RAIL
Deficiency Location/Instance	Nostrand Avenue, South Side of Building, E 31st Street
Deficiency Quantity	90
Quantity Uom	L.F.
Potential Action	REPLACE
Urgency of Action	PRIORITY 3
Purpose of Action	LEVEL 2
Deficiency Photo1

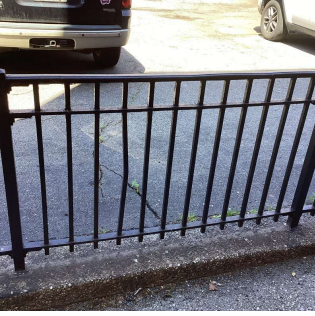
Violations	<p>Nostrand Avenue No violations recorded.</p>
Deficiency	WROUGHT IRON: DAMAGED/DETERIORATED
Deficiency Location/Instance	Rear part of Building, E 31st Street
Deficiency Quantity	600
Quantity Uom	S.F.
Potential Action	REPLACE
Urgency of Action	PRIORITY 3
Purpose of Action	LEVEL 2
Deficiency Photo1

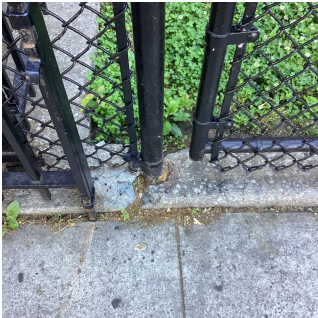
Violations	<p>Rear part of Building No violations recorded.</p>
Deficiency	CONCRETE CURB: DAMAGED/DETERIORATED

Question	Response
SITE	
FENCES	
Deficiency Location/Instance	Nostrand Avenue, E 31st Street, Meditation Garden
Deficiency Quantity	200
Quantity Uom	S.F.
Potential Action	REPLACE
Urgency of Action	PRIORITY 3
Purpose of Action	LEVEL 2
Deficiency Photo1

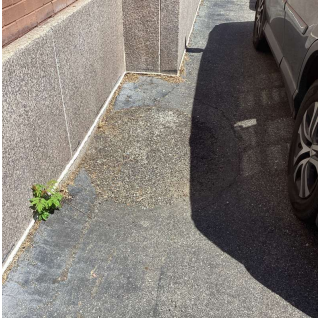
Violations	Nostrand Avenue No violations recorded.
IRRIGATION SYSTEM	Does not Exist
PAVING	Inspected
Student Non-Use	Inspected
Gravel Exists?	No
Asphalt	Inspected
Condition	4 - Between Fair and Poor
Deficiency	POTHoles
Deficiency Location/Instance	Near Exit L
Deficiency Quantity	30
Quantity Uom	S.F.
Potential Action	REPAIR
Urgency of Action	PRIORITY 3
Purpose of Action	LEVEL 2
Deficiency Photo1

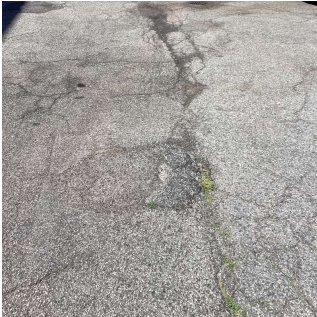
Violations	Near Exit L No violations recorded.
Deficiency	LOCALIZED SINK AREA
Deficiency Location/Instance	Near Containerization
Deficiency Quantity	30
Quantity Uom	S.F.
Potential Action	REPAIR
Urgency of Action	PRIORITY 5
Purpose of Action	LEVEL 6

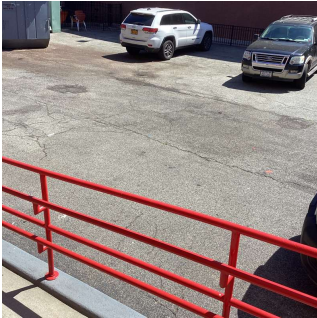
Violations	Near Containerization No violations recorded.
Deficiency	CRACKS - MAJOR
Deficiency Location/Instance	Near Exit L
Deficiency Quantity	1,500
Quantity Uom	S.F.
Potential Action	REPLACE
Urgency of Action	PRIORITY 3
Purpose of Action	LEVEL 2
Deficiency Photo1

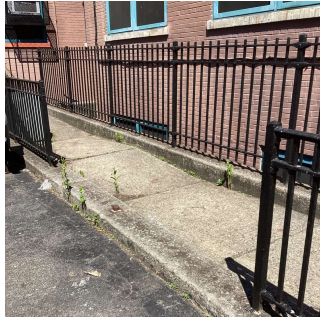
Violations	Near Exit L No violations recorded.
Concrete	Inspected
Condition	3 - Fair
Deficiency	DAMAGED/DETERIORATED/MISSING SECTIONS
Deficiency Location/Instance	Near Dumpsters
Deficiency Quantity	75
Quantity Uom	S.F.
Potential Action	REPLACE
Urgency of Action	PRIORITY 3
Purpose of Action	LEVEL 2

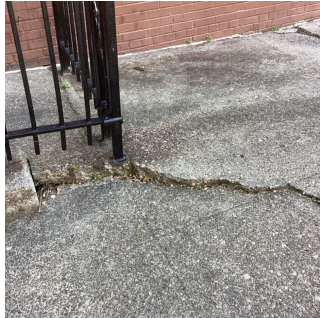
Violations	Near Dumpsters No violations recorded.
Deficiency	DAMAGED/DETERIORATED/MISSING SECTIONS
Deficiency Location/Instance	Near Dumpsters
Deficiency Quantity	50
Quantity Uom	S.F.
Potential Action	REPLACE
Urgency of Action	PRIORITY 5
Purpose of Action	LEVEL 6
Deficiency Photo1

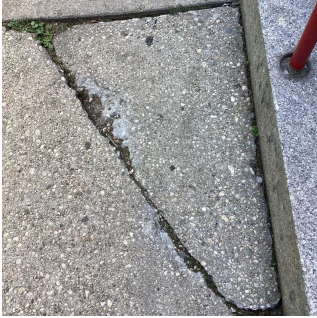
Question	Response
SITE	
PAVING	
Student Use	Inspected
Concrete	Inspected
Violations	No violations recorded.
Pavers	Does not Exist
Site Sidewalks & Walkways	Inspected
Asphalt	Inspected
Condition	2 - Between Good and Fair
Deficiency	No deficiencies recorded
Concrete	Inspected
Condition	4 - Between Fair and Poor
Deficiency	DAMAGED/DETERIORATED/MISSING SECTIONS
Deficiency Location/Instance	Exit near Auditorium
Deficiency Quantity	25
Quantity Uom	S.F.
Potential Action	REPLACE
Urgency of Action	PRIORITY 5
Purpose of Action	LEVEL 6
Deficiency Photo1

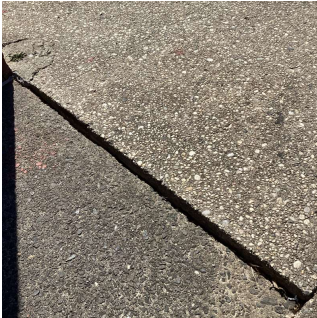
Violations	Exit near Auditorium No violations recorded.
Deficiency	HEAVING
Deficiency Location/Instance	E 31st Street, Nostrand Avenue
Deficiency Quantity	100
Quantity Uom	S.F.
Potential Action	REPLACE
Urgency of Action	PRIORITY 3
Purpose of Action	LEVEL 2
Deficiency Photo1

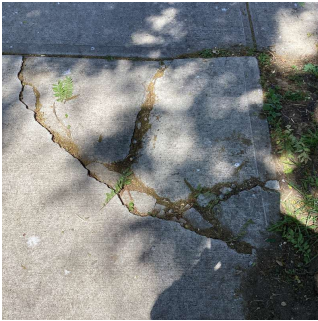
Violations	E 31st Street No violations recorded.
Deficiency	DAMAGED/DETERIORATED/MISSING SECTIONS

Question	Response
SITE	
PAVING	
Site Sidewalks & Walkways	Inspected
Concrete	
Deficiency Location/Instance	Nostrand Avenue, Near Handicap Ramp, E 31st Street, by NYC Park, East Side of Building and others
Deficiency Quantity	650
Quantity Uom	S.F.
Potential Action	REPLACE
Urgency of Action	PRIORITY 3
Purpose of Action	LEVEL 2
Deficiency Photo1

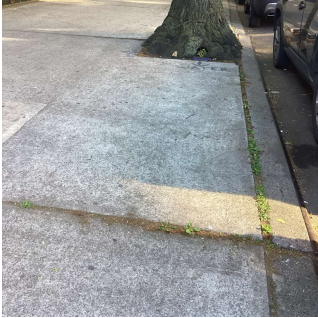
Violations	E 31st Street No violations recorded.
Pavers	Does not Exist
DOT Sidewalk	Inspected
Asphalt	Does not Exist
Concrete	Inspected
Condition	4 - Between Fair and Poor
Deficiency	HEAVING
Deficiency Location/Instance	Nostrand Avenue, E 31st Street
Deficiency Quantity	100
Quantity Uom	S.F.
Potential Action	REPLACE
Urgency of Action	PRIORITY 4
Purpose of Action	LEVEL 4
Deficiency Photo1

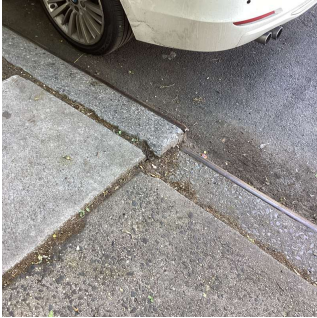
Violations	Nostrand Avenue 52517
Deficiency	DAMAGED CURBS
Deficiency Location/Instance	Nostrand Avenue, E 31st Street
Deficiency Quantity	70
Quantity Uom	L.F.
Potential Action	REPLACE

Question	Response
SITE	
PAVING	
DOT Sidewalk	
Concrete	
Urgency of Action	PRIORITY 4
Purpose of Action	LEVEL 4
Deficiency Photo1
