NYC Department of Education
Building Condition Assessment Survey 2023 - 2024

Architectural Inspection

Asset: P.S. 270 - BROOKLYN, 241 EMERSON PLACE, New York, 11205

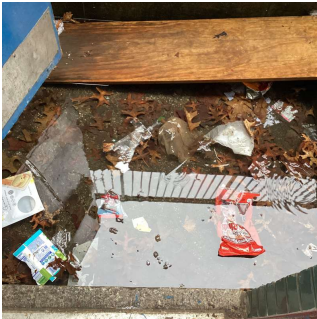
Violations	AW1 No violations recorded.
Deficiency	AREAWAY DRAINS: CLOGGED
Roof Plan reference

Deficiency Quantity	1
Quantity Uom	EACH
Potential Action	MAINTENANCE
Urgency of Action	PRIORITY 5
Purpose of Action	LEVEL 2
Deficiency Photo1

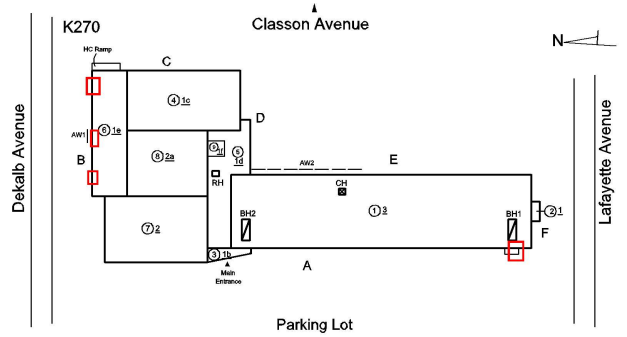
Violations	AW1 No violations recorded.
Instance on AW2	Inspected
Instance Condition	1 - Good
Instance Quantity	1
Instance Quantity Uom	EACH
Deficiency	No deficiencies recorded
AWNINGS AND CANOPIES	
Condition	Inspected 3 - Fair
Deficiency	CONCRETE: MAJOR CRACKS/SPALLING

35
S.F.
REPAIR
PRIORITY 4
LEVEL 2

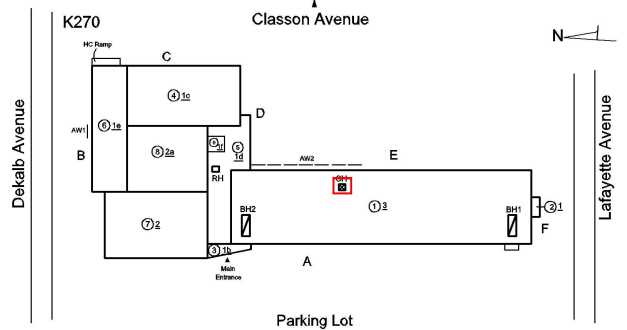
BRICK: DETERIORATED LADDER

1
EACH
REPLACE
PRIORITY 3
LEVEL 2

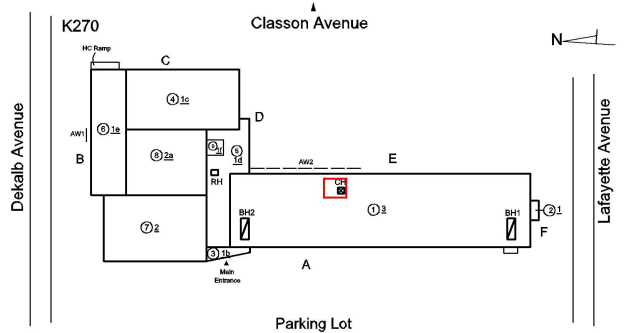
Violations	Chimney No violations recorded.
Deficiency	BRICK: MINOR CRACKS AND SPALLING
Roof Plan reference

Deficiency Quantity	40
Quantity Uom	S.F.
Potential Action	RESTITCH
Urgency of Action	PRIORITY 3
Purpose of Action	LEVEL 2
Deficiency Photo1

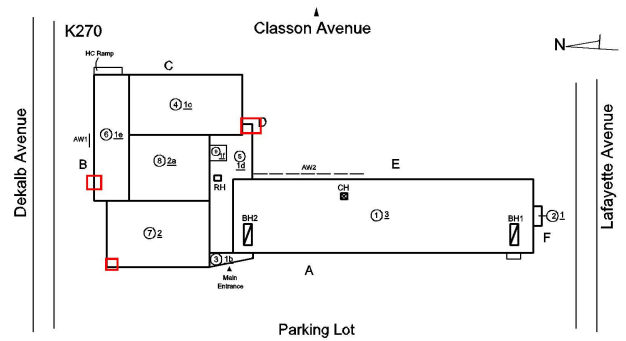
Violations	Chimney No violations recorded.
COPING	Inspected
Condition	1 - Good
Deficiency	No deficiencies recorded
CORNICE	Does not Exist
DOORS	Inspected
DOORS AND FRAMES	Inspected
Condition	5 - Poor
Deficiency	METAL CLAD: DETERIORATED DOOR AND FRAME - MAJOR DETERIORATION

5
EACH
REPLACE
PRIORITY 4
LEVEL 2

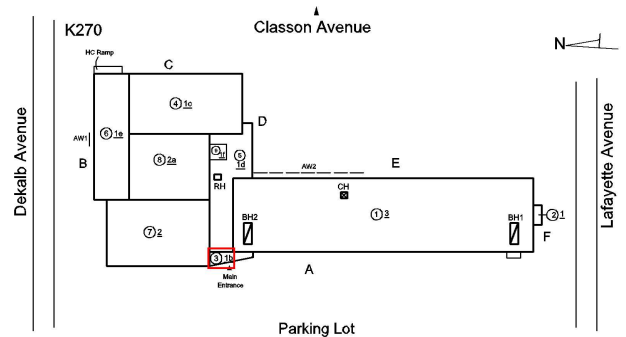
METAL: DETERIORATED DOOR AND FRAME - MINOR DETERIORATION

1
EACH
MAINTENANCE
PRIORITY 3
LEVEL 2

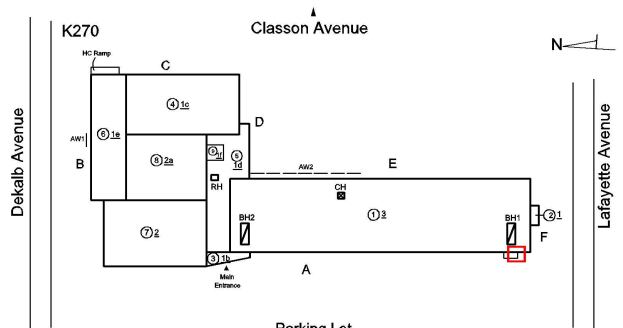
Violations	Facade A No violations recorded.
Deficiency	METAL CLAD: DETERIORATED DOOR - MAJOR DETERIORATION
Roof Plan reference

Deficiency Quantity	2
Quantity Uom	EACH
Potential Action	REPLACE
Urgency of Action	PRIORITY 4
Purpose of Action	LEVEL 2
Deficiency Photo1

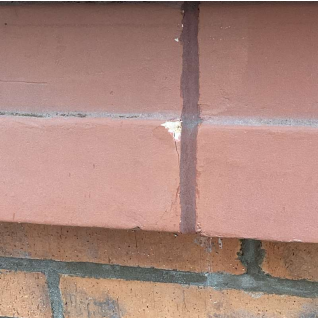
Question	Response
EXTERIOR	
EXTERIOR WALLS	
Replacement Quantity	27,000
Replacement Uom	S.F.
Instance on All Facades	Inspected
Instance Condition	3 - Fair
Instance Quantity	27,000
Instance Quantity Uom	S.F.
Deficiency	BRICK: DETERIORATED MASONRY SILLS - MINOR
Roof Plan reference

Deficiency Quantity	15
Quantity Uom	L.F.
Potential Action	REPAIR
Urgency of Action	PRIORITY 3
Purpose of Action	LEVEL 2
Deficiency Photo1

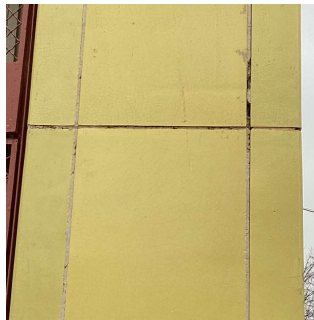
Facade D

Violations	Facade E No violations recorded.
Deficiency	TERRA COTTA: DETERIORATED JOINTS

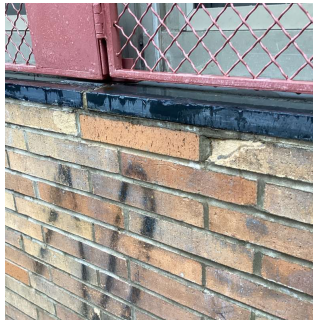
Facade C

BRICK: MAJOR / THRU CRACKS

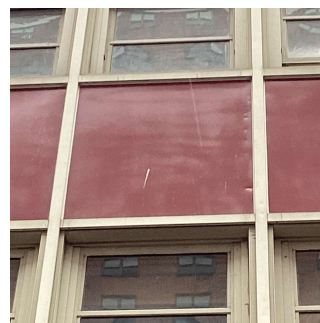
Facade A

METAL PANEL: SEVERE DENTS

100
S.F.
REPLACE
PRIORITY 4
LEVEL 2

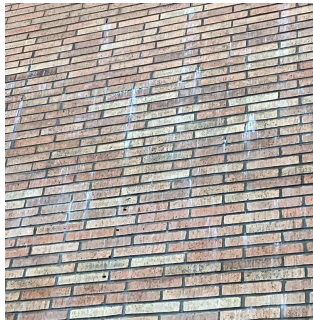
Roof 5

BRICK: EFFLORESCENCE

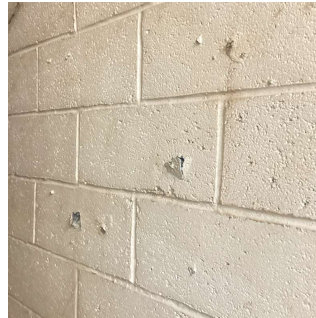
BH1

Roof 1
Instance Quantity	39,000
Instance Quantity Uom	S.F.
Does the roof have major mechanical equipment sitting on Dunnage Steel less than 18" above the Roofing?	No
Does this roof instance have a Sustainable Roof System?	Yes
Sustainable Roof Type	White Roof
Sustainable Roof Location (Roof Number)	All Roofs
Do solar panels exist on these roofs?	No
Is/Are the roof(s) suitable for Solar Panel installation?	Yes
Installation Year	2022
Source of Installation	Custodial Staff
Deficiency	No deficiencies recorded
ROOFING DRAINS	Inspected
Condition	1 - Good
Deficiency	No deficiencies recorded
Specialties	Inspected
BULKHEAD/PENTHOUSE	Inspected
Condition	3 - Fair
Deficiency	BULKHEAD/PENTHOUSE WALLS/INTERIOR: CMU CRACKS/SPALLING

Deficiency Quantity	25
Quantity Uom	S.F.
Potential Action	REPLACE
Urgency of Action	PRIORITY 3
Purpose of Action	LEVEL 2

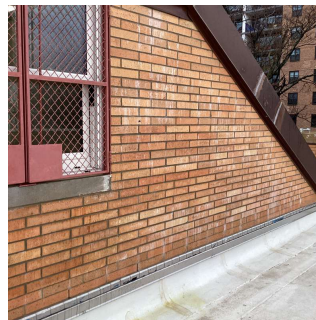
BH2

**BULKHEAD/PENTHOUSE WALLS/EXTERIOR:
EFFLORESCENCE**

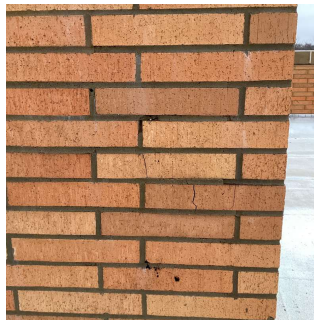
BH2

**BULKHEAD/PENTHOUSE WALLS/EXTERIOR:
CRACKS/SPALLING - MINOR**

30
S.F.
REPAIR
PRIORITY 3
LEVEL 2

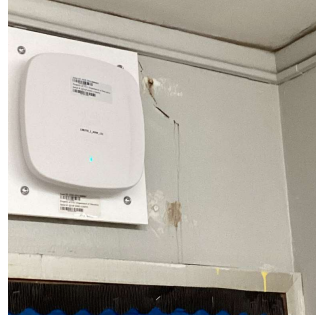
Roof 1 - Room 121

WATER INFILTRATION

100
S.F.
MAINTENANCE
PRIORITY 3

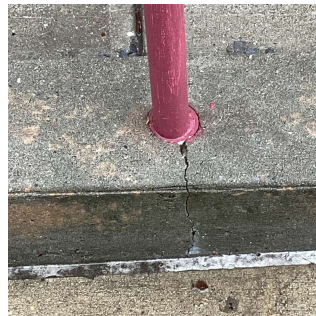
Facade C

CAST IN PLACE CONCRETE: CRACKS/SPALLING - MINOR

REPAIR

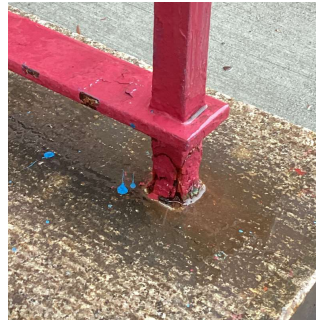
Facade E
No violations recorded.

RUST - MAJOR

10
L.F.
REPLACE
PRIORITY 4
LEVEL 2

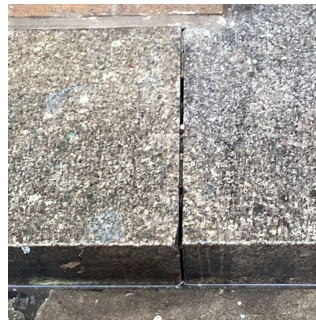
Facade A

STONE: DETERIORATED JOINTS

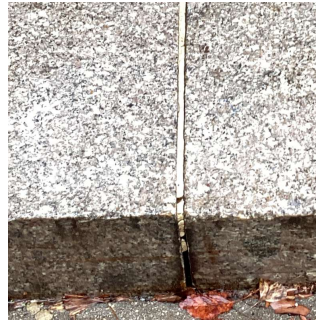
Facade A

STONE: DETERIORATED JOINTS

10
L.F.
REPOINT
PRIORITY 3
LEVEL 2

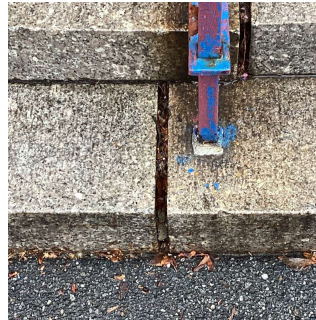
Facade F
35671934Z

STONE: DETERIORATED JOINTS

25
L.F.
REPOINT
PRIORITY 4
LEVEL 4

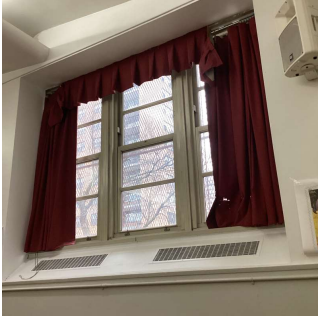
Question	Response
INTERIOR	
AUDITORIUM	
Walls	
Violations	No violations recorded.
Window Curtains/Shades/Blinds	
Instance on 1st Floor (416 Seats)	Inspected
Condition	3 - Fair
Deficiency	WORN/DAMAGED CURTAINS
Deficiency Location/Instance	Right Side (4 Half Curtains)
Deficiency Quantity	200
Quantity Uom	S.F.
Potential Action	MAINTENANCE
Urgency of Action	PRIORITY 3
Purpose of Action	LEVEL 2
Deficiency Photo1

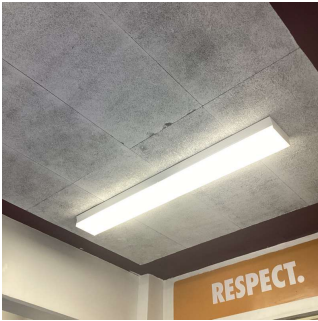
Violations	Right Side No violations recorded.
CAFETERIA	
Instance on 1st Floor	Inspected
Instance on 1st Floor	Inspected
Ceiling	
Instance on 1st Floor	Inspected
Condition	2 - Between Good and Fair
Deficiency	TECTUM: DAMAGED/MISSING
Deficiency Location/Instance	Along Windows, Center
Deficiency Quantity	20
Quantity Uom	S.F.
Potential Action	REPLACE
Urgency of Action	PRIORITY 3
Purpose of Action	LEVEL 2
Deficiency Photo1

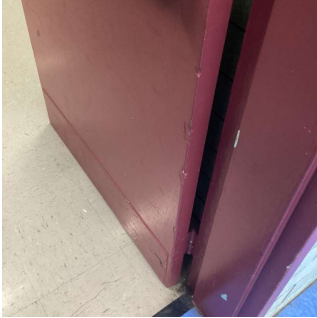
Question	Response
INTERIOR	
CAFETERIA	
Door(s)	
Condition	3 - Fair
Deficiency	WOOD: DETERIORATED DOOR
Deficiency Location/Instance	Main Entrance
Deficiency Quantity	1
Quantity Uom	EACH
Potential Action	MAINTENANCE
Urgency of Action	PRIORITY 3
Purpose of Action	LEVEL 2
Deficiency Photo1

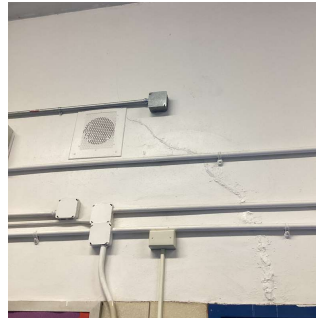
Near Exit 2

PLASTER: CRACKS/SPALLING

REPLACE

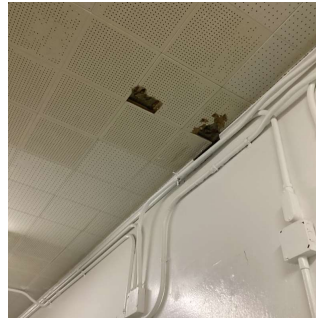
Corridor near room 317

ACOUSTIC TILES ON PLASTER: DAMAGED/MISSING

REPLACE

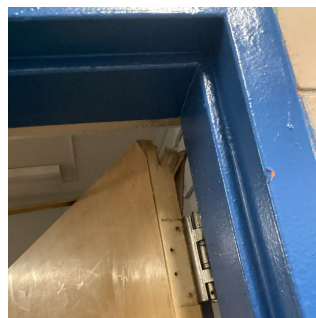
WOOD: DETERIORATED DOOR

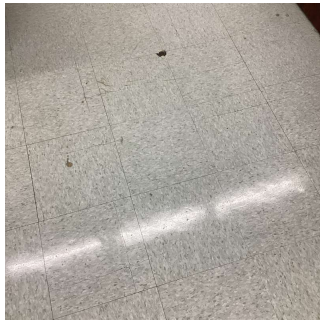
Question	Response
INTERIOR	
CLASSROOMS/CORRIDORS/ADMIN SPACES	
Door(s)	Inspected
	Room 309
Violations	No violations recorded.
Floor Finish	Inspected
Condition	2 - Between Good and Fair
Deficiency	VINYL TILES: DETERIORATED SUBSTRATE
Deficiency Location/Instance	Main Office
Deficiency Quantity	15
Quantity Uom	S.F.
Potential Action	REPLACE
Urgency of Action	PRIORITY 3
Purpose of Action	LEVEL 2
Deficiency Photo1

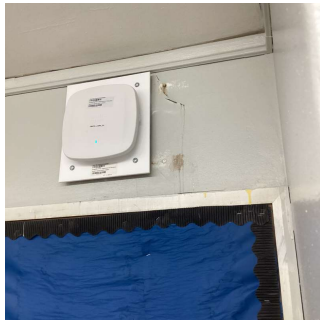
Main Office
Violations	No violations recorded.
Walls	Inspected
Condition	2 - Between Good and Fair
Deficiency	PLASTER: CRACKS/SPALLING - ACTIVE LEAK
Deficiency Location/Instance	Room 121
Deficiency Quantity	15
Quantity Uom	S.F.
Potential Action	REPLACE
Urgency of Action	PRIORITY 5
Purpose of Action	LEVEL 2
Deficiency Photo1

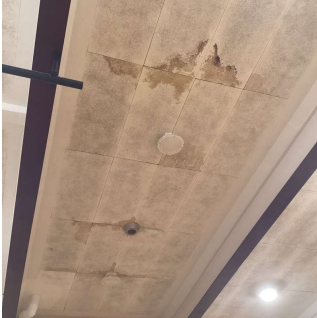
Question	Response
INTERIOR	
GYMNASIUM	
Ceiling	
Instance on 1st Floor	Inspected
Condition	2 - Between Good and Fair
Deficiency	TECTUM: DAMAGED/MISSING
Deficiency Location/Instance	Center
Deficiency Quantity	60
Quantity Uom	S.F.
Potential Action	REPLACE
Urgency of Action	PRIORITY 3
Purpose of Action	LEVEL 2
Deficiency Photo1

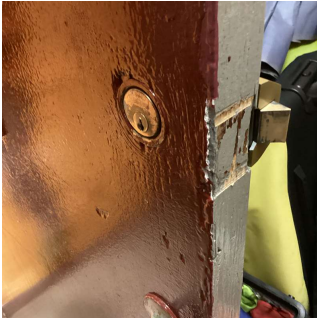
Violations	Center No violations recorded.
Door(s)	
Instance on 1st Floor	Inspected
Condition	5 - Poor
Deficiency	WOOD: DETERIORATED DOOR
Deficiency Location/Instance	Office
Deficiency Quantity	1
Quantity Uom	EACH
Potential Action	MAINTENANCE
Urgency of Action	PRIORITY 3
Purpose of Action	LEVEL 2
Deficiency Photo1

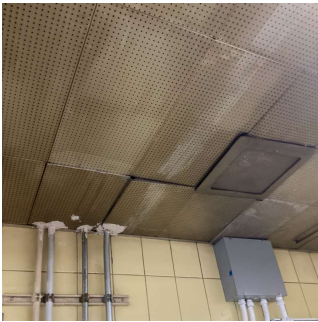
Question	Response
INTERIOR	
INTERIOR GUARDS	Inspected
Deficiency	No deficiencies recorded
KITCHEN	Inspected
Instance on 1st Floor	Inspected
Ceiling	
Instance on 1st Floor	Inspected
Condition	2 - Between Good and Fair
Deficiency	METAL PAN: DAMAGED/MISSING
Deficiency Location/Instance	Rear
Deficiency Quantity	10
Quantity Uom	S.F.
Potential Action	REPLACE
Urgency of Action	PRIORITY 3
Purpose of Action	LEVEL 2
Deficiency Photo1

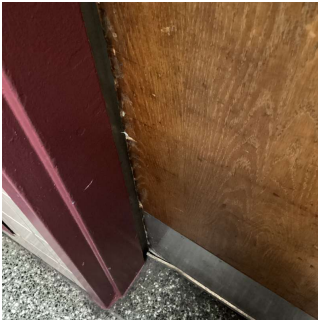
Rear
Violations	No violations recorded.
Door(s)	
Instance on 1st Floor	Inspected
Condition	4 - Between Fair and Poor
Deficiency	WOOD: DETERIORATED DOOR
Deficiency Location/Instance	Exit To Vestibule, Storage
Deficiency Quantity	2
Quantity Uom	EACH
Potential Action	MAINTENANCE
Urgency of Action	PRIORITY 3
Purpose of Action	LEVEL 2
Deficiency Photo1

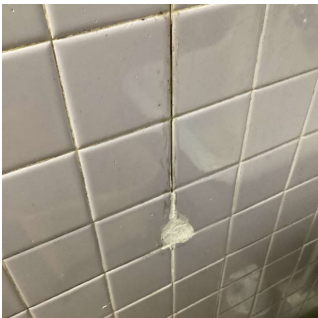
Violations	Vestibule No violations recorded.
Walls	
Instance on 1st Floor	Inspected
Condition	2 - Between Good and Fair
Deficiency	CERAMIC TILE: BROKEN/ MISSING
Deficiency Location/Instance	Near Locker Room
Deficiency Quantity	10
Quantity Uom	S.F.
Potential Action	REPLACE
Urgency of Action	PRIORITY 3
Purpose of Action	LEVEL 2
Deficiency Photo1

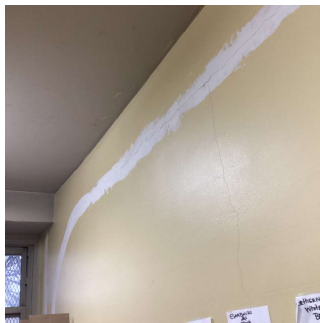
Violations	Near Locker Room No violations recorded.
Deficiency	PLASTER: CRACKS/SPALLING
Deficiency Location/Instance	Storage Room
Deficiency Quantity	25
Quantity Uom	S.F.
Potential Action	REPLACE
Urgency of Action	PRIORITY 3
Purpose of Action	LEVEL 2

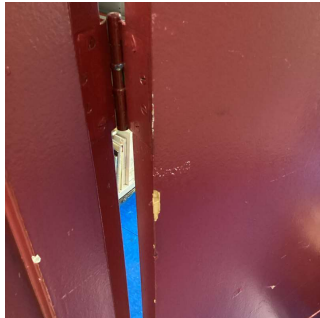
Storage Room
Violations	No violations recorded.
LIBRARY	
Instance on Room 221	Inspected
	Inspected
Built-in Furnishing	
Instance on Room 221	Inspected
Condition	2 - Between Good and Fair
Deficiency	No deficiencies recorded
Ceiling	
Instance on Room 221	Inspected
Condition	2 - Between Good and Fair
Deficiency	ACOUSTIC TILES ON PLASTER: DAMAGED/MISSING
Deficiency Location/Instance	Along Windows
Deficiency Quantity	10
Quantity Uom	S.F.
Potential Action	REPLACE
Urgency of Action	PRIORITY 3
Purpose of Action	LEVEL 2
Deficiency Photo1	 
	Along Windows
Violations	No violations recorded.
Door(s)	
Instance on Room 221	Inspected
Condition	3 - Fair
Deficiency	WOOD: DETERIORATED DOOR
Deficiency Location/Instance	Entrance
Deficiency Quantity	1
Quantity Uom	EACH
Potential Action	MAINTENANCE
Urgency of Action	PRIORITY 3

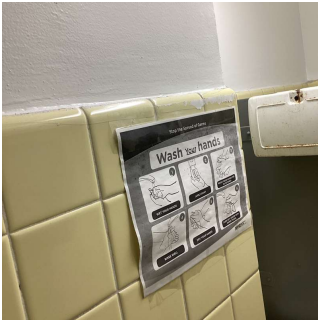
Question	Response
INTERIOR	
TOILET ROOMS - STAFF	
Floor Finish	
Deficiency Quantity	10
Quantity Uom	S.F.
Potential Action	REPLACE
Urgency of Action	PRIORITY 3
Purpose of Action	LEVEL 2
Deficiency Photo1	 
	Room 124
Violations	No violations recorded.
Stalls	Inspected
Condition	5 - Poor
Deficiency	RUST - MAJOR
Deficiency Location/Instance	Rooms 300, 200, 125, 124,
Deficiency Quantity	4
Quantity Uom	EACH
Potential Action	REPLACE
Urgency of Action	PRIORITY 3
Purpose of Action	LEVEL 2
Deficiency Photo1	 
	Room 300
Violations	No violations recorded.
Walls	Inspected
Condition	2 - Between Good and Fair
Deficiency	CERAMIC TILE: BROKEN/ MISSING
Deficiency Location/Instance	Room 300
Deficiency Quantity	10
Quantity Uom	S.F.
Potential Action	REPLACE
Urgency of Action	PRIORITY 3
Purpose of Action	LEVEL 2

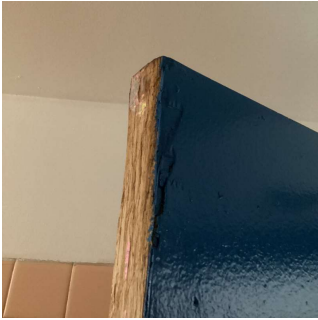
Violations	Room 300 No violations recorded.
TOILET ROOMS - STUDENTS	
Ceiling	Inspected
Condition	2 - Between Good and Fair
Deficiency	No deficiencies recorded
Door(s)	Inspected
Condition	5 - Poor
Deficiency	WOOD: DETERIORATED DOOR
Deficiency Location/Instance	Rooms 313, 310, 213
Deficiency Quantity	3
Quantity Uom	EACH
Potential Action	MAINTENANCE
Urgency of Action	PRIORITY 3
Purpose of Action	LEVEL 2
Deficiency Photo1

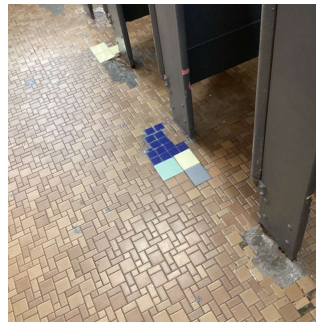
Violations	Room 313 No violations recorded.
Floor Finish	Inspected
Condition	2 - Between Good and Fair
Deficiency	CERAMIC TILE: BROKEN/MISSING TILES
Deficiency Location/Instance	Rooms 313, 310, 210
Deficiency Quantity	20
Quantity Uom	S.F.
Potential Action	REPLACE
Urgency of Action	PRIORITY 3
Purpose of Action	LEVEL 2

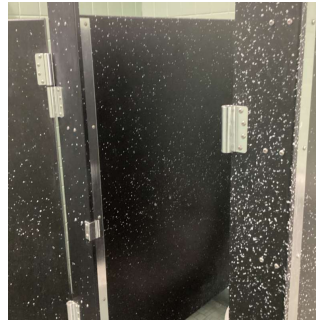
Room 110

BROKEN/MISSING

REPLACE

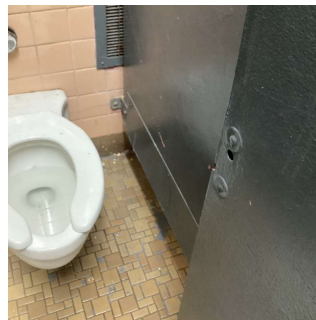
RUST - MAJOR

REPLACE

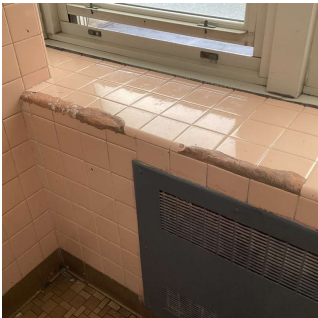
Question	Response
INTERIOR	
TOILET ROOMS - STUDENTS	
Stalls	Inspected
	Room 313
Violations	No violations recorded.
Walls	Inspected
Condition	2 - Between Good and Fair
Deficiency	CERAMIC TILE: BROKEN/ MISSING
Deficiency Location/Instance	Rooms 313, 310, 213, 113, 110
Deficiency Quantity	40
Quantity Uom	S.F.
Potential Action	REPLACE
Urgency of Action	PRIORITY 3
Purpose of Action	LEVEL 2
Deficiency Photo1

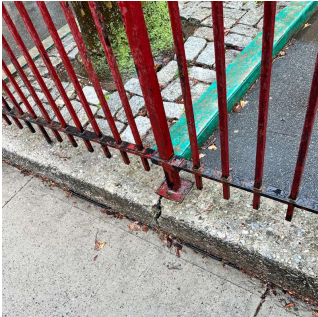
Question	Response
SITE	
FENCES	
Deficiency Location/Instance	Dekalb Avenue, Lafayette Avenue
Deficiency Quantity	50
Quantity Uom	S.F.
Potential Action	REPLACE
Urgency of Action	PRIORITY 3
Purpose of Action	LEVEL 2
Deficiency Photo1

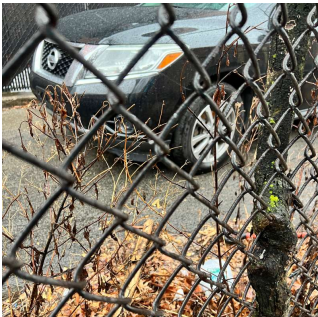
Violations	G No violations recorded.
Deficiency	CHAIN LINK: RUST - MAJOR
Deficiency Location/Instance	Along Exit 3
Deficiency Quantity	900
Quantity Uom	S.F.
Potential Action	REPLACE
Urgency of Action	PRIORITY 3
Purpose of Action	LEVEL 2
Deficiency Photo1

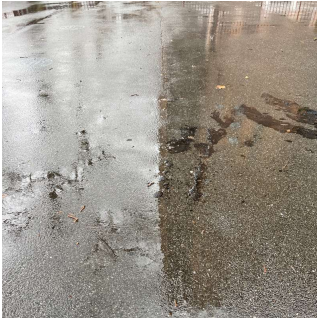
Question	Response
SITE	
PAVING	
Student Non-Use	
Pavers	
Deficiency Photo1	 
Violations	Parking Lot No violations recorded.
Student Use	Inspected
Gravel Exists?	No
Asphalt	Inspected
Condition	3 - Fair
Deficiency	CRACKS - MAJOR
Deficiency Location/Instance	Schoolyard
Deficiency Quantity	100
Quantity Uom	S.F.
Potential Action	REPLACE
Urgency of Action	PRIORITY 3
Purpose of Action	LEVEL 2
Deficiency Photo1
