NYC Department of Education
Building Condition Assessment Survey 2023 - 2024

Architectural Inspection

Asset: I.S. 271 - BROOKLYN, 1137 HERKIMER STREET, New York, 11212

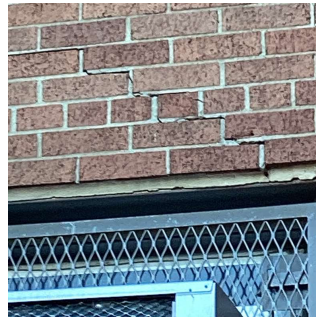
Facade E

Violations	Facade A No violations recorded.
Deficiency	BRICK: MAJOR / THRU CRACKS

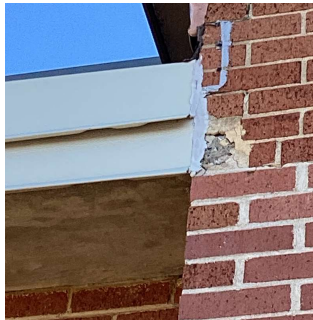
Facade B

BRICK: MINOR CRACKS AND SPALLING

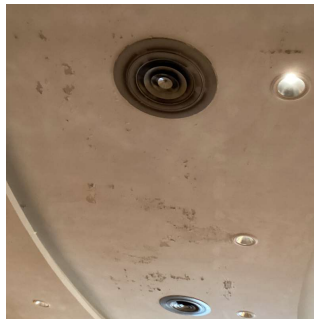
Roof 2 - Auditorium

Roof 1	Roof 1
Violations	No violations recorded.
Deficiency	BUILT-UP: ROOFING: MAJOR ACTIVE ROOF LEAKS IN INSTRUCTIONAL SPACE

100
S.F.
REPLACE ROOFING WITHOUT MAJOR EQUIPMENT
REMOVAL
PRIORITY 5
LEVEL 4

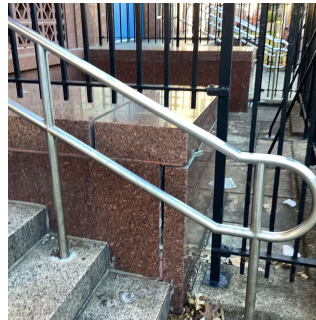
Main Entrance

STONE: DETERIORATED JOINTS

30
S.F.
REPOINT
PRIORITY 4
LEVEL 2

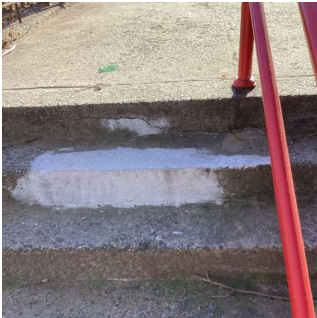
CONCRETE: CRACKS/SPALLING - MINOR

Question	Response
EXTERIOR	
STAIRS/RAMPS: EXTERIOR	
STAIRS/RAMPS	
Deficiency Quantity	100
Quantity Uom	S.F.
Potential Action	REPAIR
Urgency of Action	PRIORITY 3
Purpose of Action	LEVEL 2
Deficiency Photo1

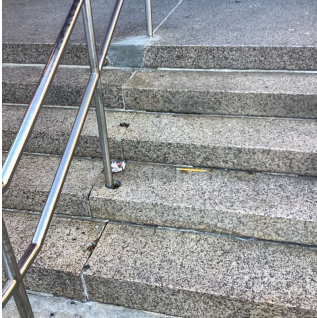
Deficiency Quantity	100
Quantity Uom	L.F.
Potential Action	REPOINT
Urgency of Action	PRIORITY 3
Purpose of Action	LEVEL 2
Deficiency Photo1

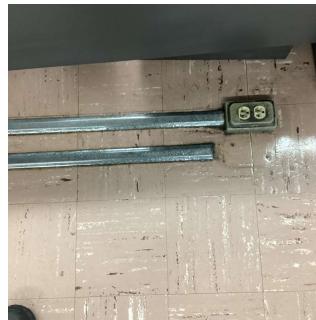
Along Dean Street

VINYL TILES: TRIPPING HAZARD - ELECTRICAL OUTLET

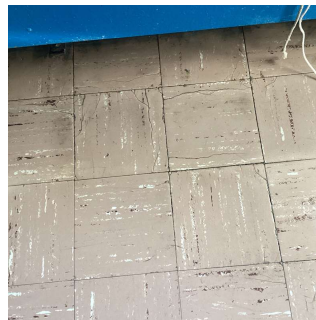
VINYL TILES: BROKEN/DETERIORATED/MISSING TILES

REPLACE

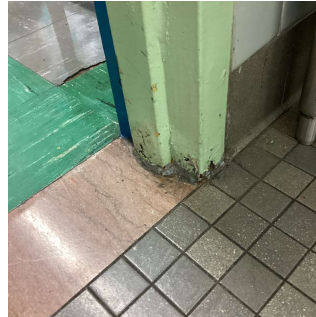
Office

Instance on Basement	Inspected
Condition	5 - Poor
Deficiency	METAL: DETERIORATED DOOR AND FRAME
Deficiency Location/Instance	Office, Exit 4 Vestibule, Mop Room, Storage Room
Deficiency Quantity	4
Quantity Uom	EACH
Potential Action	MAINTENANCE
Urgency of Action	PRIORITY 3
Purpose of Action	LEVEL 2
Deficiency Photo1

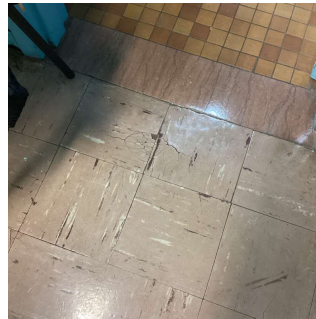
Locker Room

Instance on Basement	Inspected
Condition	3 - Fair
Deficiency	VINYL TILES: BROKEN/DETERIORATED/MISSING TILES
Deficiency Location/Instance	Locker Room, Office
Deficiency Quantity	25
Quantity Uom	S.F.
Potential Action	REPLACE
Urgency of Action	PRIORITY 3
Purpose of Action	LEVEL 2
Deficiency Photo1

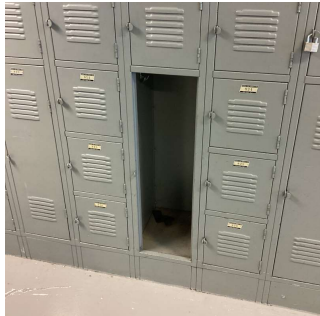
Violations	Locker 820 No violations recorded.
Walls	
Instance on 1st Floor (180 Lockers)	Inspected
Condition	2 - Between Good and Fair
Deficiency	No deficiencies recorded
MULTI-PURPOSE ROOM	
	Does not Exist
SCIENCE DEMO ROOM	
Instance on Rooms 107, 109	Inspected
Alternative use	Yes
Fixed Equipment	
Instance on Rooms 107, 109	Inspected
Condition	3 - Fair
Deficiency	CABINETRY: MISSING/DAMAGED
Deficiency Location/Instance	Rooms 107, 109

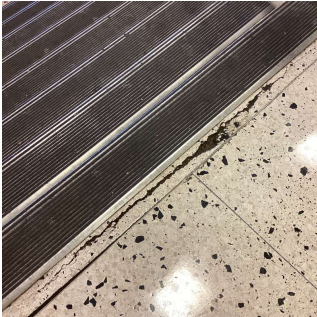
Violations	Main Entrance Vestibule No violations recorded.
Deficiency	STONE: BROKEN/MISSING
Deficiency Location/Instance	Stairs B/1, I/3, H/1, J/2,3, and others
Deficiency Quantity	140
Quantity Uom	S.F.
Potential Action	REPLACE
Urgency of Action	PRIORITY 3
Purpose of Action	LEVEL 2
Deficiency Photo1

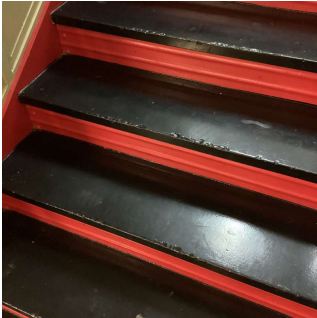
Violations	Stair B/1 No violations recorded.
Deficiency	METAL: RUST - MAJOR
Deficiency Location/Instance	Stairs B/Basement, I/Basement, 1, J/1, Basement
Deficiency Quantity	50
Quantity Uom	S.F.
Potential Action	REPLACE
Urgency of Action	PRIORITY 3
Purpose of Action	LEVEL 2

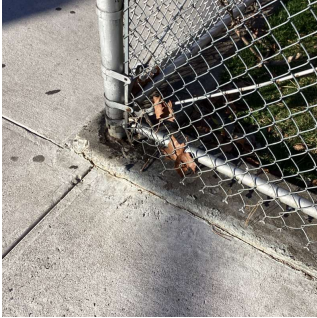
Violations	Herkimer Street No violations recorded.
Deficiency	WROUGHT IRON: DAMAGED/DETERIORATED
Deficiency Location/Instance	Herkimer Street
Deficiency Quantity	40
Quantity Uom	S.F.
Potential Action	REPLACE
Urgency of Action	PRIORITY 3
Purpose of Action	LEVEL 2
Deficiency Photo1

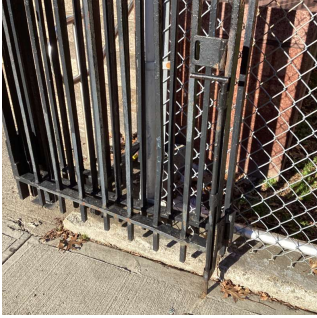
Violations	Herkimer Street No violations recorded.
Deficiency	WROUGHT IRON: RUST - MAJOR
Deficiency Location/Instance	Herkimer Street

Deficiency Quantity	40
Quantity Uom	S.F.
Potential Action	REPLACE

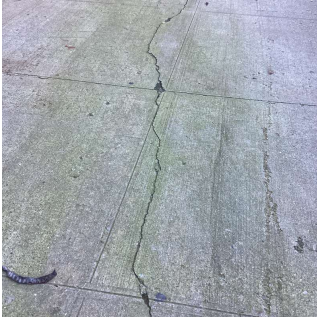
Near NYC Park
Violations	No violations recorded.
Pavers	Does not Exist
DOT Sidewalk	Inspected
Asphalt	Does not Exist
Concrete	Inspected
Condition	4 - Between Fair and Poor
Deficiency	HEAVING
Deficiency Location/Instance	Herkimer Street
Deficiency Quantity	75
Quantity Uom	S.F.
Potential Action	REPLACE
Urgency of Action	PRIORITY 3
Purpose of Action	LEVEL 2
Deficiency Photo1

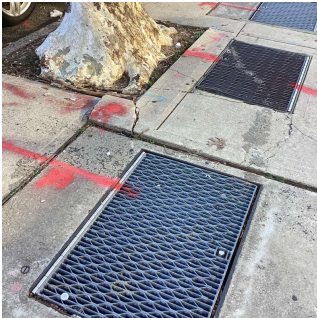
Herkimer Street
Violations	No violations recorded.
Deficiency	DAMAGED CURBS
Deficiency Location/Instance	Saratoga Avenue, Herkimer Street
Deficiency Quantity	140
Quantity Uom	L.F.
Potential Action	REPLACE
Urgency of Action	PRIORITY 3
Purpose of Action	LEVEL 2
