NYC Department of Education
Building Condition Assessment Survey 2023 - 2024

Architectural Inspection

Asset: P.S. 272 - BROOKLYN, 101-24 SEAVIEW AVENUE, New York, 11236

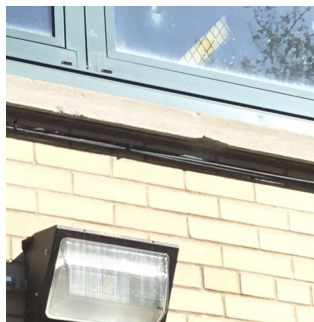
Facade F

Deficiency	BRICK: DETERIORATED MASONRY SILLS - MINOR
Roof Plan reference

Deficiency Quantity	20
Quantity Uom	L.F.
Potential Action	REPAIR
Urgency of Action	PRIORITY 3
Purpose of Action	LEVEL 2
Deficiency Photo1

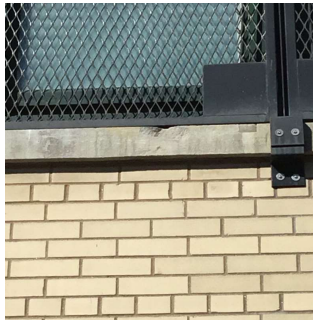
Facade E

Deficiency	BRICK: DETERIORATED MASONRY SILLS - MAJOR
Roof Plan reference

REMOVE AND REPLACE

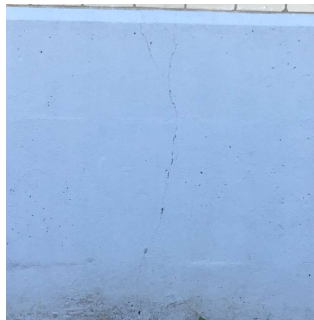
Facade A

CAST IN PLACE / PRE-CAST CONCRETE: MINOR CRACKS/SPALLING

REPAIR

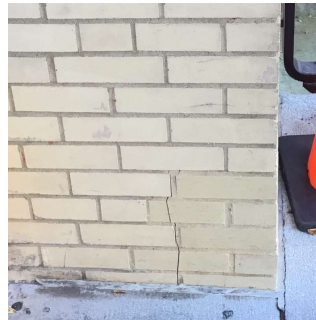
Facade A

BRICK: MINOR CRACKS AND SPALLING

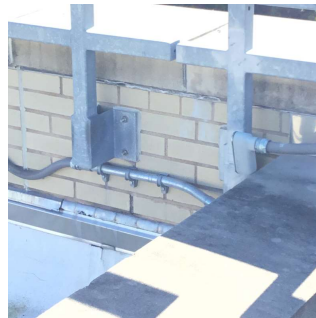
BRICK: EFFLORESCENCE

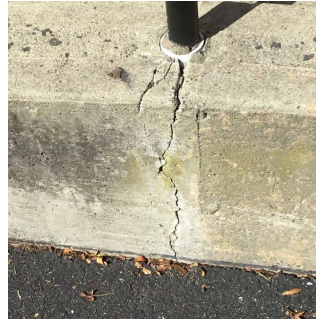
Facade C

Question	Response
EXTERIOR	
ROOF	
Specialties	
BULKHEAD/PENTHOUSE	
Violations	No violations recorded.
Deficiency	BULKHEAD/PENTHOUSE WALLS/INTERIOR: PLASTER CRACKS/SPALLING
Roof Plan reference	
Deficiency Quantity	35
Quantity Uom	S.F.
Potential Action	REPLACE
Urgency of Action	PRIORITY 4
Purpose of Action	LEVEL 2
Deficiency Photo1	
Violations	BH1 No violations recorded.
CUPOLA/ SPIRES/ TOWERS	Does not Exist
DORMER	Does not Exist
DUNNAGE STEEL	Does not Exist
SKYLIGHT/ROOF VENT	Inspected
Material Type(s)	Glass
Condition	2 - Between Good and Fair
Deficiency	No deficiencies recorded
ROOF/GRAVITY TANK	Does not Exist
STAIRS/RAMPS: EXTERIOR	Inspected
BUILDING CHEEK/FLANK WALLS	Inspected
Condition	4 - Between Fair and Poor
Deficiency	CAST IN PLACE CONCRETE: CRACKS/SPALLING - MAJOR
Roof Plan reference	
Deficiency Quantity	20

S.F.
 REPLACE
 PRIORITY 4
 LEVEL 2

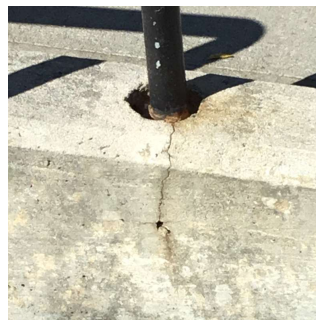
Facade B

CAST IN PLACE CONCRETE: CRACKS/SPALLING - MINOR

20
 S.F.
 REPAIR
 PRIORITY 3
 LEVEL 2

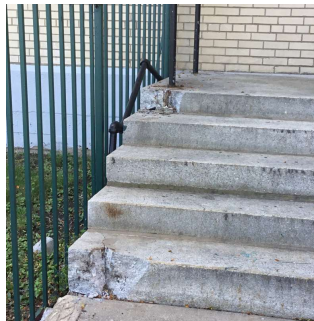
Facade B - Exit 3

RAILINGS

10
L.F.
REPLACE
PRIORITY 4
LEVEL 2

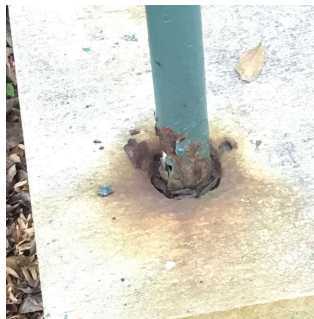
Facade A

RUST - MAJOR

25
L.F.
REPLACE
PRIORITY 4
LEVEL 2

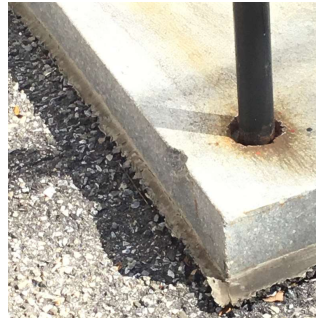
Facade F

Deficiency	STONE: CRACKS/SPALLING - MINOR
------------	--------------------------------

REPAIR

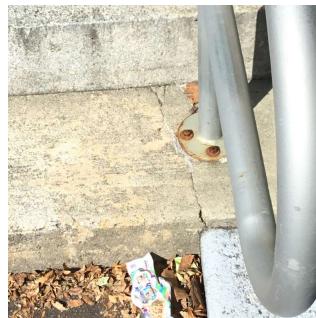
Facade E

Deficiency	CONCRETE: CRACKS/SPALLING - MINOR
------------	-----------------------------------

REPAIR

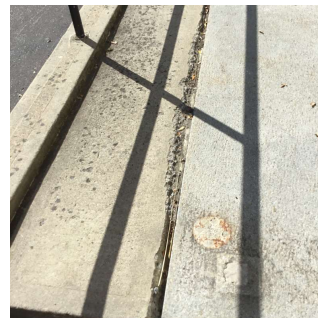
Facade C

CONCRETE: CRACKS/SPALLING - MAJOR

REPLACE

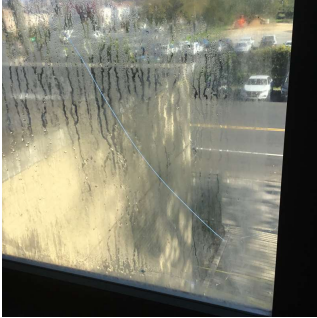
Question	Response
EXTERIOR	
STAIRS/RAMPS: EXTERIOR	Inspected
STAIRS/RAMPS	
Violations	No violations recorded.
WINDOWS	Inspected
Replacement Quantity	9,000
Replacement Uom	S.F.
EXTERIOR GUARDS	Inspected
Condition	2 - Between Good and Fair
Deficiency	No deficiencies recorded
LINTELS	Inspected
Condition	2 - Between Good and Fair
Deficiency	No deficiencies recorded
WINDOWS	Inspected
Material Type(s)	Aluminum
Instance on Aluminum - Double Hung: All Facades except B, F	Inspected
Instance Condition	3 - Fair
Instance Quantity	8,600
Instance Quantity Uom	S.F.
Are these windows insulated	Yes
Installation Year	2007
Source of Installation	Custodial Staff
Deficiency	No deficiencies recorded
Instance on Aluminum - Other: Facades A, B, C, F	Inspected
Instance Condition	3 - Fair
Instance Quantity	400
Instance Quantity Uom	S.F.
Are these windows insulated	Yes
Installation Year	2007
Source of Installation	Custodial Staff
Deficiency	ALUMINUM - OTHER: BROKEN PANE

Deficiency Quantity	60
Quantity Uom	S.F.

Violations	Facade A - Corridor near Room 226B No violations recorded.
INTERIOR	Inspected
POOLS	Does not Exist
STRUCTURAL	Inspected
COLUMNS/BEAMS/BEARING WALLS	Inspected
Condition	2 - Between Good and Fair
Deficiency	No deficiencies recorded
FLOOR STRUCTURE	Inspected
Condition	4 - Between Fair and Poor
Deficiency	CONCRETE SLAB ON GRADE: THRU CRACKS
Deficiency Location/Instance	Basement
Deficiency Quantity	90
Quantity Uom	S.F.
Potential Action	REPAIR
Urgency of Action	PRIORITY 3
Purpose of Action	LEVEL 5
Deficiency Photo1

Question	Response
EXTERIOR	
WINDOWS	Inspected
WINDOWS	
Potential Action	MAINTENANCE
Urgency of Action	PRIORITY 3
Purpose of Action	LEVEL 2
Deficiency Photo1

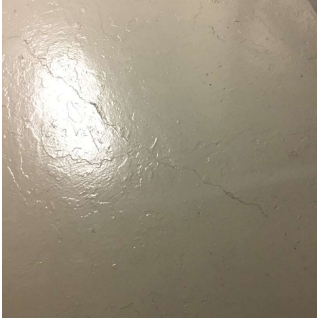
Violations	Basement Corridor (Boiler Room, Rooms B0, B4 similar) No violations recorded.
Deficiency	CONCRETE SLAB ON GRADE: WATER INFILTRATION IN NON-INSTRUCTIONAL SPACE
Deficiency Location/Instance	Basement
Deficiency Quantity	100
Quantity Uom	S.F.

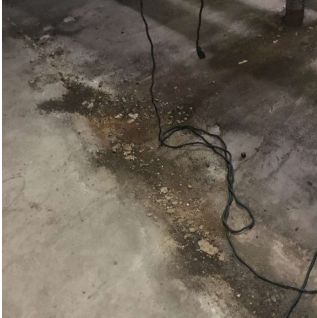
Violations	Classroom Wing Crawl Space No violations recorded.
Deficiency	CONCRETE SLAB ON GRADE: THRU CRACKS
Deficiency Location/Instance	Basement
Deficiency Quantity	300
Quantity Uom	S.F.
Potential Action	REPLACE
Urgency of Action	PRIORITY 4
Purpose of Action	LEVEL 5
Deficiency Photo1

Potential Action	INSTALL WATERPROOFING
Urgency of Action	PRIORITY 5

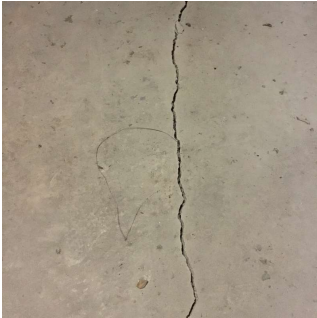
Violations	Classroom Wing Crawl Space No violations recorded.
FOUNDATION WALLS	
Material Type(s)	Inspected Concrete
Condition	4 - Between Fair and Poor
Deficiency	CONCRETE: WATER INFILTRATION IN NON- INSTRUCTIONAL SPACE
Deficiency Location/Instance	Basement
Deficiency Quantity	200
Quantity Uom	S.F.
Potential Action	INSTALL WATERPROOFING
Urgency of Action	PRIORITY 5
Purpose of Action	LEVEL 5

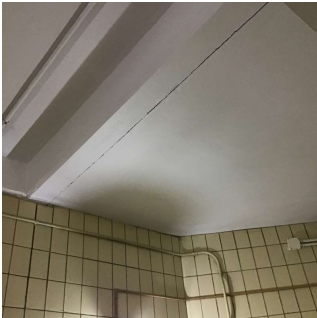
Vault
Violations	No violations recorded.
AUDITORIUM	
	Inspected
Instance on 1st Floor (422 seats)	Inspected
Ceiling	
Instance on 1st Floor (422 seats)	Inspected
Condition	2 - Between Good and Fair
Deficiency	PLASTER: CRACKS/SPALLING
Deficiency Location/Instance	Stage Vestibule - Right side

Question	Response
INTERIOR	
AUDITORIUM	
Ceiling	
Deficiency Quantity	10
Quantity Uom	S.F.
Potential Action	REPLACE
Urgency of Action	PRIORITY 3
Purpose of Action	LEVEL 2
Deficiency Photo1

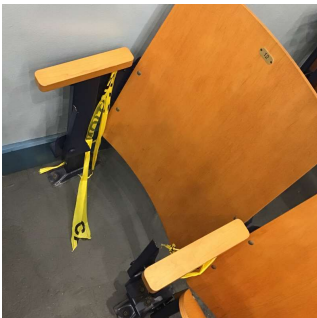
Stage Vestibule - Right side
Violations	No violations recorded.
Door(s)	
Instance on 1st Floor (422 seats)	Inspected
Condition	2 - Between Good and Fair
Deficiency	No deficiencies recorded
Fixed H/C Lift	
Instance on 1st Floor (422 seats)	Does not Exist
Fixed Seating	
Instance on 1st Floor (422 seats)	Inspected
Condition	3 - Fair
Deficiency	DAMAGED/BROKEN/INOPERABLE
Deficiency Location/Instance	Seat P/12, Q/4, S/8, C/1
Deficiency Quantity	4
Quantity Uom	EACH
Potential Action	REPLACE
Urgency of Action	PRIORITY 5
Purpose of Action	LEVEL 6
Deficiency Photo1

Seat P/12
Violations	No violations recorded.
Deficiency	DAMAGED/BROKEN/INOPERABLE
Deficiency Location/Instance	Seats N/10, 1, P/8, Q/10, 8, and others
Deficiency Quantity	10

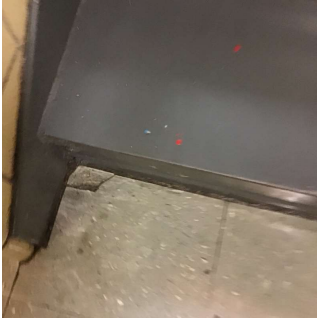
Deficiency	No deficiencies recorded
Stairs and Landings	
Inspected	
Condition	3 - Fair
Deficiency	VINYL TILES: BROKEN/DETERIORATED/MISSING TILES
Deficiency Location/Instance	Stair D/1, C1, A/2
Deficiency Quantity	30

Question	Response
INTERIOR	
STAIRS/RAMPS: INTERIOR	
Stairs and Landings	
Quantity Uom	S.F.
Potential Action	REPLACE
Urgency of Action	PRIORITY 3
Purpose of Action	LEVEL 2
Deficiency Photo1

Violations	Stair D/1 No violations recorded.
Deficiency	CONCRETE: CRACKS/SPALLING - MAJOR
Deficiency Location/Instance	Stair D/Bulkhead
Deficiency Quantity	20
Quantity Uom	S.F.
Potential Action	REPLACE
Urgency of Action	PRIORITY 3
Purpose of Action	LEVEL 2
Deficiency Photo1

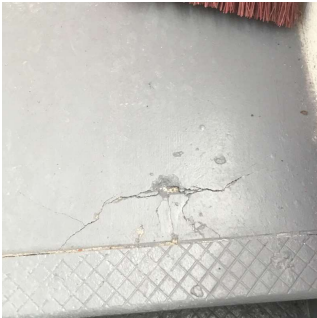
Violations	Stair D/Bulkhead No violations recorded.
Deficiency	TERRAZZO: CRACKS
Deficiency Location/Instance	Stair D/1 Vestibule, B/1 Vestibule
Deficiency Quantity	20
Quantity Uom	S.F.
Potential Action	REPLACE
Urgency of Action	PRIORITY 3
Purpose of Action	LEVEL 2

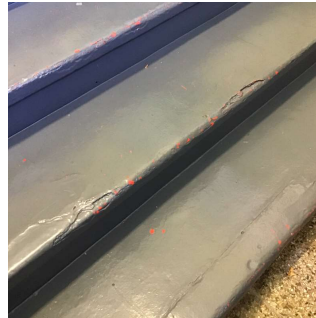
Main Entrance Vestibule

STONE: BROKEN/MISSING

REPLACE

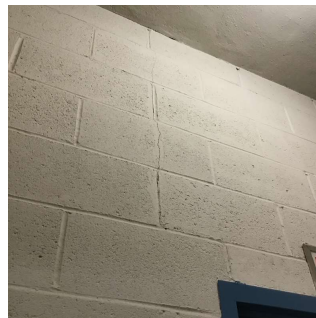
MASONRY: CRACKS/SPALLING

REPLACE

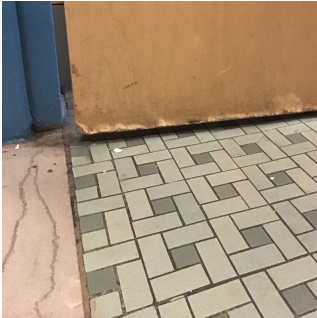
Question	Response
INTERIOR	
TOILET ROOMS - STAFF	
Stalls	Inspected
Condition	5 - Poor
Deficiency	RUST - MAJOR
Deficiency Location/Instance	1st Floor - Women, Room 101B
Deficiency Quantity	2
Quantity Uom	EACH
Potential Action	REPLACE
Urgency of Action	PRIORITY 3
Purpose of Action	LEVEL 2
Deficiency Photo1	 
Violations	1st Floor Womens No violations recorded.
Walls	Inspected
Condition	2 - Between Good and Fair
Deficiency	CERAMIC TILE: BROKEN/ MISSING
Deficiency Location/Instance	1st Floor - Women, Mens, Room 131, 101B
Deficiency Quantity	40
Quantity Uom	S.F.
Potential Action	REPLACE
Urgency of Action	PRIORITY 3
Purpose of Action	LEVEL 2
Deficiency Photo1	 
Violations	1st Floor - Women No violations recorded.
TOILET ROOMS - STUDENTS	
Ceiling	Inspected
Condition	2 - Between Good and Fair
Deficiency	No deficiencies recorded
Door(s)	Inspected
Condition	4 - Between Fair and Poor
Deficiency	WOOD: DETERIORATED DOOR
Deficiency Location/Instance	2nd Floor - Girls

Question	Response
INTERIOR	
TOILET ROOMS - STUDENTS	
Door(s)	
Deficiency Quantity	1
Quantity Uom	EACH
Potential Action	MAINTENANCE
Urgency of Action	PRIORITY 3
Purpose of Action	LEVEL 2
Deficiency Photo1

2nd Floor - Girls
Violations	No violations recorded.
Floor Finish	Inspected
Condition	3 - Fair
Deficiency	CERAMIC TILE: BROKEN/MISSING TILES
Deficiency Location/Instance	3rd Floor - Girls, Boys, Room 107, 2nd Floor - Boys, Girls
Deficiency Quantity	100
Quantity Uom	S.F.
Potential Action	REPLACE
Urgency of Action	PRIORITY 3
Purpose of Action	LEVEL 2
Deficiency Photo1

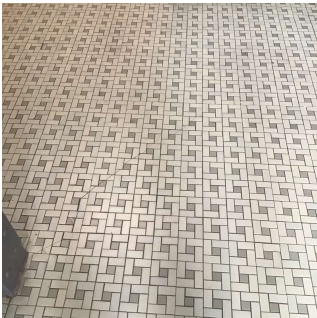
3rd Floor - Girls
Violations	No violations recorded.
Stalls	Inspected
Condition	5 - Poor
Deficiency	RUST - MAJOR
Deficiency Location/Instance	3rd Floor - Girls, Room 110, 2nd Floor Gender Neutral, Girls
Deficiency Quantity	9
Quantity Uom	EACH
Potential Action	REPLACE
Urgency of Action	PRIORITY 3
Purpose of Action	LEVEL 2

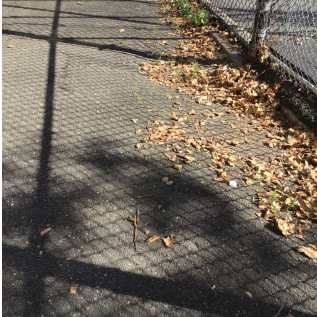
Question	Response
SITE	
PAVING	
Student Use	
Pavers	
Deficiency Photo1	 
Violations	Schoolyard No violations recorded.
Site Sidewalks & Walkways	Inspected
Asphalt	Inspected
Condition	4 - Between Fair and Poor
Deficiency	LOCALIZED SINK AREA
Deficiency Location/Instance	Between school and NYC park
Deficiency Quantity	50
Quantity Uom	S.F.
Potential Action	REPAIR
Urgency of Action	PRIORITY 3
Purpose of Action	LEVEL 2
Deficiency Photo1

Violations	Between school and NYC park No violations recorded.
Deficiency	POTHOLES
Deficiency Location/Instance	Between school and NYC park
Deficiency Quantity	10
Quantity Uom	S.F.
Potential Action	REPAIR
Urgency of Action	PRIORITY 3
Purpose of Action	LEVEL 2

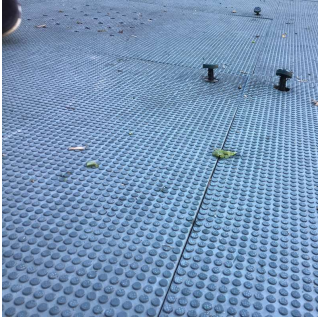
Question	Response
SITE	
PAVING	Inspected
DOT Sidewalk	
Concrete	Inspected
Violations	No violations recorded.
Pavers	Does not Exist
PLAYGROUNDS	Inspected
Instance on Schoolyard	Inspected
Benches	
Instance on Schoolyard	Does not Exist
Fence	
Instance on Schoolyard	Does not Exist
Pavement	
Instance on Schoolyard	Does not Exist
Play Equipment	
Instance on Schoolyard	Inspected
Condition	2 - Between Good and Fair
Deficiency	No deficiencies recorded
Safety Surfacing	
Instance on Schoolyard	Inspected
Condition	3 - Fair
Deficiency	DETERIORATED/MISSING
Deficiency Location/Instance	Schoolyard
Deficiency Quantity	50
Quantity Uom	S.F.
Potential Action	REPLACE
Urgency of Action	PRIORITY 5
Purpose of Action	LEVEL 6
Deficiency Photo1

Violations	Schoolyard No violations recorded.
Unpaved Area	
Instance on Schoolyard	Does not Exist
PLAYING SURFACE	Does not Exist
RETAINING WALLS	Inspected
Are there any Retaining Walls 6' OR higher facing public street/sidewalk?	No
